**EN RESEARCH REPORT NO.61**

**Northey Island Set-back Scheme  
Report 3**

Institute of Estuarine and Coastal Studies  
University of Hull  
February 1993

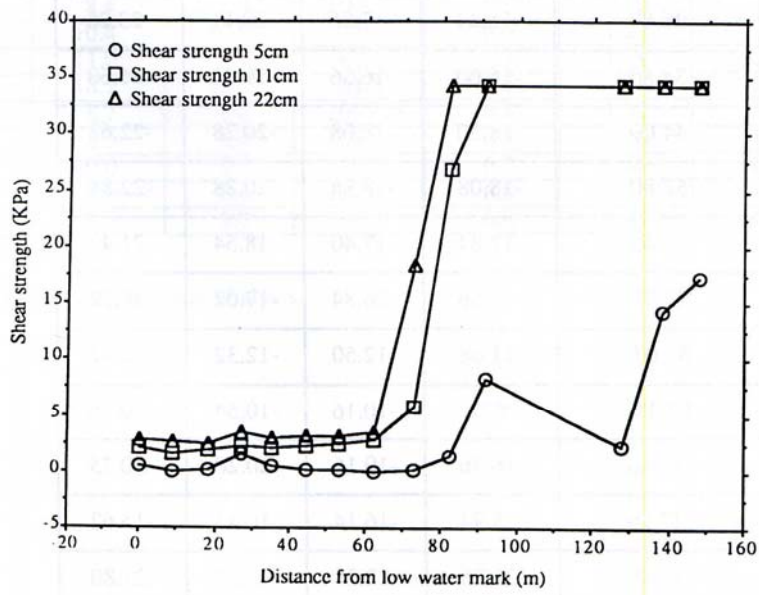
Figure 5

The results, shown in figure 5, display a fairly consistent trend up to 60m from low water, at which point the underlying estuarine clays begin to affect the data. Up to this point, near-surface readings average about 0.2 KPa, readings at 11cm depth run at 2.0 KPa and values approaching 3KPa are found at 22cm depth. To landward of this point, the underlying estuarine clays cause a rapid increase in readings up to the 30KPa limit on the instrument at depths below 11cm. On the marsh surface, it was hoped to obtain baseline data on the strength of newly-deposited sediment, but insufficient deposition had taken place by this time to allow this measurement. It was therefore decided to obtain readings immediately below this surface

veneer, with the results shown in figure 5. These high readings do not reflect the true nature of the sediment at this depth, but arise from the presence of rotting vegetation which displays high shear strengths. Readings taken at 22cm depth merely represent the underlying estuarine beds and therefore are not to be seen as relevant to the surface sediments. An appropriate method will be devised to overcome these problems and provide subsequent data to compare to this baseline survey.

Shear vane results taken 1m east of accretion plates.

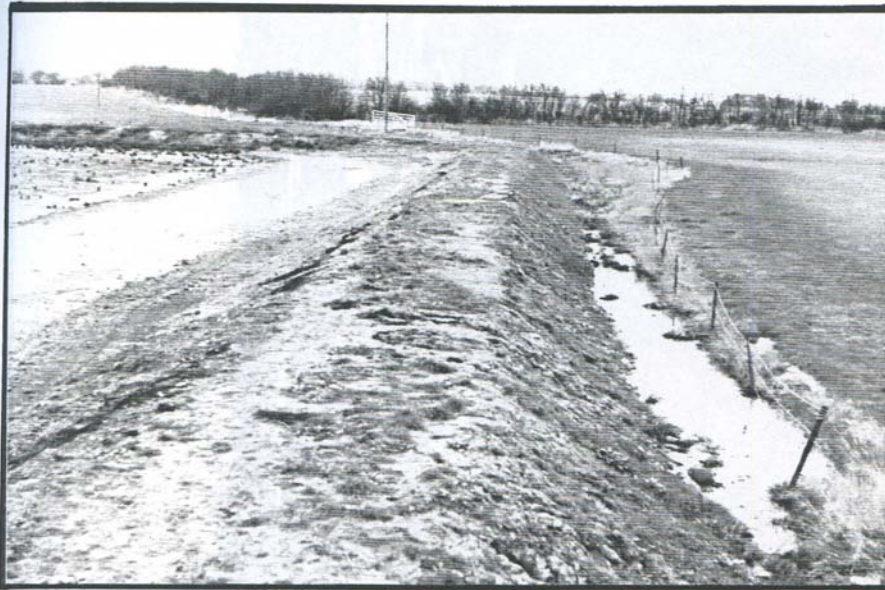
The seepage through the east wall outlined in Report 2 is still a significant problem (plate 2). This is possibly associated with the erosional problem at this end of the site as it does not seem to occur at any other locations.

Plate 2. Enclosure wall at east end of site. Note severe erosion on western face and increased level of seepage at foot of wall

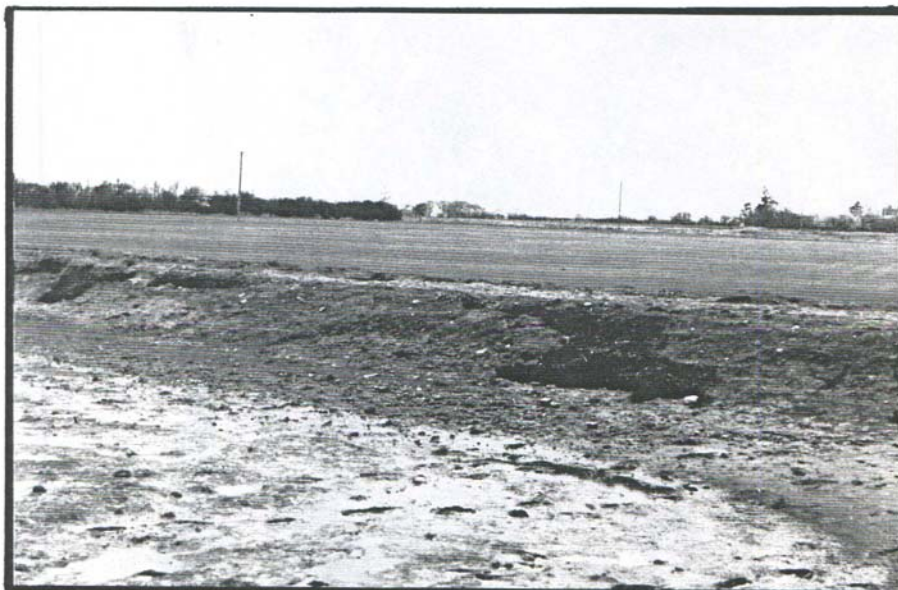
Wall erosion is still a major problem at the eastern end of the site. The extent and seriousness of the problem can be seen in plates 3 and 4. The east wall was repaired by the NRA during its maintenance program at the site in June 1992, but the wall has since been eroded severely in several places to such an extent that the geo-fabric used to strengthen the wall is now visible. It is believed that the erosion is due to a combination of ebb current velocities and wind-generated waves across the site. It is difficult to be more precise about the mechanisms involved without further detailed study of the current velocities generated during a flood/ebb cycle.

Plate 3. View of eastern wall erosion, geo-fabric exposed at several locations (see Plate 4).

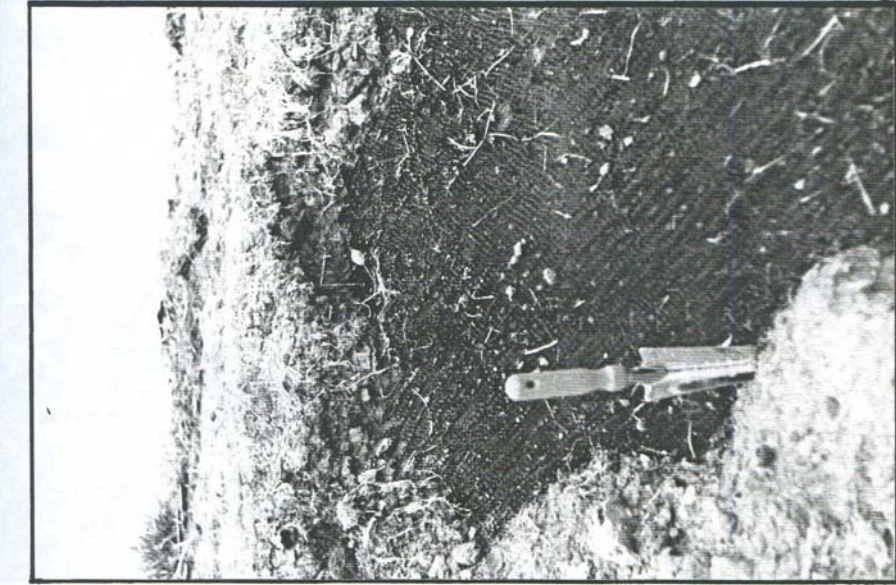
Plate 4. Close up view of extensive erosion and exposed geo-fabric

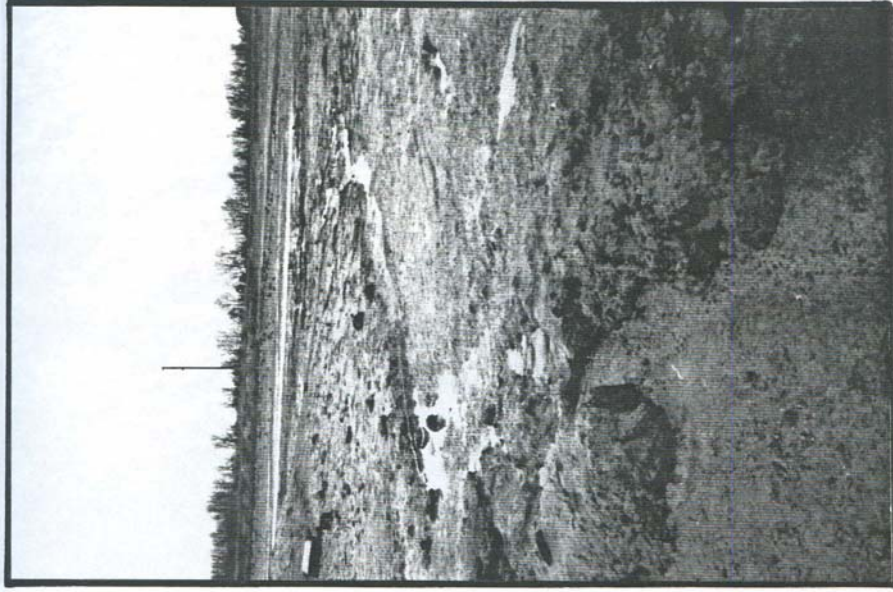
Plate 5. View from mudflat side of spillway. Note presence of new channel.

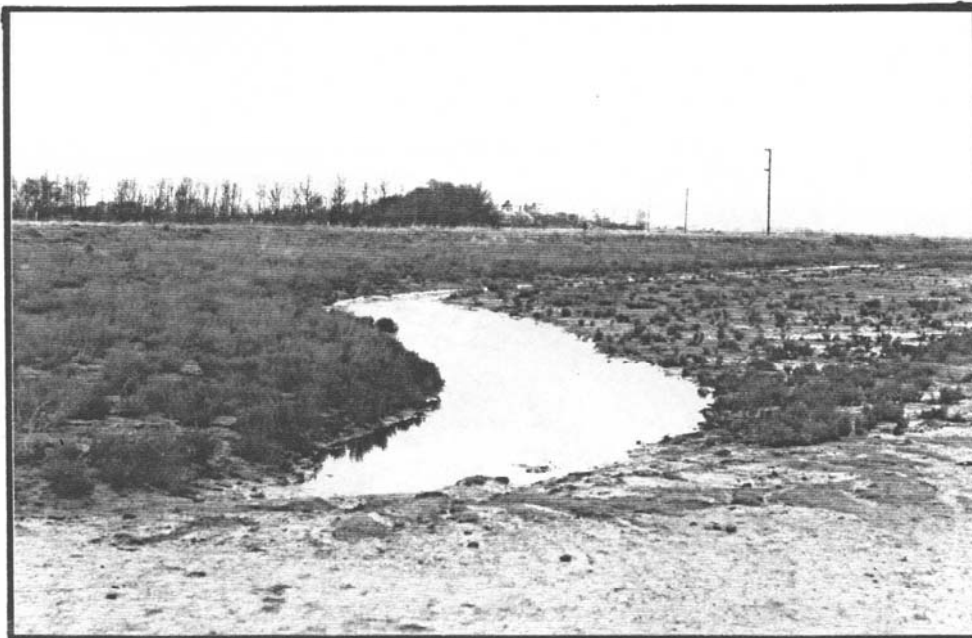
Ebb drainage of the site is also determined by topography, although there are several locations where areas of standing water are generated. This occurs most noticeably at the relic creek in the middle of the site and at the remains of the borrow pit of the old sea wall (see plates 8, 9, and 10).

Plate 9. Vegetation zonation can clearly be seen. Zone 3 - the western most zone - is heavily vegetated in comparison to the other two zones. Note standing water in creek

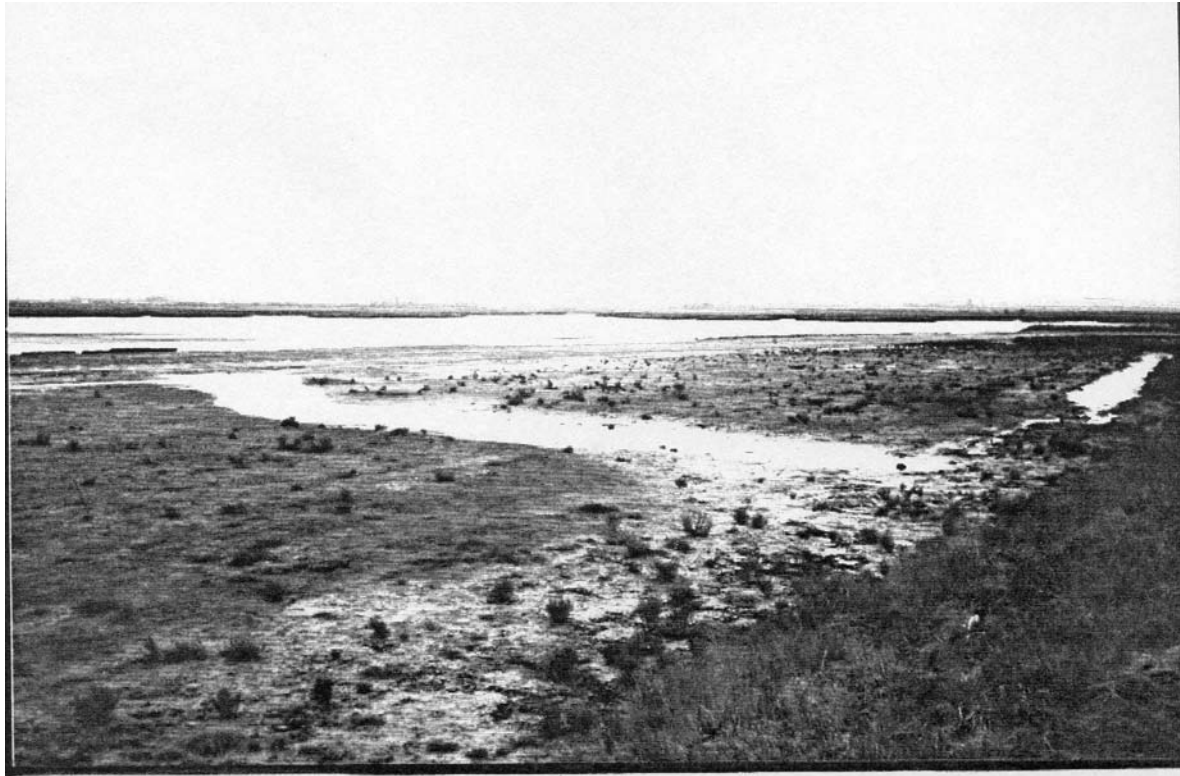
Plate 10. View from the northern wall. Relic creek in foreground dividing zones 1 & 2.  
Note standing water.

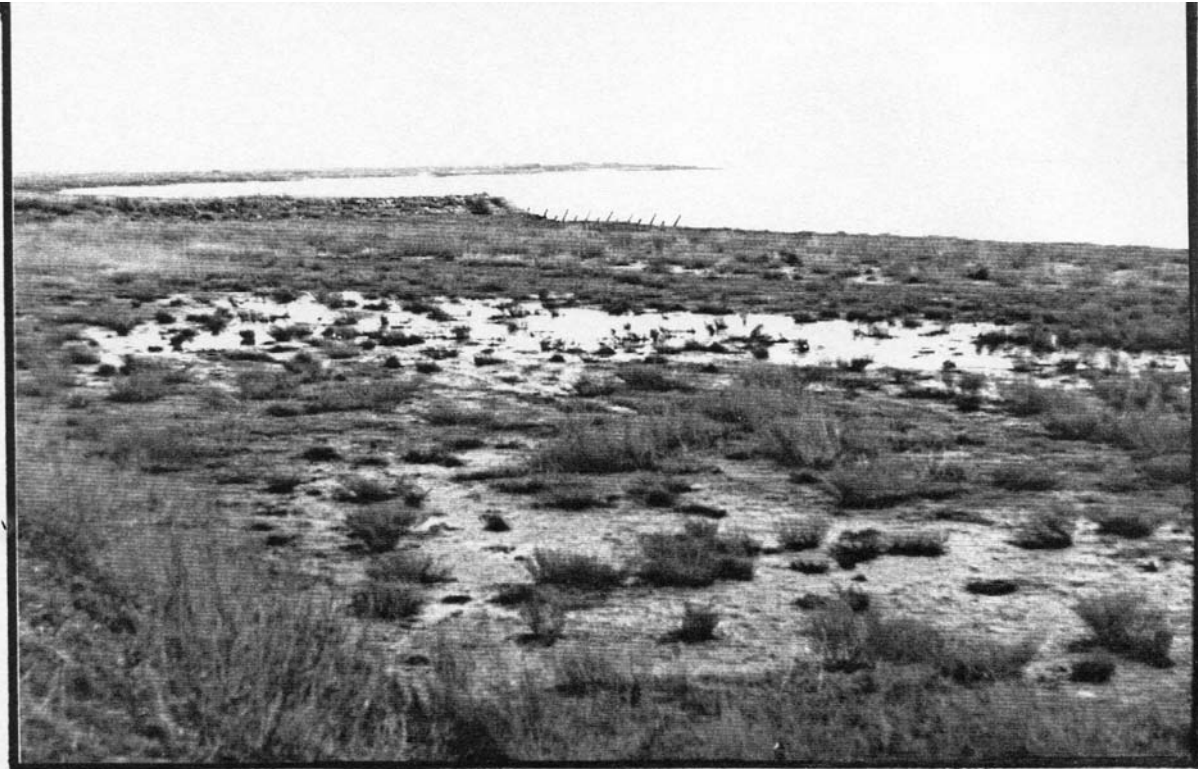
Although beyond the scope of this report some mention is made of the apparent zonation of the vegetation on the set-back surface. Three distinct zones of vegetation can be readily identified: zone 1 corresponds to the lower-lying most frequently inundated areas at the eastern end of the site; zone 2 is that area which lies between the relic creek in the middle of the site, and the remains of the flooded borrow pit towards the west end of the site; zone 3 is westwards of the old flooded borrow pit. The level of vegetation colonisation increases as one moves westwards. Zone 1 contains sparse patches of vegetation mainly towards the rear of the site, zone 2 has a higher level of vegetation cover whilst still being generally sparse; zone 3 is comparatively heavily vegetated, particularly along the edge of the old borrow pit. This zonation can be seen in plates 8, 9, and 10. Plate 11 shows the area of original saltmarsh to the west of the set-back site and is included to show the similarity between the set-back site and an area of adjacent marsh.

Plate 11. Original saltmarsh immediately to the west of the study site. Although relatively heavily vegetated it has a similar appearance to the study site.
