Natural England Commissioned Report NECR239

Remedial Works for the Catch Dykes at Decoy Carr, Acle

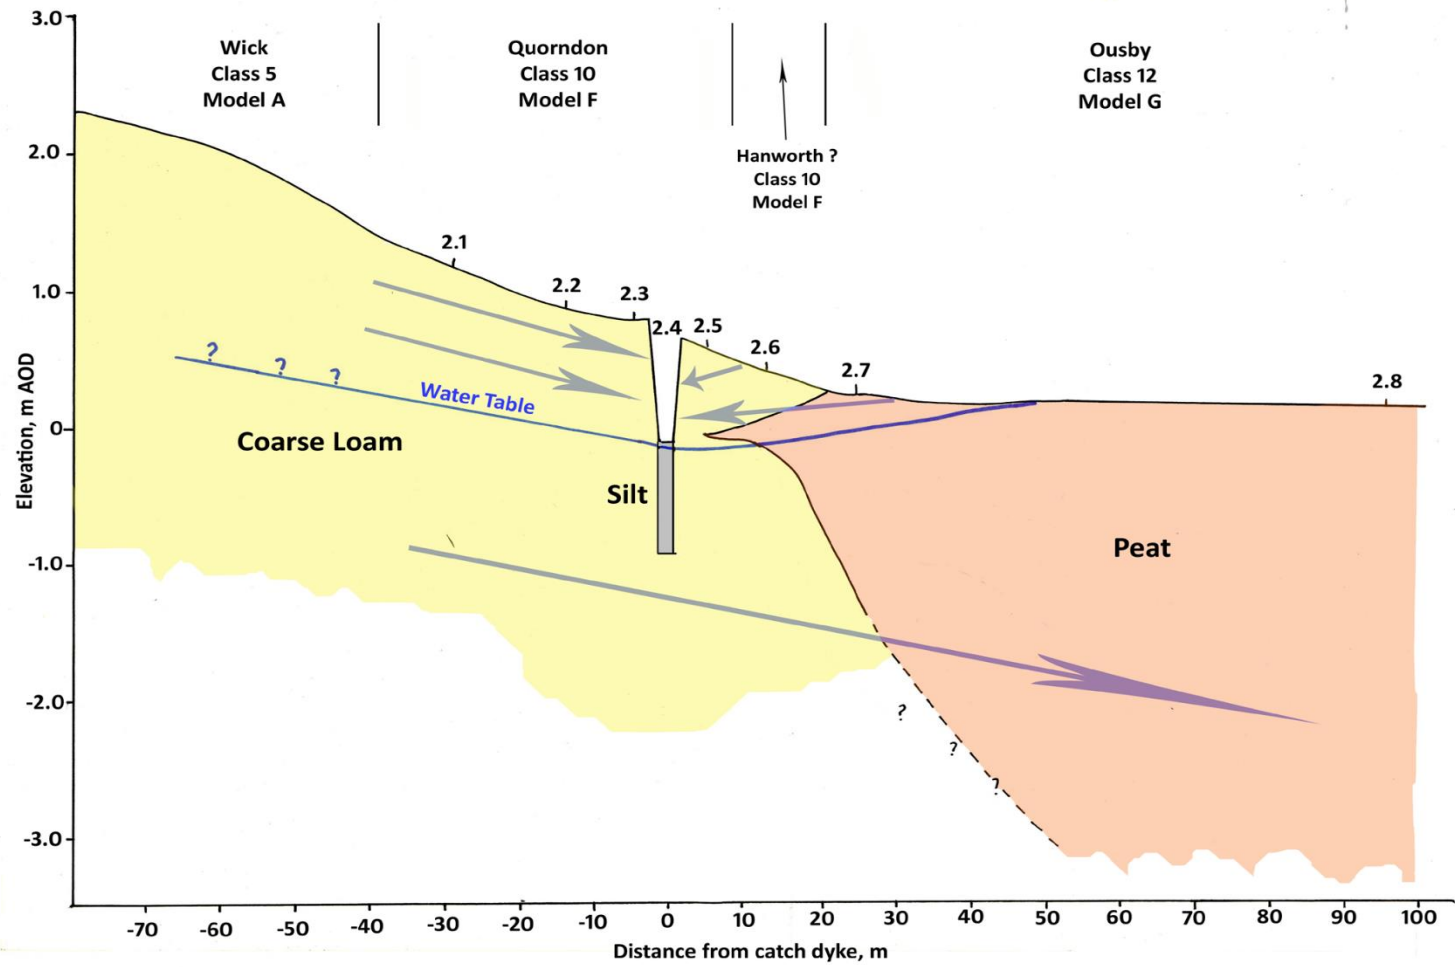
Figure 4b: Scaled Cross-Section of Soils and Hydrology for Transect 2

The catch dyke in Transect 2 did not have perched water, the water table being just below the dyke bed. Below the organic dyke silt is a deeper profile of non-organic sandy silt. If this is also in-fill silt, the original dyke seems unnecessarily deep. Otherwise, the catch dyke sits within deep coarse loam. With deep permeable profiles both sides of the catch dyke, and no low permeability clay or even stiff silt, the water table profile adopts an unusually regular and shallow sloped profile, dipping towards the catch dyke in both directions. Consequently, impacts of the dyke extend for some distance in both directions, around 50m into the fen. Soil water in the fen moves against the topographic gradient into the catch dyke.

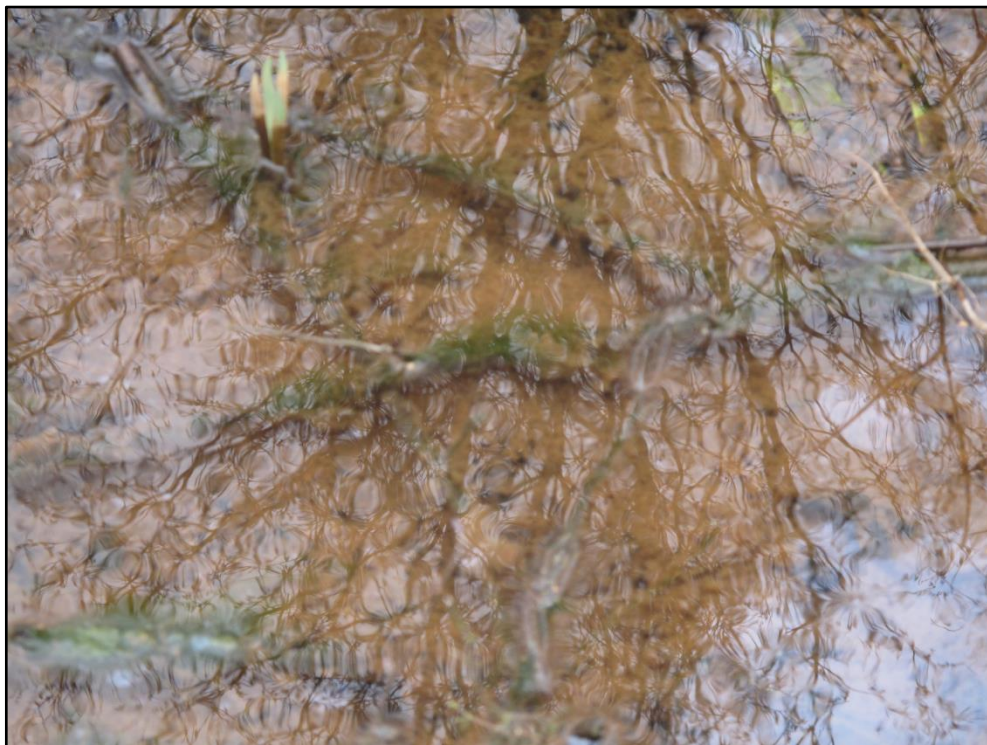
Figure 8: Ochre On The Bed Of The West-East Catch Dyke.

Ochre has been observed in the west-east and south-north catch dykes as a bed deposit (see Figure 8). It has not been observed in suspension, nor in the fen dykes. Some deposits have also been noticed in shallow depressions or terrestrialised dykes on the site margins. There is significant ochre in some (but not all) the dykes in the Damgate Marshes.

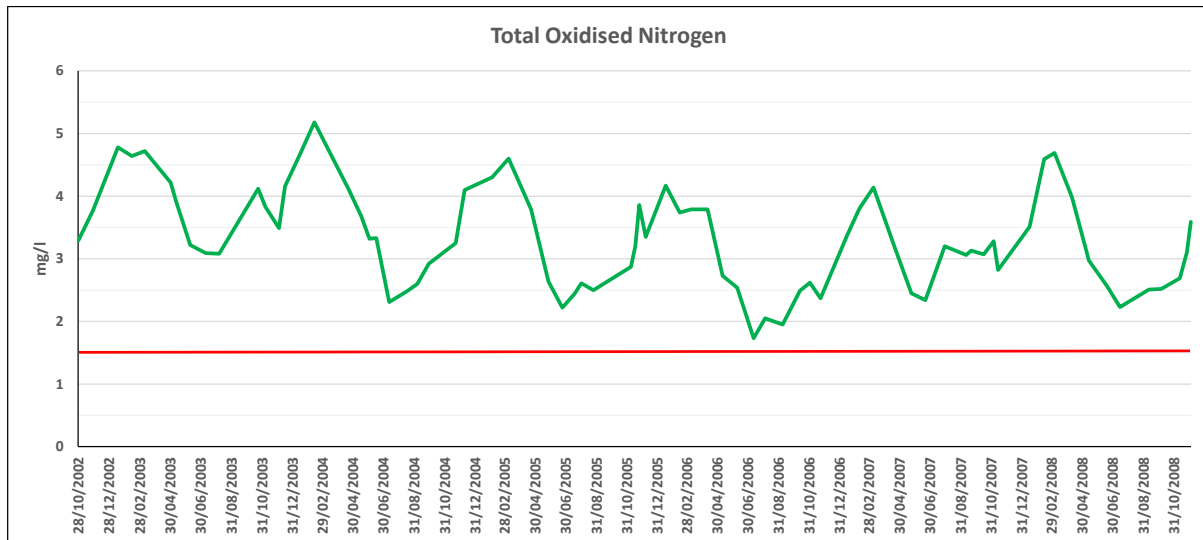
Figure 9: Orthophosphate and Total Oxidised Nitrogen for the Acle Landspring, October 2002 to December 2008. Data Courtesy of EA. The red lines indicate the target for Total P and Total N respectively (JNCC 2015).

Figure 9 shows graphs for the period October 2002 to December 2008, and includes 75 evenly spaced recordings⁵. They show determinands to be permanently above the target levels for Total N and P. There is strong seasonality for both, with the lows being in summer when these available forms of nutrient are removed from the water column by macrophyte growth. Peak concentrations are in winter, despite effects of dilution, perhaps reflecting flushing from agricultural soils in the upper catchment as well as lack of utilisation by plants. The pattern is more disrupted for orthophosphate, with some atypical spikes in summer, and the growing season sag in values is more confined to spring and early summer.

Overall, the data suggest water in the Acle Landspring is too eutrophic for at least aquatic communities. This may raise concerns regarding use of this water to support dykes in the Damgate Marshes SSSI, where the principle feature is mesotrophic dyke communities. Although relating stream sampling of mineral nutrient determinands to peat fertility and fen condition is extremely difficult, it is probable that these waters are too enriched to sustain low fertility fens were the Landspring to regularly inundate the peatland.

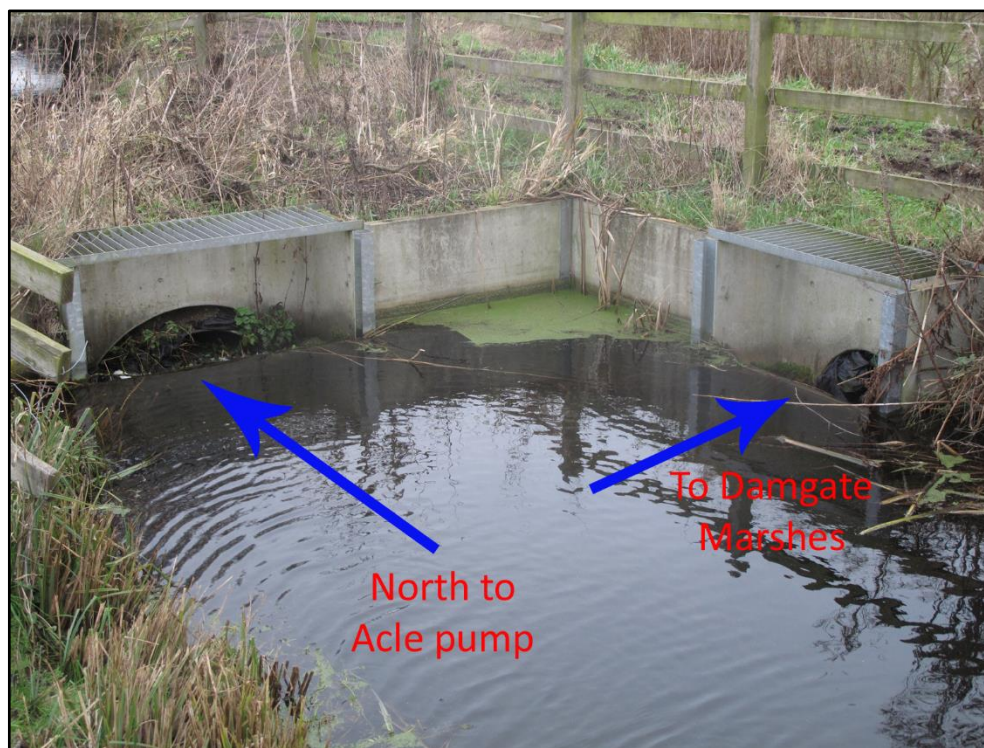
Figure 11: The Broads IDB Sluice At The North End Of The Landspring Dyke.

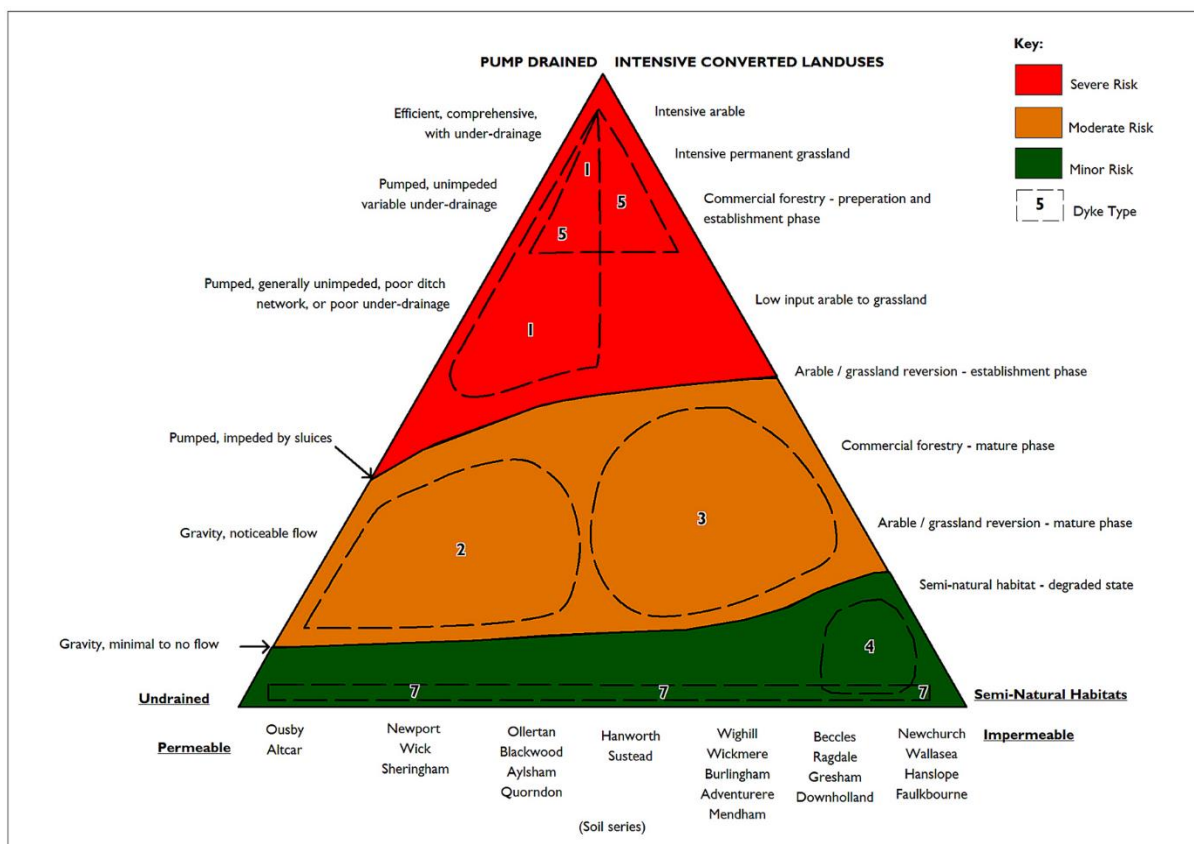
Figure 13: Risk Triangle. Type 1 Dykes are in the Severe Risk Zone but risk of agricultural pollution/eutrophication at Decoy Carr is low.

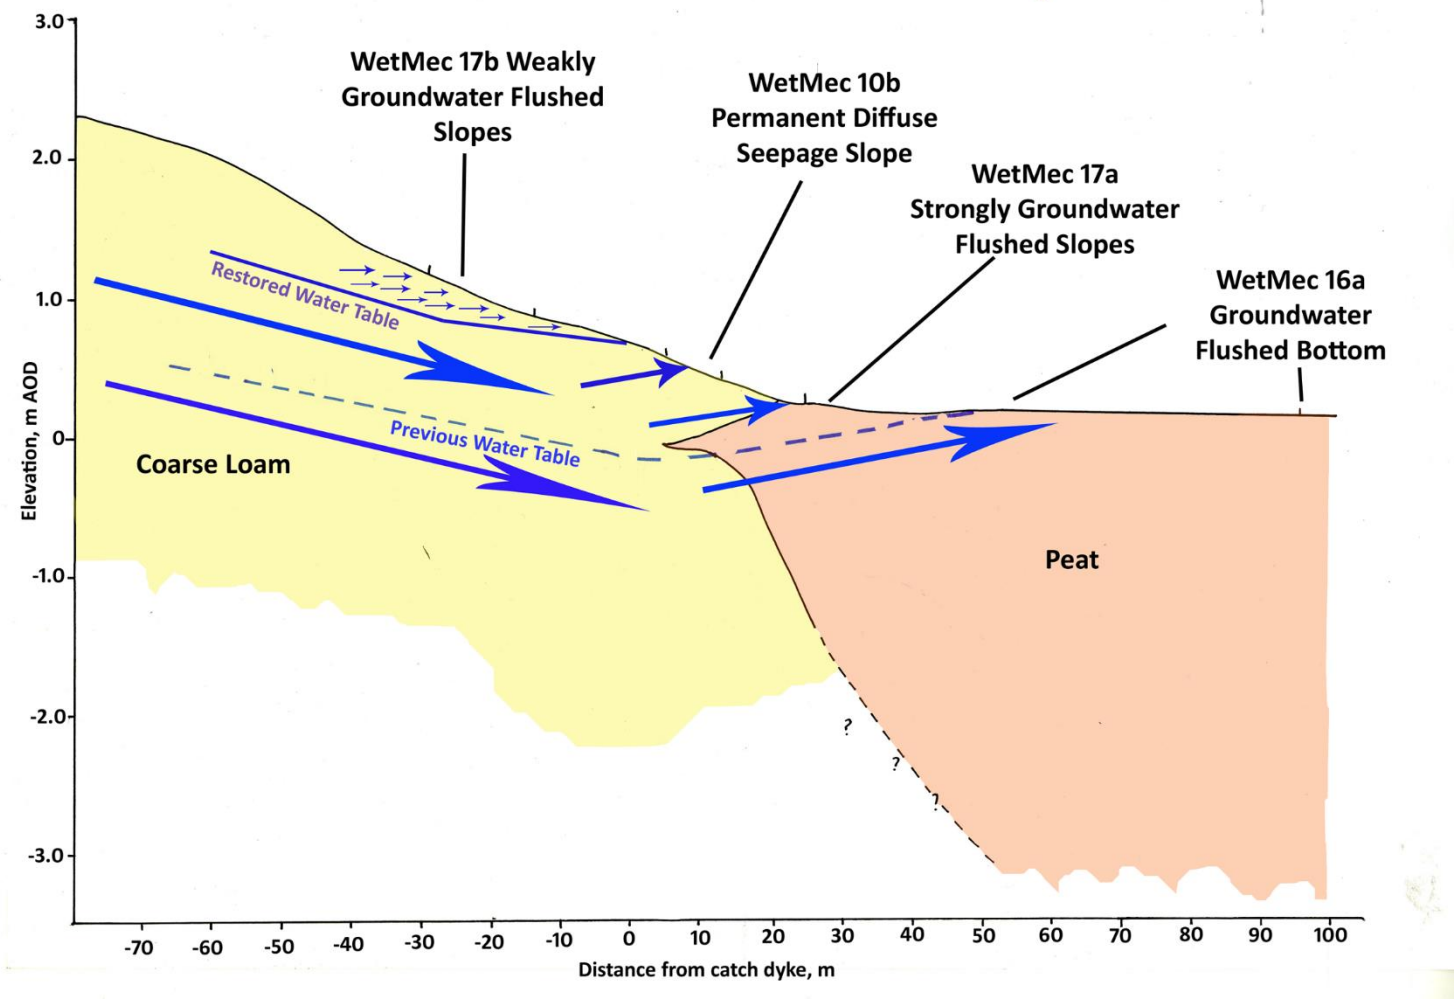
Figure 15: Possible Water Table Adjustment and Arrangement of WetMec Types Following Catch Dyke Restoration. Base Cross-section is taken from Soil Core Transect 2.

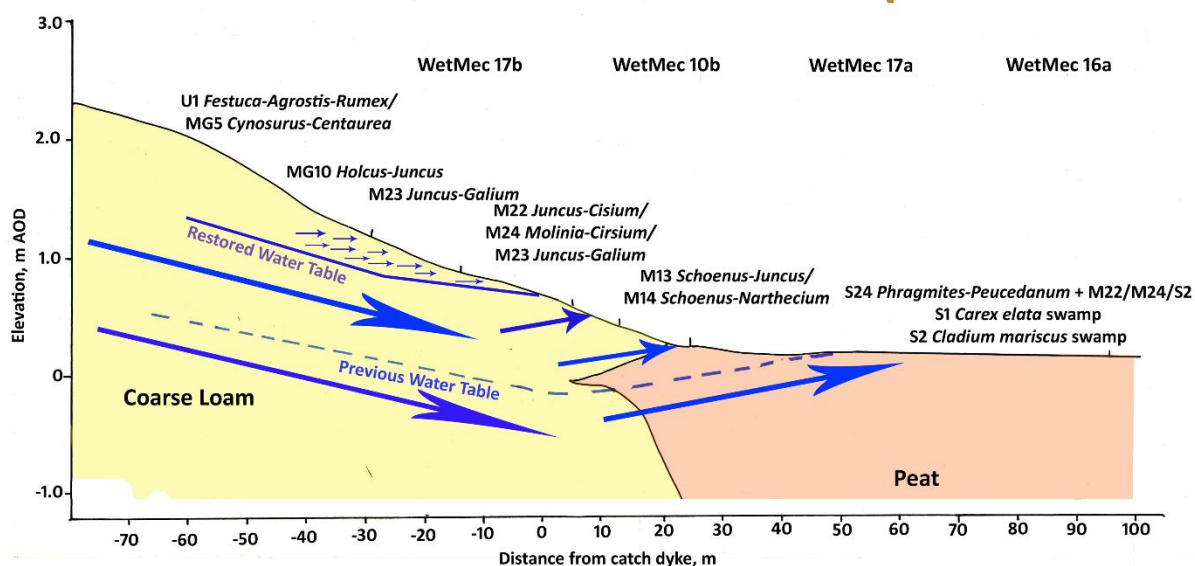
Figure 16: Potential Arrangement of Habitats Following Catch Dyke Restoration

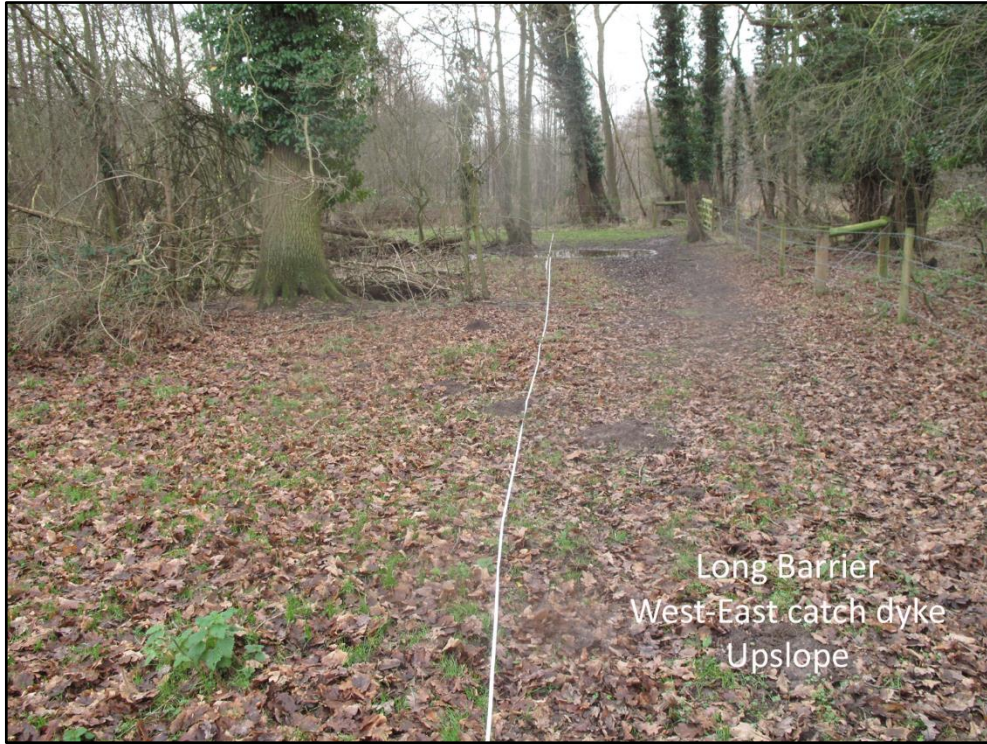
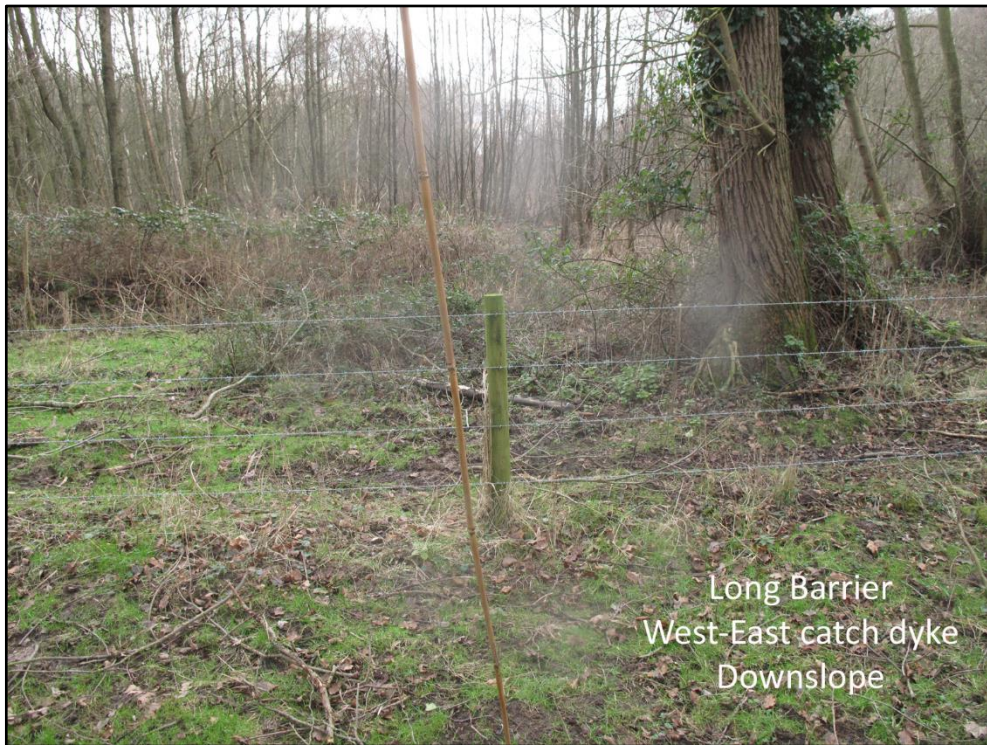
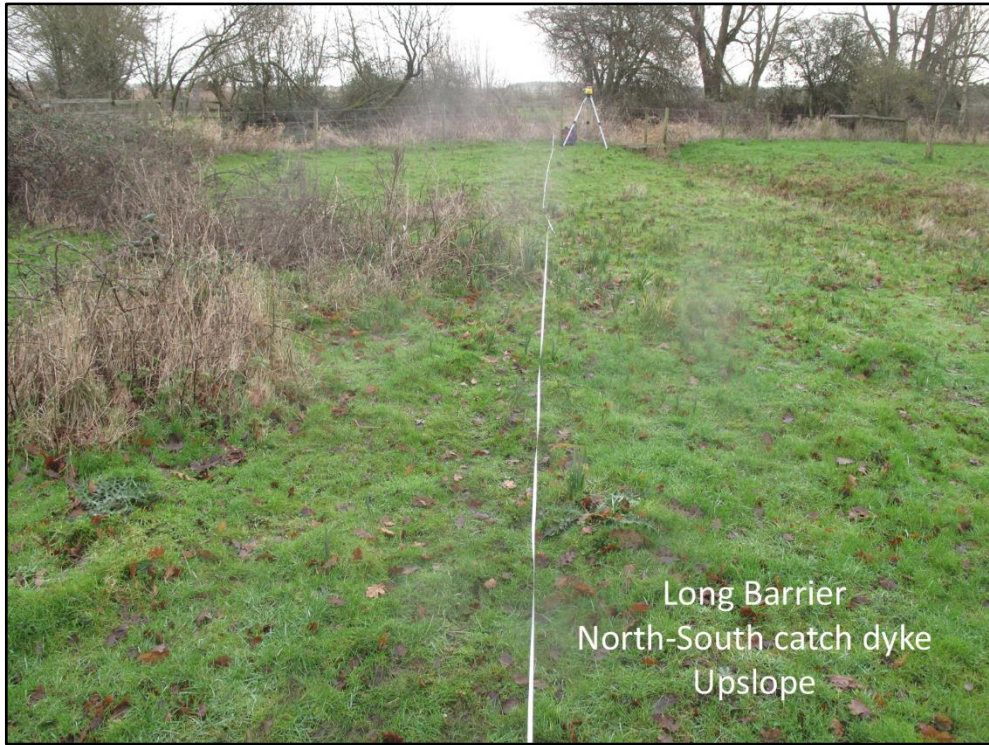
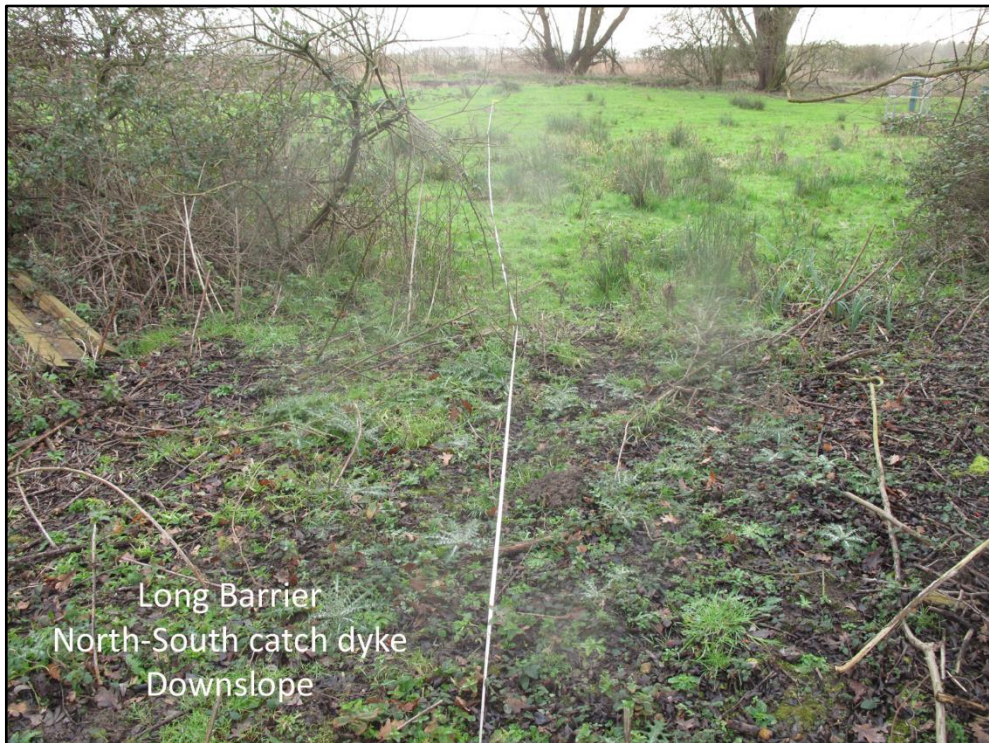
Figure 22: Photos Of The Line Of The Long Barriers.

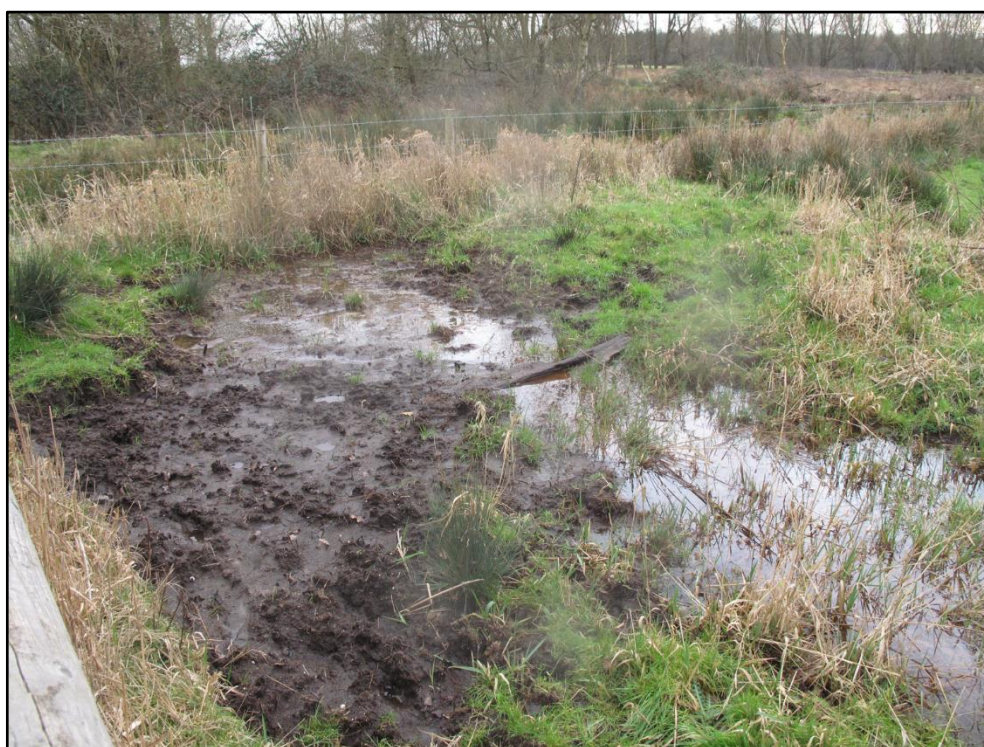
Figure 23: Current Condition of the Gateway.

The gateway should be dug out to a depth of 1.50m or to hard bottom, for a width of 5m and a length of 10m. This should then be back-filled with mineral soil (which can be impermeable) won locally from the toe slope. The in-fill should be compressed as hard as possible. The final surface should grade to the slope to the north and be cambered to shed water. The middle of the gate should be 300mm above surrounding level.
