Natural England Commissioned Report NECR141

New Forest SSSI Ecohydrological Survey Overview

Annex M: Little Wootton Inclosure

First published 06 March 2014

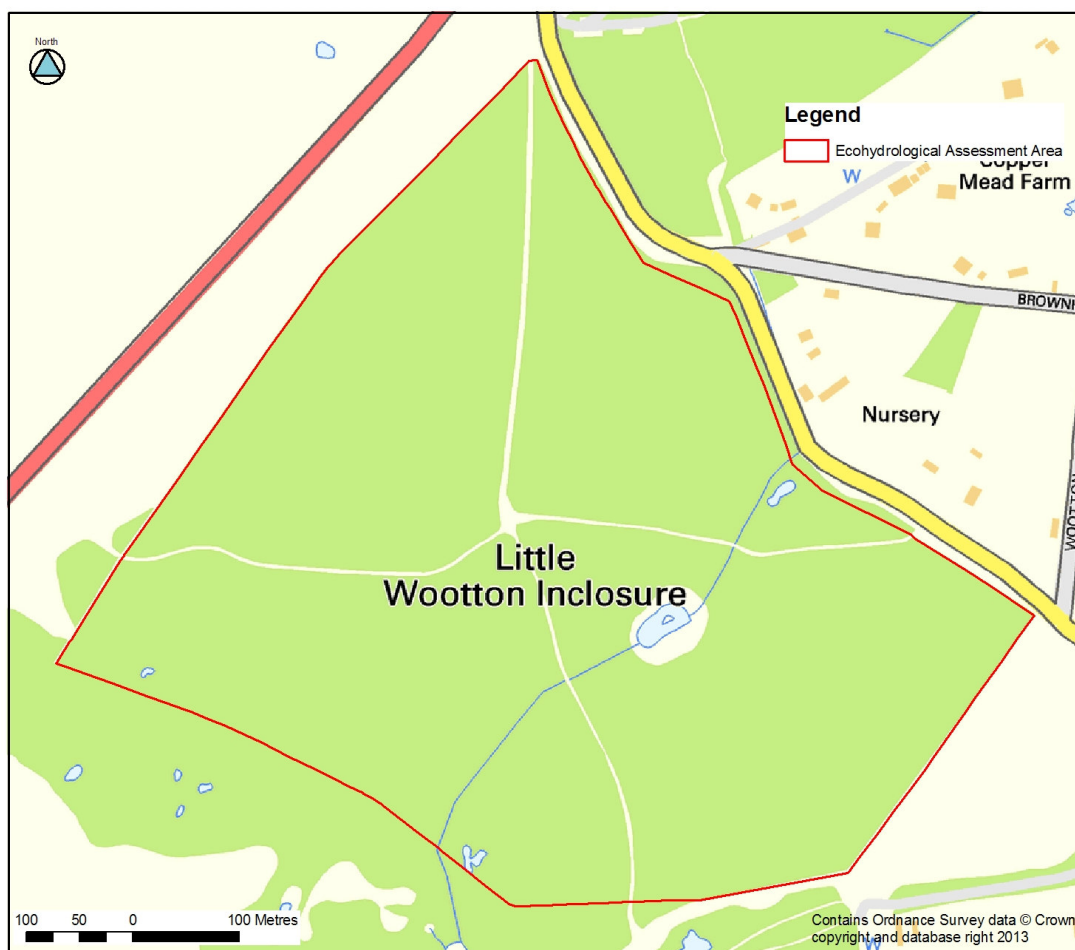
Figure 1-1: Location Map

This Ecohydrological Assessment Area (EcoHAA) covers 38.1ha and is contained within SSSI Unit 538 with its centre at National Grid Reference (NGR) 422587, 098895 (see Figure 1-1).

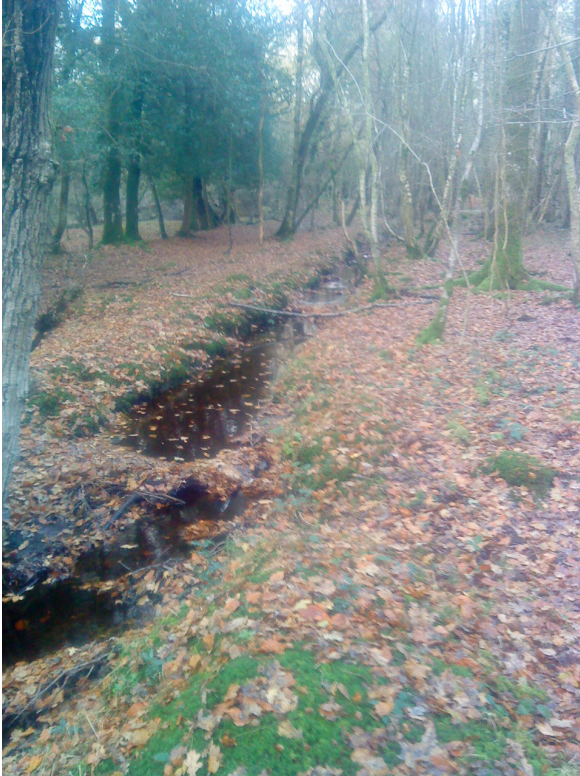
Figure 1-2: Drain in the base of Walkford Brook Valley (NGR 422465, 098660)

Within the Walkford Brook Valley are a series of parallel drains which appear to affectively drain this valley bottom (see Figure 1-2).

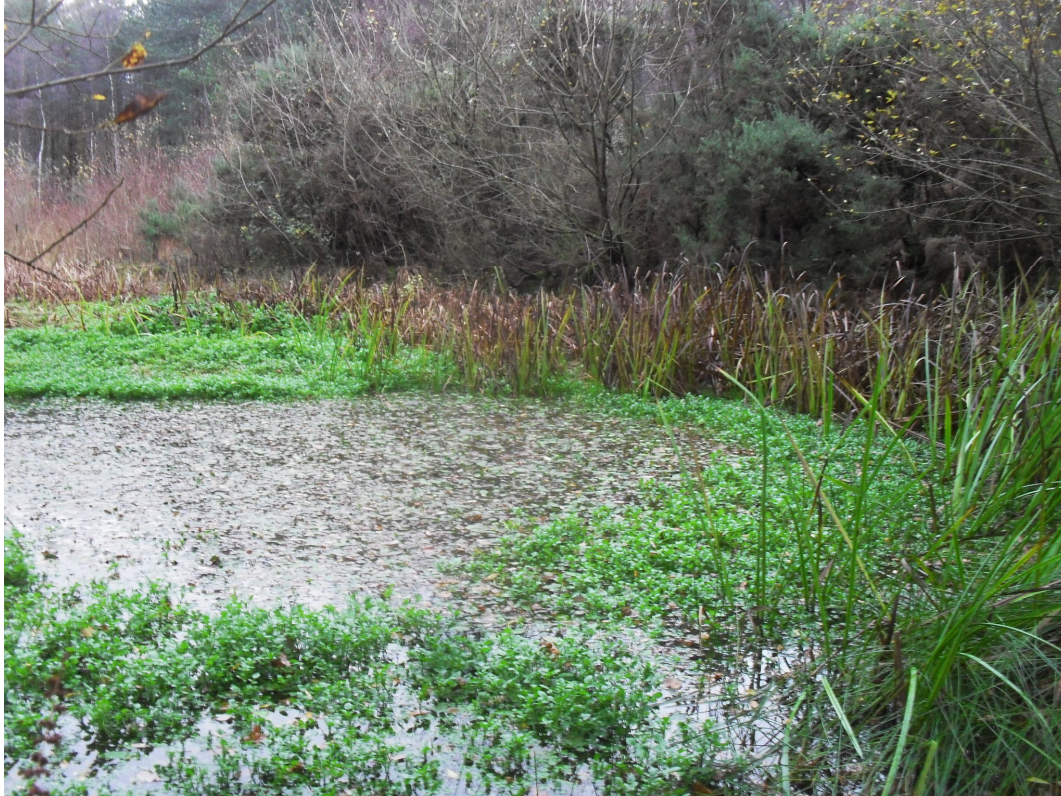
Figure 1-3: Large Species-rich Pond (NGR 422700, 098820)

In the middle of the unit there is a large pond with Water-cress *Rorippa nasturtium-aquaticum*, Common Duckweed *Lemna minor*, Soft Rush *Juncus effusus*, Reedmace *Typha latifolia*, and Common Reed *Phragmites australis* present (Figure 1-3). In previous surveys the highly invasive Australian Swamp Stonecrop *Crassula helmsii* has been noted as a problem within the pond; however it was not recorded during the survey. This could possibly be due to the time of the year the survey was carried out, high water levels in the pond, and the difficulty in accessing the pond margin. The surrounding area and outlet from the pond are dominated by wetland species with Purple Moorgrass *Molinia caerulea* tussocks, Wood Horsetail *Equisetum sylvaticum* and *Sphagnum* patches forming a wet woodland habitat.

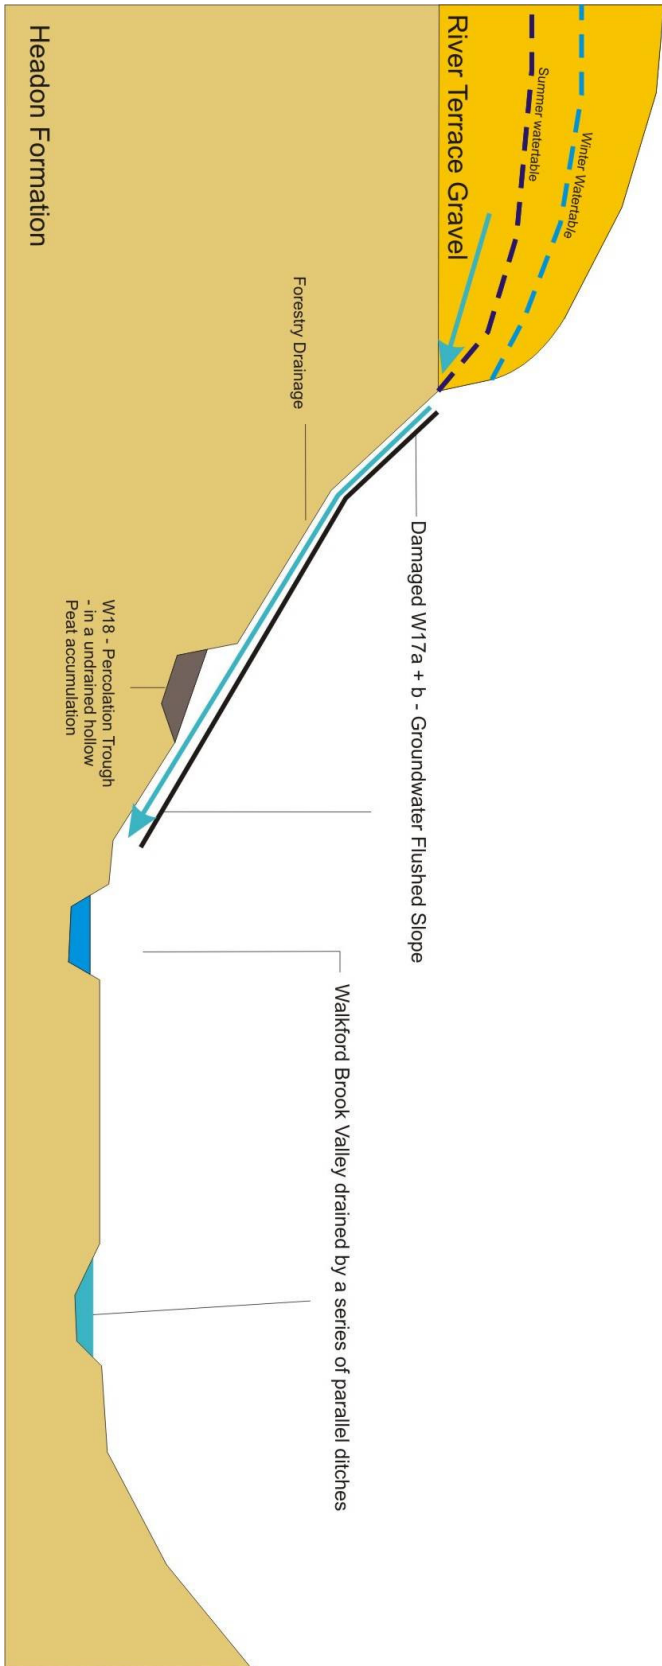
Figure 1-4: Conceptual Model Diagram

The forestry drainage network and other drains within the valley bottom have limited the extent of wetland to a small area in the south-west corner of the site. If these were not here flush dominated wetlands would have been supported by a seepage face at the junction between the river terrace deposits (aquifer) and the underlying Headon Formation (aquitard). In parts of this area there are some areas of sphagnum amongst the trees where the forestry drainage has never been particularly effective.

Only a very small area of wetland has been identified which could be described as W18 Percolation Trough. The flushed slopes before the drainage might have supported W17a and W17b (groundwater flushed slope).

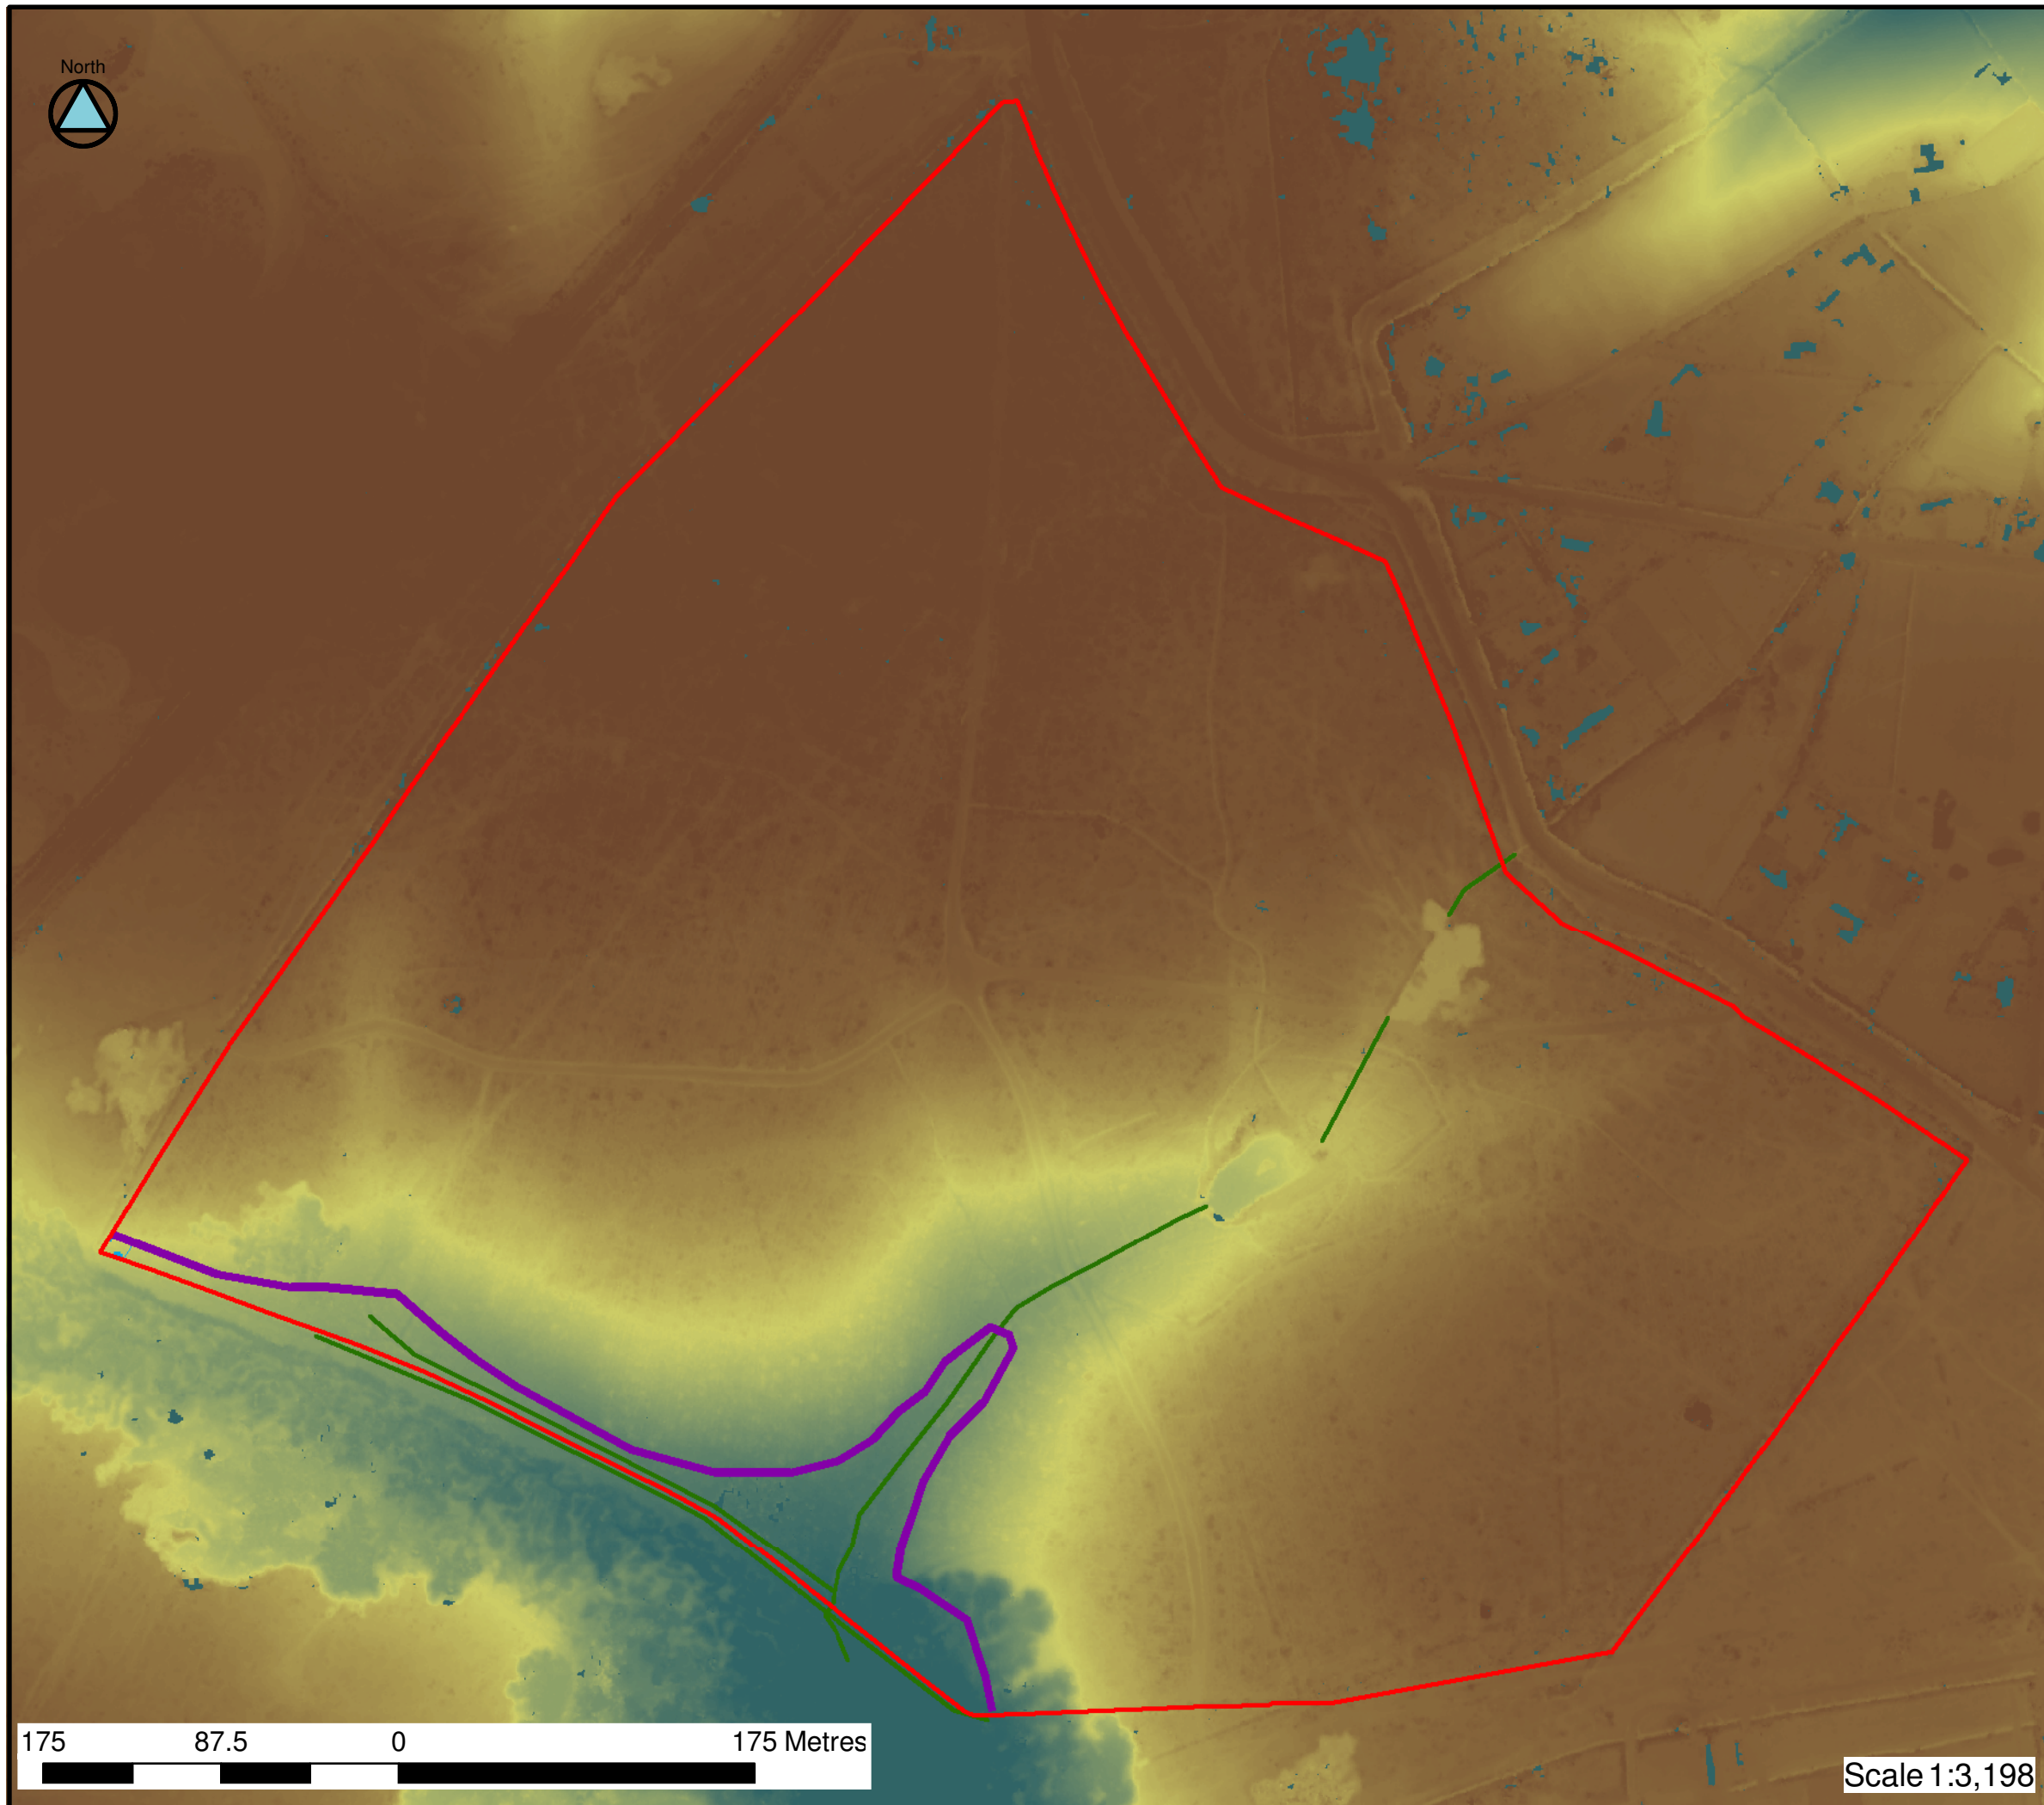
MAP 3

Topography, Hydrology and Wetland Distribution

The site is mainly occupied by a mixed woodland plantation covered plateau which slopes along its southern boundary down into the Walkford Brook valley. The plateau is covered with regular forestry drainage. Running north-south through the centre of the site is a larger drain which is connected to a pond in the centre of the site on the plateau. The pond is surrounded by embankments (possibly dredging from the ponds creations. A water control structure was removed from the outfall in recent years (Natural England pers. comm.).

The forestry drainage and drains within the valley bottom have limited the extent of wetlands to a small area in the south-west corner of the site. There are some areas of sphagnum on the edges of the plateaux where the forestry drainage is not working effectively.
