Natural England Commissioned Report NECR141

New Forest SSSI Ecohydrological Survey Overview

Annex Q: Northern Mires

First published 06 March 2014

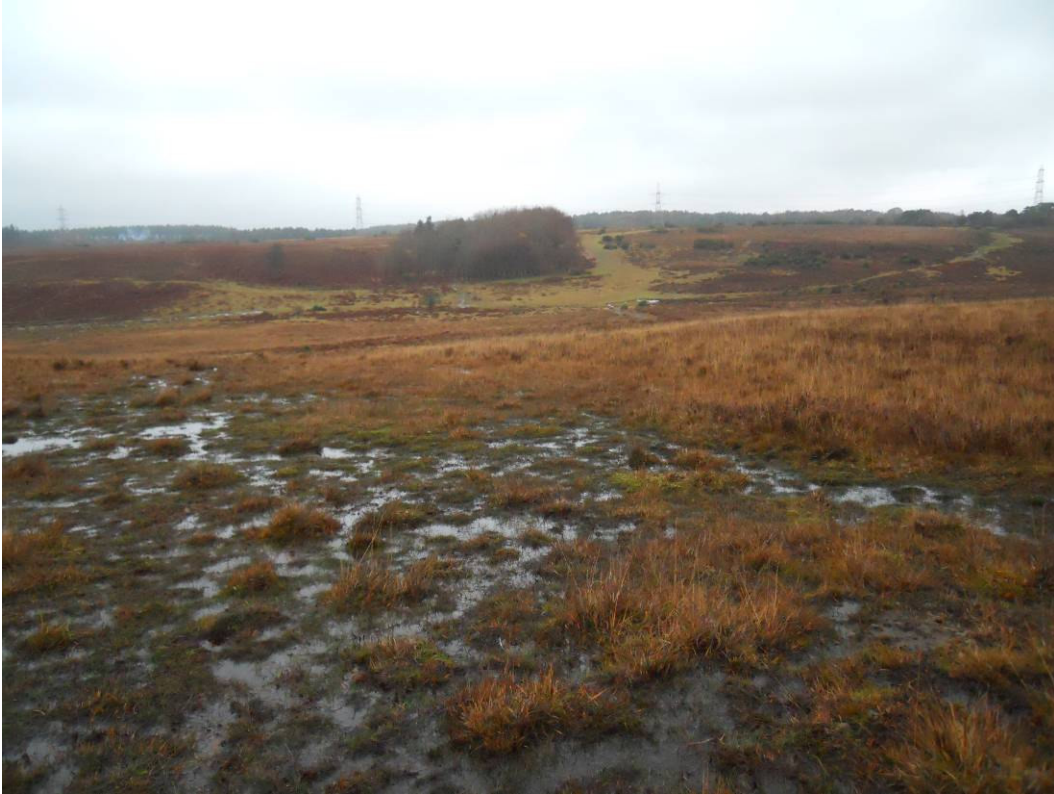
Figure 1-2: Long Flushed Slope of south side of Unit 32 (NGR 421225, 117163)

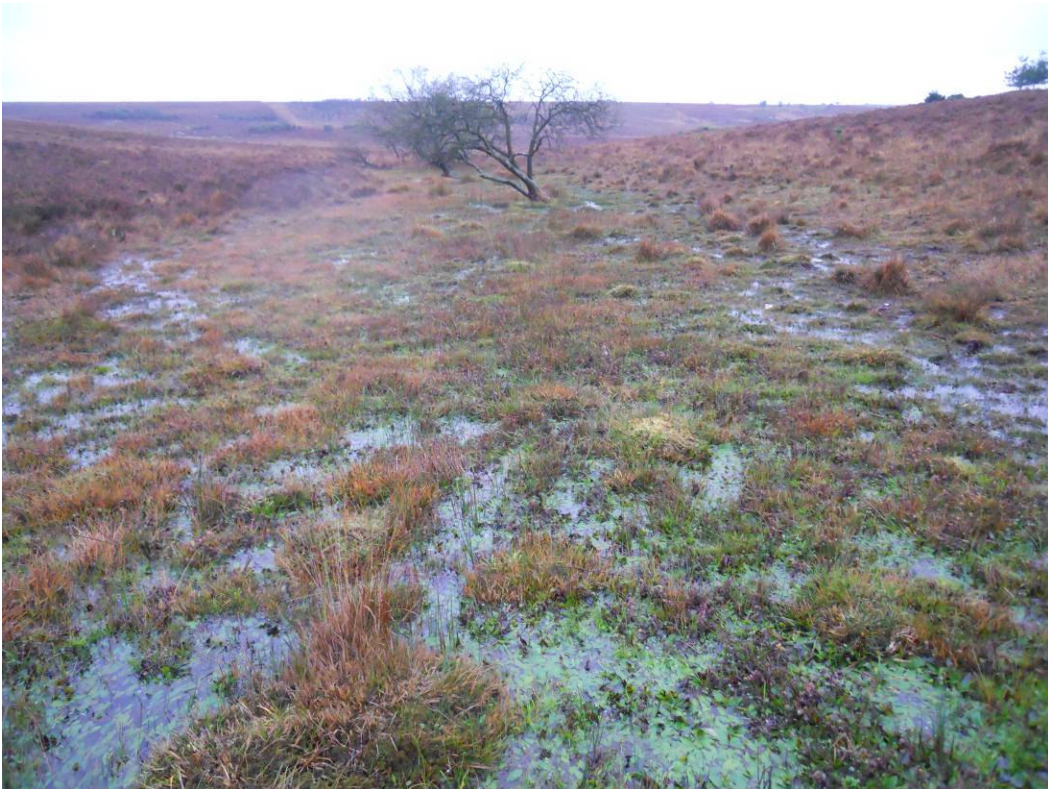
Figure 1-3: Valley Bottom Wetland in Unit 32 (NGR 421290, 117265)

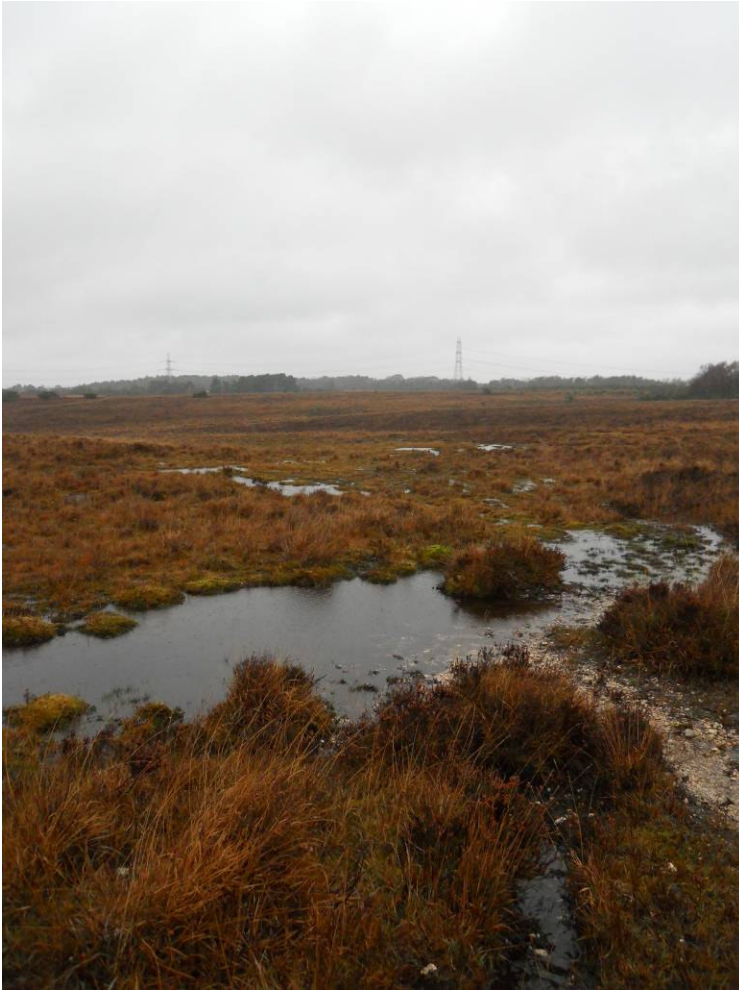
Figure 1-4: Head of valley in Unit 32 with seepage face from river terrace gravels (NGR 421515, 117170)

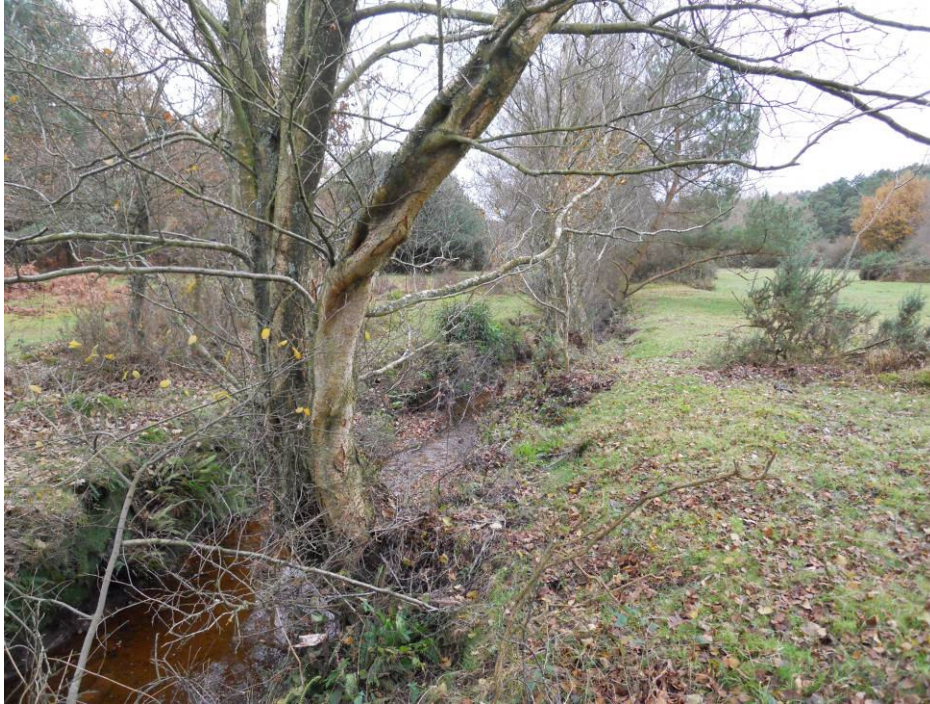
The area occupies the valley of the middle reach of Miller Brook. The valley has a narrow bottom and Miller Brook appears to have been artificially straightened and deepened over several sections. The narrow nature of the valley bottom and the works to the brook have limited the areas of valley bottom wetland (although it was never likely to have been extensive).

Figure 1-5: Straightened Miller Brook at the top of Unit 33 (NGR 419005, 116865)

- Unit 33 - Geomorph Area - construction of woody debris dams will encourage sediment accumulation upstream and raise water table levels across the valley bottom;
- Unit 33 - Valley Side Drains - a series of regular plugs made from suitable available material (earth, heather bails, plastic sheet piling) should be constructed to block the valley side ditches in this area;
- Unit 41 - as this gully seems stable and runs along an area of woodland, regular monitoring is likely to be the best option for this stretch. If restoration is needed, it might require an engineered solution, due to the size of the gully.

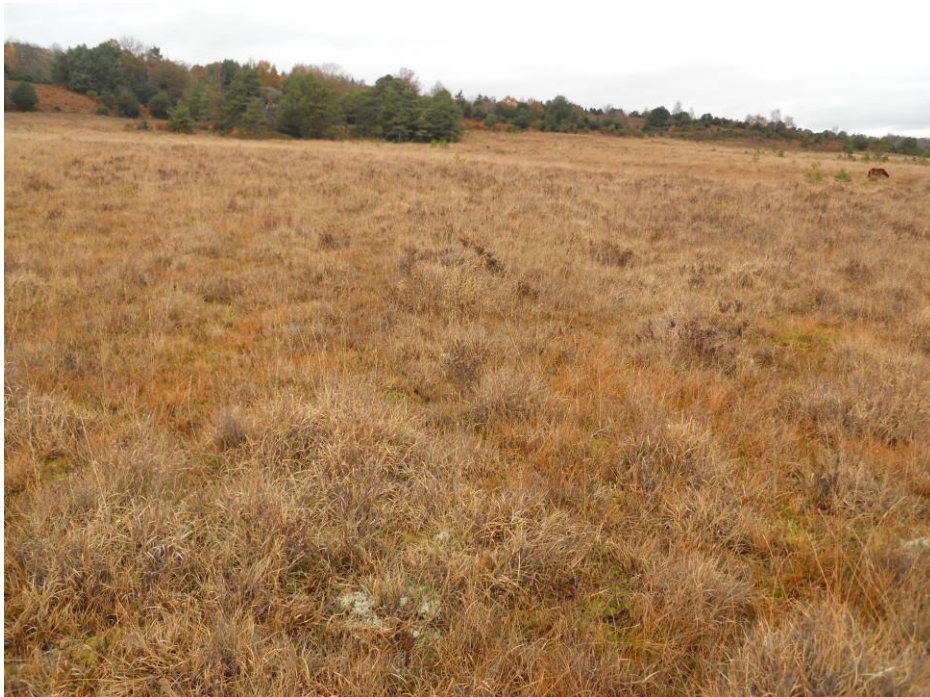
On the valley sides are long extensive areas of flush dominated valley side wetland. Where this flow concentrates the slope is wetter and where drainage collects water or the natural shape of the valley side sheds water the valley side is drier. There are several areas where there have been limited attempts to drain the valley side. This has been most successful at the bottom end of the site, where an area on the lower slopes (outside the SSSI unit) has been converted to fields.

Figure 1-6: Example of an extensive area of Flushed Slope on the right bank of Miller Brook in Unit 33 (NGR 418400, 116350)

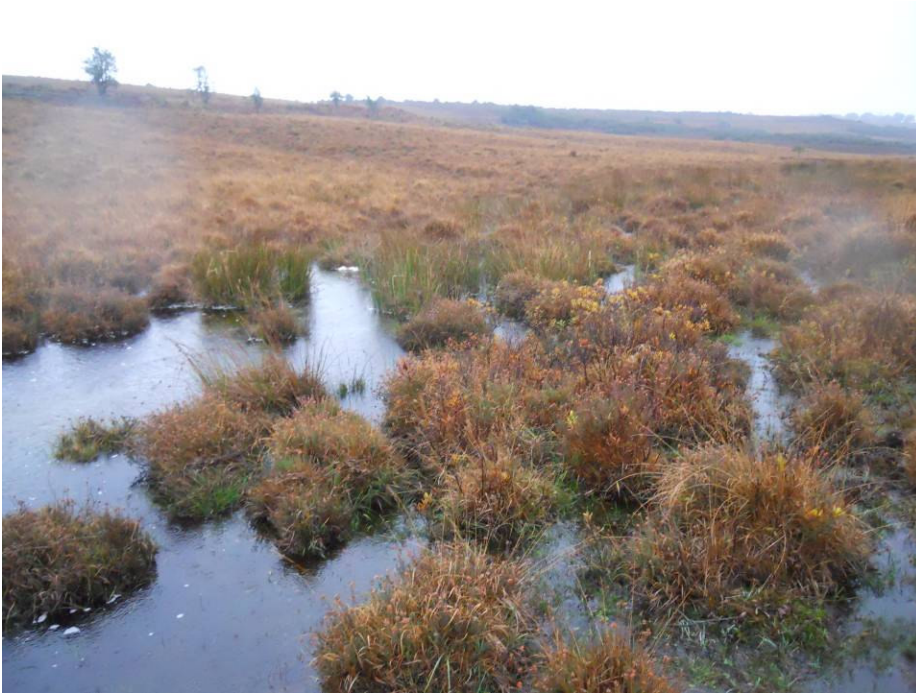
Figure 1-7: Upper part of the main valley in Unit 41 containing a valley bottom wetland (NGR 420815, 115490)

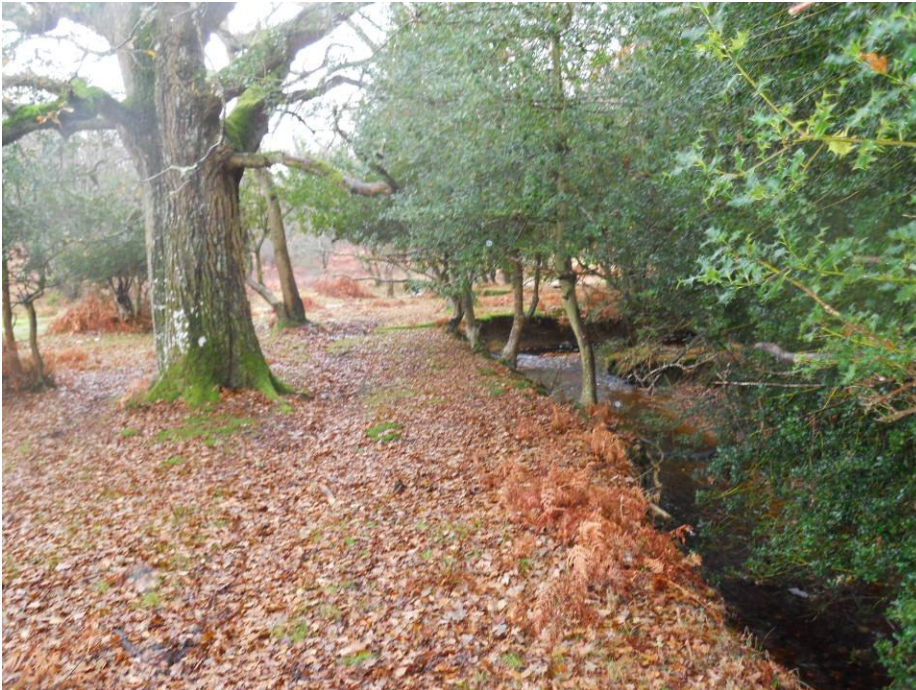
Figure 1-8: Gulleys straightened section of drain in the lower part of Unit 41 (NGR 420255, 114635)

- Unit 41 Enlarged Drain - Where the stream runs along the side of a wood at the bottom of the valley, it has been straightened into a drain which has subsequently gulleied. This gulleying does not seem to extend beyond the area where the stream was straightened, therefore it might be relatively stable.

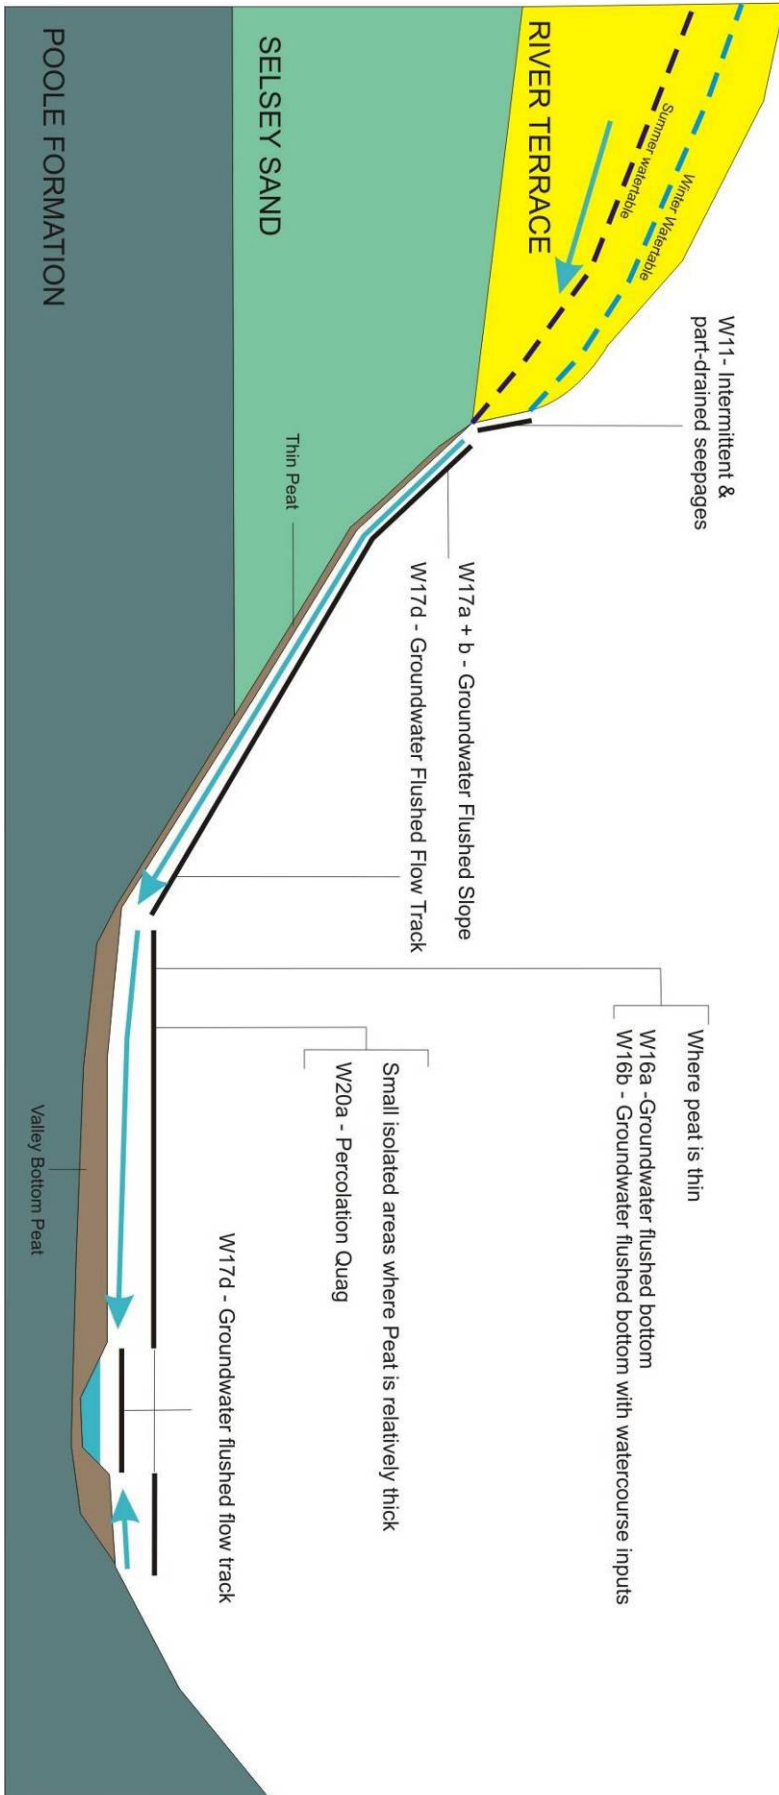
Figure 1-9: Conceptual Model Diagram for Unit 32 and 41

All the wetlands on site are flush dominated (see Figure 1-9 and Figure 1-10). Units 32 and 41 receive water from a seepage face at the junction between river terrace deposits (aquifer) and the underlying Selsey Sands Formation (aquitard), whereas Unit 33 receives water from the junction of the Poole Formation and the underlying London Clay. The water runs over the surface of the slopes, forming flushed surfaces before reaching the valley bottoms.
