Natural England Commissioned Report NECR141

New Forest SSSI Ecohydrological Survey Overview

Annex S: Ogdens Purlieu

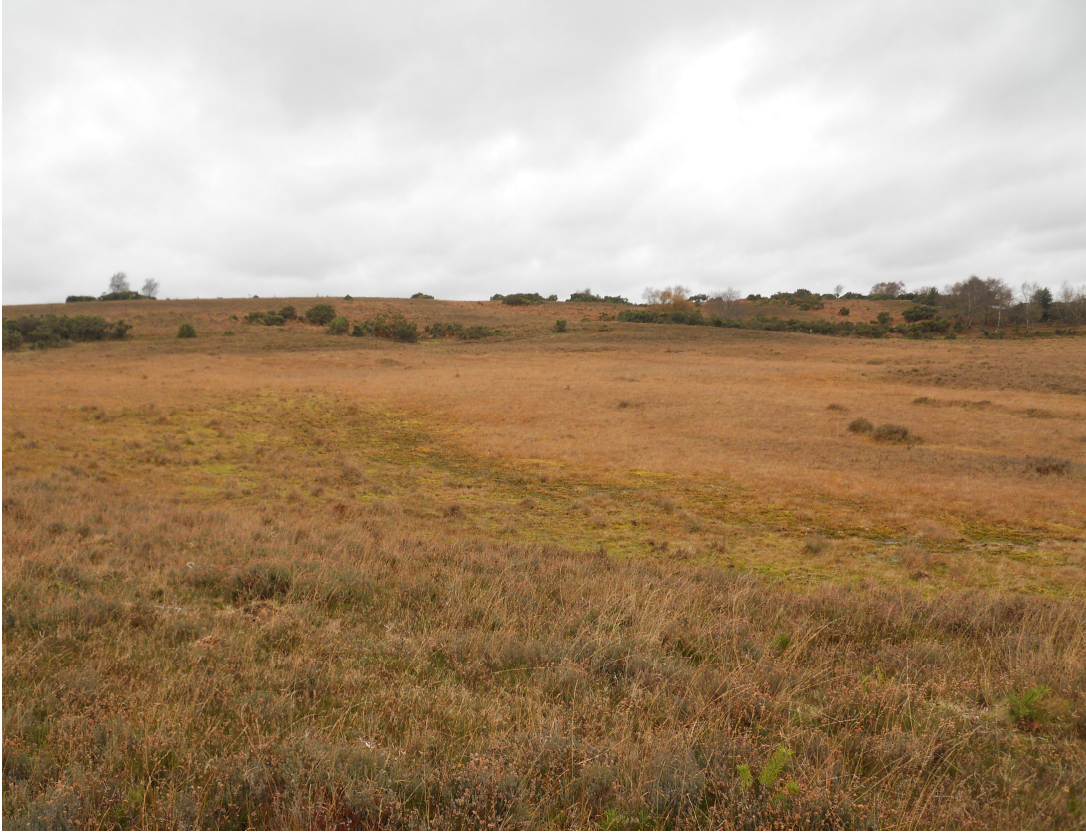
Figure 1-2: Western Valley Bottom Wetland (NGR 418235, 111640)

The site occupies two adjoining valleys surrounded by a plateau separated by a low ridge (see Figure 1-2 and Figure 1-3). In the lower part of the eastern valley there is a series of small drains (see Figure 1-4). The small stream at the bottom of the western valley appeared natural.

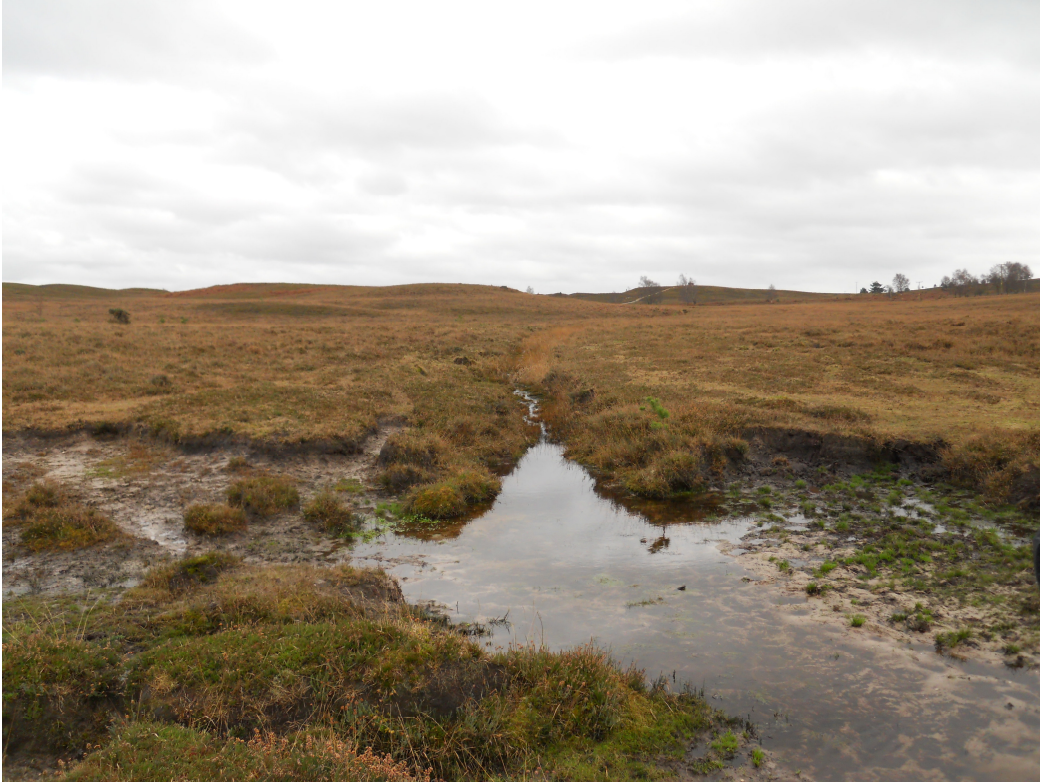
Figure 1-4: Drainage at base of the Eastern Valley Bottom Wetland

There is one area of significant damage (see Figure 1-6) - the Drainage Area. In this area a series of small drains have been cut draining the wetland area.

The cutting of the drain has resulted in scrub development occurring on the low spoil banks. This consists of Gorse, Silver Birch and Scot's Pine. The effects of drainage have also resulted in a change in the species composition parallel to the ditch where those areas closest to the drain have dried out.

The drains in the Drainage Area are small and so could be blocked by a series of regular plugs. The nature of these plugs could vary depending on the materials available locally. In the upper seepage dominated wetland, the underlying sand would not form good material for creating earth bunds.

Removal of scrub from within this unit should be undertaken in combination with drain blocking to remove a seed source and the drying effect of evapo-transpiration from this type of vegetation.

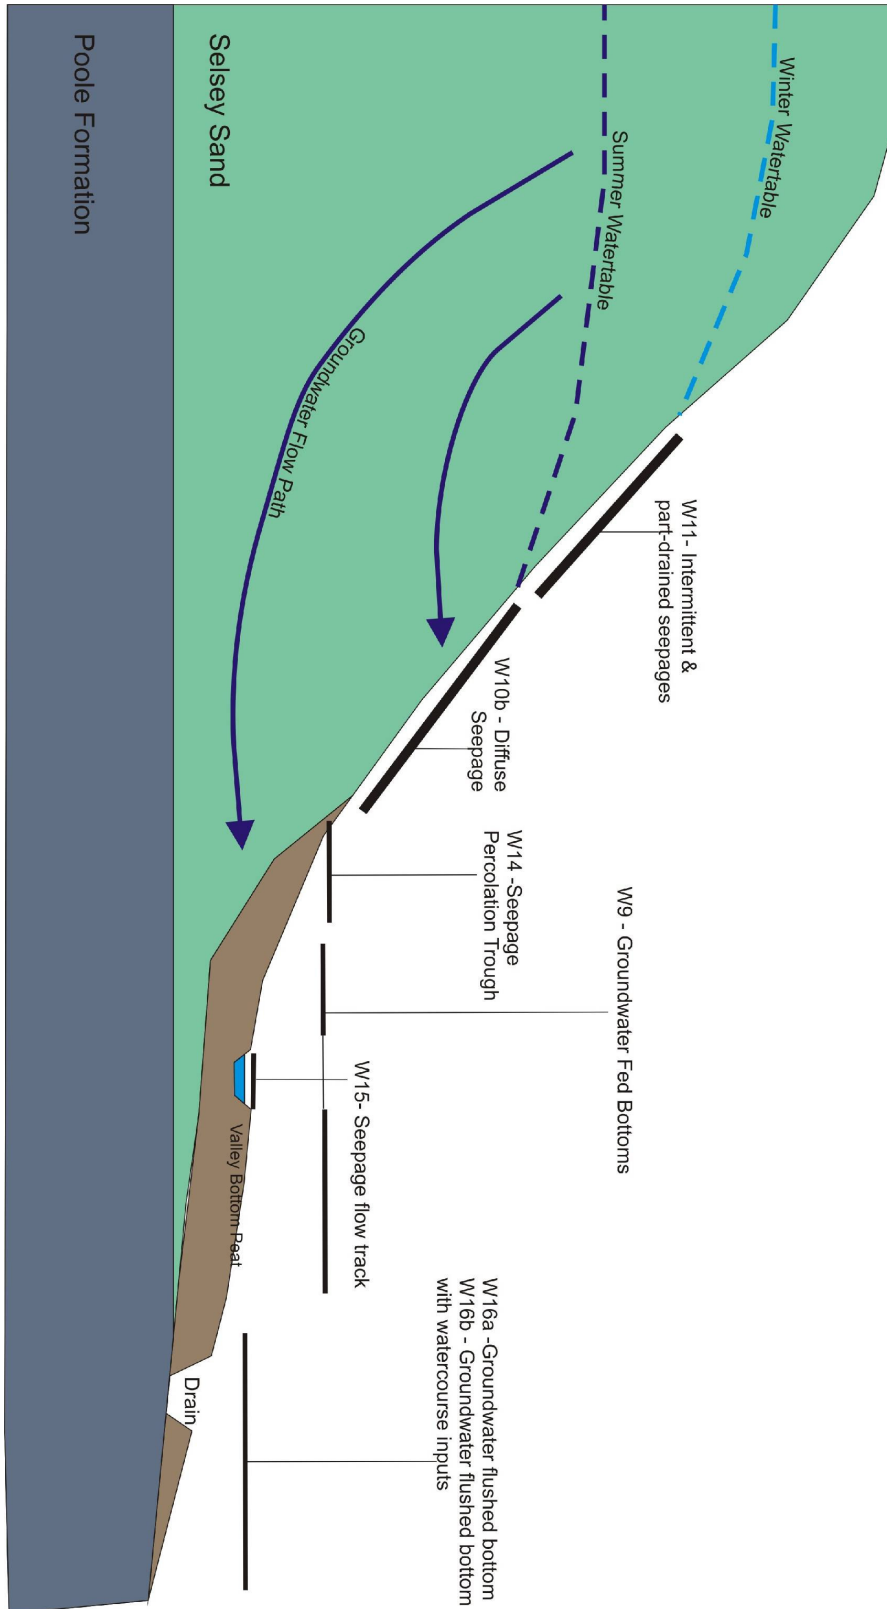
Figure 1-5: Conceptual Model Diagram

Odgen Purlieu is a complicated wetland. The upper part of the site (and the upper part of the wetlands) is underlain by the coarse sand Selsey Formation from which it receives groundwater flow and so is seepage dominated. Within the valley bottoms in this area peat has accumulated (augering showed up to 50cm in thickness).

The lower parts of the site are underlain with clay. The seepage dominated wetland valley bottom transitions into a flush dominated wetland valley bottom. In this area, without significant groundwater input, the drainage appears more effective and the peat has wasted.

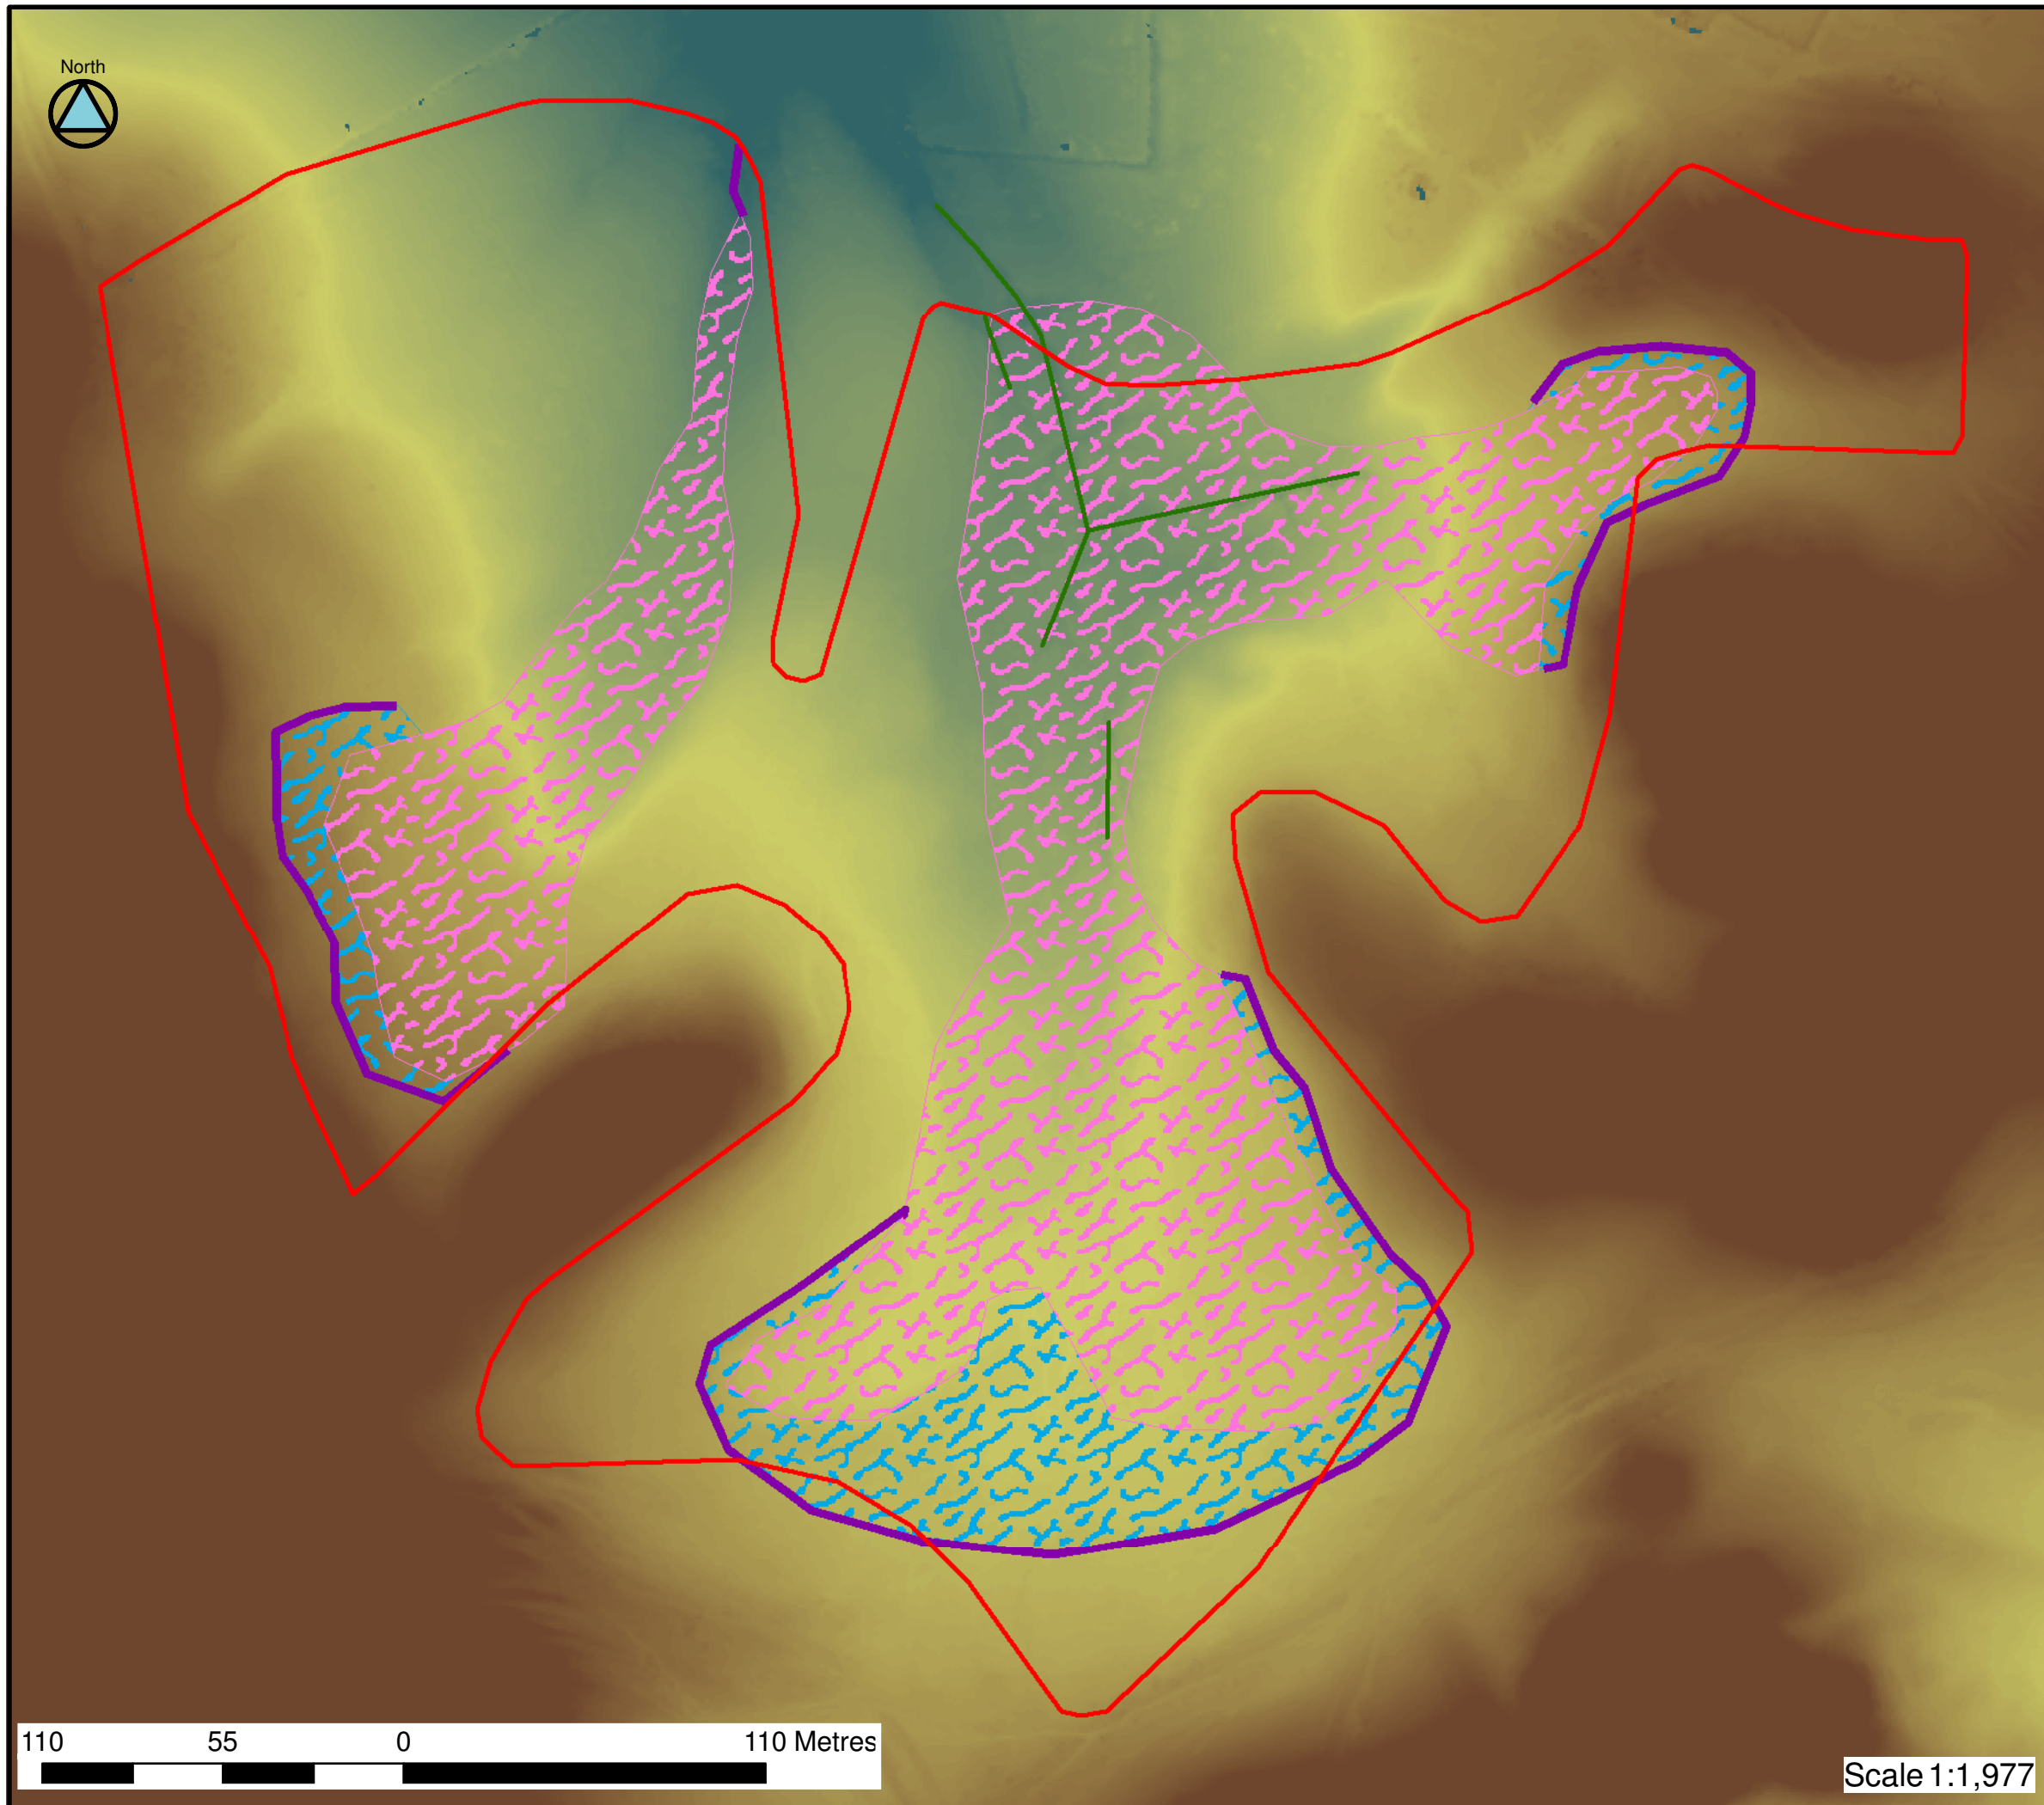
MAP 3

- Ecohydrological Assessment Area
- Seepage face
- Drainage
- Valley Bottom Wetland
- Valley Side Wetland

Topography, Hydrology and Wetland Distribution

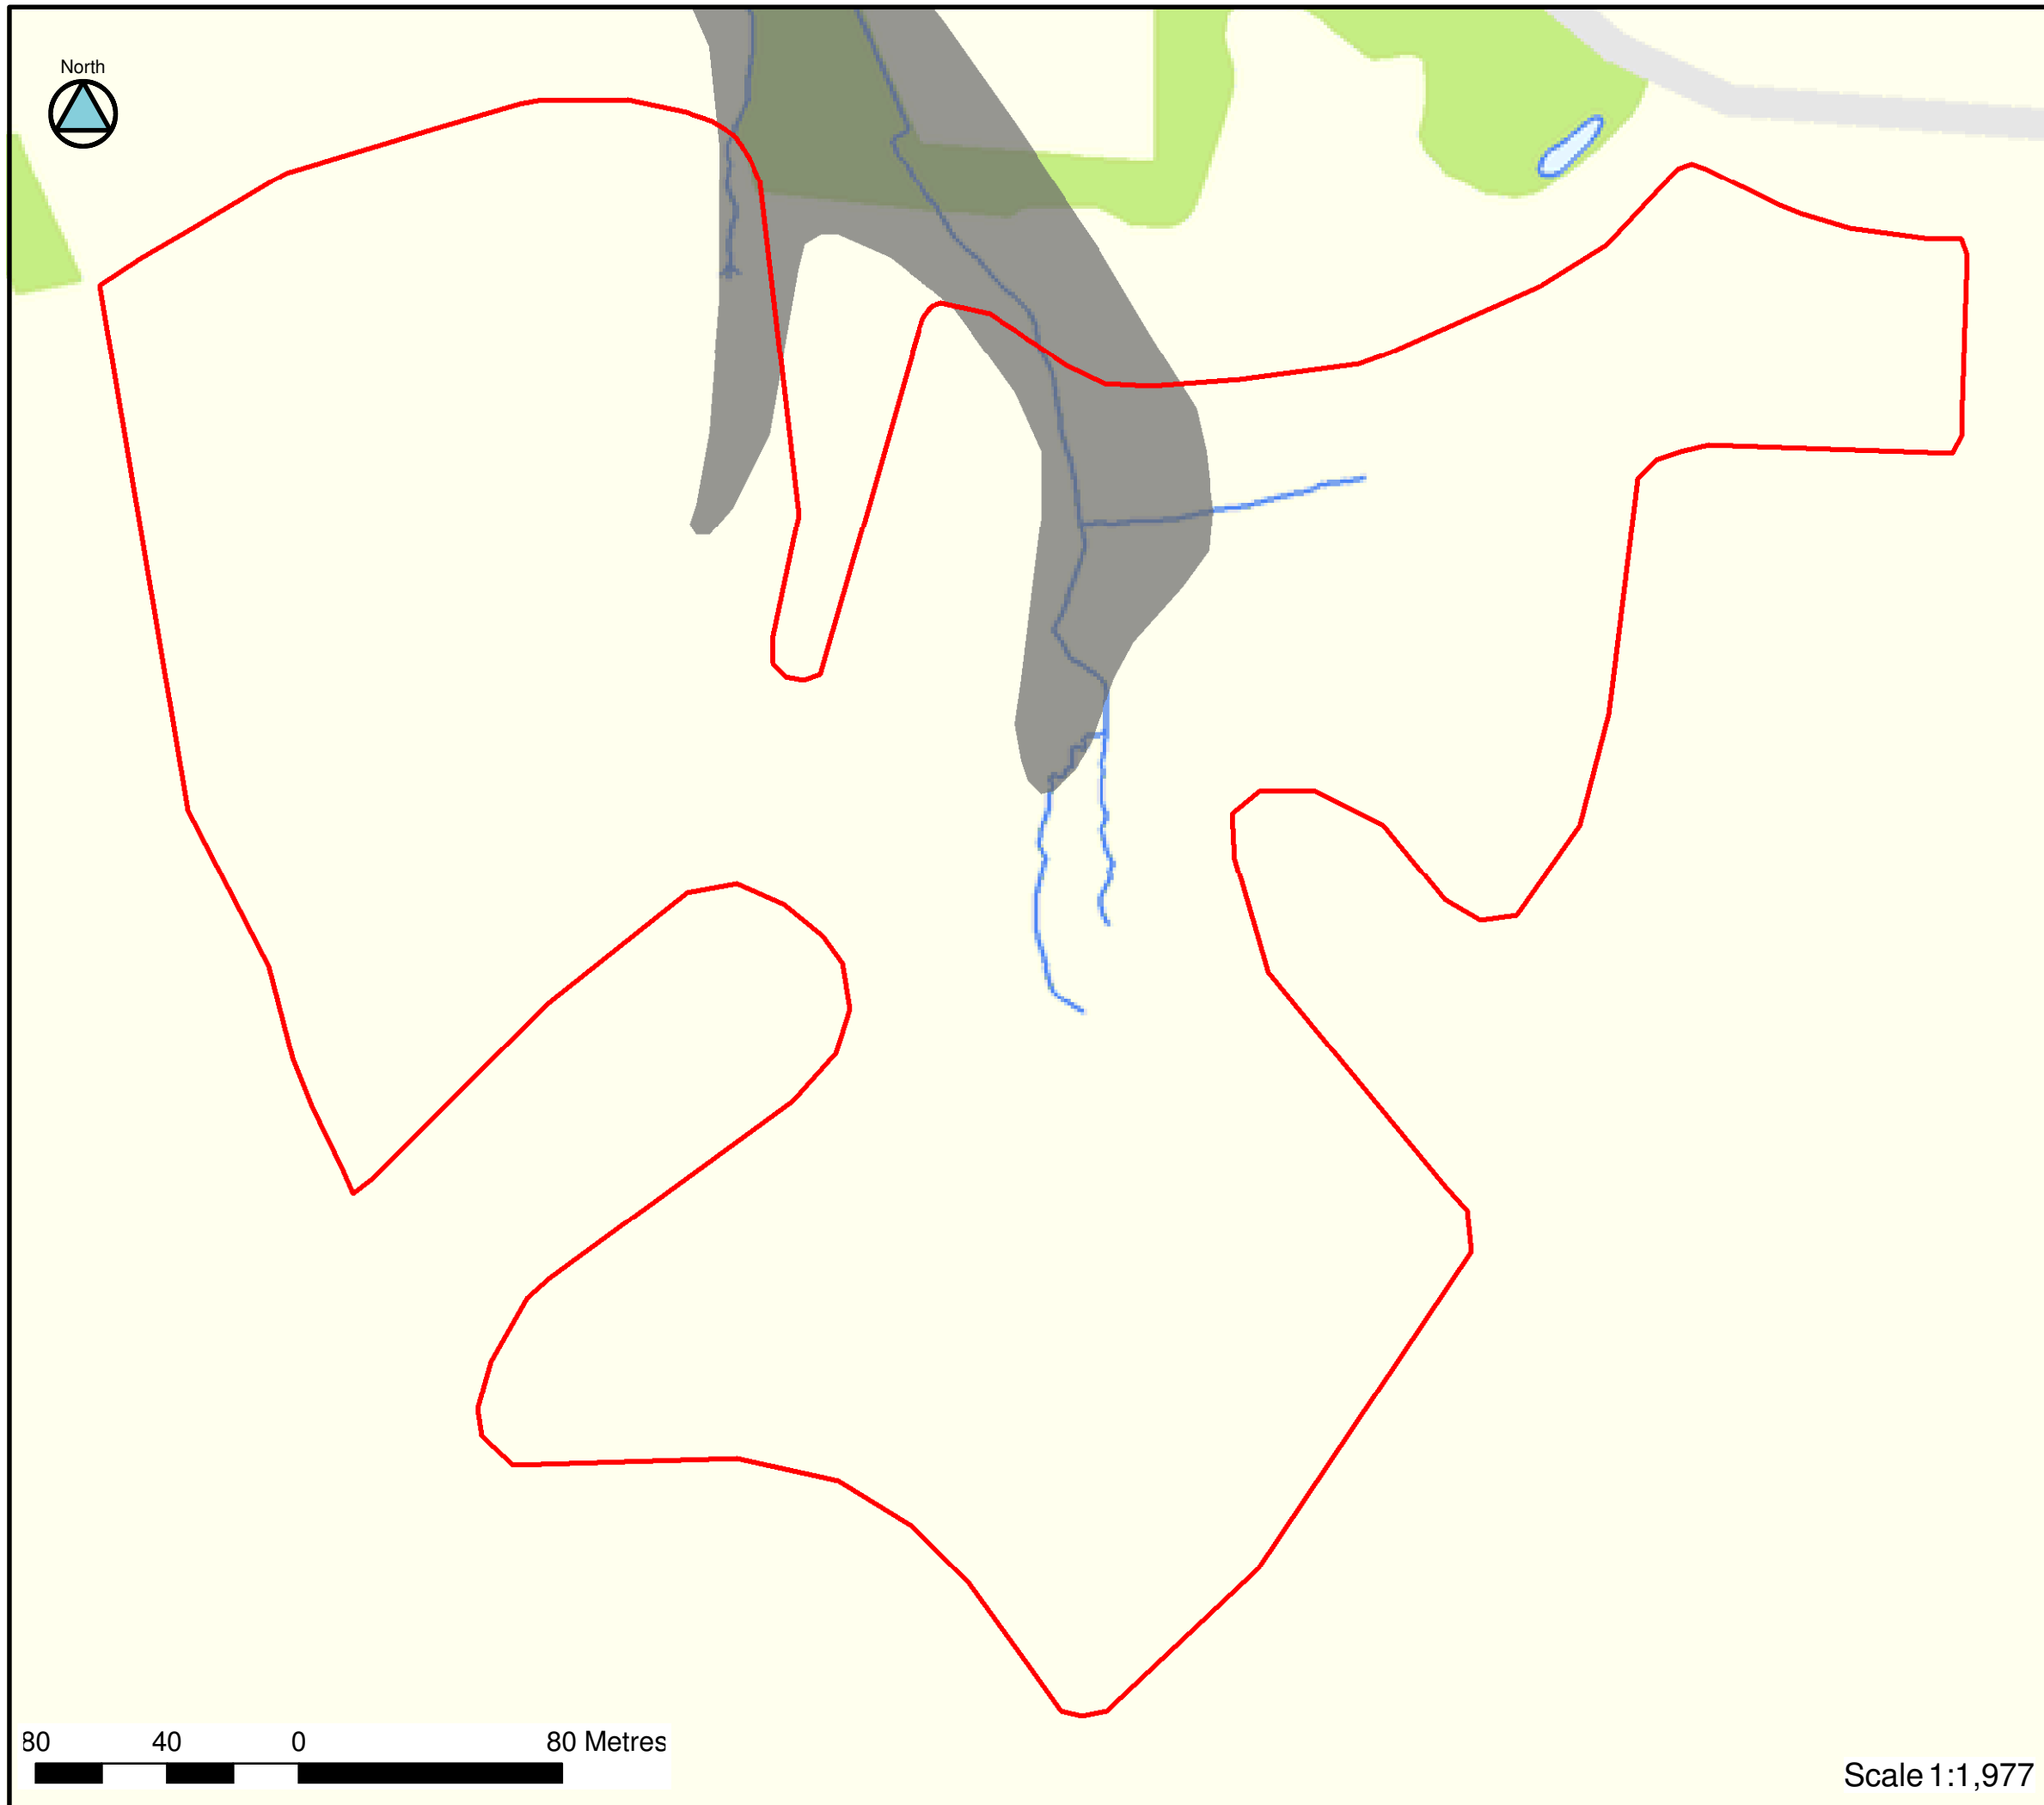
MAP 5

Drift Geology

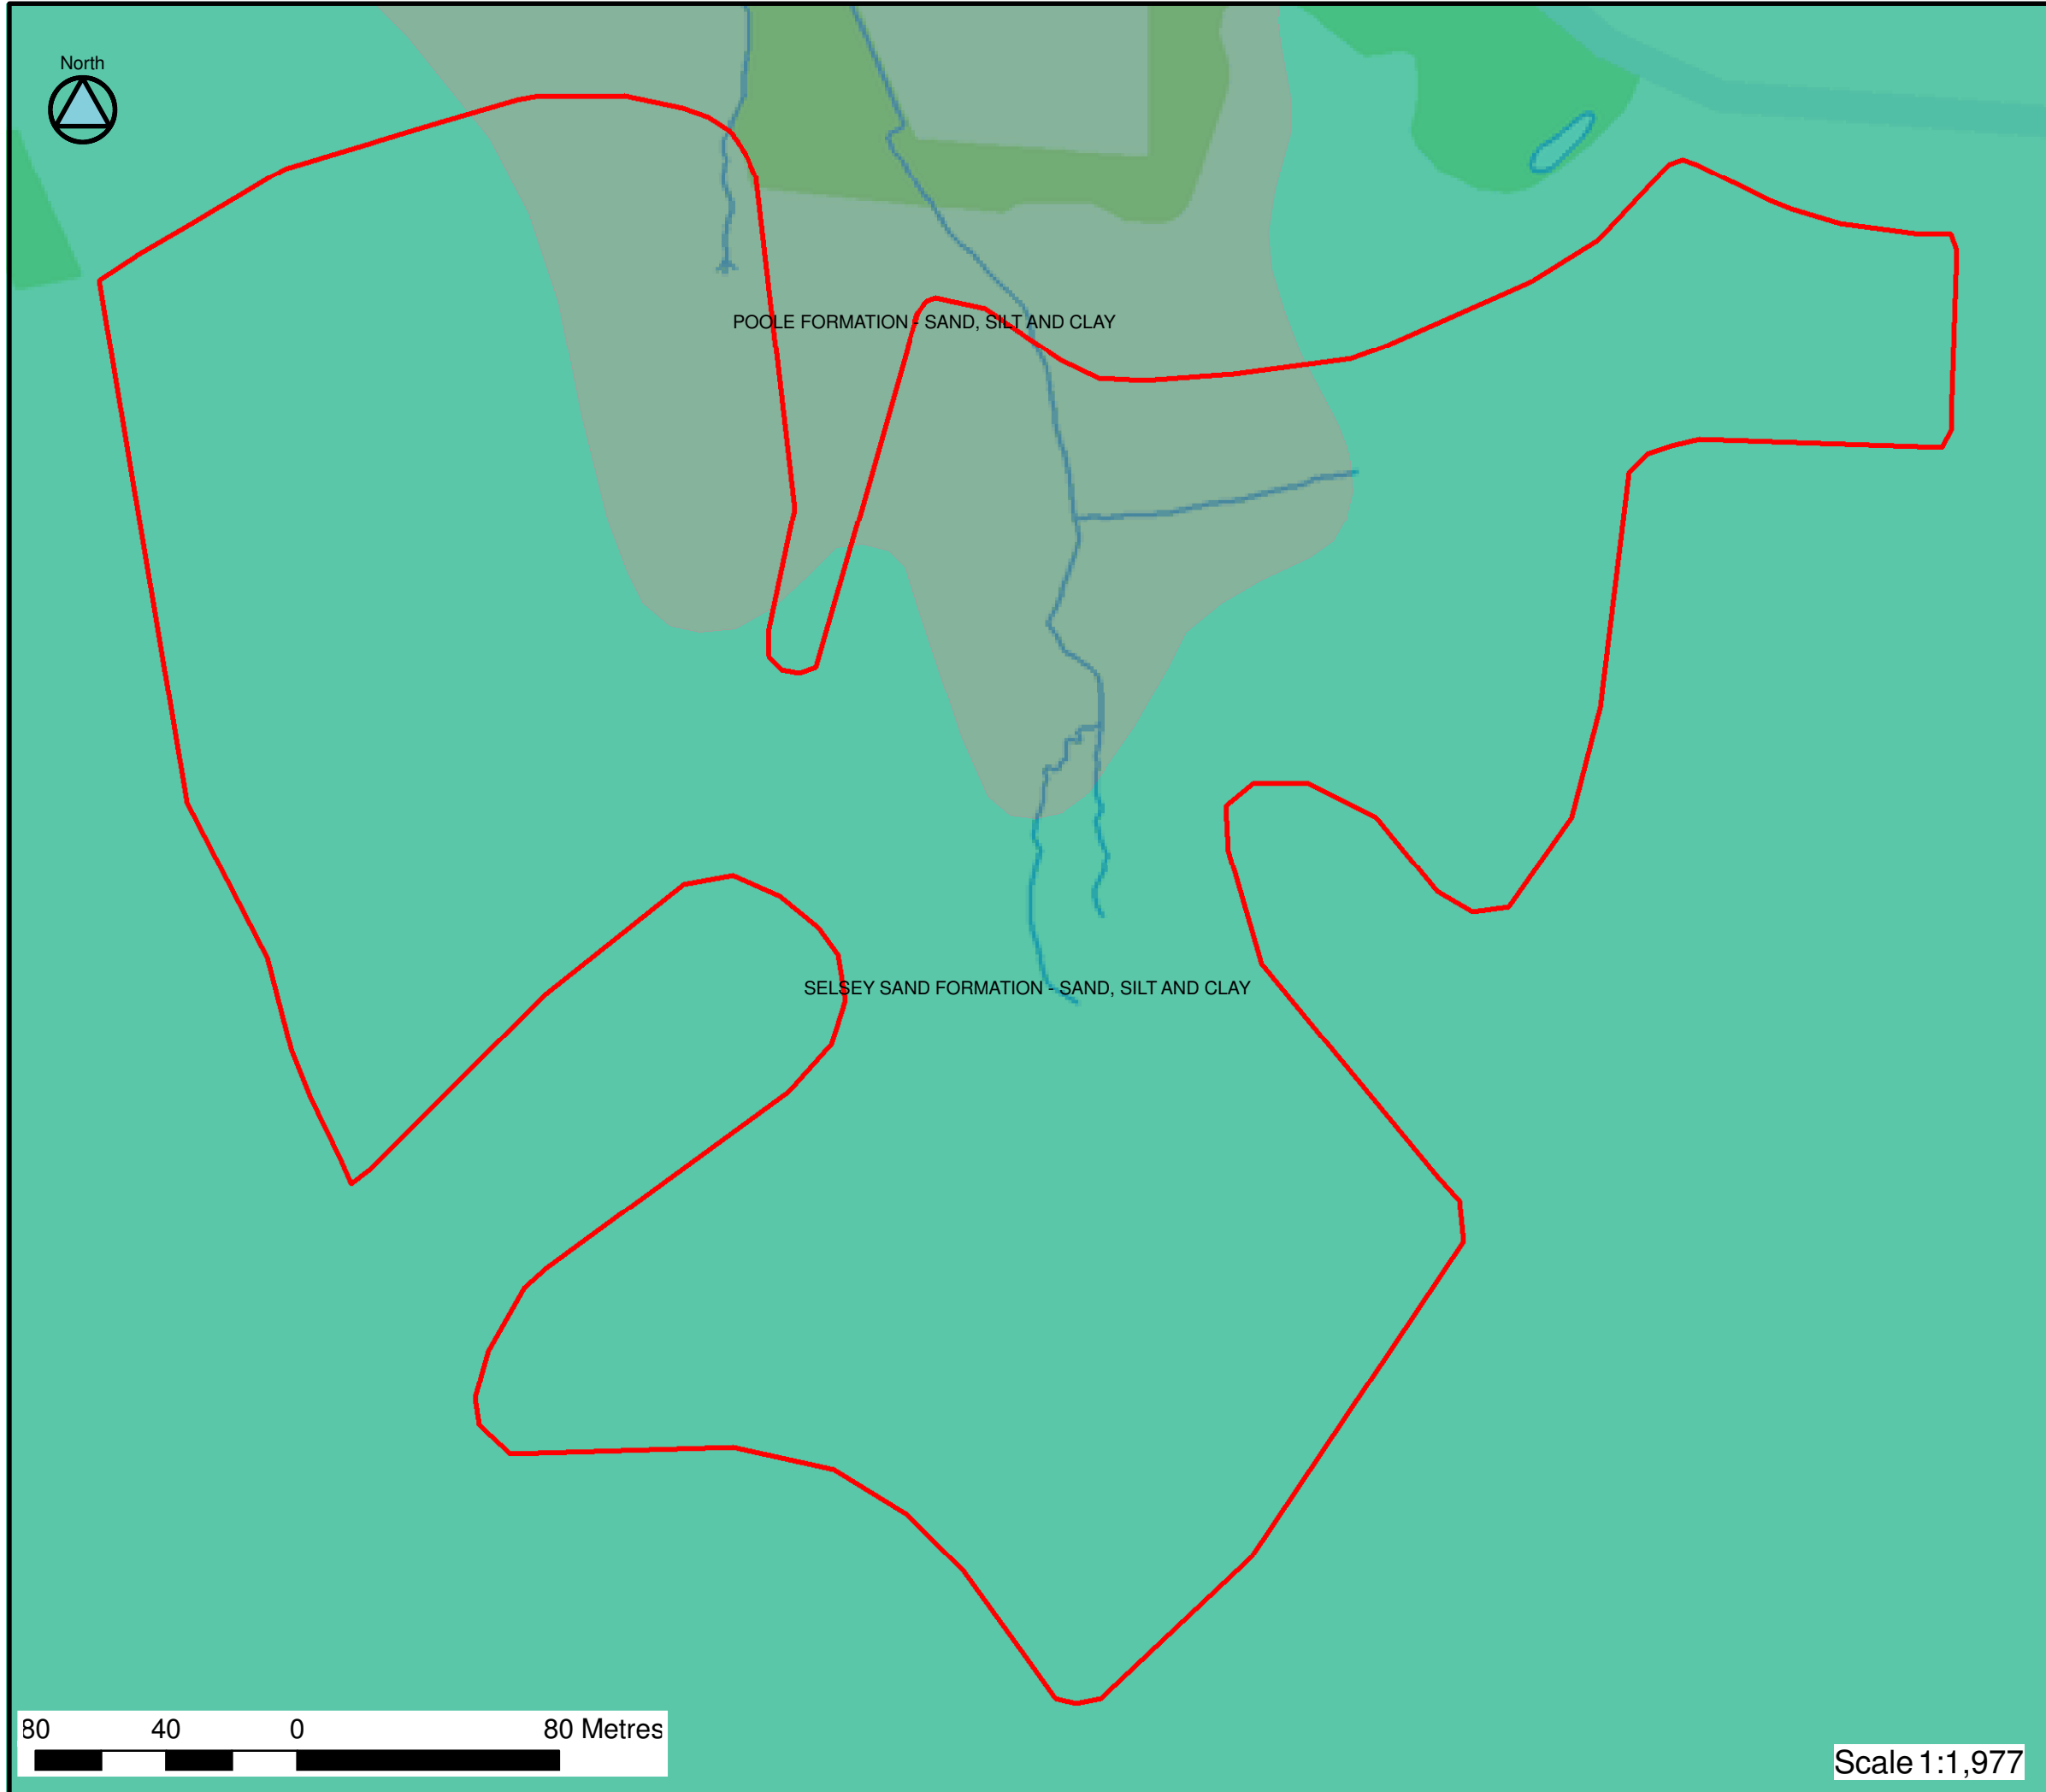
MAP 6

Bedrock Geology

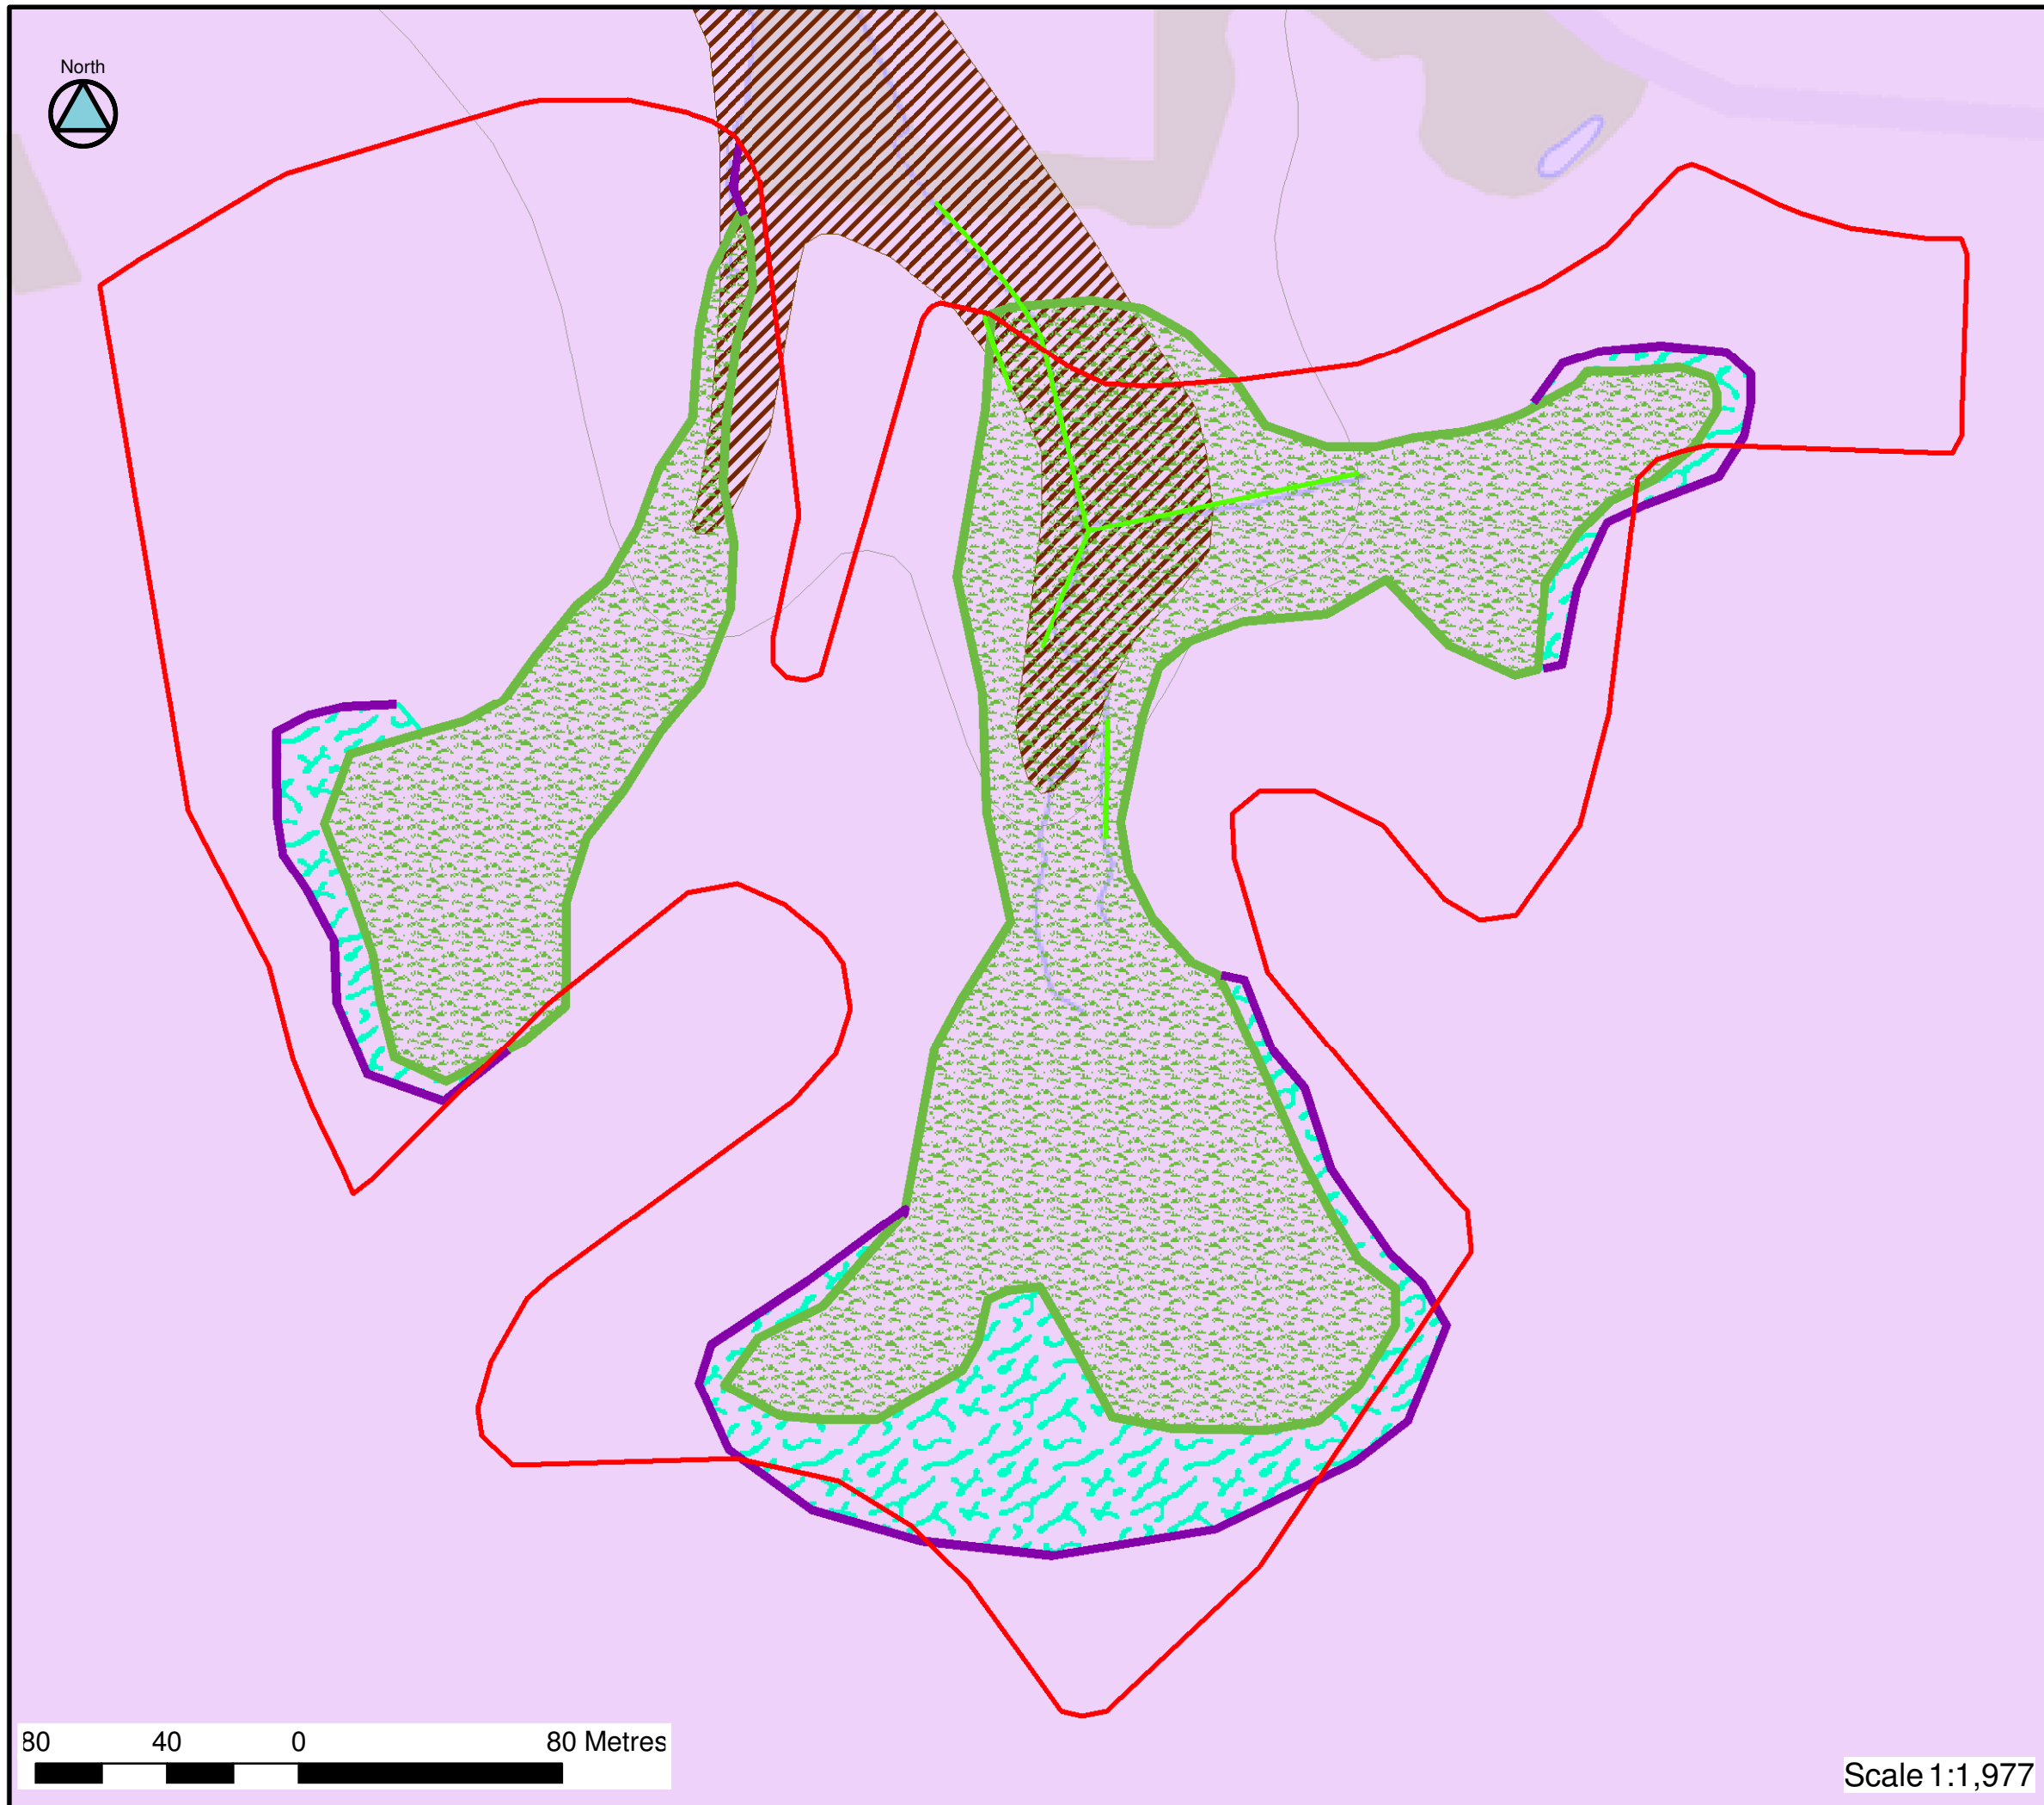
MAP 7

Eco-hydrology
