# Northey Island managed retreat

Report 5 - Results to February 1995

**Northey Island Managed Retreat  
Report 5  
Results to February 1995**

**Institute of Estuarine and Coastal Studies  
University of Hull, HULL, HU6 7RX**

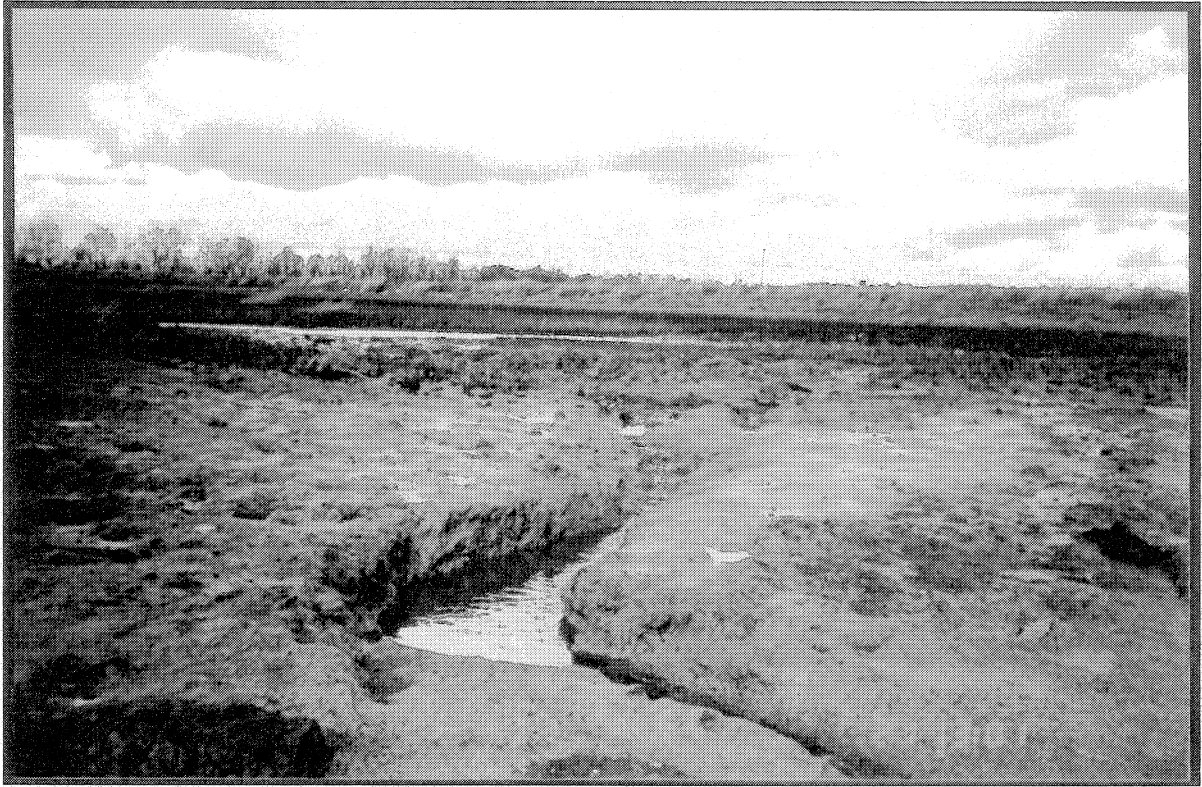
**Photograph 1: February 1995**  
From the mudflat across the spillway, showing incision of the channel

A channel started to become incised into the compacted clays of the spillway at an early stage in the site development. Photographs 1 and 2 show that this channel has become significantly deeper, with steep sides in the lower sections through the spillway itself. Further up, although now an obvious channel line, the cross section is still relatively shallow, with a series of steps longitudinally along the channel.

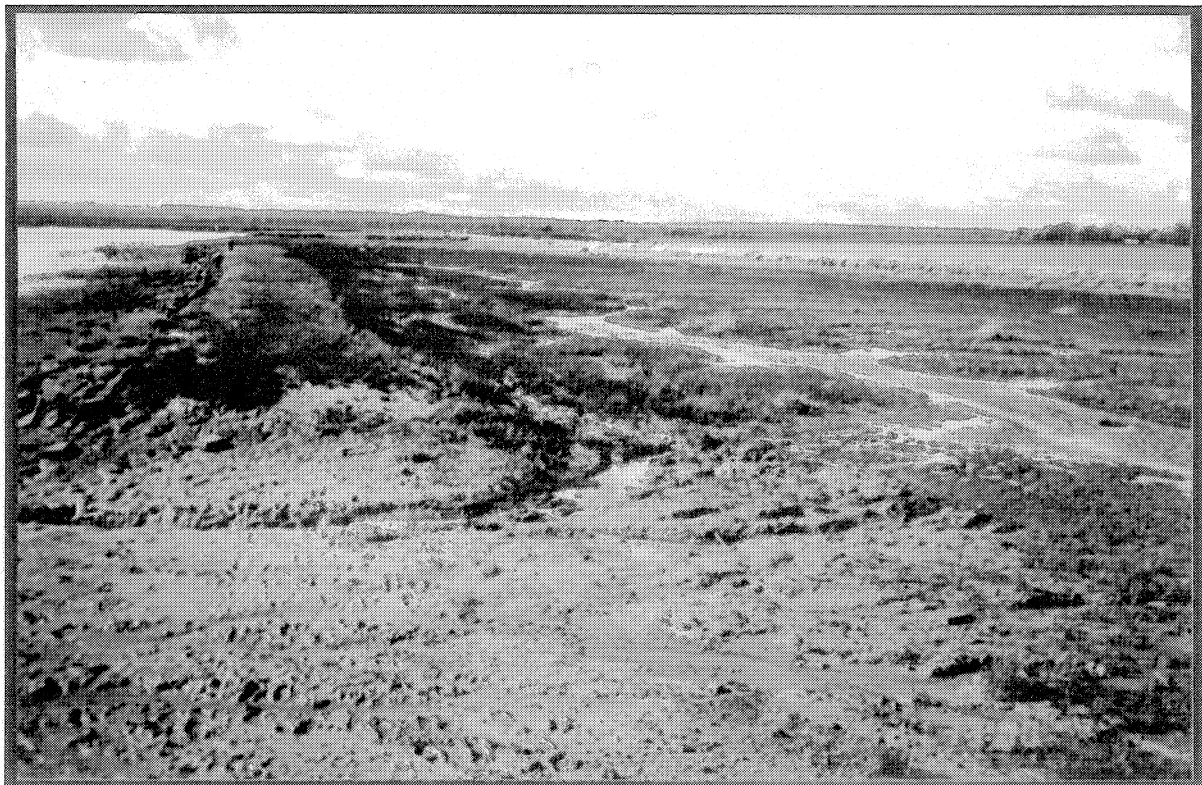
**Photograph 2: February 1995**  
Looking from east to west across the spillway. This shows that the spillway channel has not yet become connected with the 'creek'.

This suggests that development of the channel is continuing as expected, but connection to the areas of standing water within the site has still not occurred. There are now three discrete areas of standing water:

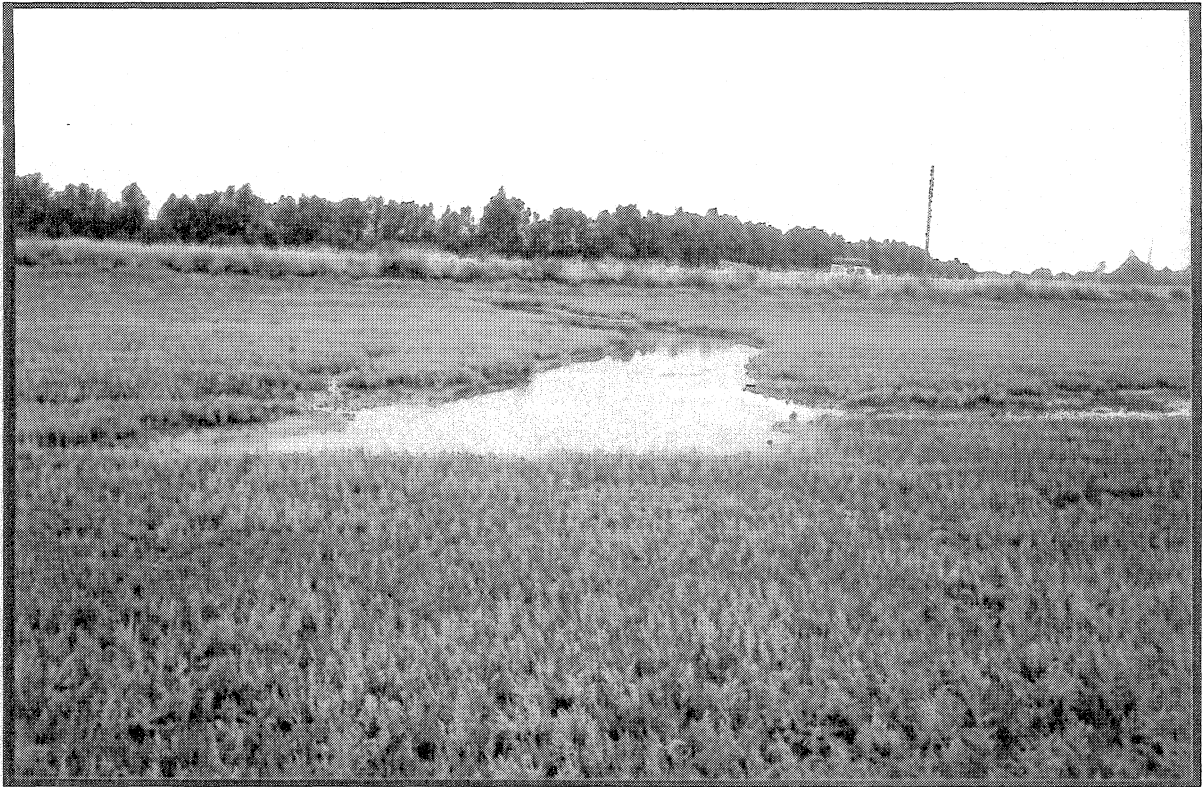
**Photograph 3: August 1994**  
Looking across the centre of the site, showing the well-defined creek edges

- the line running behind the front wall and across the centre of the site which was predicted to become the main creek (Photographs 3 and 4);

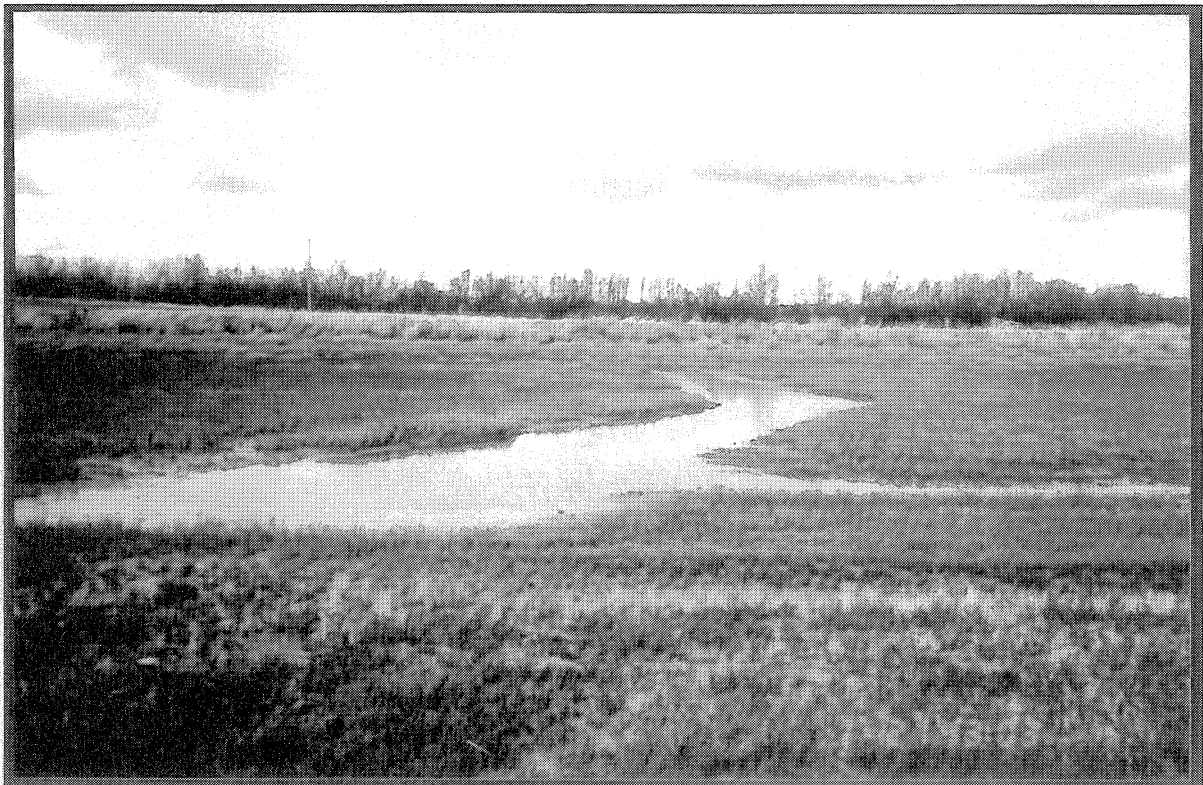
**Photograph 4: February 1995**  
As above (at a slightly lower state of the tide)

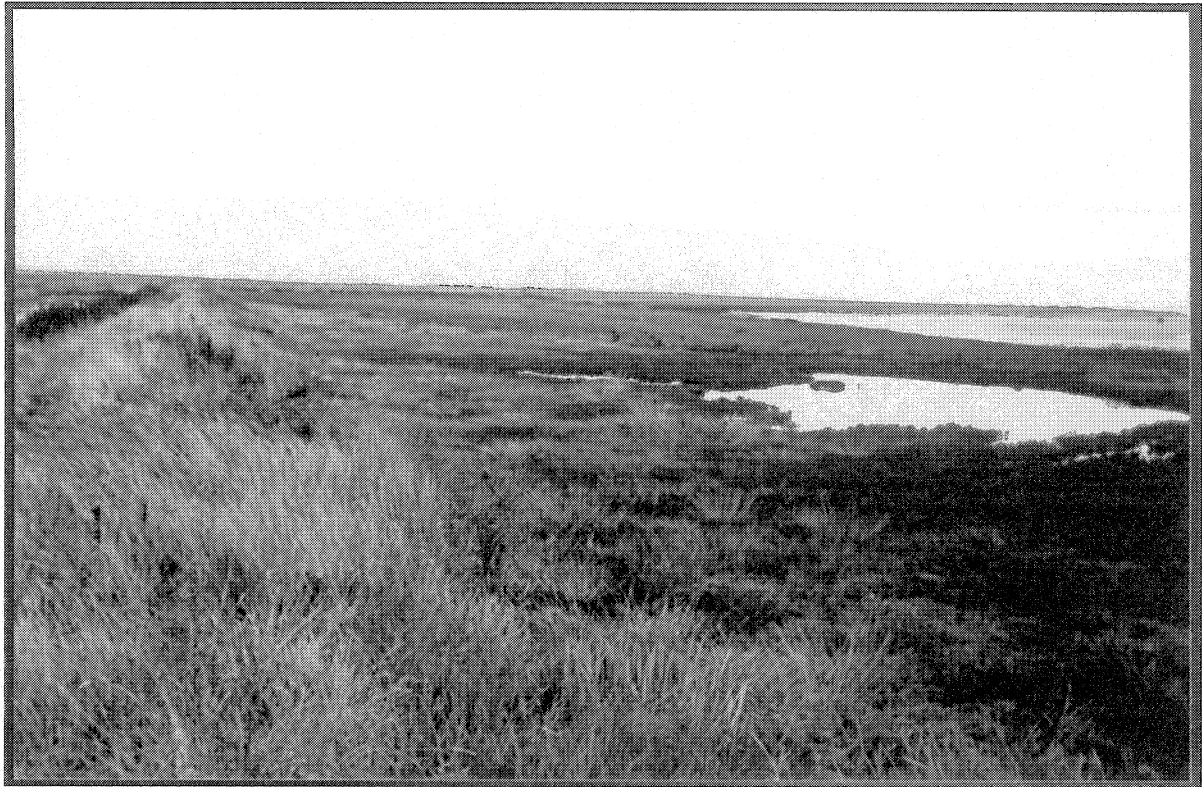
**Photograph 5: August 1994**  
From the back of the site (western end) showing large pond and degree of vegetation diversity in the higher areas

- the borrow pit of the original inner wall line running from the back of the site diagonally to the west (Photographs 5 and 6);
- a large ponded area at the western end of the site (also shown in Photographs 5 and 6).

Photographs 5, 9, 10 and 16 show the differences in vegetation patterns in different topographic situations. Along the slightly higher areas at the back of the site (Photographs 5, 9 and 16) the vegetation is more diverse and significantly more vigorous than across the majority of the site which is dominated by annual *Salicornia*. Similarly, towards highest portion of the site in the western corner the vegetation becomes progressively more dominated by grasses. Along the levee at the back of the borrow pit which runs diagonally across the western end of the site the vegetation is again more diverse and more vigorous as shown in Photograph 10. This is contrasted by sparse colonisation along the consolidated sediment seen in the front of the photograph. The steep sides of the levee are also shown in this photograph.

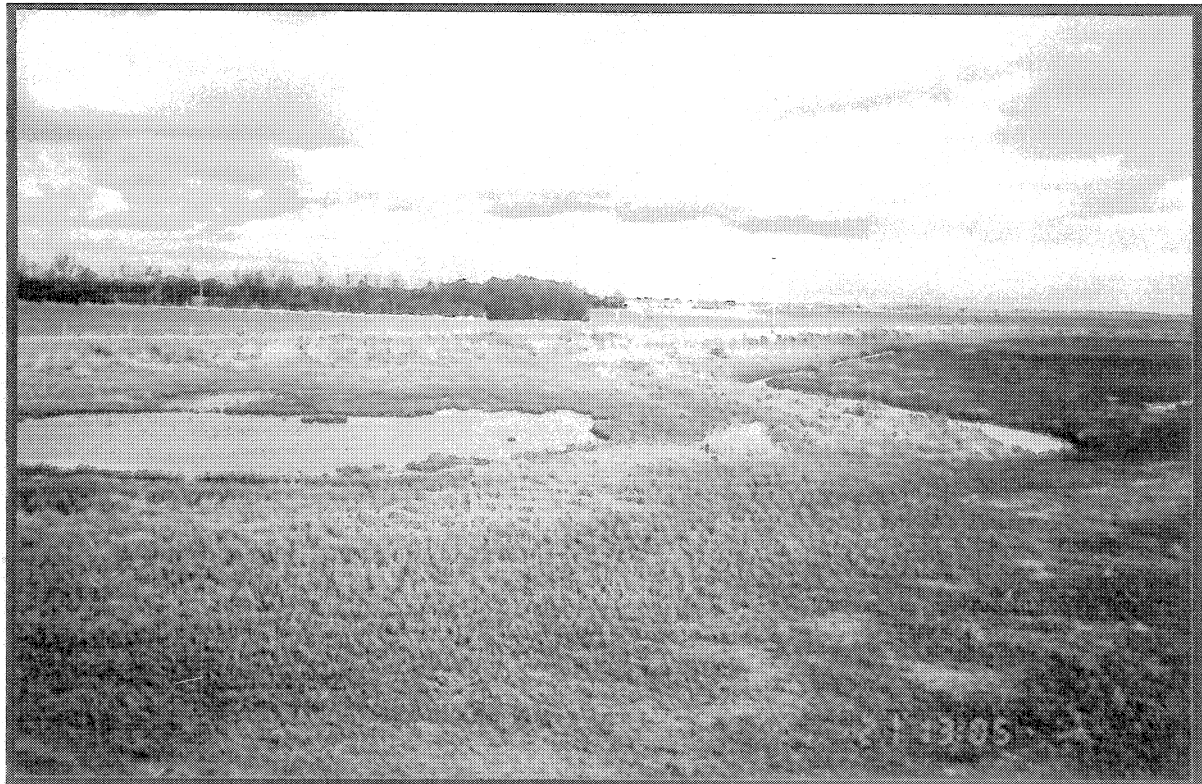
**Photograph 6: February 1995**  
From the front of the site (western end) showing inner borrow pit and large pond

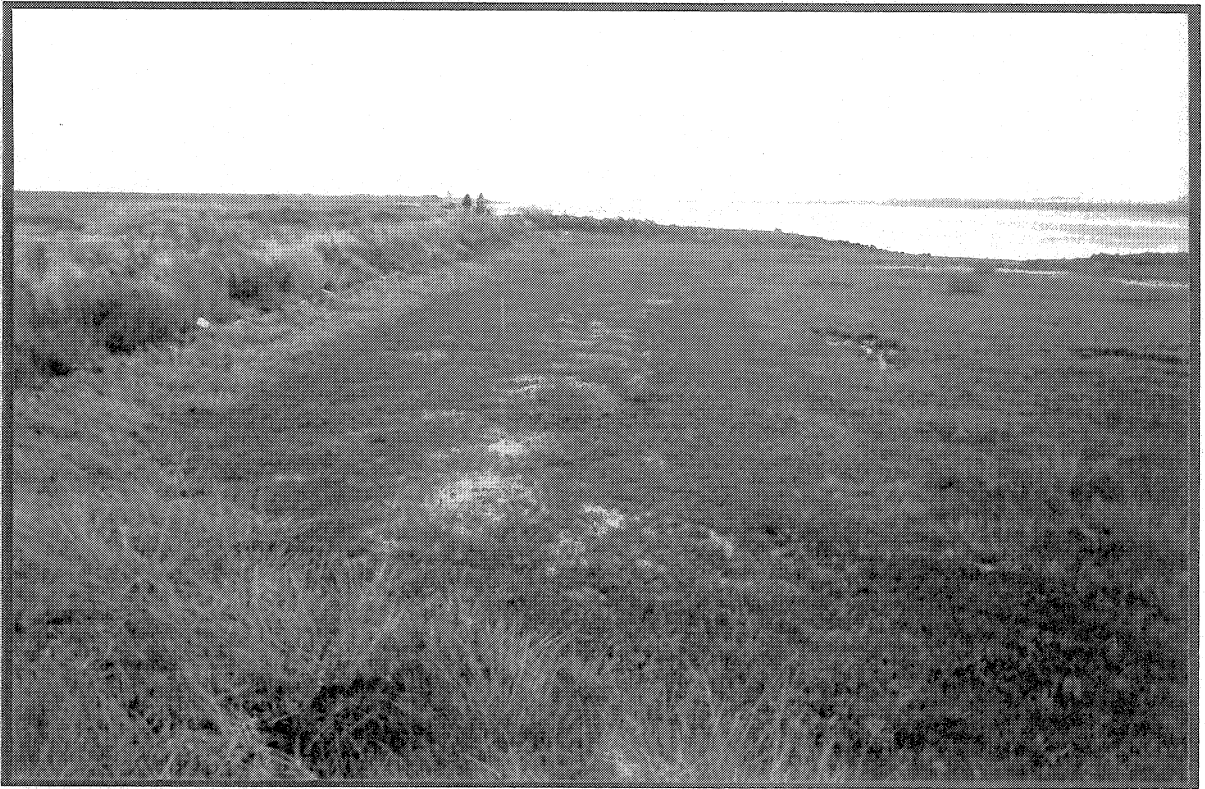
**Photograph 7: August 1994**  
From the back of the site (eastern end) showing increased degree of *Salicornia* colonisation since previous year

The photographs of the site taken in the summer of 1994 show the extent of vegetation colonisation which has occurred over the previous growing season. Photograph 7 at the eastern end of the site shows that the consolidated sediment of the borrow pits, although still more sparsely colonised than the rest of the site, now has a reasonable cover of *Salicornia*. This suggests that consolidation of the sediments delays but does not prevent vegetation colonisation, particularly by the opportunistic *Salicornia* species. Photograph 8, taken in the winter of 1995, shows that the line of the borrow pit appears to have a greater algal cover than adjacent areas which have been vegetated for longer. It is uncertain why this should be the case.

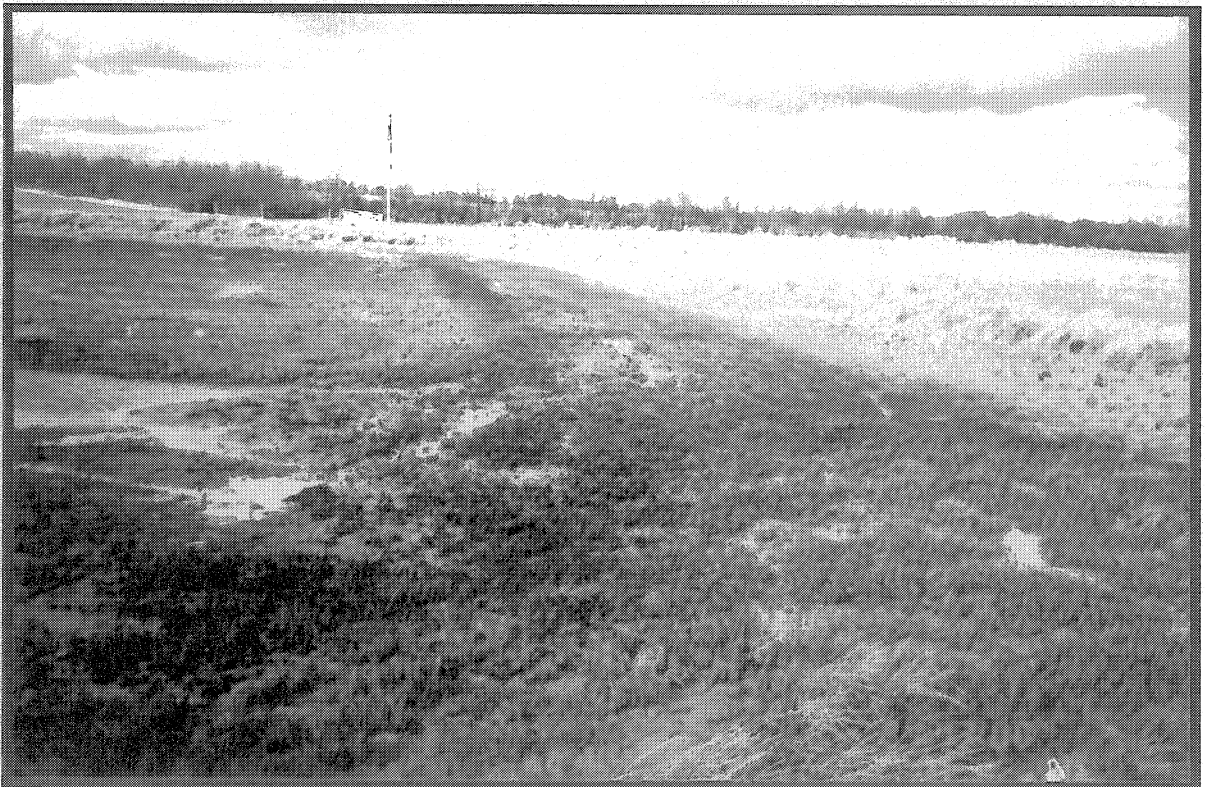
**Photograph 8: February 1995**  
From the front of the site (eastern end) showing the greater degree of algal cover along the old borrow pit line

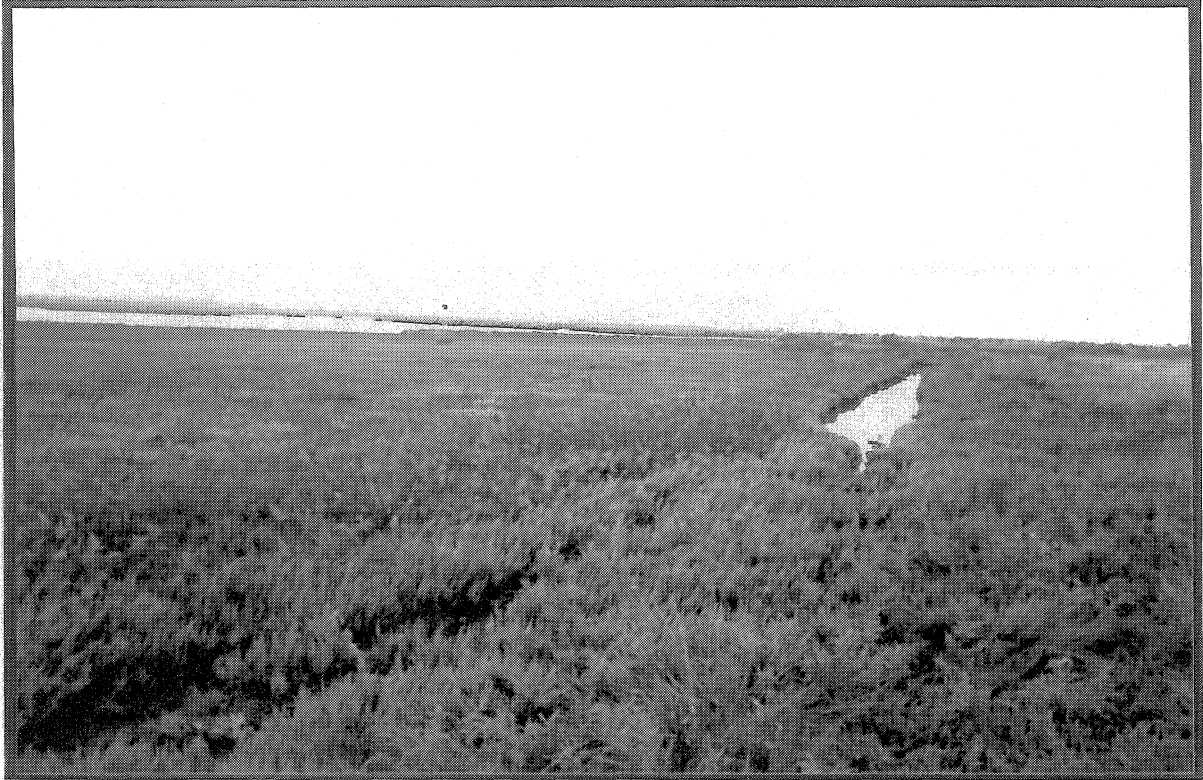
**Photograph 9: August 1994**  
Looking along the back of the site, showing the increased vigour and diversity of plants in the higher areas

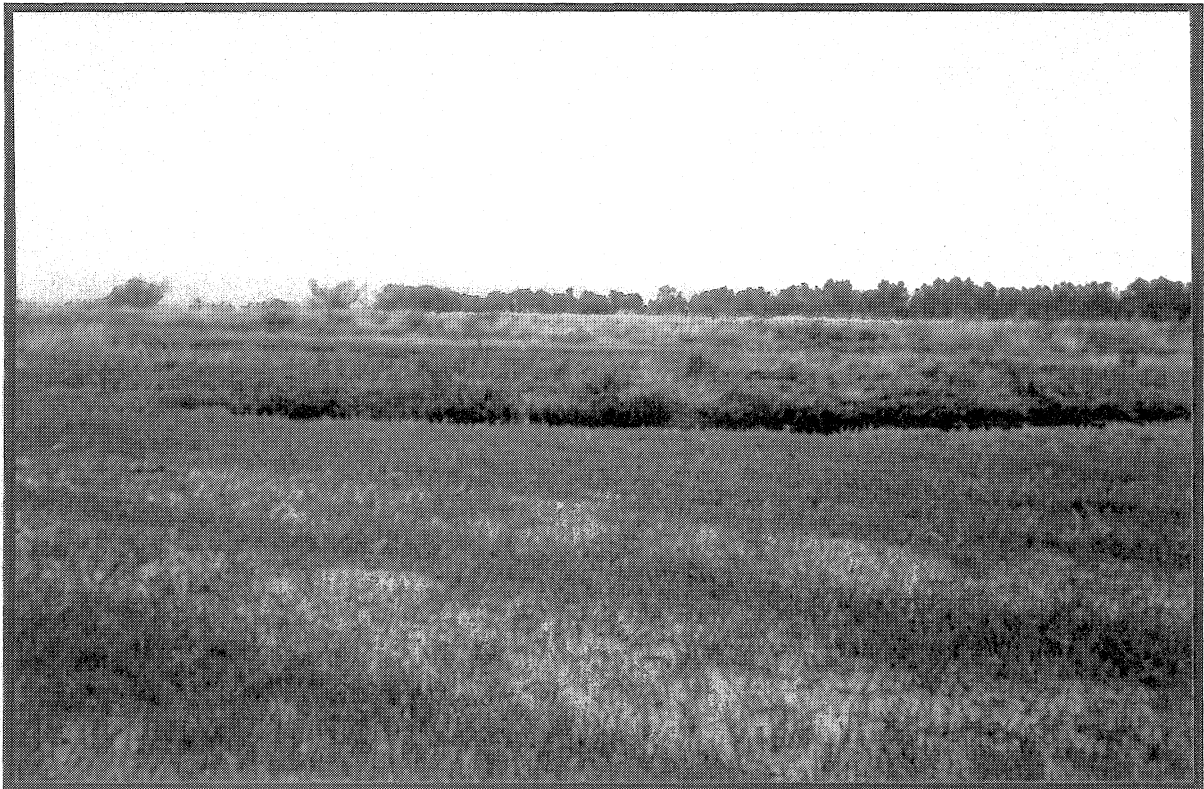
**Photograph 10: August 1994**  
From the front of the site across the inner borrow pit. Note the steep edge and degree of vegetation diversity along the levee

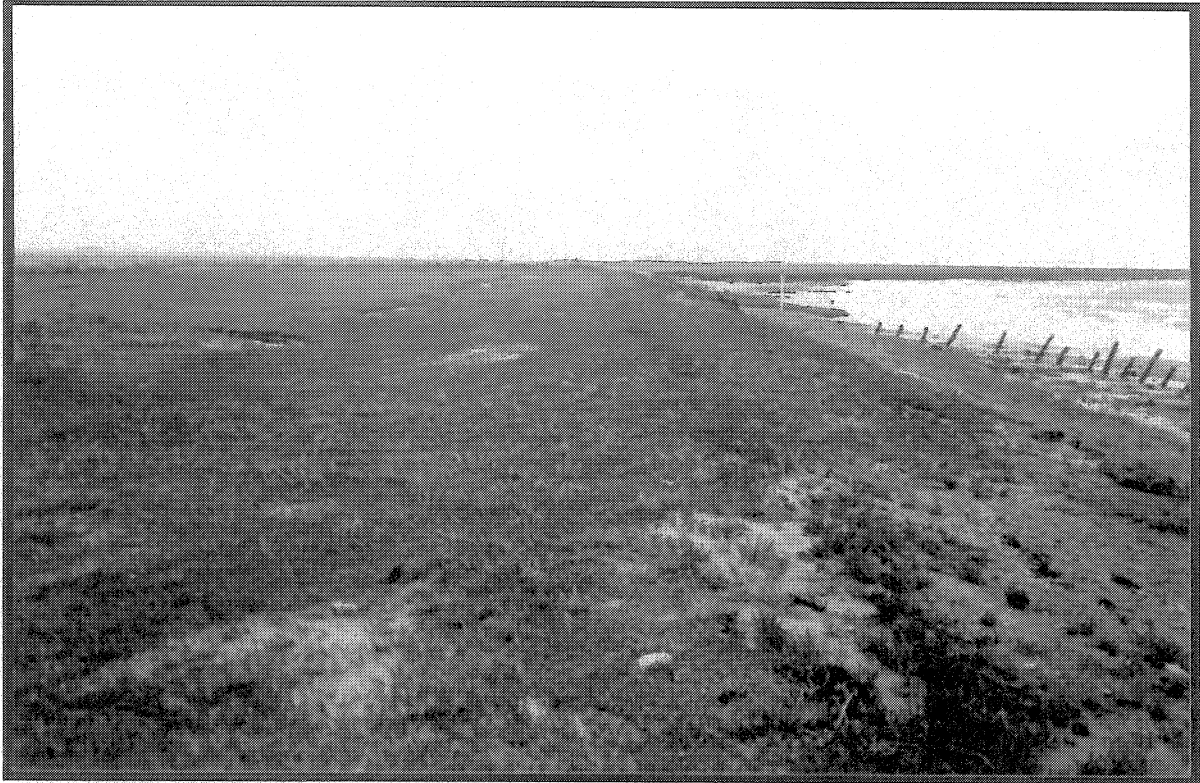
**Photograph 11: August 1994**  
Looking along the front sea wall. Note vegetation colonisation on wall top and *Spartina* (new areas?) on the foreshore

Conditions have been sufficiently favourable up to the summer of 1994 to allow *Salicornia* also to colonise the lowered front wall as seen in Photographs 11 and 12. These photographs also show that the fronting mudflats are being colonised by patches of *Spartina*. This suggests that the wave climate outside the wall may have been reduced with the removal of the sea wall and its fronting blockwork. Continued observations will be made of any further development of the marsh outside the retreat site.

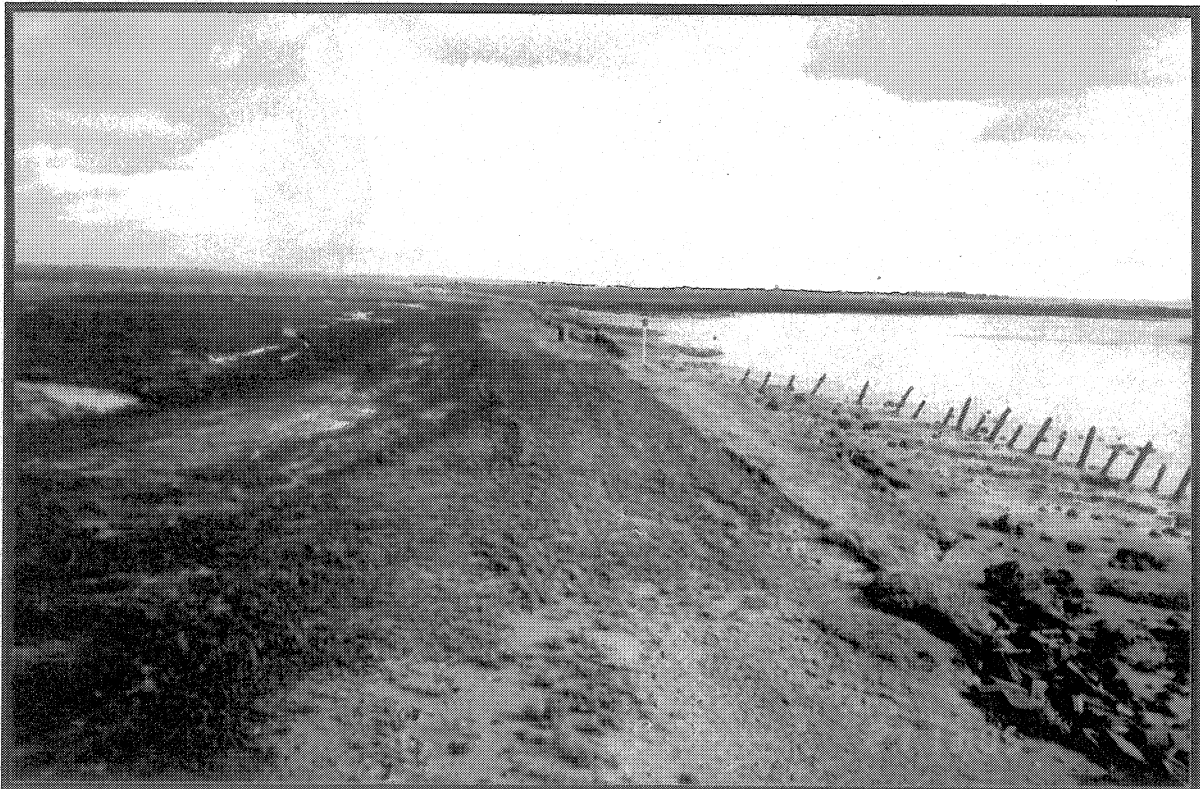
**Photograph 12: February 1995**  
As above

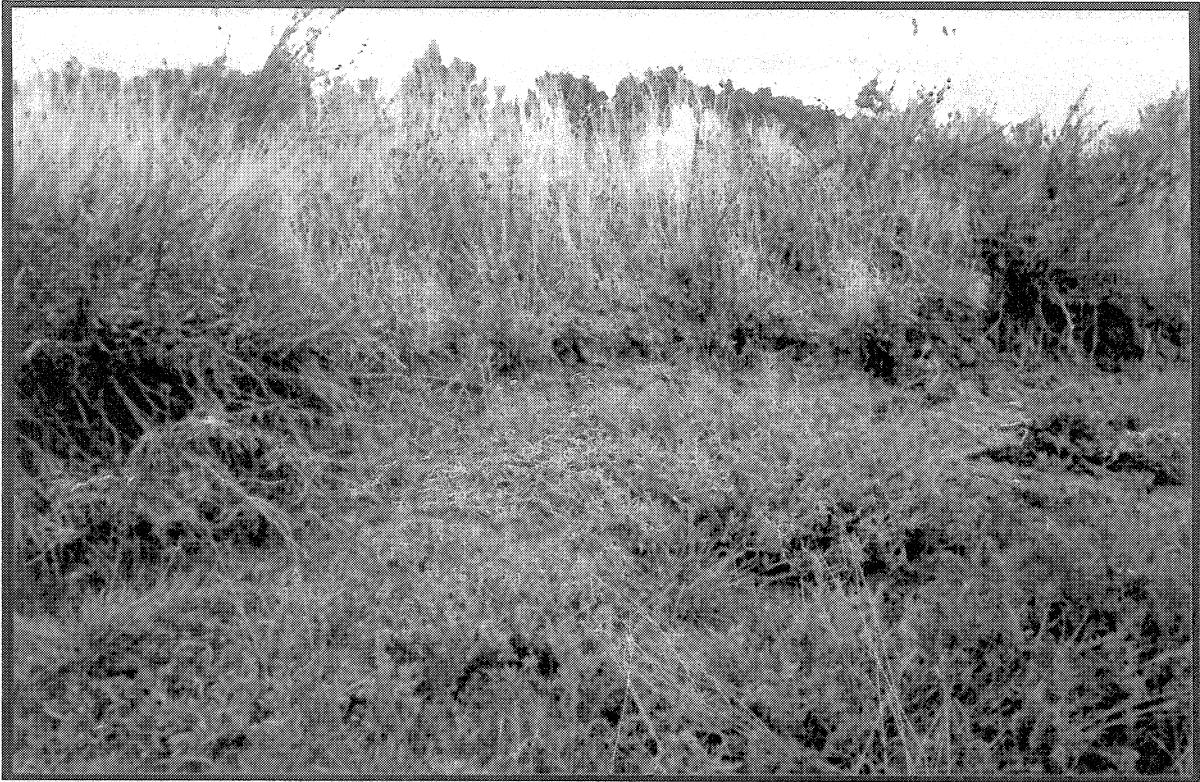
**Photograph 13: August 1994**  
Erosion of sea wall at the head of the transverse creek

Although there are signs of minor erosion along several parts of the inner walls the most significant area occurs at the head of the main creek line as reported in report 4. The extent of the erosion is seen in Photographs 13 and 14. It is believed that the permanent presence of standing water along this creek line is contributing to this erosion, allowing internally-generated waves to reach this portion of the wall at most states of the tide.

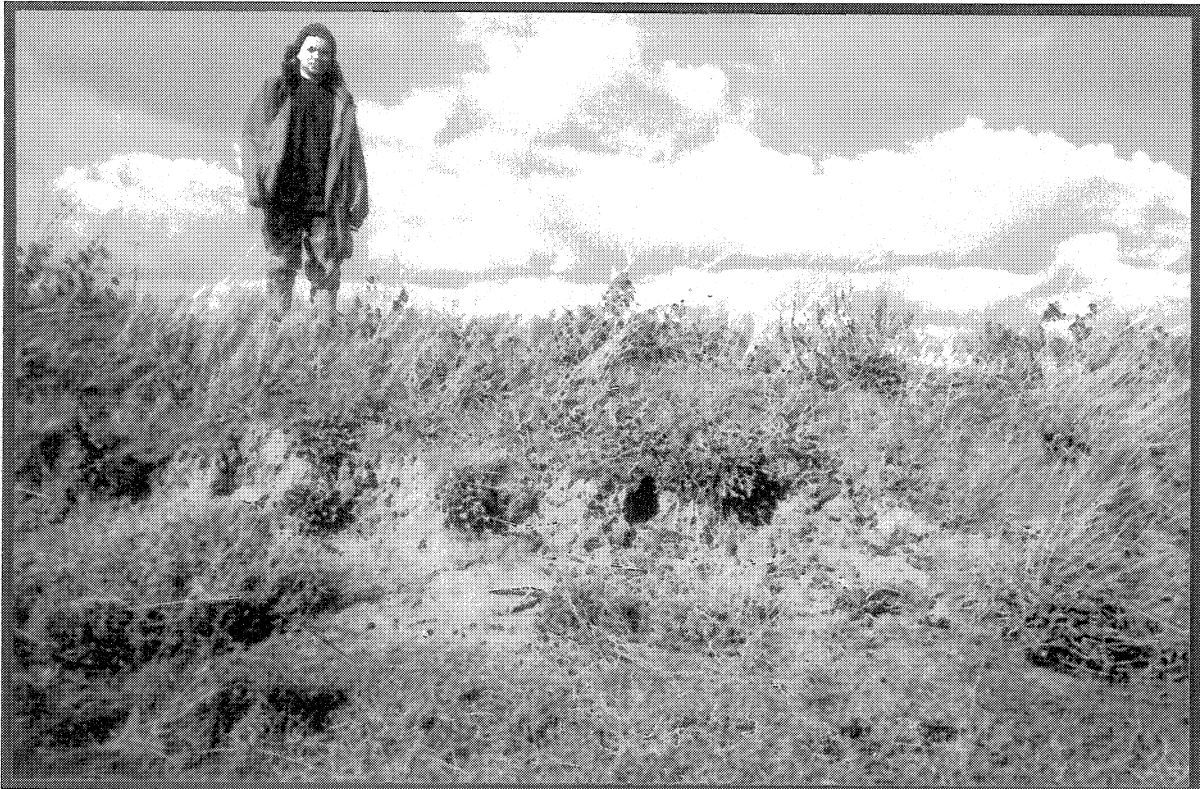
**Photograph 14: February 1995**  
As above

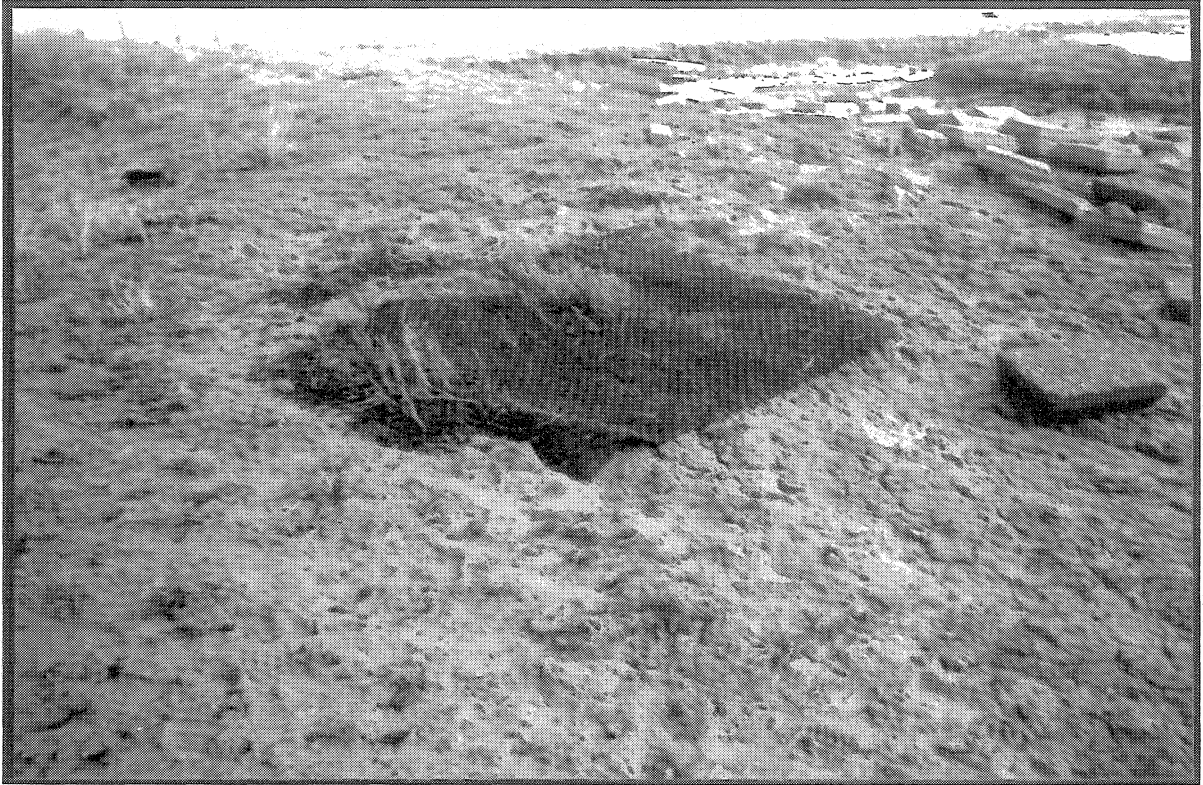
**Photograph 15: February 1995**  
Erosion of sea wall adjacent to the spillway exposing geotextile fabric

A further area of erosion is located on the eastern side of the wall adjacent to the spillway as seen in Photograph 15. Here the wall has eroded back sufficiently to expose the stabilising geotextile fabric. It is unknown whether this geotextile has been recently utilised in an attempt to stabilise the wall, or whether this was an original part of the wall construction.

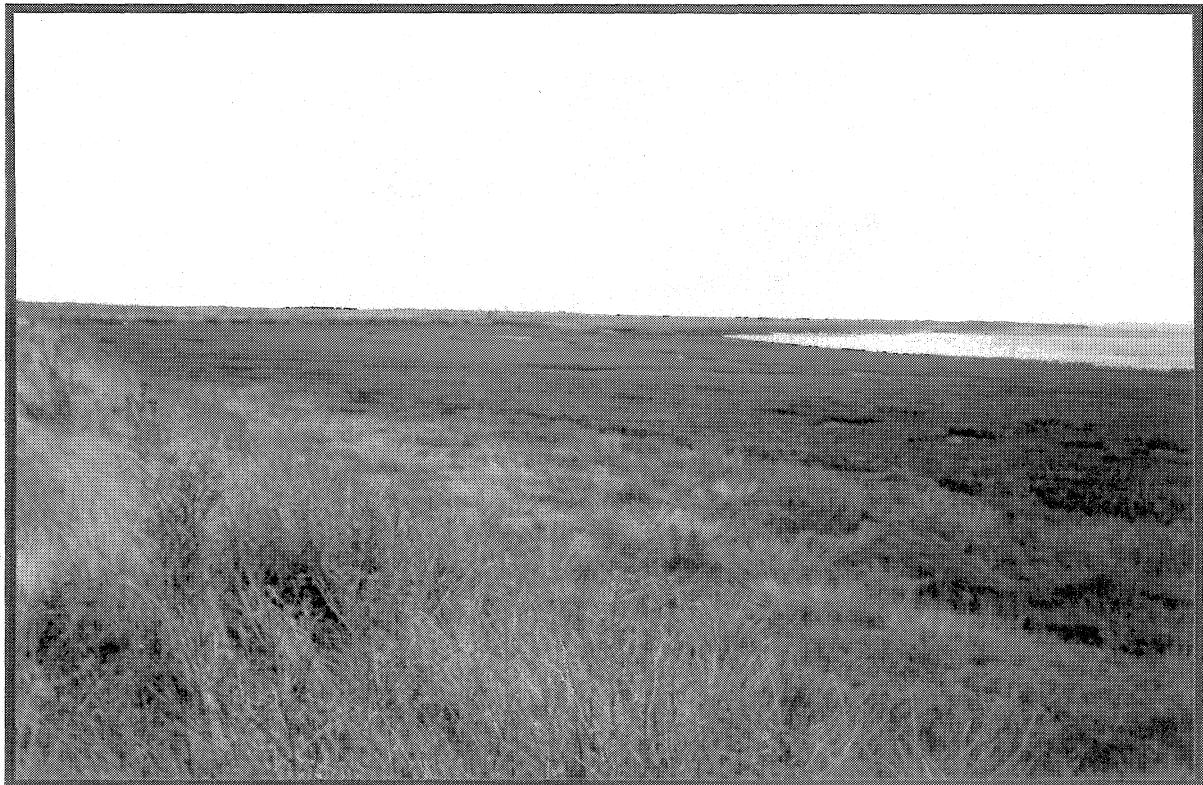
**Photograph 16: August 1994**  
Possible development of 'pan' structures within the newly vegetated marsh

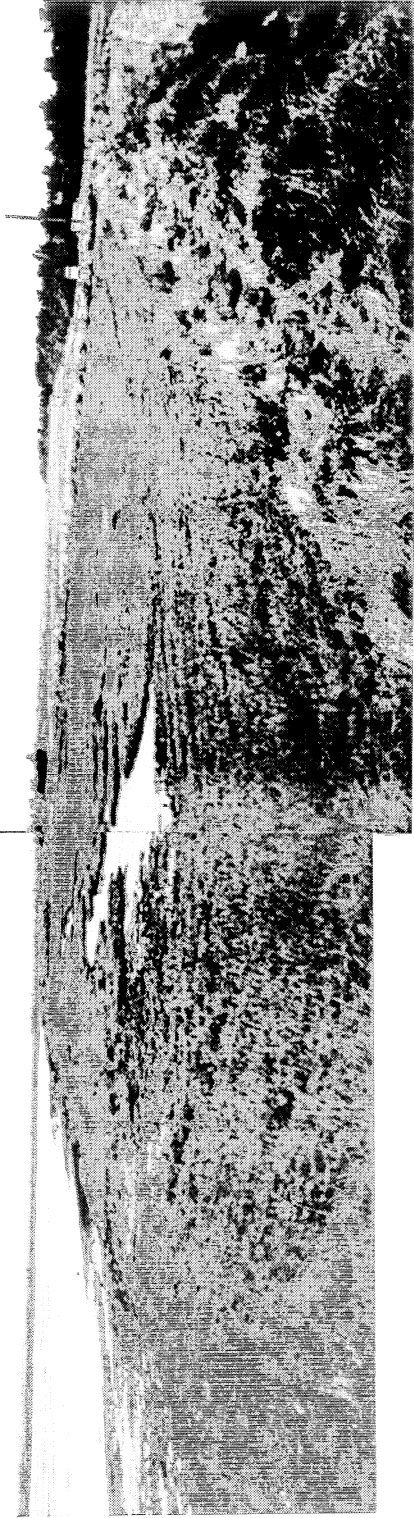
**Photograph 17: August 1994**  
General view across the site looking west from the spillway corner

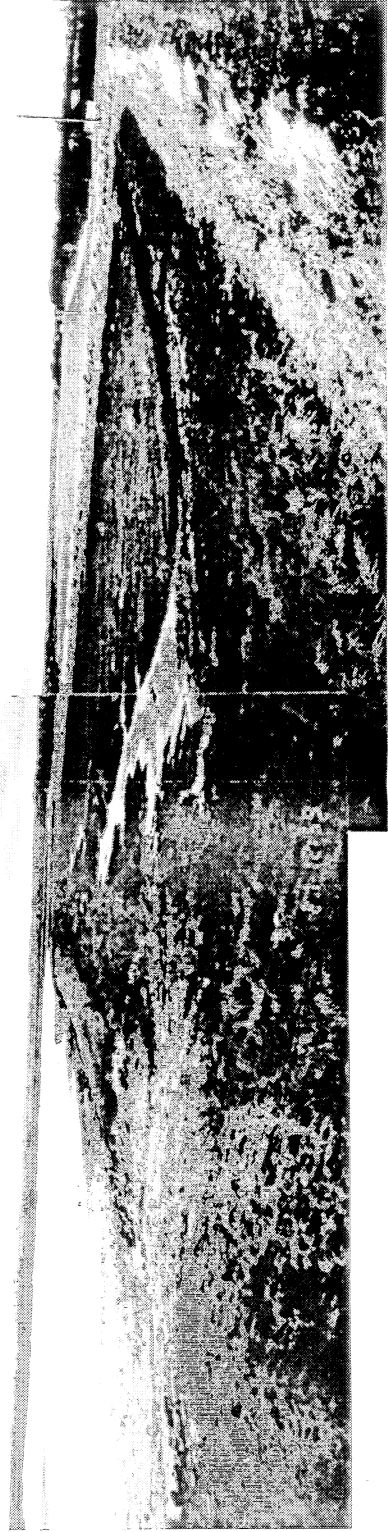
**Photograph 18: February 1995**  
Similar general view for comparison. Both views may be compared with Plates 15 and 16 in report 4 to show general site development
