Survey and analysis of vegetation and hydrological change in English dune slack habitats

Annex 2 - Site report for Sefton Coast: Ainsdale NNR, Ainsdale
LNR, Birkdale Hills LNR

First published 14 August 2014

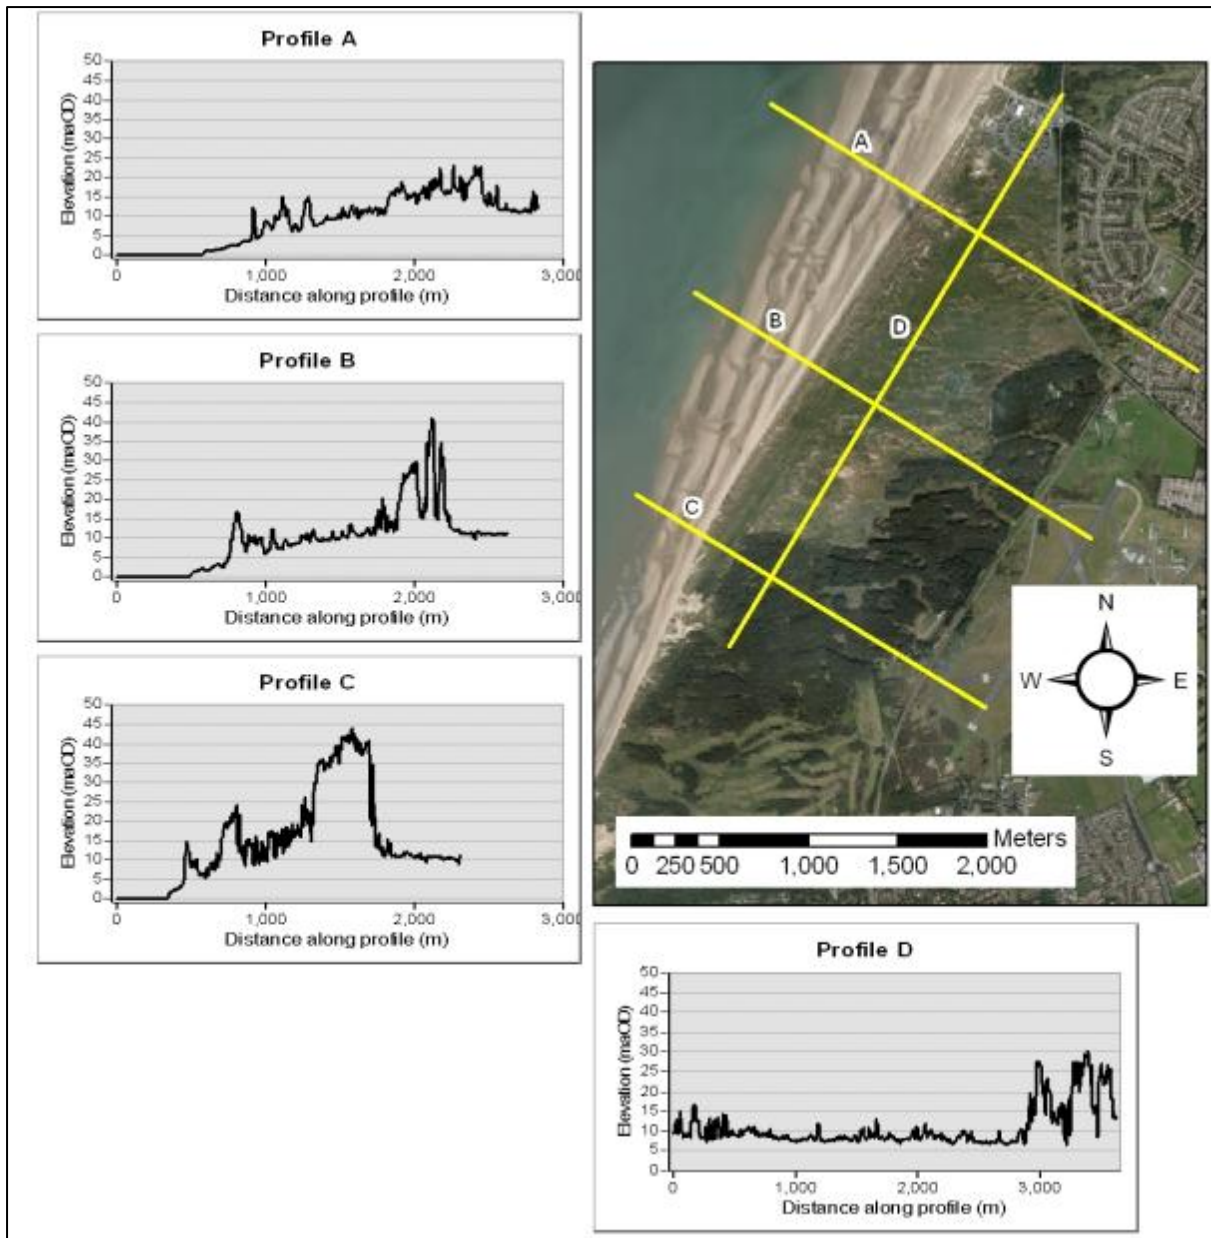
Figure 3. Elevation profiles at several locations along Ainsdale NNR and Ainsdale LNR. Values represent the elevation of the top surface, not the ground surface, so are affected by vegetation height. This is particularly noticeable in profiles B and C. © NERC (CEH) 2013, © Next Perspectives.

Ainsdale dunes is a hindshore system with a frontal dune ridge rising to an elevation of ~15 m AOD. Behind the frontal dunes, the dune floor elevation is between 5 and 7 m AOD, and this rises inland to an elevation of ~15 maOD. The north of the site is largely unforested, whilst pine forest covers a large proportion of the south of the site. The elevation of the tops of the trees is illustrated in Figure 3, profiles B and C.

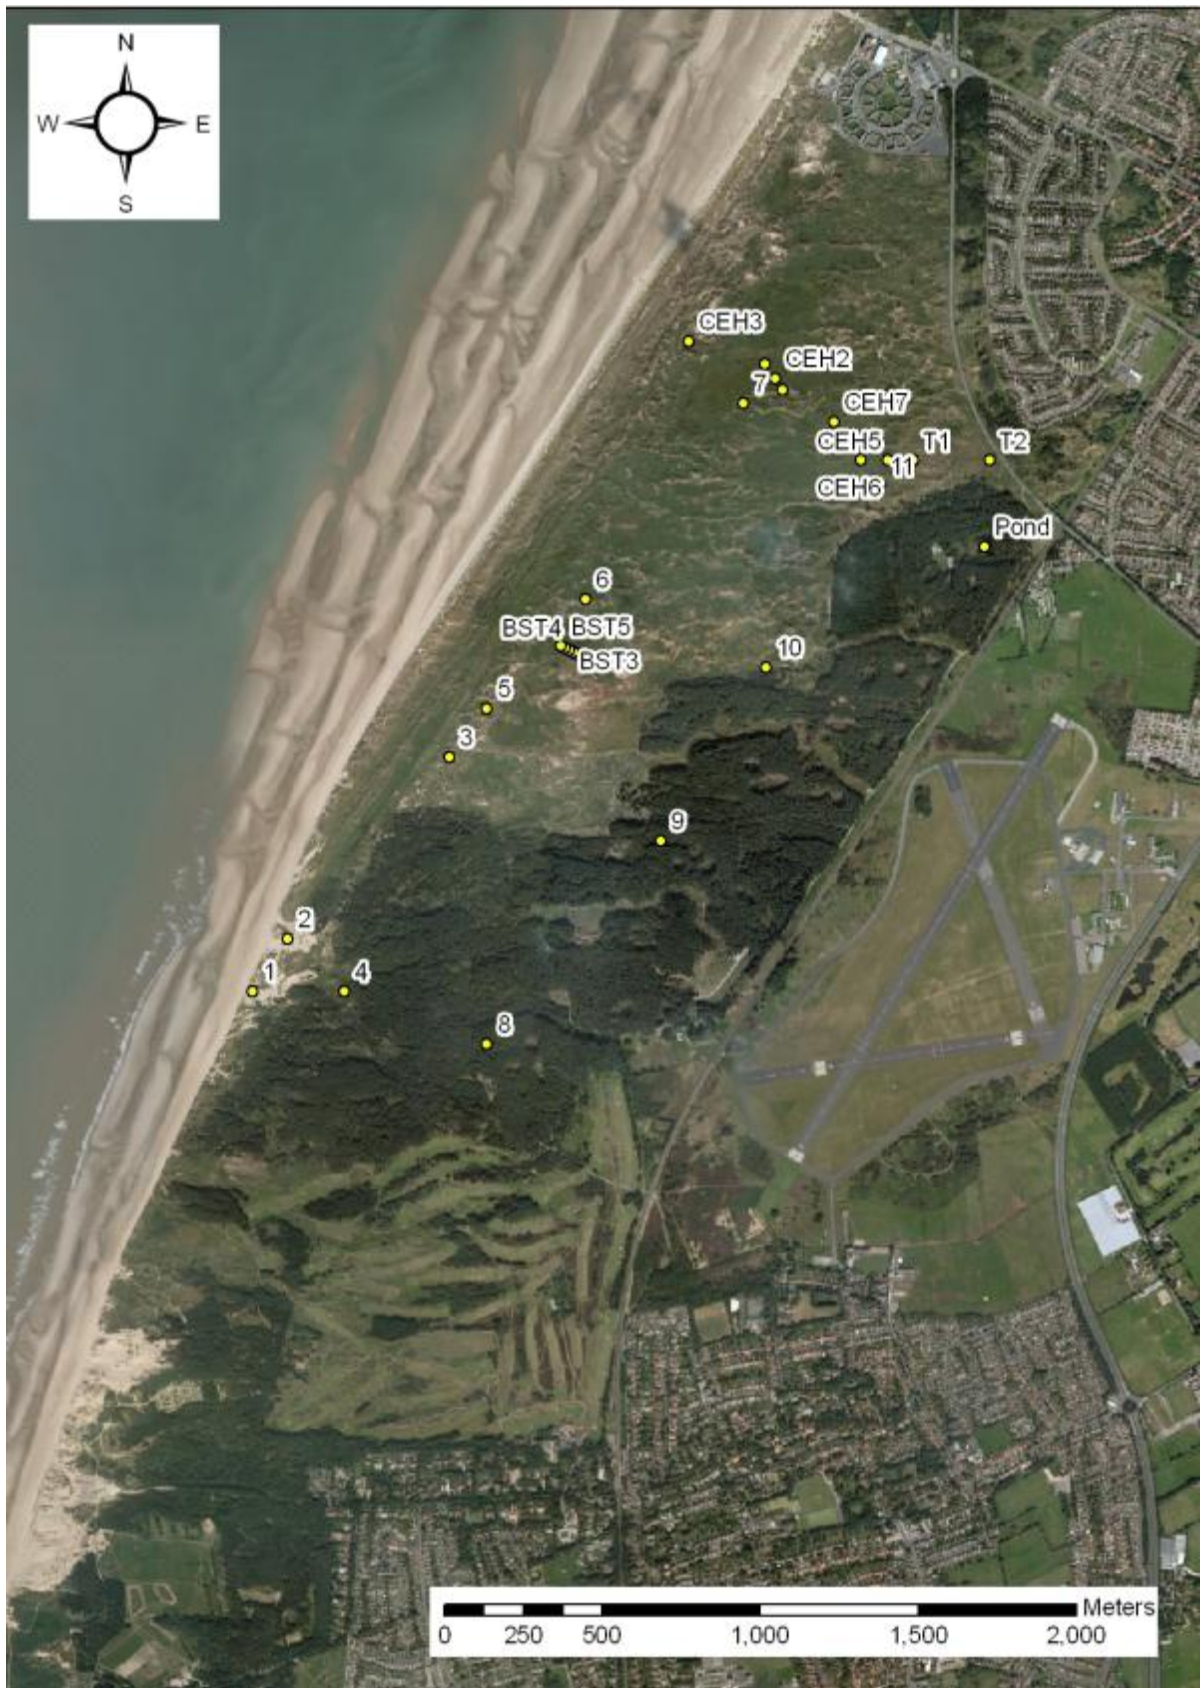
Figure 5. Dipwell monitoring network at Ainsdale NNR and Ainsdale LNR. © NERC (CEH) 2013, © Next Perspectives.

This hydrological summary focuses on the Ainsdale Sands area of the Sefton Coast and is based almost entirely on the work of Derek Clarke, who installed a network of dip wells in 1972 (Figure 5) and has overseen the monthly monitoring of water table levels ever since. For more detail, the reader is recommended to refer to the following publications: Clarke (1980), Clarke and Pegg (1992), Clarke and Sanitwong (2007), Clarke and Sanitwong (2010), Clarke and Stratford (2011) and Stratford *et al.* (2013b).

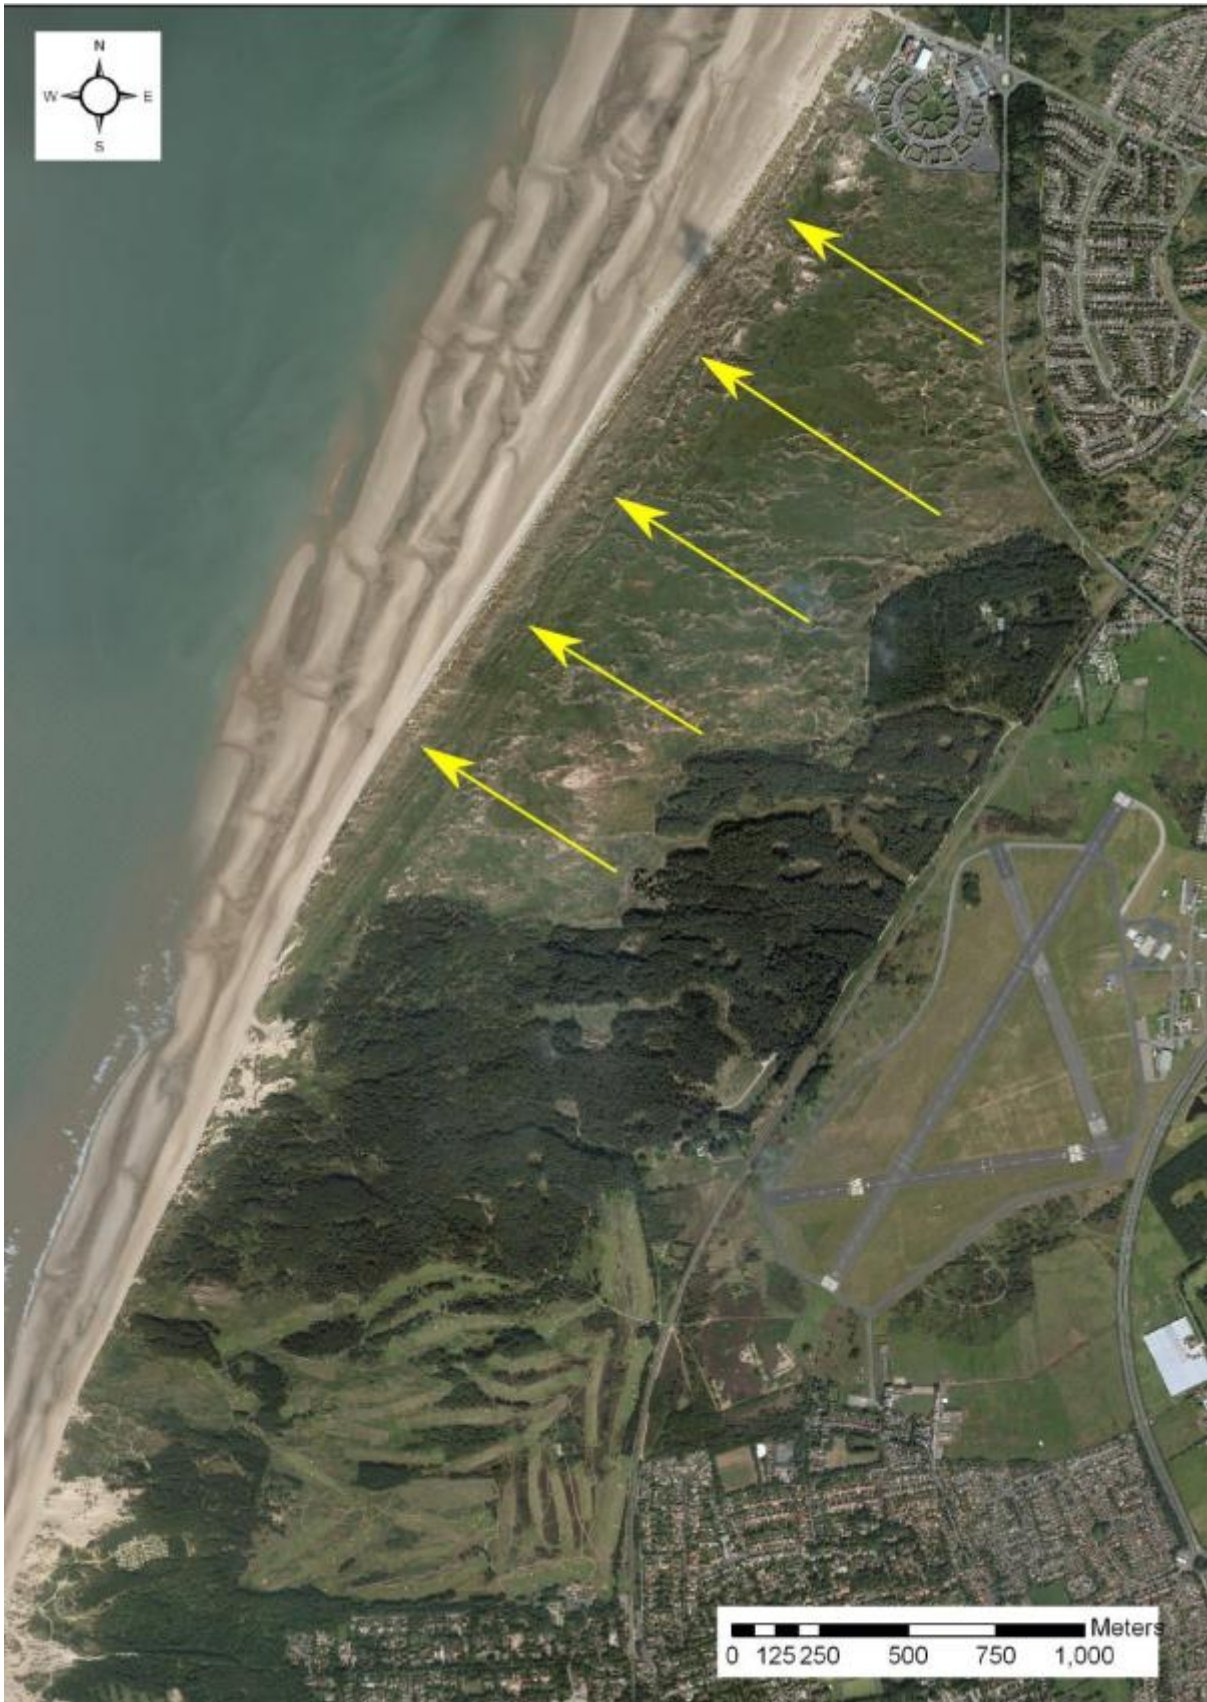
Figure 6. Ainsdale NNR and Ainsdale LNR conceptual groundwater flow diagram. The yellow arrows indicate the direction of groundwater flow. © NERC (CEH) 2013, © Next Perspectives.

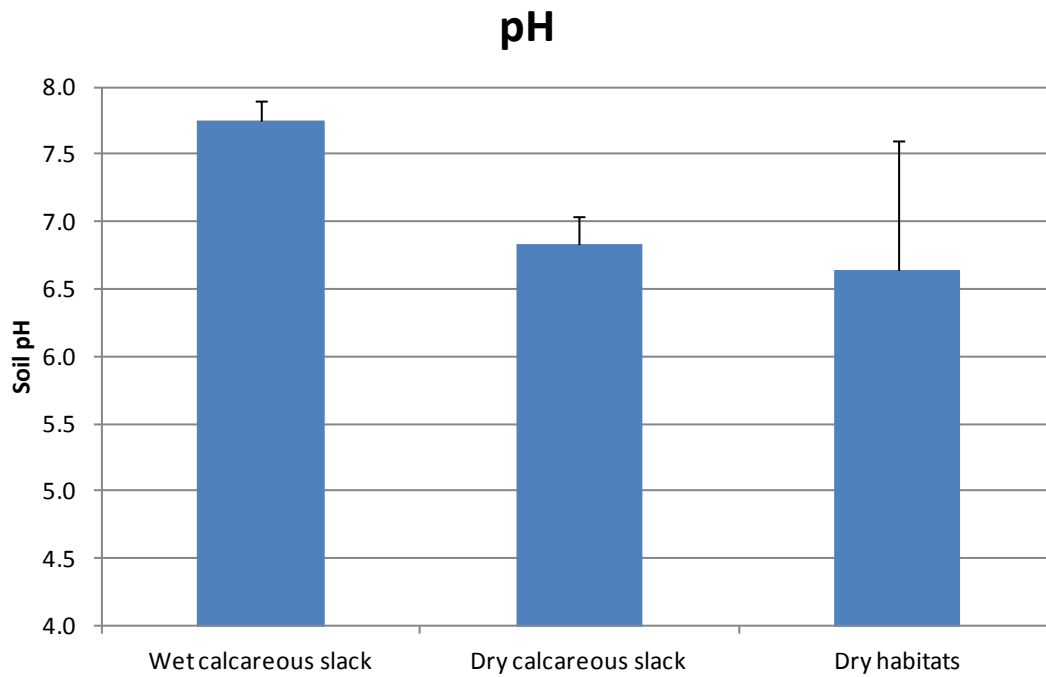
Figure 7. Ainsdale NNR. Soil pH, by broad vegetation type.

Soil pH (Figure 7) was highest in the wet calcareous slacks, where the soil is well buffered by the groundwater. Soil pH was below 7, and approaching the level of pH 6.5 at which one would expect decalcification. It is likely that surface soil pH is already below 6.5, since these are measures of pH of the full soil profile to 15 cm.

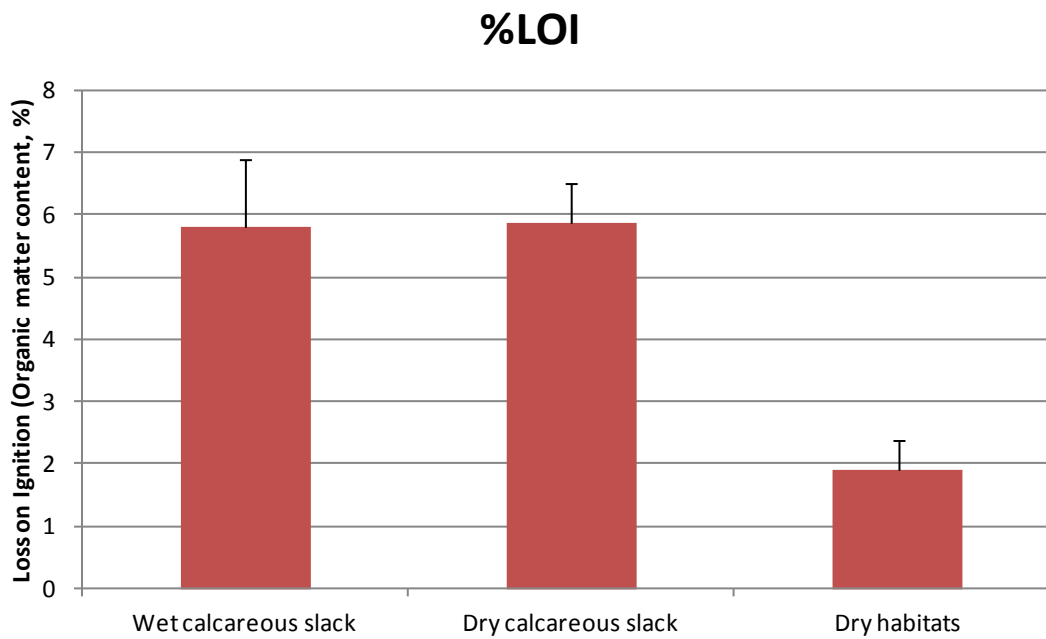
Figure 8. Ainsdale NNR. Organic matter (as Loss On Ignition, %), by broad vegetation type.

Organic matter contents (Figure 8) are reasonably high in the slack vegetation types, around 6%, but are much lower in the dry habitats, around 2%.

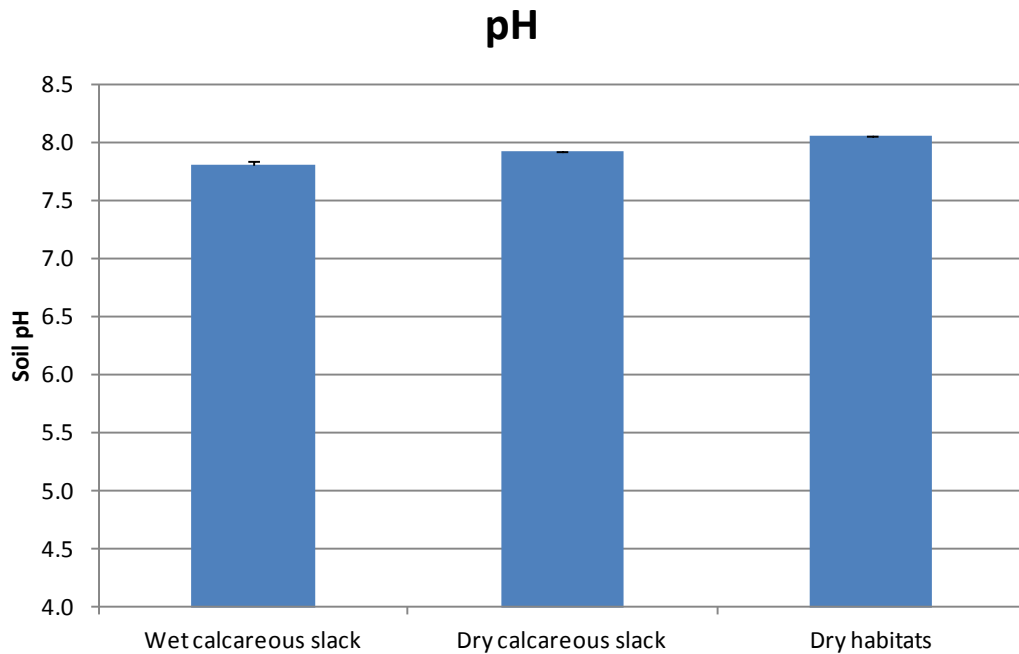
Figure 9. Ainsdale LNR. Soil pH, by broad vegetation type.

Soil pH (Figure 9) was high in all habitats, above 7.5, suggesting relatively young soils in these four quadrats, with no decalcification.

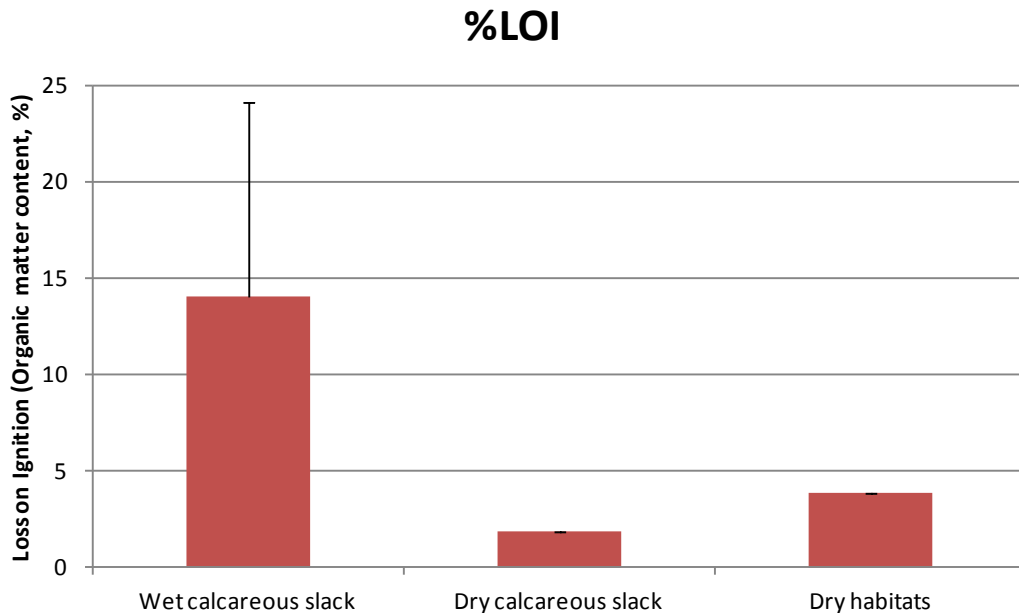
Figure 10. Ainsdale LNR. Organic matter (as Loss On Ignition, %), by broad vegetation type.

Organic matter contents (Figure 10) were high in the wet slack vegetation type, around 14%, but were rather lower in the drier habitats, under 4%.

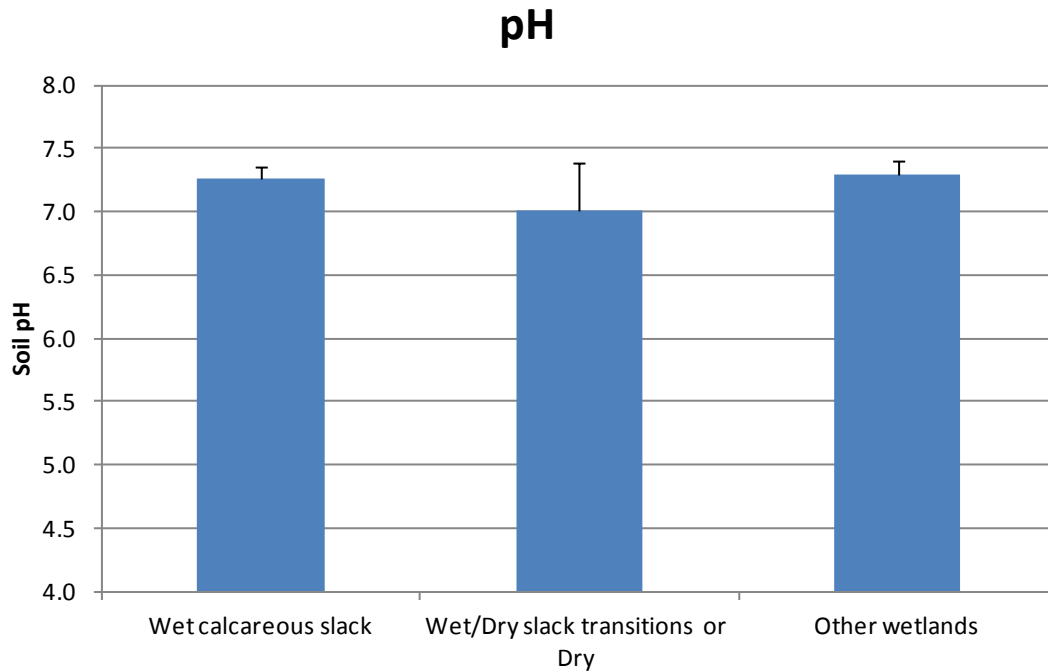
Figure 11. Birkdale LNR. Soil pH, by broad vegetation type.

Soil pH (Figure 11) was reasonably high in all habitats, averaging above 7.0, however some individual quadrats had pH values as low as pH 6.

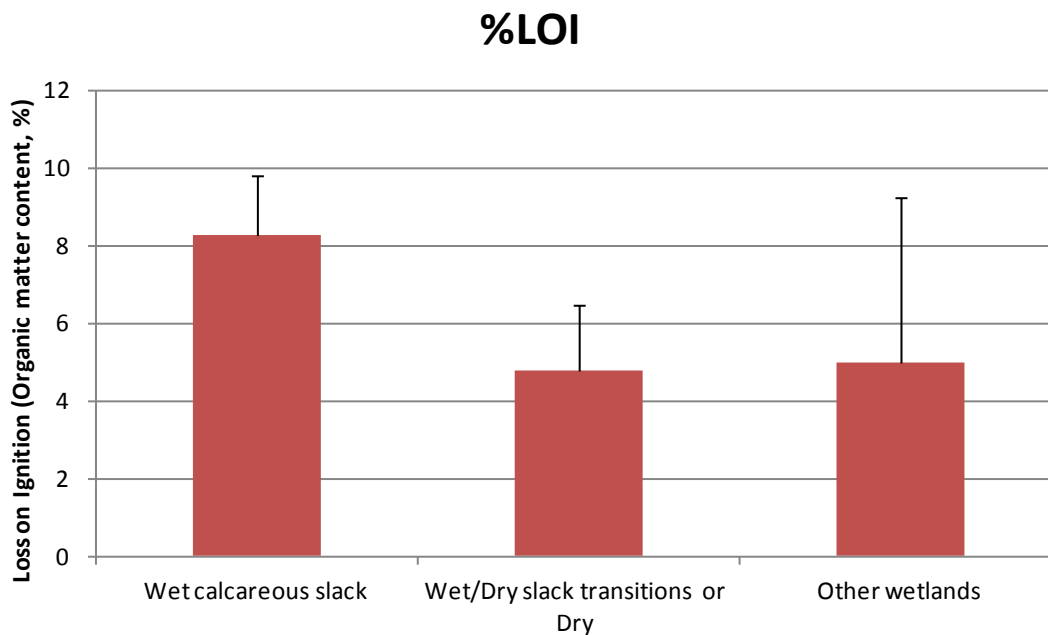
Figure 12. Birkdale LNR. Organic matter (as Loss On Ignition, %), by broad vegetation type.

Organic matter content (Figure 12) was high in the wet slack vegetation type, around 8%, but rather lower in the dry habitats and other wetlands, around 4-5%.

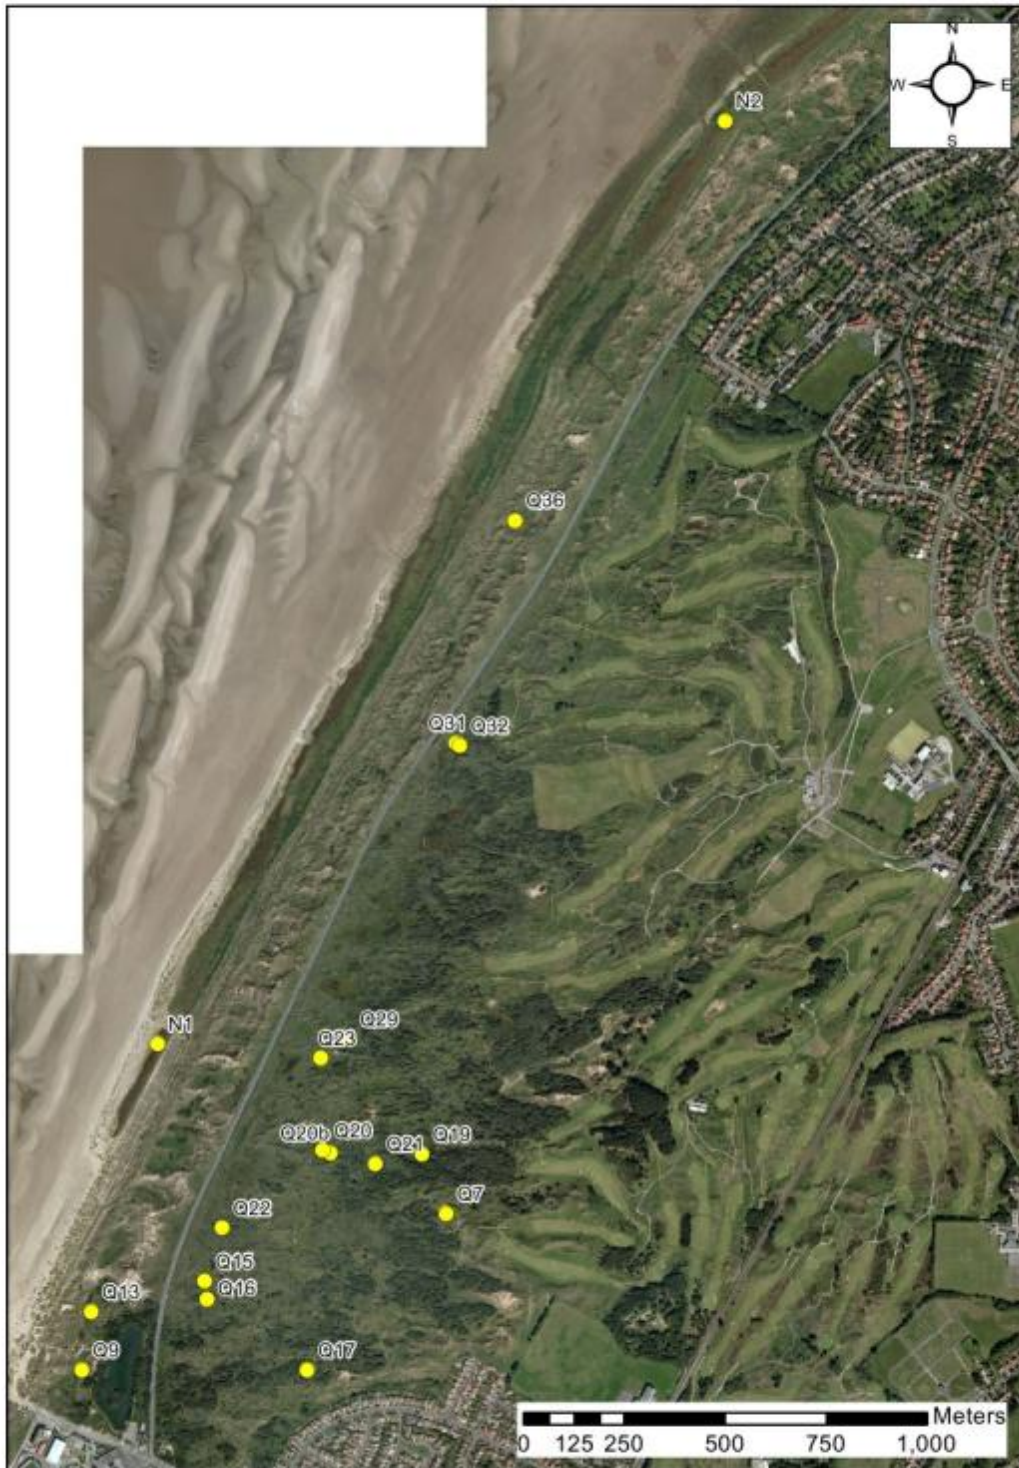
Figure 13. Locations of quadrats surveyed at Birkdale Hills LNR. © NERC (CEH) 2013, © Next Perspectives.

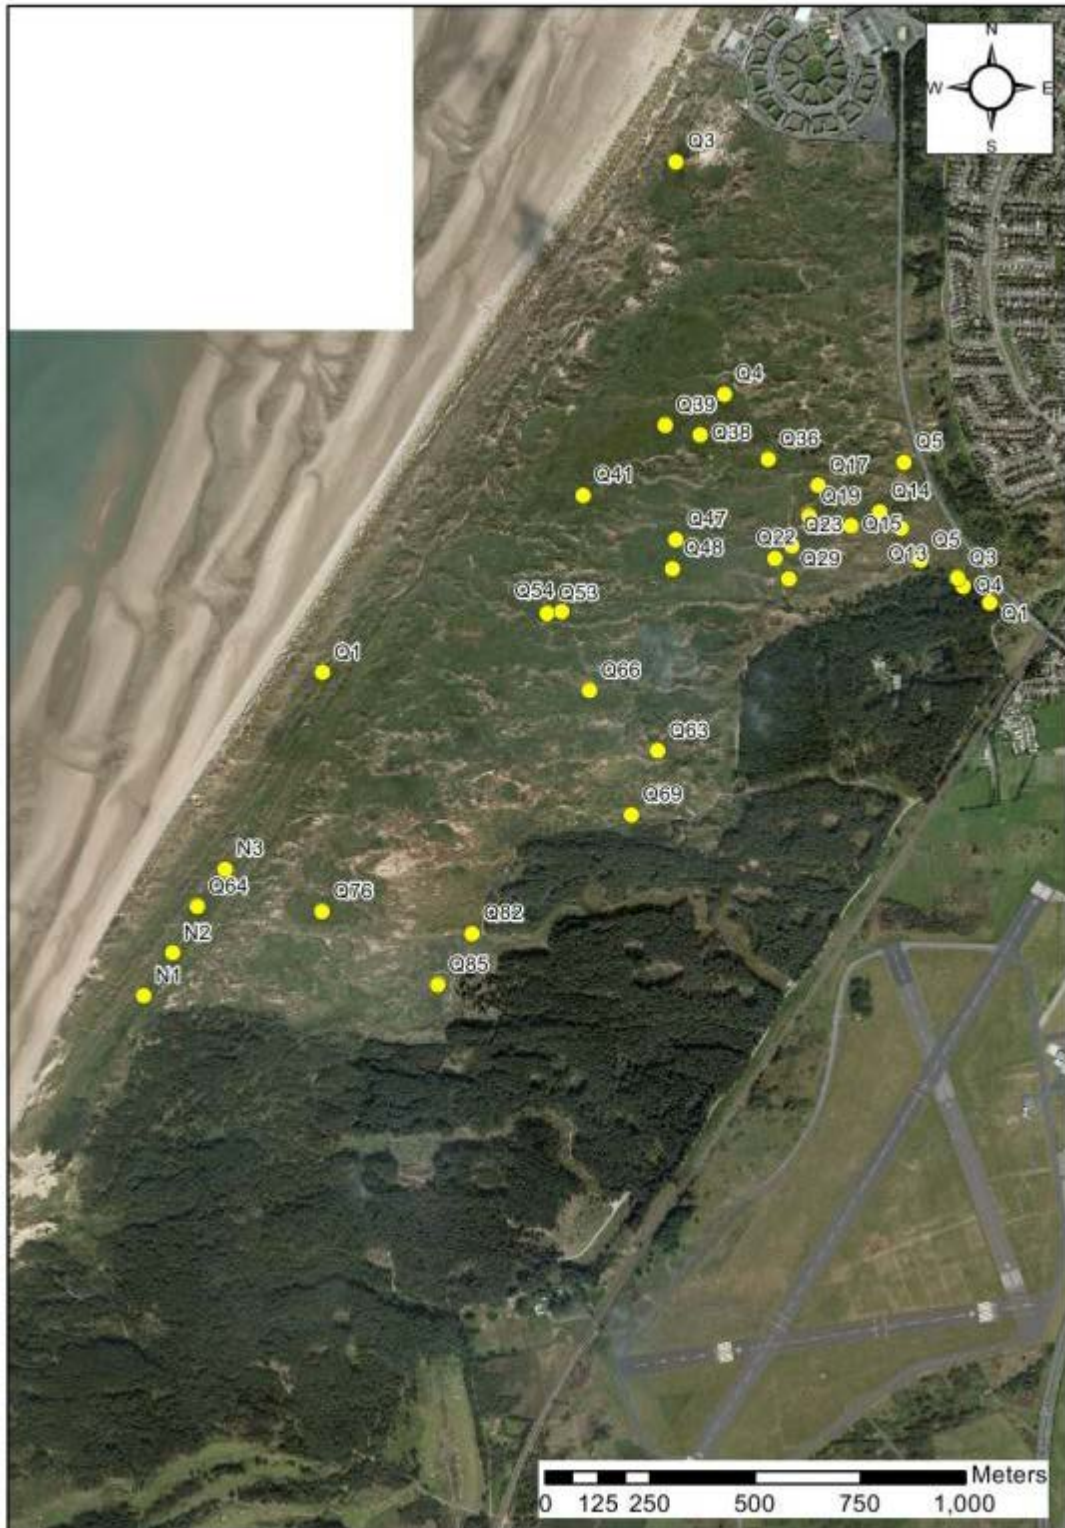
Figure 14. Locations of quadrats surveyed at Ainsdale NNR & Ainsdale LNR. © NERC (CEH) 2013, © Next Perspectives.

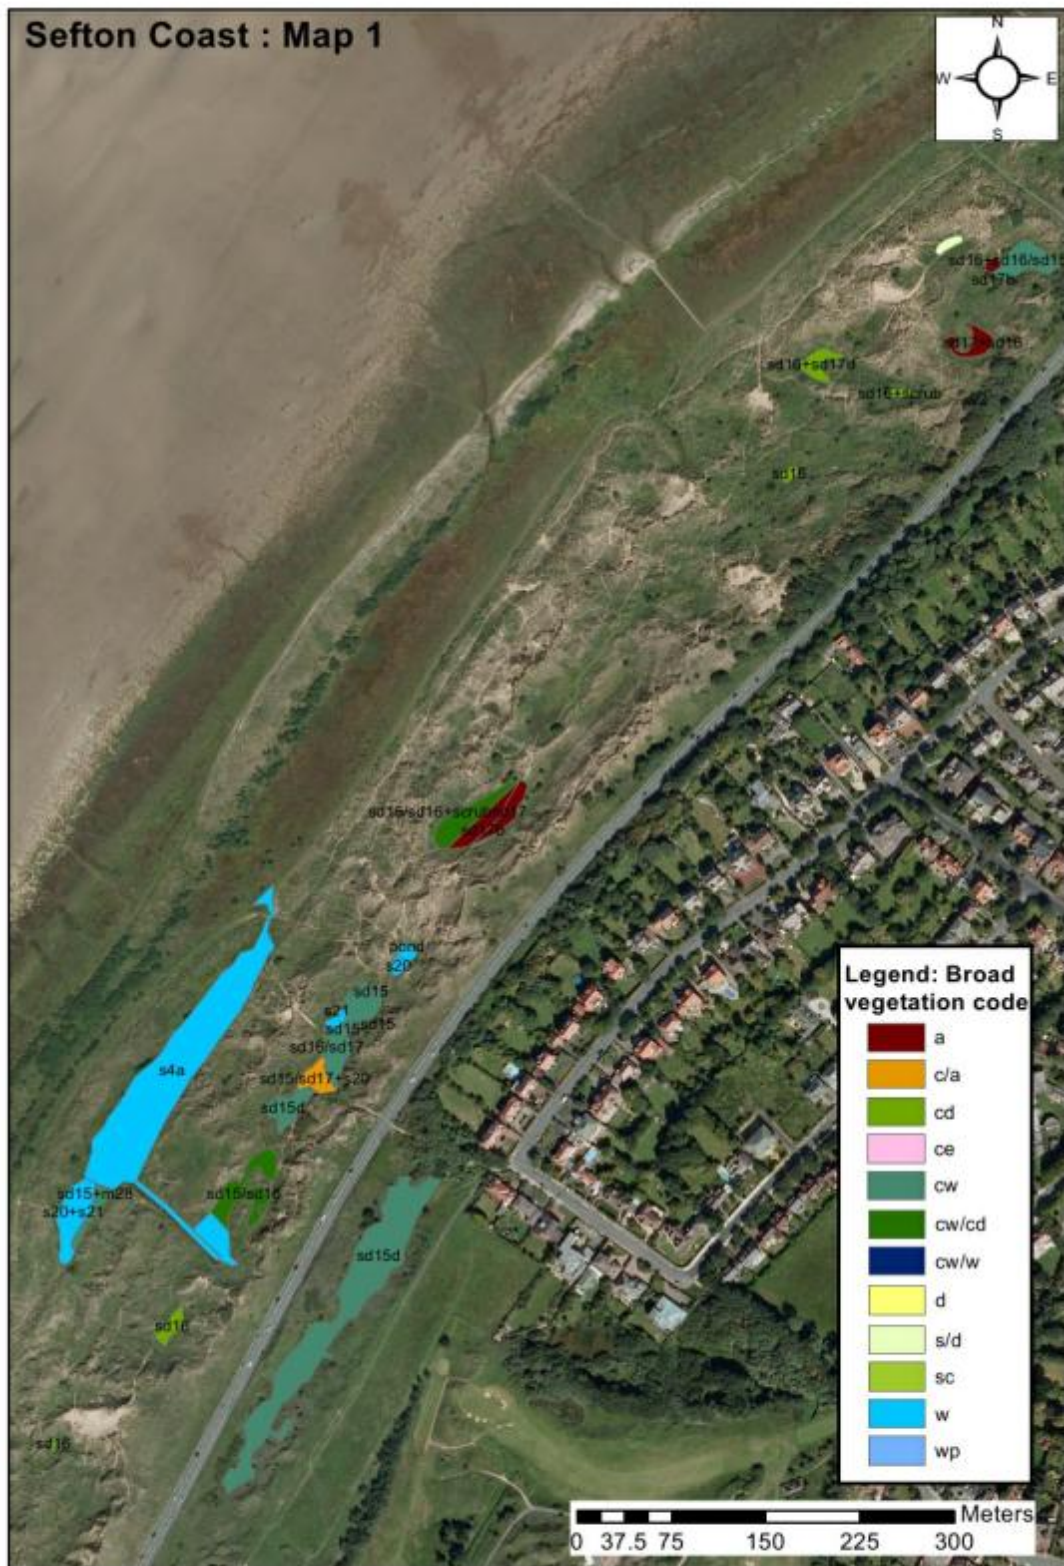
Figure 17. Sefton Coast Map 1; Birkdale Hills LNR (north). NVC communities mapped during the 2012 vegetation survey. Broad vegetation codes are described in Table 3. © NERC (CEH) 2013, © Next Perspectives.

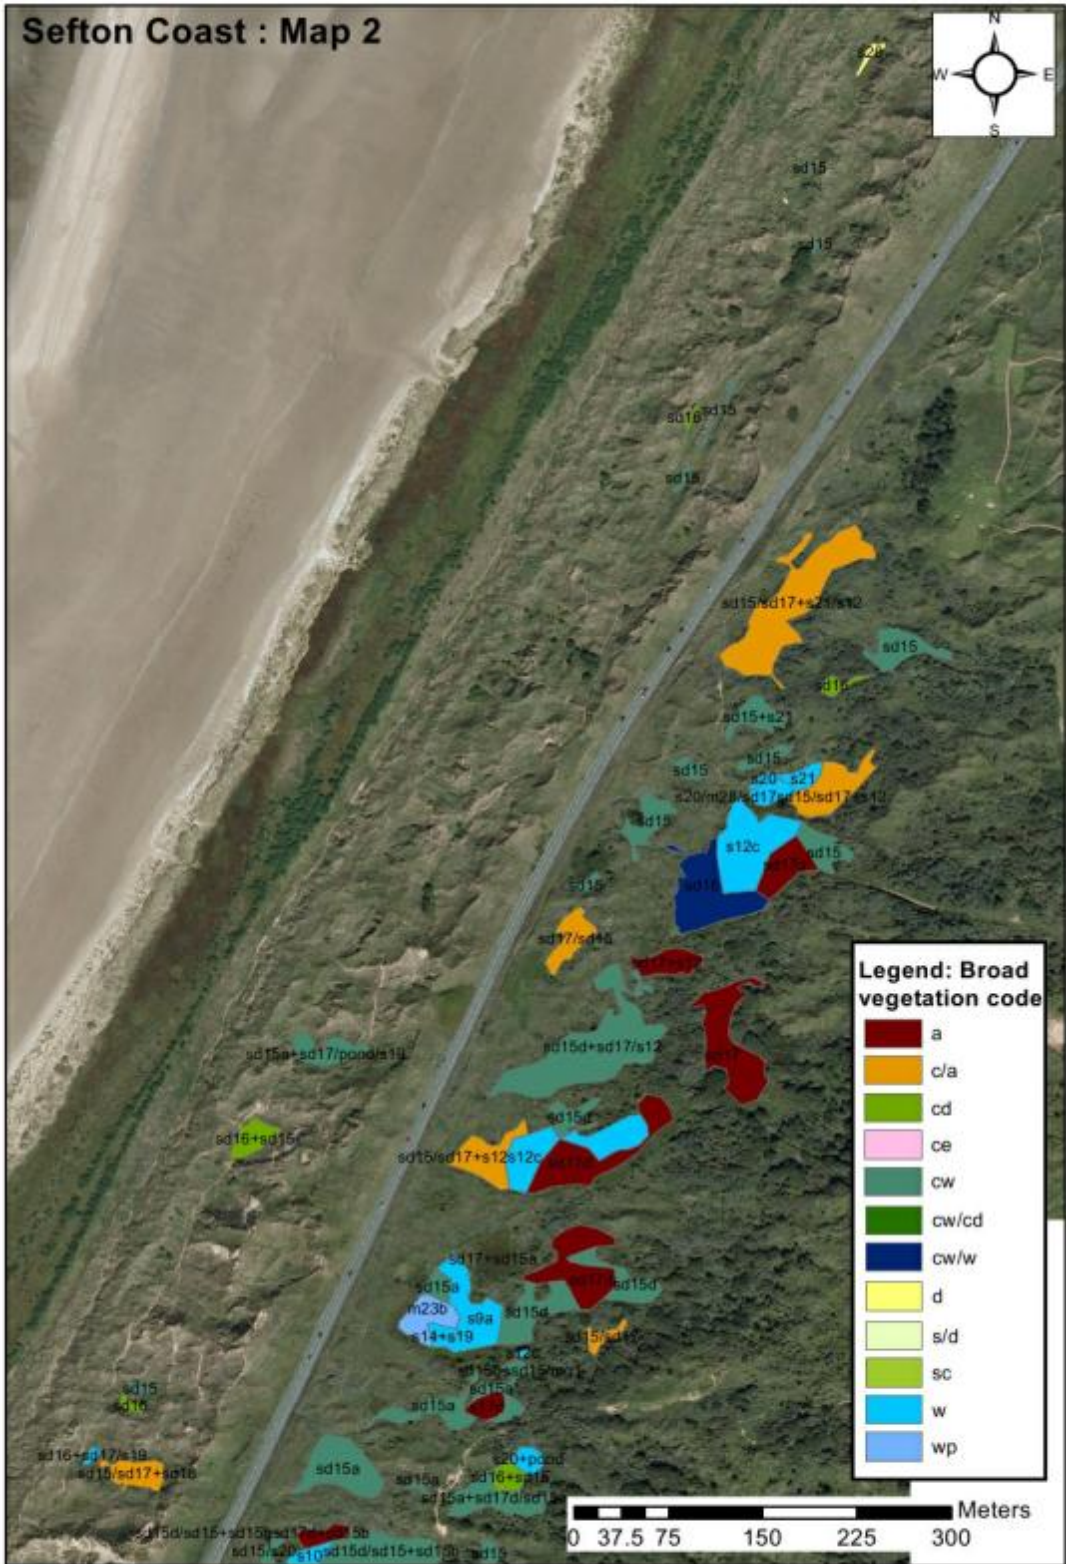
Figure 18. Sefton Coast Map 2; Birkdale Hills LNR (central). NVC communities mapped during the 2012 vegetation survey. Broad vegetation codes are described in Table 3. © NERC (CEH) 2013, © Next Perspectives.
