Physical and biological monitoring of STREAM restoration projects

Year One Report

Natural England

February 2007

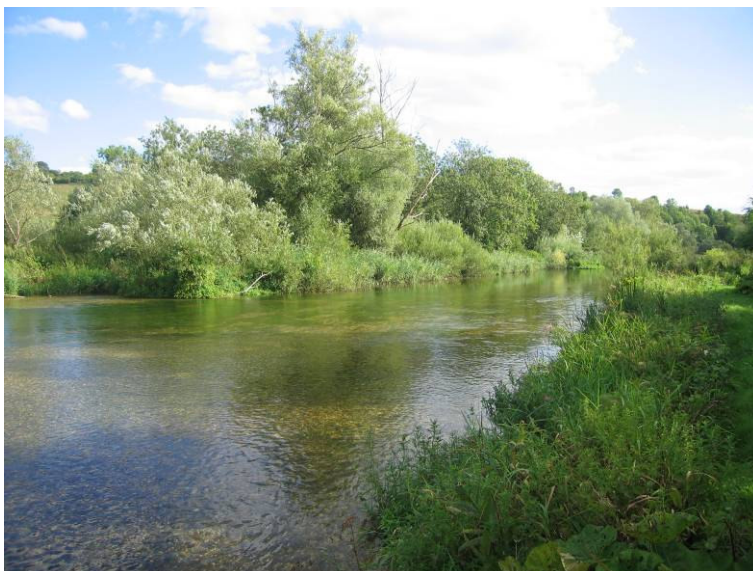
Photo UWC01c:
 Run biotope towards the upstream end of site UWC, looking downstream.

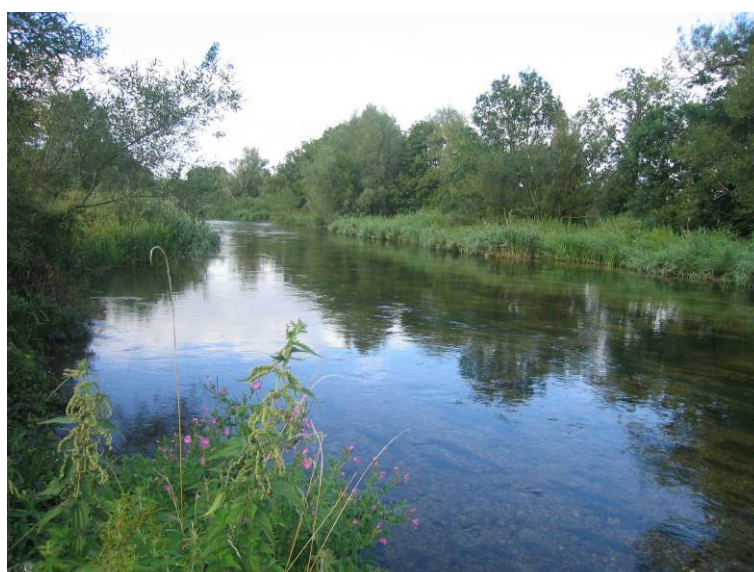
Photo UWC01g:
 Glide biotope looking upstream from the downstream boundary of site UWC.

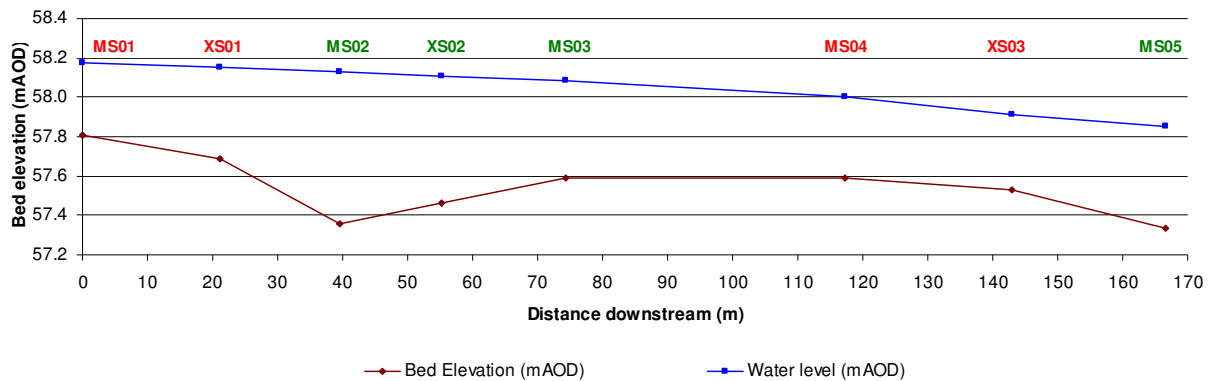
Figure 3.1 Long profile derived from cross-sectional data from MS01 to MS05

Over a distance of 167m (between cross-section MS01 and MS05), there is a fall in bed elevation of 0.48m, corresponding to a gradient of 0.003. The long profile illustrates that the channel is typically deeper through the glide sections of the channel in comparison with the run sections.

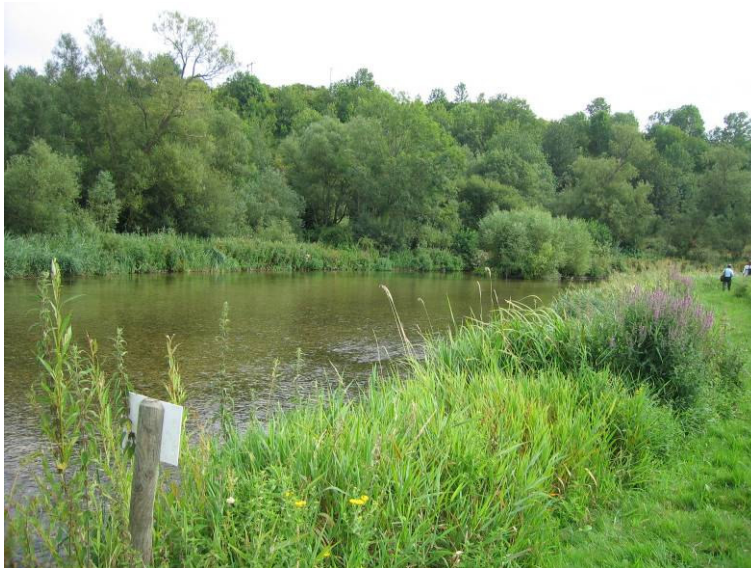
Photo UWR01-MS02c:
 Run biotope at upstream end of site UWR, looking downstream.

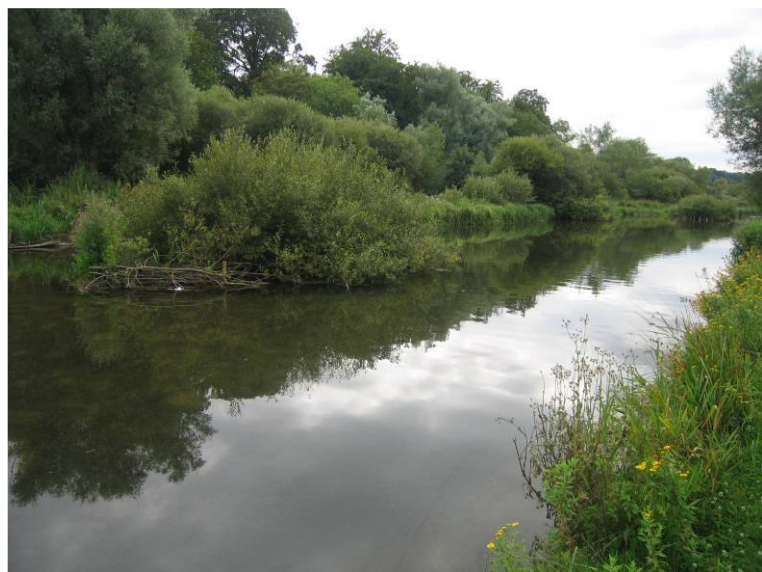
Photo UWR03b:
 Glide biotope looking downstream towards third and fourth in-channel islands.

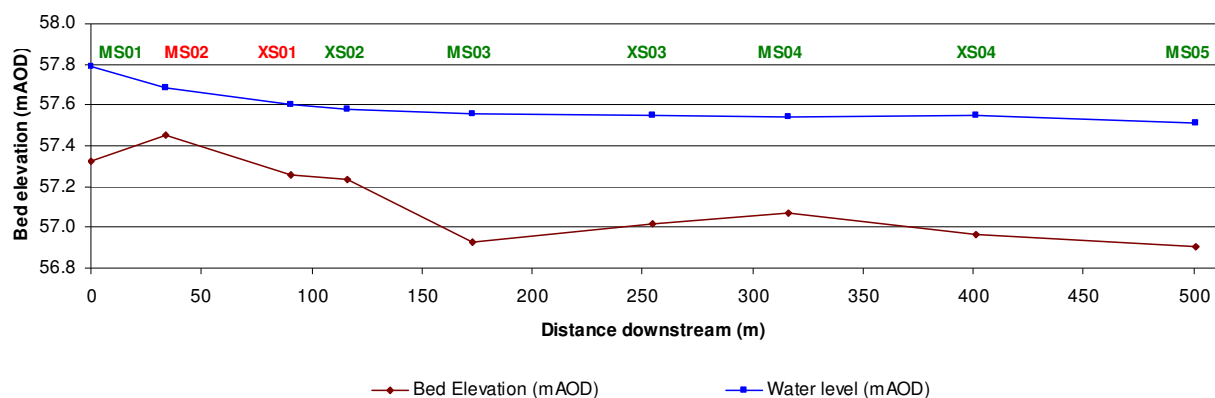
Figure 3.3 Long profile derived from cross-sectional data from MS01 to MS05

Over a distance of 501m (between cross-section MS01 and MS05), there is a fall in bed elevation of 0.42m (a gradient of 0.001). The long profile also illustrates that the channel is deeper through the glide sections of the channel in comparison with the run sections at the upstream of the site (MS02 and XS01).

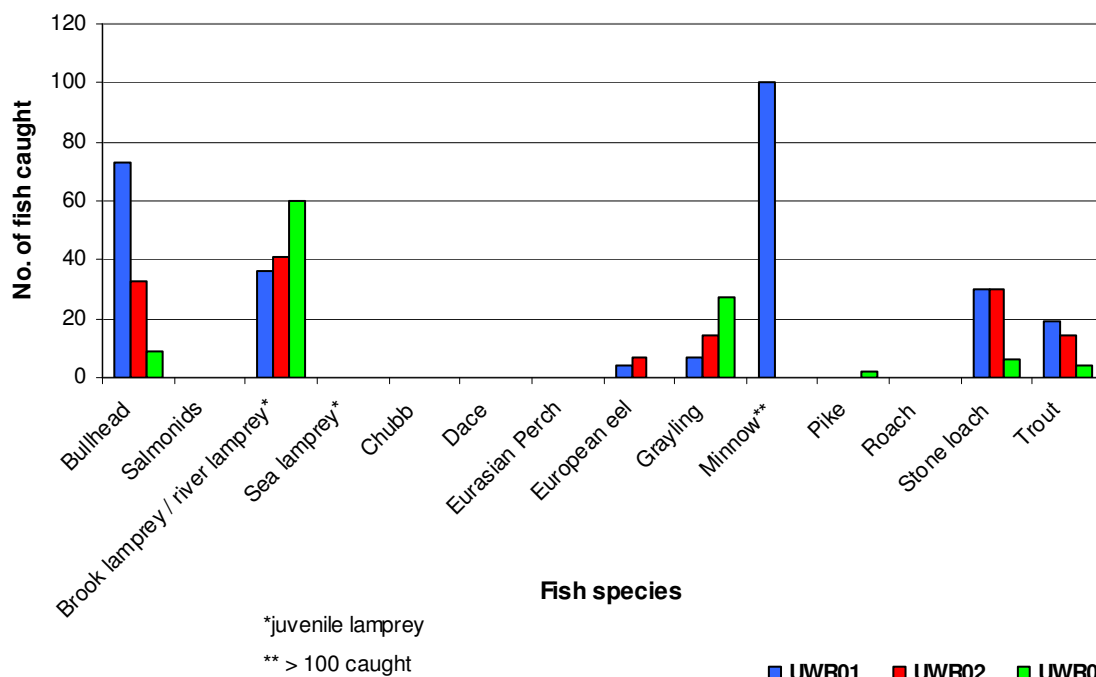
Figure 3.4 Number of fish caught during electrofishing of sites UWR01, UWR02 and UWR03.

Table 3.10 indicates that while the observed minimum density of brook lamprey is greater within the glide meso-habitats, the observed minimum density of bullhead is greatest within the run meso-habitat.

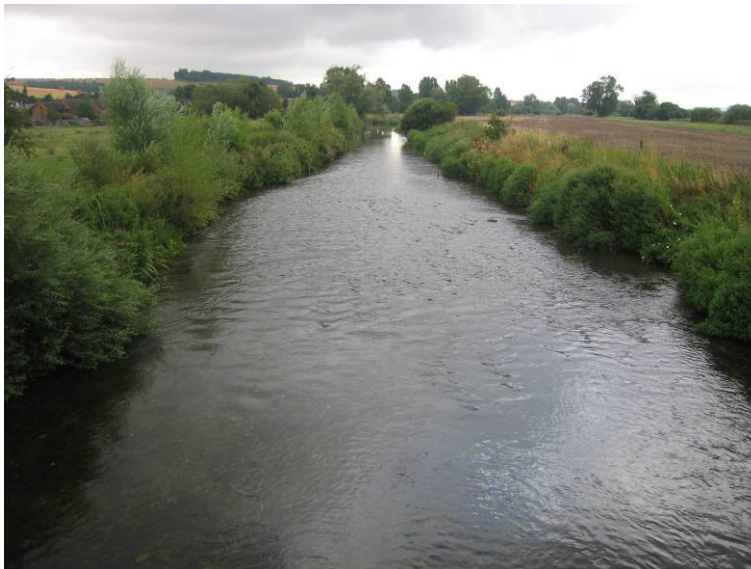
Photo SHC01a:
 Looking downstream from footbridge over “riffle” and glide physical biotopes.

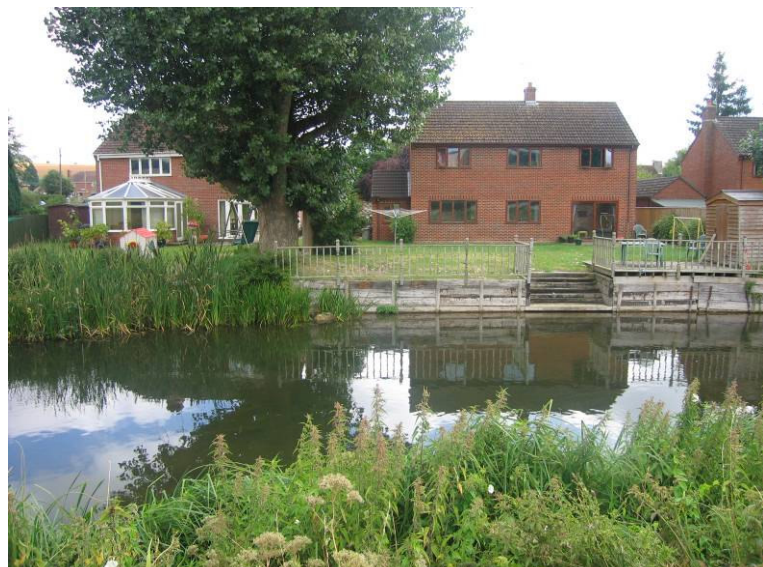
Photo SHC02b:
 Looking across deep channel towards private gardens on left hand bank.

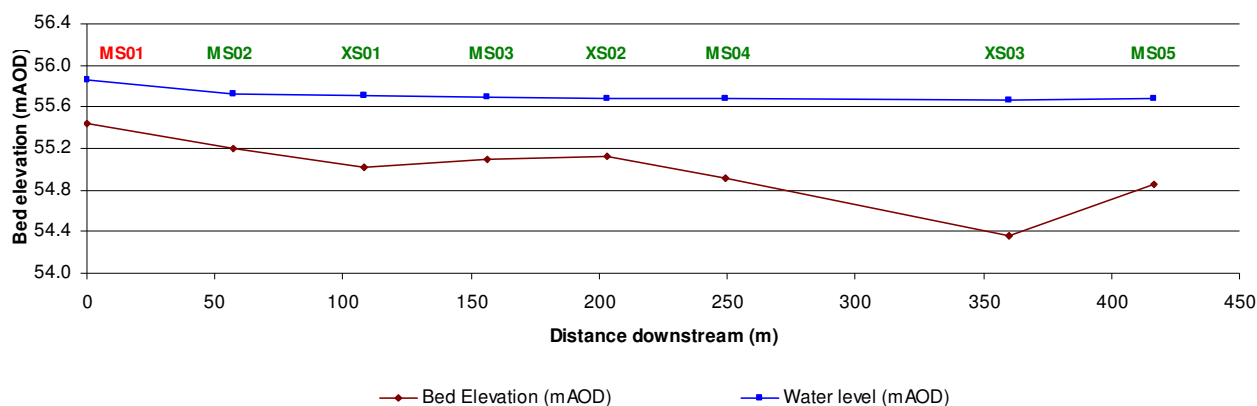
Figure 3.5 Long profile

Over a distance of 416m (between cross-section MS01 and MS05), there is a fall in bed elevation of 0.59m (a gradient of 0.001). The long profile illustrates the uniformity of bed elevation and water depth upstream of cross-section MS04 and how the channel deepens downstream as it flows around the meander bend. The cross-sectional profile of the channel downstream of MS04 is overdeep in comparison with the channel upstream.

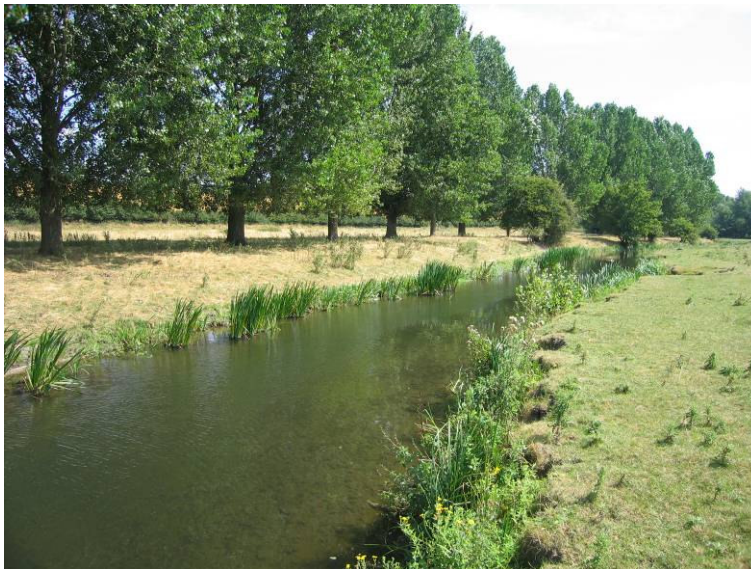
Photo SHR02f:
 Looking downstream along uniform glide section downstream of the Seven Hatches structure.

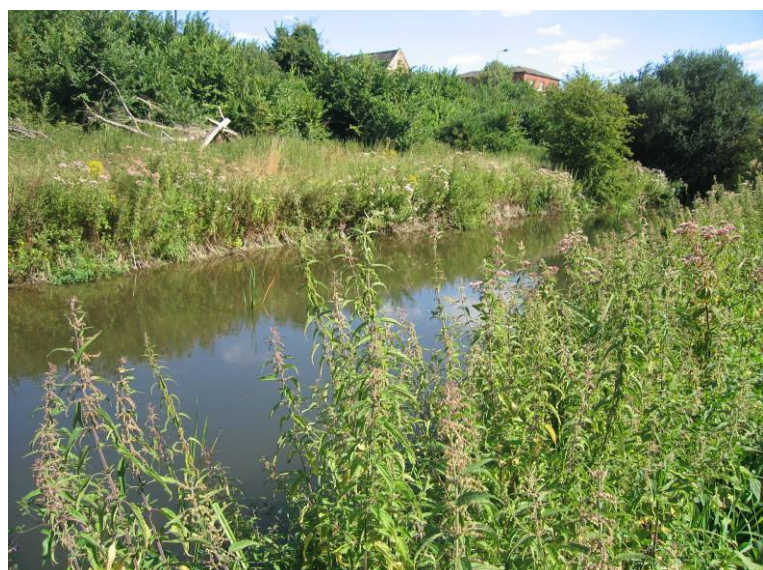
Photo SHR04g:
 Looking downstream along uniform glide downstream of the first railway crossing.

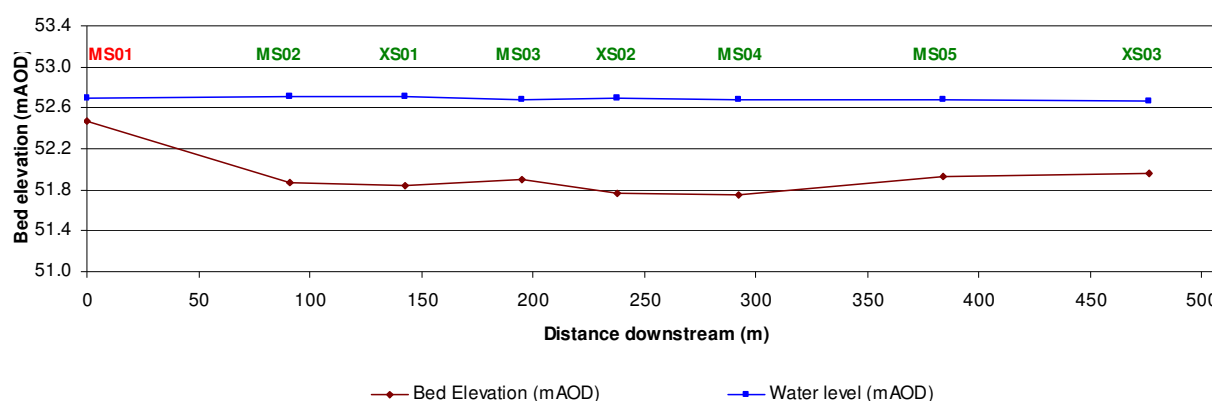
Figure 3.7 Long profile

Over a distance of 476m (between cross-section MS01 and XS03), there is a fall in bed elevation of 0.51m (a gradient of 0.001). The long profile also illustrates the depth of the channel between cross-sections MS02 and XS03 in comparison with the “riffle” section at the upstream of the site (MS01).

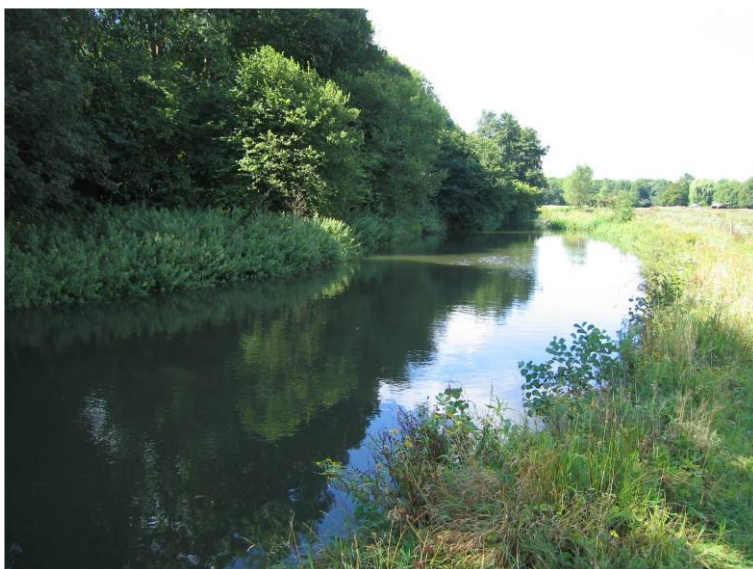
Photo FOR01h:
 Looking upstream along the glide physical biotope with broadleaved woodland along the right hand bank.

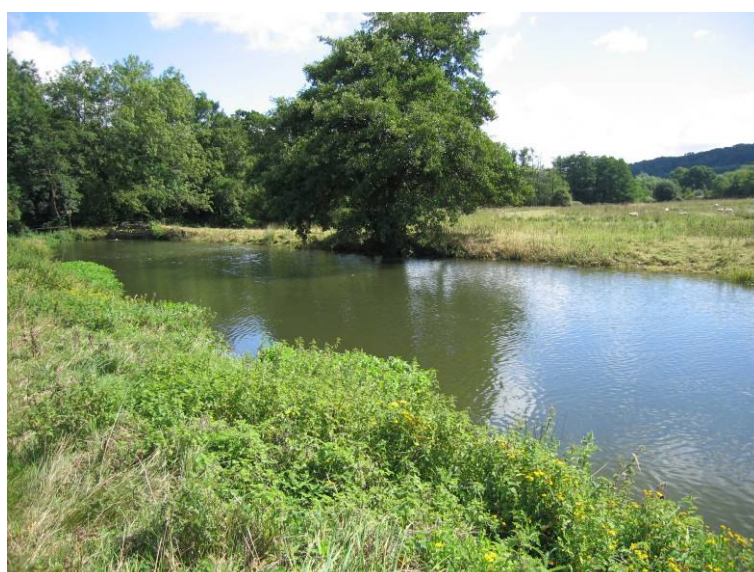
Photo FOR01s:
 Looking across downstream towards iron hatches structure at the downstream site boundary.

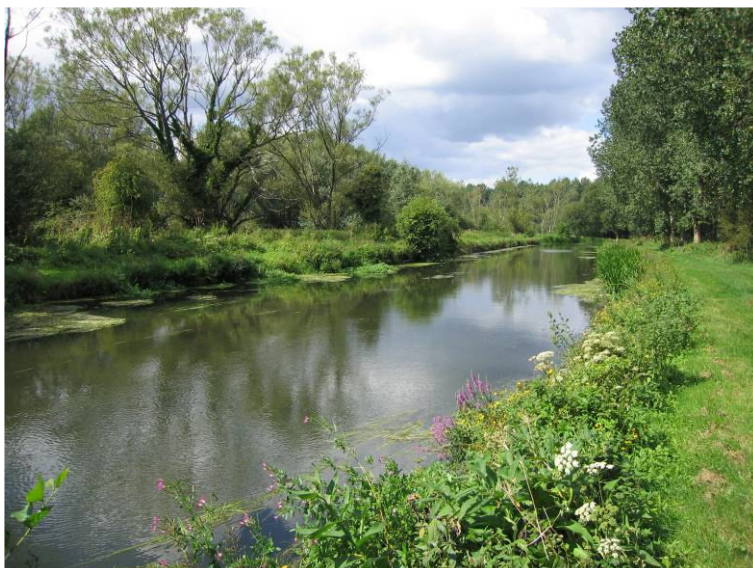
Photo AMR01j:
Looking upstream along the glide physical biotope upstream of the road crossing. The fisherman's path is along the left hand bank.

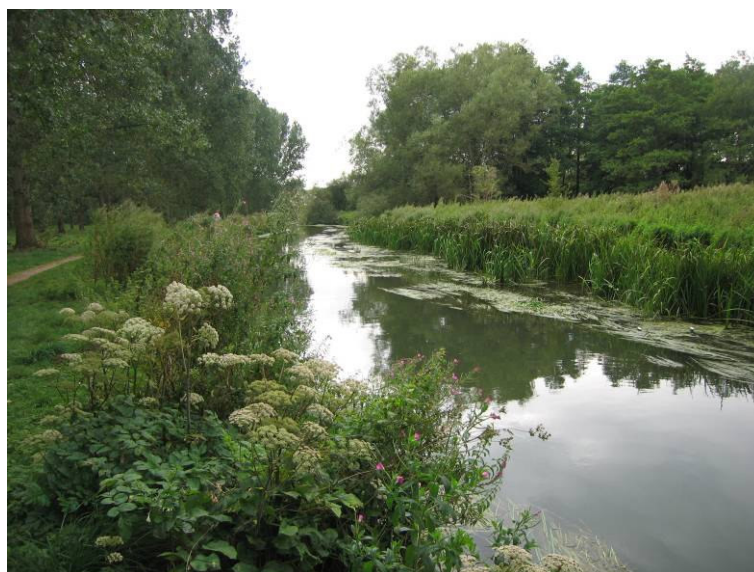
Photo AMR02e:
Looking downstream along glide physical biotope downstream of the road crossing. The public footpath is along the left hand bank.
