# Historical study of sites of natural sea wall failures in Essex

No. 15 - English Nature Research Reports

**Historical study of sites of natural  
sea wall failures in Essex**

**Institute of Estuarine and Coastal Studies  
University of Hull  
February 1992**

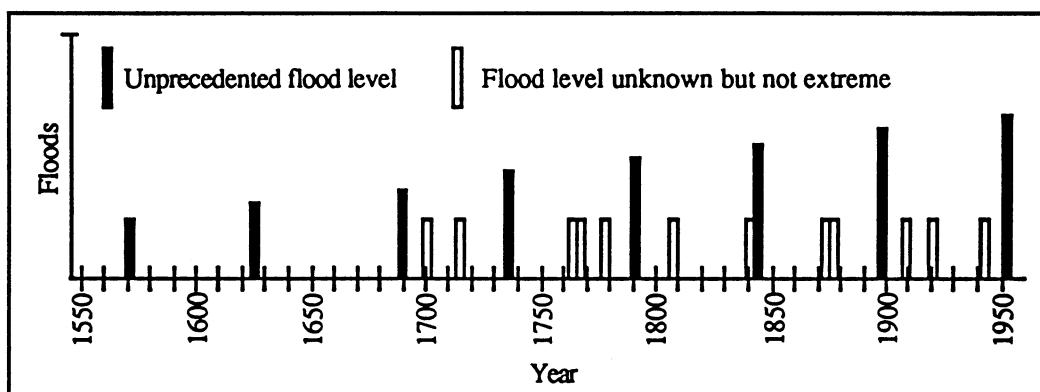
**Figure 2. Pattern of flood occurrence in Essex**

The dates in this table and the figure below show that historically the major floods of unprecedented level have continued to occur at intervals of approximately 55 years. This indicates that although sea level is rising, which accounts for the successive unprecedented flood heights, the rate of sea level rise has not increased.
