Pulborough Brooks Nature Reserve eco-hydrology and peat assessment report

A report into the investigation of Pulborough Brooks
Site of Special Scientific Interest.

May 2025

Natural England Commissioned Report NECR602

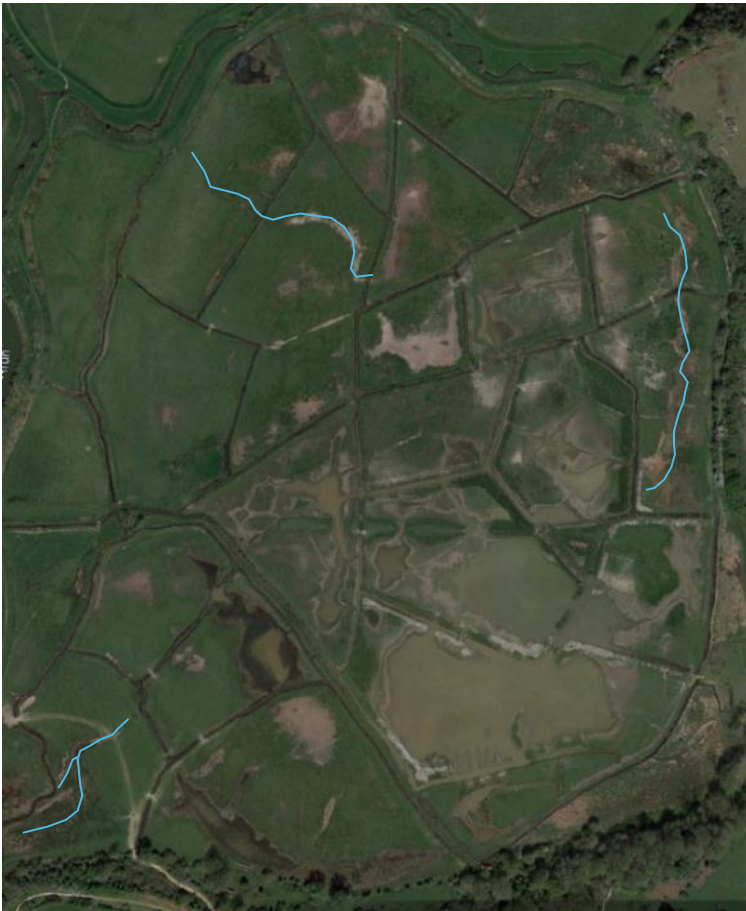
Figure 5 2015 aerial photography with clear sinuous palaeochannels highlighted by vegetation patterns (Pulborough North). Google Earth (2024a).

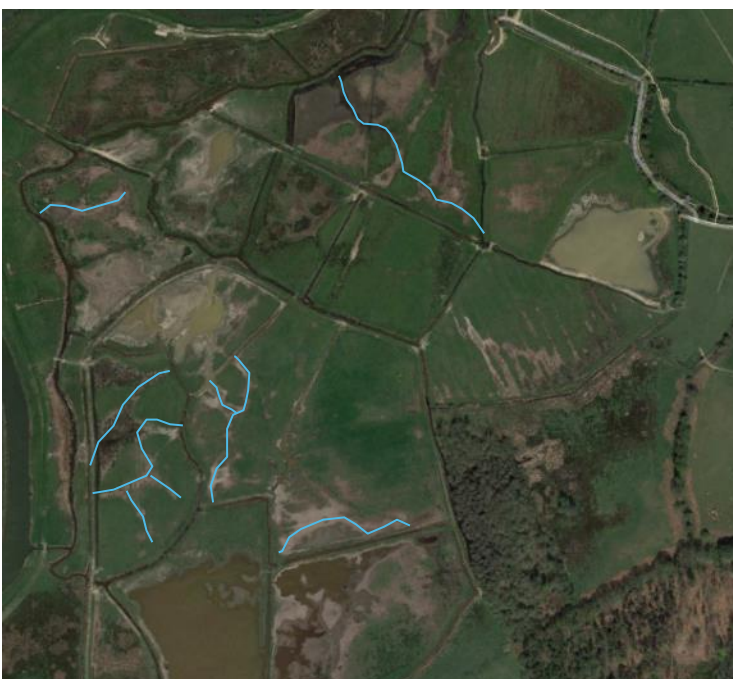
Figure 6 2015 aerial photography with clear sinuous palaeochannels highlighted by vegetation patterns (Pulborough South). Google Earth (2024b)

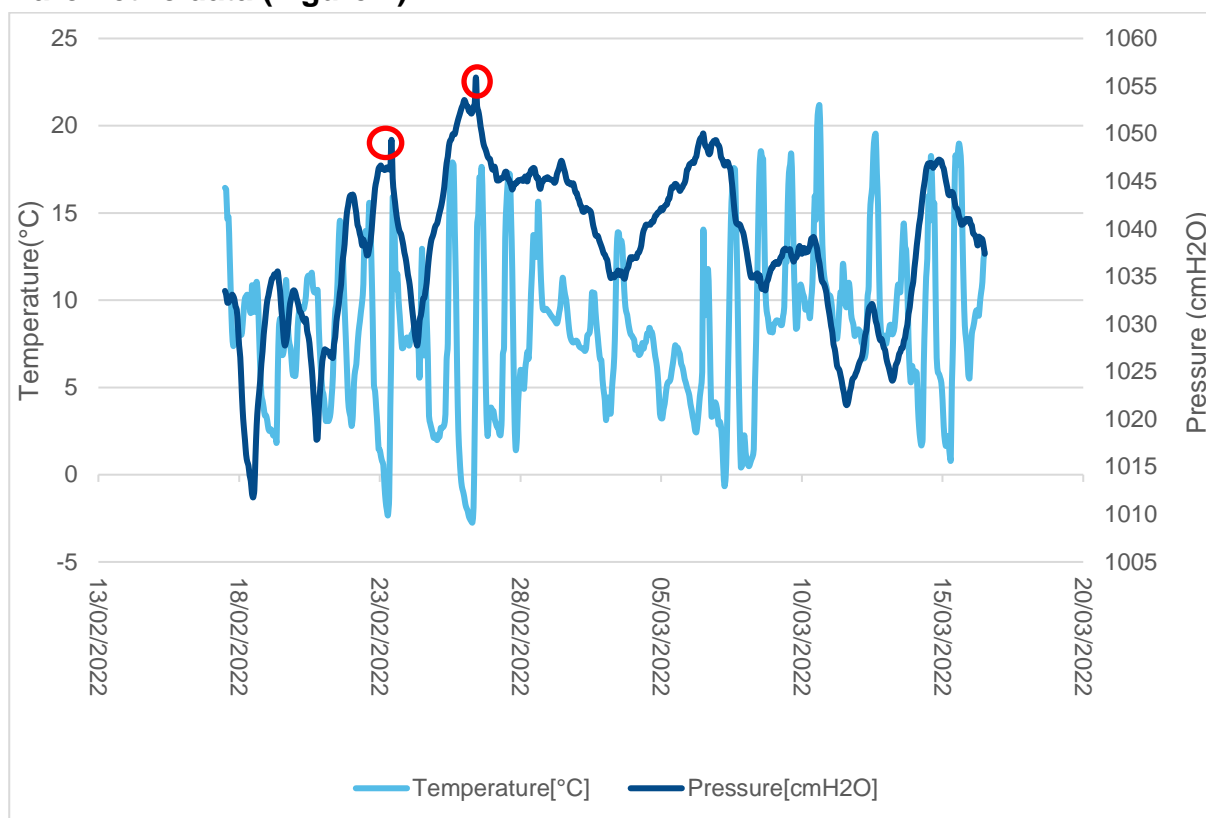
Barometric data (Figure 7)

Barometric data has recorded pressure and temperature fluctuations on Site for the monitoring period ranging through February and March 2022. Two distinct peaks of high pressure were noted on the 23/02/2022 and 26/02/2022 with corresponding temperatures falling below freezing on both dates. A period of low pressure was noted on the 18/02/2022 with a slight rising trend to higher pressure throughout the month.

There are two distinct troughs in the temperature data on 23/02/2022 and 26/02/2022, corresponding with two peaks in atmospheric pressure. The two pressure peaks are sustained over a period of hours, but with a single additional spike on each occasion (circled in red in Fig 7). These correspond to anomalous spiked troughs in all of the groundwater and surface water datasets, as displayed on subsequent graphs (fig. Y-Z). The consistency of the presence and marked nature of these troughs in the groundwater/surface water data is such that these are interpreted to be artefacts of the barometric data, rather than representative of troughs in the water level data (i.e. these two instantaneous peaks have provided an artificial corresponding dip in water levels during the compensation process, which is not truly reflective of water levels).

in the Alluvium. These troughs coincide with two distinct periods of high pressure and low temperatures shown in the barometric graph above.

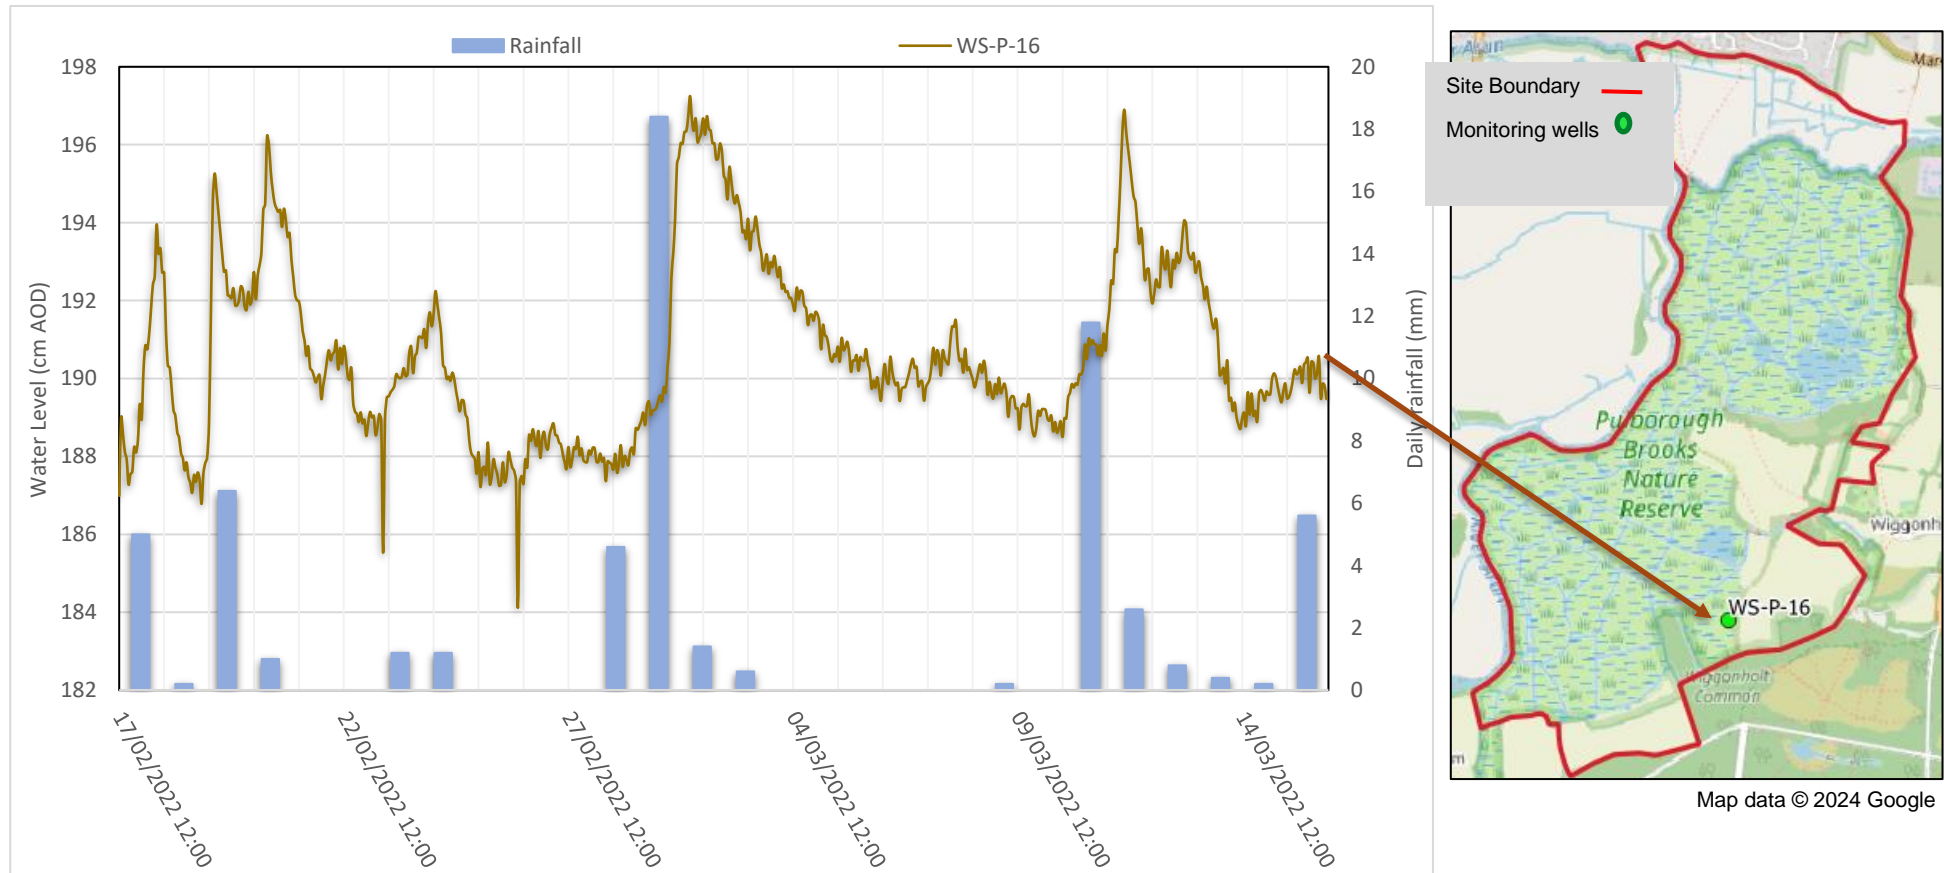
Figure 8 Groundwater hydrographs (head)

Head deposits show a sharp rapid response to rainfall events. The hydrograph is characterised by a rapid response to rainfall, with sharp rise, followed by a slower return to lower water levels over the subsequent days.

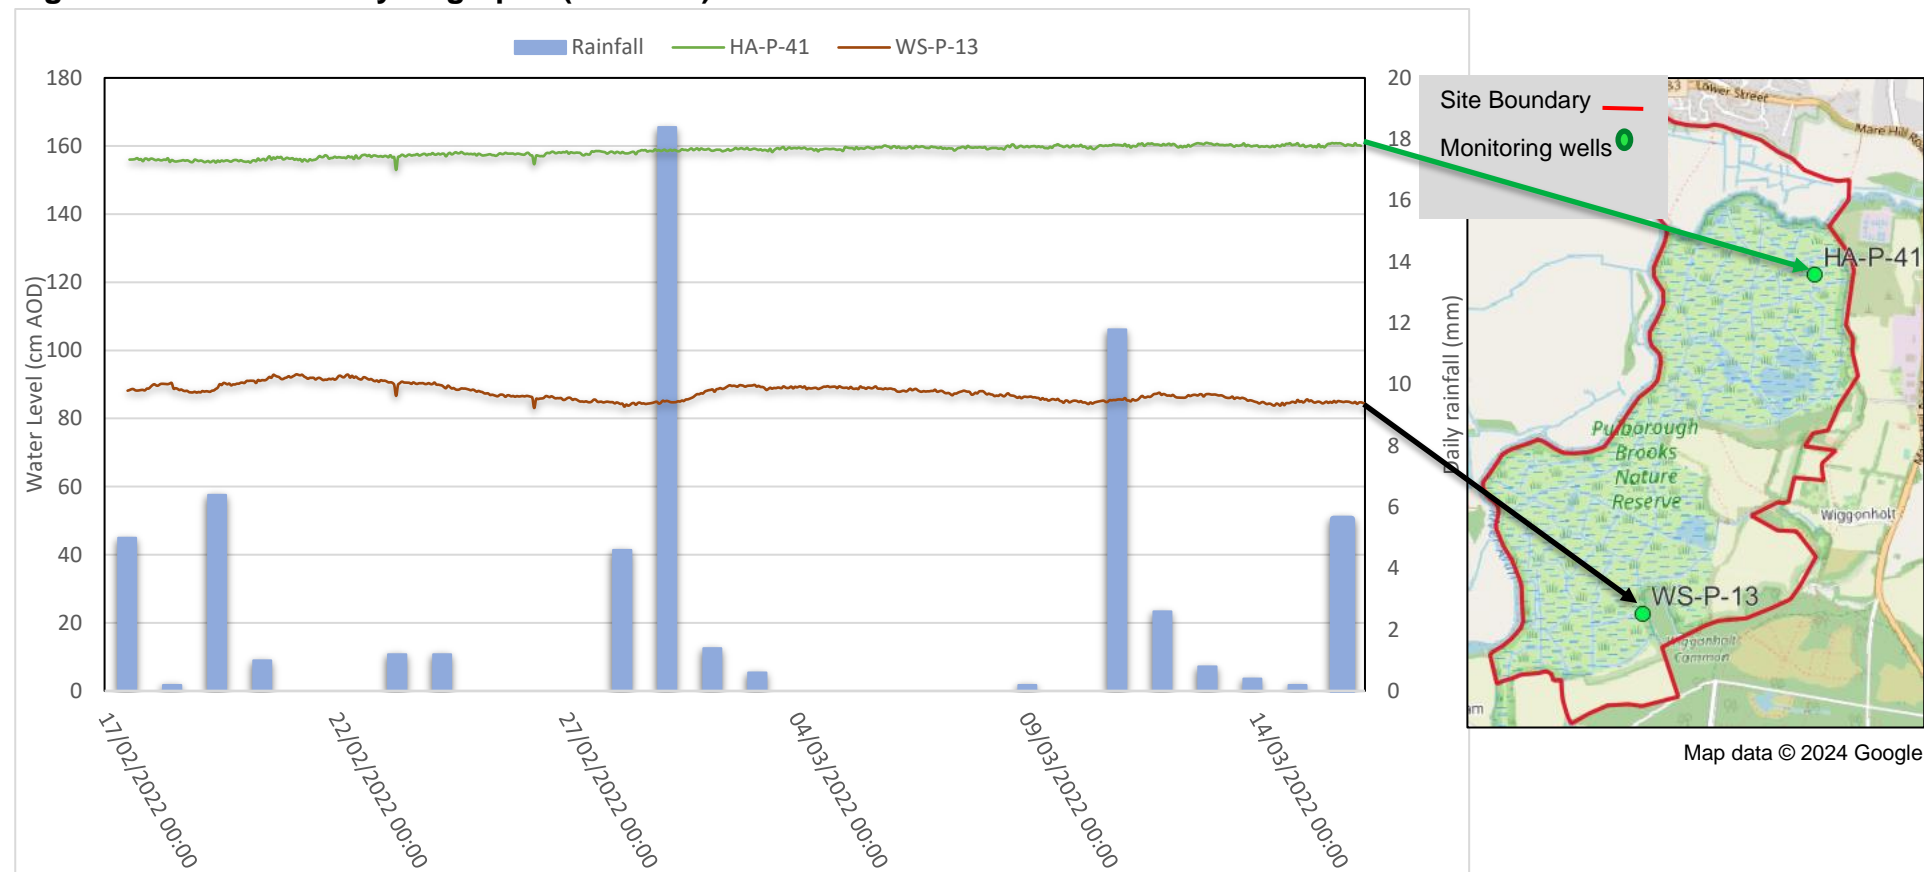
Figure 9 Groundwater hydrographs (alluvium)

Alluvium water levels have remained fairly constant over the monitoring period. Their hydrograph is much more muted in comparison with the head above, with the wavelength of response much longer, albeit with similar amplitude. HA-P-14 sees very little response to rainfall at all, but a gradual increase in levels of over the monitoring period.

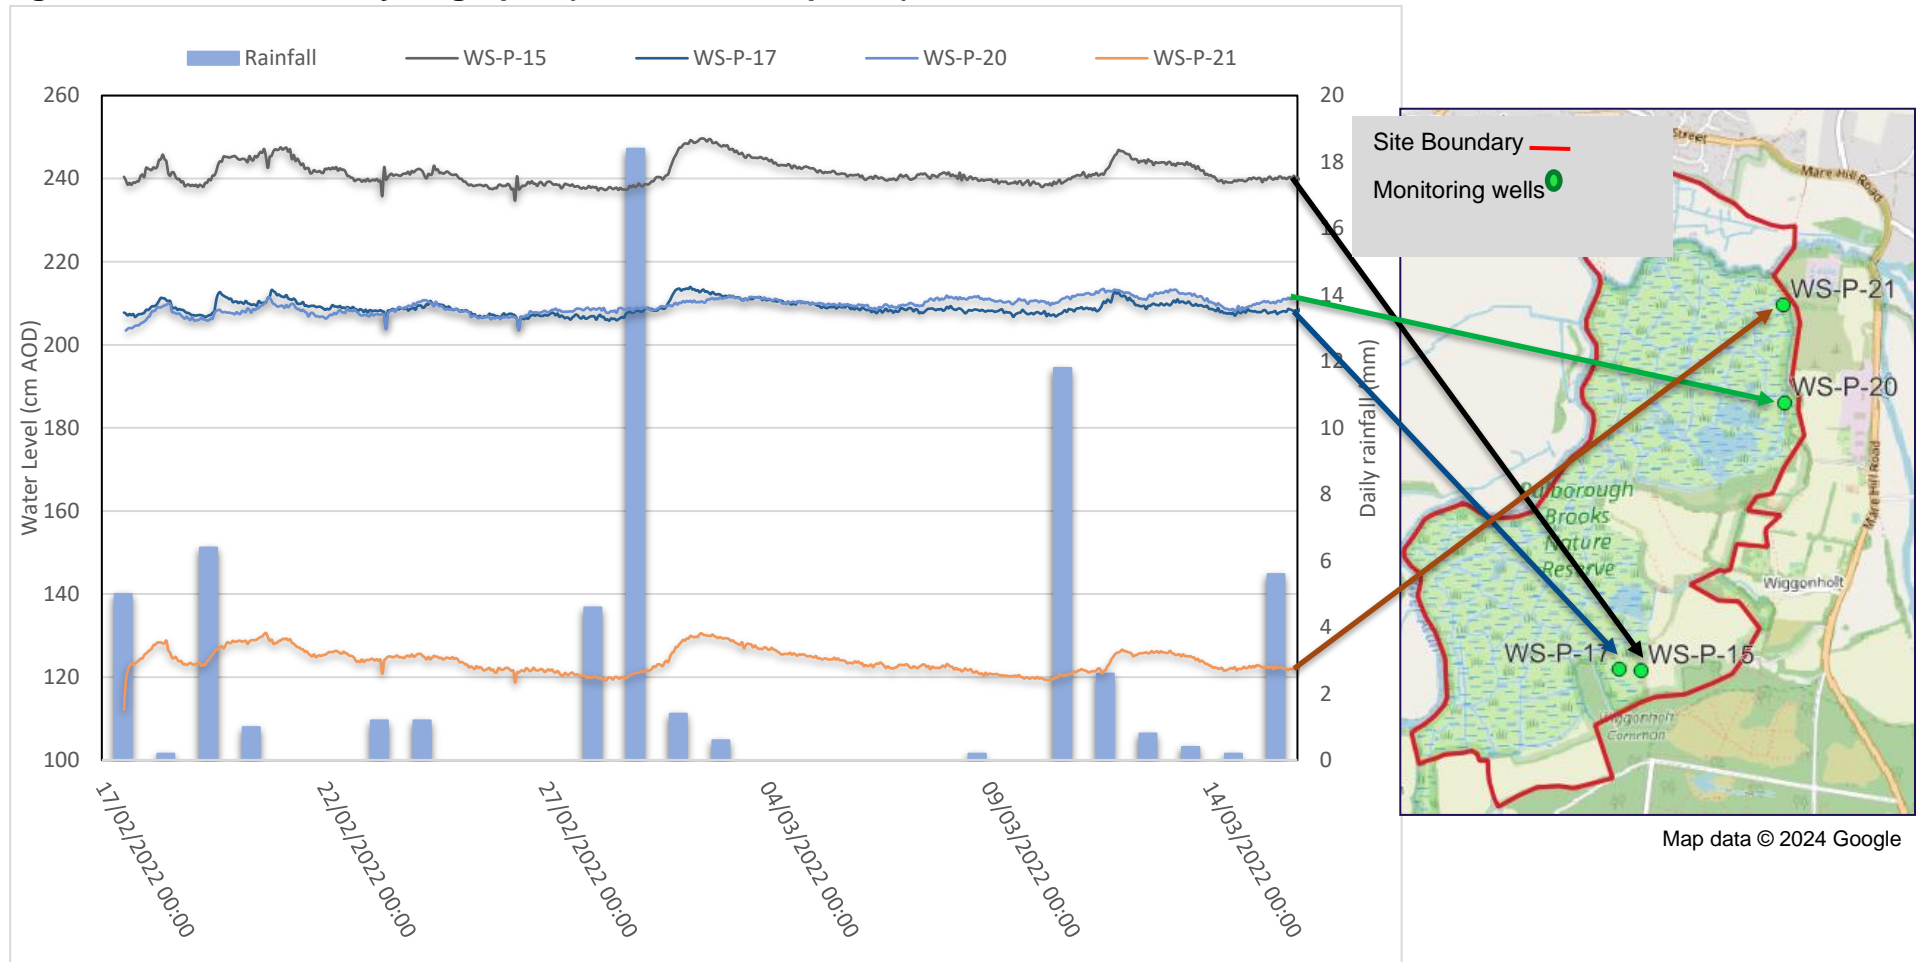
Figure 10 Groundwater hydrographs (river terrace deposits)

Arun RTD deposits show delayed smooth peaks in response to rainfall events. This delayed response hints that groundwater may be the controlling mechanism feeding the water level in this stratum. The RTD shows similar troughs on 23/02/2022 and the 26/02/2022 as seen

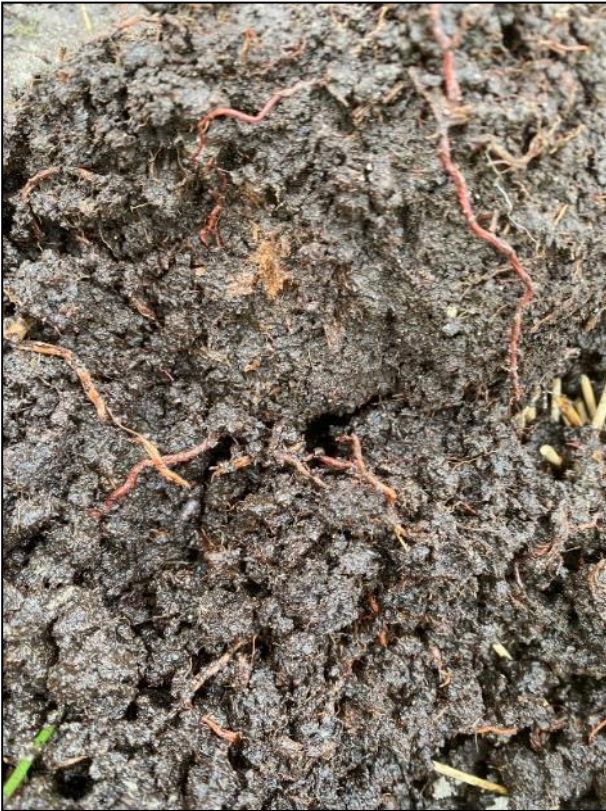
Figure 18 WS-P-17 Desiccated Peat

As seen in Figure 18, some of the peat deposits across the Site had a very low water content with discernible levels of decomposing rootlets and wood fragments noted. Many of the peat deposits had standing water at the surface above, a dry upper peat layer and then a wetter lower peat layer. This shows the peat is displaying hydrophobic behaviour described above.

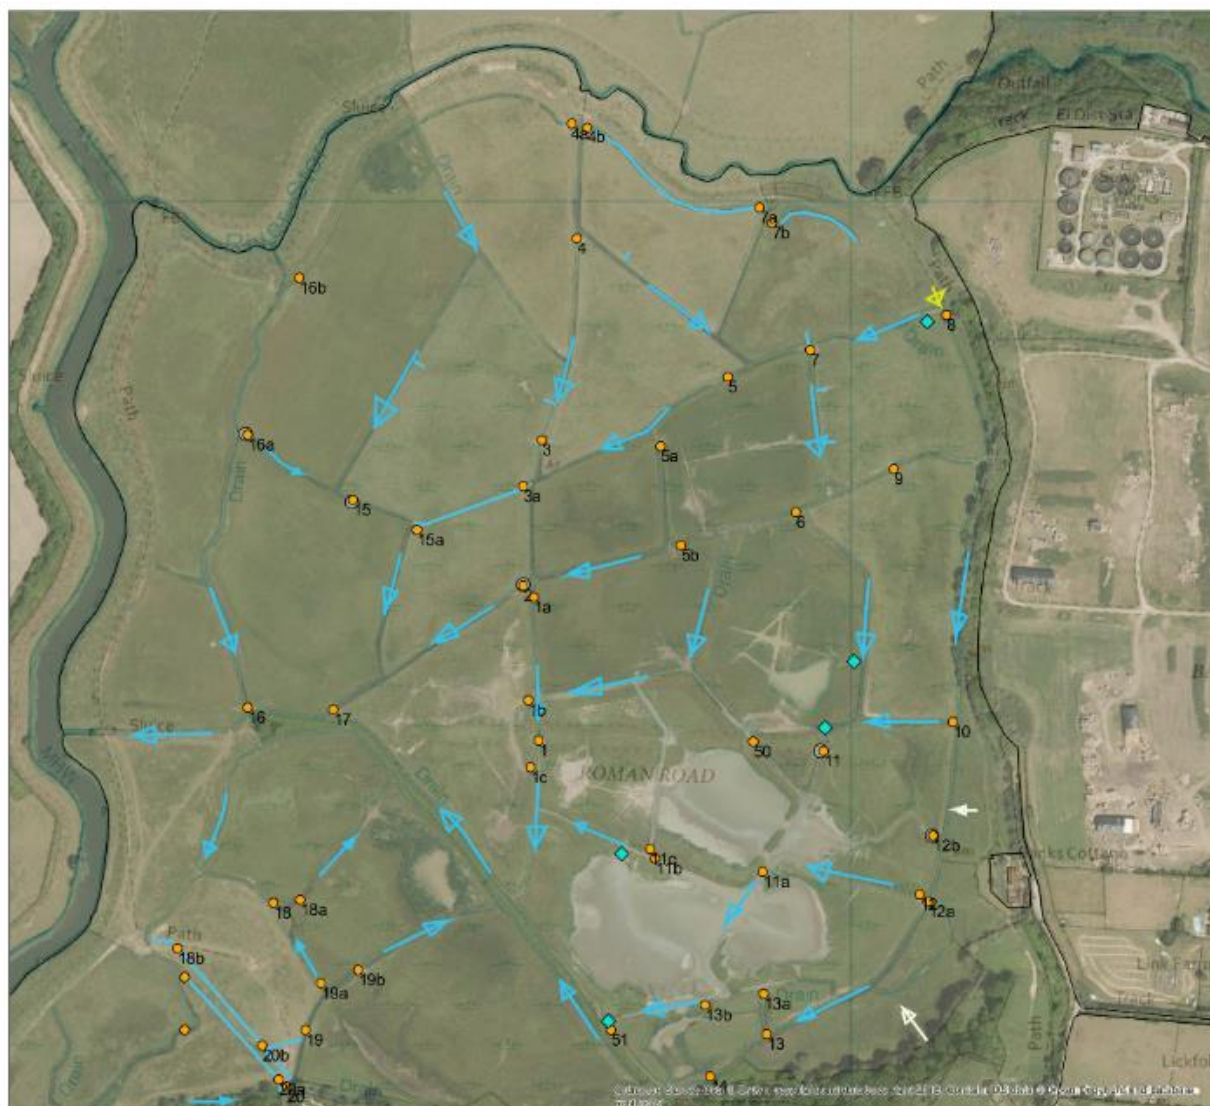
Figure 20 North Pulborough Brooks Water Movement

As can be seen in Figure 19, there is an abundance of very small catchments, rising at the head of the raised ground along the eastern and southern reaches of the Site. Although the typical sandstone geology of these catchments will allow for a large amount of infiltration along these catchments, some water will flow onto the Site from these catchments. In addition to this, there will be a component of incident rainfall that has infiltrated into the underlying aquifer that rises out of the ground at spring and seep lines. The RSPB have identified springs and seeps in the vicinity of Brooks Cottage and again in the extreme south-west of the Site, as shown on in Figure 20 and Figure 21.

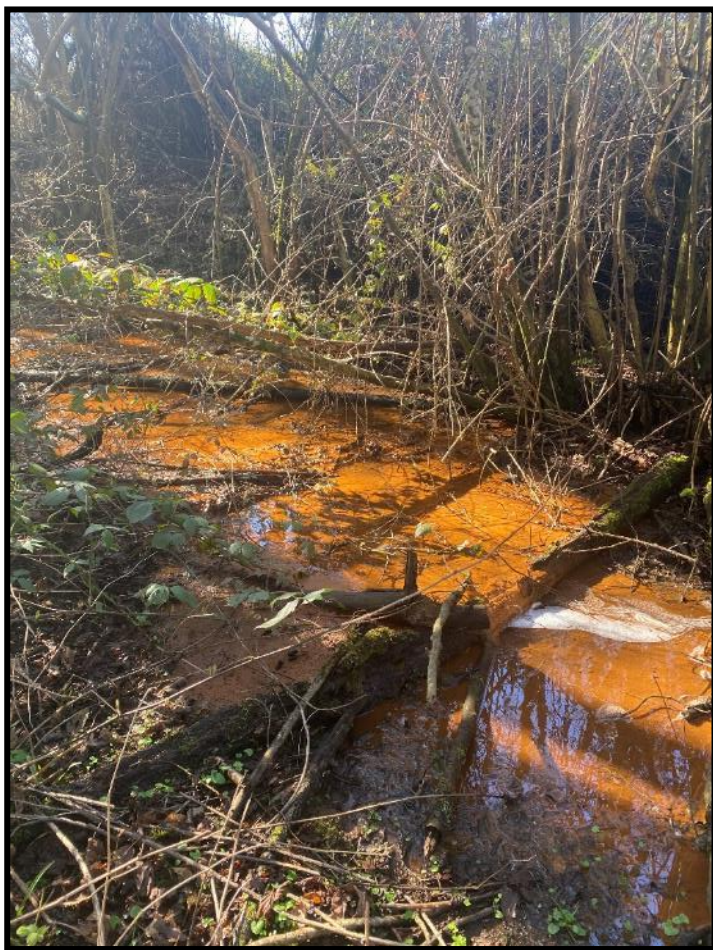
Figure 25 Ochreous spring line in southern Pulborough

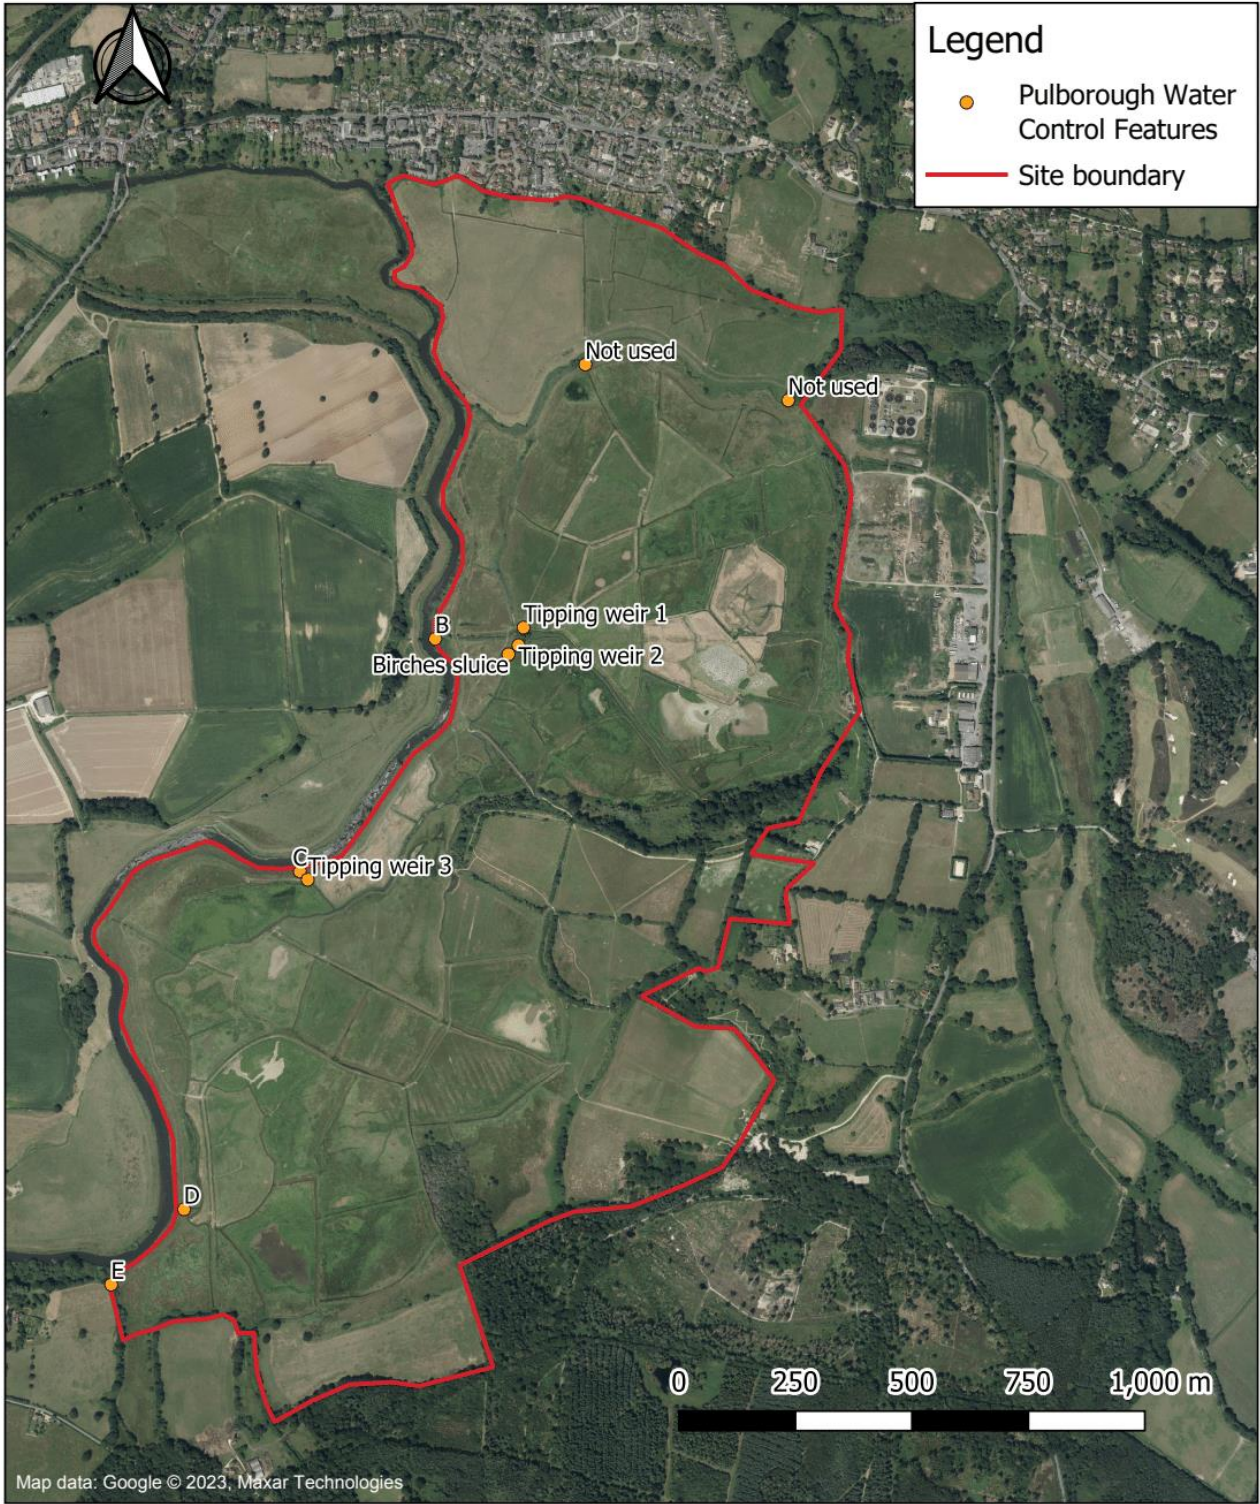
Figure D – Water Control Features, Pulborough Brooks

Manipulation of water levels happens consistently throughout the year by RSPB operatives using sluices at various points across the Site as shown in Drawing Figure D. To increase retention time and water levels throughout Pulborough Brooks, it may be possible to raise sluice heights.

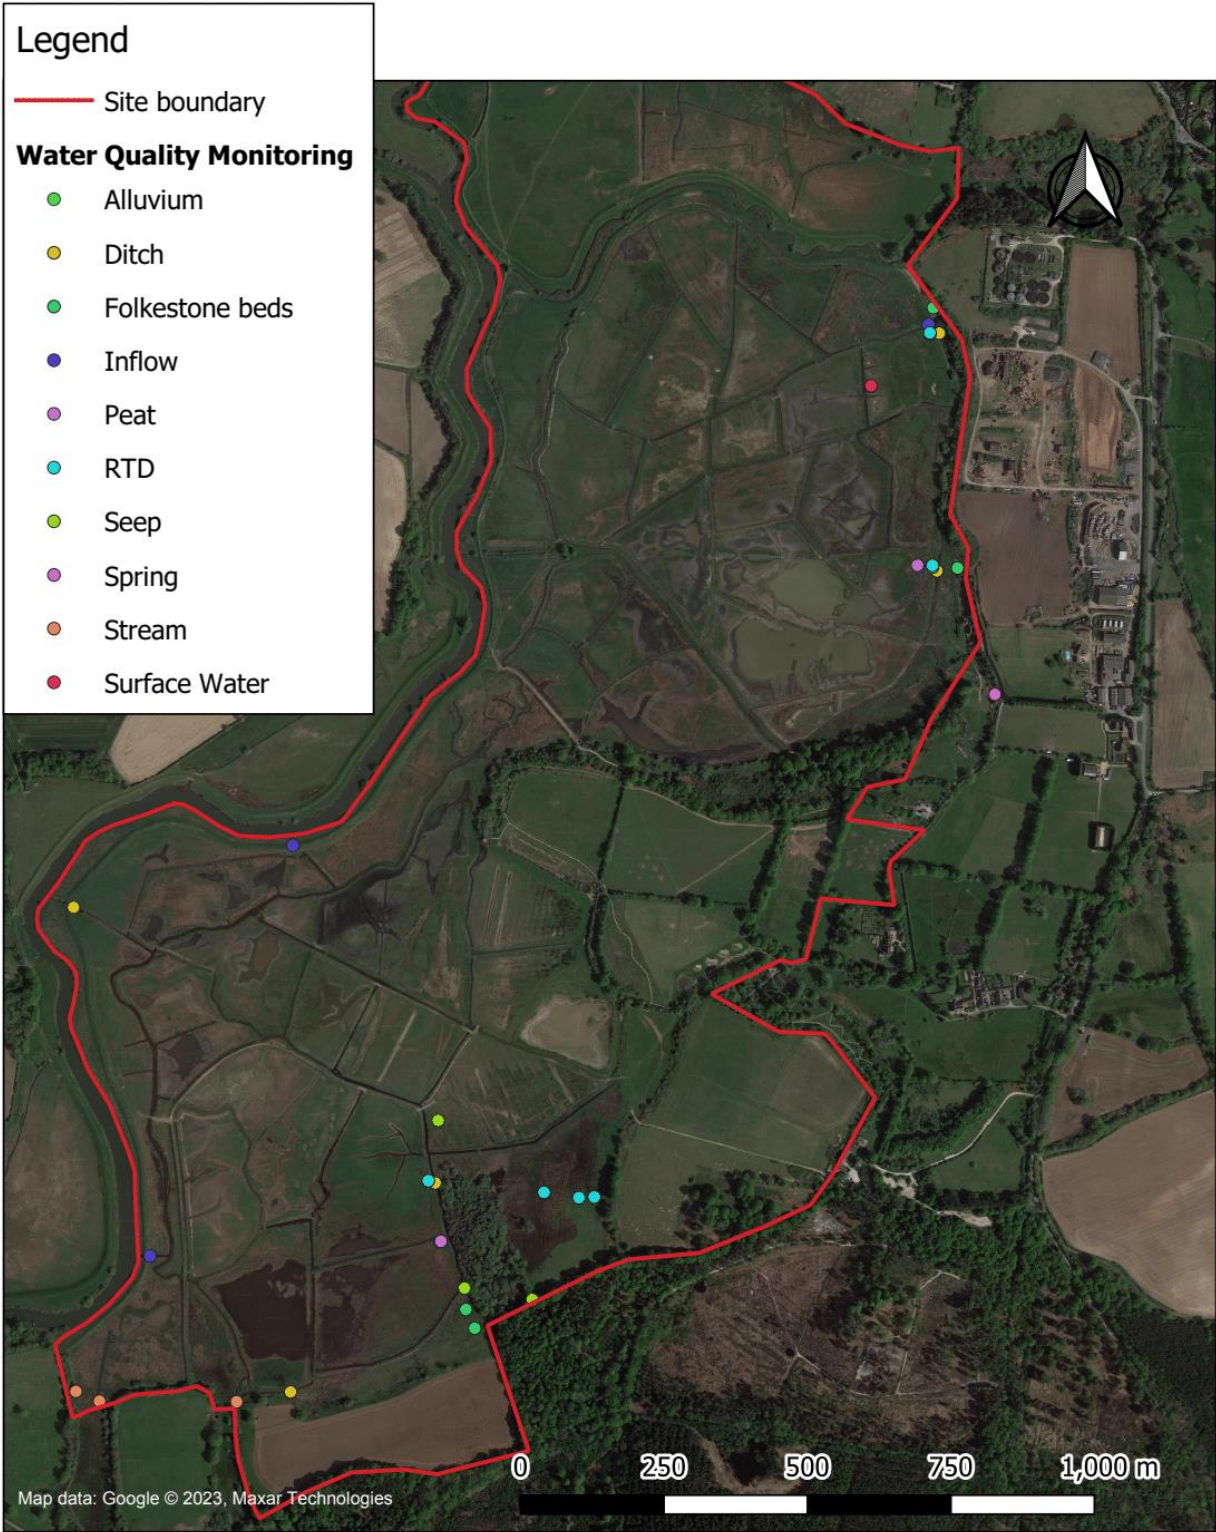
Figure K – Water Quality Monitoring Points, Pulborough

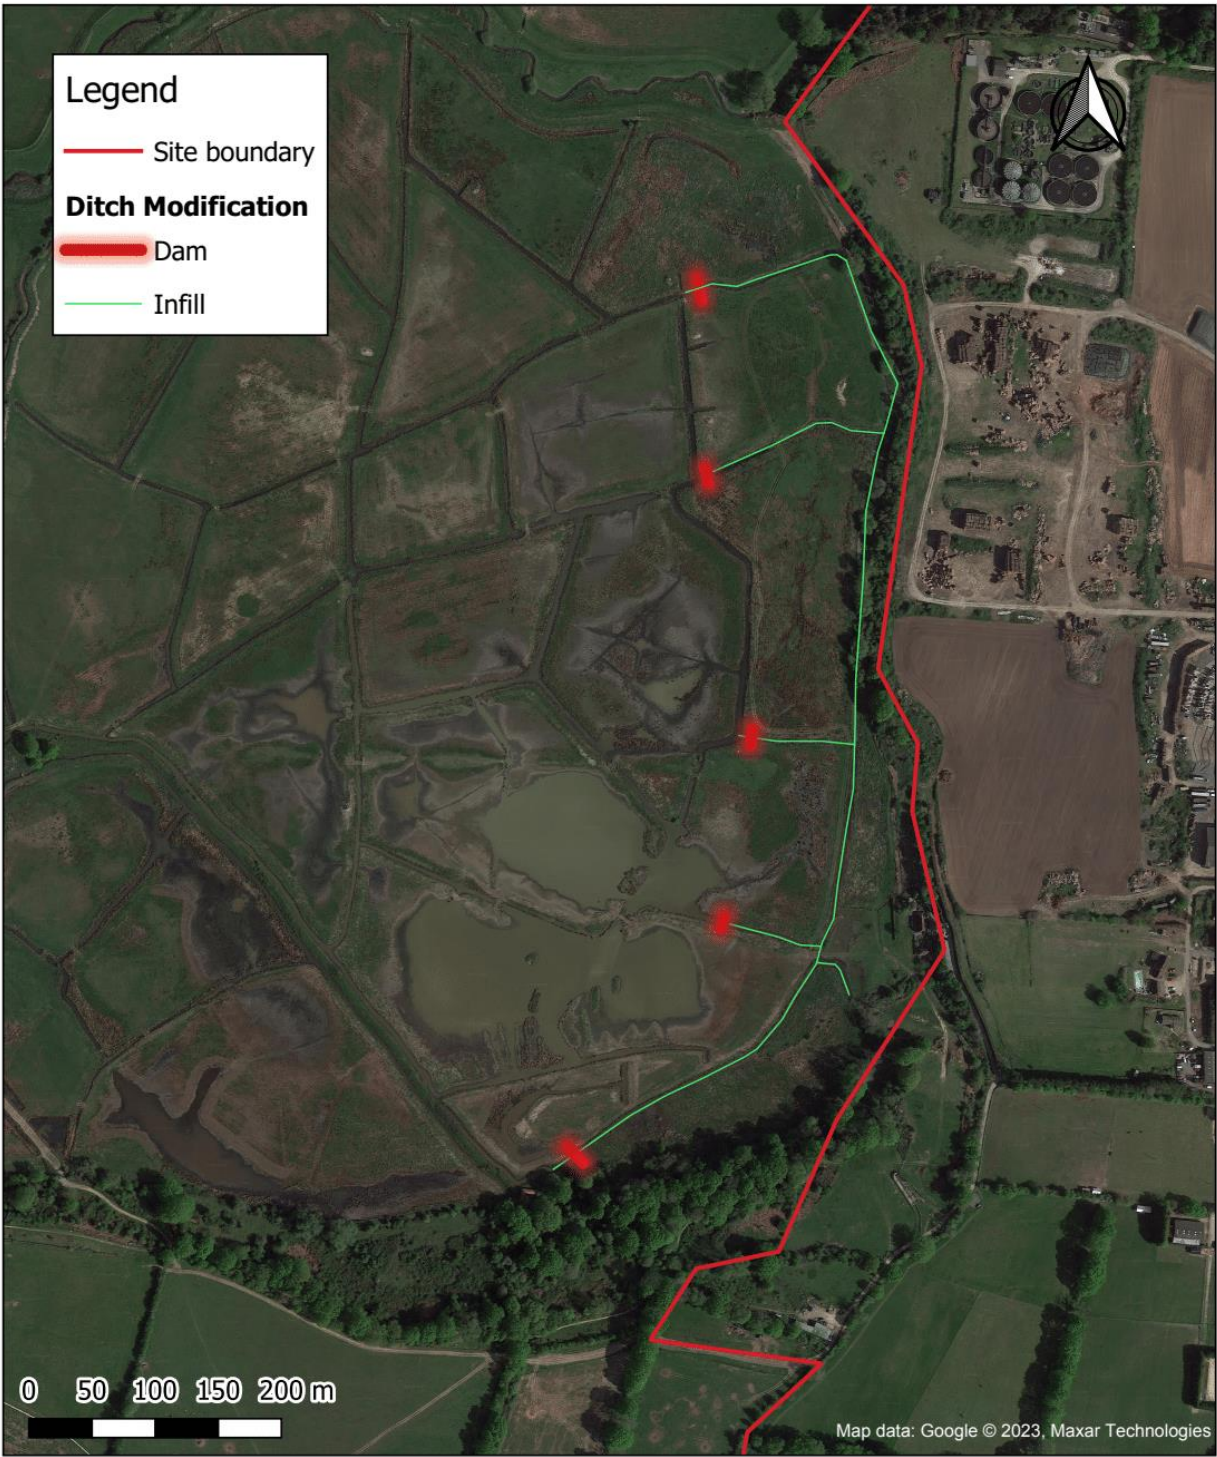
Figure M – Suggested Ditch Modifications, Pulborough Brooks North

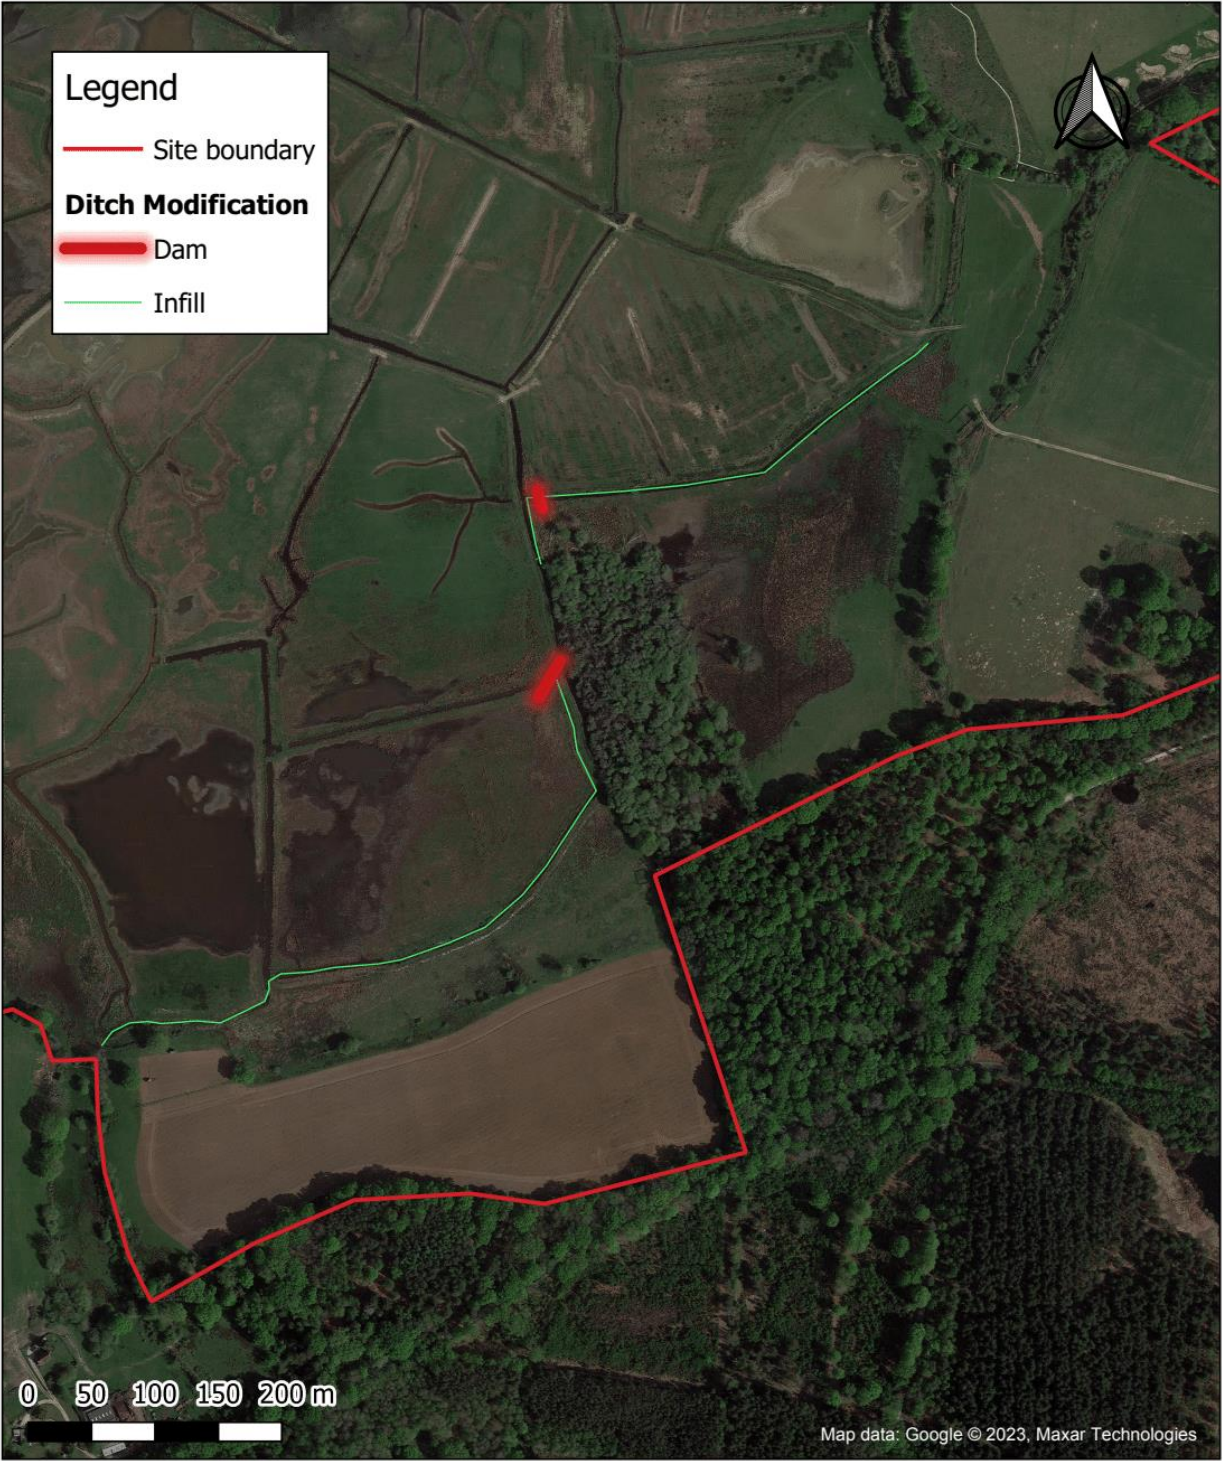
Figure N – Suggested Ditch Modifications, Pulborough Brooks South
