Natural England Commissioned Report NECR141

New Forest SSSI Ecohydrological Survey Overview

Annex U: Hazel Hill Lawns

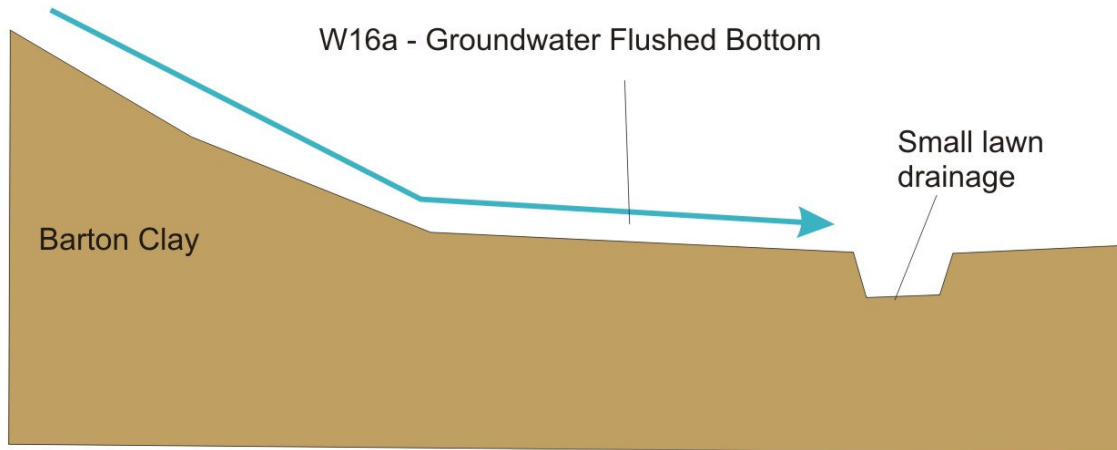
Figure 1-2: Conceptual Model Diagram

The lawn wetland areas on site are poorly drained flush dominated bottoms which collect surface run-off from the surrounding low permeability ground. Some lawn drainage in these areas may have slightly drained these areas degrading peaty soils, which might have once occupied the bottoms.

Surface water run-off
from surrounding low
permeability catchment

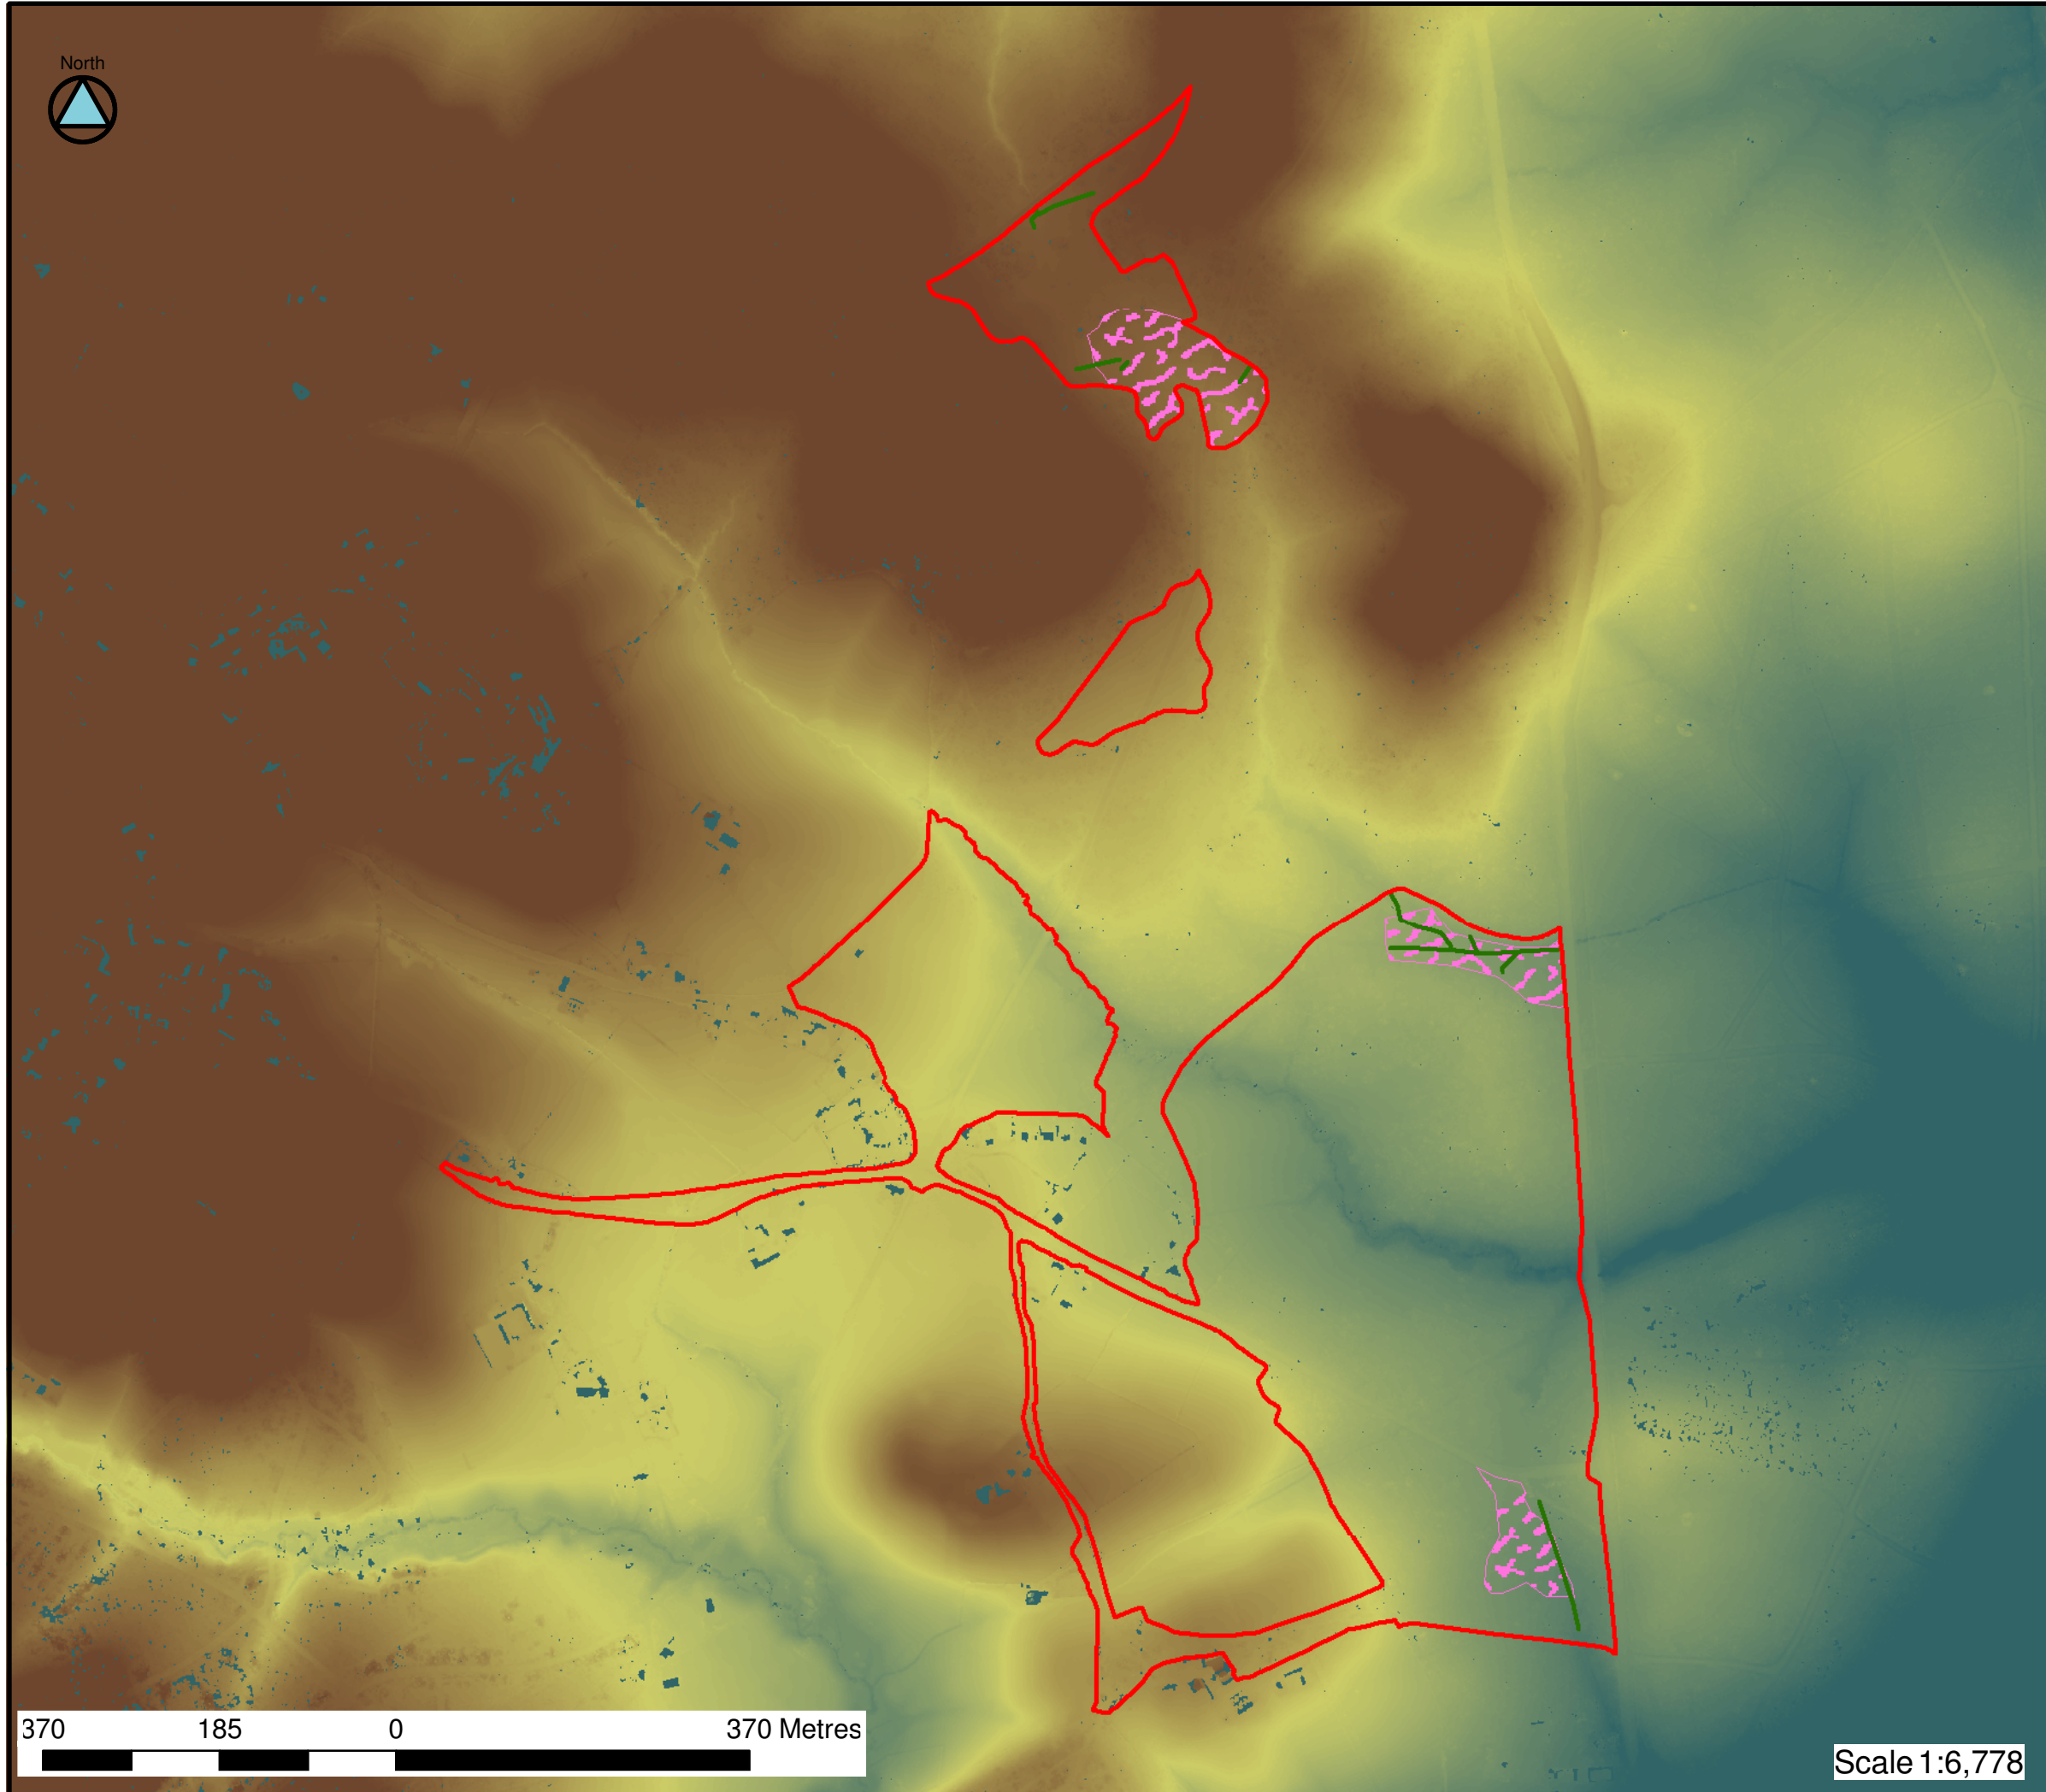
MAP 3

This area is a series of lawns surrounded by woodland. The lawns vary in their wetness depending on whether they occupy the base or sides of a series of small valleys which occupy the site. Three of the lawns can be described as valley bottom wetlands on clay soils. Within these areas there is evidence of lawn drainage, most clearly in the area marked as Hampton Green on the Ordnance Survey map.

Topography, Hydrology and Wetland Distribution

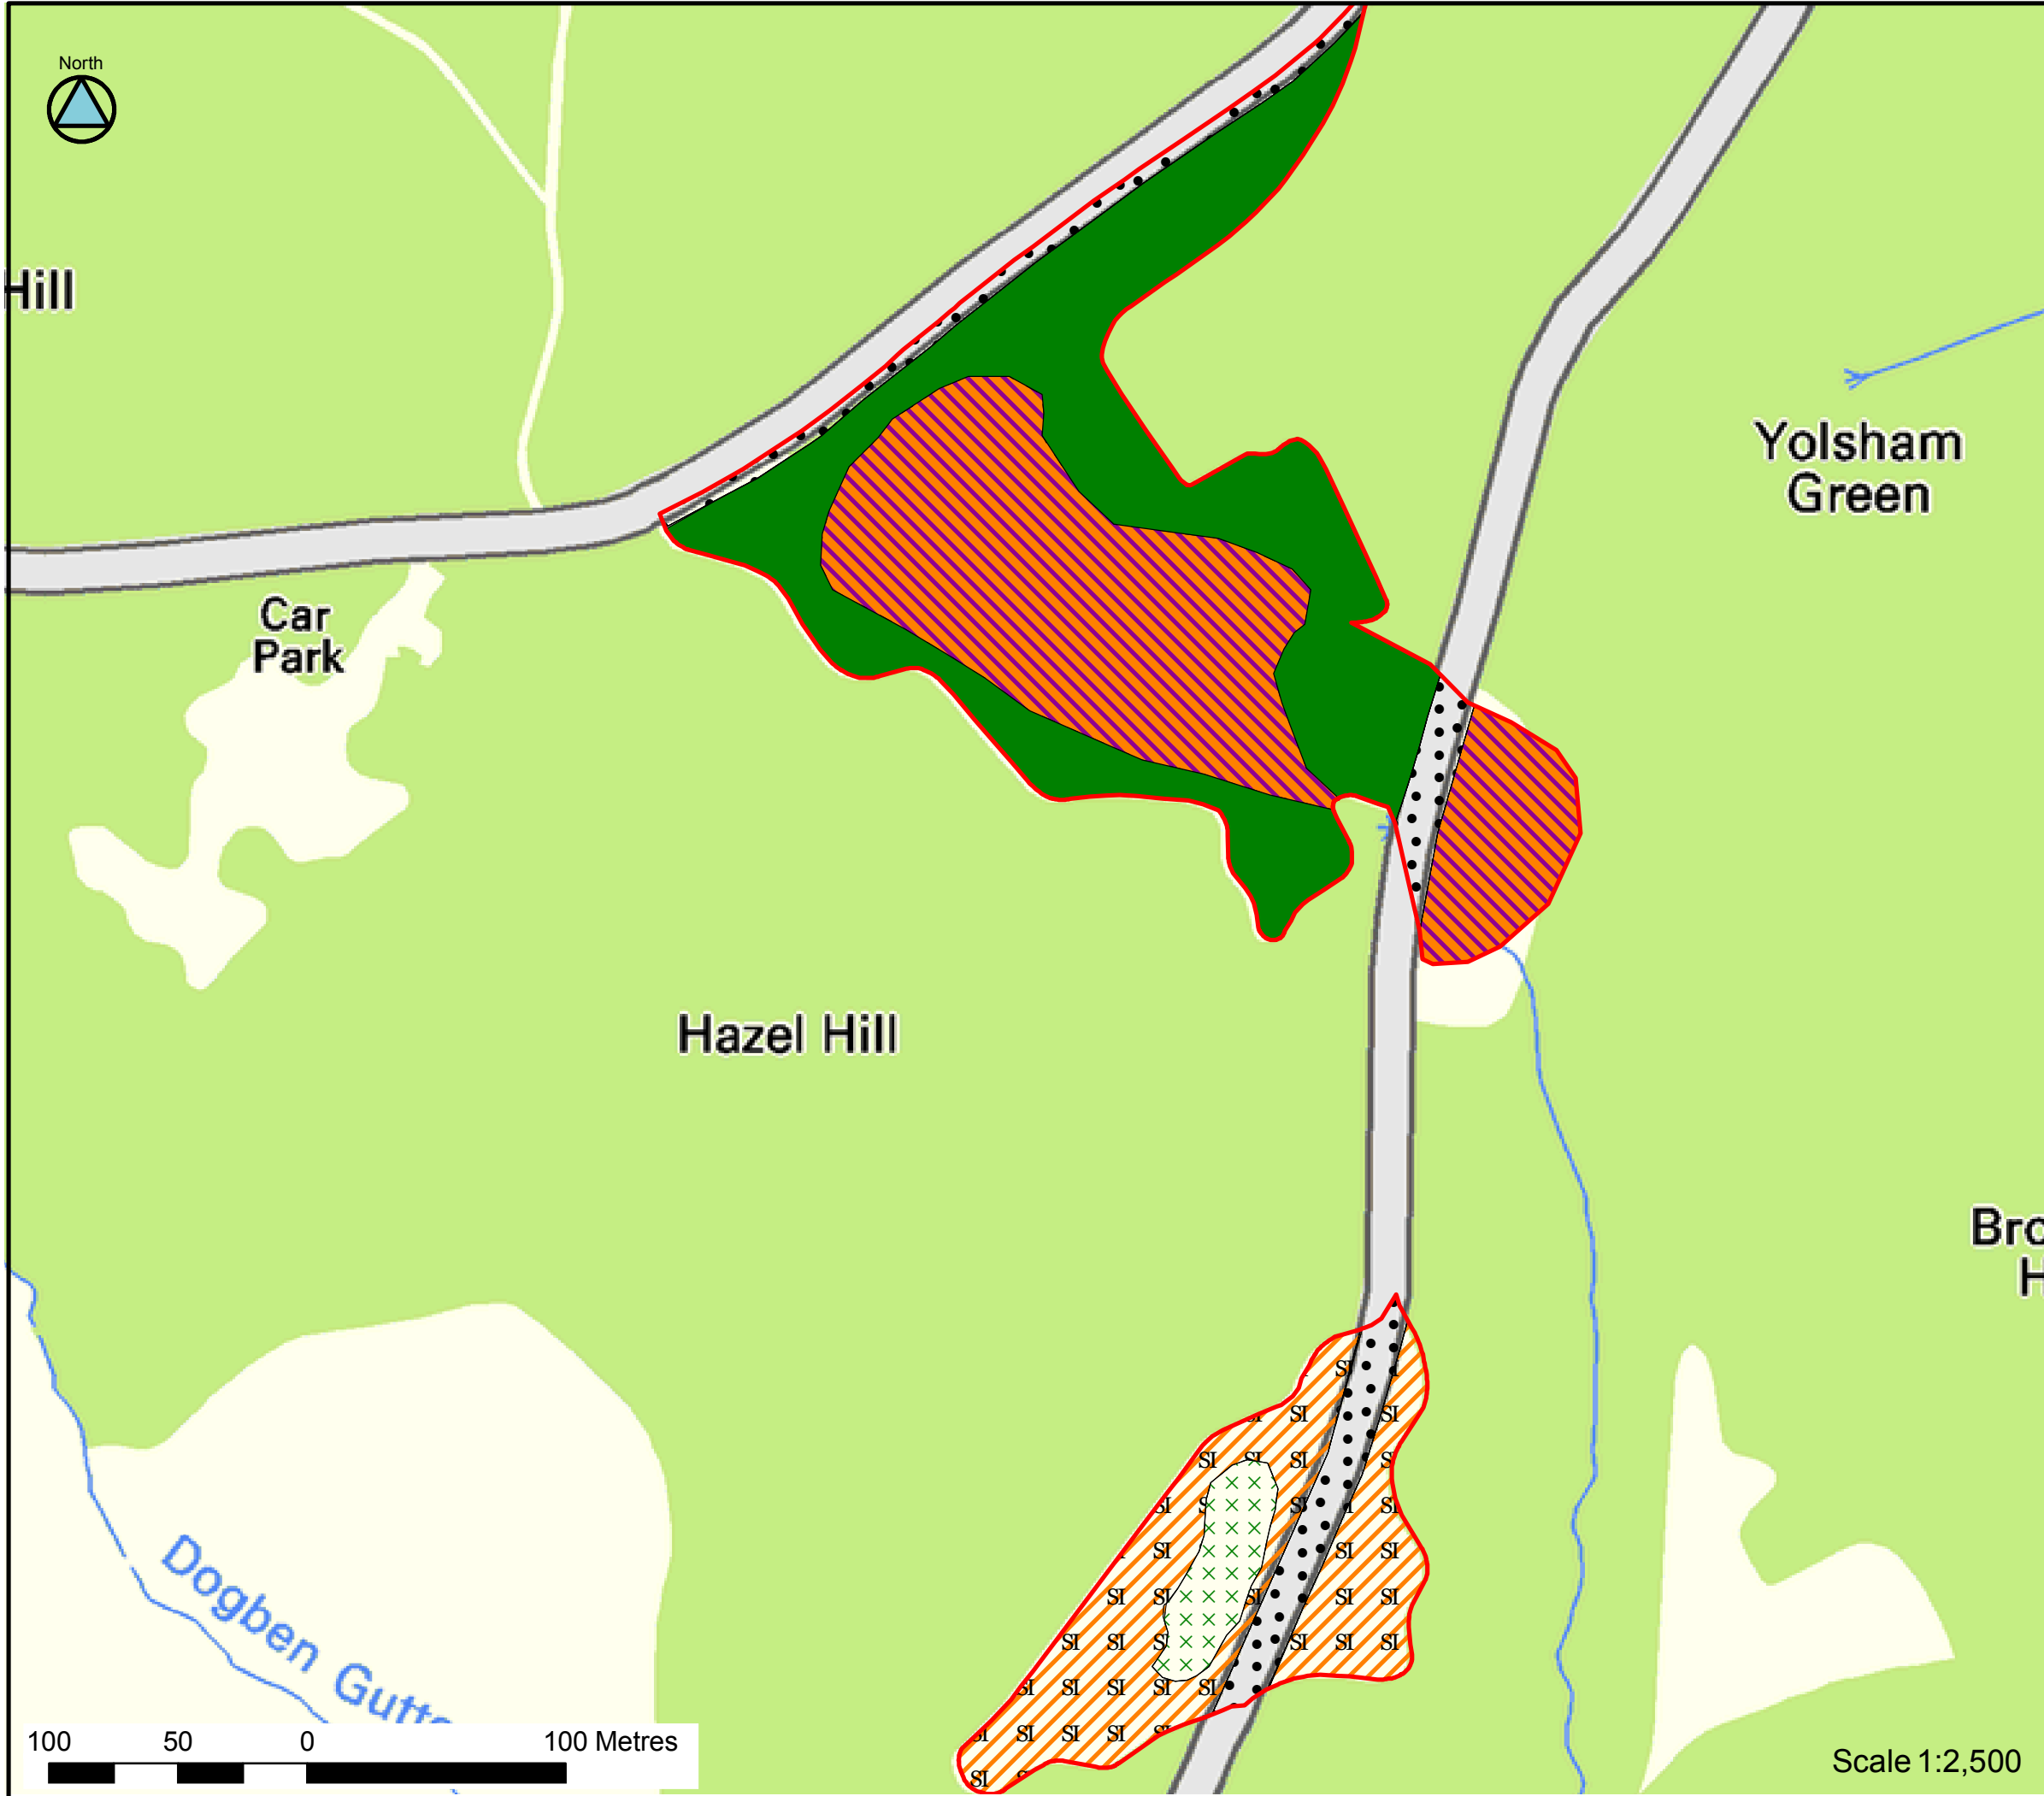
MAP 4

Phase One Habitat

Unit 376 is a composite site made up of several smaller sub-sites. The first is Ways Green which comprises a marshy grassland lawn with *Sphagnum* species present. It has been heavily grazed. The lawn is surrounded by broad-leaved woodland with species including Birch *Betula pendula* and Oak *Quercus robur*, with Bracken *Pteridium aquilinum* and Holly *Ilex europaeus* in the shrub layer. The water is held on site by low permeability clay and is not fed by any kind of groundwater, e.g. a seepage face. There are two old historic, silted-up drains cutting across the site, however, today these are only slight depressions which still manage to direct surface water to a collect marked on the 1:10,000 Ordnance Survey map located next to the road at the south eastern end of the site.

The very last section of Unit 376 is located on and around Hampton's Green (near Duell's Farm). The area has a mixture of both natural streams and artificial drainage running through it, interspersed with areas of poor semi-improved grassland and patches of mixed woodland.

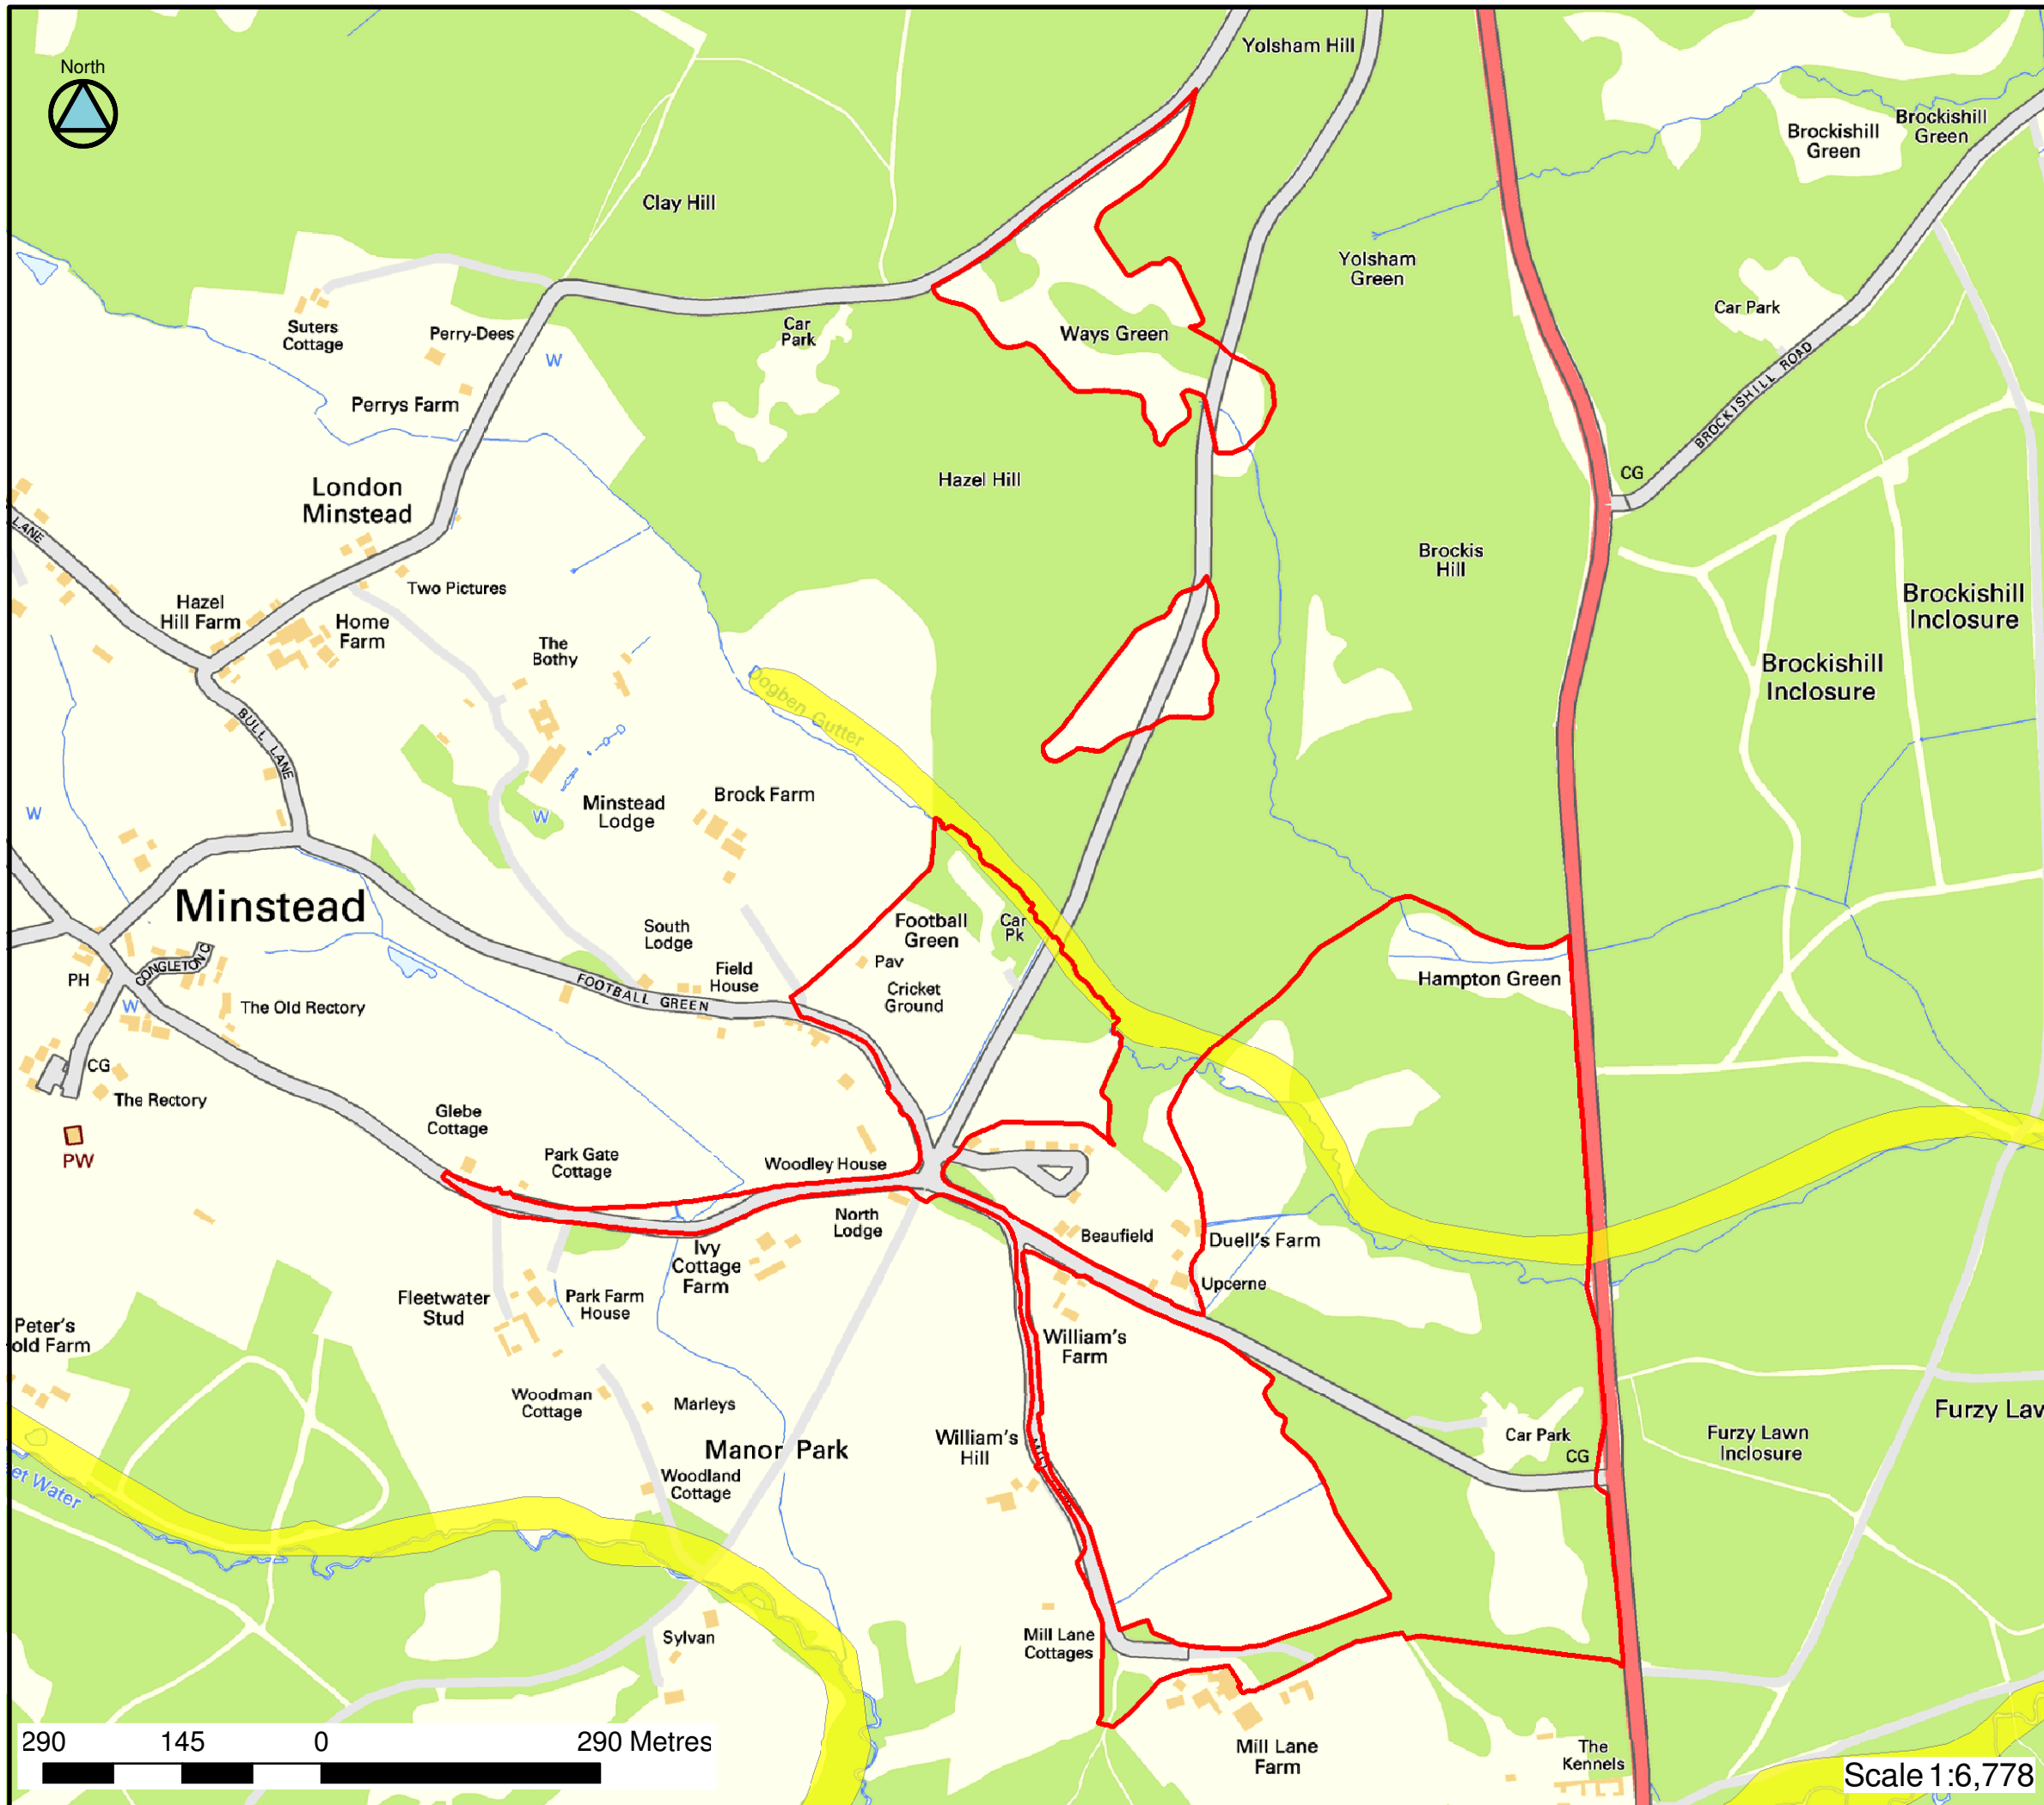
MAP 5

Drift Geology
