Natural England Commissioned Report NECR240

Remedial Works for the Catch Dykes at Ebb and Flow Marshes

GARDINER, A. 2017. Remedial Works for the Catch Dykes at Ebb and Flow Marshes, Number240.

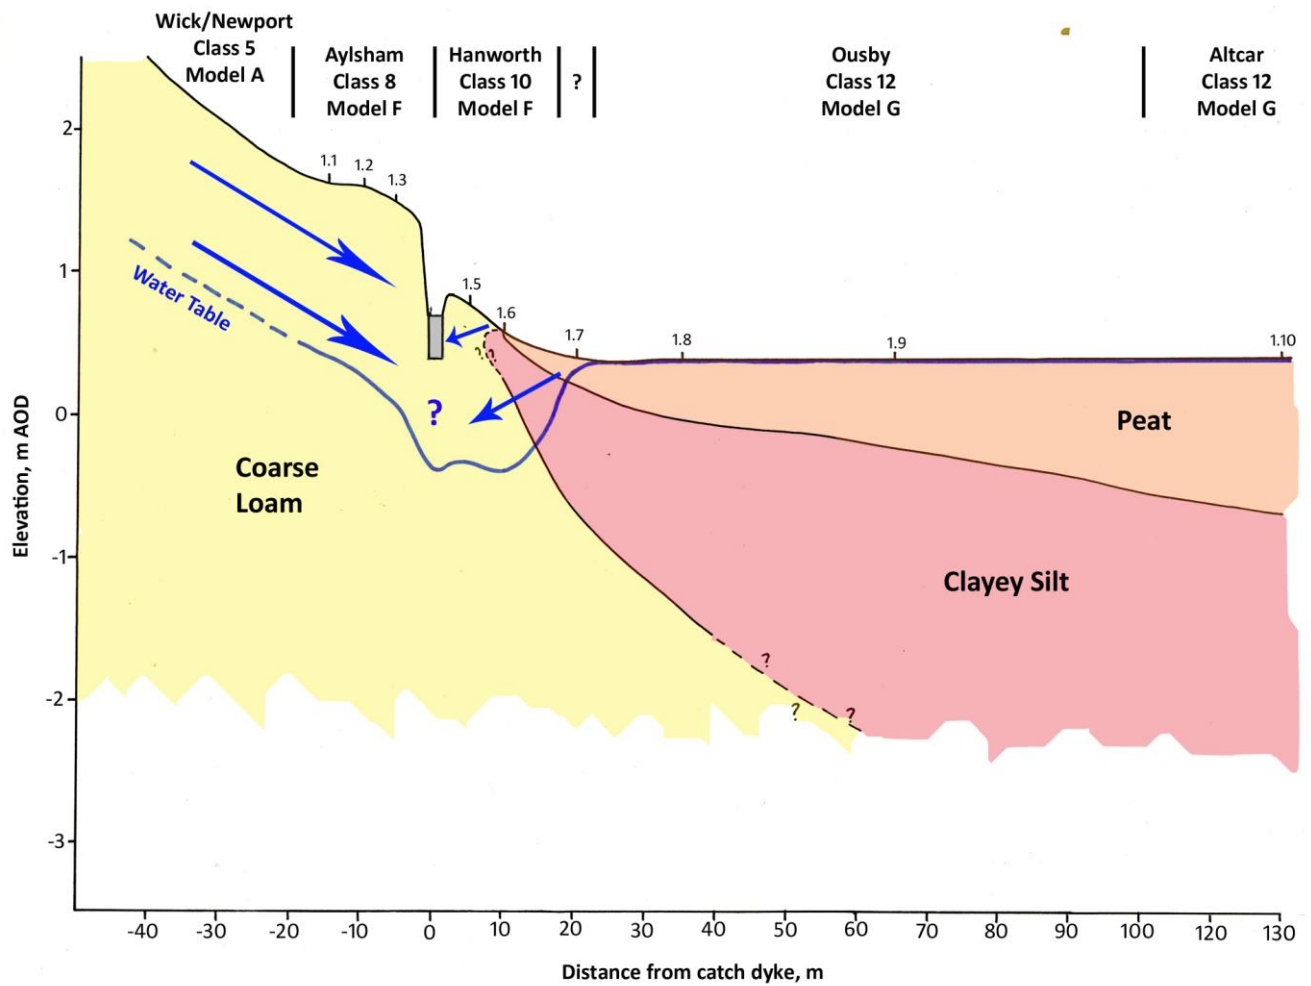
Figure 4: Cross Section at Transect 1 showing Water Table and Shallow Stratigraphy

The water table on 15/10/15 shows a deep trough below the catch dyke, with no perched water in the dyke itself. The expected water table shape – highest on the slope, declining toward and then across the floodplain until the river level and groundwater equilibrate – has clearly been disrupted by the catch dyke. Reversed groundwater flow from the fen to the catch dyke occurs, against the topographic gradient. The water table only meets the fen surface when the thick clayey and silty alluvium is reached, 20m downslope of the catch dyke (Core 1.7). River levels, distributed by the meagre dyke system, maintains the fen water table from this point, with no groundwater support. The water table gradient back towards the catch dyke is very steep, reflecting the steepness of the aquaclude margin.

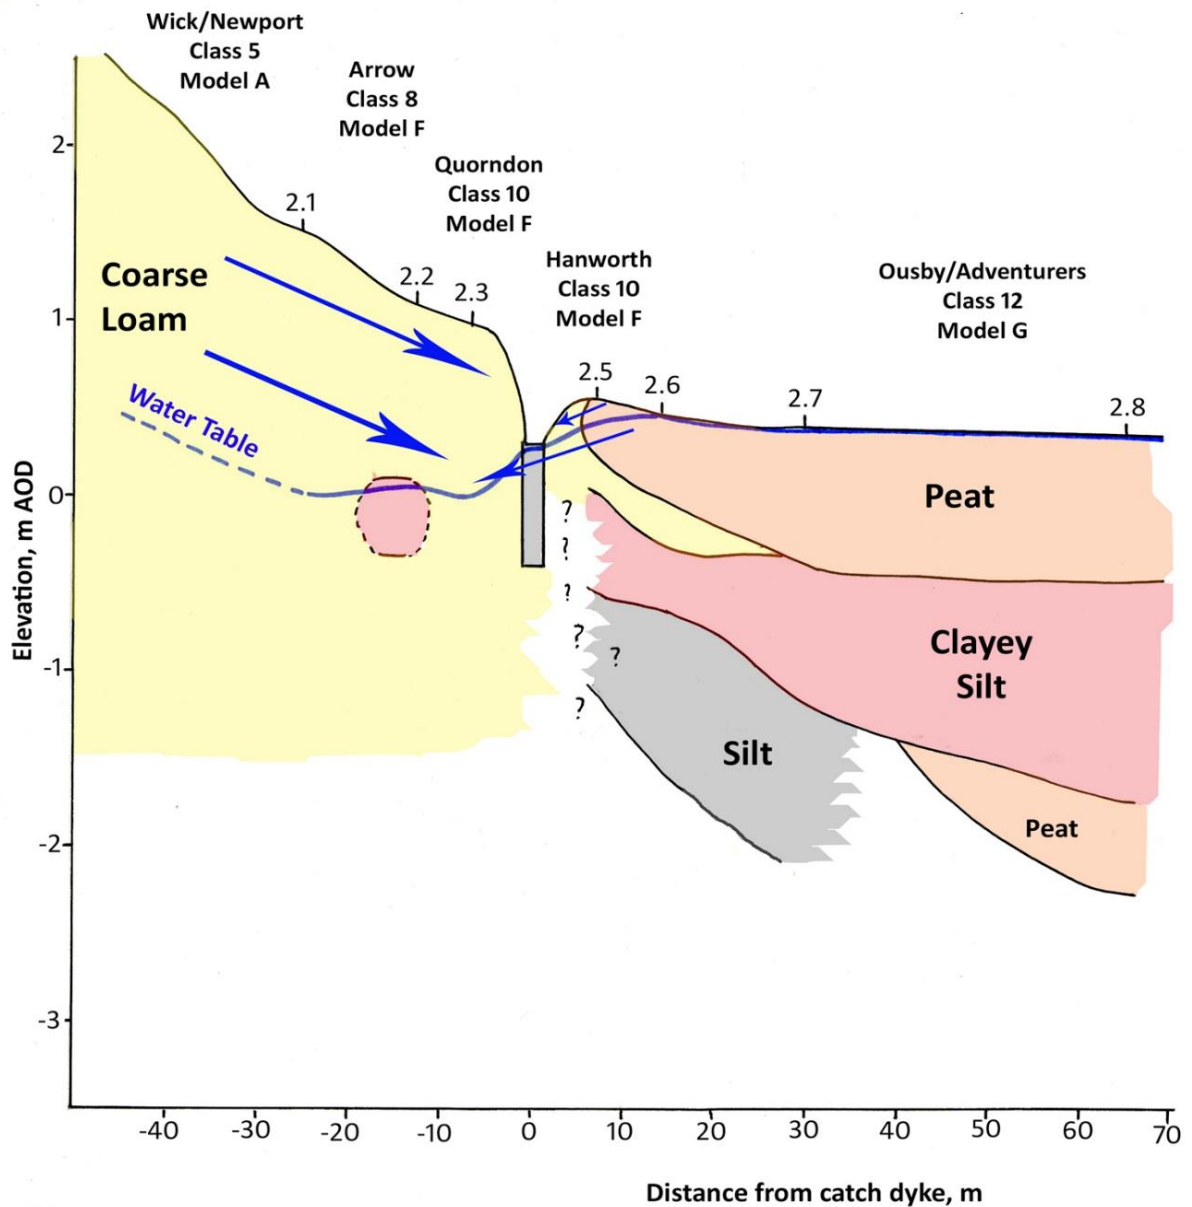
Figure 5: Cross Section at Transect 2 showing Water Table and Shallow Stratigraphy

The catch dyke lies in similar coarse loamy drift. There is around 0.75m of organic dyke silt, the upper parts almost peaty, supporting shallow water.

Downslope of the catch dyke, Core 2.5 shows a transition to true fen soils. Surface peat is first recorded, although here at the fen edge it is very shallow and well humified. There is a thin band of sandy silt loam between the peat and alluvium which is strongly mottled indicating a

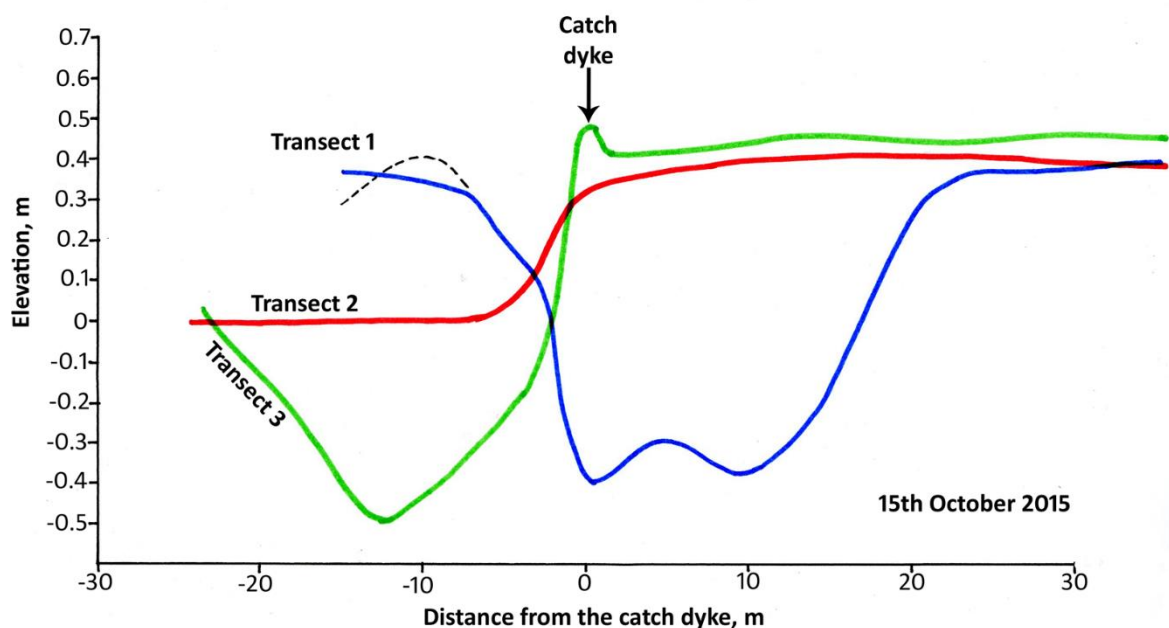
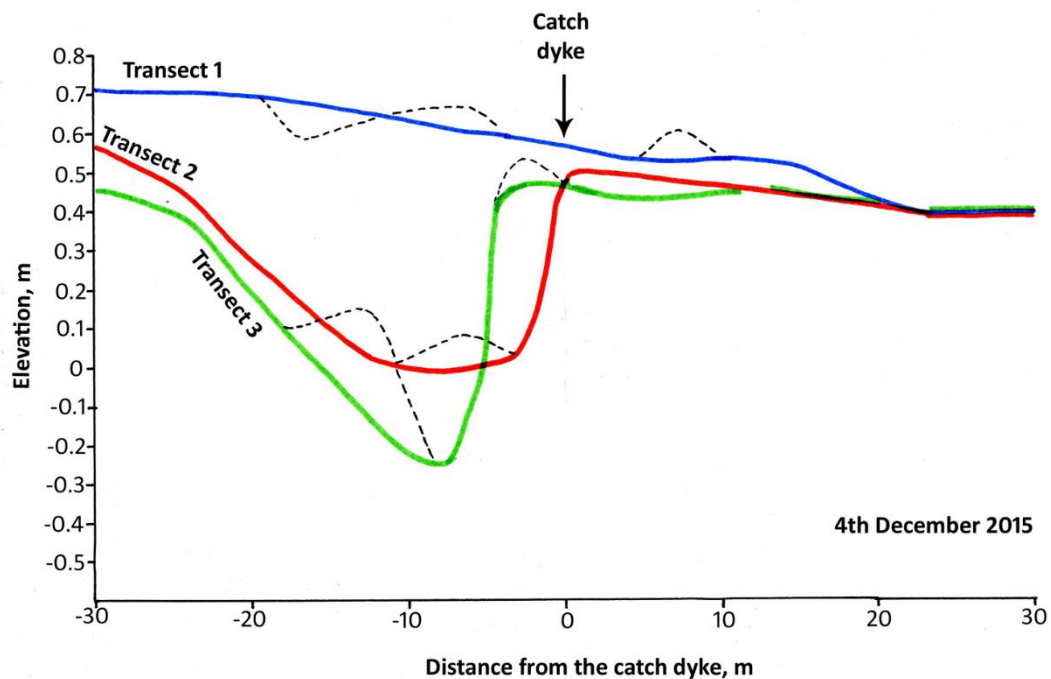
Profiles are smoothed; dashed black line indicates level recorded in the field.

The graphs show that in both periods, the water table of all three transects equalise over the aquaclude, reflecting the overriding influence of the river and alluvium on surface water levels. Water tables further than 10m downslope from the catch dyke show only a very modest increase in level (up to 10cm but usually much less) between October and December. The increase in water table level in the coarse loams upslope of the catch dyke is by contrast very marked, 30.5cm on average but closer to 40cm for T1 and T3. The rest level in December was well within the mottled zone of the toe slope soils. The data suggests water levels are relatively stable in the peat fen but dynamic along the catch dyke corridor and the toe slope.

In October, the position of the trough is closely aligned to the upslope edge of the aquaclude. In Transect 1, the aquaclude lies further into the fen, hence the trough underlies the dyke and extends into the fen. In Transects 2 and 3, where the aquaclude more or less reaches the catch dyke, the trough is pushed upslope of the dyke.

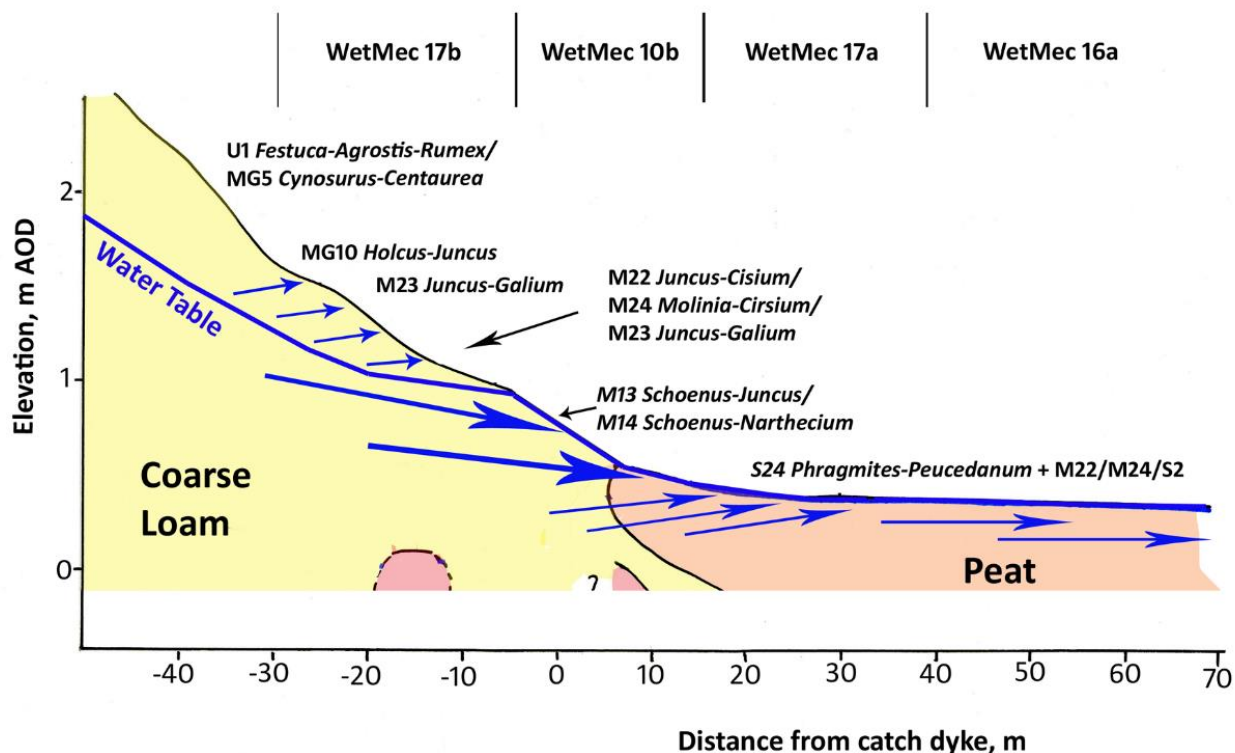
Figure 20: Potential Arrangement of Habitats Following Catch Dyke Restoration

The dryland habitats, being restored on former arable, would take time to re-establish. *Calluna* heath has not been suggested. The soils are too fine-textured, lacking coarse gravelly-sandy soils typical of natural heather heath. Instead, a grassland somewhere between U1 *Festuca ovina-Agrostis capillaris – Rumex acetosella* acid grassland and MG5 *Cynosurus cristatus-Centaurea nigra* mesotrophic grassland would likely develop. The U1 acid grassland would favour coarser sand soils, the MG5 more likely on profiles with siltier topsoils. The more mesic acid grassland types – such as the *Anthoxanthum odoratum-Lotus corniculatus* sub-community – and the more low-nutrient mesotrophic grassland – such as the *Danthonia decumbens* sub-community – would be most likely, reflecting the intermediate nature of the soils.

There would be a narrow zone of rush pasture where soils are water logged in winter and summer dry. At higher elevations, the MG10 *Holcus lanatus-Juncus effusus* rush pasture would most likely develop, while further down the toe slope in wetter situations, there would be a transition to a form of M23 *Juncus acutiflorus/effusus- Galium palustre* rush pasture where ground water flushing is more reliable and raises the water table close to the surface in summer. Communities on the acid side of neutral are expected on the coarse loams with groundwater derived from the Happisburgh Formation decalcified drift.

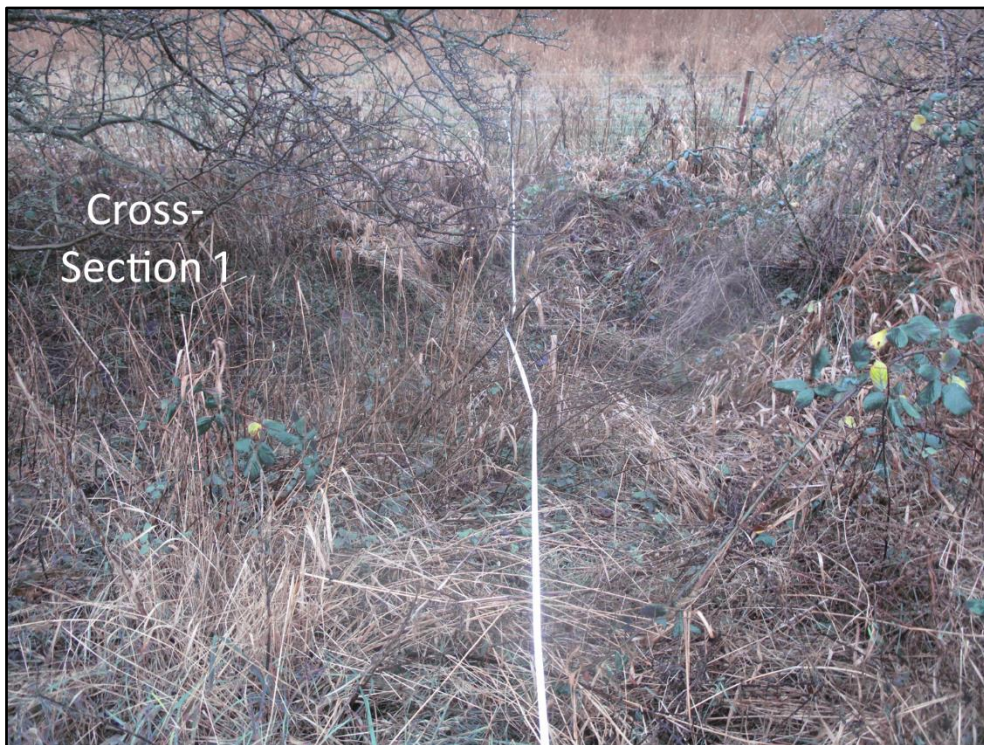
Figure 23 shows representative cross sections of the existing dykes, with a generalised red line showing the approximate desired finished profile. The silt in the dykes is firm and therefore the cross-sections show the top of the dyke silt. The sections were constructed using levels taken every 1m and are diagrammatic, with the elevation not to Ordnance Datum.

Figure 23: Representative Cross-sections of the Catch Dyke. Blue line is the top of the silt which is firm. The red line is the approximate desired finished profile. A photo of the section follows each graph.

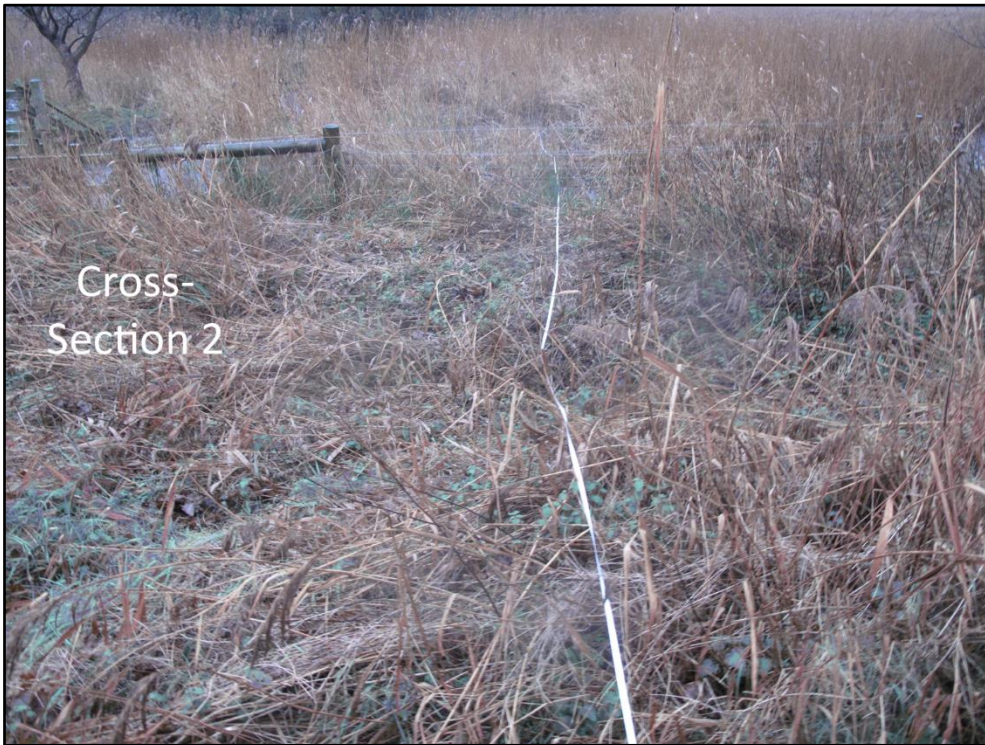
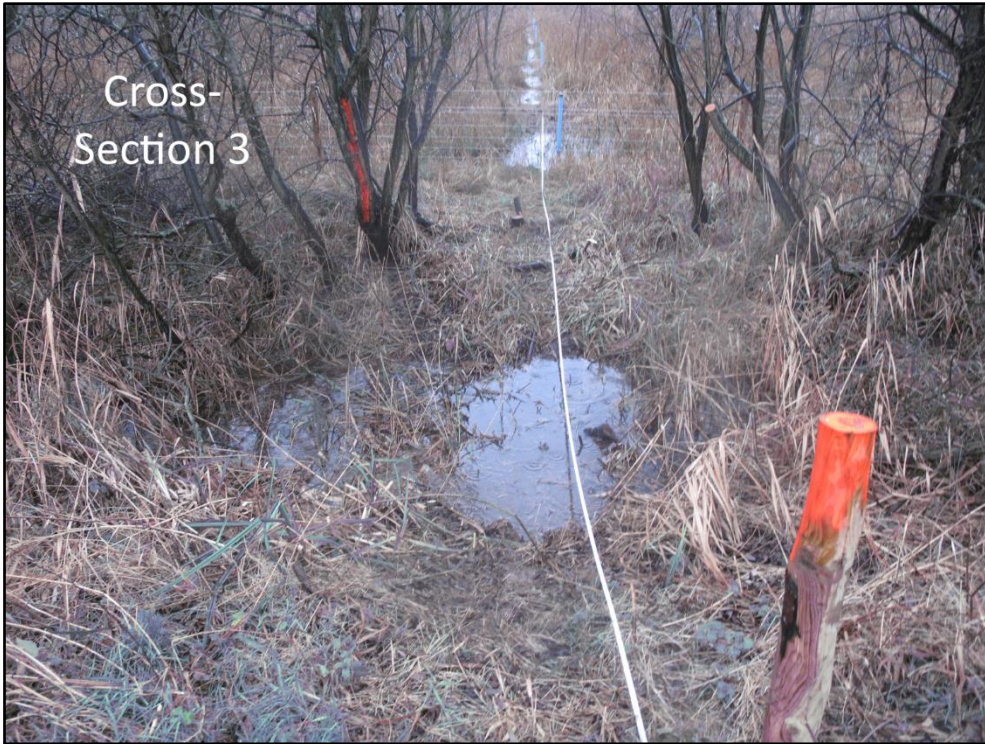
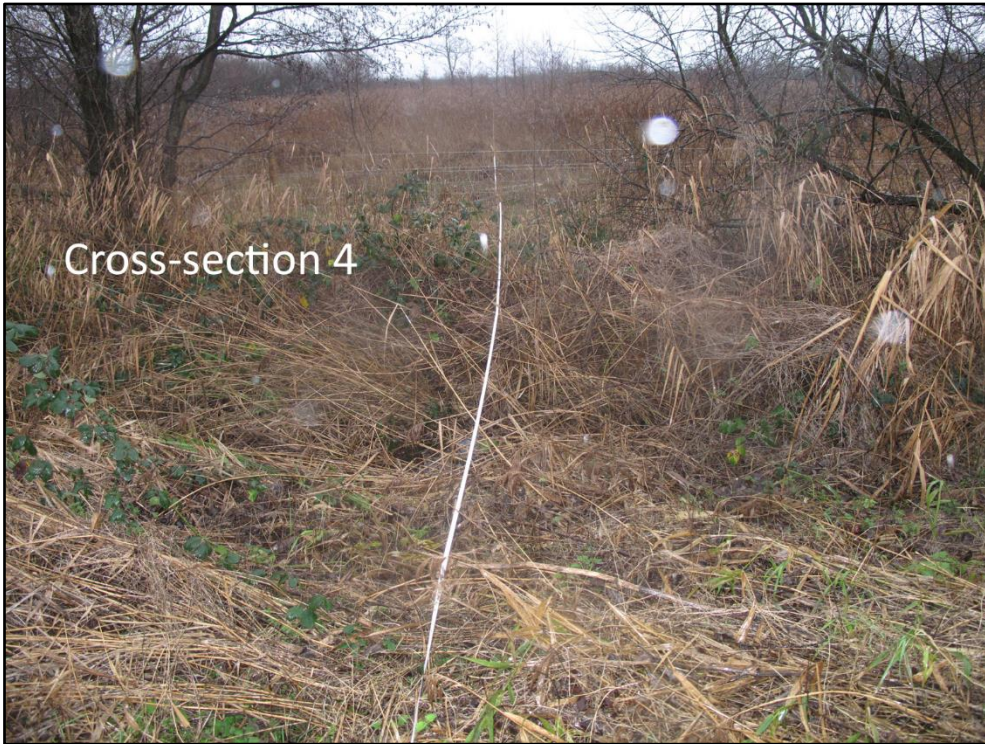
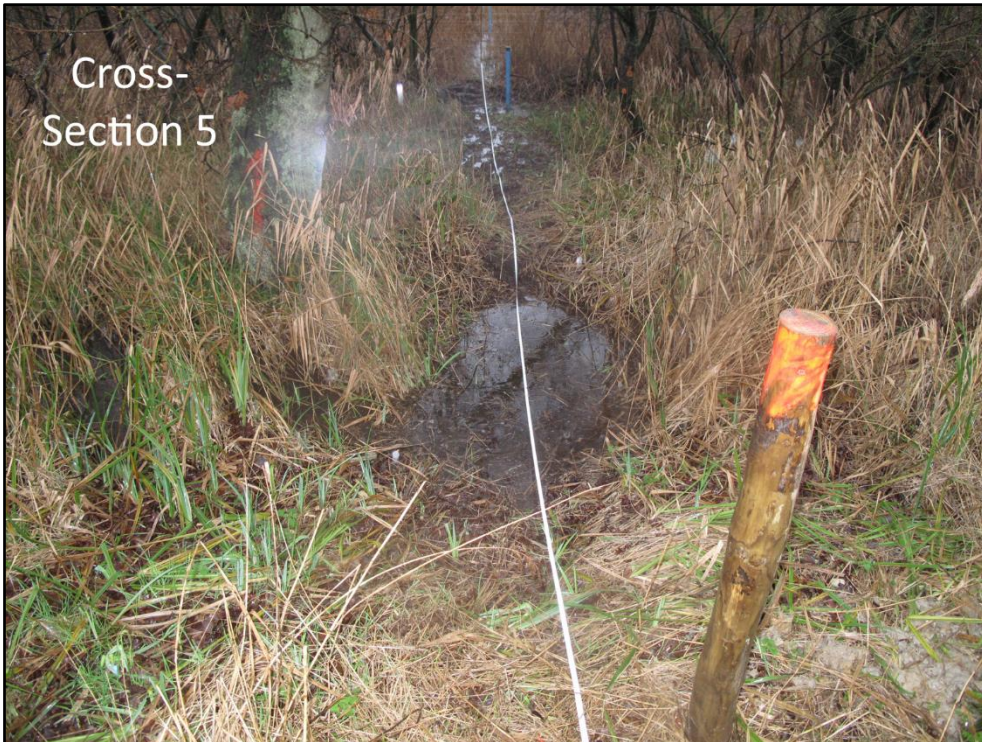
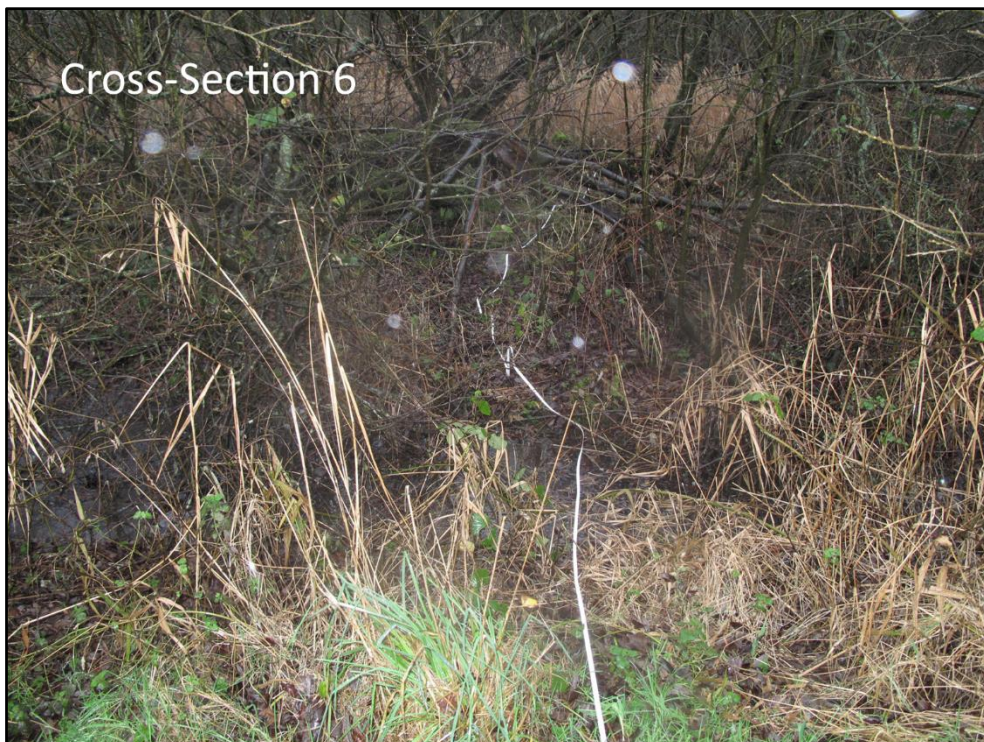
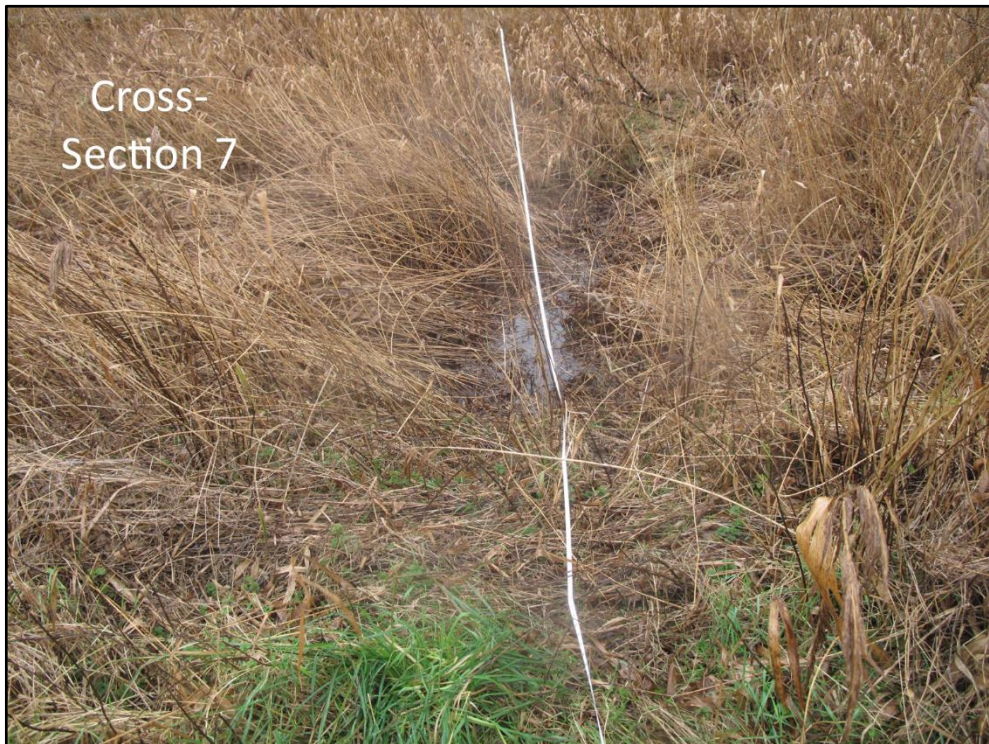
Figure 24: Cross-Dyke Sheet Piling Barrier To Prevent Eastern Flow of Groundwater. The red line is the ground surface. The barrier should extend from ground surface to -1.50m AOD. It should extend 35m upslope and 20m downslope of the centre of the catch dyke, 55m total.

One major cross-barrier is needed to prevent the proposed draw-down of the water table under or around the catch dyke at the east end of the valley. This will need to penetrate down to base drainage level, which is taken as the low level dyke east of the site. This was measured as minus 0.78m AOD in October 2015, but will be lower in summer. A design base depth of -1.50m is suggested for the barrier. Sealing should extend downslope of the catch dyke to meet the clayey alluvium. Transect 3 suggests this is close to the catch dyke at the east end of the site, hence 20m from the centre of the catch dyke. It should extend upslope from the centre of the dyke by 35m, a total of 55m. Interlocking trench sheeting should be used. It should be located at the track location at the east end of the marsh (Figure 21).

Figure 24 shows a topographic survey of the line of the barrier with a level to mAOD recorded every 1m from 35m upslope to 30m downslope of the centre of the catch dyke (culvert location). To reach design depth of -1.50m AOD, the piles will need to be longer upslope to account for the rise in land. From a point 10m upslope of the centre of the catch dyke to the downslope end of the barrier, a length of 30m, the piles will need to be 2.5m long to reach target level. From the upslope start point, the sheet piles need to be c.3.5m long diminishing to 2.5m to the point 10m upslope of the centre of the catch dyke.

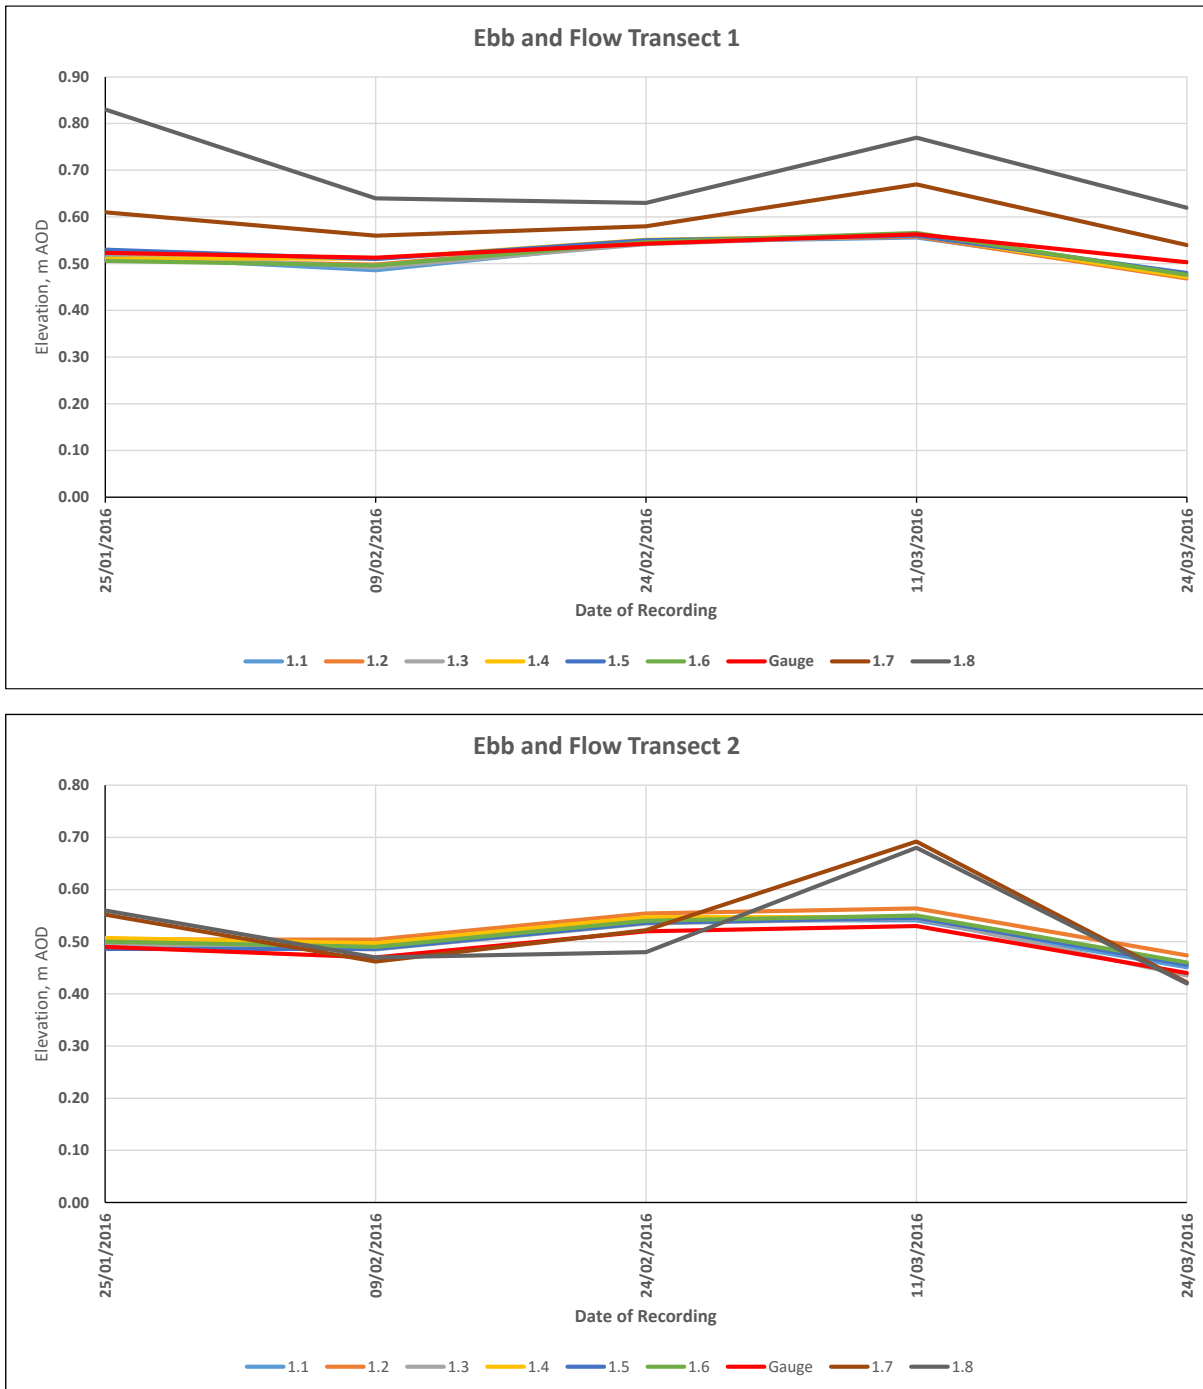
Figure 29: Dipwell Records to 1st April 2016. First graph is Transect 1, the second Transect 2.
