Survey and analysis of vegetation and hydrological change in English dune slack habitats

Annex 7 - Site report for Winterton

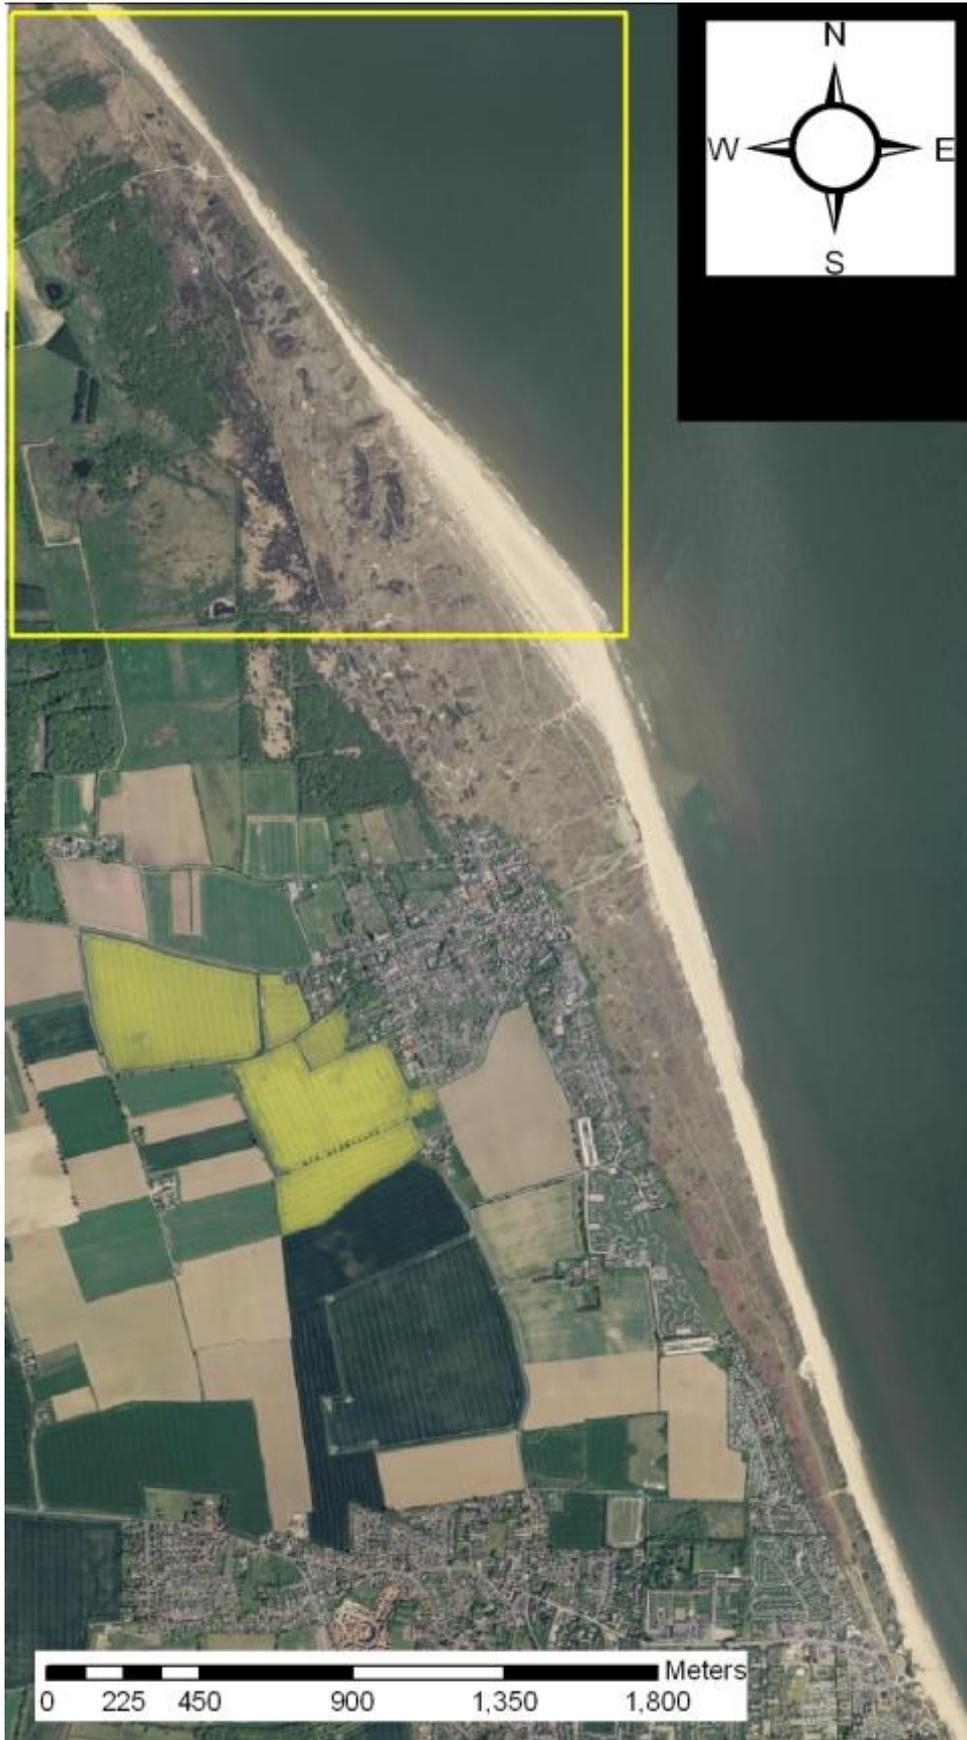
Figure 2. Aerial photo of Winterton Dunes. The yellow box indicates the area discussed in more detail later in this report. © Next Perspectives.

Winterton Dunes NNR is located on the east coast of Norfolk, approximately 8 miles north of Great Yarmouth (Figure 1). It is a hindshore dune system with low-lying land to the west and beach to the east (Figure 2). Blown sand in the north western part of the site overlies the sand and gravel of the coastal barrier complex, which in turn overlies till. The blown sand in the south eastern part of the site directly overlies till. The full sequence is likely to be blown sand over the sand and gravel of coastal barrier complex, over silt and clay, over peat, over Crag (Geology map 148). The dune system is up to 800 m wide by 6 km long, but continues for a further 8 km to the north west with a width of between 50 and 100 m. The fine-grained quartz sand that comprises the dunes is up to 7 m thick.

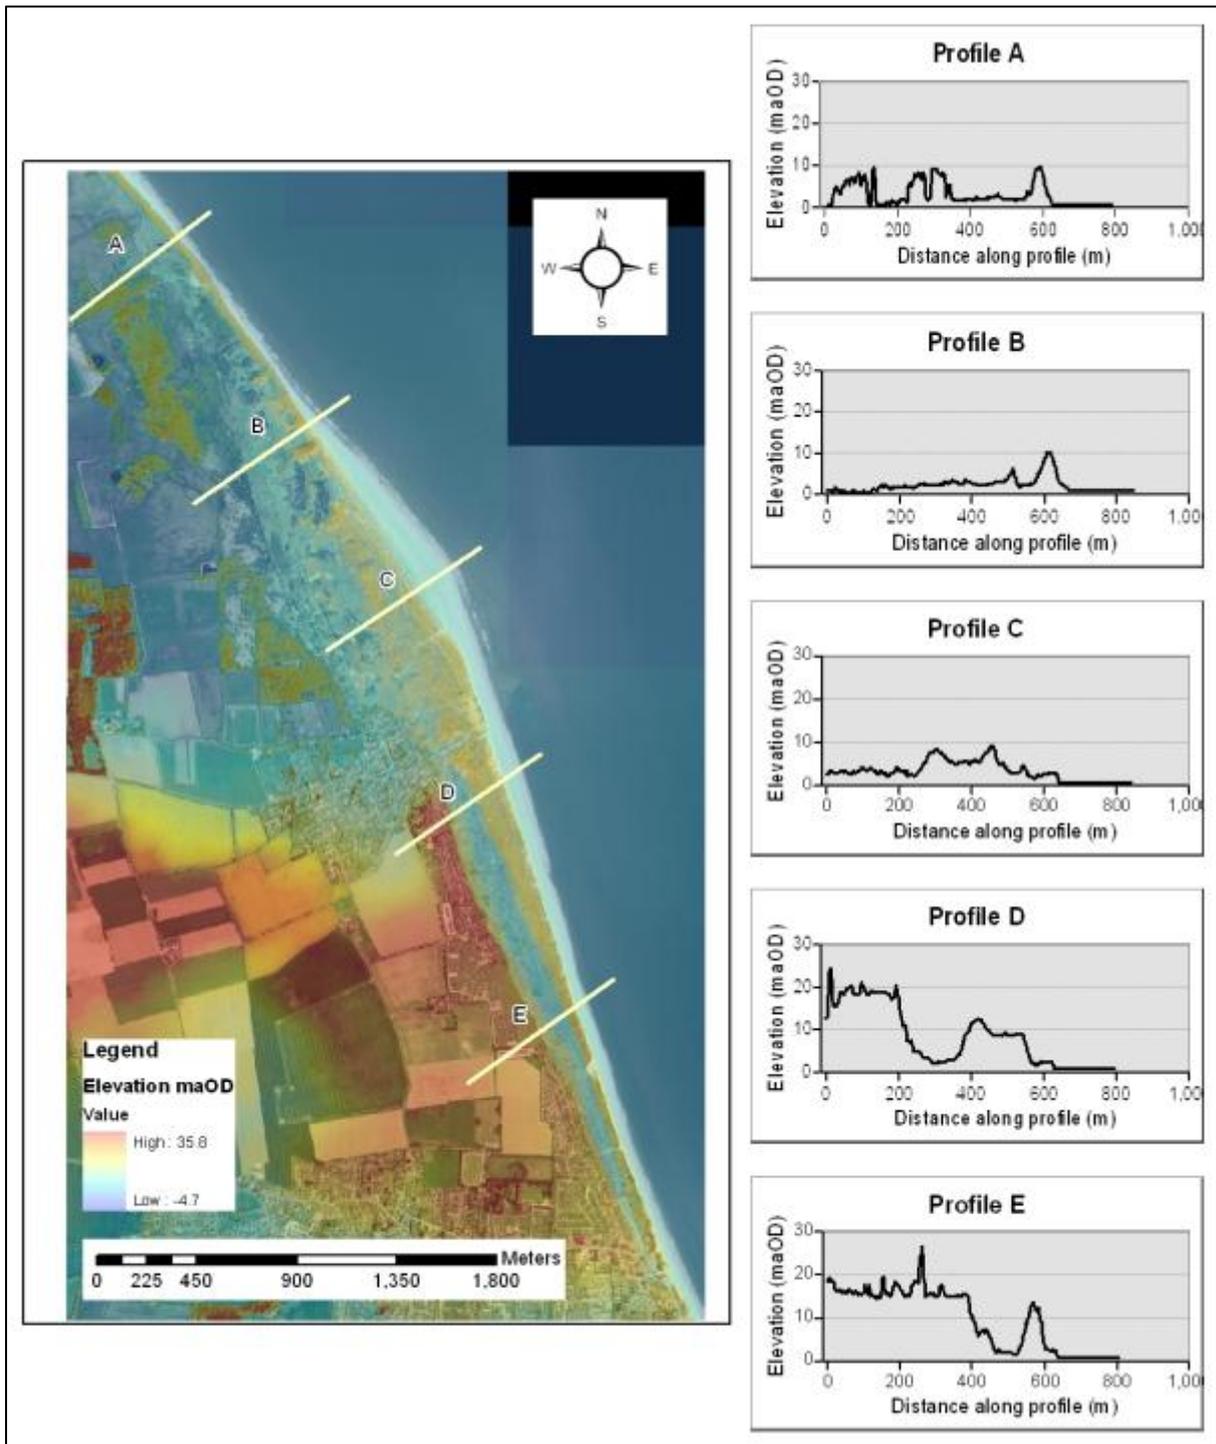
Figure 3. Elevation profiles at several locations along Winterton Dunes. Values represent the elevation of the top surface, not of the ground surface, so are affected by vegetation height. This is particularly noticeable in Profile A from 0 m to 400 m along the profile. © NERC (CEH) 2013, © Next Perspectives.

The frontal dune ridge has a fairly consistent height of ~ 10 m AOD (metres above Ordnance Datum) for the length of the dunes, and at least some of this, most noticeably in the north, coincides with the sea wall (Figure 3). Behind this, in the north of the site the surface slopes gradually inland to an elevation of ~ 0 m AOD (Figure 3, profiles A and B). To the south, the frontal dunes are wider. Inland of the southerly frontal dunes is a low lying area (termed locally as 'The Valley'), and to the west of this, higher ground. The surface elevation to the inland side of the dunes varies considerably (~20 m) between the north and south of the site.

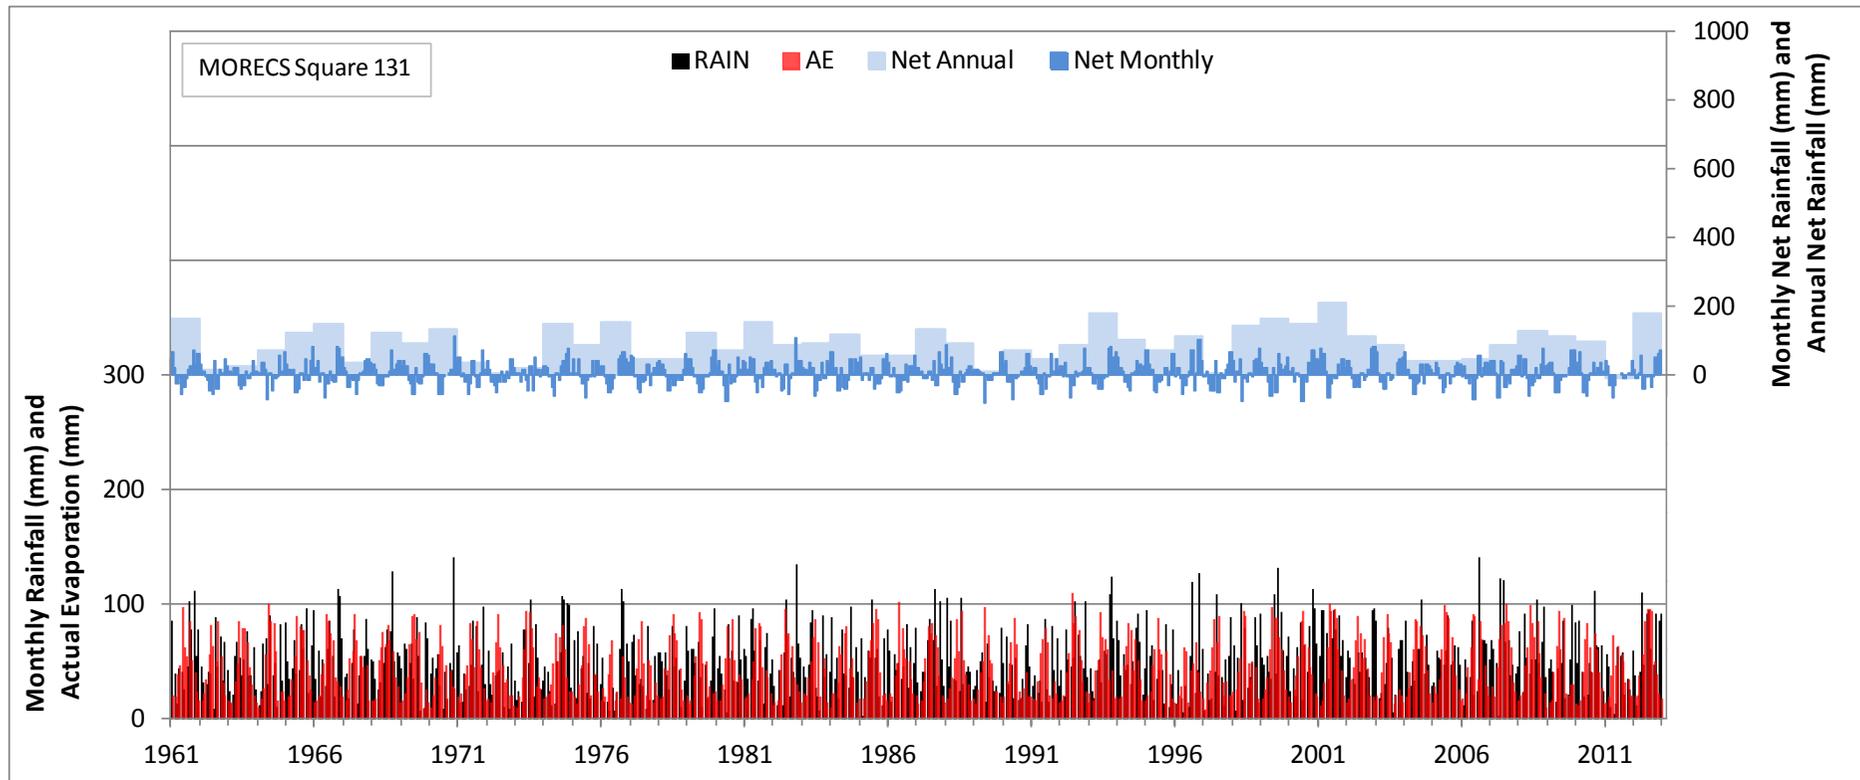
Figure 4. Monthly Rainfall and Evaporation data for MORECS square 131. Net (Rainfall - actual evaporation) monthly and annual totals also shown. MORECS data © Crown copyright 2013, the Met Office.

Long-term data for the basic hydrological drivers (rainfall and evaporation) are shown in Figure 4. Whilst evapotranspiration is broadly similar across many of the UK sites, rainfall varies considerably, and Winterton is one of the sites receiving the lowest average amounts of rainfall. The long term (1961 to 2012) average annual rainfall for this area (area defined as the 40km x 40km grid square calculated using the Meteorological Office Rainfall and Evapotranspiration Calculation System (MORECS)) is 622 mm, and the long term (1961 to 2012) average annual net (rainfall – actual evaporation) is 92 mm. This means that there is very little water available to drive or support a rising water table, and that relatively small changes in the timing and amount of rainfall could bring about a recharge deficit.

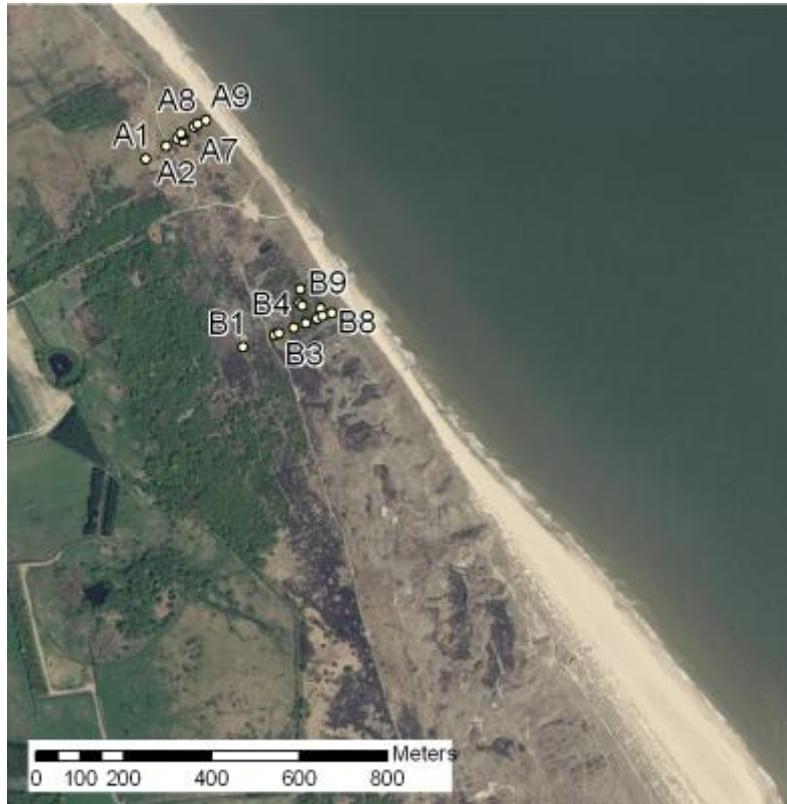
Figure 5. Dipwell monitoring network in the north of the site. Refer to Figure 2 for the location this in the dune system. © NERC (CEH) 2013, © Next Perspectives.

Analysis of water level data collected during 2006 and 2007 from a network of dipwells in the north of the site (Figure 5) was carried out by William Coulet (Coulet, 2007), and this described the idea of the sea wall preventing groundwater flow towards the sea. Groundwater flow instead moves inland until it is intercepted by a ditch running along the inland edge of the dunes.

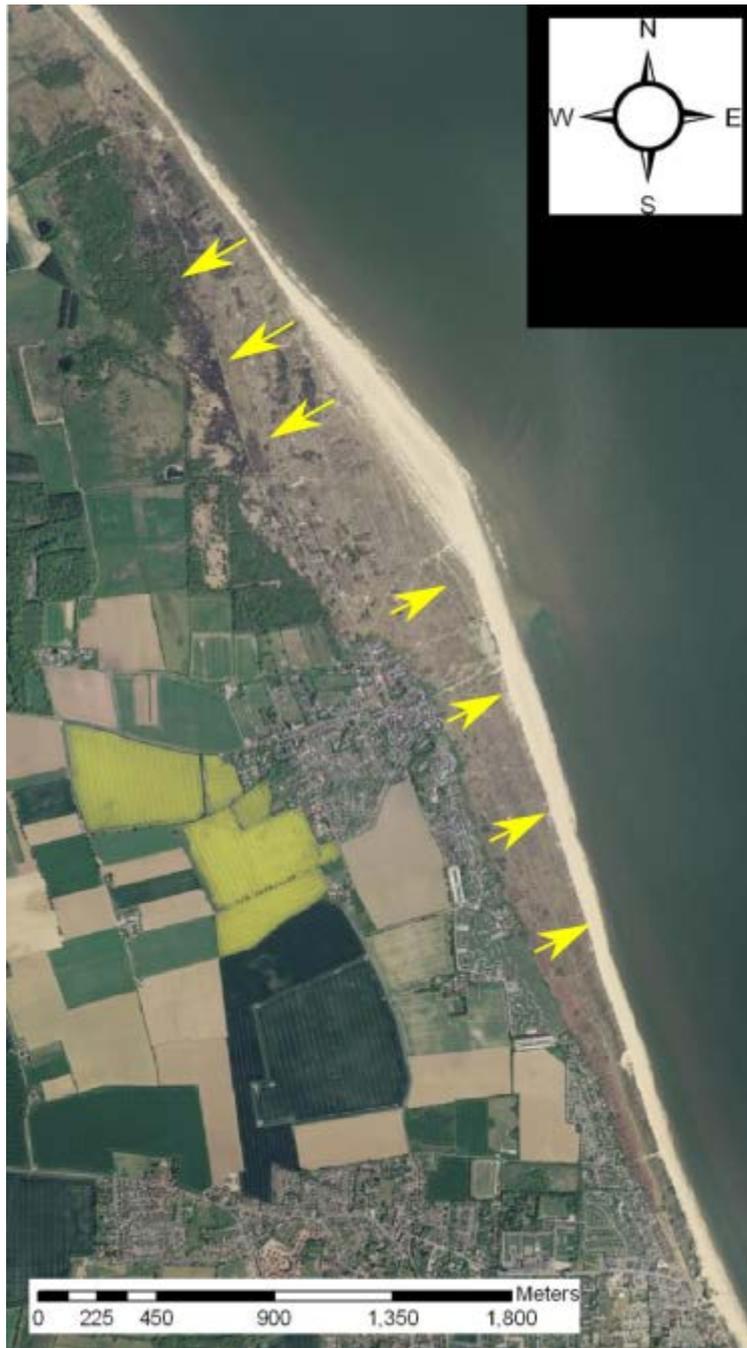
Figure 6. Winterton Dunes conceptual groundwater flow diagram. The yellow arrows indicate the direction of groundwater flow. © NERC (CEH) 2013, © Next Perspectives.

Although monitoring has not been installed across the rest of the site, a conceptual groundwater flow diagram has been developed based on observations made during the site visit in September 2012. This conceptualisation reflects the confining effect of the sea wall in the north and the free draining sands in the south (Figure 6).

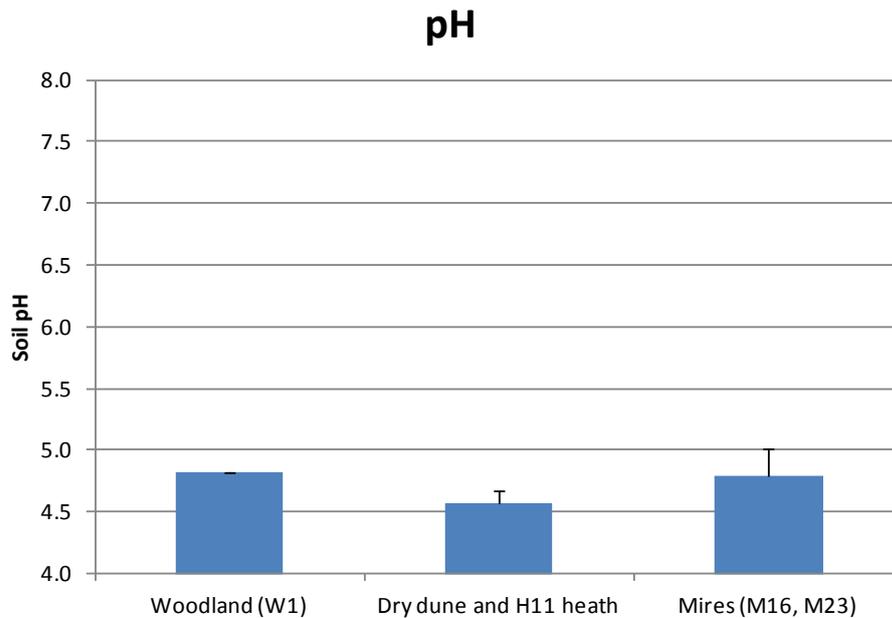
Figure 7. Soil pH, by broad vegetation type.

Simple physical data from soil cores are shown in Figure 7 and Figure 8 below, grouped by broad vegetation type. Soil pH (Figure 7) was consistently acidic in all community types, at or under pH 5.

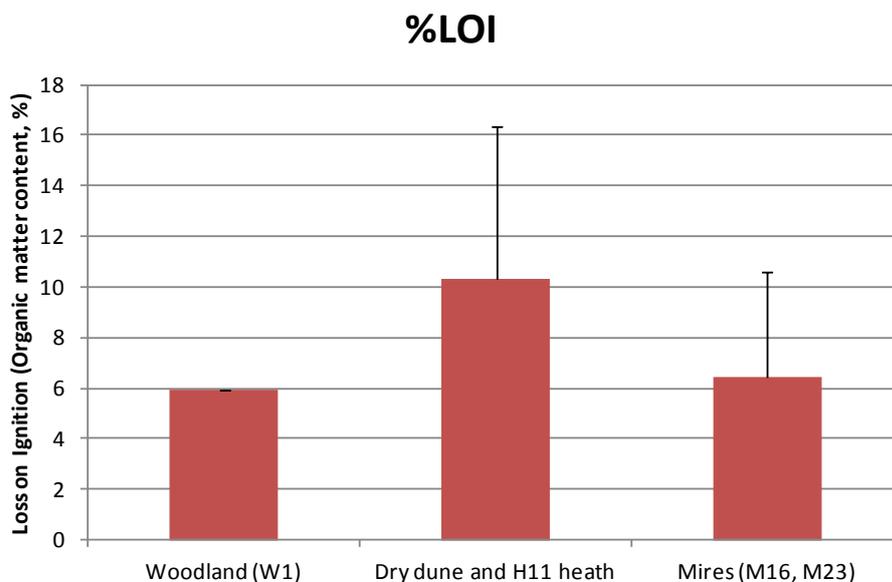
Figure 8. Organic matter (as Loss On Ignition, %), by broad vegetation type.

Organic matter contents (Figure 8) are generally high in all vegetation types, all above 6%, being highest in the heath communities, with one sample of 22%. There are relatively few data from other acidic sites against which to compare these values.

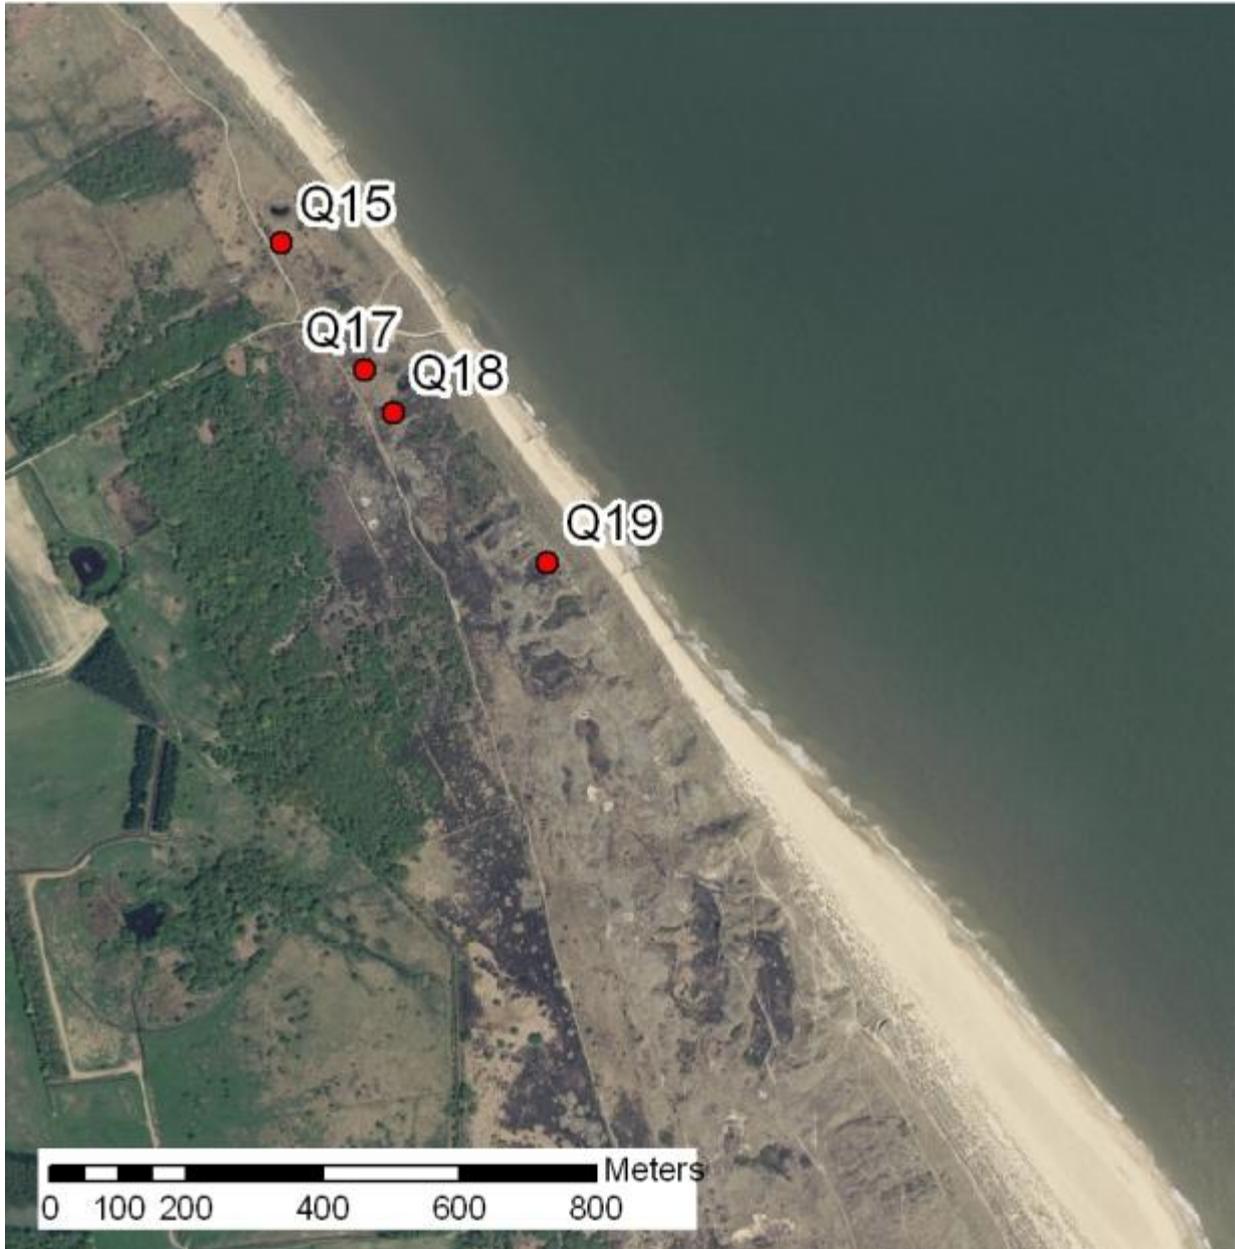
Figure 9. Locations of quadrats surveyed at Winterton Dunes. Note: quadrats Q4 and N1 are located to the north of the area covered by the aerial photography and are not shown in this figure. © NERC (CEH) 2013, © Next Perspectives.

Using the GIS resources described above in the mapping methodology, SDGB quadrats for which data were available were re-located. Some expert judgement by the surveyors was required to re-locate the original quadrat position, particularly where error or distortion in the SDGB survey map was evident. Where possible, additional new quadrats were recorded in less common habitats and young natural slacks formed since the SDGB survey. Locations of quadrats recorded in 2012 are shown in Figure 9.

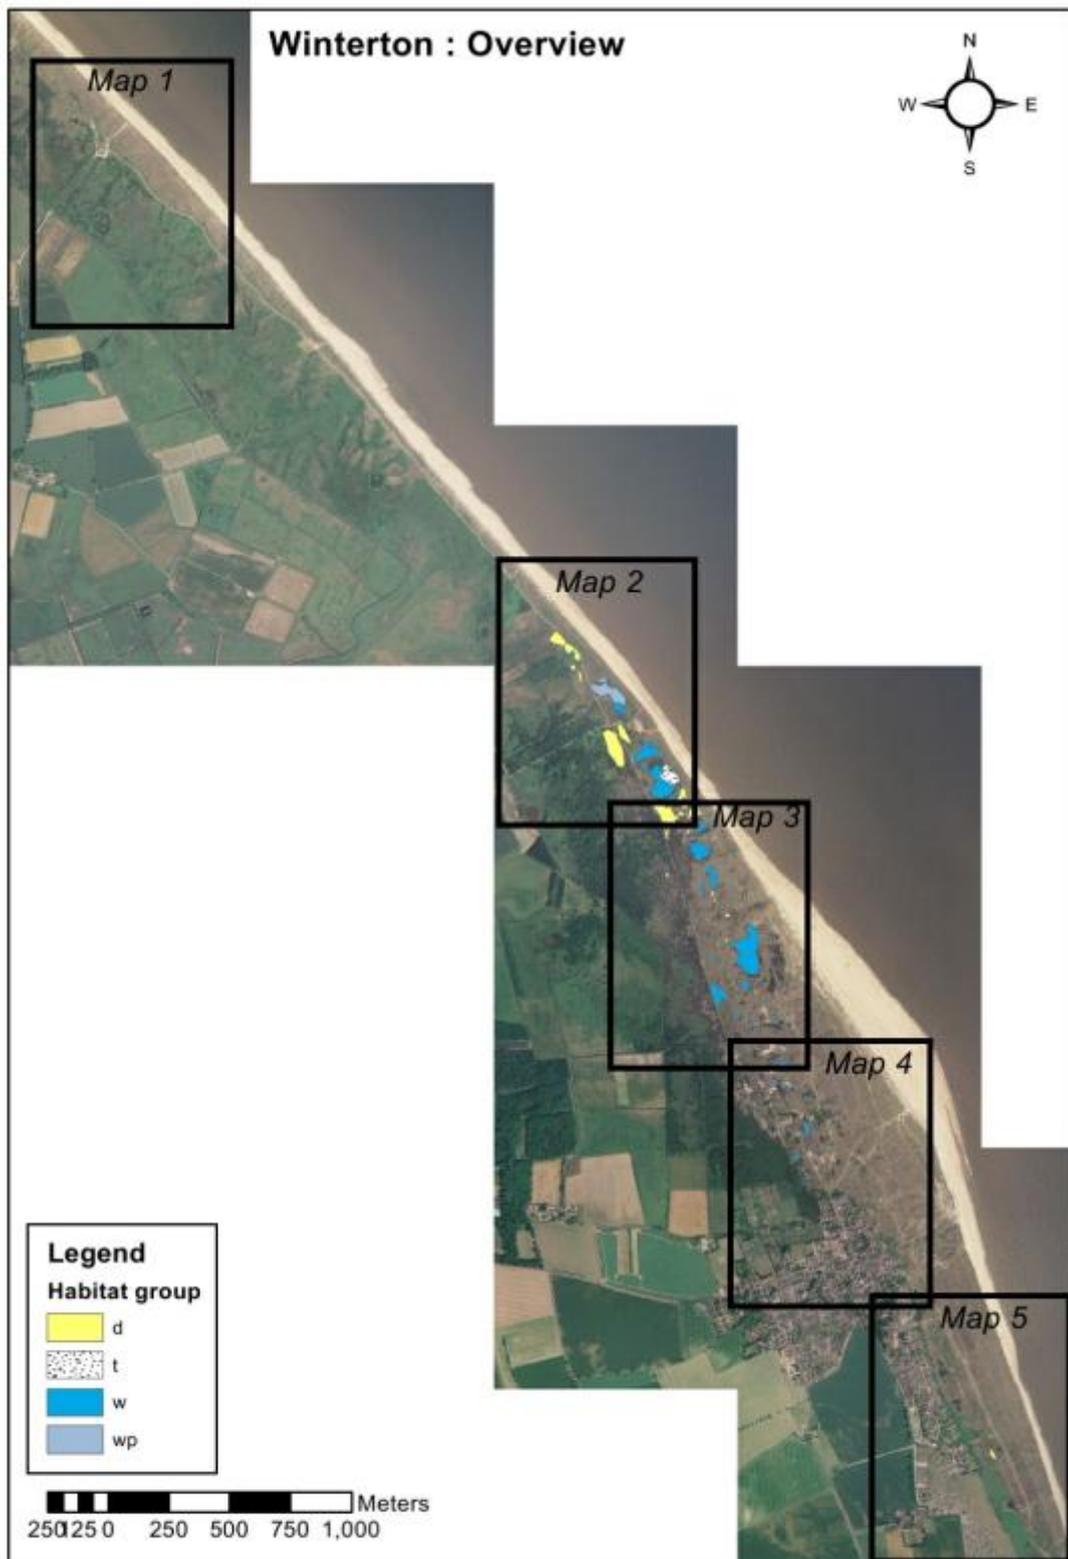
Figure 10. Winterton. Overview of NVC communities mapped during 2012 vegetation survey, with reference to areas covered by maps 1-5 (Figures 11-15). Habitat groups (broad vegetation codes) are described in Table 3. © NERC (CEH) 2013, © Next Perspectives.

Changes in mapped area of dune wetlands at Winterton between 1989 and 2012 are summarised in Table 4 below. Figures 10-15 show the extent of the area mapped in 2012, with polygons colour-coded by broad vegetation code (Table 3), and labelled with the NVC communities assigned.

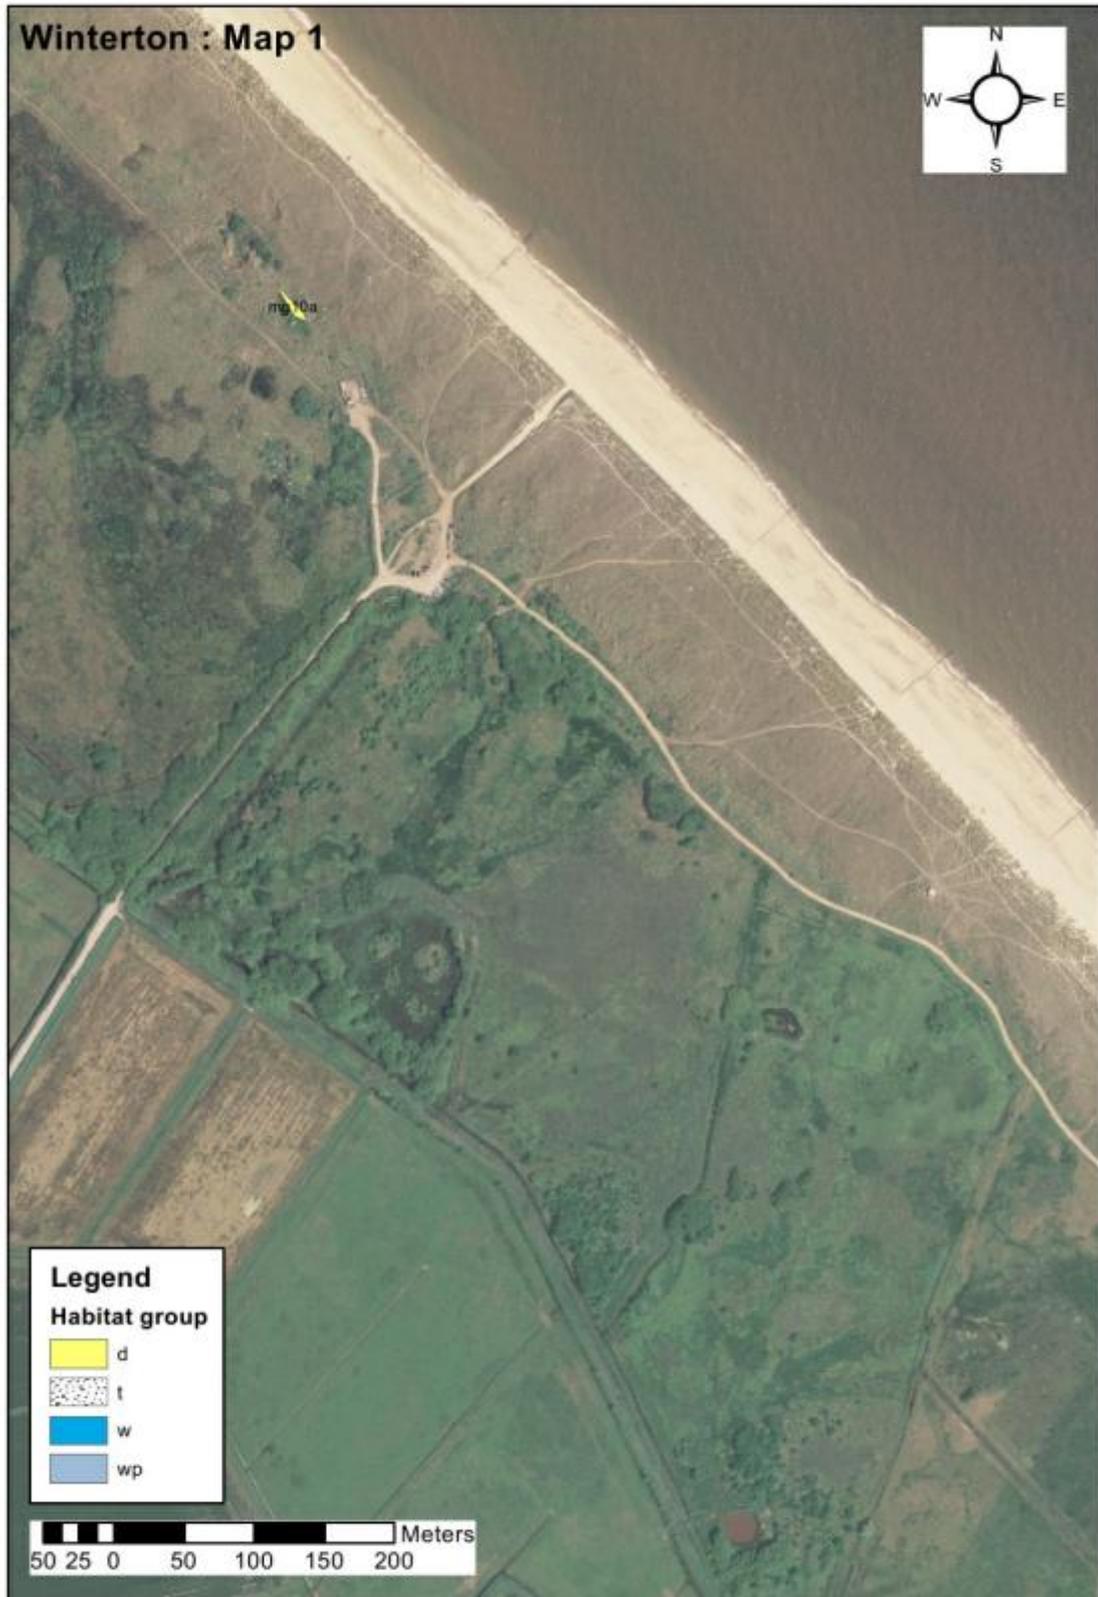
Figure 11. Winterton Map 1. NVC communities mapped during 2012 vegetation survey. Habitat groups (broad vegetation codes) are described in Table 3. © NERC (CEH) 2013, © Next Perspectives.

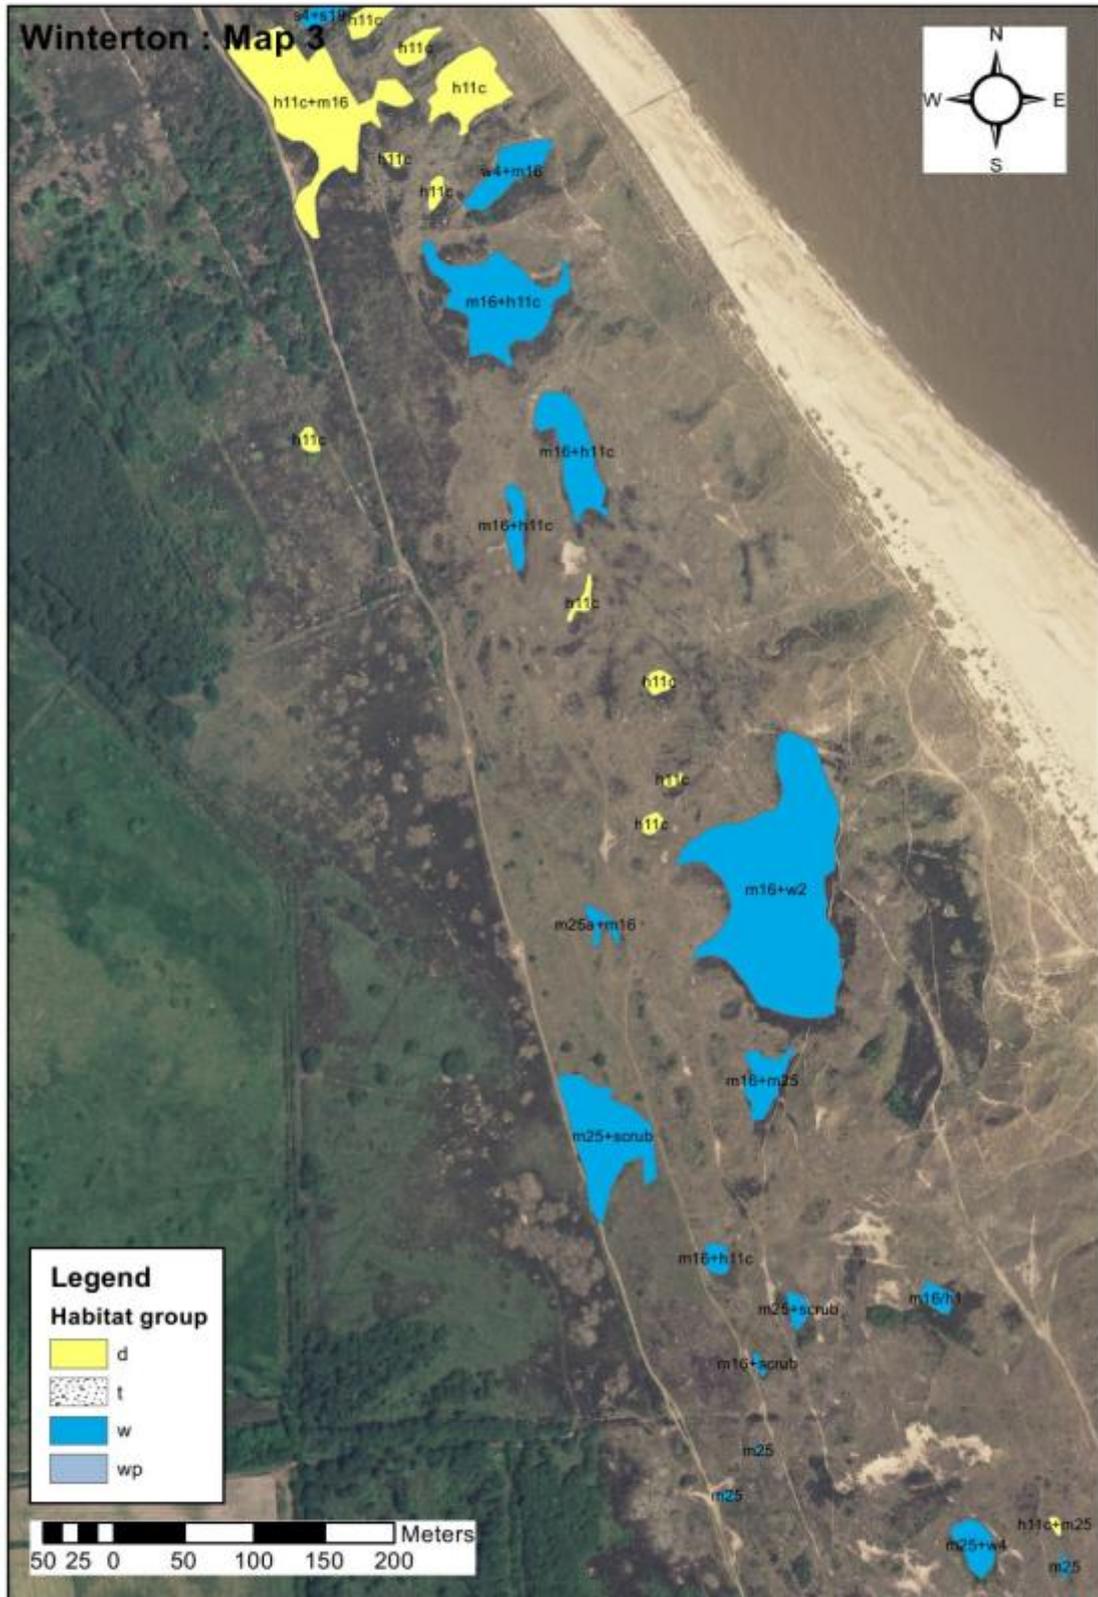
Figure 13. Winterton Map 3. NVC communities mapped during 2012 vegetation survey. Habitat groups (broad vegetation codes) are described in Table 3. © NERC (CEH) 2013, © Next Perspectives.

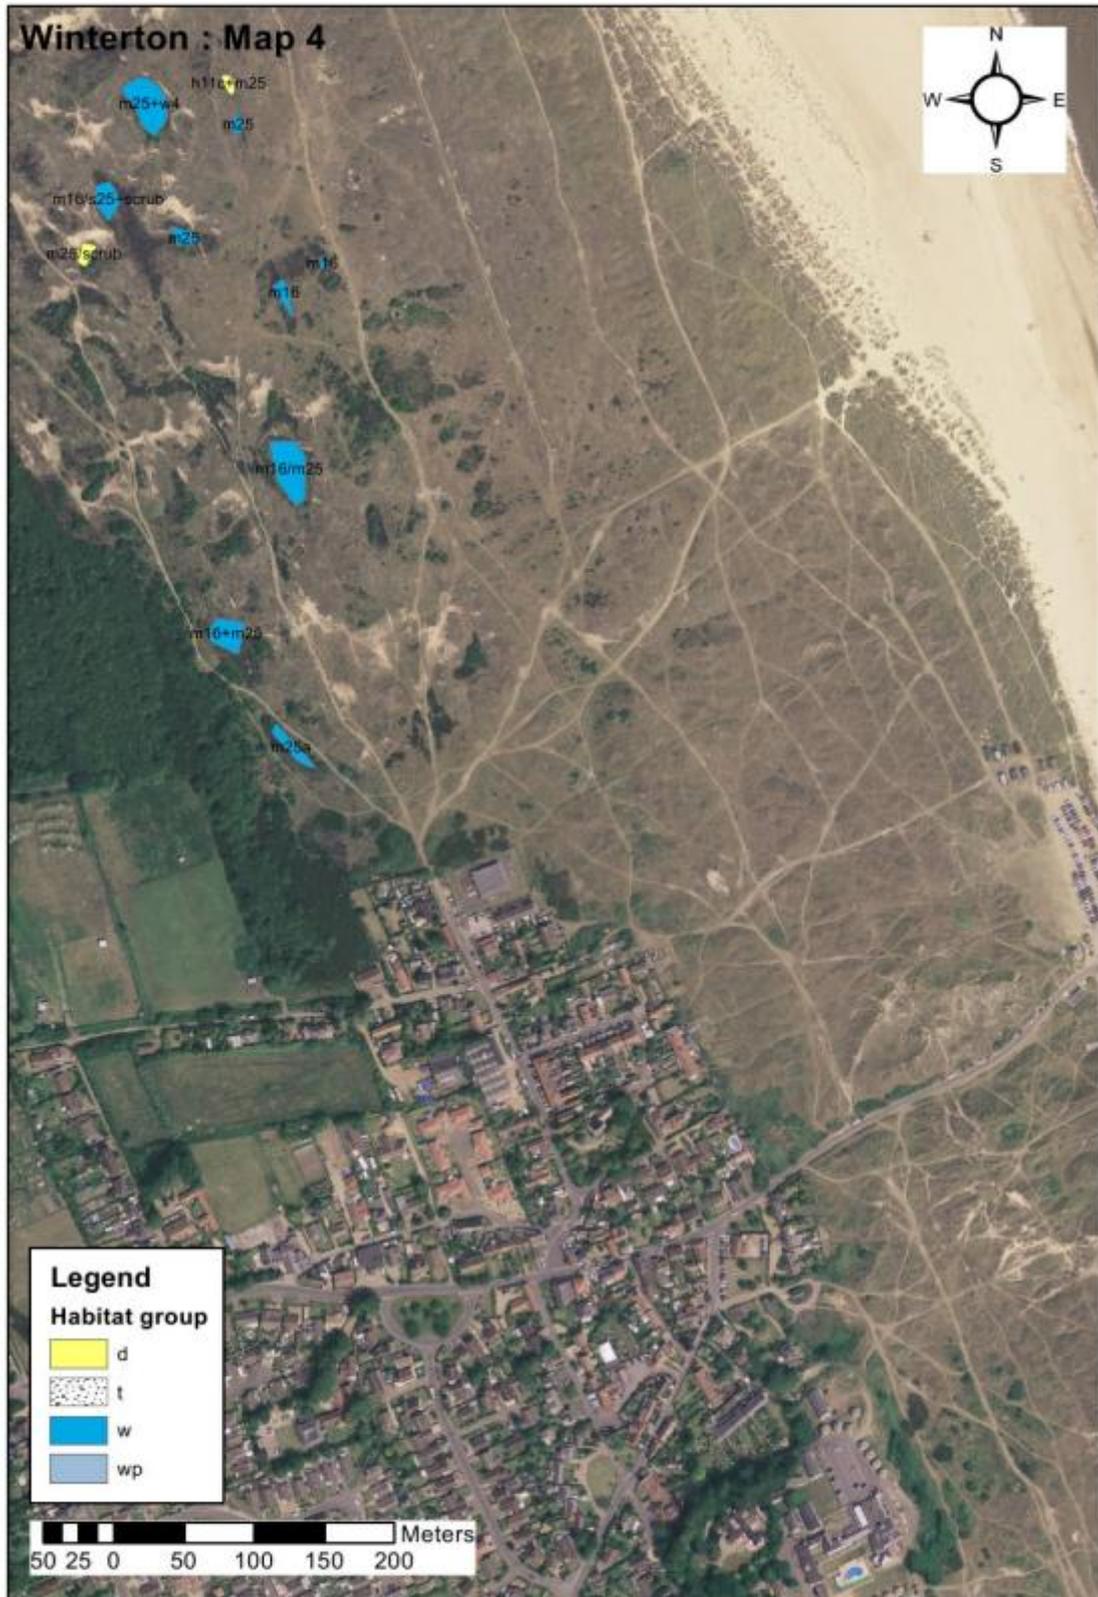
Figure 14. Winterton Map 4. NVC communities mapped during 2012 vegetation survey. Habitat groups (broad vegetation codes) are described in Table 3. © NERC (CEH) 2013, © Next Perspectives.

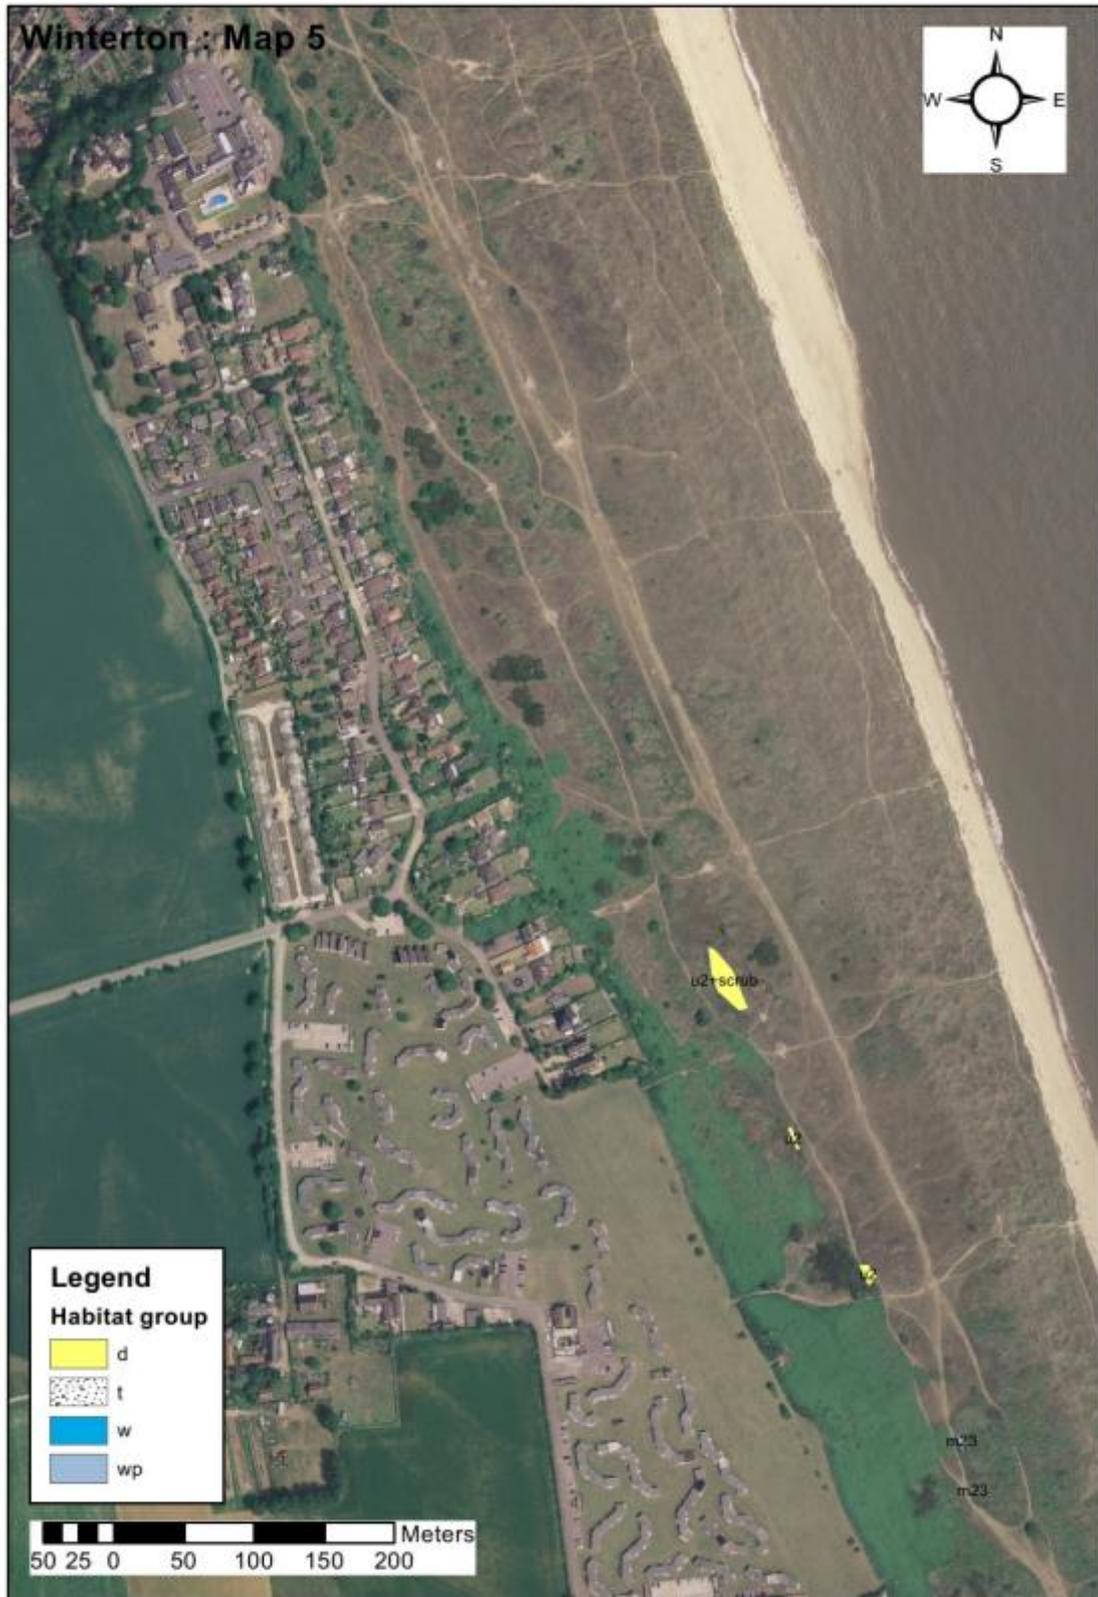
Figure 15. Winterton Map 5. NVC communities mapped during 2012 vegetation survey. Habitat groups (broad vegetation codes) are described in Table 3. © NERC (CEH) 2013, © Next Perspectives.
