# Strategy for Monitoring Groundwater Quality

West Penwith Moors and Downs SSSI

May 2025

Natural England Commissioned Report NERC579

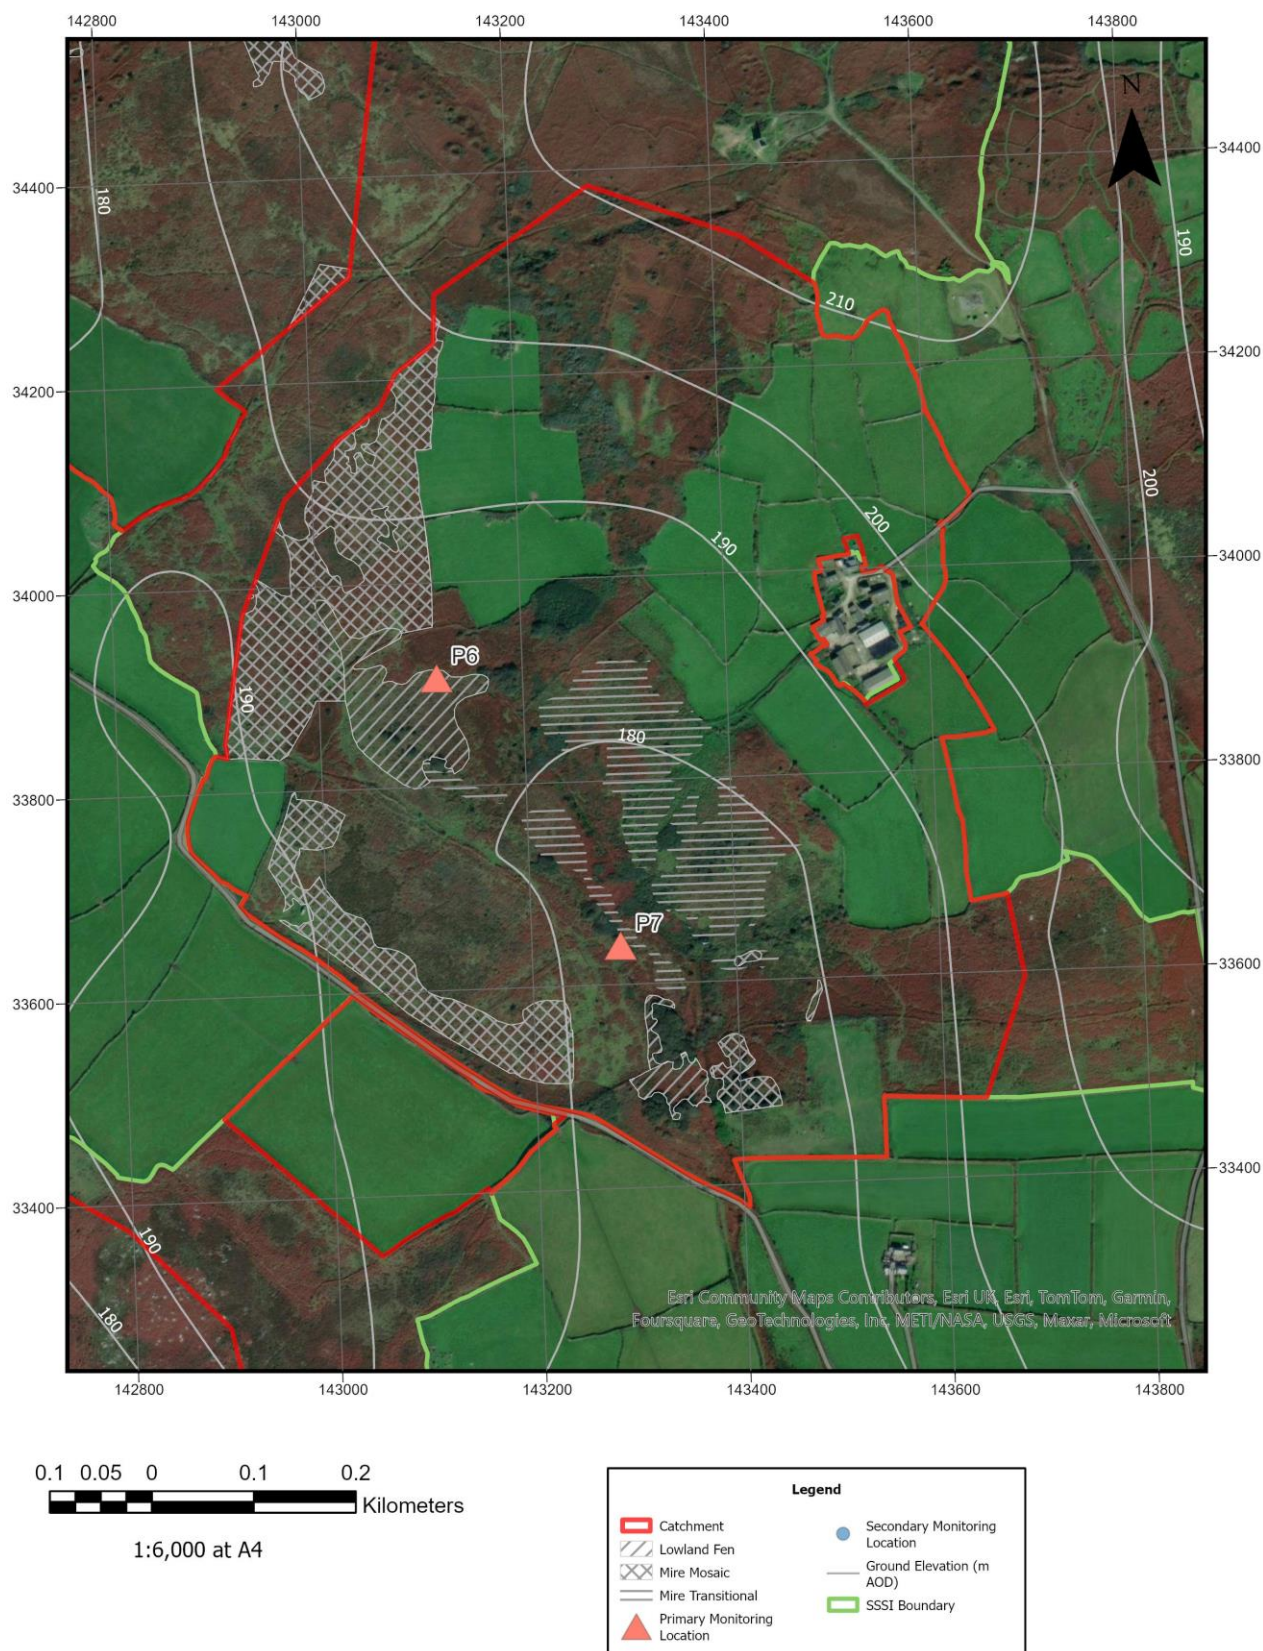
Figure 5: Bosilliack Sampling Locations

This mire is located within a valley with groundwater flow expected to follow topography in a southerly direction. The primary upgradient land use is heathland within the catchment with a mix of heathland and pastoral beyond the catchment.

The sampling locations are shown in Figure 5.

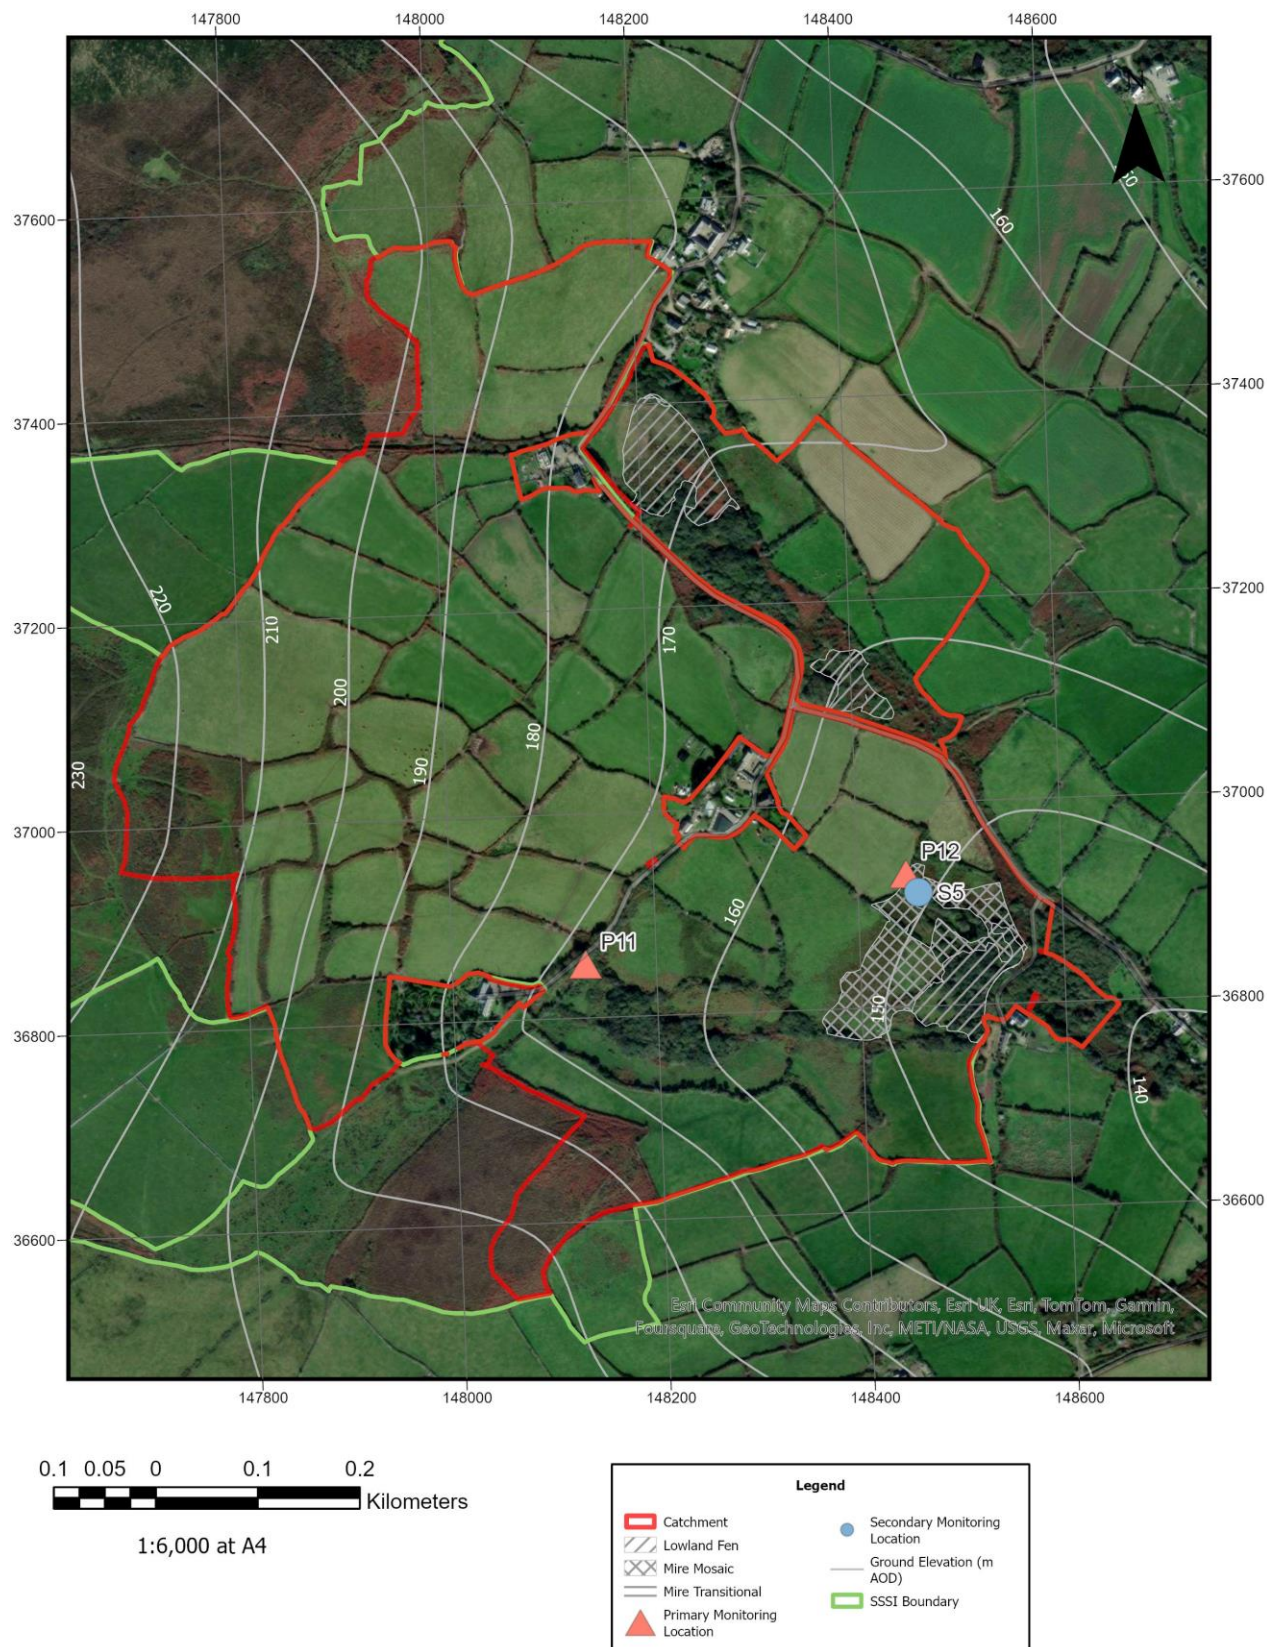
Figure 8: Embla Sampling Locations

Embla is located on a steep east facing slope of a northwest-southeast trending valley. The land use within the catchment is almost entirely pastoral and used for cattle grazing. Groundwater flow is expected to be in south-easterly direction.

The sampling locations are shown in Figure 8.

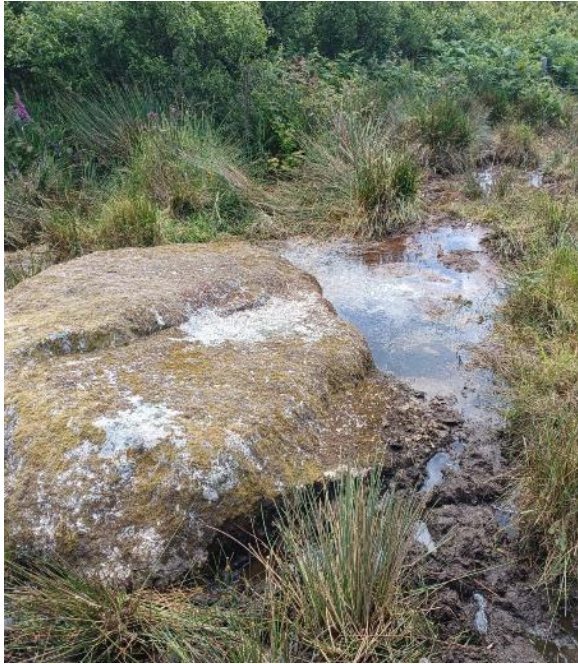
<p data-bbox="236 969 539 1014"><b>Sample location P2</b></p>

Location ID	Type	Recommendations	What3Words	Latitude	Longitude
P1	Spring	Install monitoring point to increase chance of sampling all year	///lushly.strictest.energy	50.1343117	-5.652342
S1	Spring	-	///light.screening.supreme	50.133368	-5.654188
P2	Spring	Fence from livestock	///beams.reputable.kindness	50.133099	-5.655029

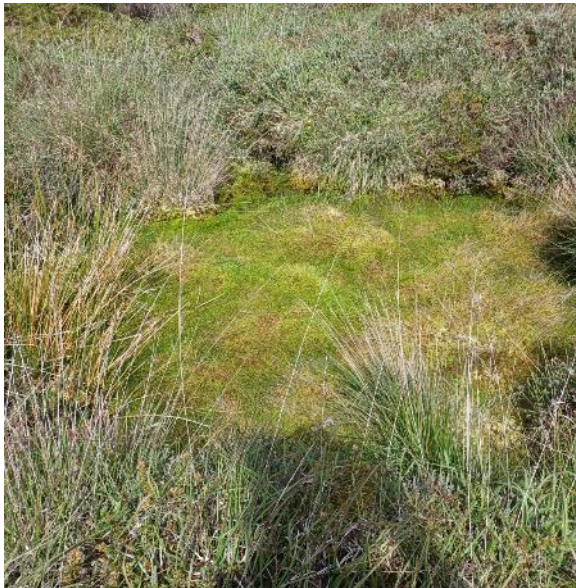
<p>Sample location P3</p>

Location ID	Type	Recommendations	What3Words	Latitude	Longitude
P3	Spring	Install monitoring point to increase chance of year round sampling	///evolving.safety.imprints	50.1747644	-5.5762267

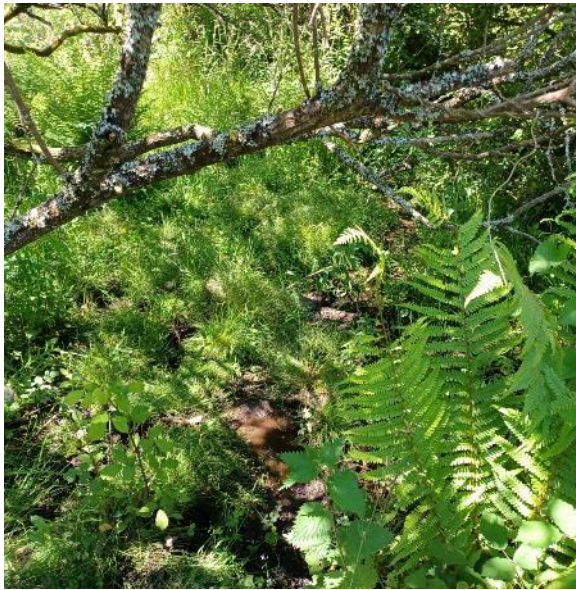
<p data-bbox="236 891 536 936"><b>Sample location S3</b></p>

Location ID	Type	Recommendations	What3Words	Latitude	Longitude
S3	Spring	Install monitoring point to increase chance of year round sampling	///resonates.rating.fidelity	50.146709	-5.60756
P8	Spring	Install monitoring point to increase chance of year round sampling	///reconnect.napped.spinning	50.146655	-5.60772
S4	Spring	Install monitoring point to increase chance of year round sampling	///novels.couch.message	50.146574	-5.60886
P9	Spring	Install monitoring point to increase chance of year round sampling	///lights.label.patrolled	50.143799	-5.60768

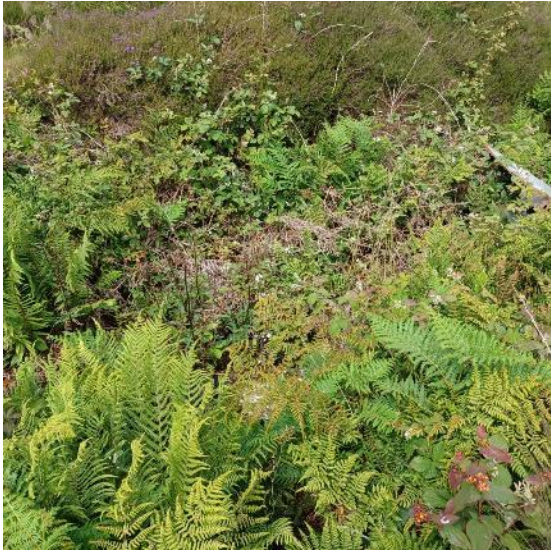
<p data-bbox="256 857 555 902"><b>Sample location S8</b></p>

Location ID	Type	Recommendations	What3Words	Latitude	Longitude
S8	Spring	Install monitoring point to increase chance of year round sampling	///dices.nails.recruiter	50.144176	-5.63458
P19	Spring	Install monitoring point to increase chance of year round sampling	///waltzed.blindfold.quibble	50.143206	-5.63218
S9	Spring	None	///chucked.blacked.spent	50.142343	-5.62982
P20	Spring	Install monitoring point to increase chance of year round sampling	///polka.rentals.prep	50.142774	-5.63075
S10	Spring	None	///slouched.joins.downcast	50.1422783	-5.6282
P21	Spring	Install monitoring point to increase chance of year round sampling	///syndicate.instant.thundered	50.143286	-5.62788
