# Agricultural Land Classification

## Worthing Borough Local Plan

### Site 1: Goring Crossways

## Location of Auger Borings Worthing Borough Local Plan Site 1: Goring Crossways

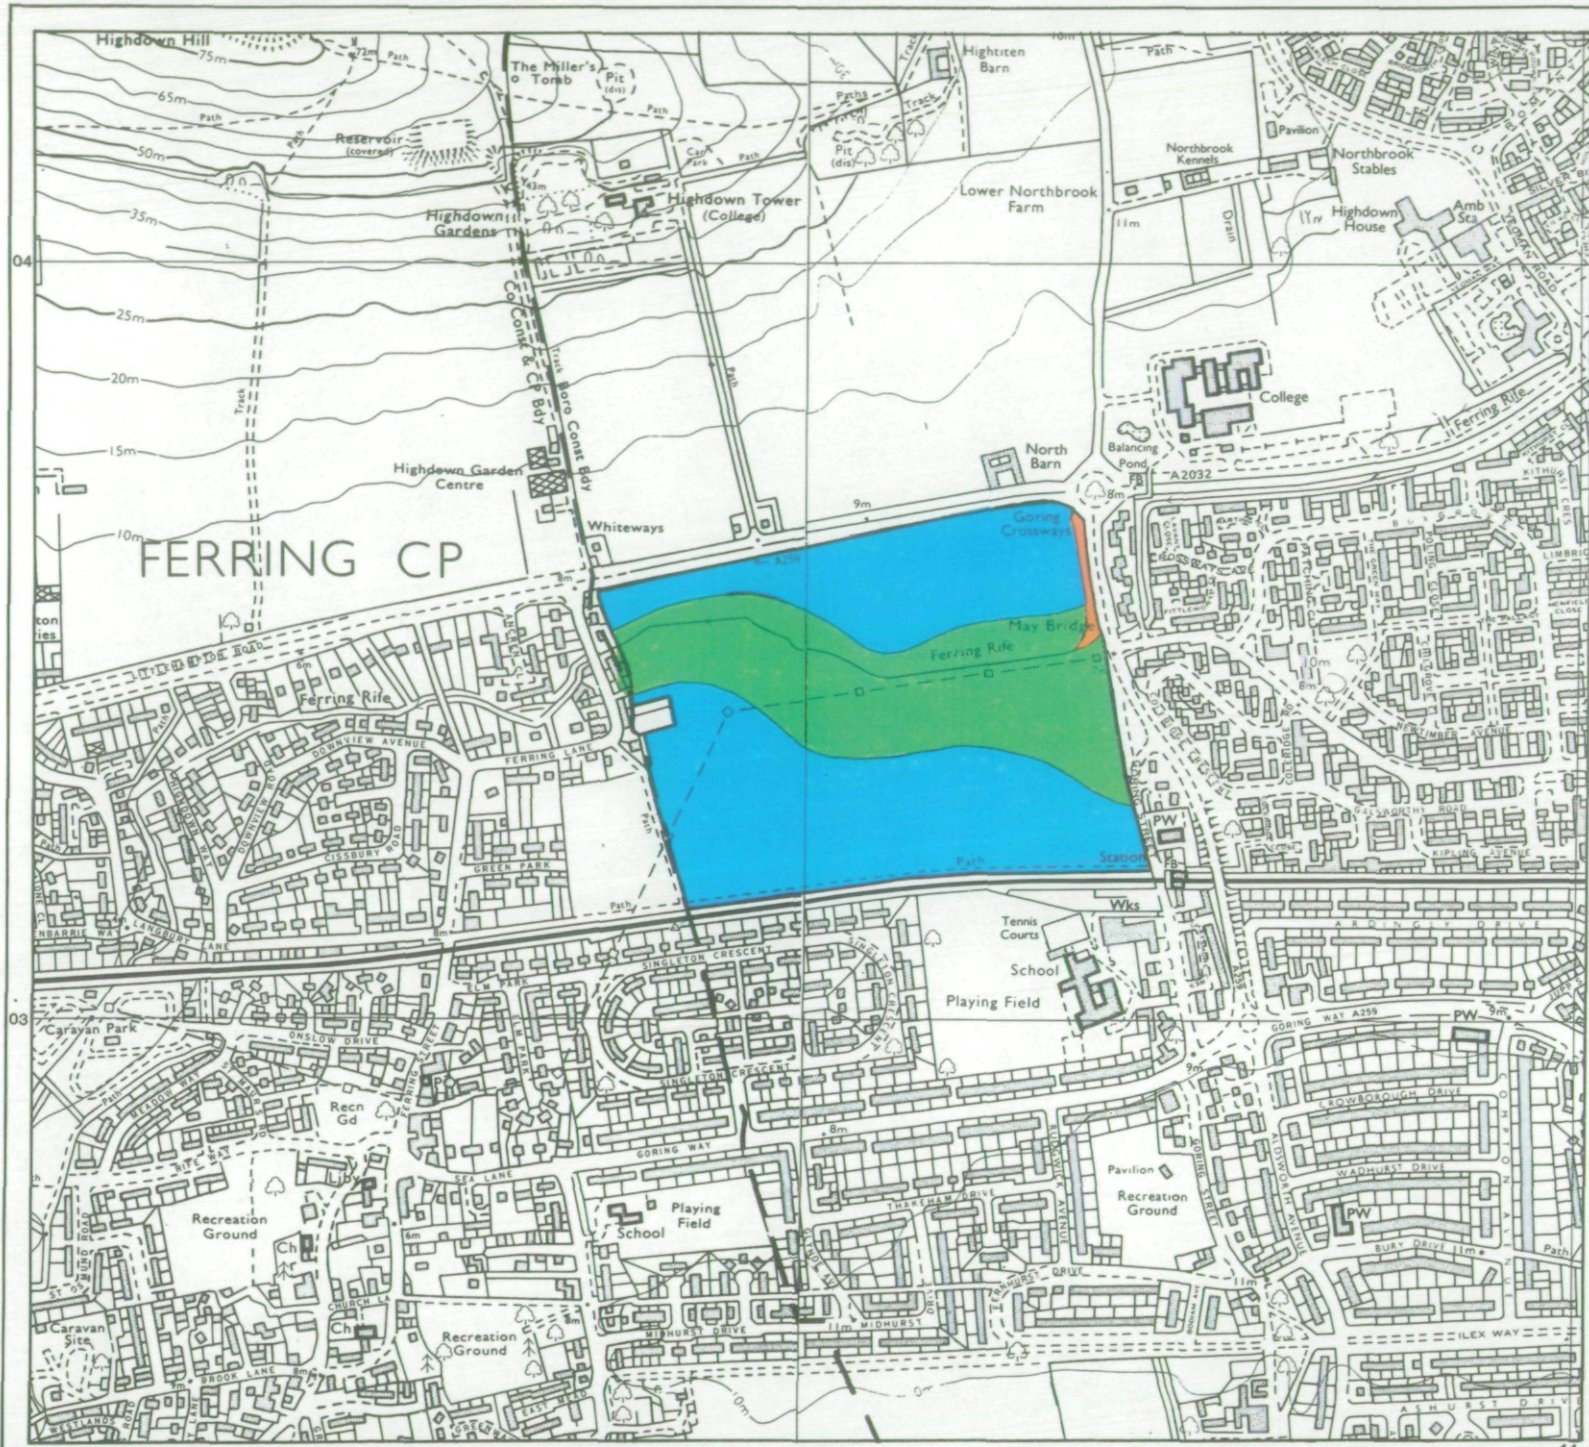
Agricultural Land		
Grade	Quality	Area(ha)
1	Excellent	nil
2	Very Good	17.8
3a	Good	nil
3b	Moderate	9.6
4	Poor	nil
5	Very Poor	nil

Other Land Categories		
Symbol	Category	Area (ha)
*	Urban	nil
■	Non-Agricultural	0.2
*W	Woodland	nil
*B	Agricultural Buildings	nil
*O	Open Water	nil
*S	Not Surveyed	nil

Total agricultural land area 27.4  
 Total survey area 27.6  
 \*Grade/category not present within survey area

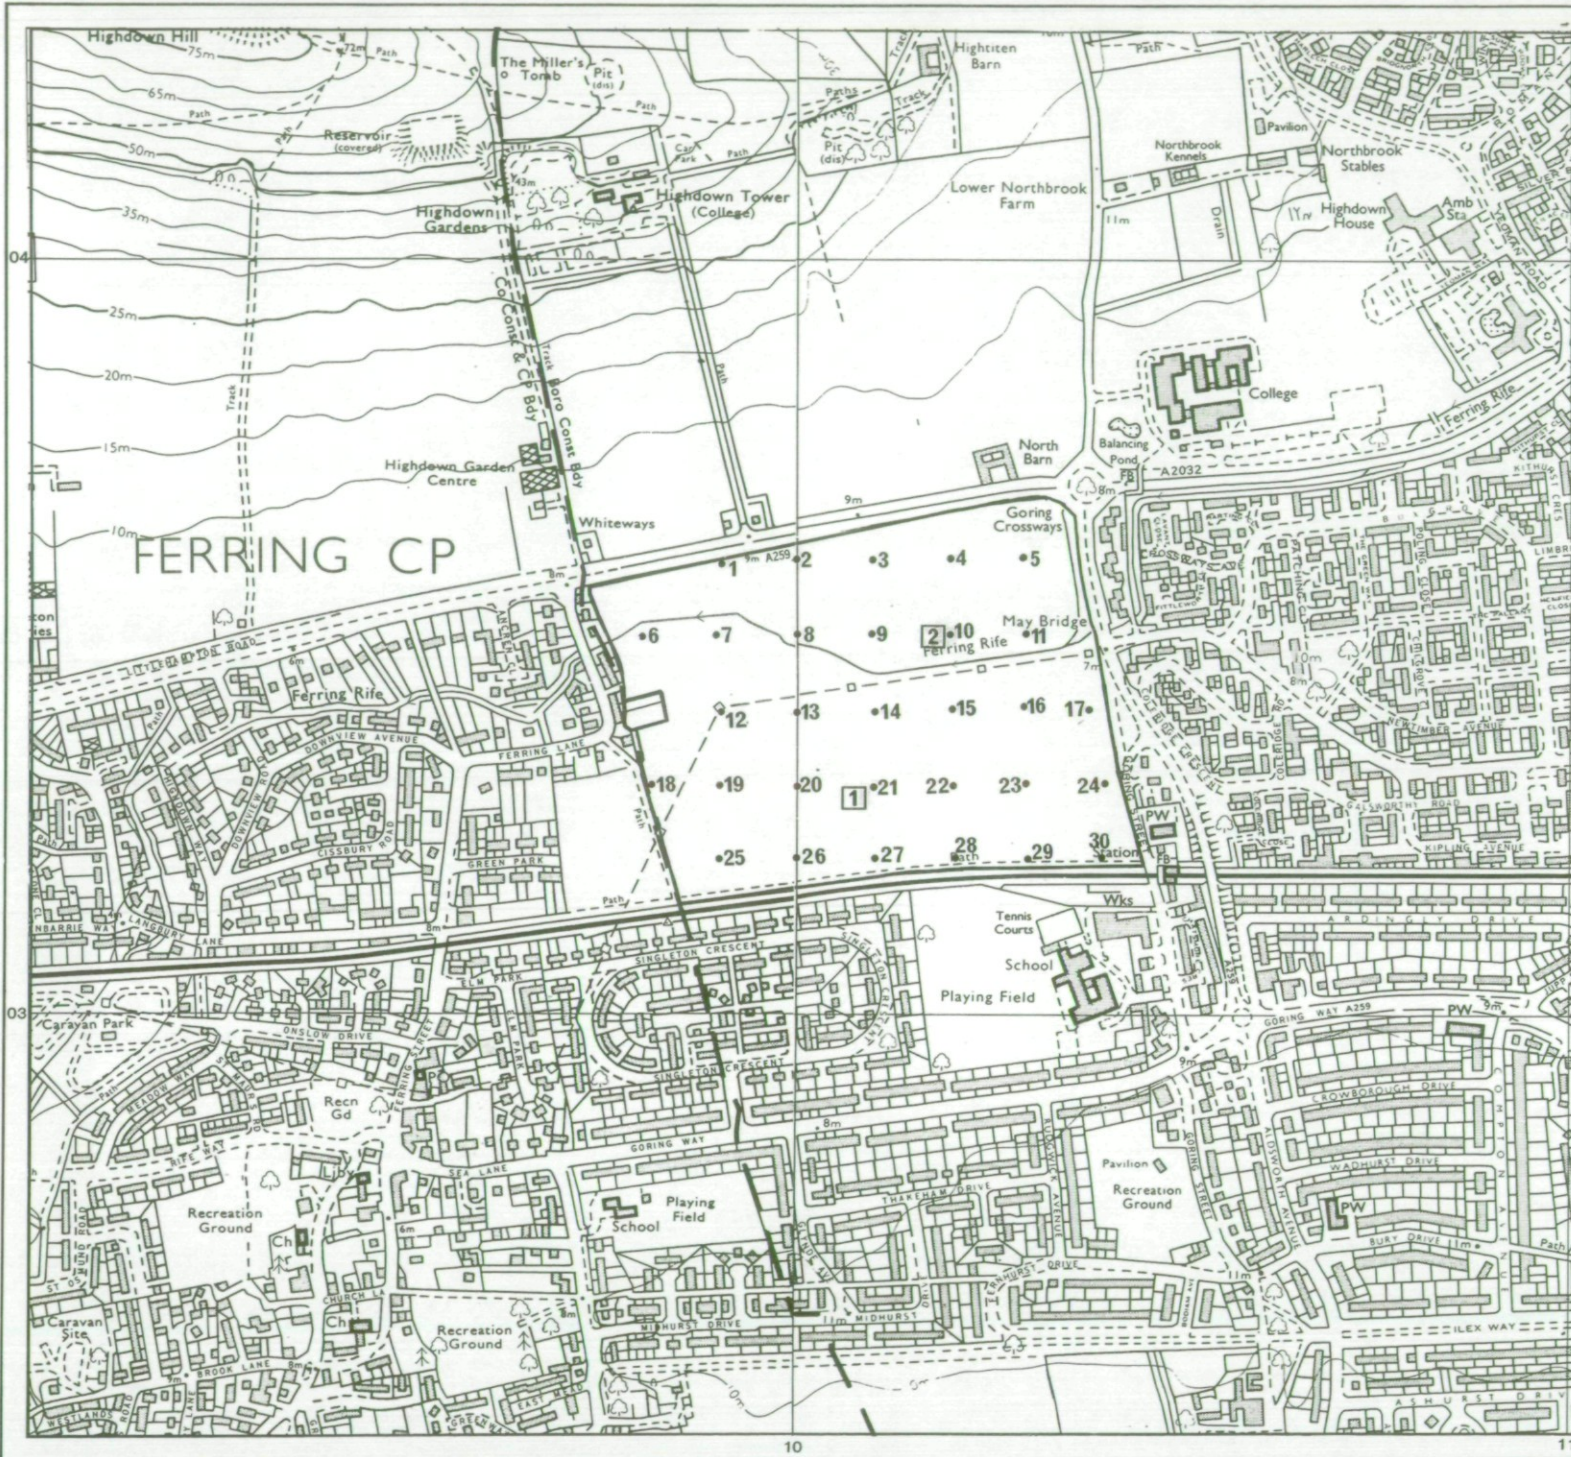
- 5 Auger boring
- 2 Profile pit
