Northey Island managed retreat

Report 6: Results to February 1996

**Northey Island Managed Retreat
Report 6
Results to February 1996**

**Institute of Estuarine and Coastal Studies
University of Hull, HULL, HU6 7RX**

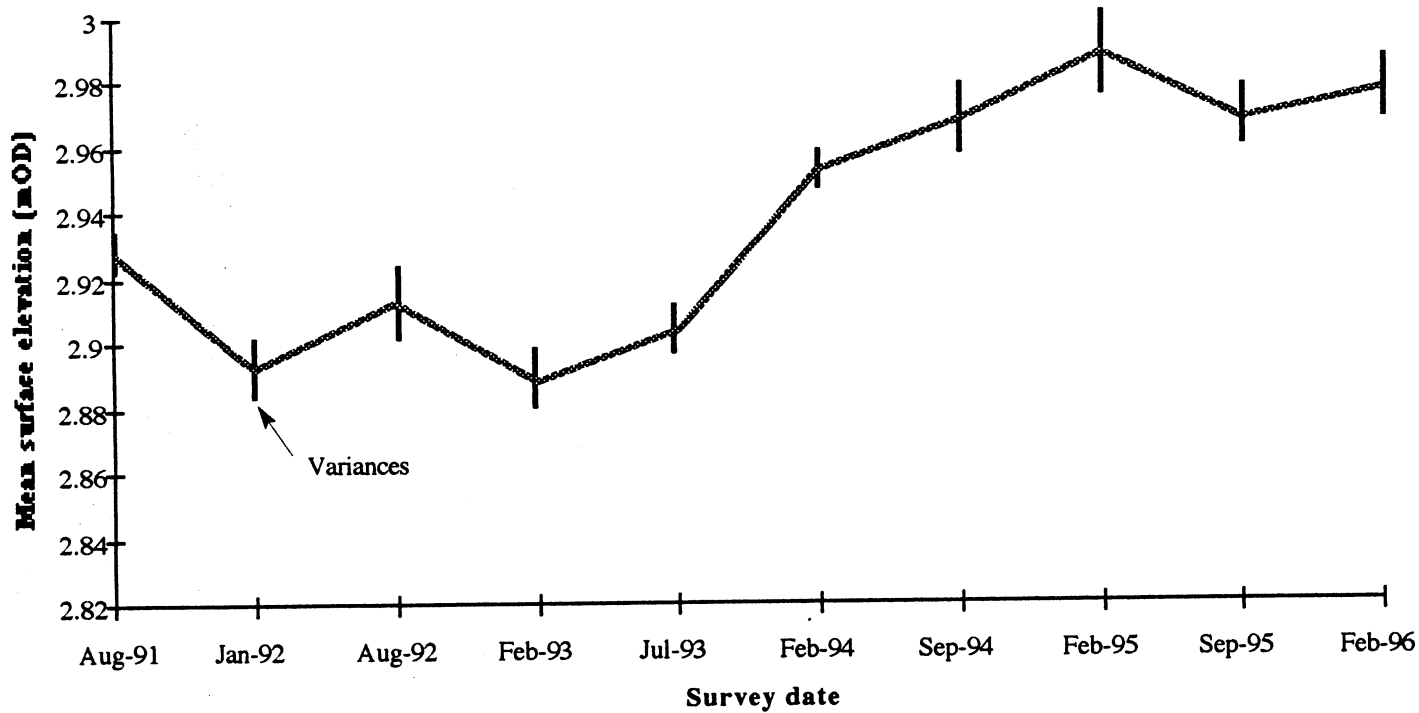
Figure 1 shows the overall change in mean surface elevation from commencement of the scheme to the present day. The initial loss of the surface peat layer is shown as a lowering of the surface, followed by a period of variability as the surface elevation fluctuated with no overall net change. From July 1993, however, there was a period of net accretion, reaching a peak elevation of 2.988 mOD in February 1995, 3.5 years after the breach. From this point there now appears to be a further period of variability, again with very little net change, although the surface is now lower than the peak level. This confirms the findings of the contour analysis which also suggest that the topography has reached overall stability for the

Changes in mean surface elevation (August 1991 to February 1996)

present. This stability, reached less than five years after the breach, would be expected given that the site is relatively high in the tidal frame.

The patterns observed in the statistical findings are expected, with the most significant results attained in February 1995 when the elvation was at its highest. This was followed by a fall in the significance of the results in September 1995 when the elevation decreased, and a further rise in t-values with the subsequent slight increase in elevation in February 1996.

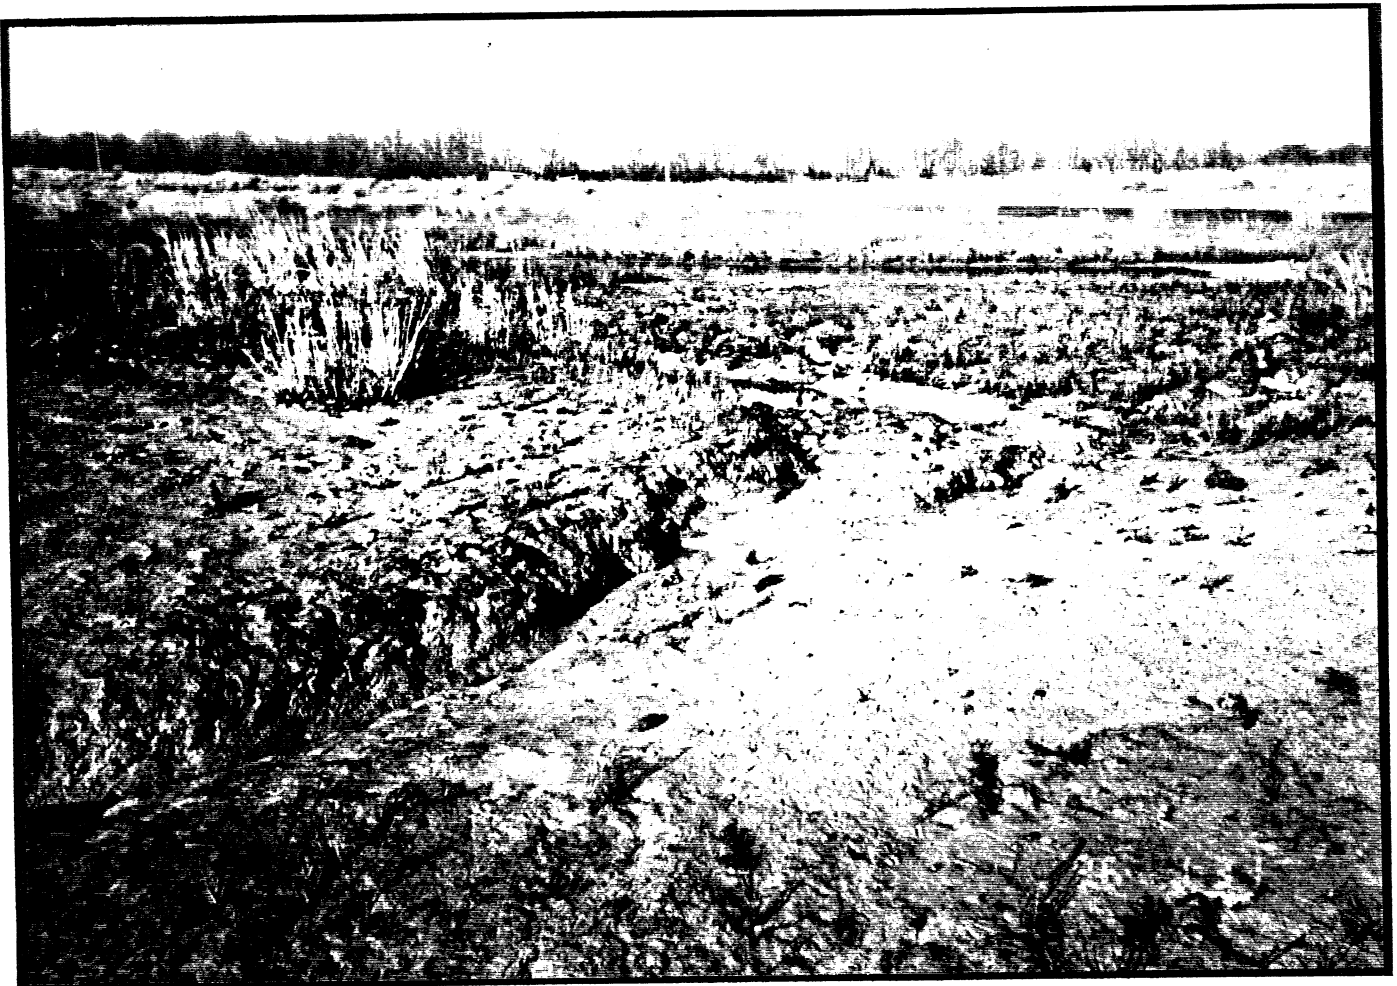
There has been further incision of the channel in the spillway into the site as shown in plate 3, but as plate 4 shows there is still some distance between the head of this channel and the area of standing water. Several more years may therefore be required before the channel eventually cuts into the pond and allows better drainage of this end of the site. All standing water areas have now been present for sufficient time to become well-established with no vegetation colonisation and increasingly well-defined sides. Thus it may be expected that even when the channel reaches the pond there will be significant differential flows through this area which may continue to prevent vegetation colonisation.

Plate 3. February 1996: Further incision of spillway channel

Results from monitoring to date, and the conclusions from the American work, suggest that an appropriate drainage pattern will take a very long time to develop, if ever. There would therefore be an advantage in speeding the natural process of headward erosion which is occurring in the spillway, such that at least one area of ponding may be more effectively drained. Although this is unlikely to affect drainage of the inner areas, possibly even that of the middle channel, observation of the results of this work may enhance our understanding of the system. Resistance of this natural inclination to speed a slow geomorphological process may also be appropriate, but it is suggested that the possibilities should be discussed at this stage.

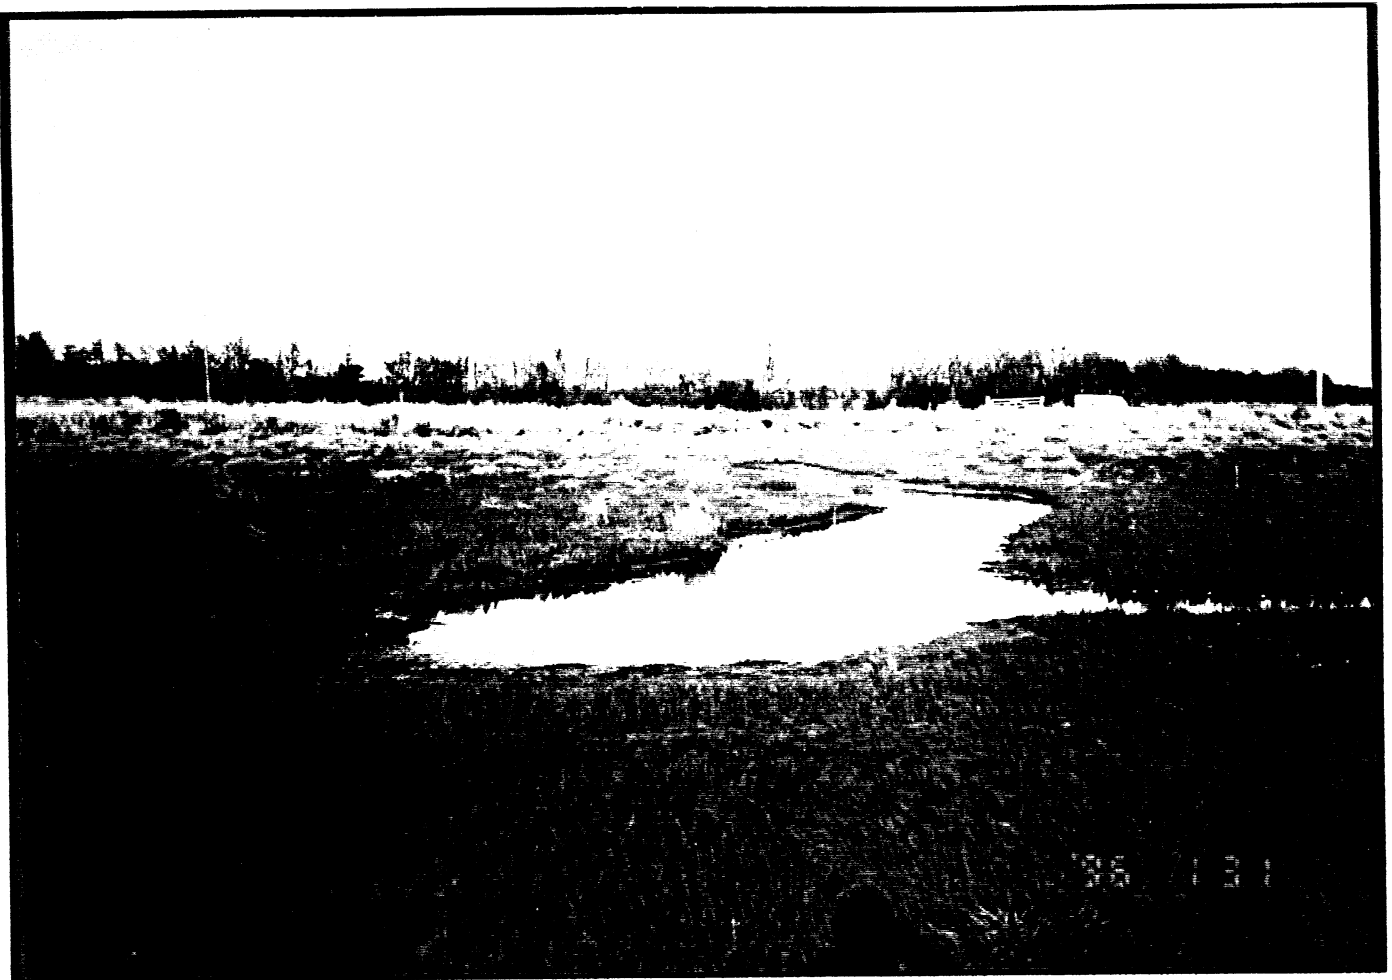
The erosion the back wall at the head of the middle creek does not appear to have deteriorated significantly since the previous survey, possibly as a result of the dense vegetation cover which has now established on this wall (see plate 5).

Plate 5. February 1996: Channel across middle of site
