# River Camel Valley and Tributaries SSSI

## Condition Assessment

Natural England Research Report NERR151

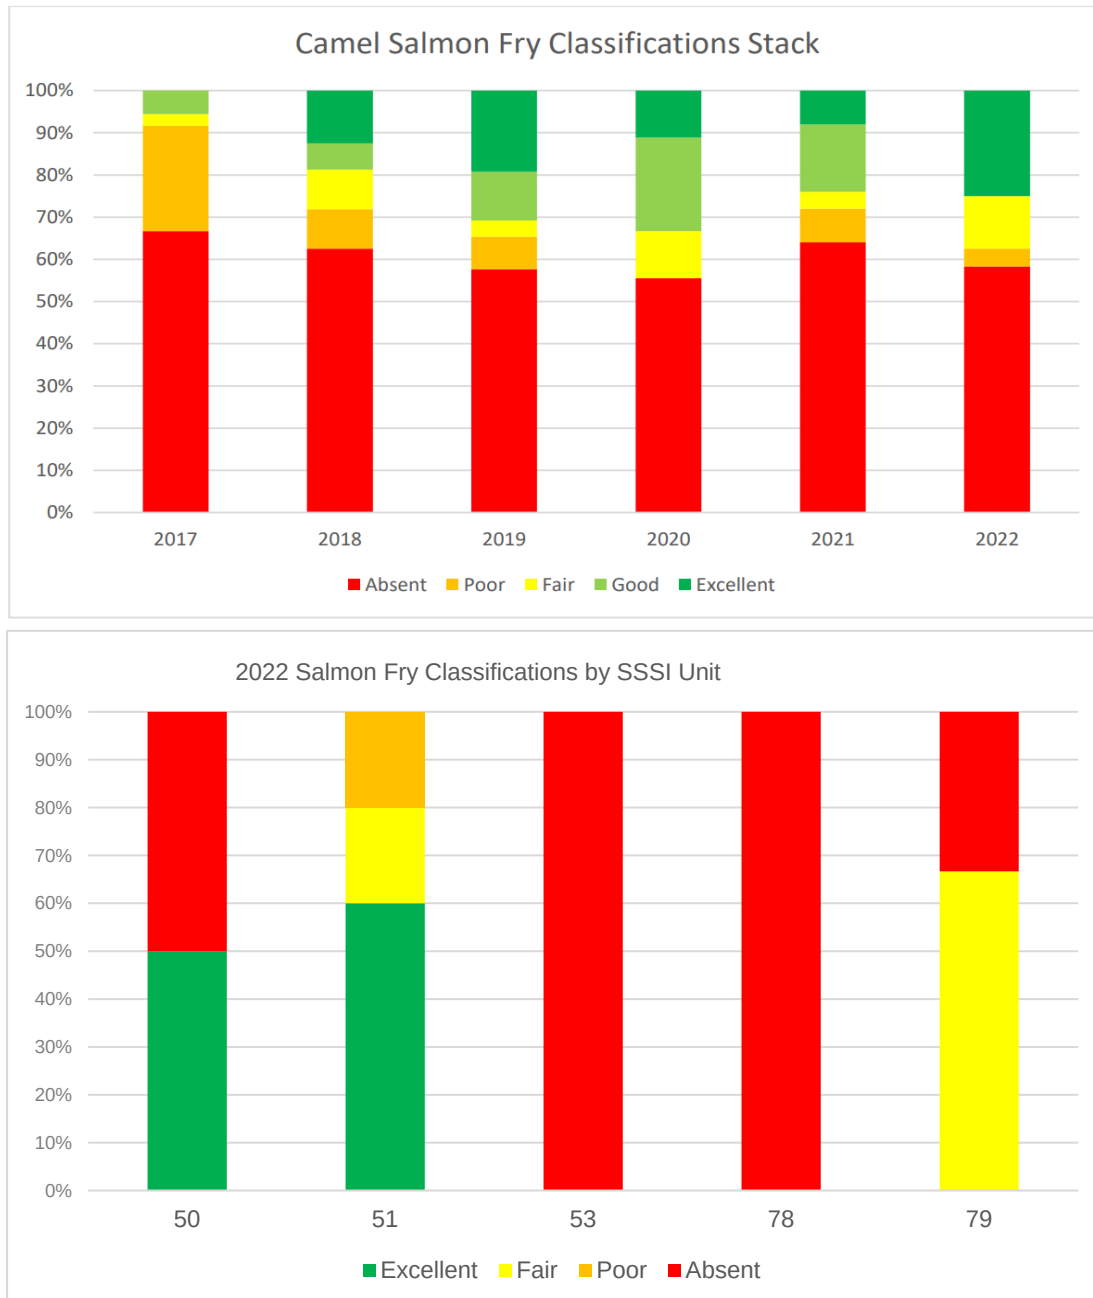
**Figure 2 (top): 2017- 2022 electrofishing salmon fry classifications (WRT, 2023) & Figure 3 (bottom): - 2022 salmon fry classifications by SSSI unit distribution**

Salmon fry were recorded as absent for Unit 53 (River Allen) however trout fry were located. This demonstrates that suitable habitat is available, and it is hoped that salmon reestablish following the barrier easement works completed by WRT beyond Trewen.
