Natural England Commissioned Report NECR141

# New Forest SSSI Ecohydrological Survey Overview

Annex L: Long Beech

First published 06 March 2014

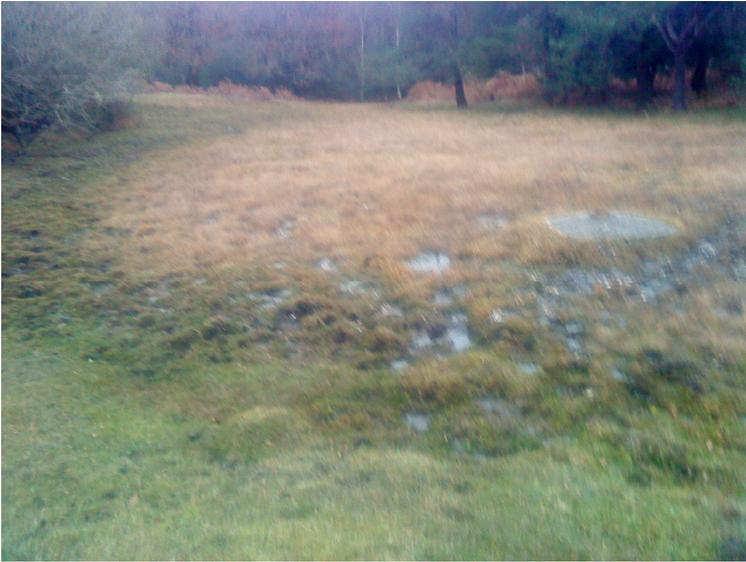
Figure 1-2: Northern Mire at Long Beech - the slight dome indicates the build up of peat deposits (NGR 424960, 112525)

The site occupies the eastern side of a plateau. The wetlands in the site are limited to two small narrow incision valleys high up the main valley side. Within these wetlands there is some peat accumulation (Figure 1-2). These wetlands stop abruptly as they enter the woodland that occupies the lower slopes as water is channelled into drains. These drains appear stable (i.e. no headward erosion) so the extent of the valley side wetlands is not reducing.

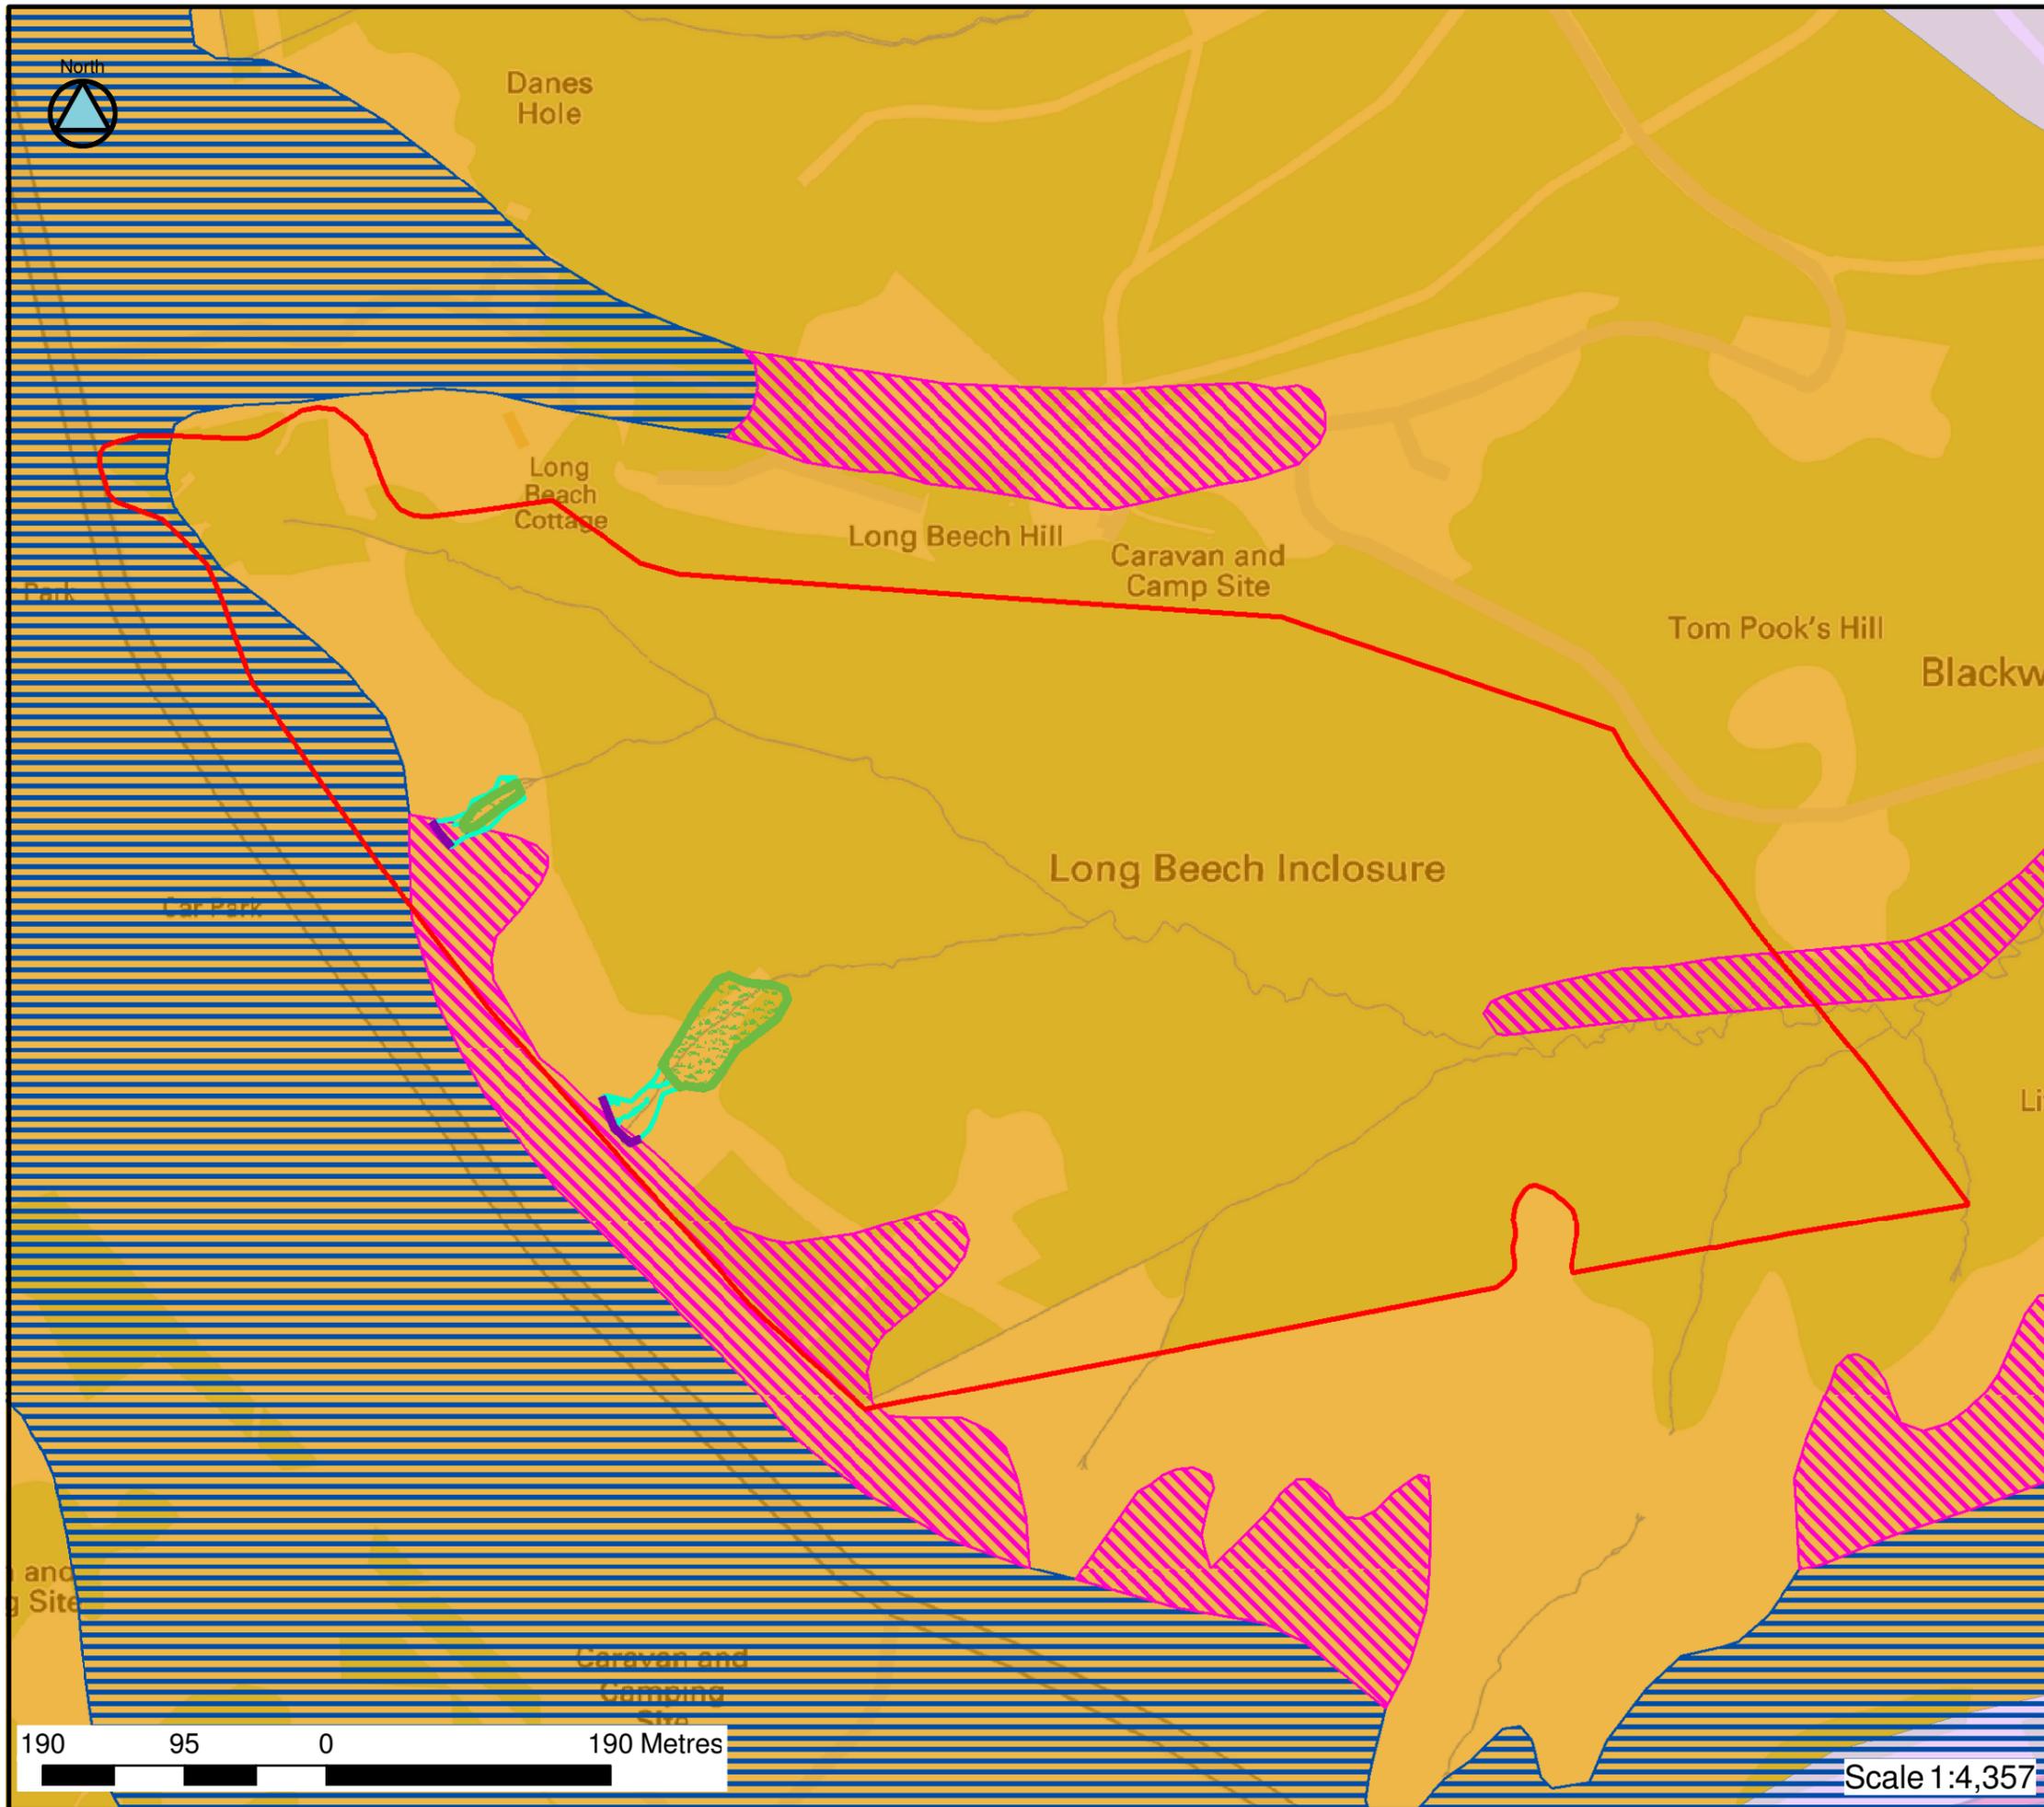
**MAP 7**

Eco-hydrology

**Map 7: Eco-Hydrology Map**

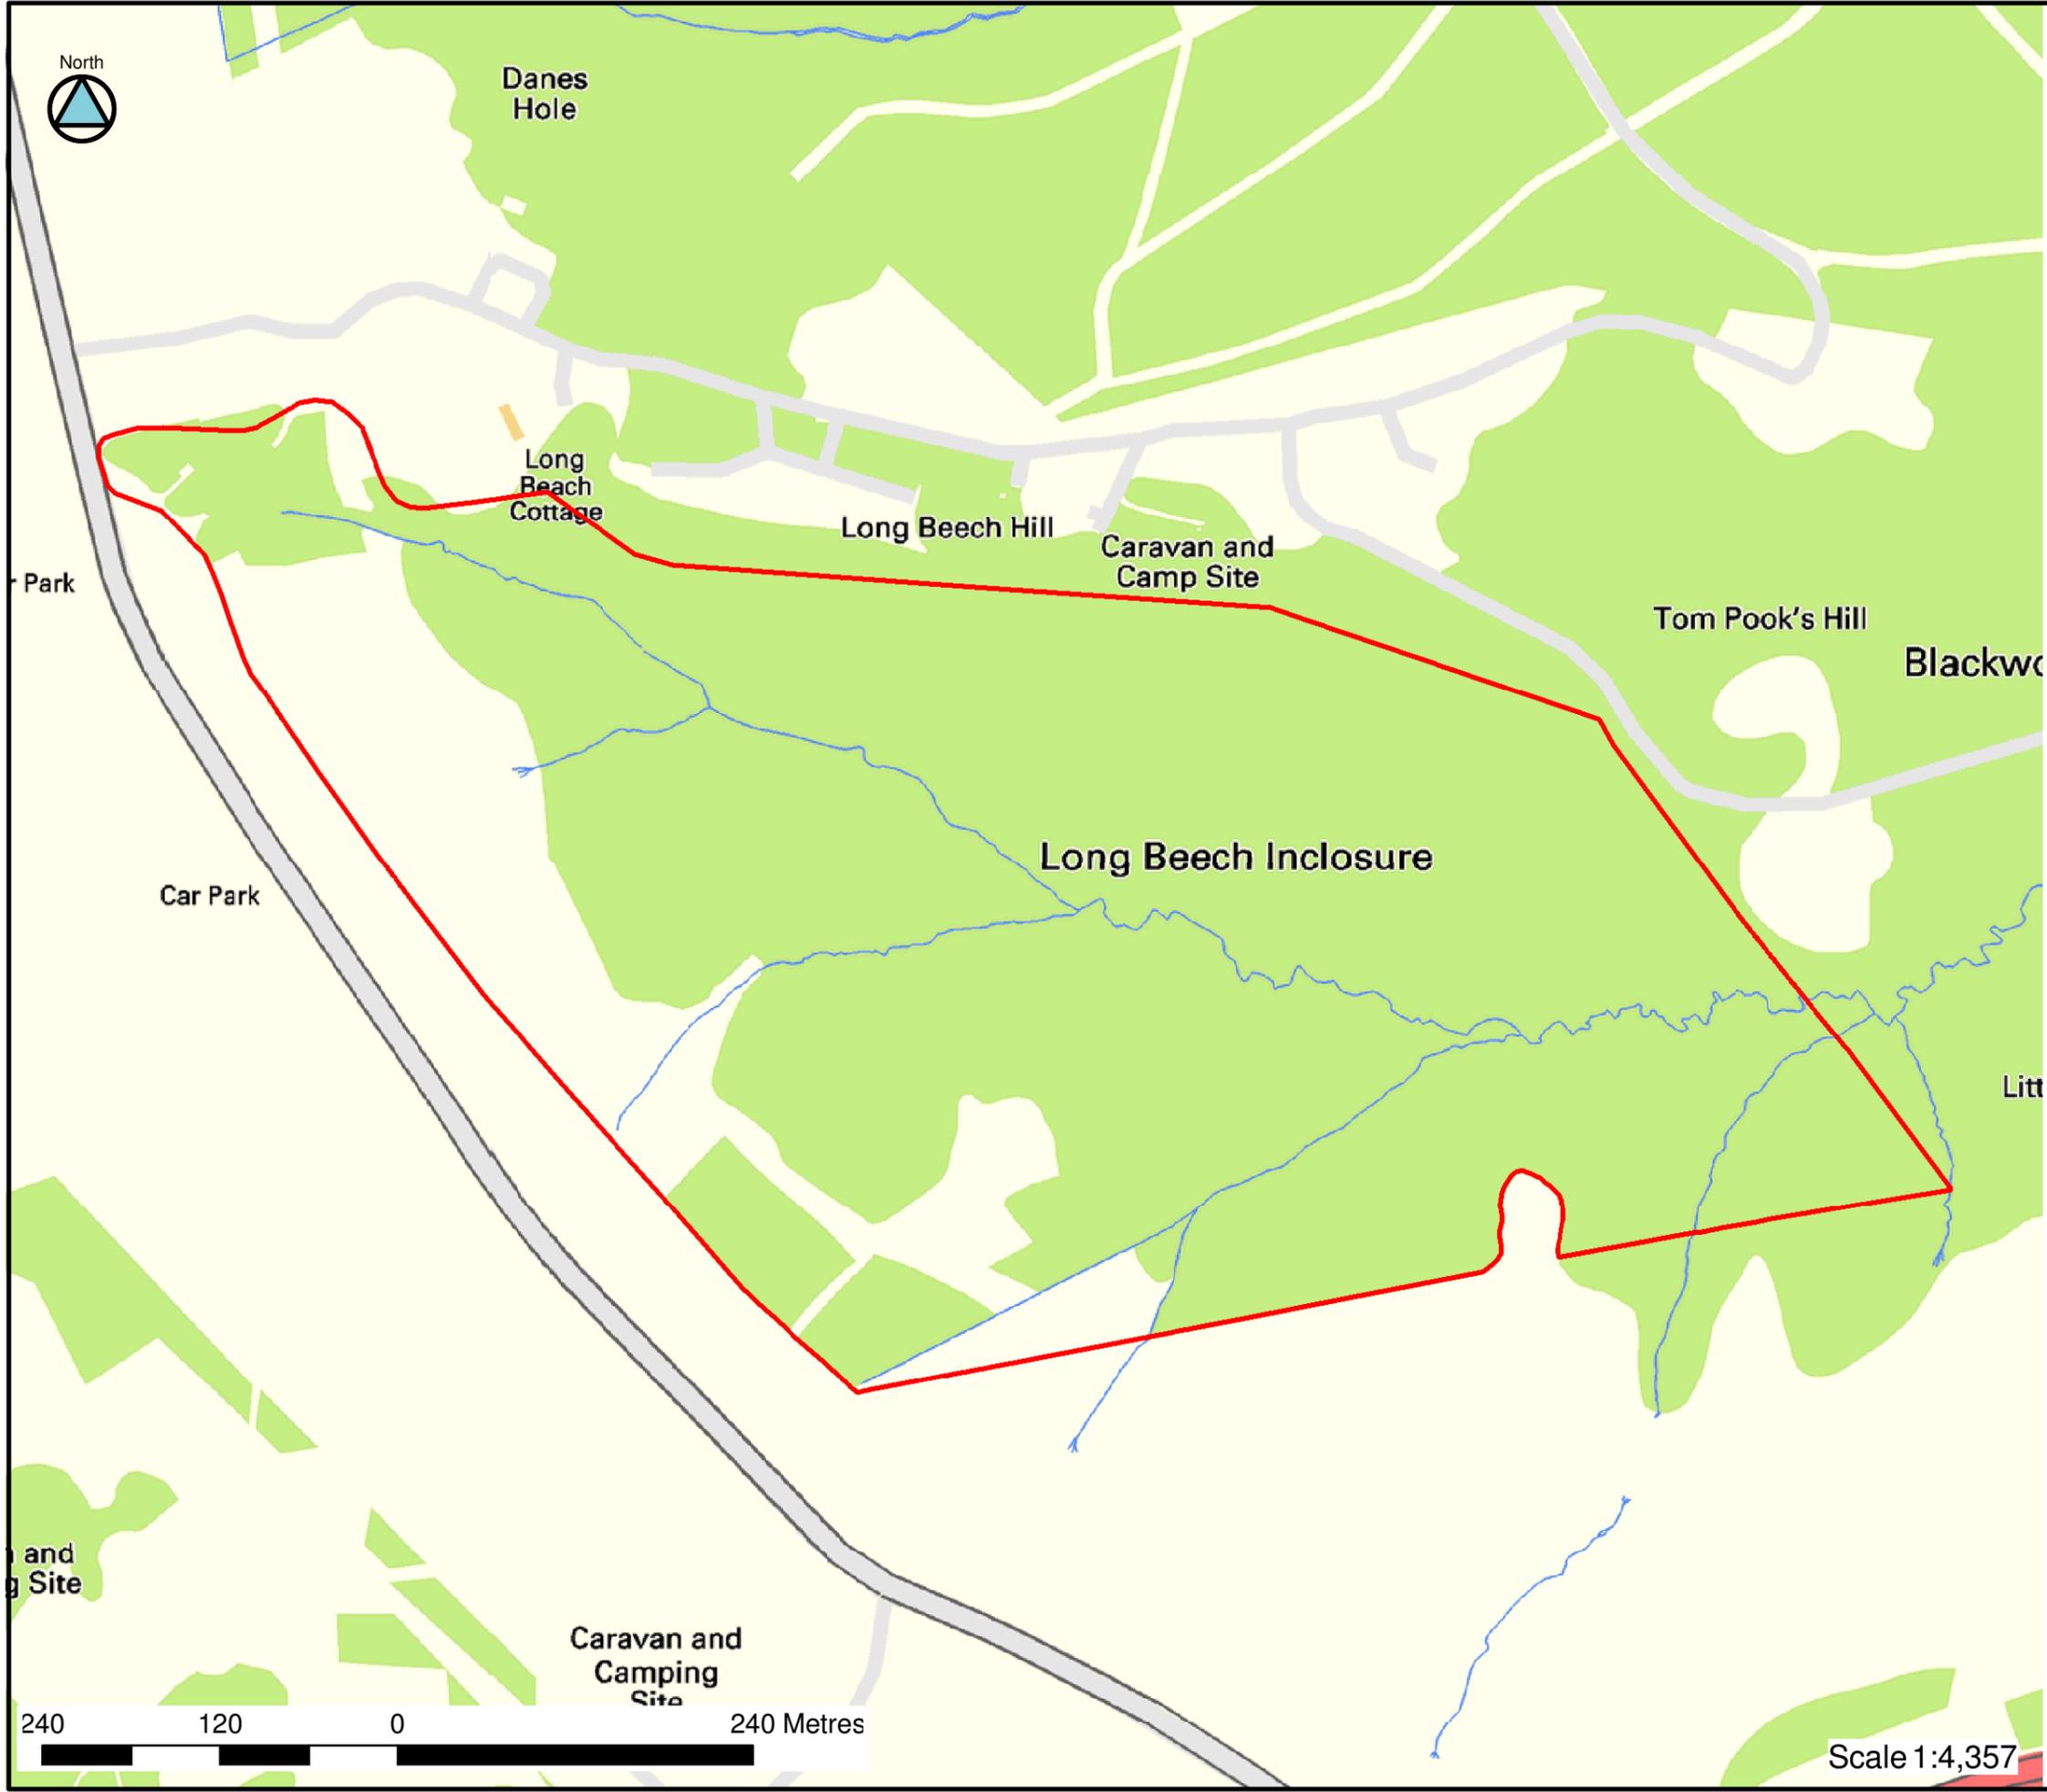
**MAP 8**

Restoration Plan

**Map 8: Restoration Plan**
