# Amberley Wild Brooks Eco-Hydrology and Peat Assessment Report

A report into the investigation of Amberley Wild  
Brooks Site of Special Scientific Interest

Natural England Commissioned Report NECR603

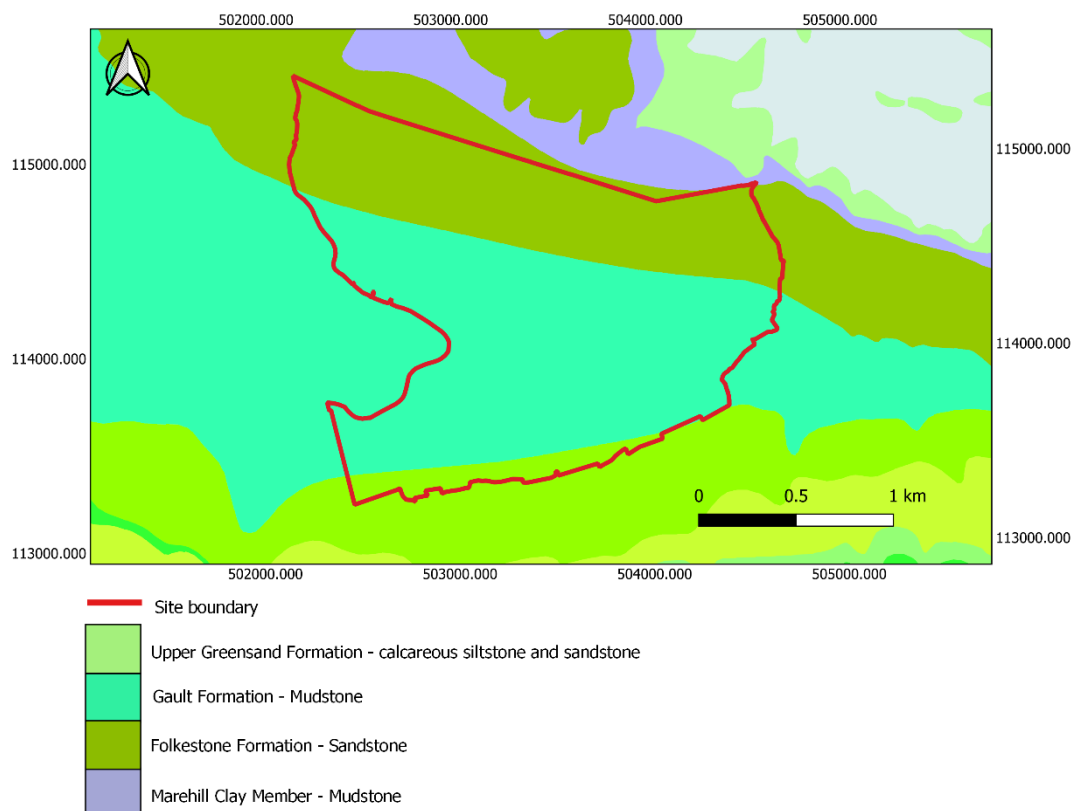
**Figure 3 Bedrock geology from BGS 50K mapping**

According to the British Geological Survey (BGS) 1:50,000 mapping, the bedrock geology comprises (Figure 3):

- Upper Greensand Formation – Sandstone and Siltstone
- Gault Formation - Mudstone
- Folkestone Formation – Sandstone
- Marehill Clay Member – Mudstone

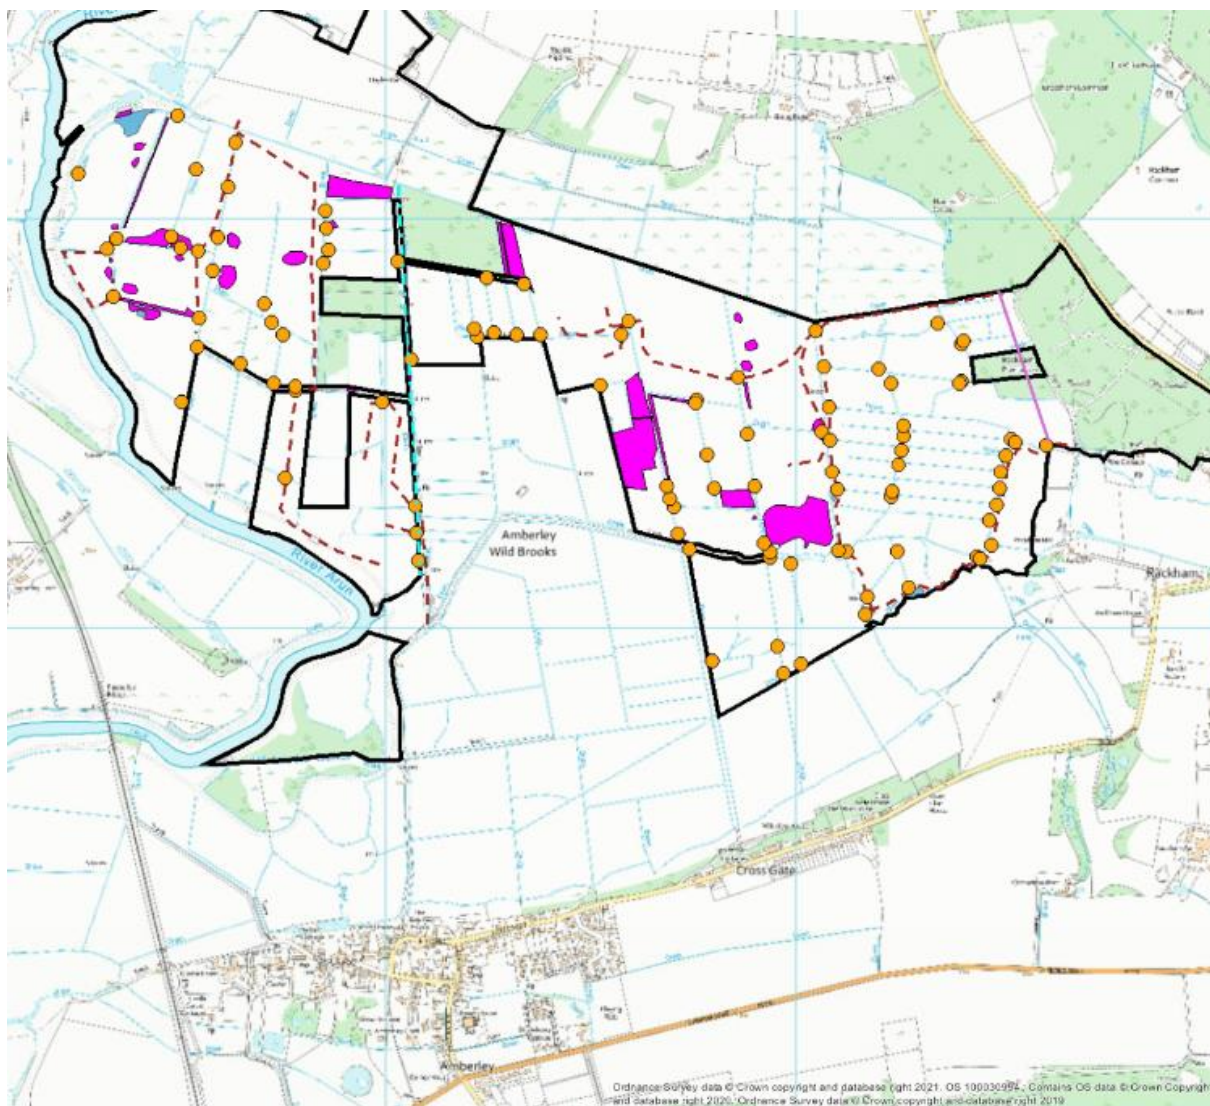
**Figure 4 RSPB Hazard Map of Amberley Wild Brooks. Produced by the RSPB.**

Peat deposits have been mapped in the northern extent of site with a small section to the east. RSPB hazard maps show soft peat in small areas across northern and central regions of the site in fields 11, 12, 14, 15, 10, 9, 17, 20, 61, 54, 56 and 57 (Figure 5). The northern extent of field 12 is also flagged as unsafe areas to drive on. These areas are shown in Figure 5.

Distribution of peat is shown along the northern portion of the site and in the north-east of the site in BGS mapping (Figure 4). RSPB hazard mapping indicates peat present in the north-west, central-north and central-east part of the site. The ground investigation therefore aimed to characterise the depth of peat deposits across the site and to provide transects across the peat and the drift/solid boundary at the edge of the reserve. This was in order to provide data on comparative geology and groundwater conditions along floodplain and peat margins.

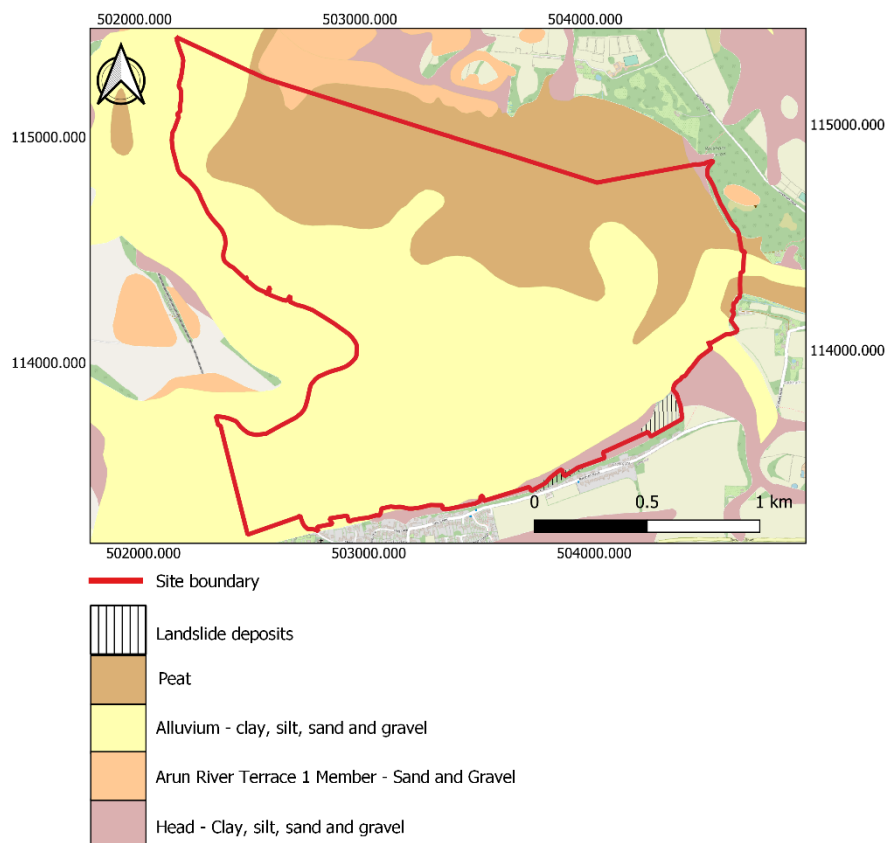
**Figure 5 Superficial geology and mass movement from BGS 50K mapping**

Head deposits are mapped underlying the Alluvium in the south-eastern sections of the site. Characterised by poor sorting and stratification, angular gravel and local lenses of silt, clay, peat or organic material, head is termed a polymict deposit. Head deposits are typically linked to the Pleistocene periglacial solifluction. Landslides were noted on the southern edge of the site, shown in Figure 4, associated with the over steepened slope due to the river paleochannel.

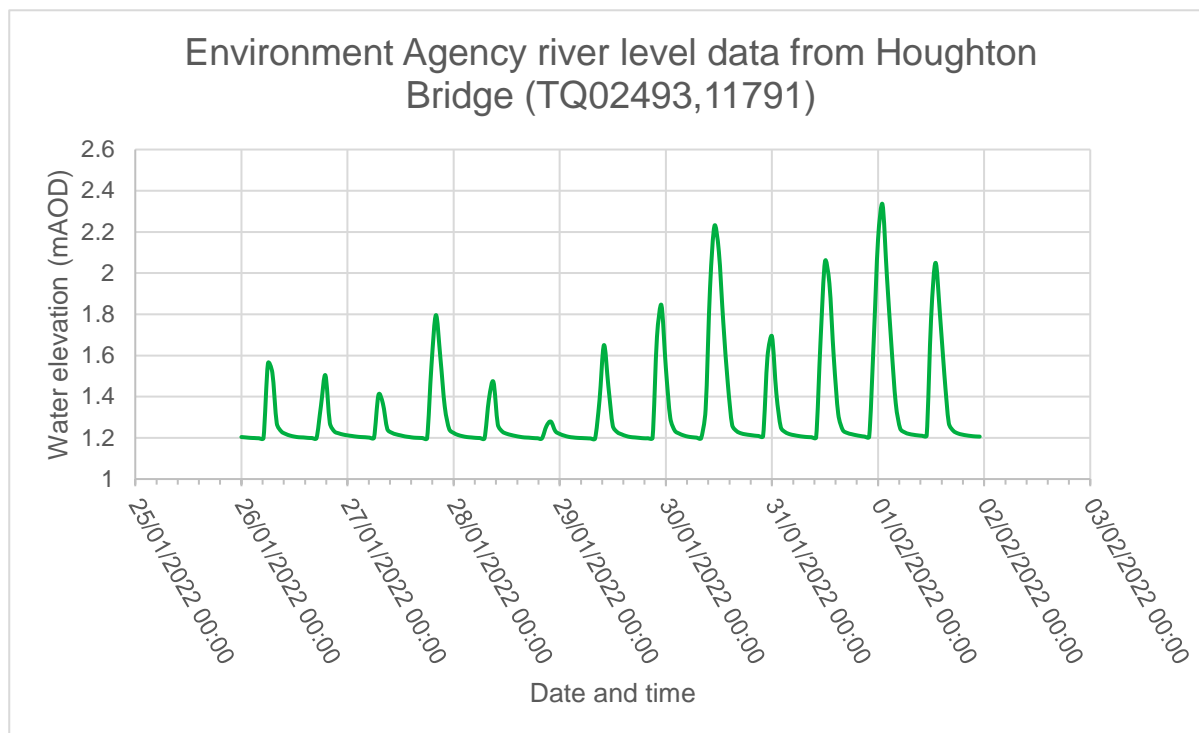
**Figure 6 River Arun level data, Houghton Bridge sourced from the Environment Agency (Contains public sector information licensed under the Open Government Licence v3.0 © Crown Copyright 2024)**

The site lies further upstream than this, with approximately 4.5 km of river channel between Houghton Bridge and the southern edge of the site. Various sources suggest that the River Arun is tidally affected with a tidal influence detectable in river water levels all the way to its confluence with the River Rother at Pulborough, upstream of the site. The tidal influence seen along the Arun adjacent to the site is likely due to the indirect influence of saltwater intrusion/regression, in the form of the backing up/release of freshwater through the tidal cycle.

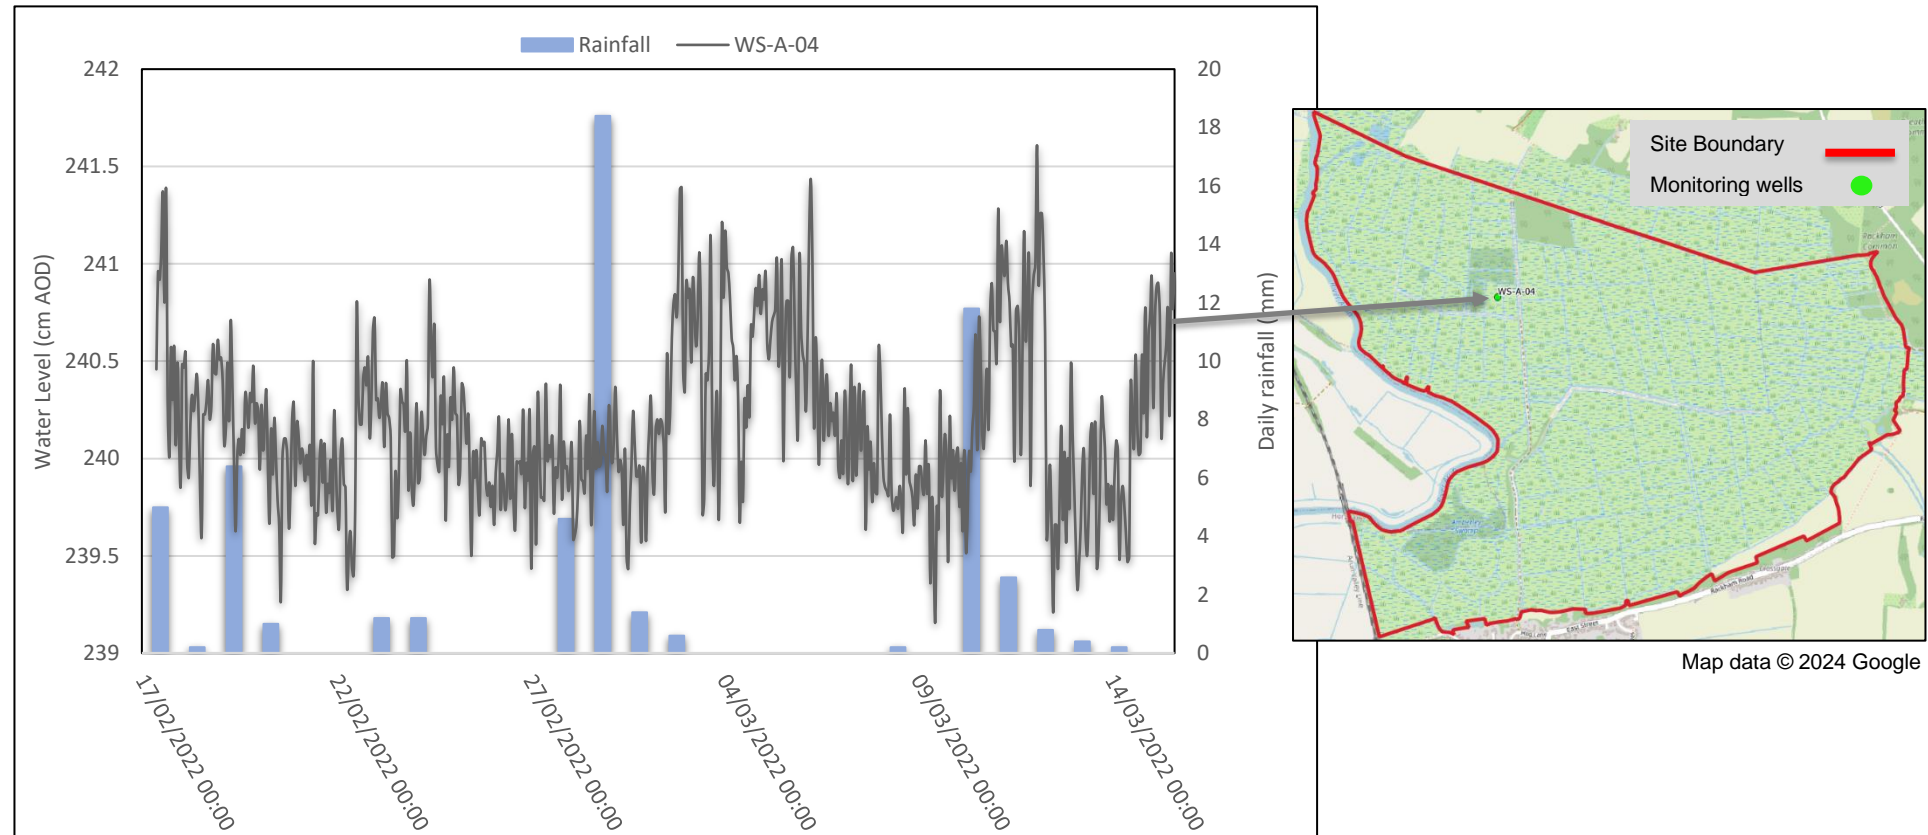
**Figure 9 Water levels observed for wells with Arun River Terrace Deposits over a 1-month period on site**

There is a single well within the RTD deposits. The response to rainfall events shows a degree of delay, with an approximate 2-day delay between rainfall event and hydrograph peak on 29<sup>th</sup> February, and a 2-day delay on 11<sup>th</sup> March. However, the change is small in amplitude (3 to 4 cm). This suggests the response delay is associated with recharge of the RTD aquifer from the surrounding area, where it is not confined by the overlying alluvium as it is at WS-A-04.

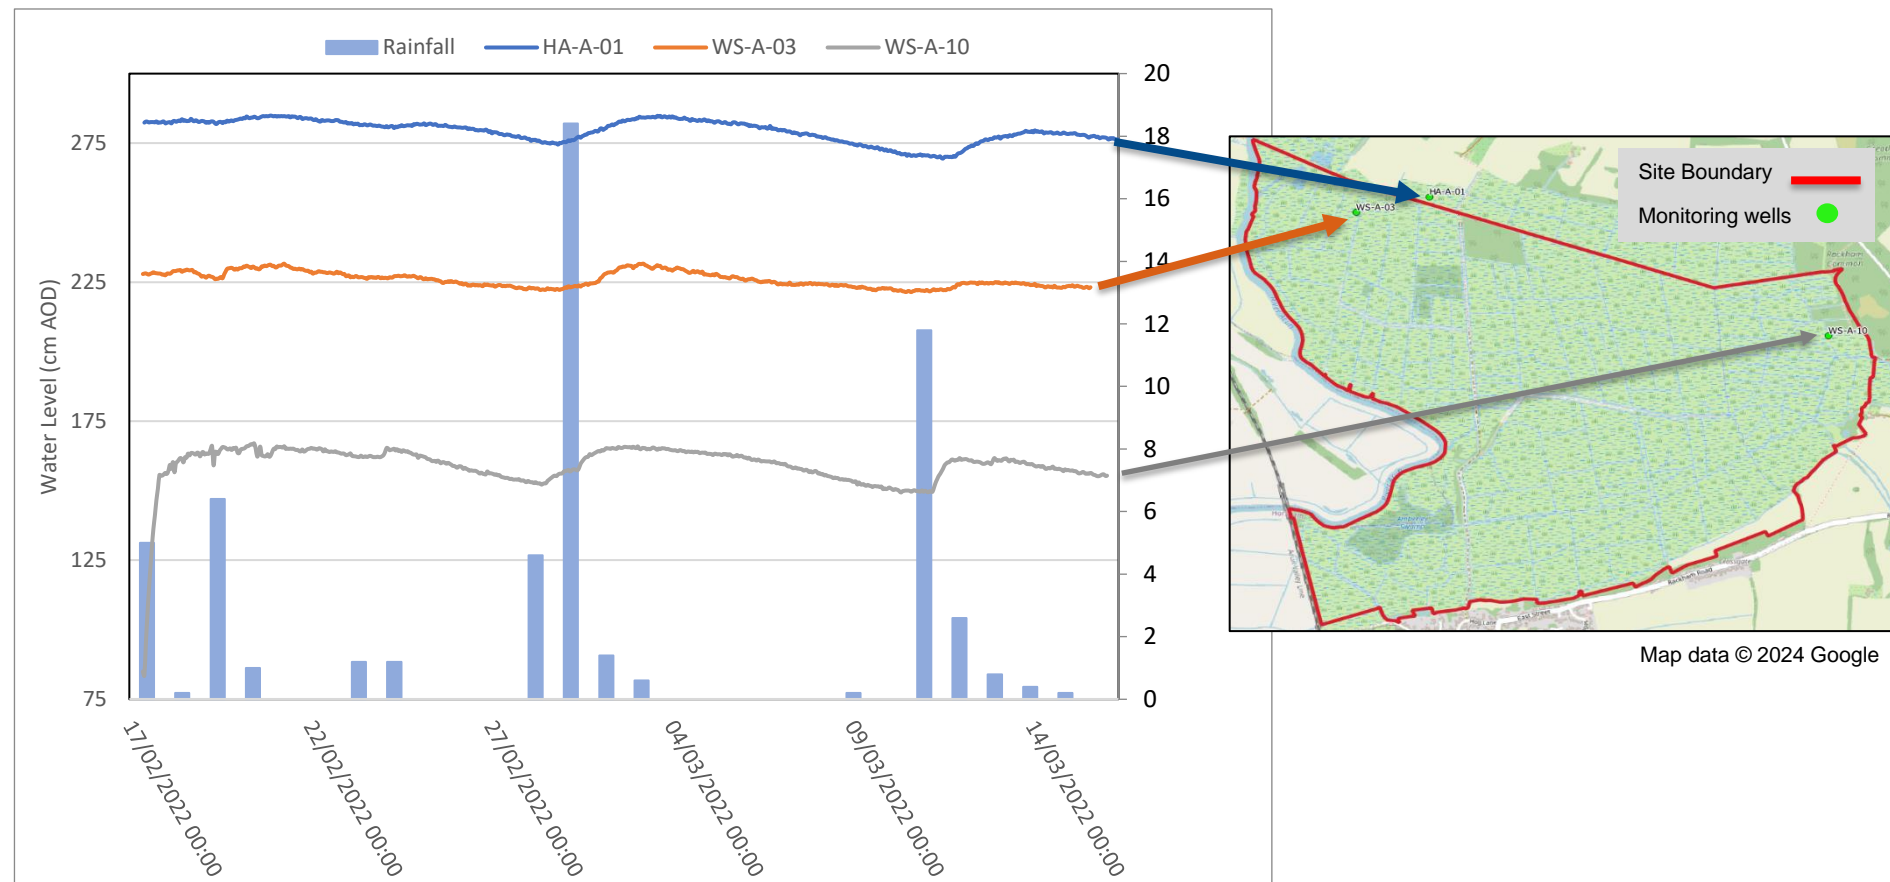
**Figure 10 Water levels observed for wells with Alluvium over a 1-month period on site**

The hydrograph within WS-A-10 has a rising trend following installation, indicating that groundwater levels within the well were equilibrating with the surrounding ground. This early period of data for this well is not considered representative of actual groundwater conditions. From approximately 25<sup>th</sup> February onwards, this well then has a similar hydrograph to the other two installations within the alluvium, showing a fairly rapid response to rainfall, but of limited amplitude. Peaks are typically one day after the rainfall event.

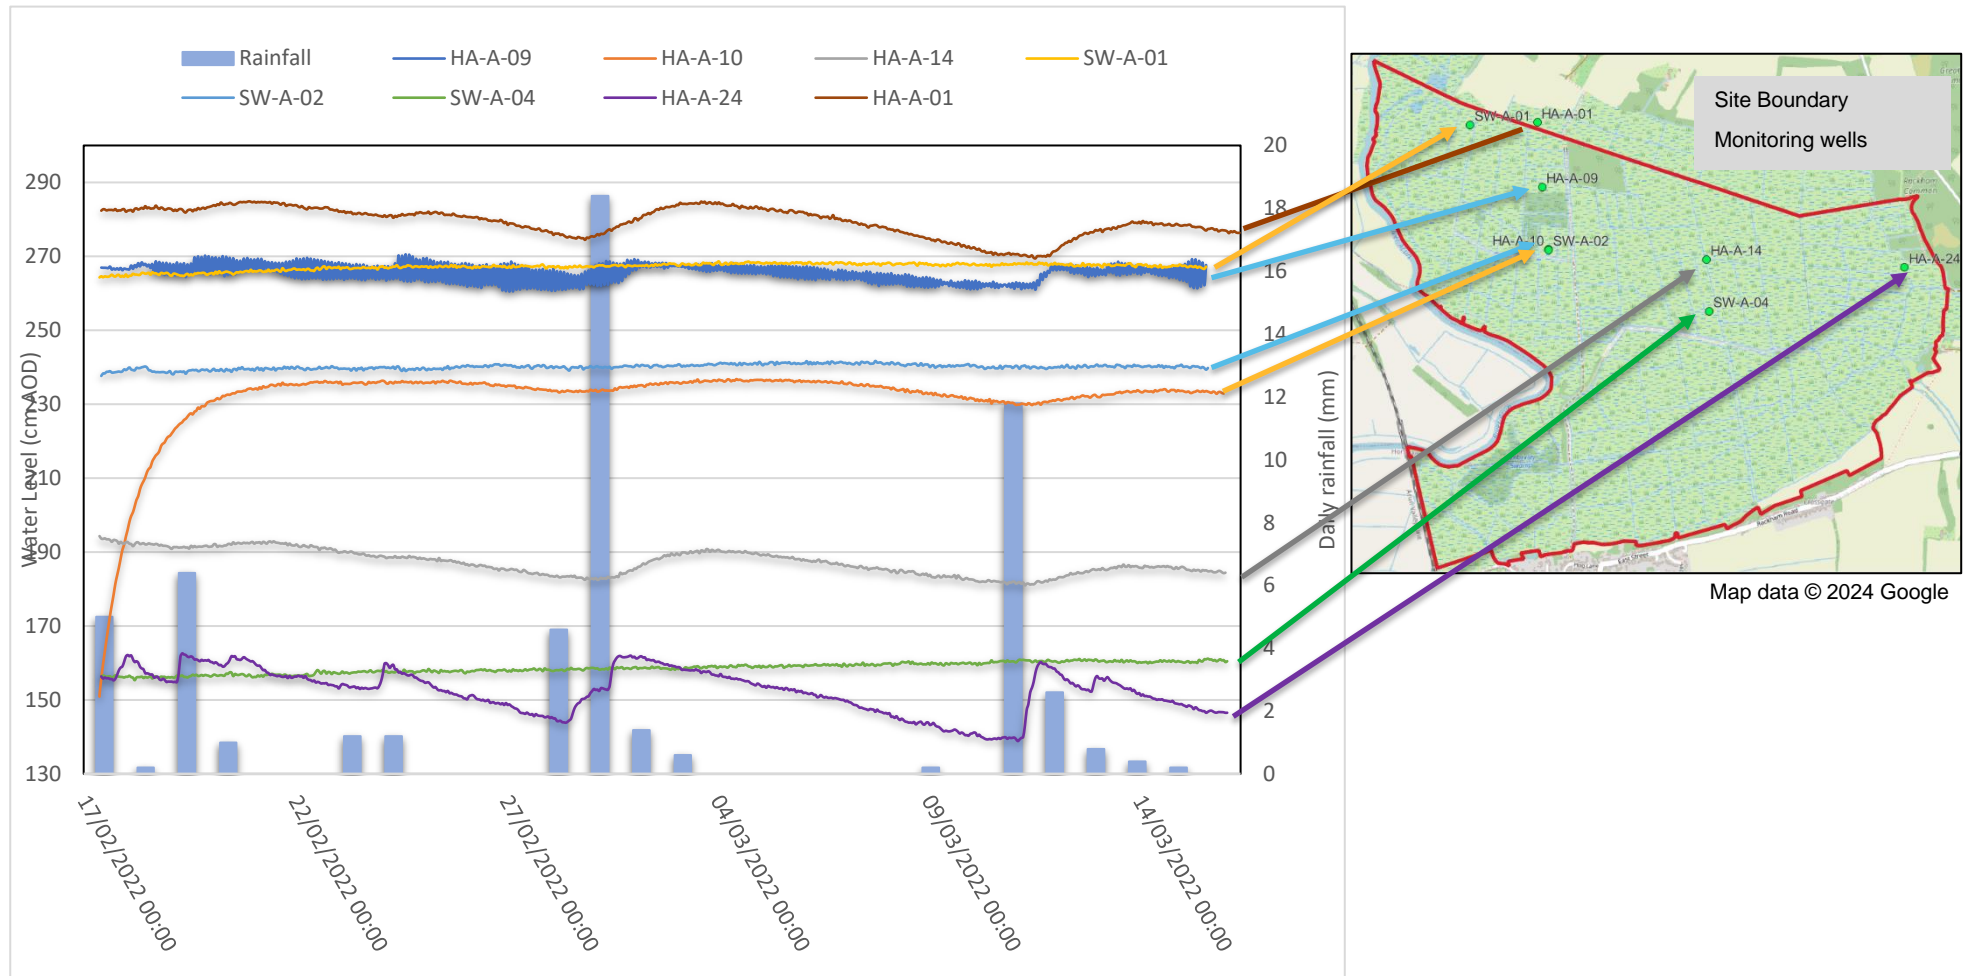
**Figure 11 Water levels observed for wells with peat over a 1-month period on site**

HA-A-10 has a rising trend for the first five days of the monitoring period, suggesting that water within the well is equilibrating with the groundwater in the surrounding peat over this period. After 20<sup>th</sup> February, this well then has a similar pattern to the hydrographs of HA-A-01, HA-A-09 and HA-A-14. These all show a low amplitude, delayed response to rainfall, with a 1-to-4-day lag between rainfall event and hydrograph peak. HA-A-09 is the most flashy of these four wells, with a one-day delay in the peak and with a more pronounced rise.

(The broad trend in HA-A-09 is overlaid by an hourly oscillation in the data, suggesting that there may be an issue with the logger in this installation).

As discussed in Figure 11, there are differences within those wells installed in the peat, with HA-A-10 and HA-A-14 showing a more muted response to rainfall typical of low permeability/ groundwater influence, whereas HA-A-24 shows a spikier response typical of rainwater influence. HA-A-09 shows an element of both. All the surface water wells show no discernible response to rainfall with the

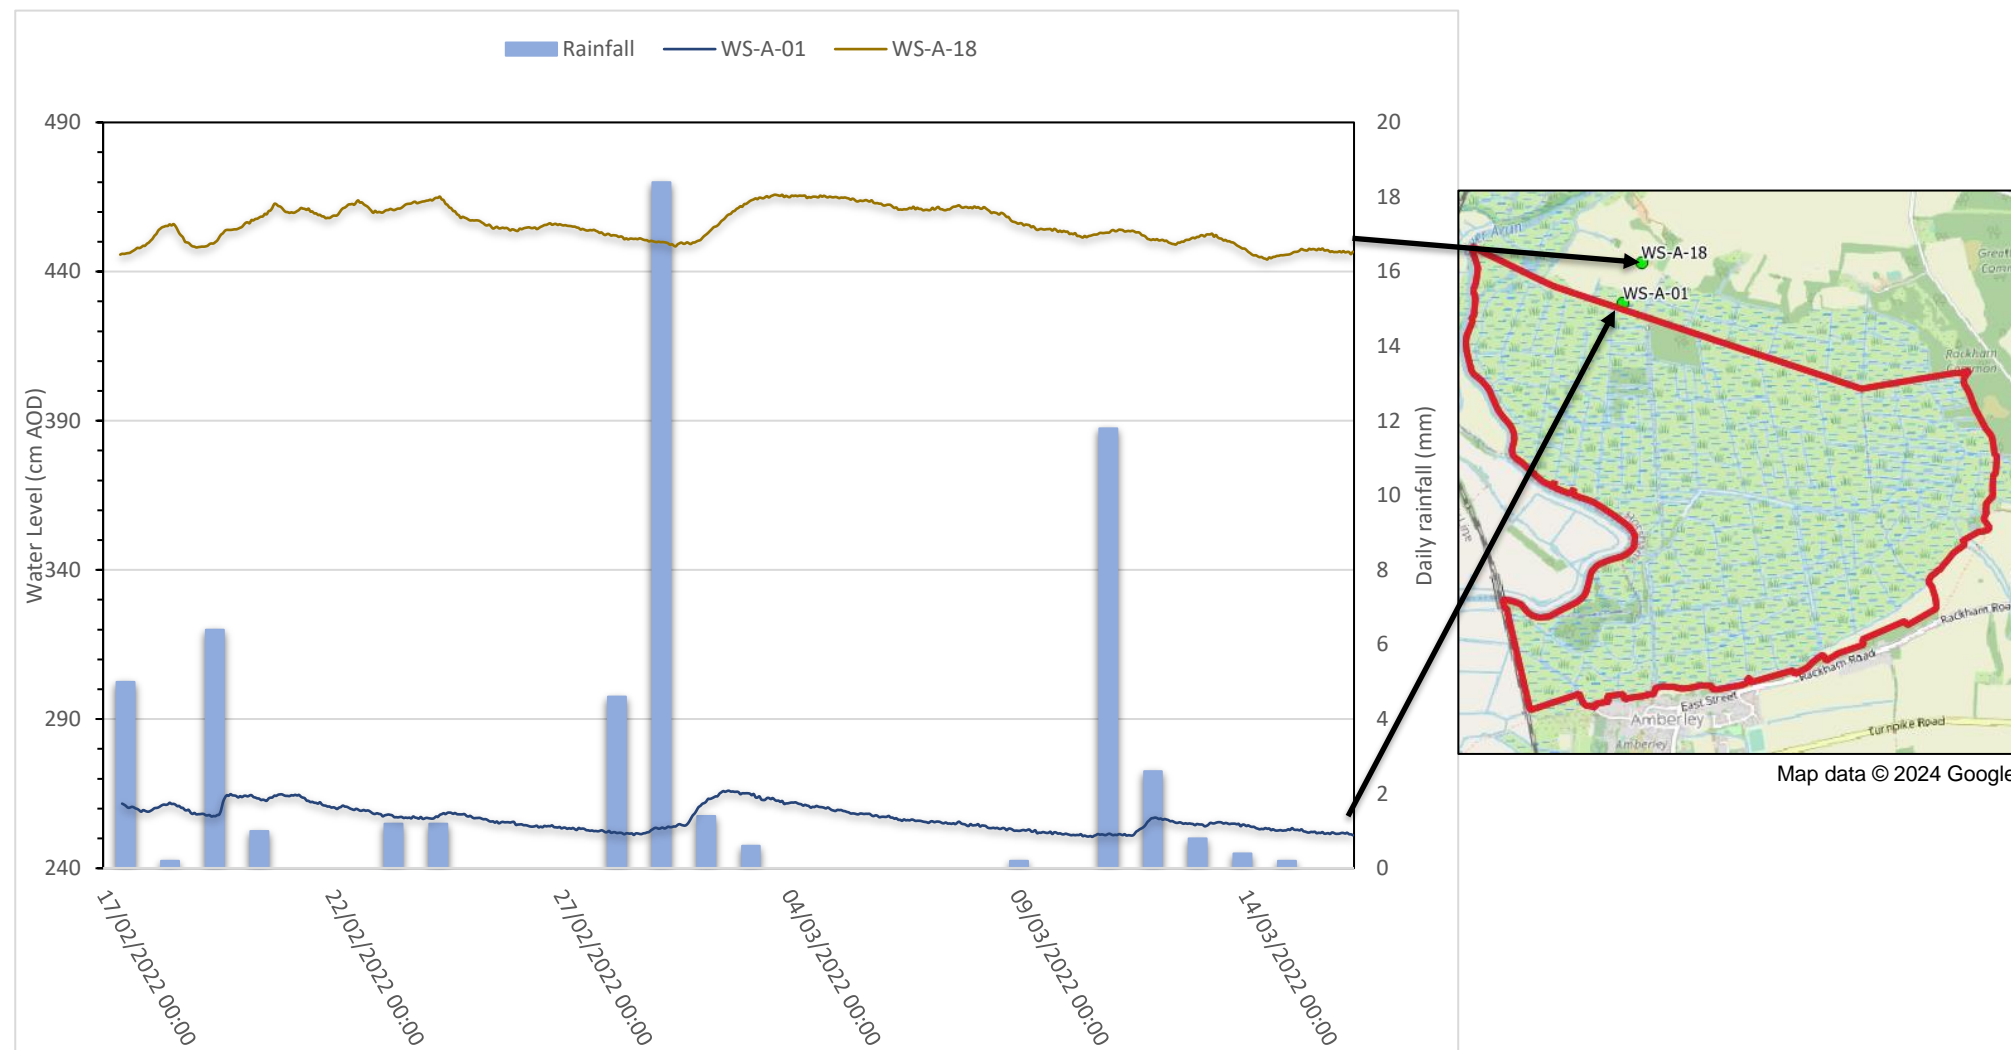
**Figure 12 Water levels observed for wells with Folkestone Formations over a 1-month period on site**

The two wells within the Folkestone Beds are in a similar location in the north of Amberley. WS-A-18 is further upslope, at the base of the gently sloping apron of higher ground. WS-A-01 lies at the lower edge of this apron, near to the commencement of floodplain deposits. The hydrographs show much similarity in shape, with levels decreasing with topographical elevation (i.e. groundwater surface reflects

topographical surface, as might be expected in a highly permeable and porous sandstone aquifer). The wells show an approximate 1-day delay between rainfall and hydrograph peak, with a slow and steady decline in elevations in drier periods.

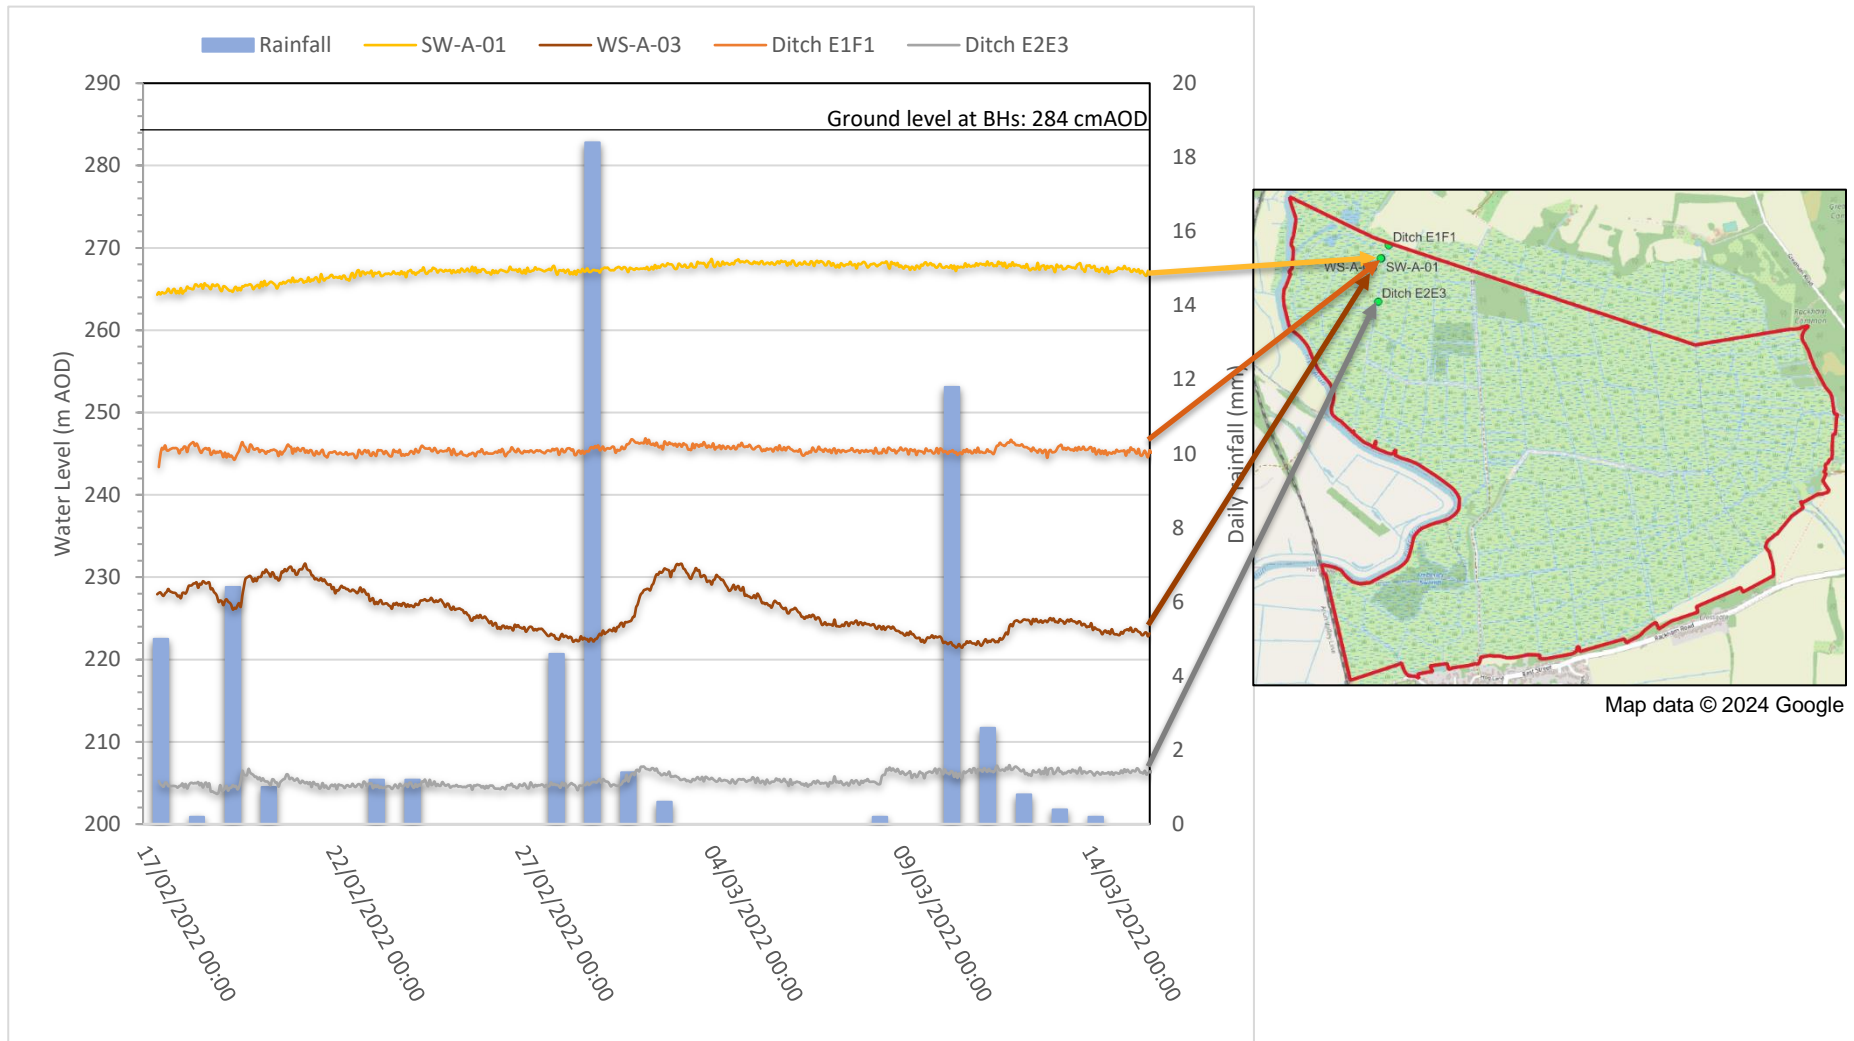
**Figure 13 Water levels observed for E2 paired wells with Alluvium and surface water over a 1-month period on site**

There is a marked difference in elevation of ponded surface water (SW-A-01) and ditch levels. The two ditches show a small response to rainfall events, with the muted response likely attributable to the large storage capacity of the ditch network. The groundwater within the alluvium in WS-A-03 can clearly be seen to be isolated from the ditch water, with very different elevations. At present the comparative

elevations would suggest that the perimeter ditch (E1-F1) may contribute water to the groundwater, whereas the groundwater may then be losing water to the north-south trending Ditch E1. These observations are made based on the period of time monitored, i.e. in cold, early spring conditions. Typically, monitoring at this time of year would be representative of wet conditions, although February and March 2022 were drier than average.

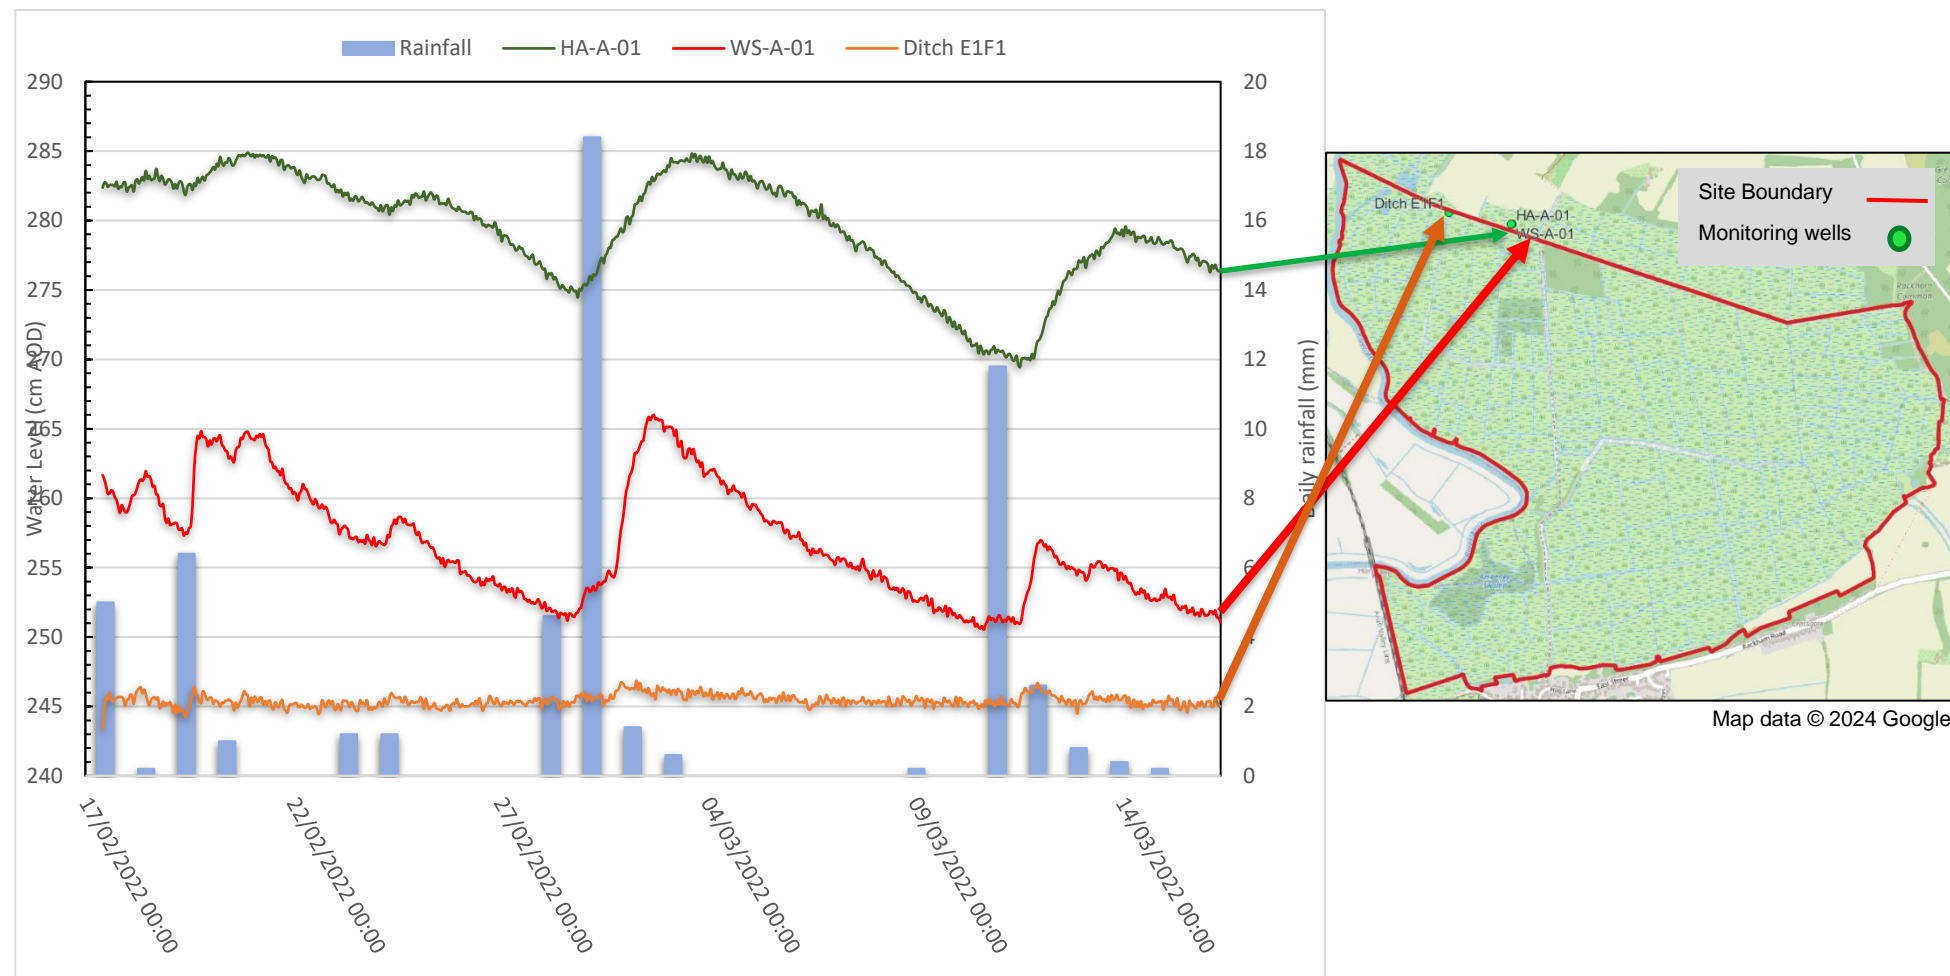
**Figure 14 Water levels observed for the F1 paired wells with Folkestone formation (WS-A-01) and Alluvium (HA-A-01) over a 1-month period on site**

The groundwater in the alluvium and underlying Folkestone Beds show a very similar response to rainfall, suggesting a commonality of response that may be attributable to hydraulic connection. However, the difference in elevation indicates that there is a local downwards head gradient between the alluvium and Folkestone. The groundwater table in both units is above that of the Ditch E1-F1. This must be

viewed in the context of location however, as on-site constraints necessitated the placing of the ditch installation some 100m or so to the west. This stretch of ditch visually seems to have a constant water elevation due to the blockage downstream of it, so the ditch water levels are considered likely representative of the ditch near to the boreholes, but this has not been confirmed.

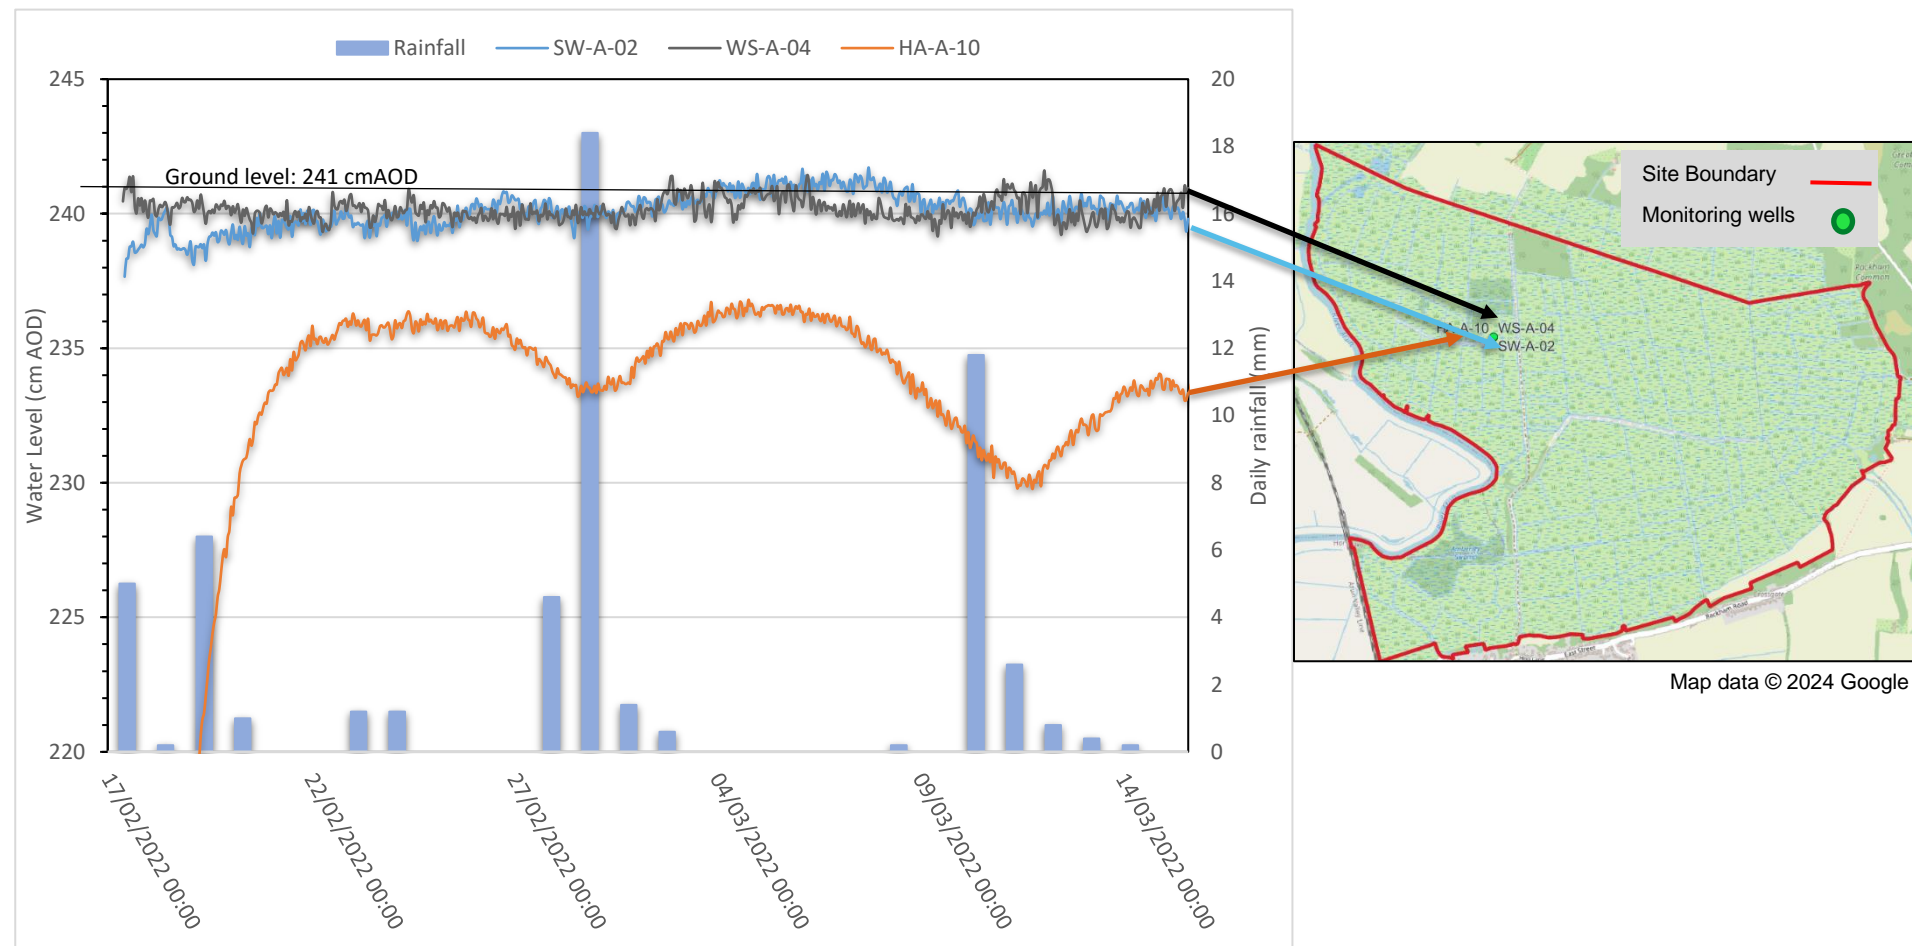
**Figure 15 Water levels observed for the F2 triple wells with RTD and peat over a 1-month period on site**

This triple install of wells are all located within 2 m of each other. Following an initial period of equilibration, the groundwater within HA-A-10 in the peat can be seen to have a laggy response to rainfall, with an amplitude of approximately 5-6cm. Water in the peat is between 5cm and 13cm beneath ground surface. Pondered water on the ground surface (SW-A-02) can be seen to respond to rain events but is completely isolated from the water within the peat below. The 10cm layer of organic rich clay topsoil and the upper drier hydrophobic peat appear to act to isolate the ponded surface water from the peat.

The deeper groundwater within the RTD can be seen to be artesian/ sub-artesian and this is corroborated by site observations of water filling and overtopping the metal protective cover and ochreous staining forming at the point of overflow. This groundwater body shows very little, if any reaction to rainfall, suggesting it is significantly isolated from meteoric waters. The higher head elevation of this deep groundwater suggests an upwards head gradient between the deep superficial deposits and the shallower peat.

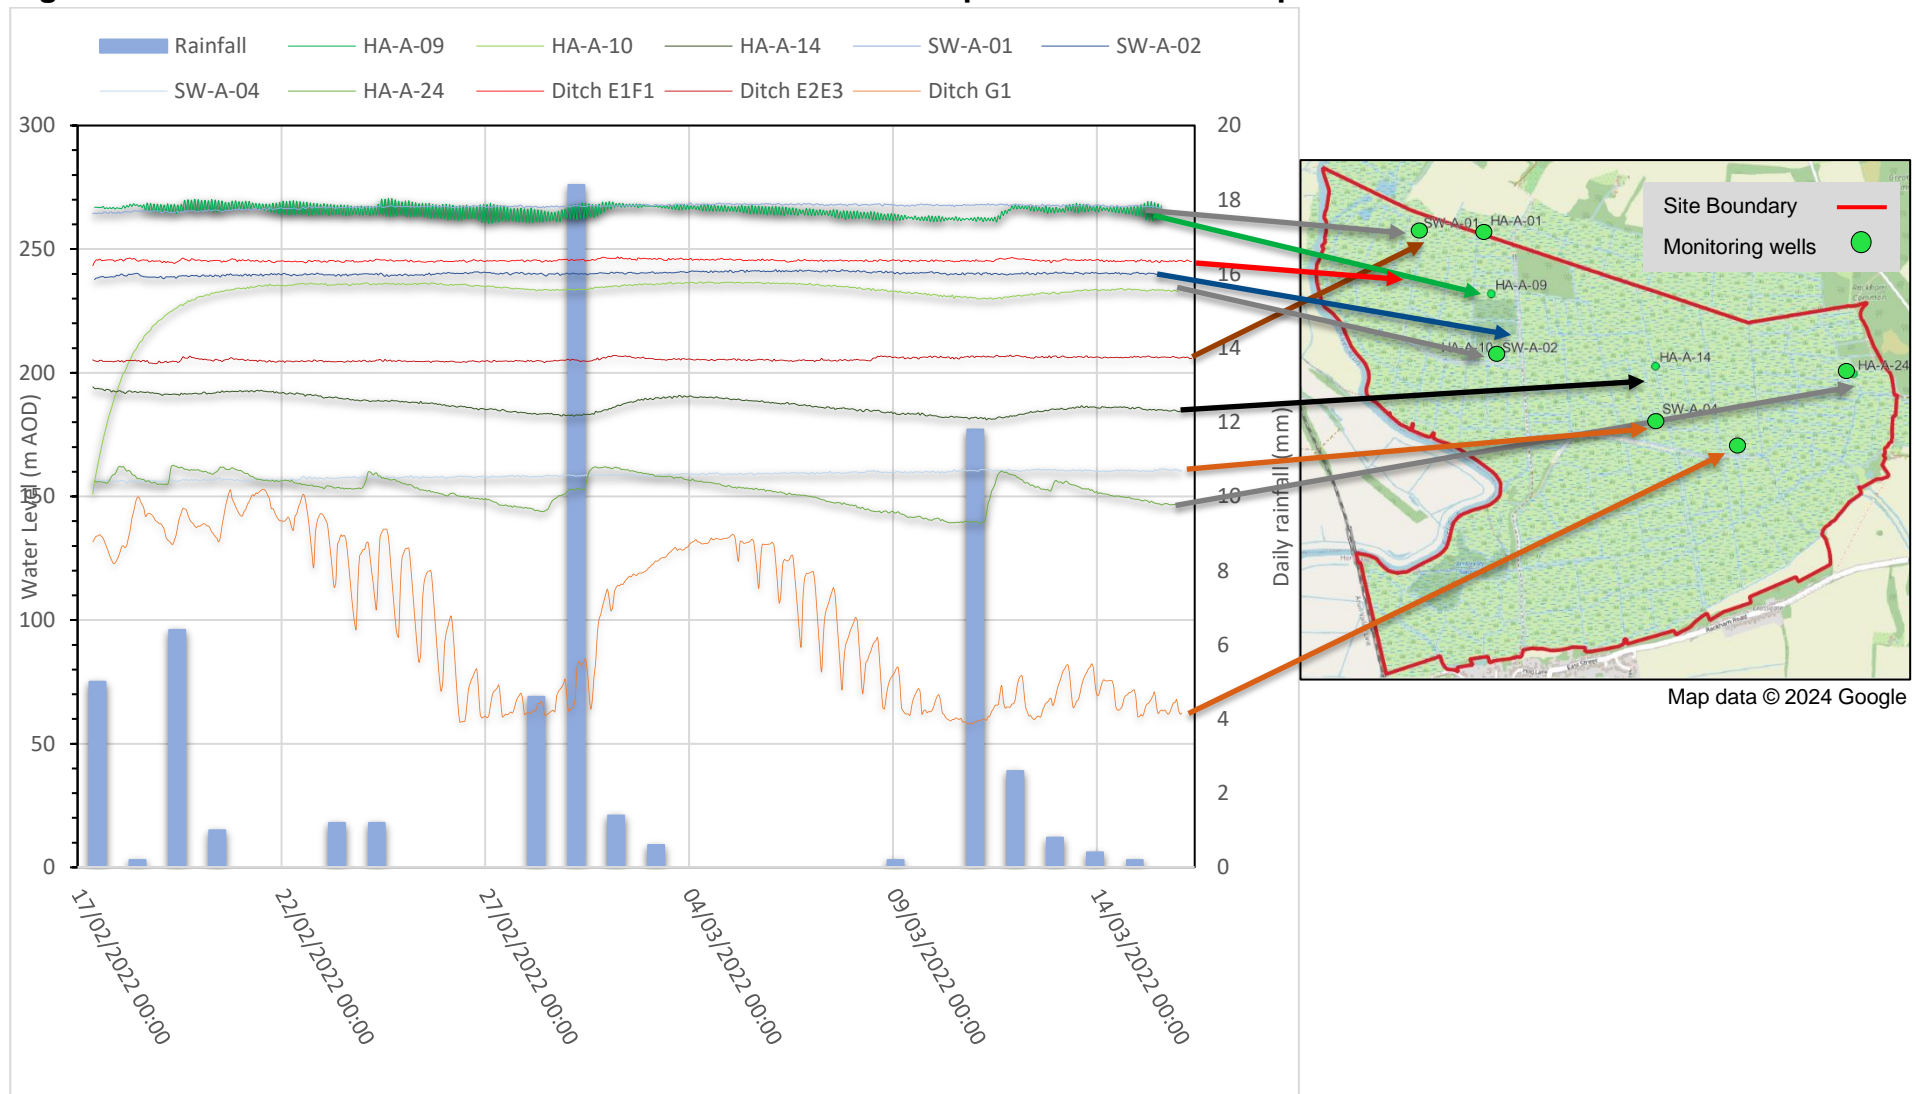
**Figure 16 Water levels observed for the ditches and wells with peat over a 1-month period on site**

exception of SW-A-02. The distinct differences between surface water hydrograph and peat hydrograph supports the hypothesis that peat is largely isolated from ponded surface water by the intervening layer of clay-rich topsoil and/ or hydrophobic dry peat.

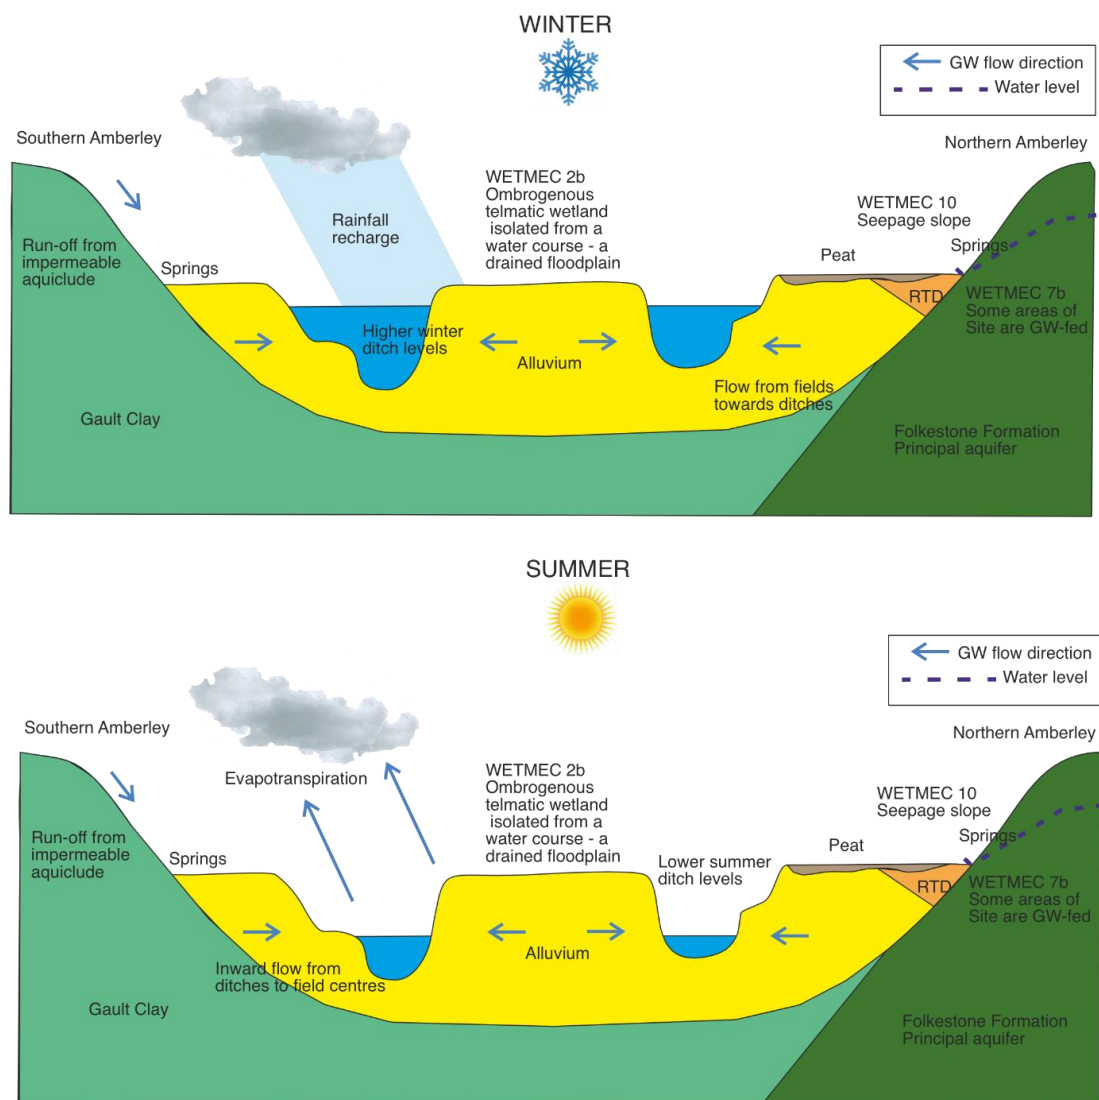
**Figure 17 Schematic cross section of WETMECs on Amberley**
