# Amberley Wild Brooks Eco-Hydrology and Peat Assessment Report

A report into the investigation of Amberley Wild  
Brooks Site of Special Scientific Interest

Natural England Commissioned Report NECR603

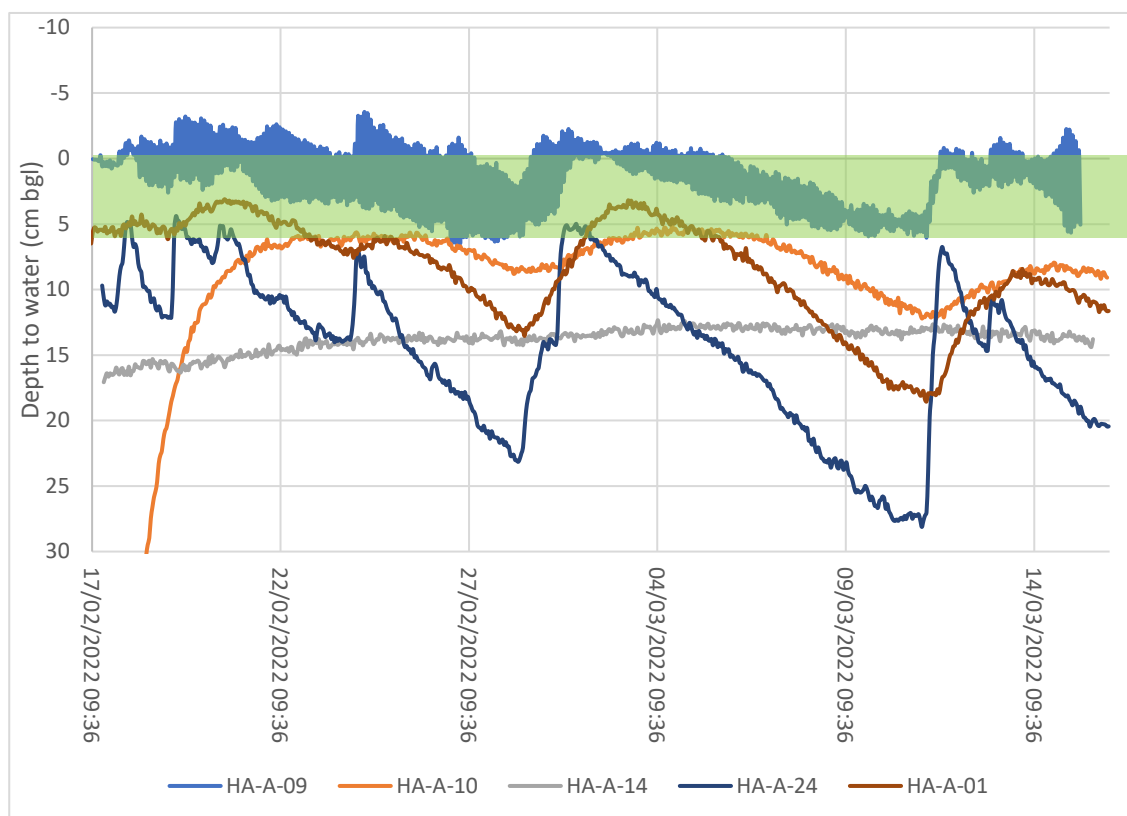
**Figure 18 Water level fluctuations in peat at or near ground surface in cm bgl. The green band between 0-5cm bgl depth to water indicates the healthy bracket for peat.**

The creation of drainage channels across site pre-dating 1800s mapping has helped to accelerate the water outflow from the peatland in both magnitude and speed. Over time on site more ditches have been added although the general layout remains similar to the 1800s. Water tables can be drawn down up to 50m away from a ditch in fibrous peat however drainage ditches have less of an impact of already decomposed peat. The drainage ditches also divert water emitting from springs mapped around site flowing through the ditches and off-site rather than across the surface of the peat.

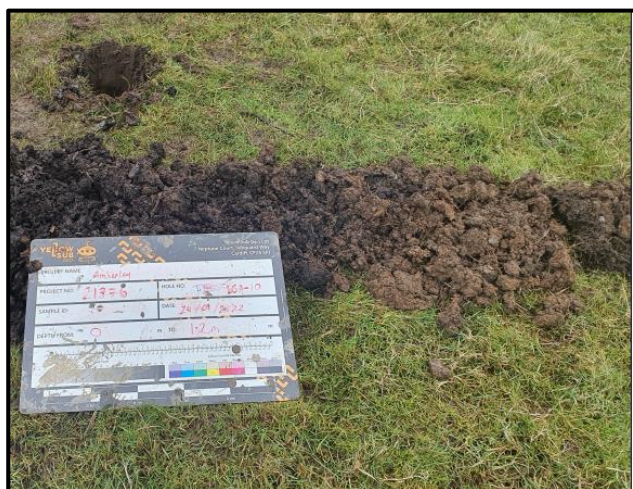
**Figure 19 Image of Desiccated Peat at Exploratory Hole HA-A-10, taken by surveyors during fieldwork**

As seen in Table 8, some of the peat deposits across the site had a very low water content with discernible levels of decomposing rootlets and wood fragments noted. Many of the peat deposits had standing water at the surface above, a dry upper peat layer and then a wetter lower peat layer. This shows the peat is displaying hydrophobic behaviour described above.

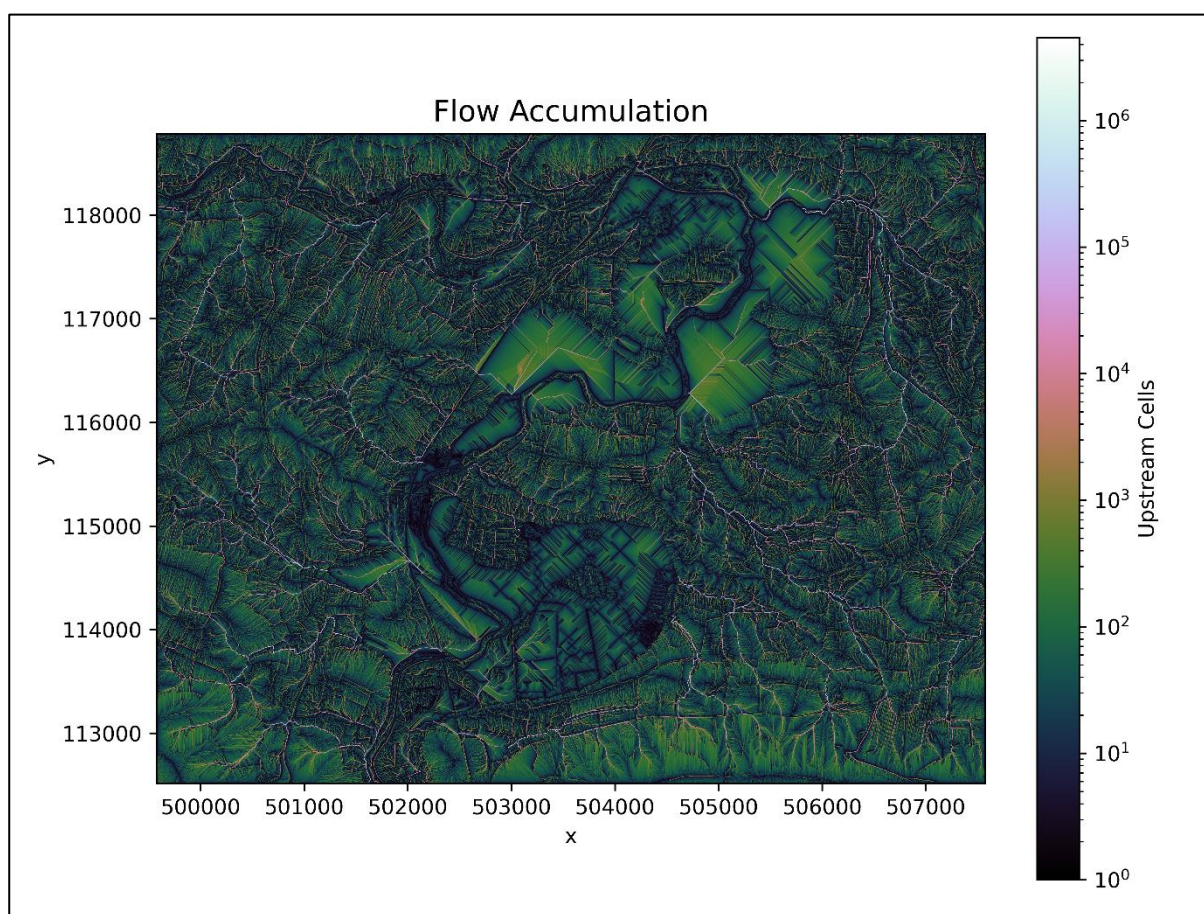
**Figure 20 LiDAR imaging detailing flow accumulation**

As can be seen in Figure 20 there is an abundance of very small catchments, rising at the head of the raised ground along the northern and southern site boundary. Although the typical sandstone geology of these catchments will allow for a large amount of infiltration along these catchments some water will flow onto the site from these catchments. In addition to this, there will be a component of incident rainfall that has infiltrated into the underlying aquifer that rises out of the ground at spring and seep lines. The RSPB have identified springs and seeps along the northern site and boundary and east of the site where the Folkestone beds are not confined by aquicludes. These springs and seeps, due to the small area they are fed from are likely to be ephemeral and 'flashy' and may not represent a baseflow to the reserve during the summer months.

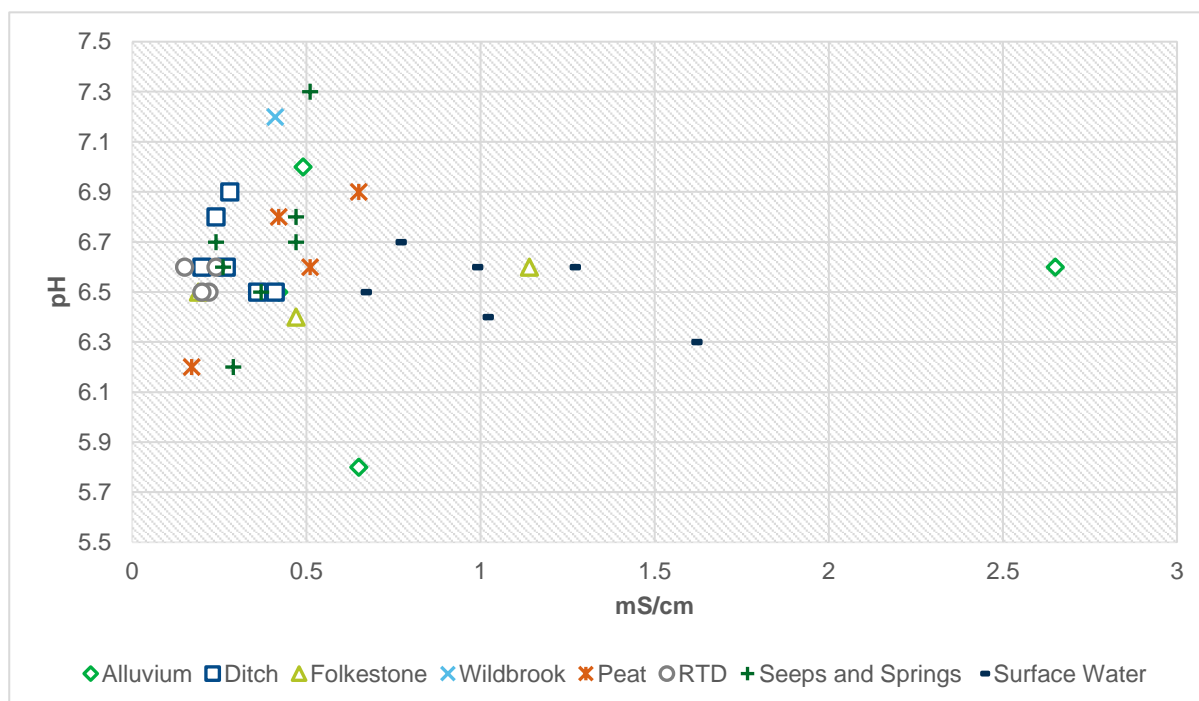
**Figure 23 Graph of pH versus Electrical Conductivity Amberley Wild Brooks**

The highest pH readings were pH 7.2 at Wildbrook Stream as it flows onto the site and pH 7.3 at the spring close to Quell Farm. Wildbrook stream catchment originates in the chalk uplands to the south-east of the site and this chalk is likely the cause of the elevated pH. Quell farm has deposits of Marehill Clay upgradient which can have a significant glauconitic component, this glauconite may be elevating the pH in the spring at Quell Farm. The springs and seeps that form a large inflow component to the system have an average electrical conductivity when compared to the other localities sampled and also have a relatively low pH with the exception of the previously mentioned Quell Farm Spring. Conductivity was initially thought to likely be relatively high in these springs and seeps due

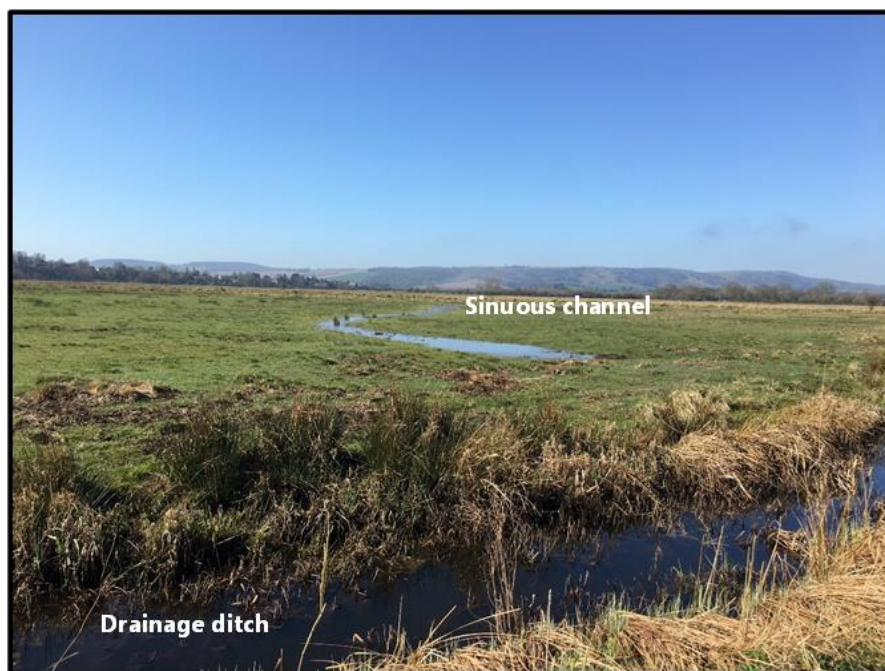
**Figure 24** An image showing an example of the current sinuous channel on the site, taken during fieldwork by surveyors.

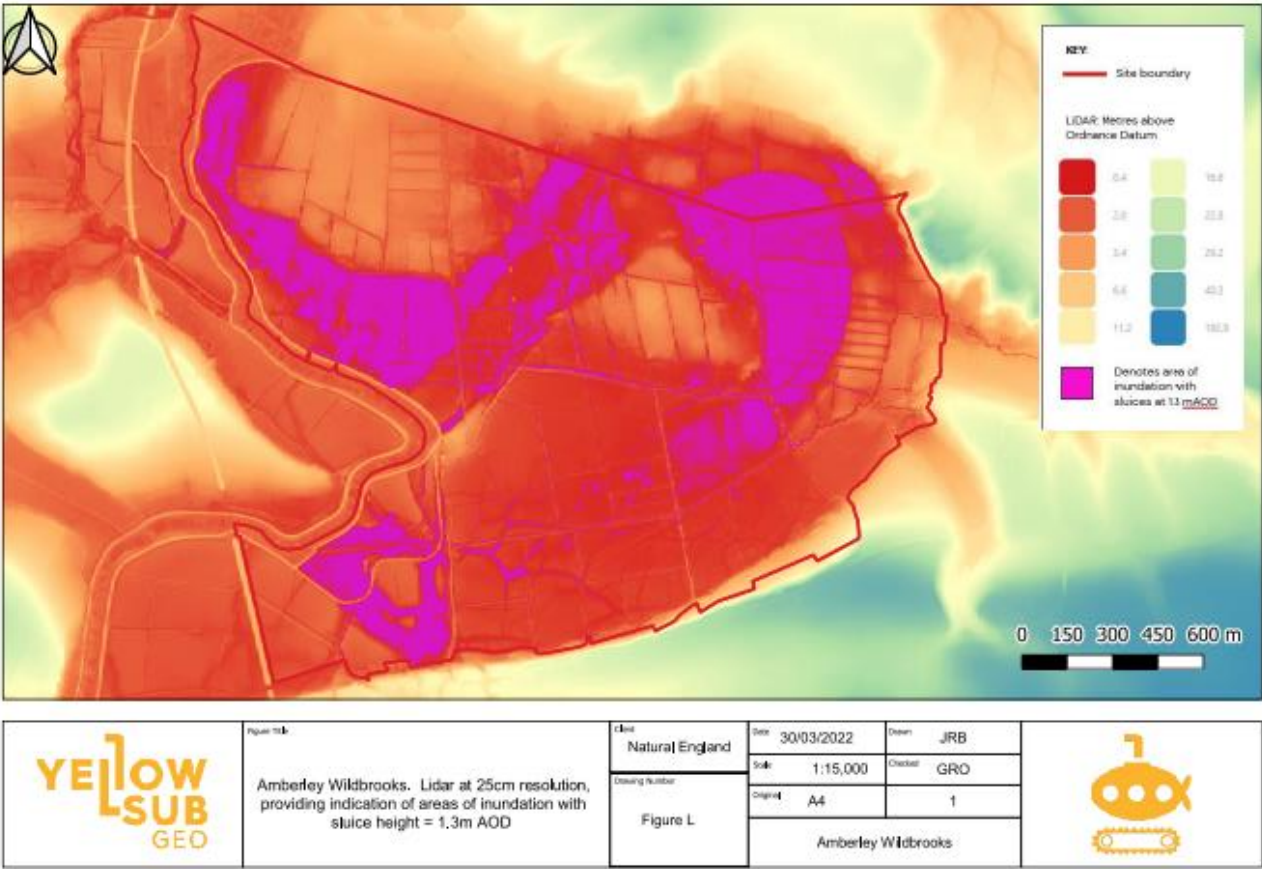
**Figure L – Amberley Wildbrooks. Lidar at 25cm resolution, providing indication of areas of inundation with sluice height = 1.3m AOD**

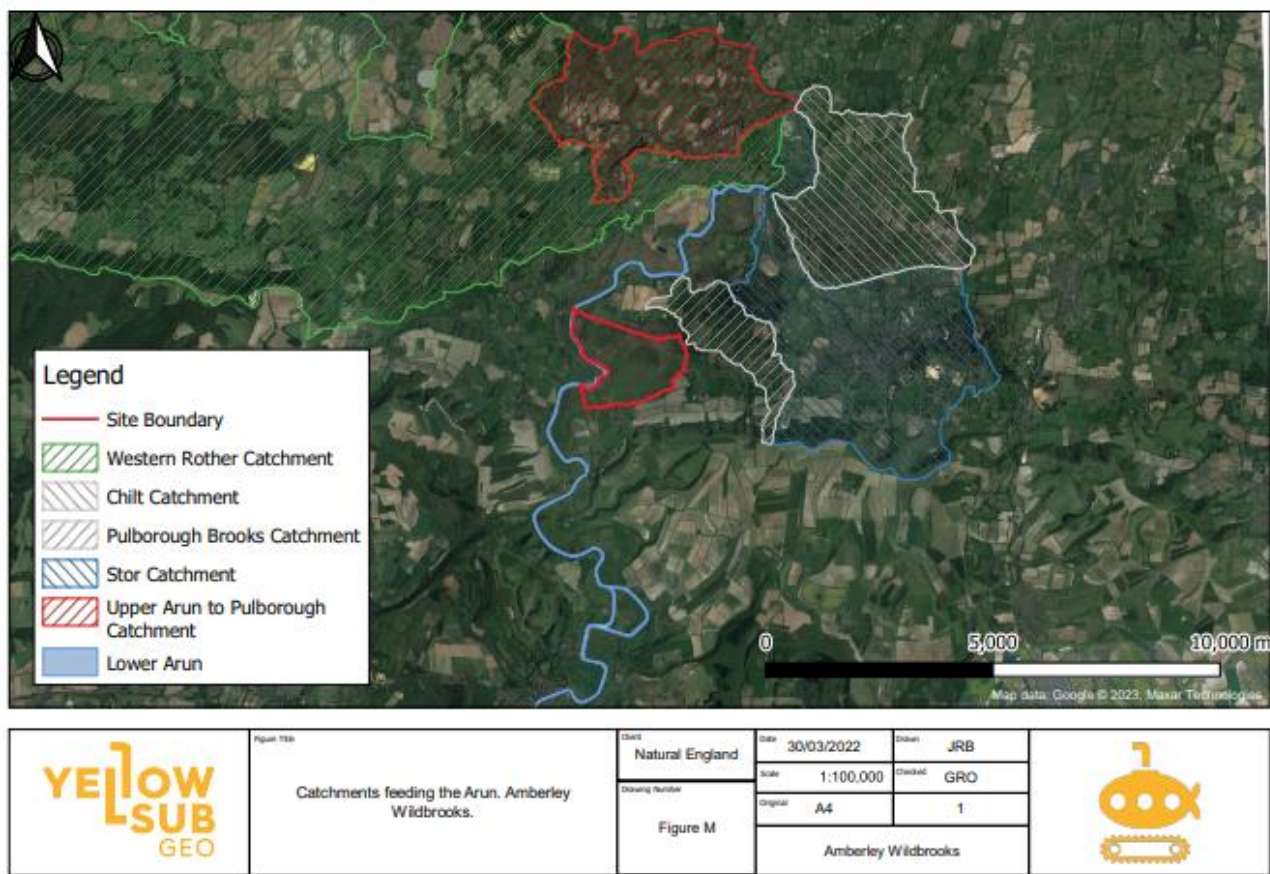
Figure M – Catchments feeding the Arun. Amberley Wildbrooks
