White-clawed Crayfish *Austropotamobius pallipes* Survey of the River Dove between Hollinsclough and Beresford Dale, Peak District National Park

Peak District Dales Special Area of Conservation (SAC)

'White-clawed Crayfish *Austropotamobius pallipes* Survey of the River Dove between Hollinsclough and Beresford Dale, Peak District National Park. July-September 2014'

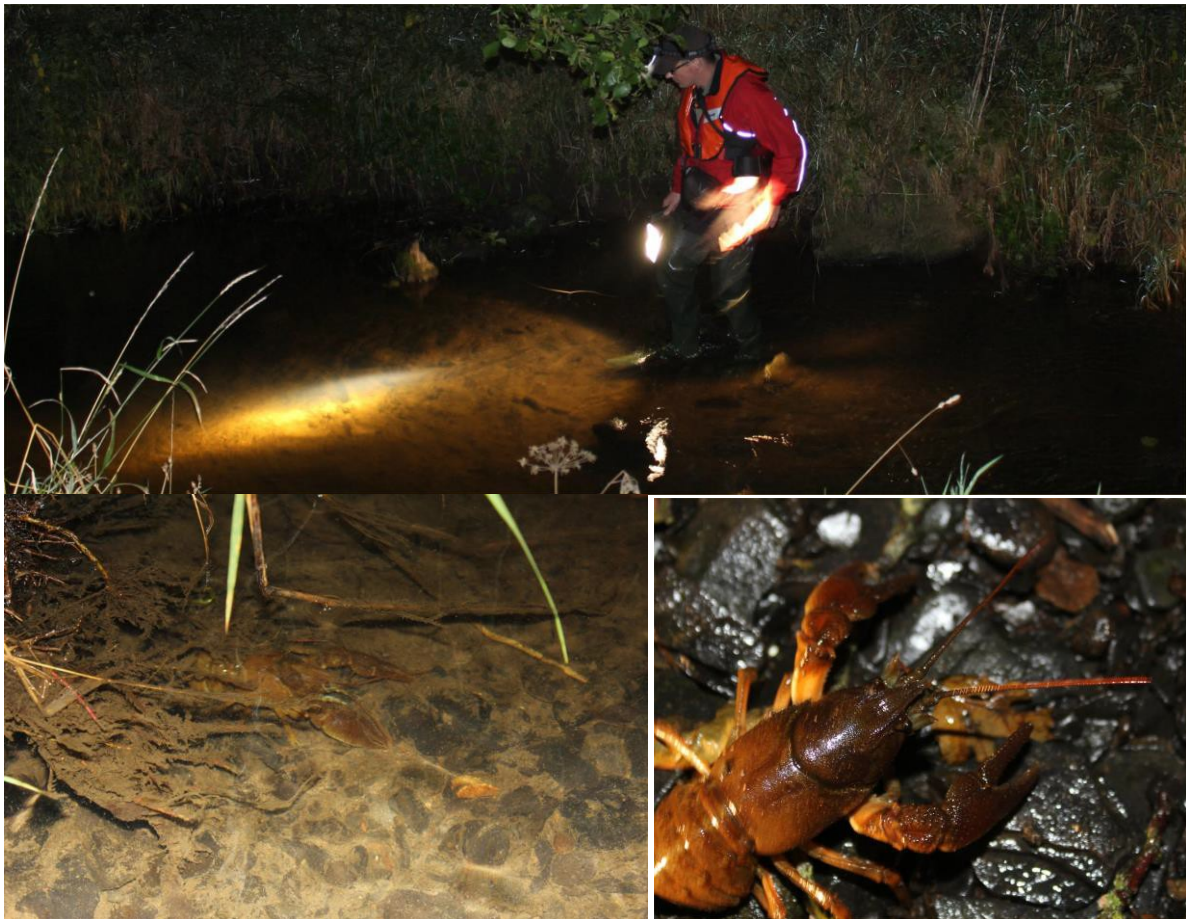
A single adult female White-clawed crayfish was recorded during the torching survey carried out at the Upper Whittle site on the 25th September 2014 (SK 11026 64257).

Images from the night-torching survey on the R.Dove at Upper Whitle Farm on 25th September 2014.

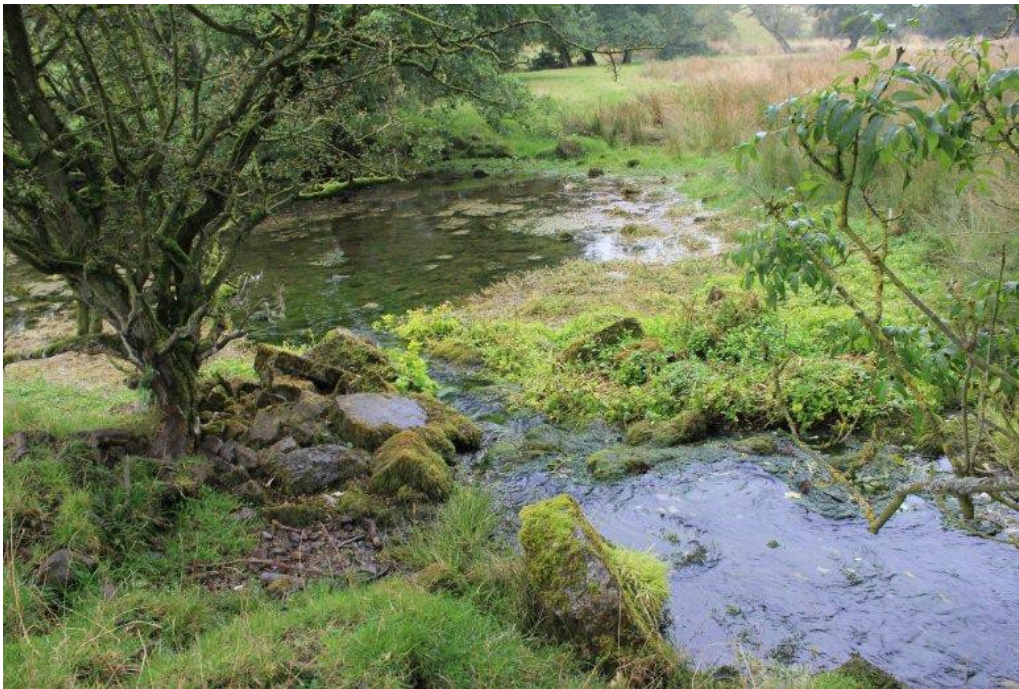
An underground stream emerging from the limestone to join the Dove near Sprink. These features provide additional high-quality habitat for white-claws as well as refuges from spates and pollution incidents. The area in the photograph was examined as a sub-site (an additional 250 refuges were searched).

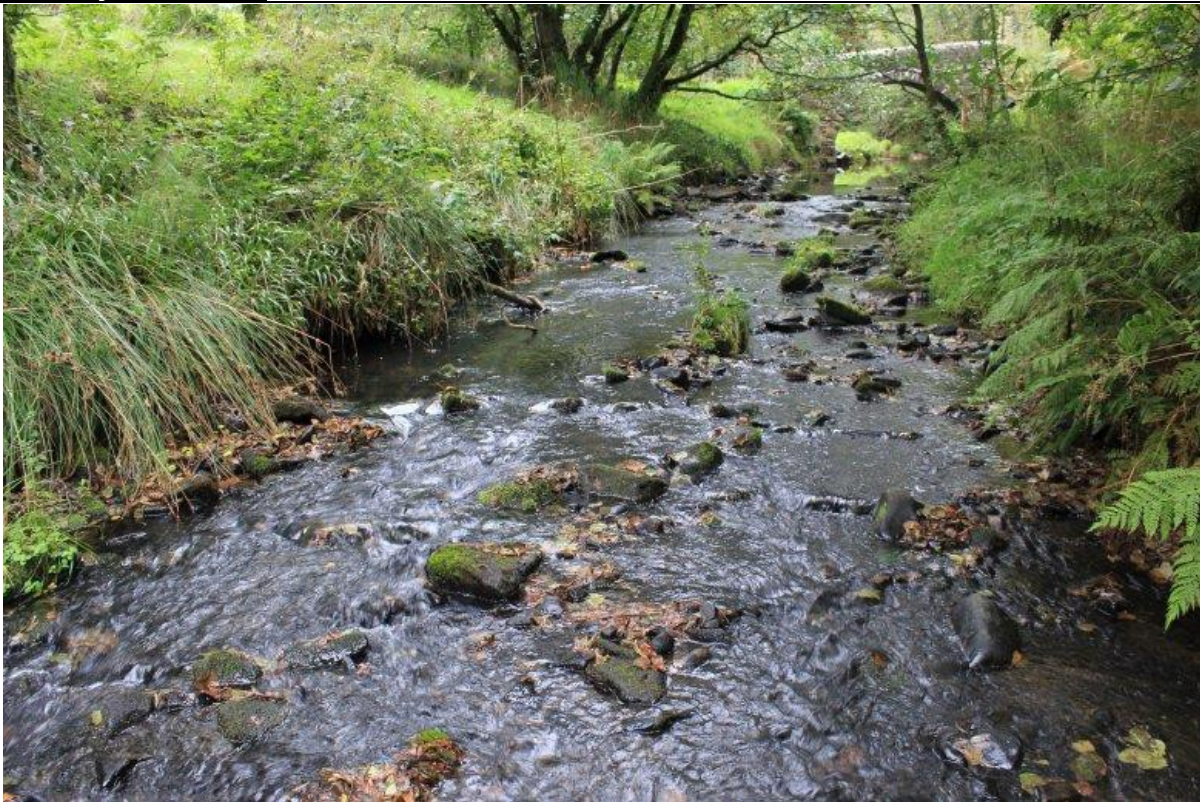
Site / Section	Hollinsclough, Section 1
Watercourse	R.Dove-Swallow Brook confluence
Date	25/09/2014
Grid Ref (Cent.)	SK 06550 66890
# refuges	250
Depth	0.10m-0.65m
Flow	Fast
Substrate	Bedrock 30%, Boulders 10%, Cobbles 55%, Gravels 1%, Sand/Mud/Silt 4%
Riparian Zone	Exposed Riverine Sediments (ERS), Ruderal vegetation, Deciduous Woodland, Mixed Woodland, Scrub
Comments	1 Stone Loach <i>Barbatula barbatula</i> was caught and >15 Bullhead <i>Cottus gobio</i> . Brown trout <i>Salmo trutta</i> , dipper and otter spraint (no crayfish remains) also observed.
<i>A.pallipes</i>	High potential suitability
Result	Negative
Survey methods	Hand net, Aquaviewer

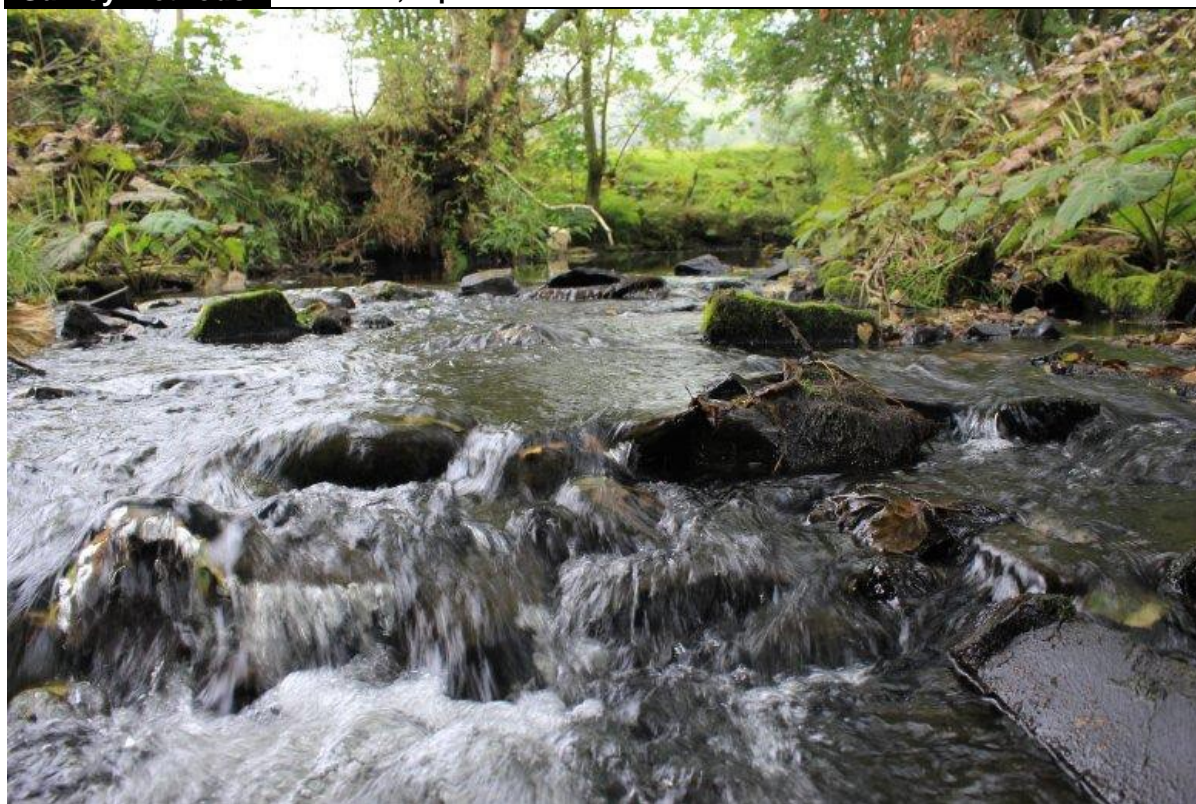
Site / Section	Glutton Bridge, Section 2
Watercourse	R.Dove
Date	25/09/2014
Depth	0.10m-0.50m
Grid Ref (Cent.)	SK 08500 66500
# refuges	250
Flow	Fast
Substrate	Bedrock 10%, Boulders 15%, Cobbles 70%, Gravels 0%, Sand/Mud/Silt 5%
Riparian Zone	Exposed Riverine Sediments (ERS), Ruderal vegetation, Deciduous Woodland, Scrub, Marshy grassland
Comments	2 Stone Loach <i>Barbatula barbatula</i> were caught and 13 Bullhead <i>Cottus gobio</i> . Brown trout and dipper also observed. A stand of Japanese Knotweed was also observed on the right bank at approximately SK 08538 66308. Some areas with livestock poaching.
<i>A.pallipes</i>	High potential suitability
Result	Negative.
Survey methods	Hand net, Aquaviewer

- **Control Japanese Knotweed.** It is recommended that the stand of Japanese Knotweed at Glutton Bridge be treated and monitored to ensure against future regrowth.

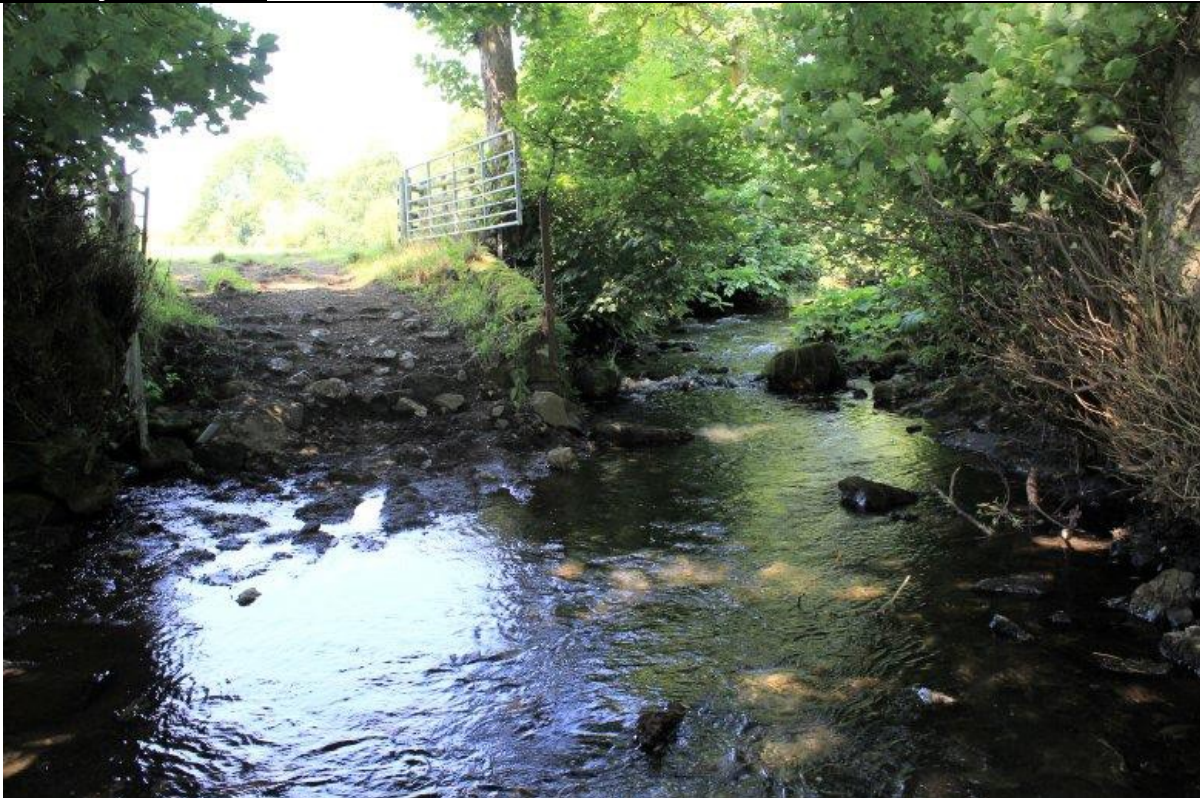
Site / Section	Crowdicote, Section 3
Watercourse	R.Dove
Date	13/07/2014
Grid ref (Cent.)	SK 10300 64710
# Refuges	50
Depth	0.10m-0.35m
Flow	Slow
Substrate	Bedrock 10%, Boulders 20%, Cobbles 65%, Gravels 0%, Clay 2%, Sand/Mud/Silt 3%
Riparian Zone	Exposed Riverine Sediments (ERS), Deciduous Woodland, Scrub,
Comments	9 Bullhead <i>Cottus gobio</i> . Major pathway for fine sediment run off (see photo below)
<i>A.pallipes</i>	High potential suitability
Result	Negative.
Survey methods	Hand net

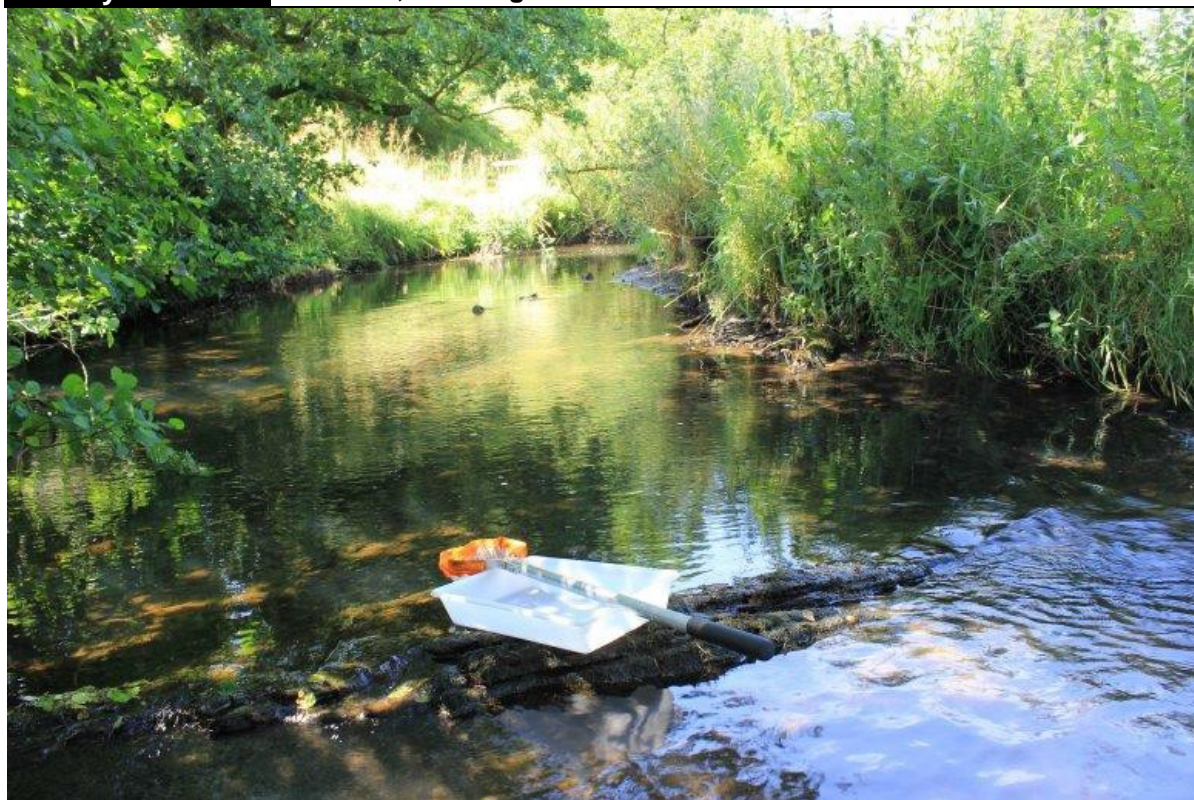
Site / Section	Upper Whittle, Section 4
Watercourse	R.Dove
Date	13/07/2014 & 25/07/2014
Grid ref (Cent.)	SK 10934 64336
# Refuges	250
Depth	0.10m-1.5m
Flow	Slow
Substrate	Bedrock 30%, Boulders 5%, Cobbles 55%, Gravels 5%, Mud/Silt 5%
Riparian Zone	Exposed Riverine Sediments (ERS), Deciduous Woodland, Scrub, SI grassland
Comments	Previous positive: June 2014. Bullhead <i>Cottus gobio</i> . Brown Trout <i>Salmo trutta</i> . Tawny owl. Daubenton's bat.
<i>A.pallipes</i>	High potential suitability
Result	Positive on 25/07/2014 (Torching). 1 adult female (carapace length approximately 38-40mm) at SK 11026 64257.
Survey methods	Hand net, Torching

- **Biosecurity.** This is the most important issue to address in order to protect the small, surviving native crayfish population at Upper Whittle. Raised awareness and disinfection routines need to be promoted to anglers and other visitors to the river. The priority are angling clubs that have beats on other watercourses within known areas for American signal crayfish (e.g.s. the Leek & District Fly Fishing Association who fish 'signal crayfish' sections of the River Hamps, the Bentley Brook and the River Churnet and who also fish the Dove at Dovedale). The Check, Clean, Dry campaign is a good introduction to this subject <http://www.nonnativespecies.org/checkcleandry/biosecurity-for-anglers.cfm>, but is recommended that more direct biosecurity measures are discussed directly with these clubs including talks and advice via site visits. Biosecurity measures can also be written in as conditions to the fishing tenancy agreements. Updated 'management accords' with clubs and landowners should also be investigated.

- **Further surveys.** It is recommended that a re-survey of the Upper Whittle Farm site reach be carried out in 2015 (July-September).
- **Habitat work.** The torching survey at the Upper Whittle Farm demonstrated that the river channel at night is dominated by predatory brown trout and that native crayfish would need to restrict their foraging movements to the cover of submerged roots and in-channel woody debris. Unfortunately, a lack of woody debris was observed throughout the upper Dove. In order to bolster the surviving white-claw population, it is recommended that significant amounts of woody debris are introduced to the channel. Techniques include the 'chopping & dropping' sycamores and multi-stemmed alders, hinging appropriate stems into channel, introducing root plates (from a biosecure source) as key pieces and 'wood traps'. These techniques are also beneficial to brook lampreys and a number of Red Data Book invertebrates. Benefits should also be afforded for natural sediment trapping and processing, the sorting of gravels, Natural Flood Management (through increased 'roughness' which slows flows to increase the overall 'journey time' of water), cooler water and overall water quality. Further information about these techniques and benefits can be found here:

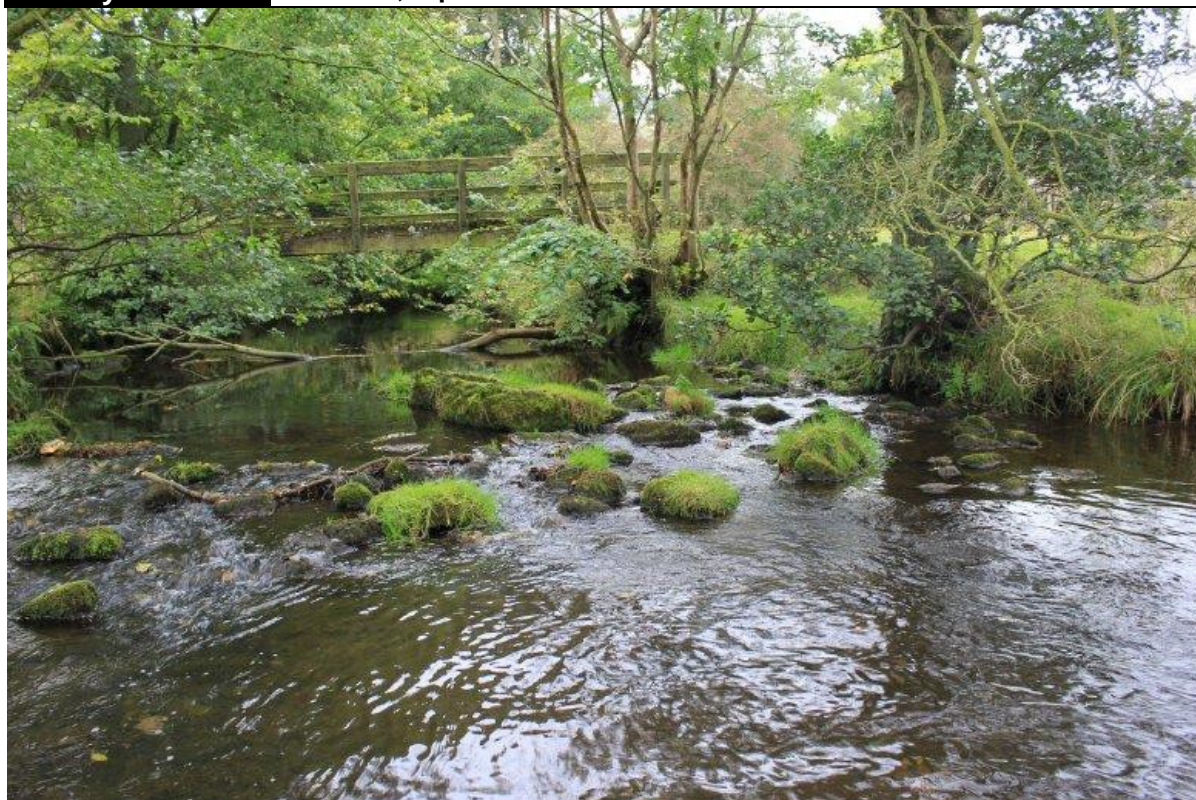
Site / Section	Pilsbury, Section 5
Watercourse	Upper Leek Brook trib.
Grid ref (Cent.)	SK 11603 63263
# Refuges	250
Date	25/07/2014
Depth	0.10m-0.80m
Flow	Slow-Fast
Substrate	Bedrock 30%, Boulders 15%, Cobbles 45%, Gravels 2%, Sand/Mud/Silt 8%
Riparian Zone	Exposed Riverine Sediments (ERS), Ruderal vegetation, Deciduous Woodland, Scrub, Marshy grassland
Comments	1 Stone Loach <i>Barbatula barbatula</i> were caught and >10 Bullhead <i>Cottus gobio</i> . 2 dippers, Otter spraint (no crayfish remains).
<i>A.pallipes</i>	High potential suitability
Result	Negative.
Survey methods	Hand net, Aquaviewer

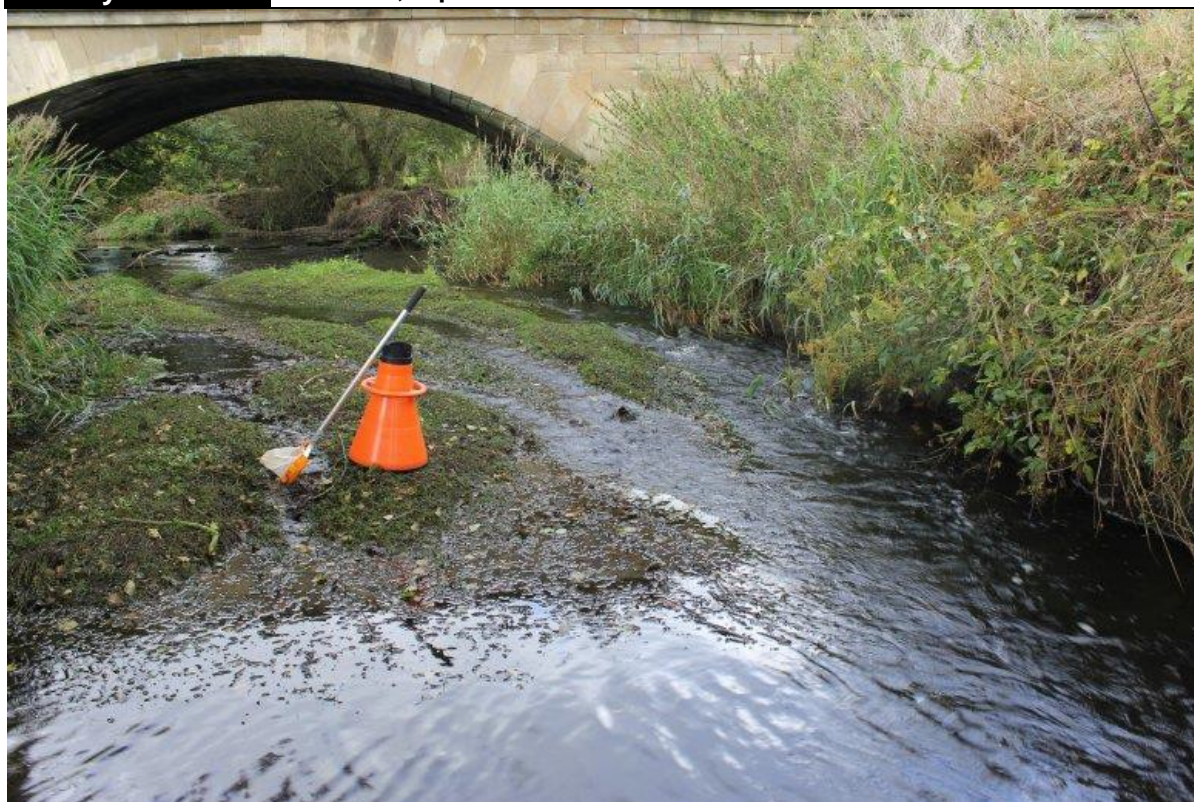
Site / Section	Hartington Bridge, Section 7
Watercourse	R.Dove
Date	26/09/2014
Grid ref (Cent.)	SK 12081 59795
# Refuges	50
Depth	0.10m-0.80m
Flow	Slow-Fast
Substrate	Boulders 15%, Cobbles 35%, Gravels 35%, Sand/Mud/Silt 15%
Riparian Zone	Exposed Riverine Sediments (ERS), Ruderal vegetation, Deciduous Woodland, Scrub
Comments	A pollution incident was reported to the Environment Agency (EA incident Ref # 01281585) involving a cracked, leaking soakaway from a private residence. Otter spraint (recent & old- no crayfish remains observed).
<i>A.pallipes</i>	Good potential suitability
Result	Negative.
Survey methods	Hand net, Aquaviewer

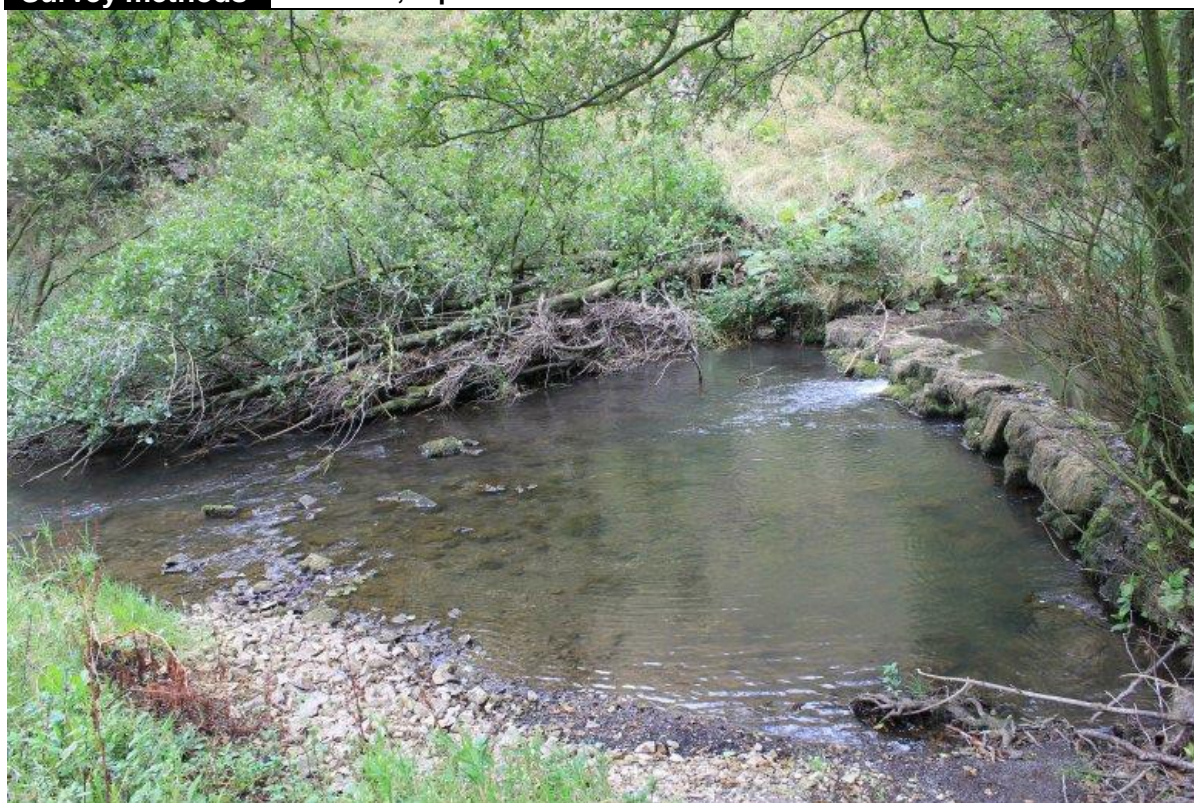
Site / Section	Beresford-Upper Wolfscote Dale, Section 9
Watercourse	R.Dove
Date	26/09/2014
Grid ref (Cent.)	SK 13299 57986
# Refuges	50
Depth	0.10m-0.95m
Flow	Sluggish-Fast
Substrate	Bedrock 8%, Boulders 15%, Cobbles 75%, Gravels 0%, Sand/Mud/Silt 2%
Riparian Zone	Exposed Riverine Sediments, Deciduous Woodland, Scrub, Limestone grassland, Marshy grassland
Comments	>10 Bullhead <i>Cottus gobio</i> . Brown Trout <i>Salmo trutta</i>
<i>A.pallipes</i>	High potential suitability
Result	Negative.
Survey methods	Hand net, Aquaviewer
