Diversion of field and road run-off

Great Cressingham Fen

Little Ouse (Thetford) Catchment (10) *CSFO: Eric Popp*

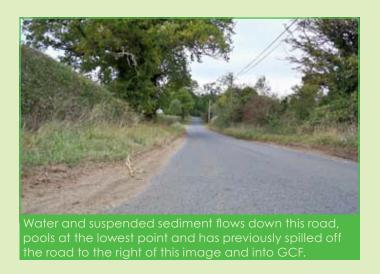
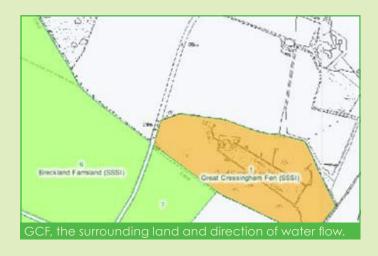
In times of heavy or prolonged rainfall, water runs off the fields bordering the road. It flows down the road and roadside drainage ditches, pools at the lowest point on the Estate side and then spills over the road into the fen.

This process has previously flushed quantities of nutrient rich soil sediment into the fen. Over time, this could potentially alter the soil chemistry and delicate balance of plant communities found within the Fen.

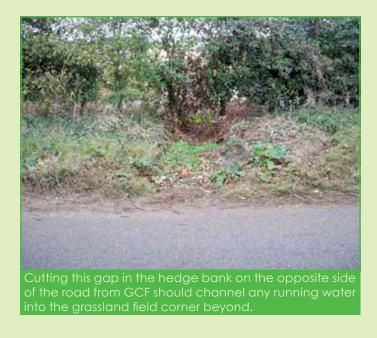
The road bank modification was a quick and inexpensive task. The work was done by South Pickenham Estate several months ago [Photo 2] at no cost to CSF. Through involvement in this project the Estate have strengthened their ties with NE and Catchment Sensitive Farming and significantly improved the chances of the Great Cressingham Fen SSSI moving into improving condition. The Fen owner was not directly involved, but is known to take a keen interest in the environmental health of the site.

After discussing the problems, it was decided that a quick and appropriate solution to help prevent future road wash incidents would be to cut a channel through the hedge bank on the Estate side of the road. This would allow water running down the road and that already in the roadside ditch, to flow away from the fen and into the grassland field corner.
