Morecambe Bay SAC Subtidal Cobble and Boulder Skear Communities Drop-down Video Survey

Final Report

Natural England Commissioned Report NECR394

Seastar Survey Ltd. Project Number - J/14/411

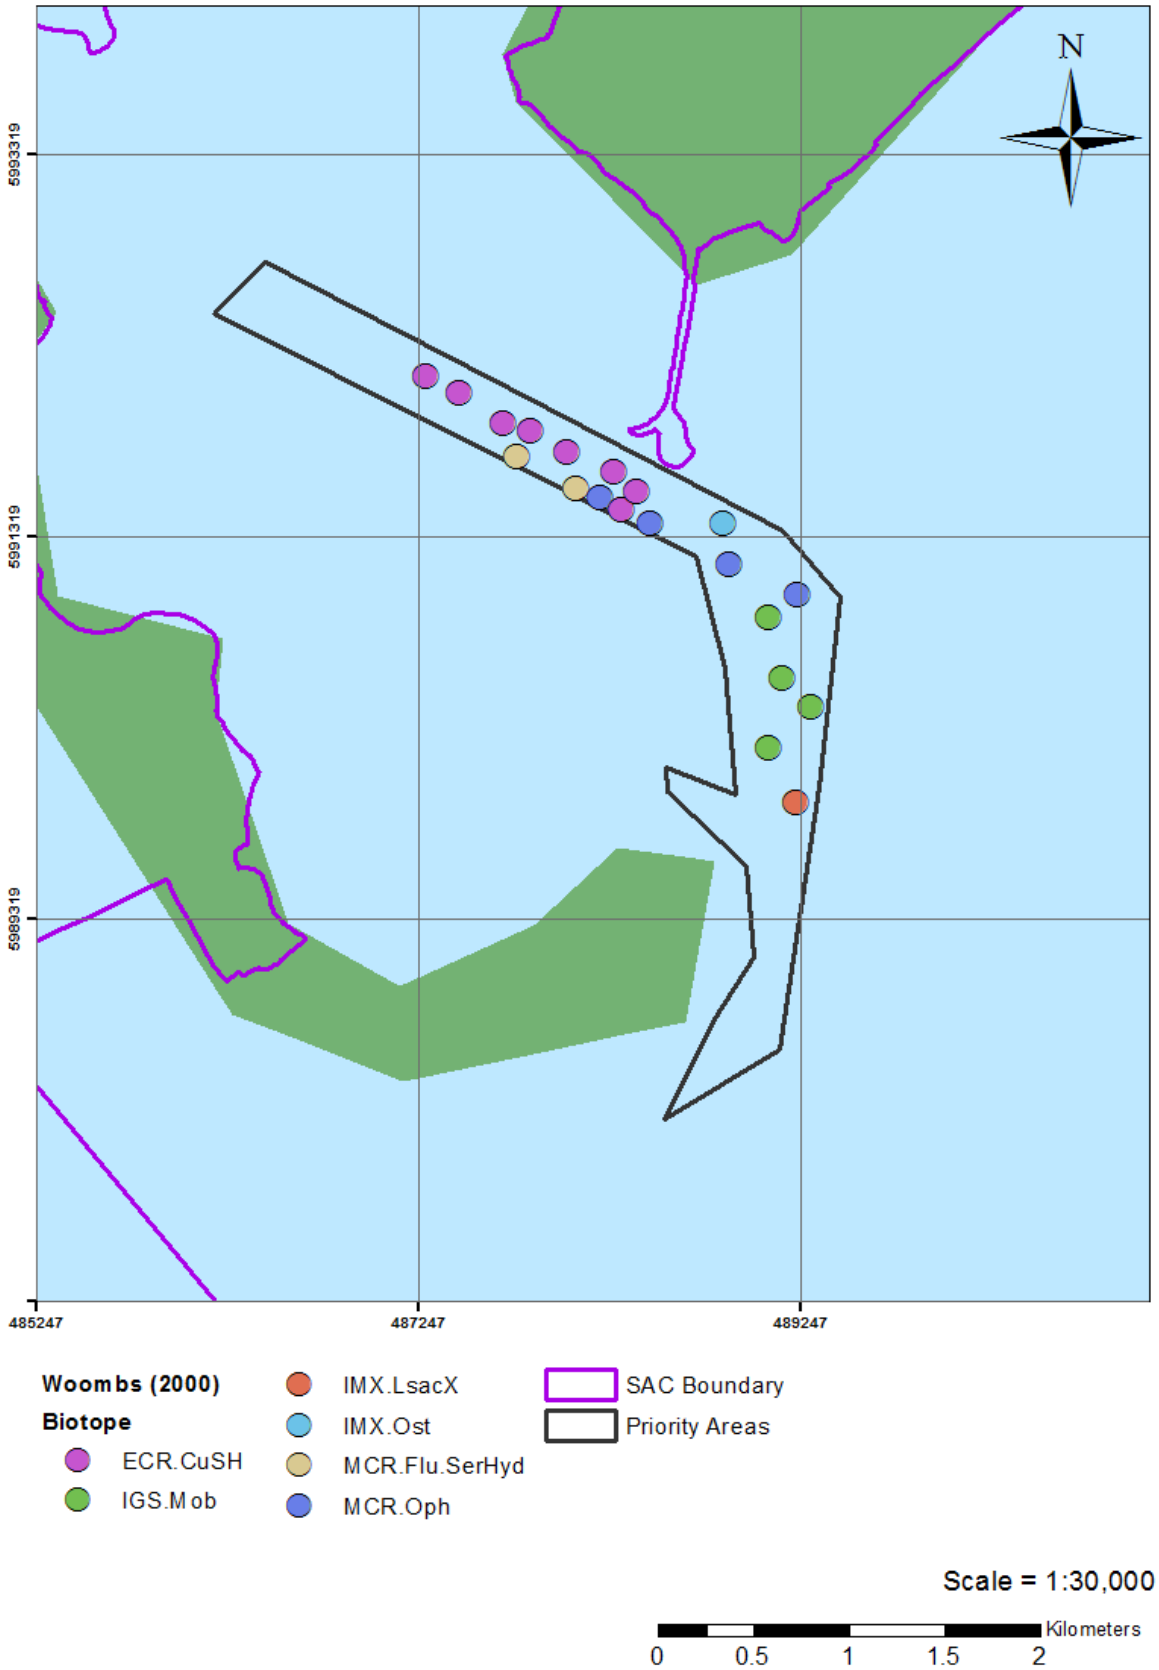
Figure 1.6: Sampling locations and general results of the survey conducted by Woombs (2000) in the Walney Channel

The seabed within the Morecambe Bay SAC is dominated by sedimentary infaunal communities, similar to those found in the wider Irish Sea region, with a low species diversity and corresponding high biomass (Irving *et al.*, 1996). Previous studies of the subtidal communities within the SAC have been limited in success or in extent. The results of three major surveys conducted within the SAC are shown in Figures 1.5 and 1.6.

Surveys not illustrated in Figures 1.5 and 1.6 include a survey conducted by Envision Mapping Ltd. in 2008 (Envision Ltd., 2008), which involved the acquisition of drop-down video, sediment sampling and Acoustic Ground Discrimination System (ADGS) work in the waters adjacent to the Morecambe Bay SAC. The results of this survey indicate that the sediments closest to the SAC are primarily composed of muddy sands.
