Natural England Commissioned Report NECR140

# New Forest SSSI Geomorphological Survey Overview

First published 06 March 2014

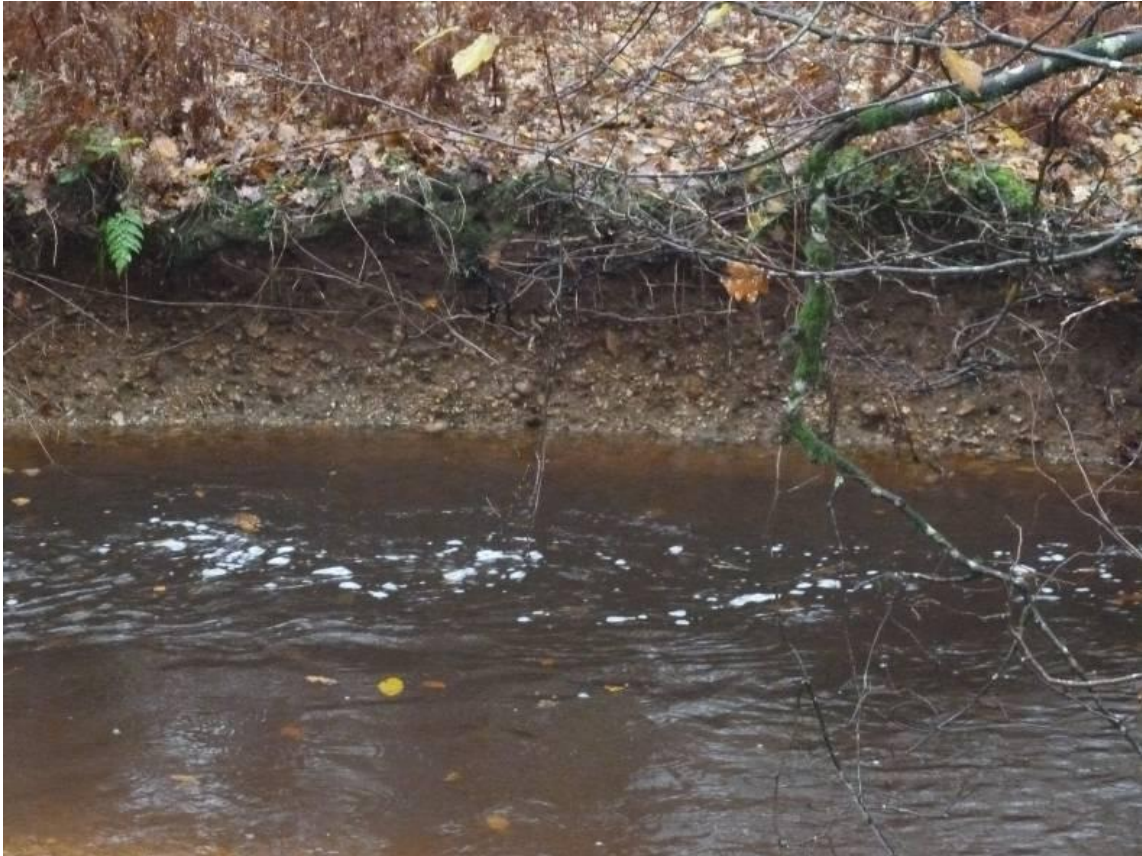
**Figure 4-1: Local Gravel Supply**

Most of the single thread river / stream sections are active, particularly the wandering sections which are capable of moving significant amounts of gravel during elevated flows. Gravel supply is often from local bank and in-channel sources combined with significant upstream supply (Figure 4-1).

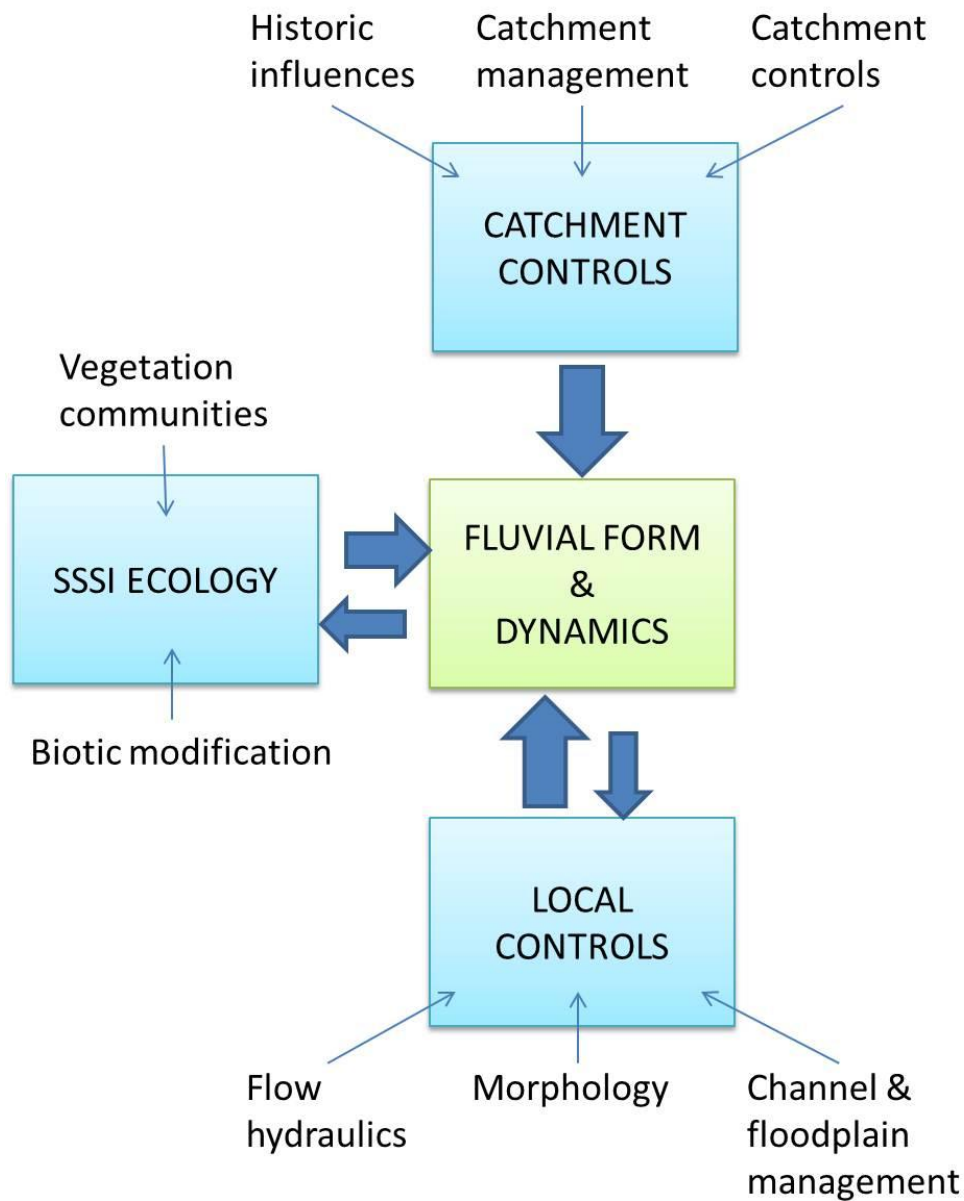
**Figure 4-2: Principal controls on the character and dynamics of the New Forest Geomorphological Assessment Areas**

As such it is vital in this study to identify the process – behaviour linkages present in the catchment, identifying the controls on sediment movement and associated sedimentation and erosion along the watercourses (Figure 4-2).

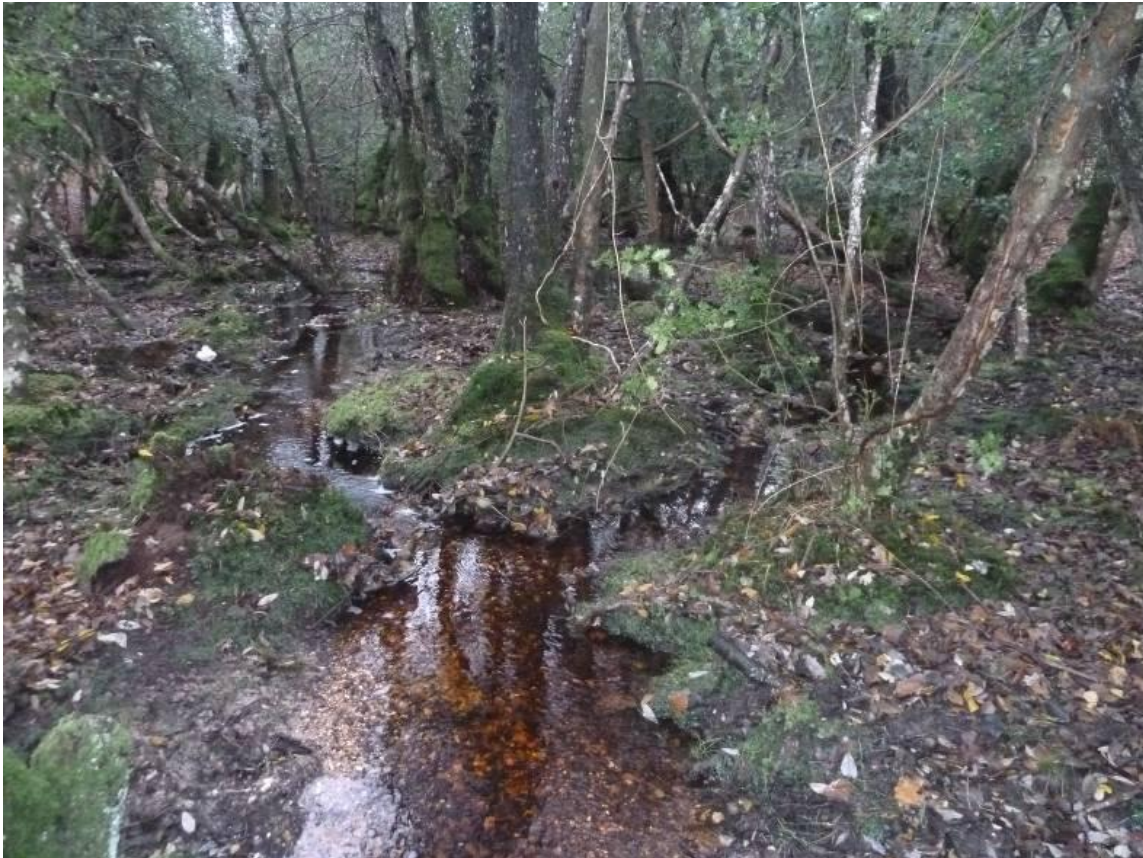
**Figure 4-3: Anastomosed river type within the New Forest SSSI**

Lowland anastomosed reaches are often lower energy with a shallow gradient multi-thread channel network split by stable islands (often in the form of trees) and bars (Figure 4-3). The channel bed is often a mixture of gravels and fine sediments. The connectivity to the floodplain is good in these sections and is set in a wider valley. Some channels are activated at varying flow levels, with some dry during low flow levels. The formation is sometimes assisted by impoundment created by natural woody debris jams (live or dead). This river type has often been used as a target typology for some of the SSSI units as part of the restoration plan, as anastomosed networks are likely to be the natural river type for many of the streams visited, this is also discussed in the literature review, section 3.3.

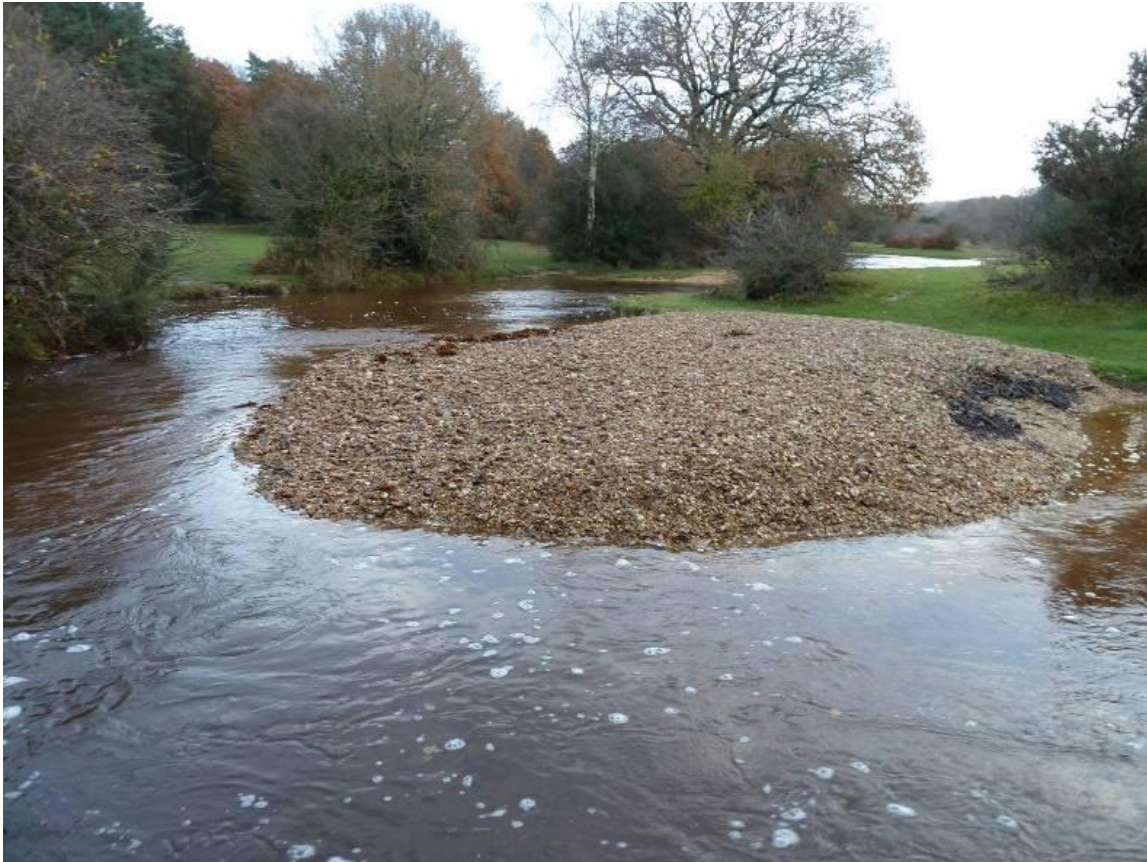
**Figure 4-4: Wandering river type within the New Forest SSSI**

Wandering reaches are characterised by a moderately steep gradient and by extensive gravelly deposits and active lateral movement. The channel is set in a wider valley but is often over-deep due to gravel removal / dredging and fluvial incision linked partly to the confinement of flood flows within over-deepened channels. The river is characterised by large gravel bars (point, mid and lateral) with occasional plane bed reaches and deeper pools (Figure 4-4).

Lateral movement is strong but localised and is intrinsically linked to bar deposition.

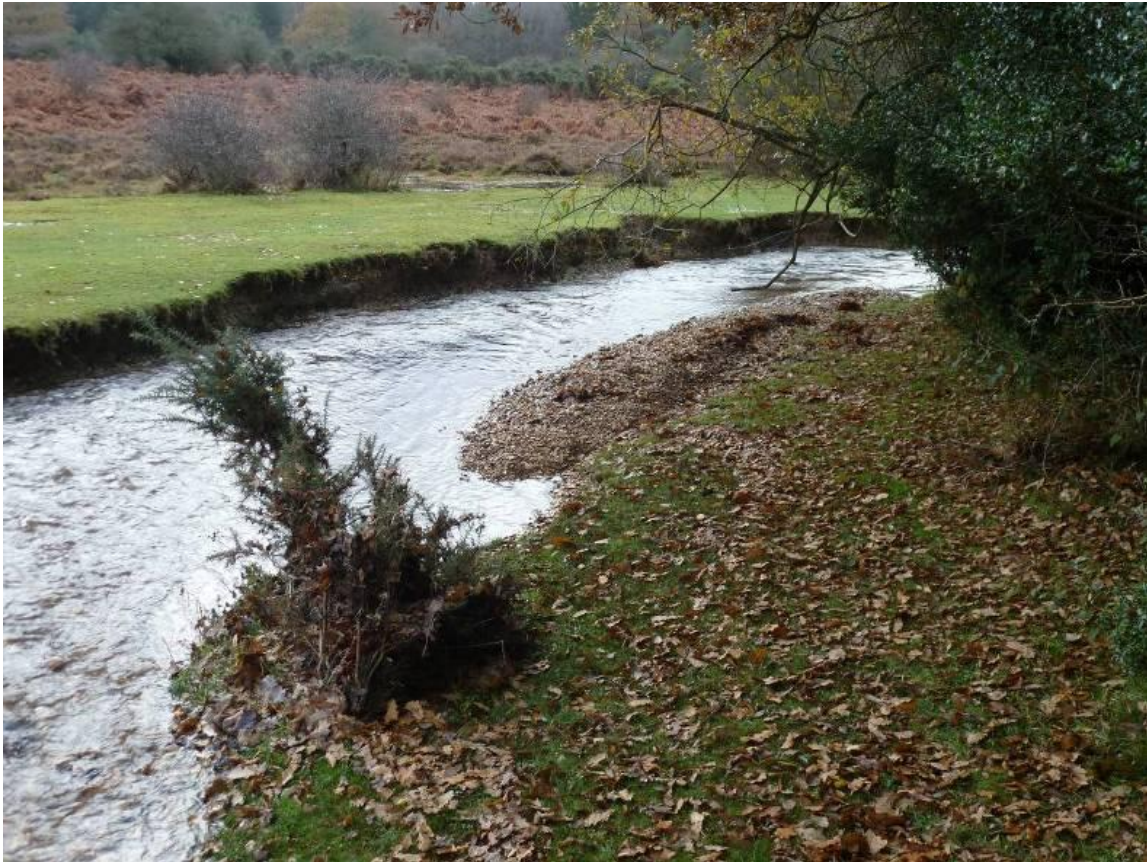
**Figure 4-5: Active single thread river type within the New Forest SSSI**

This river type is less steep and is characterised by a gravelly bed, with a weakened gravel supply compared to the wandering river type. The channel is set in a wider valley but is often over-deep due to gravel removal / dredging and fluvial incision linked partly to the confinement of flood flows within over-deepened channels. The river displays stable riffle pool sequences with occasional plane bed reaches, point bars and lateral bars (Figure 4-5).

Lateral movement is restricted due to the reduced gravel presence and the reduced fluvial energy through these reaches and due to the presence of more resistant boulder clays in the banks rather than fluvio-glacial gravels, or where riparian woody vegetation is dense enough to provide a coherent resistant root mat.

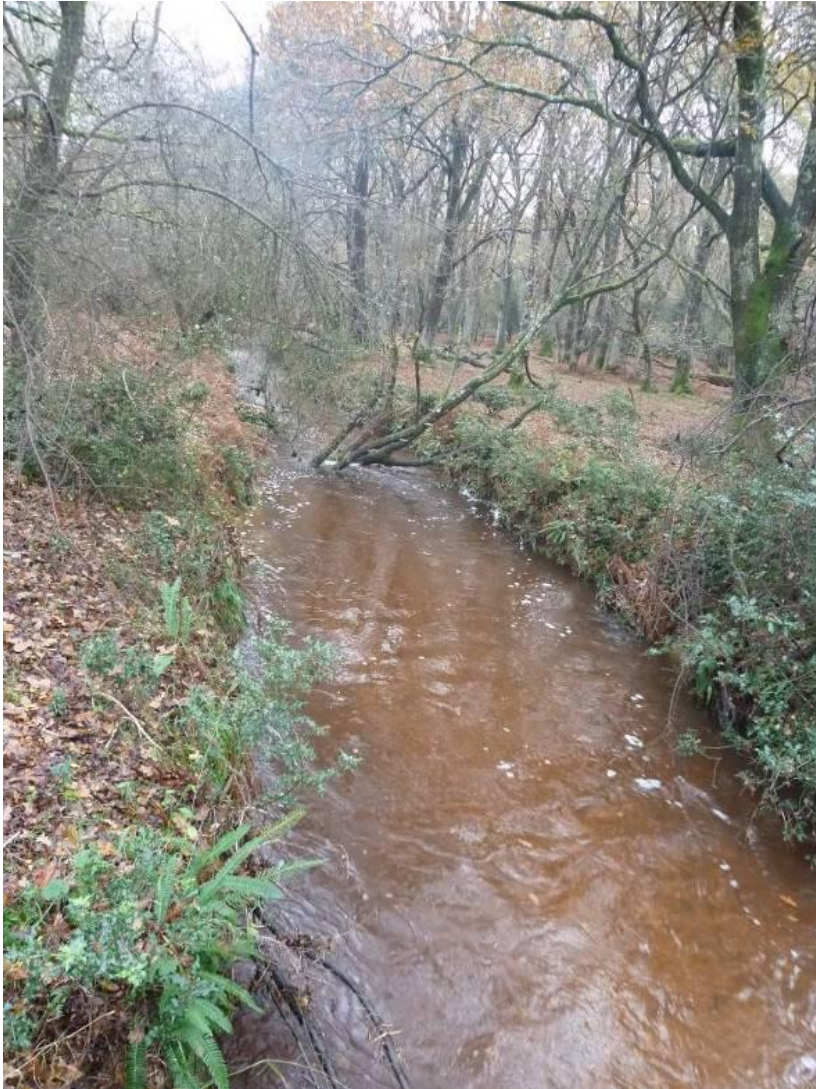
Figure 4-6: Passive single thread river type within the New Forest SSSI

This river type is less steep than active single thread and is characterised by a mixed gravel and fine sediment bed (Figure 4-6). The channel is set in a wider valley but is often over-deep due to gravel removal / dredging and fluvial incision linked partly to the confinement of flood flows within over-deepened channels. Where bar deposits are present, these are poorly formed and flow types are dominated by glides with some runs. Lateral erosion is limited and where bank collapse has occurred, this is often a response to incision.

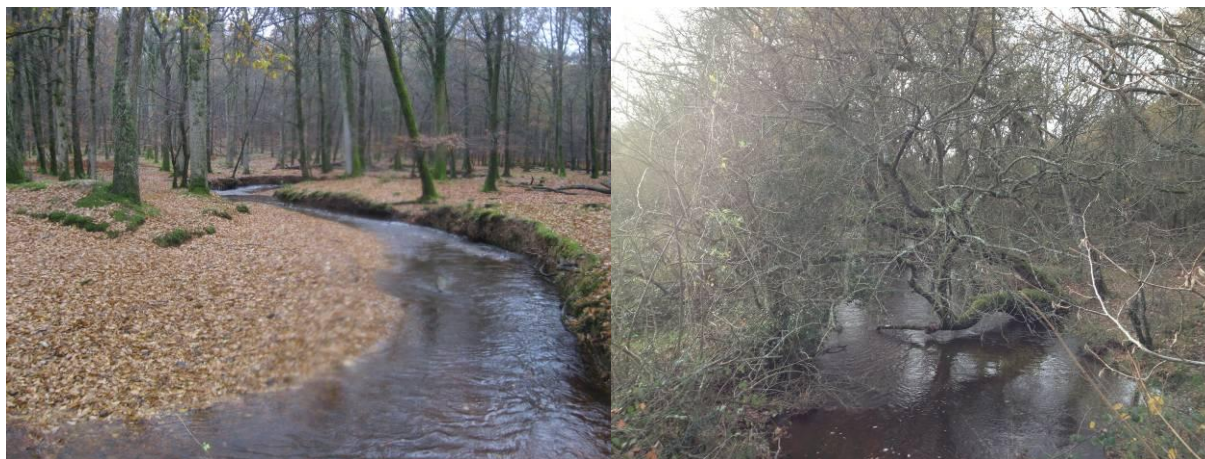
Being located in woodland areas these anastomosed watercourses were generally very shaded and contained significant quantities of leaf litter (Figure 4-7). As a result of the shading, aquatic macrophyte diversity was generally poor. Where the canopy was more open, species-richness increased, with patches of Floating Sweet-grass and Bog Pondweed abundant, with occasional Stream Water-crowfoot *Ranunculus pencillatus* ssp. *pencillatus*, Fool's Water-cress *Apium nodiflorum* and Water Forget-me-not *Myosotis scorpioides*. The riparian habitat of these more open areas was often heavily grazed and had a marshy grassland, closely cropped sward.

**Figure 4-7: Woodland streams in Islands Thorn/Amberwood (left) and Linford Bottom (right)**

The wandering, active single thread and passive single thread river types were much less habitat specific, being variably recorded in both woodland and mire/heathland habitats. Where wandering, active or passive single thread watercourses were present within woodland areas the riparian habitat tended to be consistent in nature with the surrounding woodland habitat (Figure 4-7), predominantly being Oak and Beech *Fagus sylvatica* dominated pasture woodland, with an understorey of Holly. Although in places more wet woodland types were present with Alder and Grey Willow. Several of the watercourses, of all these types, also flowed through areas of plantation woodland (e.g. Amberwood/Alderhill). Again, due to the shading, aquatic macrophyte diversity was generally poor within these woodland watercourses.

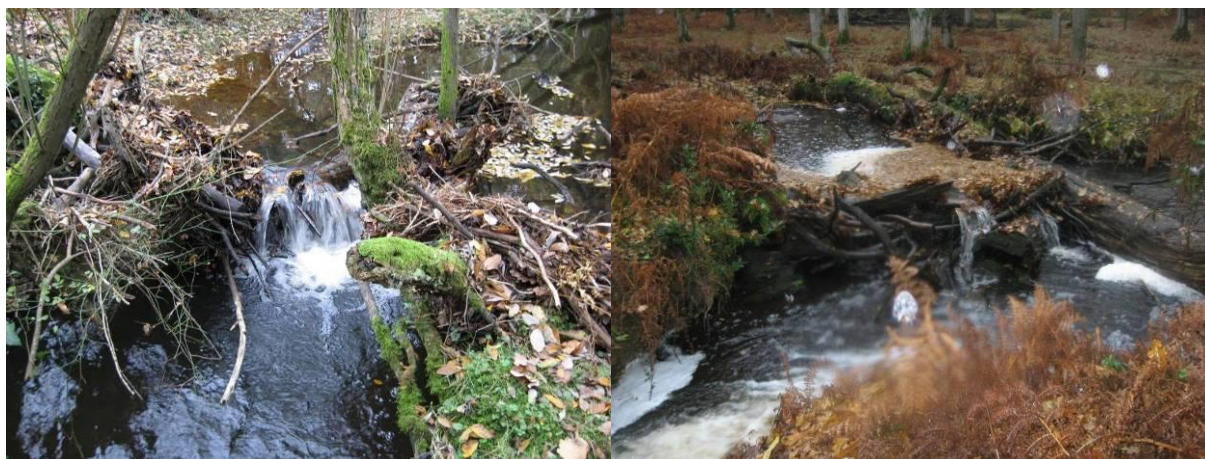
**Figure 4-8: Debris Jams in Dockens Water Woods (left) and Amberwood/Alderhill (right)**

Along the woodland watercourses, of all types but primarily the lowland anastomosed channels, coarse woody debris jams were a key feature (Figure 4-8). In many cases these had a localised impact on the geomorphology of the stream and consequently created additional micro-habitats of interest.

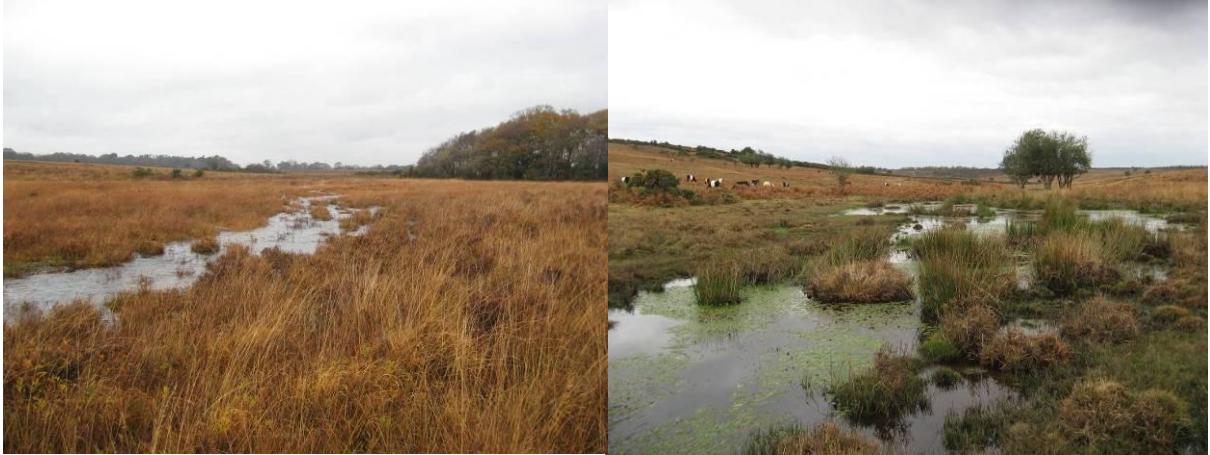
**Figure 4-9: Mire/Heathland streams in Black Gutter Bottom (left) and Cowleys Heath Central (right)**

The streams within the more open, heathland and mire dominated units were generally of the wandering, active single thread or passive single thread type and showed an increased abundance of aquatic macrophytes in comparison with the woodland streams (Figure 4-9). This was particularly the case where the watercourses were shallower overland flow features, yet to become a distinct single thread feature. Creeping St. John's-wort and Bog Pondweed were the most dominant species, often present in very extensive patches. Other species recorded included Fennel Pondweed *Potamogeton pectinatus*, water-starwort species *Callitriche* sp., Purple Moor-grass tussocks and Floating Sweet-grass.

The riparian habitats of these mire/heathland streams were often varied, with grazed marshy grassland, wet heath and valley mire habitats the most frequent. The wet heath habitats tended to be dominated by Cross-leaved Heath and Purple Moor-grass, with some Heather, whereas the valley mire habitats were much more Purple Moor-grass dominated (Figure 4-9).

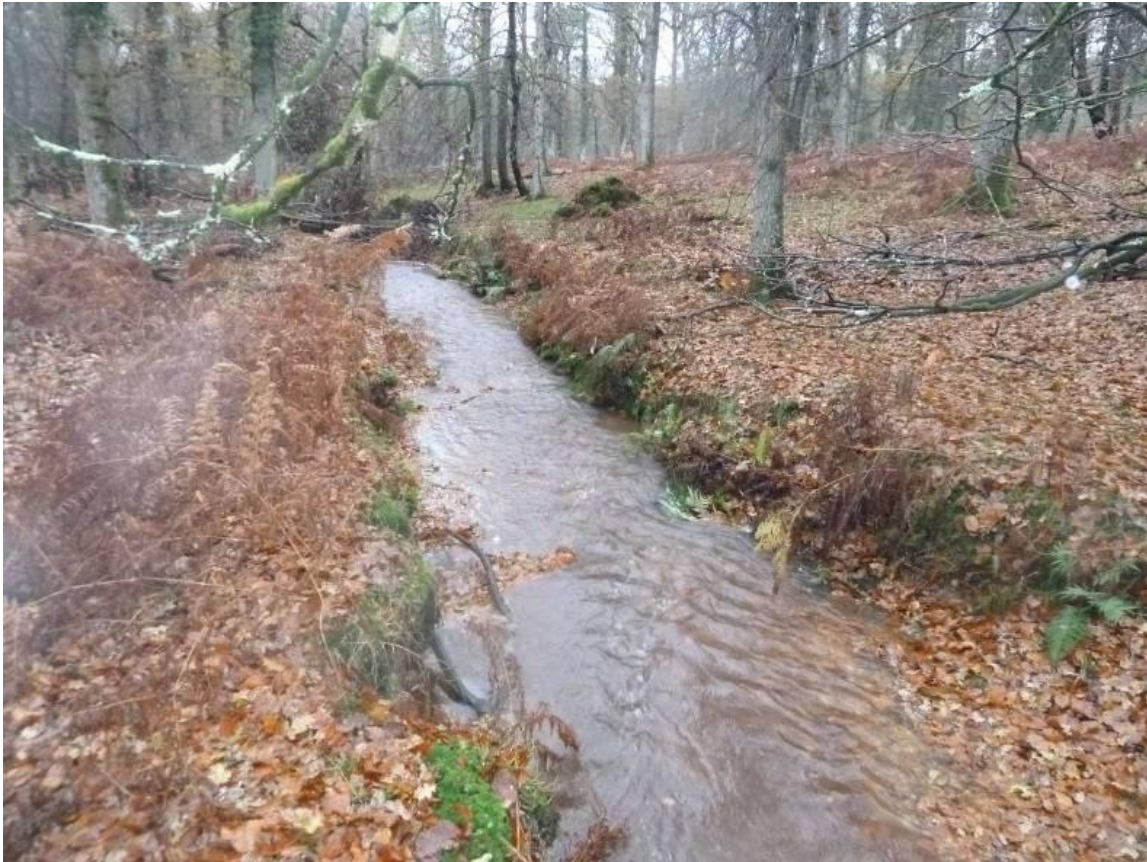
**Figure 4-10: Example of significant channel straightening within the New Forest**

Many of the watercourses within the Geomorphological Assessment Areas displayed evidence of straightening (Figure 4-10) during the survey with various palaeo-channels identified. These have also been identified in aerial photography and from the LiDAR. Areas may have responded by cutting down into the bed rather than by eroding laterally, particularly where bank cohesion is strong. Often the straightening occurred to maximise utilisable land in the valley bottom, creating a channel following one edge of the valley bottom and infilling or cutting of the original channel.

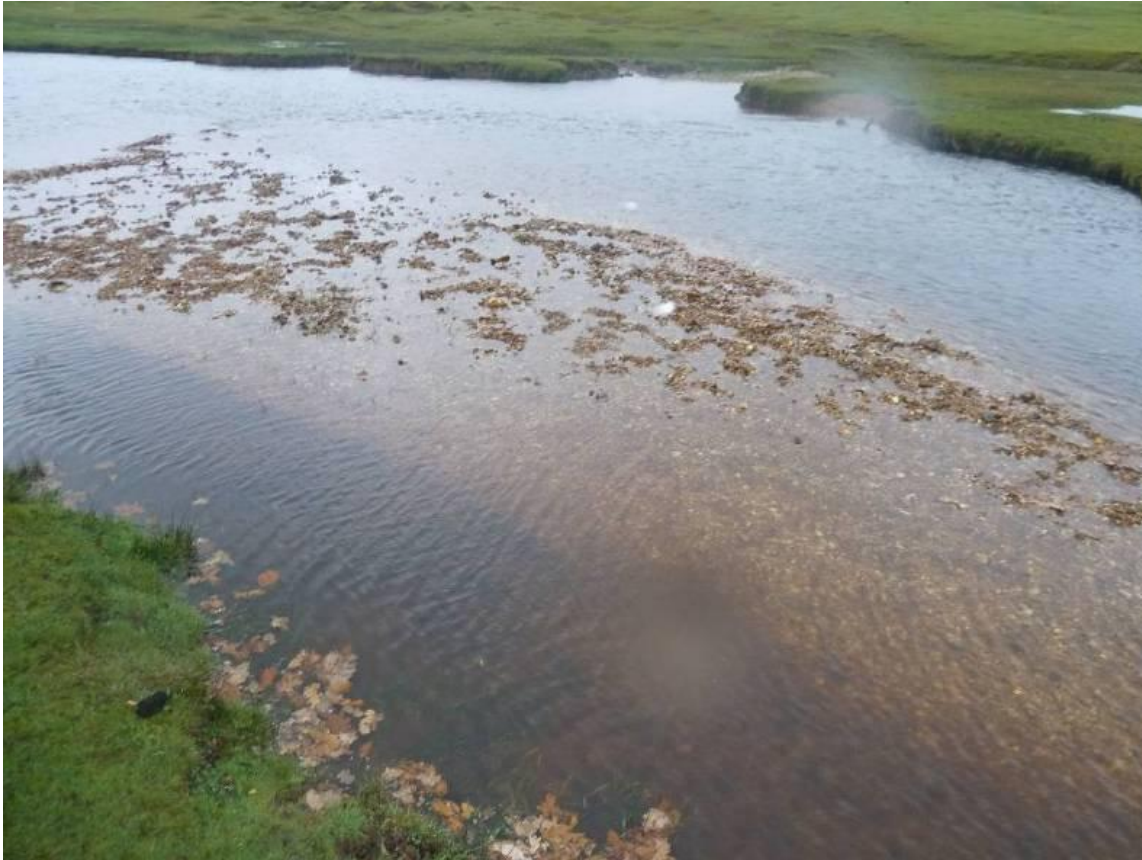
**Figure 4-11: Gravel bed recovery**

There is significant evidence of gravel removal and dredging within the main channels and in the drainage networks throughout the New Forest, which was mostly undertaken to lower the water table locally, improve capacity and reduce floodplain wetting (associated to commoning). Where this is no longer regularly occurring, gravel features are returning (Figure 4-11) and deposition alongside bank erosion can be seen in numerous locations.

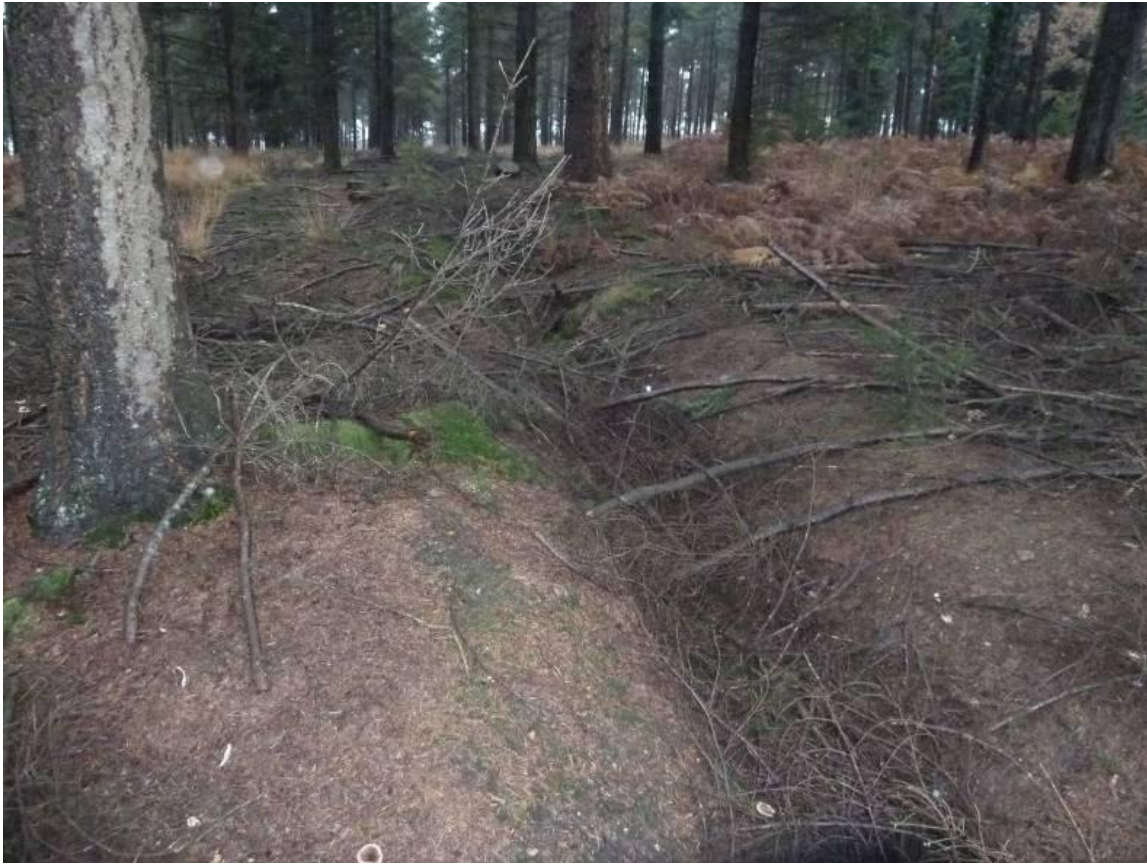
**Figure 4-12: Typical embankments within the New Forest**

Low level embankments occur along some of the rivers / streams within the Geomorphological Assessment Areas, and are very common along the network of drains (Figure 4-12). These are created from dredged material associated to channel straightening and capacity enhancement. These are creating channel incision through reducing floodplain connectivity (resulting in higher in-channel energy levels where flood flows are no longer spread across the floodplain), floodplain drying and ponded areas where overland flow routes into the main channel have been blocked.

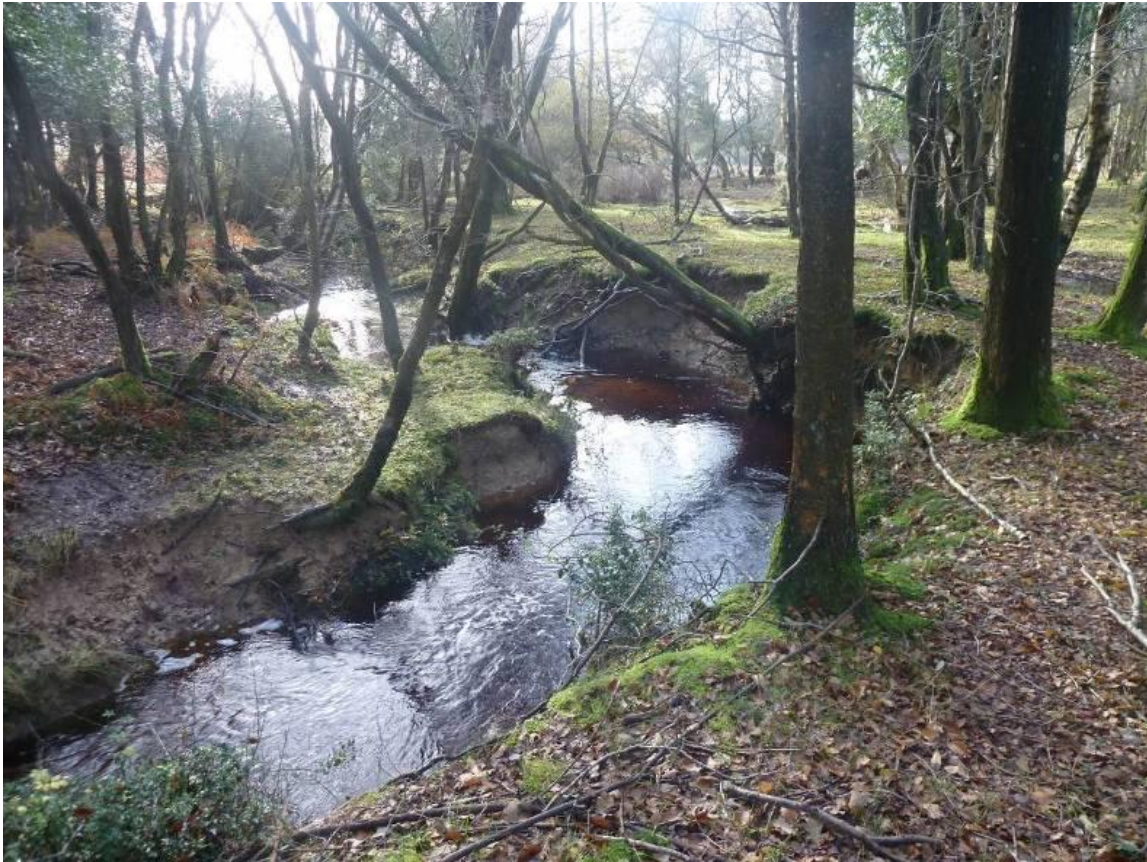
**Figure 4-13: Example incision where floodplain connectivity has been reduced**

Connectivity between the river and the floodplain is poor in numerous locations throughout the New Forest, with the flood inundation and groundwater regime adversely affected. Key opportunity areas exist for reconnection, particularly where incision is a primary driver (Figure 4-13).

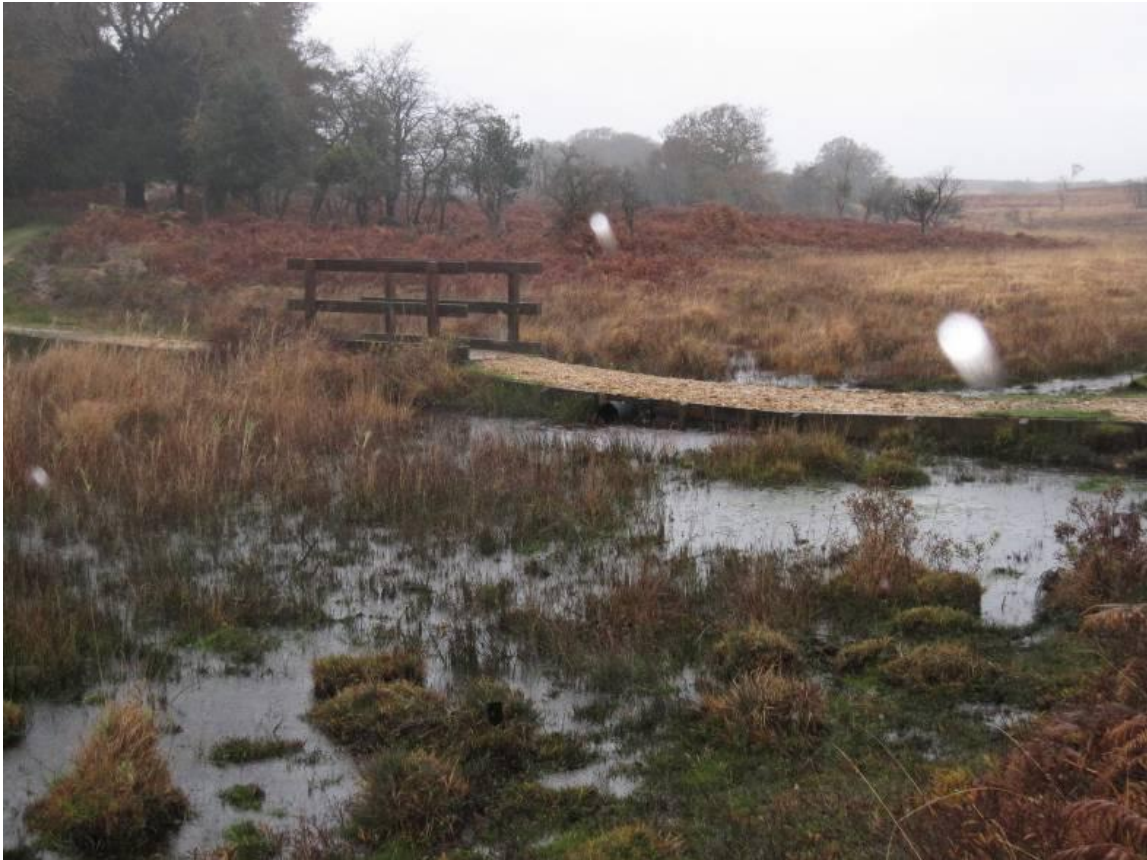
**Figure 4-14: Trackway causing localised ponding of water on Soldiers Bog**

In several locations watercourses are crossed by trackways, footpaths and bridges. In several locations the construction of crossing points across the watercourses has resulted in an impediment to flow, causing water to pond and spread out over the floodplain in localised areas, significantly impacting upon the habitats present in these areas. This was noted as a particular problem on Soldiers Bog where upstream of the bridge the unit was depositional as a result of the impounding influence of the bridge, and downstream erosional as a result of the disruption to the natural flow and sediment regime (see Figure 4-14). Flow regime alteration and ditching are also common pressures associated to the installation of crossing points.

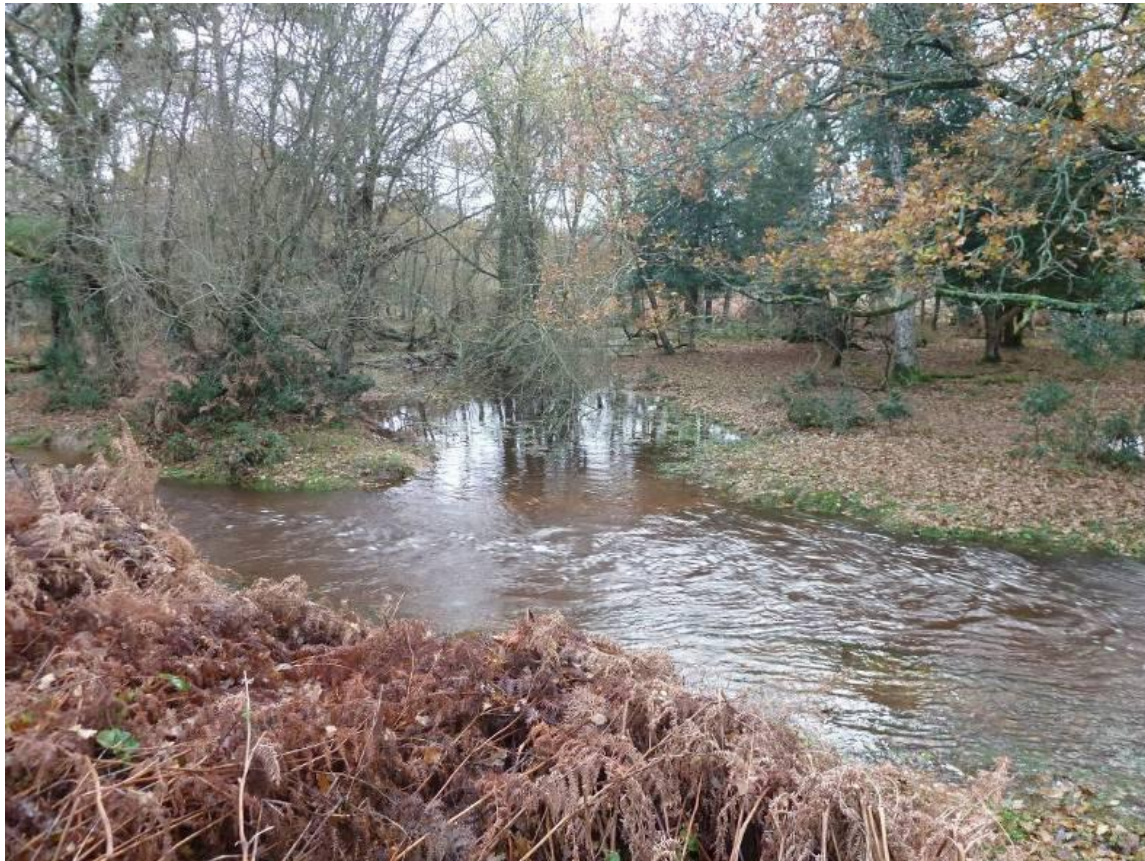
**Figure 4-17: Palaeo feature identification**

Palaeo channel reconnection has been recommended in the unit restoration plans where significant channels have been identified in the floodplain during the site visit, from aerial photography and from LIDAR. The location and suitability for reconnection may need to be determined as part of future detailed restoration plan development and recent JFLOW modelling for Unit 48 (Latchmore Brook) has helped to refine restoration plan proposals for palaeo reconnection. Reconnection is likely to be achieved through local floodplain works at the up and downstream ends of the palaeo channel to ensure bed levels are suitably aligned with the existing main channel. Works may also be required along the palaeo channel length depending on the degree of infilling. In some cases, palaeo channel reconnection may be achieved through local channel blocking (e.g. debris jams) of the main channel to raise bed and water levels to encourage flow into the palaeo channel. This will also maintain some flow within the existing channel, particularly where notable species / habitats exist in the current main channel, reducing the need for costly channel infilling.

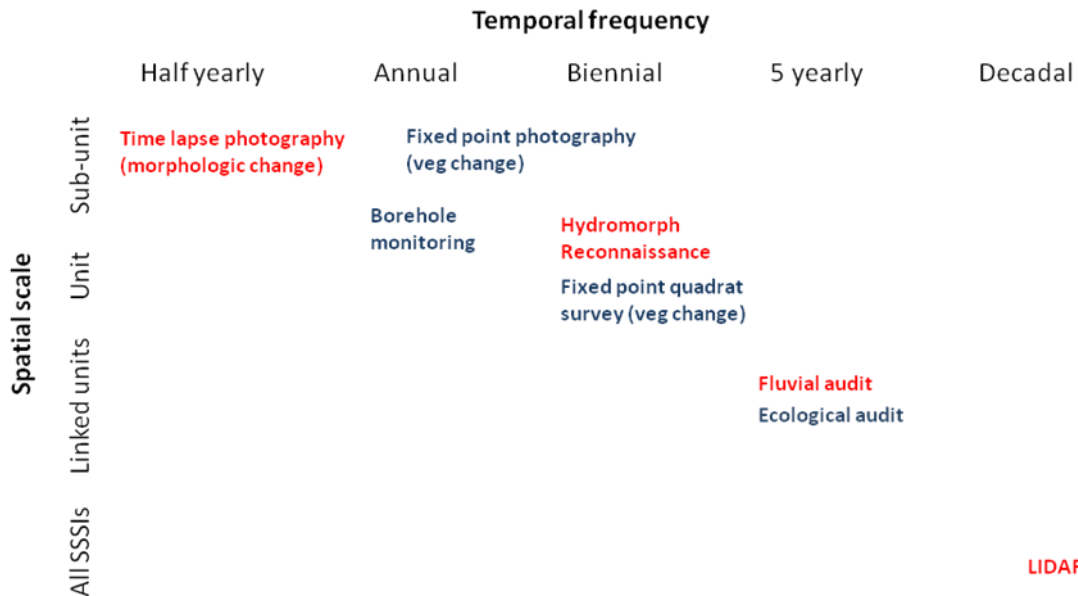
Figure 5-2: Spatial and temporal monitoring scales for the New Forest.

The general dynamics of all the SSSI units should be assessed on a less frequent basis to ensure that their functioning is not deteriorating and rapid reconnaissance audits are suggested in combination with routine key site monitoring on a 2 yearly basis. The reconnaissance audits will include a biotope mapping component, to quantify process adjustment between 2 yearly audits. It is recognised that SSSI site restoration and response will influence linked systems and this should be assessed every 5 years using an approach similar to the combined ecological / hydromorphic assessment conducted for this project. Ten year LIDAR resurvey will allow whole system reassessment, looking in detail at channel and mire response and comparing flow path change over the decade. This approach is summarised in Figure 5-2 and Table 5-2 where generic costs are also given.

This spatially and temporally nested approach has been applied to the New Forest SSSI units with more frequent monitoring techniques suggested at key sites identified in the restoration reports (Table 5-3) and described further in section 6. The unit restoration plans provide explanation around the site specific monitoring proposals shown in Table 5-3 and Table 5-4.
