Natural England Commissioned Report NECR010

# River Wensum restoration strategy

First published 26 June 2009

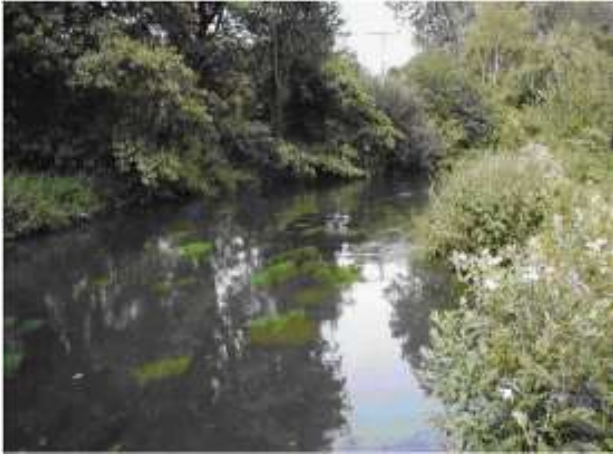
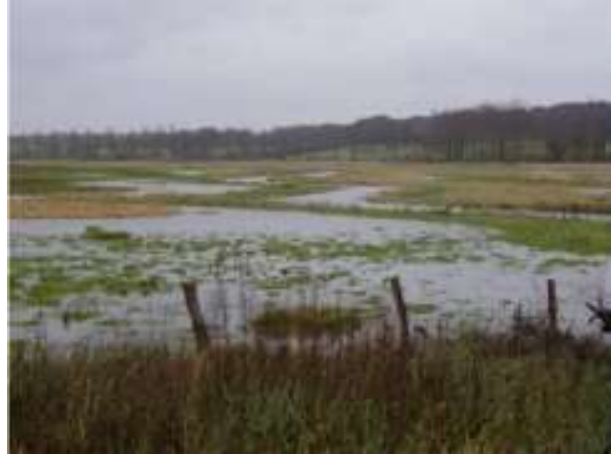
**Plate 1** Views of the River Wensum. Left: *Ranunculus* vegetation; Right: Winter flooding of grazing marshes

- 1.11 The River Wensum is a low gradient, groundwater dominated river. It flows at an average slope of 0.00082 over Senonian Chalk that has been overlain by a complex sequence of glacial drift, sands and gravels. These deposits tend to increase in thickness towards the lower end of the catchment. As the river is often separated from the chalk aquifer by considerable depths of superficial material, it does not exhibit some of the characteristics of the 'classic' chalk rivers of southern England. Intensive arable land-use dominates the landscape on the higher plateaus and valley sides, and grazing marsh, fen, reedbed, scrub and scattered woodland characterise the floodplain. Unusually for a lowland river, much of the floodplain of the River Wensum is still traditionally managed and relatively natural, although there are a series of flooded gravel pits, particularly in the vicinity of Costessey, Lenwade, Lyng, Fakenham and Great Ryburgh. Views of the River Wensum and its floodplain are shown in Plate 1.

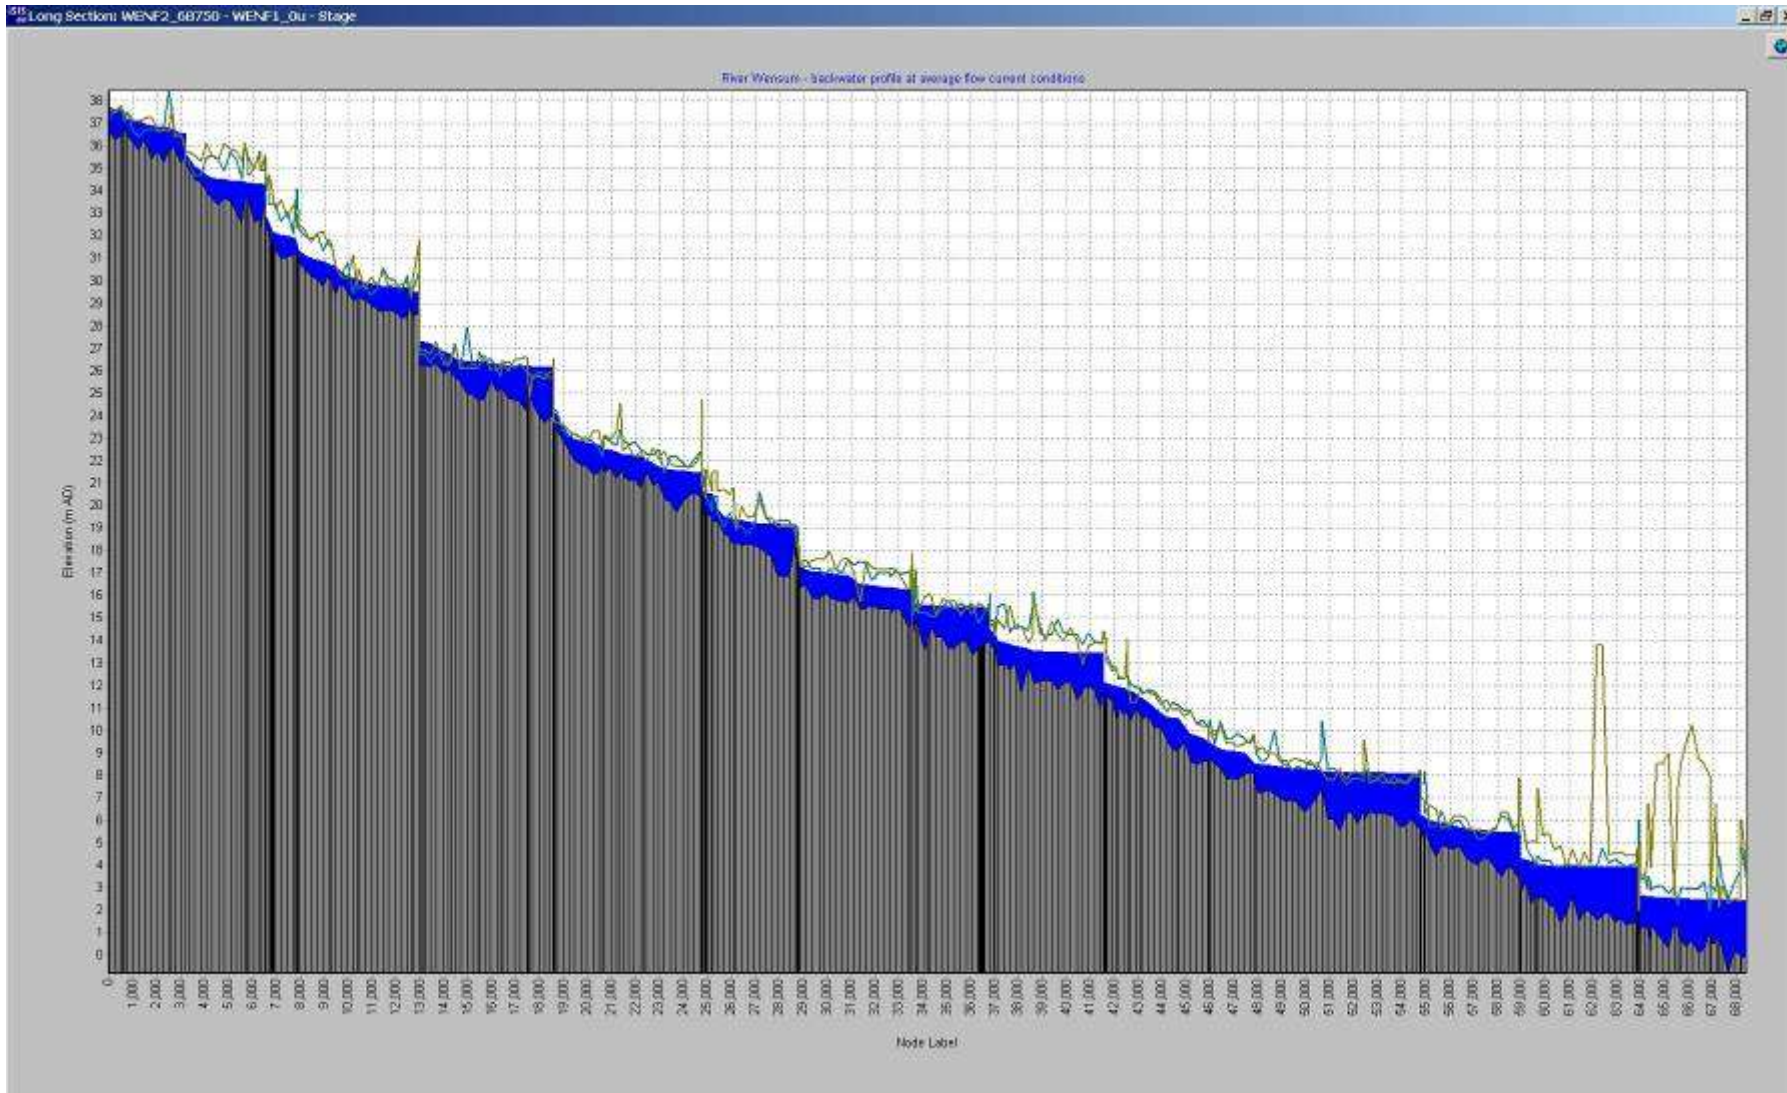
**Figure 2** Long profile of the River Wensum showing average flow

Note: Grey area is bed level; blue area shows water level at average flow; green lines represent top of banks.

- 2.10 Out of a total fall in water head along the Wensum of 34.2m (from above Sculthorpe Mill to downstream of Hellesdon Mill), 60% of the drop occurs at mill structures, rather than occurring progressively along the channel. The result is a stepped profile, with impounded reaches upstream of mills and short, steeper reaches downstream. Between Shereford and Hellesdon, 67% of the River Wensum (45.7km) is affected by backwater conditions (Figure 3 and Table 2). Due to the relatively small distance between many of the mills, there is an almost uninterrupted impoundment of river channel between Sennowe Hall (upstream of Bintry Mill) and Lenwade. The longest stretch of river with no backwater effect is between Lenwade and Ringland. This is because the distance between Lenwade and Taverham mills is relatively large (13.2km) and the channel is able to recover and maintain a more naturally functioning regime downstream of Lenwade before being influenced by the ponded water upstream of Taverham Mill.

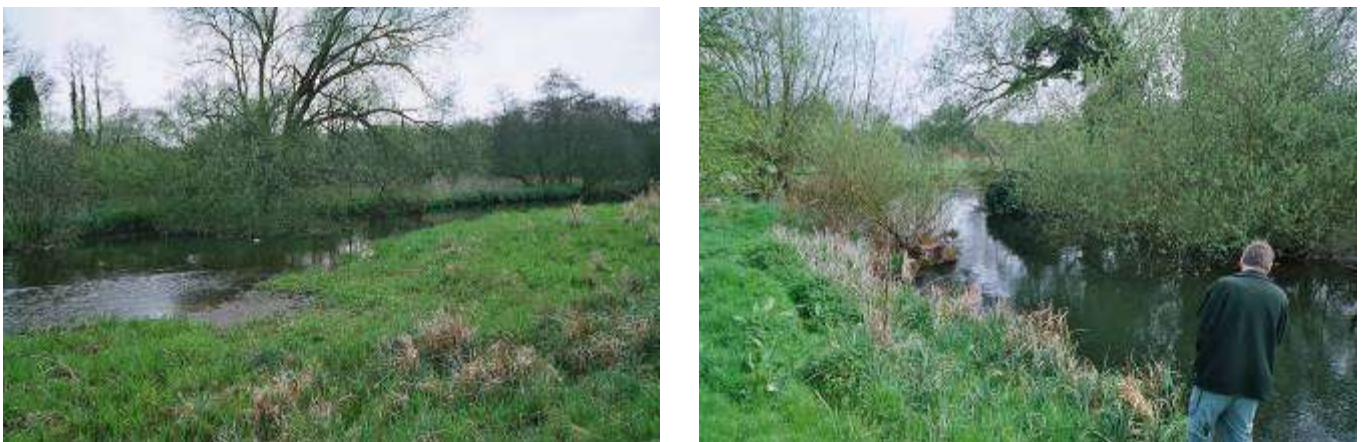
**Plate 2** Previous rehabilitation sites - Lyng. Left: Downstream Lyng Mill - riffle, Right: Downstream Lyng Mill - pool

- The Sayers Meadow Habitat Restoration Project<sup>1</sup> - Downstream of Lyng Mill at Sayer's Meadow is a Norfolk Anglers Conservation Association rehabilitation site aimed at improving instream and bankside habitats (Plate 2). Beginning in the 1990's, a series of restoration measures have been implemented. These include the construction of riffles and pools, channel narrowing, backwater creation and tree planting.

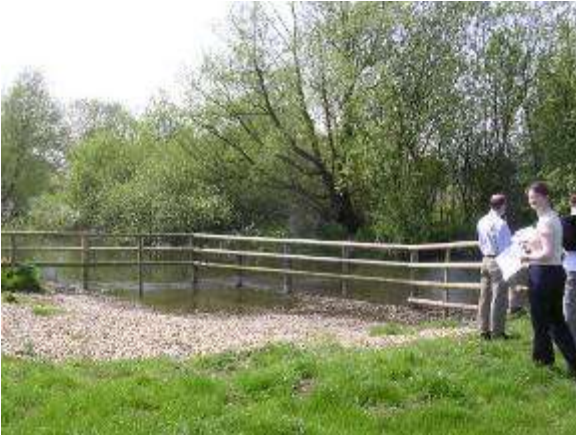
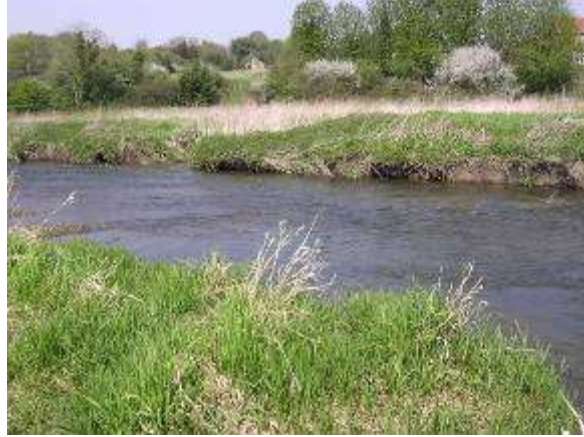
**Plate 3** Previous rehabilitation sites - Costessey. Left: Costessey Point - fenced cattle drink, Right: Costessey Point - riffle

- The Costessey Point Project<sup>2</sup> - Costessey Point/Drayton - Norfolk Anglers Conservation Association habitat restoration (Plate 3). Measures implemented here include the restoration of an important fish spawning and recruitment riffle at 'The Point' (confluence of the Old Costessey Mill stream with the River Wensum). Additional riffles, fry refuges and compensation floodplain storage were constructed.
- Hempton (upstream Fakenham Mill) - restoration of a by-passed meander bend (approximately 280m - vegetation clearance and restoring original channel dimensions) and installation of three riffles in the existing river course to divert flow into the meander loop (Plate 4).

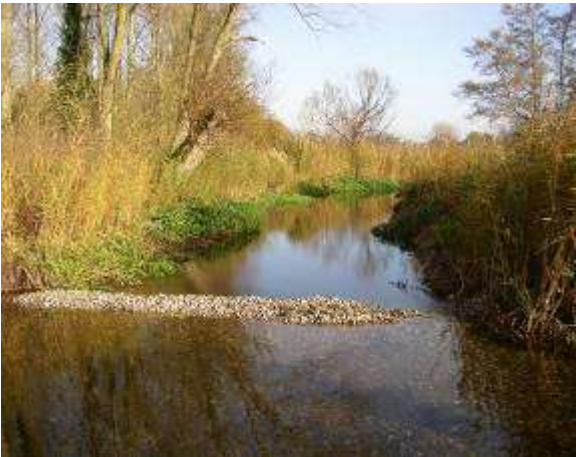
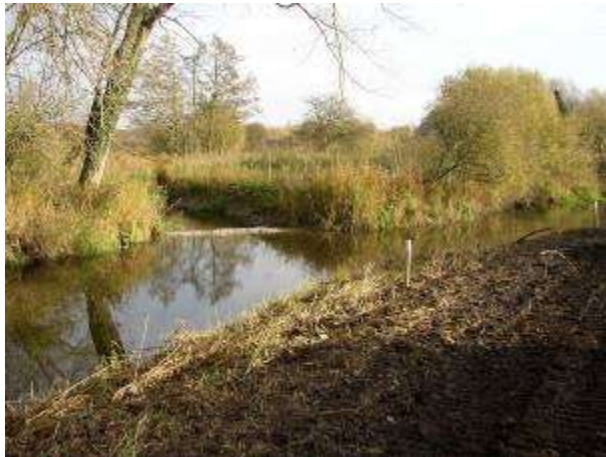
**Plate 4** Consented works - Hempton. Left: Upstream Hempton site - entrance to meander, Right: Upstream Hempton site - entrance to meander

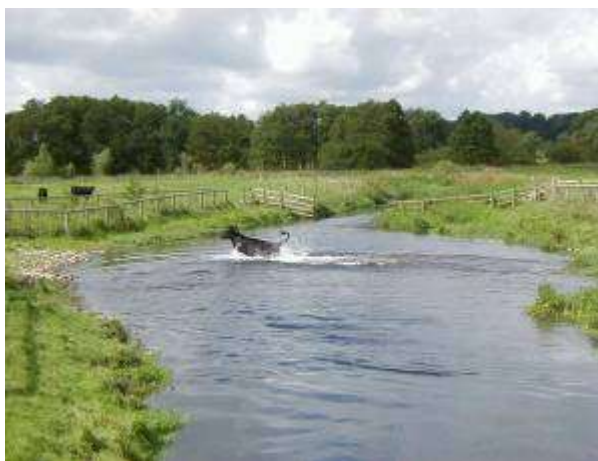
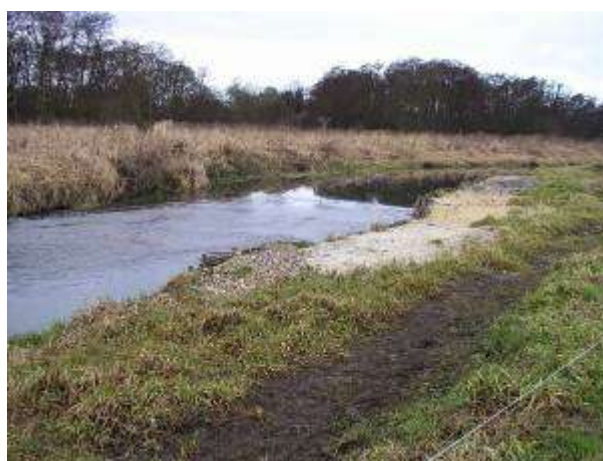
**Plate 5** Consented works - Bintry Mill site. Left: Bintry Mill restoration - cattle drink, Right: Bintry Mill restoration - restored pipeline riffle

- Bintry Mill (Plate 5) - Installation of a gravel glide and riffle in 2004 by Bintry Mill Trout Fishery to provide further habitat for brown trout and to extend previous Environment Agency restoration works (7 riffles, flow deflectors to create pool habitat, narrowing using faggot and chalk/gravel back-fill and 2-stage channels in 2001) at Bintree. The work in 2004 was commissioned by the Bintry Mill Trout Fishery and was part grant aided by the Environment Agency.

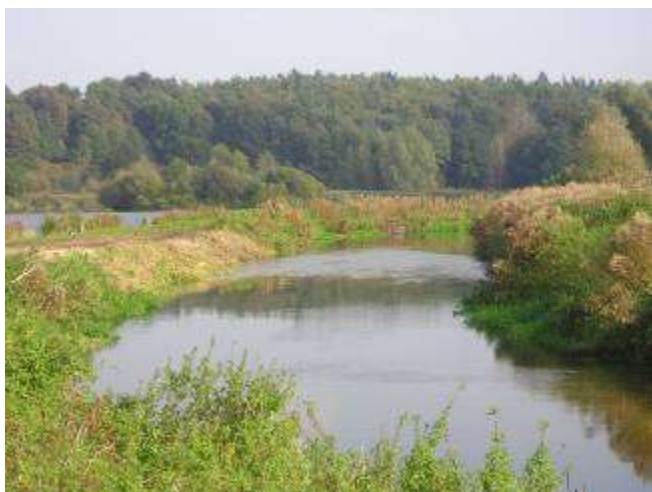
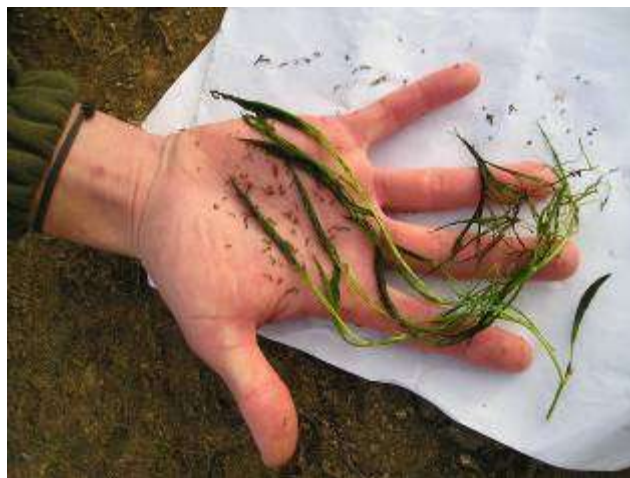
**Plate 6** Consented works - Swanton Morley. Left: Swanton Morley restoration - lower riffle, Right: Swanton Morley restoration - water crowfoot

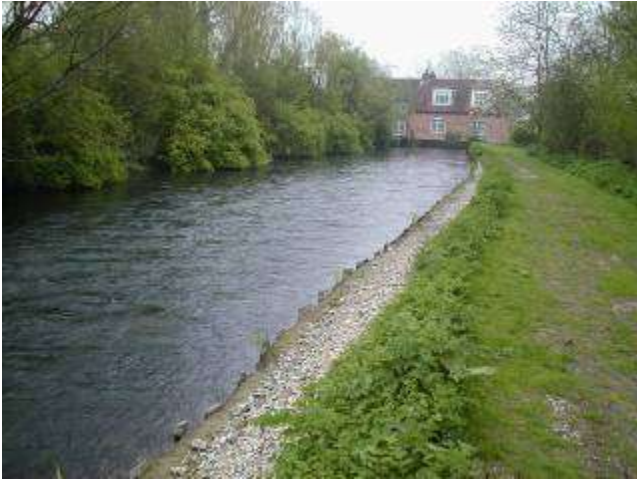
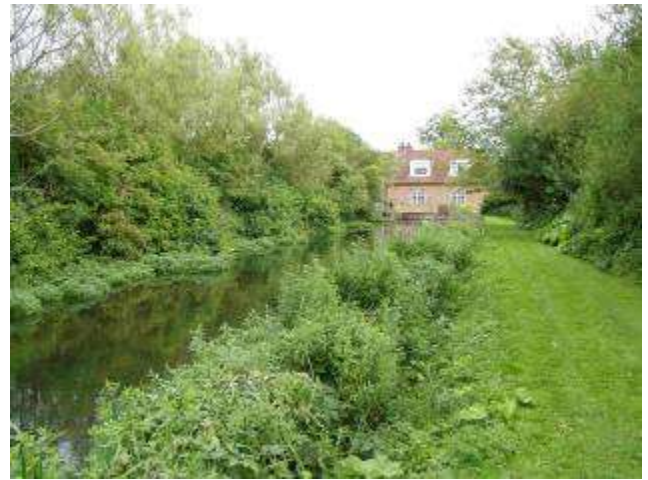
**Plate 7** Other chalk river projects - Upper Kennet example. Left: Upper Kennet- narrowing upstream of Kennet Mill Right: Upper Kennet - In 2003, following establishment of marginal vegetation

- The Upper Kennet Rehabilitation Project (1993 to 2004) - 10km stretch of channel with similar pre-scheme characteristics to the Wensum (SSSI chalk stream that is ponded upstream of mills, generally overly wide and silty, but which is a focal point in the landscape and a valued fishery). Rehabilitation focussed on restoring reaches that were particularly degraded, where landowners supported restoration, where value for money could be demonstrated, where work was practical and where restoration would not increase flood risk to people and property. Seven schemes have been implemented with early indications of success (Plate 7). Case studies for each of these schemes are available from Thames Water, including river narrowing (creation of an island, ledges and the use of deflectors and coir rolls), Ranunculus planting, bed raising, overbank spillways and modified water level management. Case studies give detailed design methods and post-project appraisal remarks. Further, a post-project monitoring report concludes much of the rehabilitation works have been successful (Hankinson Duckett Associates, 2004).

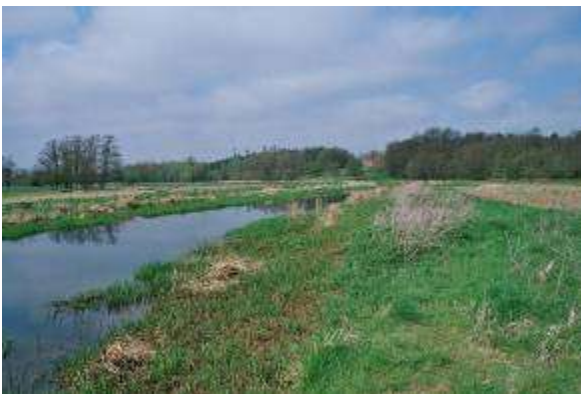
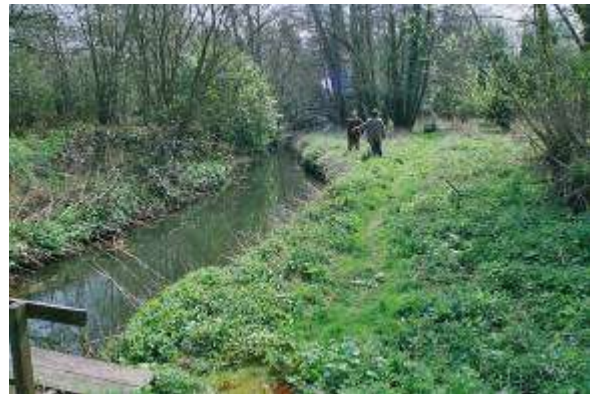
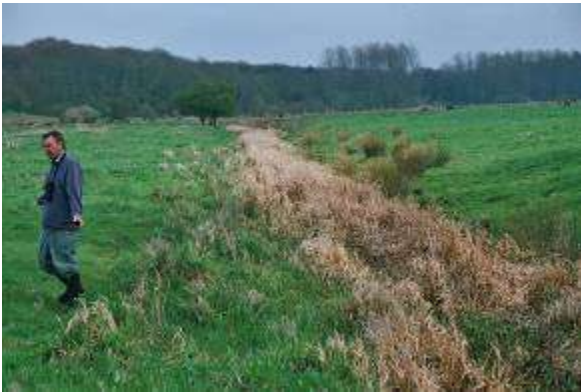
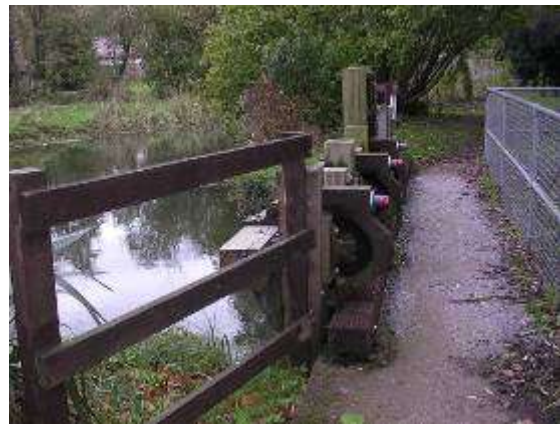
**Plate 8** Potential pilot sites for restoration - Top Left: Upstream of Lyng Mill - present channel, Top Right: Upstream Lyng Mill - old course Bottom Left: Downstream Great Ryburgh Mill - old course, Bottom Right: Taverham Mill - sluice
