Natural England Commissioned Report NECR141

# New Forest SSSI Ecohydrological Survey Overview

Annex J: Bratley

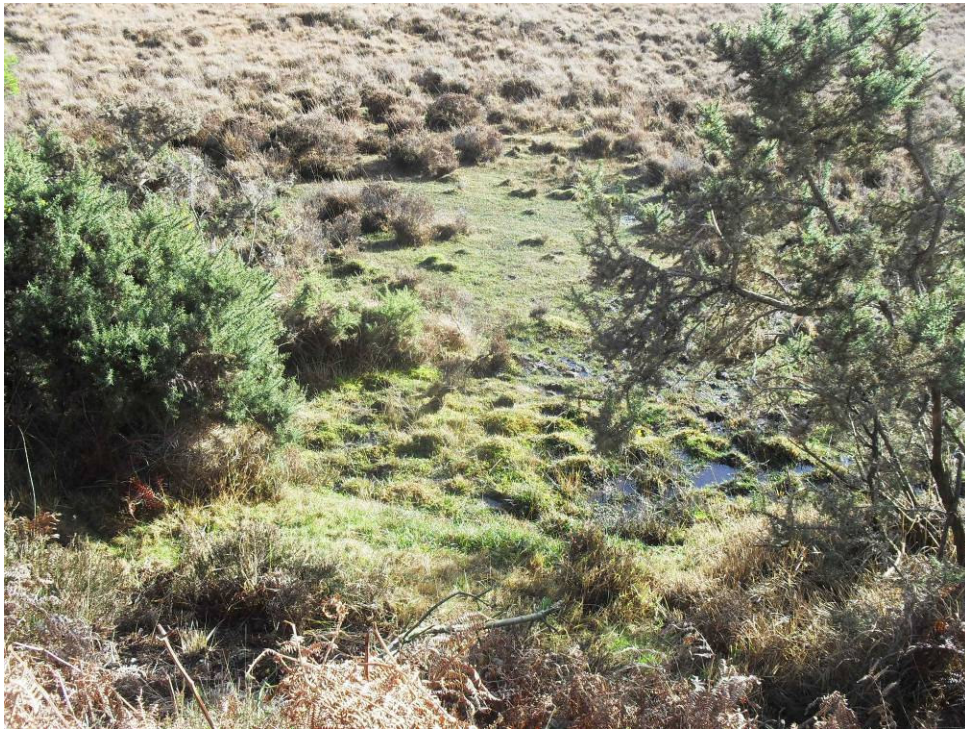
**Figure 1-2: View down seepage face. Valley mire-wet heath habitat (NGR 423751, 109525)**

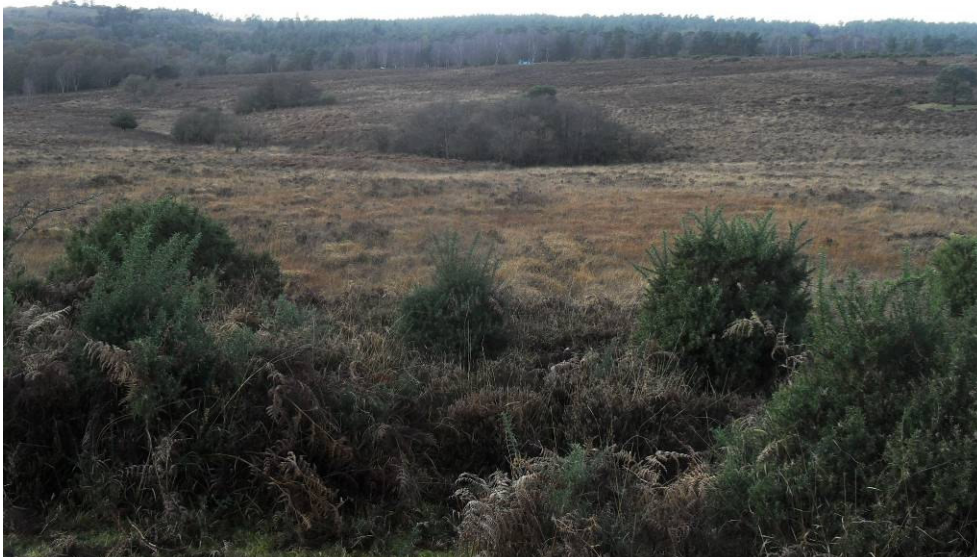
More valley mire habitat (M21a) is present along the northern and eastern unit boundaries where it is clearly associated with seepage faces. These wetlands then gradually peter-out downstream as the habitat once again reverts to the ubiquitous *Molinia* dominant wet heath mentioned above. The definite changes between wet heath habitat (on slightly higher ground) and valley mire can clearly be seen in Figure 1-3.

**Figure 1-3: View West across the site from its eastern boundary (NGR 423765, 109315)**
