# Condition review: Arun Valley Sites

## Freshwater-dependent features

Natural England Research Report NERR143

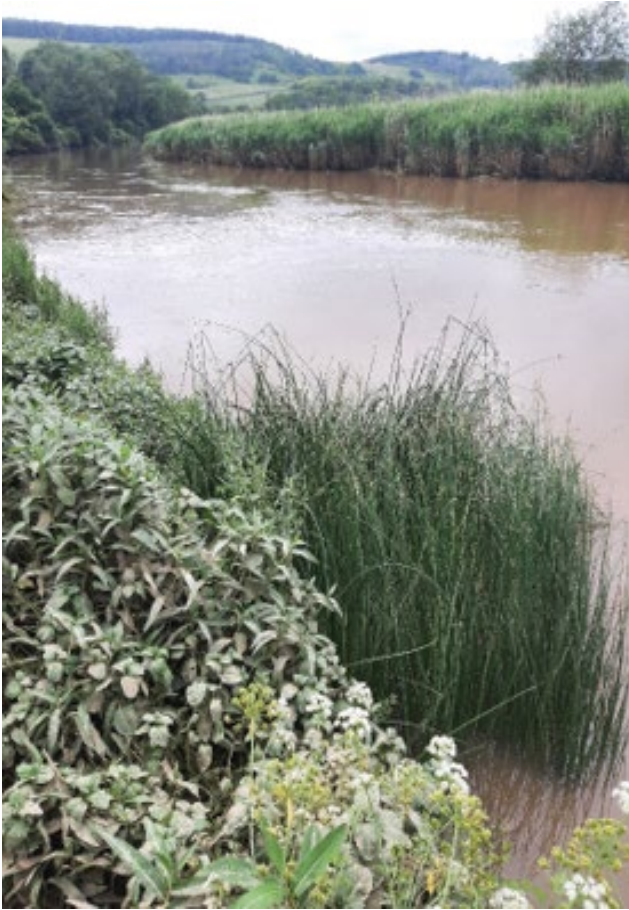
Figure 3.1 - *Schoenoplectus x kuekenthalianus* on the banks of the River Arun, Arun Banks SSSI. Photo by B.Bennatt (Southern Water).

In 2021, on behalf of Natural England, Southern Water's botanical ecologists undertook a presence/absence assessment of the nationally notable plant species: *Schoenoplectus x kuekenthalianus*, one of the interest features of this site. The results of this survey found the species to be in healthy condition, with numerous 'clumps' being observed in the area designated (within unit 1, Figure 3.1), a noticeable improvement compared to previous records. Due to this apparent increase in species presence and extent as identified by expert plant ecologists, this feature has been concluded to be meeting the associated targets, with a high confidence in the recorded data.

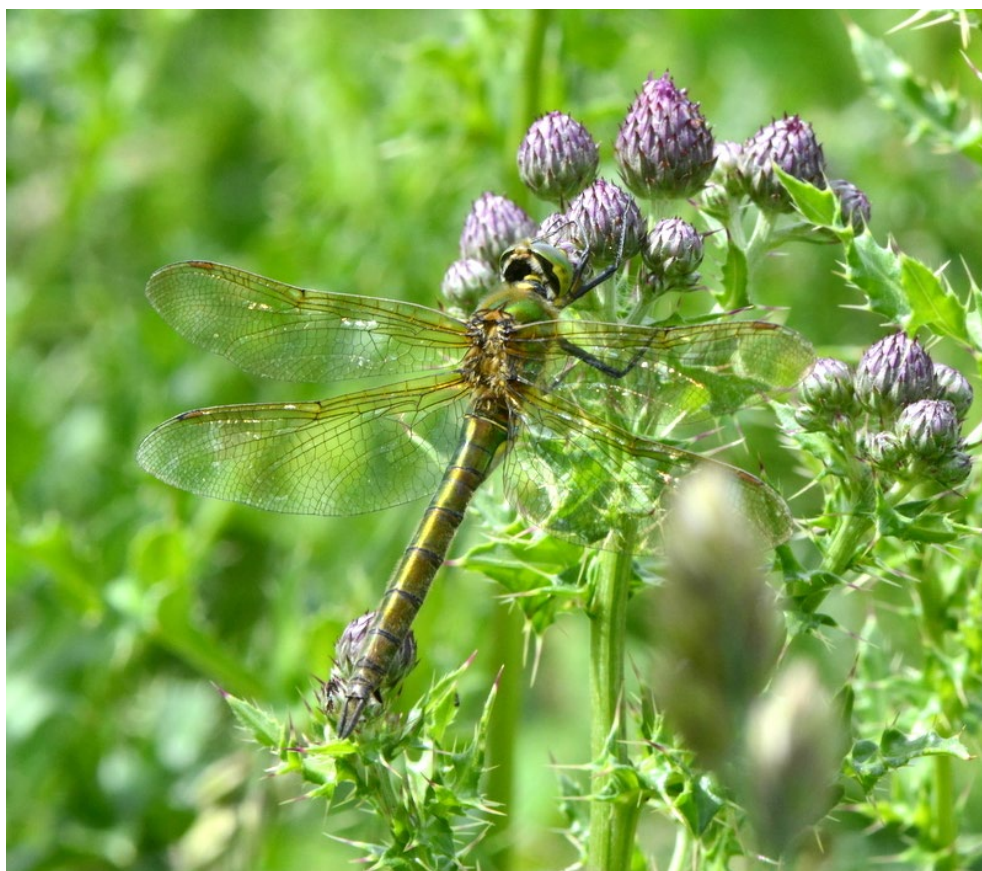
Figure 4.1 - Brilliant emerald (*Somatochlora metallica*) dragonfly in Upper Arun SSSI. Photo by H. Stanworth (Natural England).

At the time of notification, 15 species were known to be present and breeding within the SSSI, this includes four notable species: Scarce Chaser, Club-tailed Dragonfly, Hairy Dragonfly, and Brilliant Emerald (Figure 4.1). For the maintenance of Favourable condition of this feature, this number of species (15) must be achieved, and although not essential, it is desired that the four notable species should also be present. During the survey period (May-September 2021) it was observed that a total of 22 species were present, 17 of which had evidence of breeding, with all four of the notable species of importance recorded as present in good numbers. This exceeded all the required targets as detailed under the Presence, Evidence of breeding, and Number of species attributes (including notable species) and for these attributes, Favourable condition status was concluded.

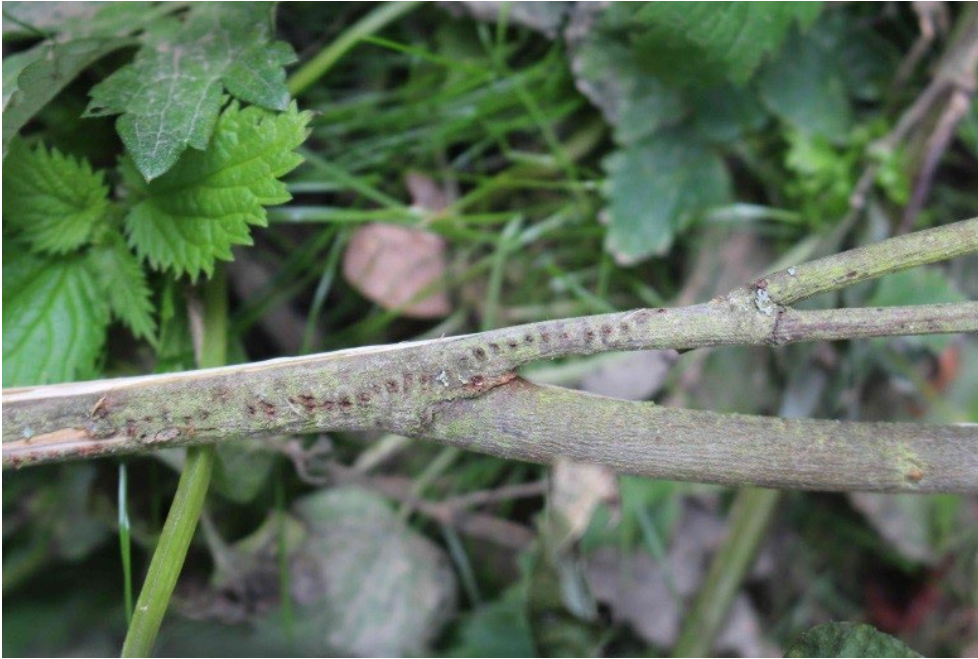
Figure 4.4 - Willow emerald (*Chalcolestes viridis*) damselfly oviposition scars on a broken stem in Arun Banks SSSI. Photo by A. Barker.

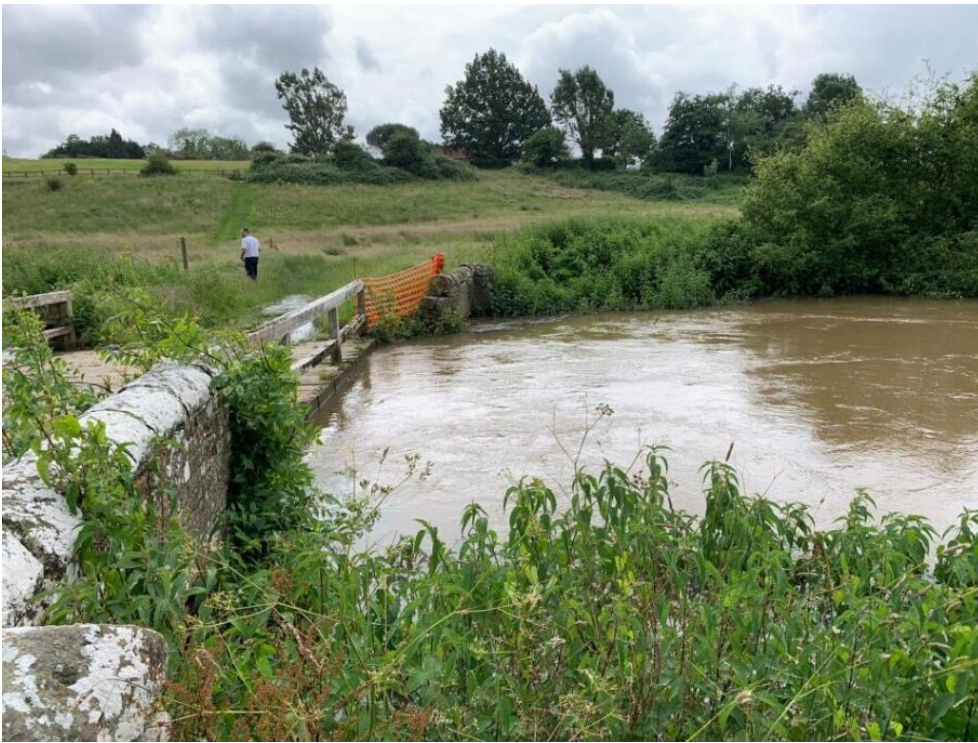
Figure 4.6 - High water levels of the River Arun, Arun Banks SSSI, during the survey period. Photo by H. Stanworth (Natural England).

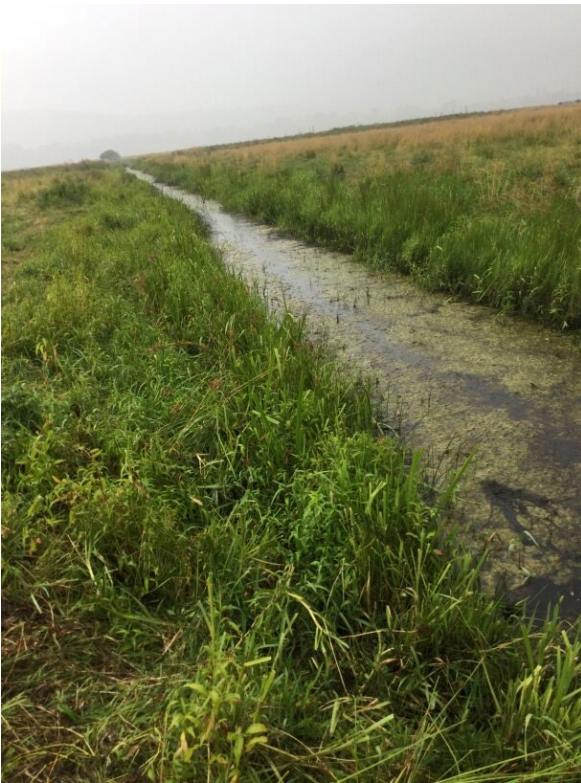
Figure 8.1 - Ditch with trapezoidal sides and high algal cover in Amberley Wild Brooks SSSI. Photo by Natural England.

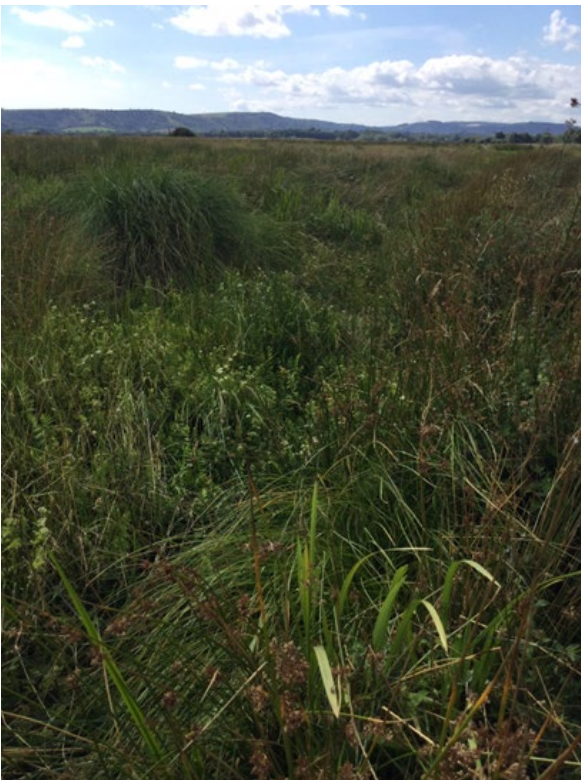
Figure 8.2 - Late stage succession ditch in Amberley Wild Brooks SSSI. Photo by Natural England.

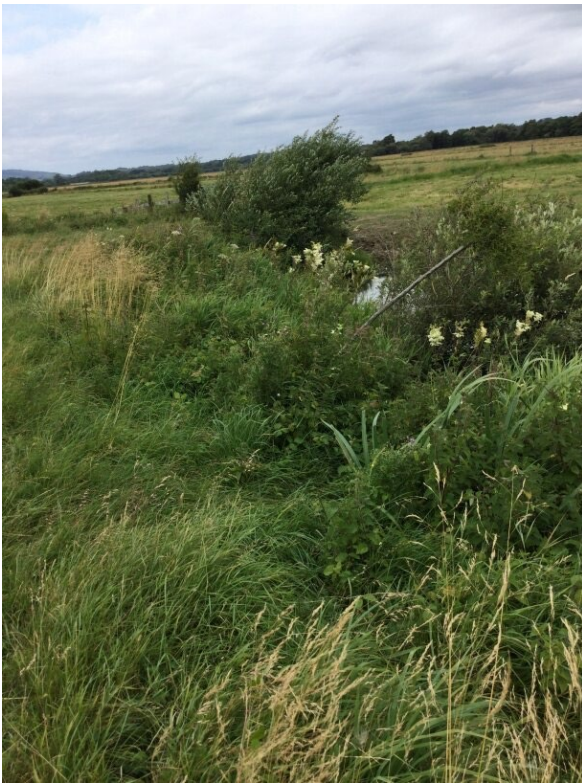
Figure 8.3 - Ditch with high vegetation cover in Amberley Wild Brooks SSSI. Photo by Natural England.

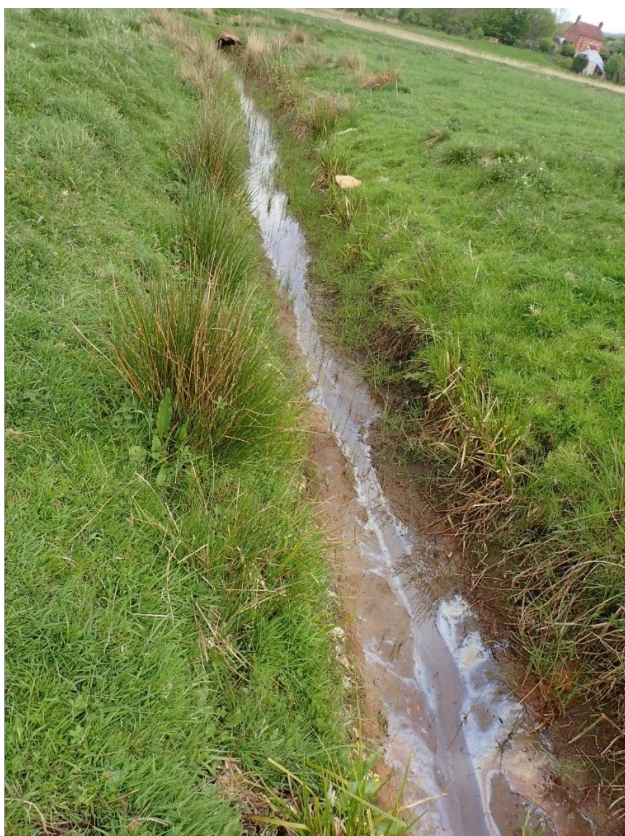
Figure 8.4 - Low water levels in a ditch in Amberley Wild Brooks SSSI in May 2022. Photo by M. Willing.

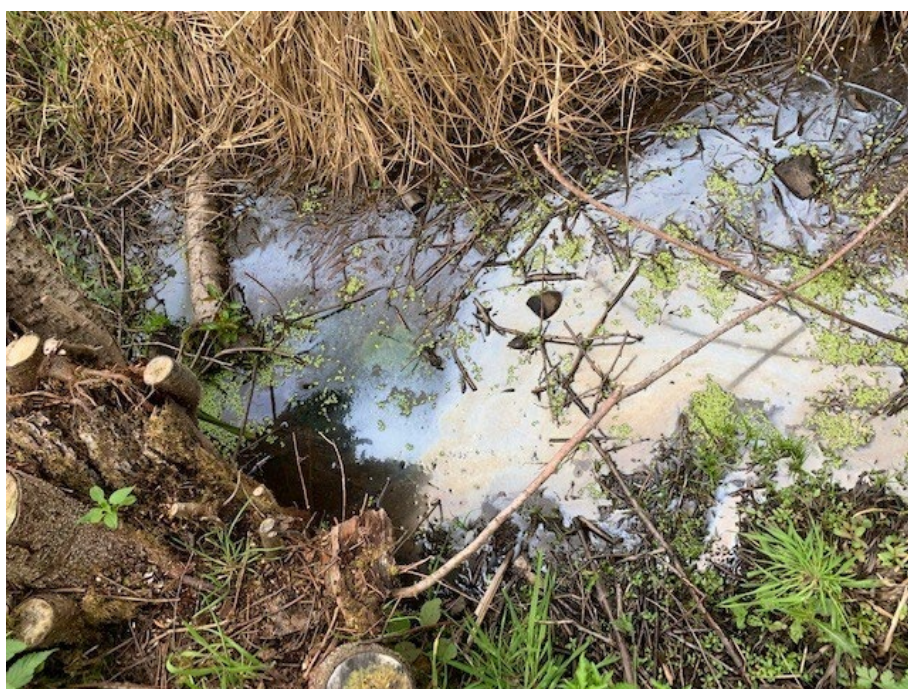
Figure 8.5 - Oily film on the surface of a ditch in Amberley Wild Brooks SSSI in June 2022. Photo by Natural England.

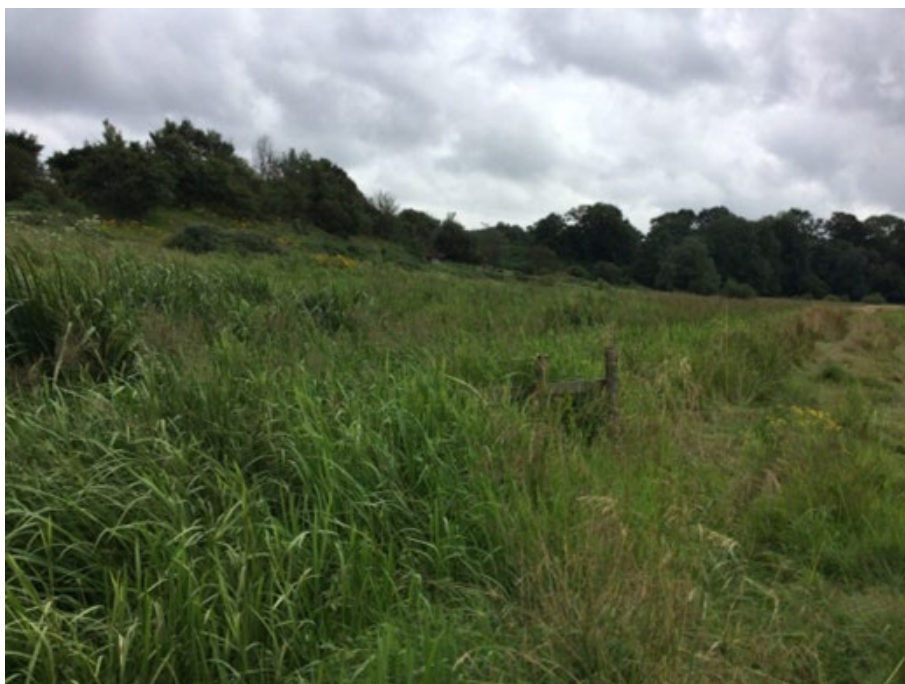
Figure 8.9 - Late-stage succession of a ditch in Pulborough Brooks SSSI. Photo by H. Frost (Natural England).

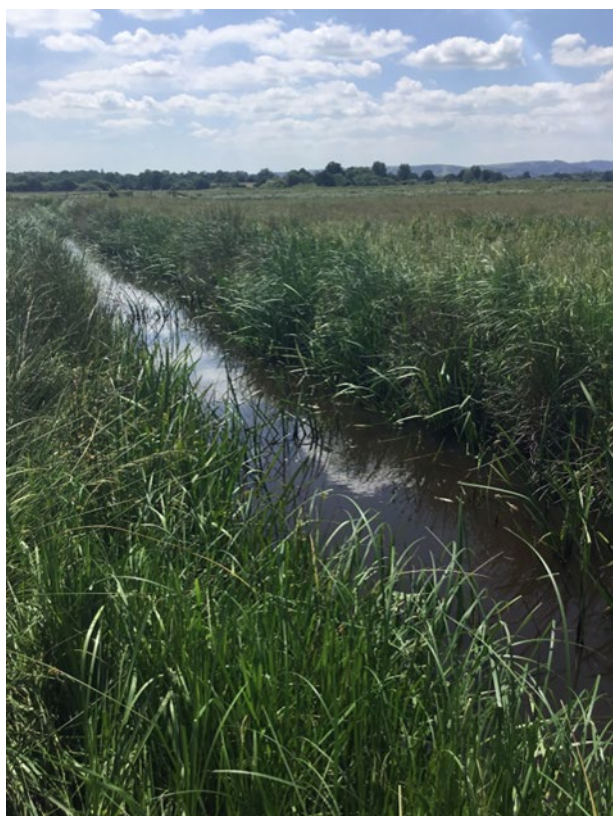
Figure 8.10 - Ditch with trapezoidal sides in Pulborough Brooks SSSI. Photo by Natural England.

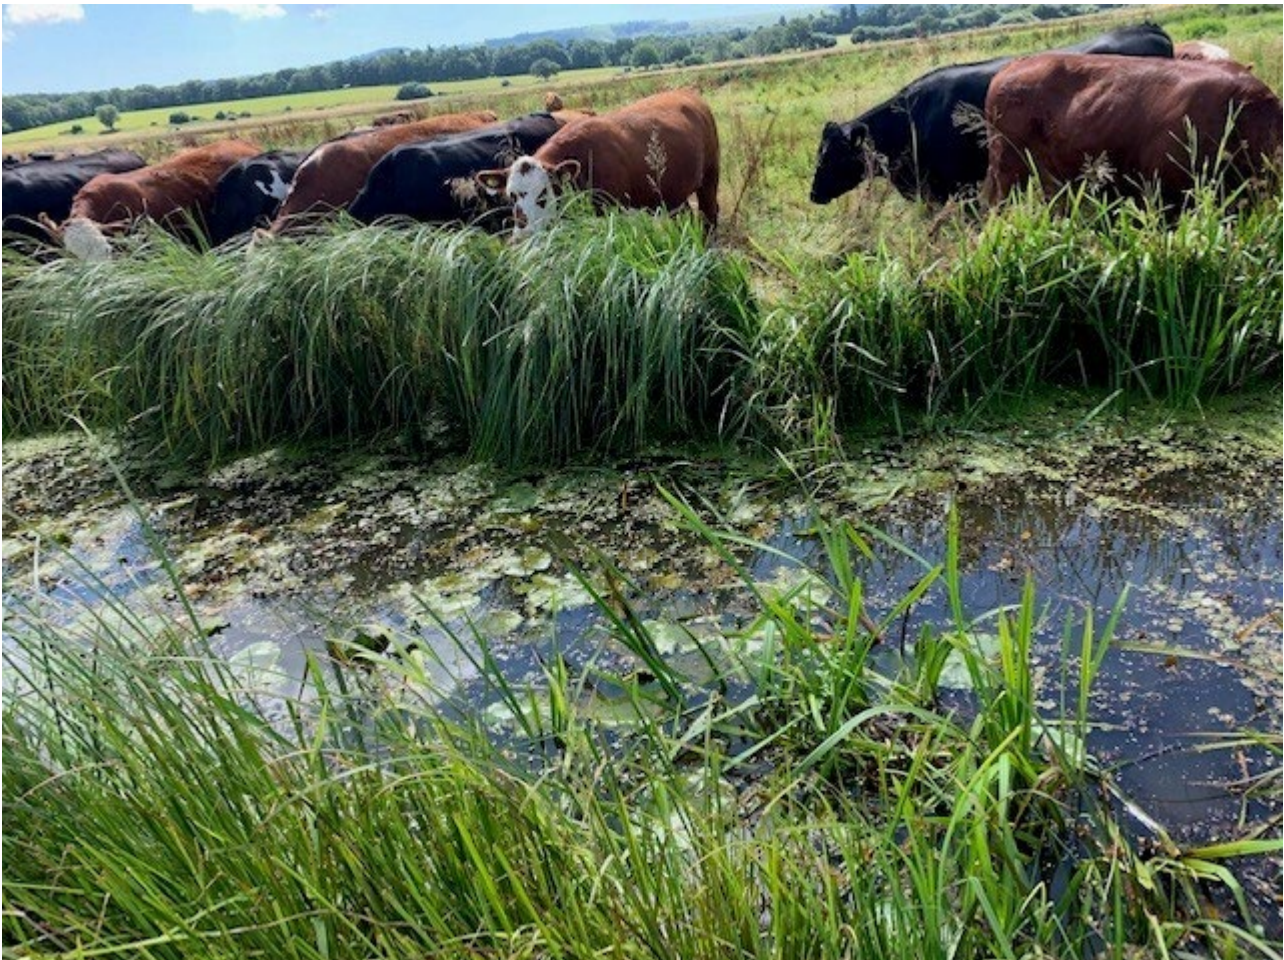
Figure 8.14 - Vegetation in a ditch in Pulborough Brooks SSSI. Photo by Natural England.

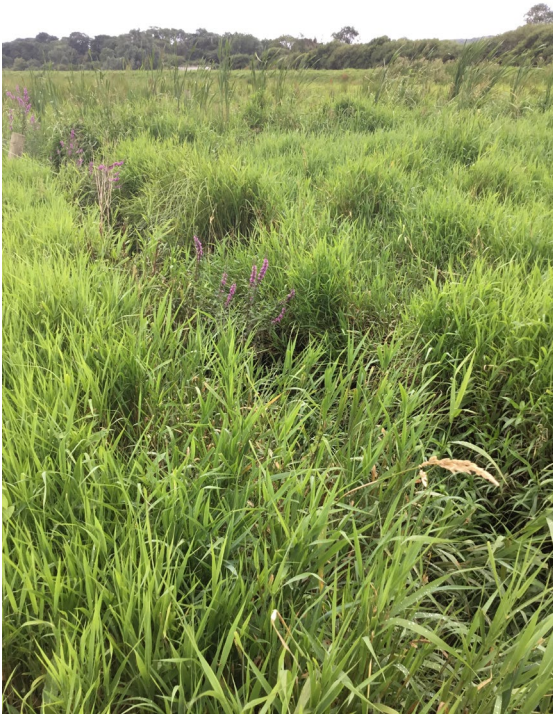
Figure 8.15 - Overshaded ditch with low water levels in Waltham Brooks SSSI. Photo by Natural England.

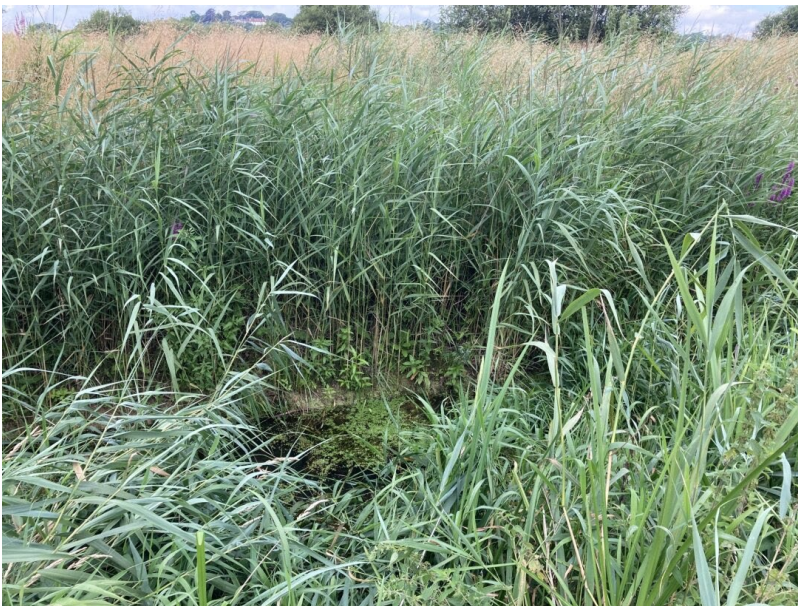
Figure 8.16 - Overshaded ditch with low water levels in Waltham Brooks SSSI. Photo by H. Stanworth (Natural England).

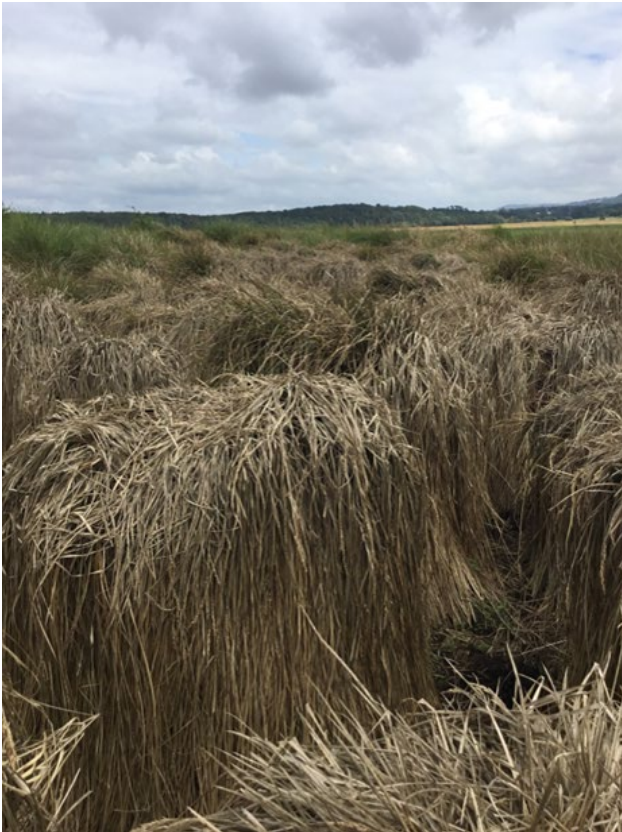
Figure 9.1 - Grassland site with a high cover of tussock sedge (*Carex stricta*) in Amberley Wild Brooks SSSI in June. Photo by Natural England.

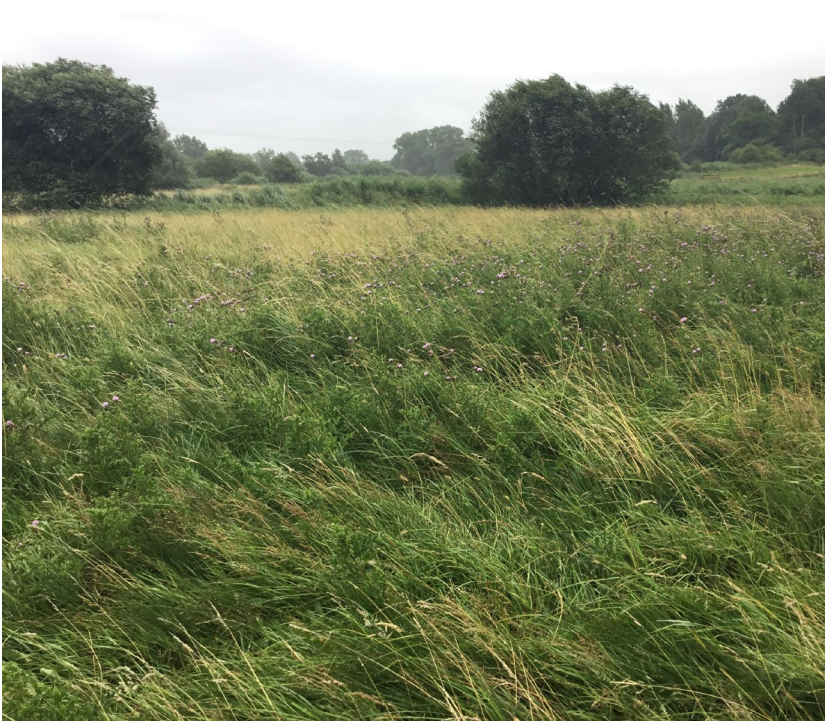
Figure 9.2 - Grassland site with high cover of thistle and high sward height in Amberley Wild Brooks SSSI. Photo by Natural England.

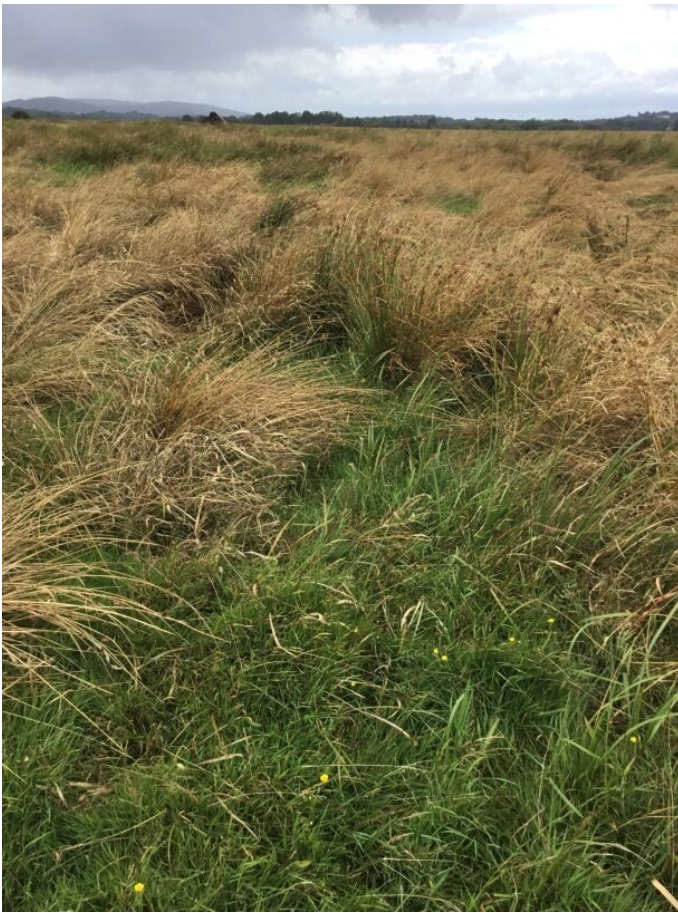
Figure 9.3 - Grassland with high cover of rush (*Juncus* spp.) in Amberley Wild Brooks SSSI. Photo by Natural England.

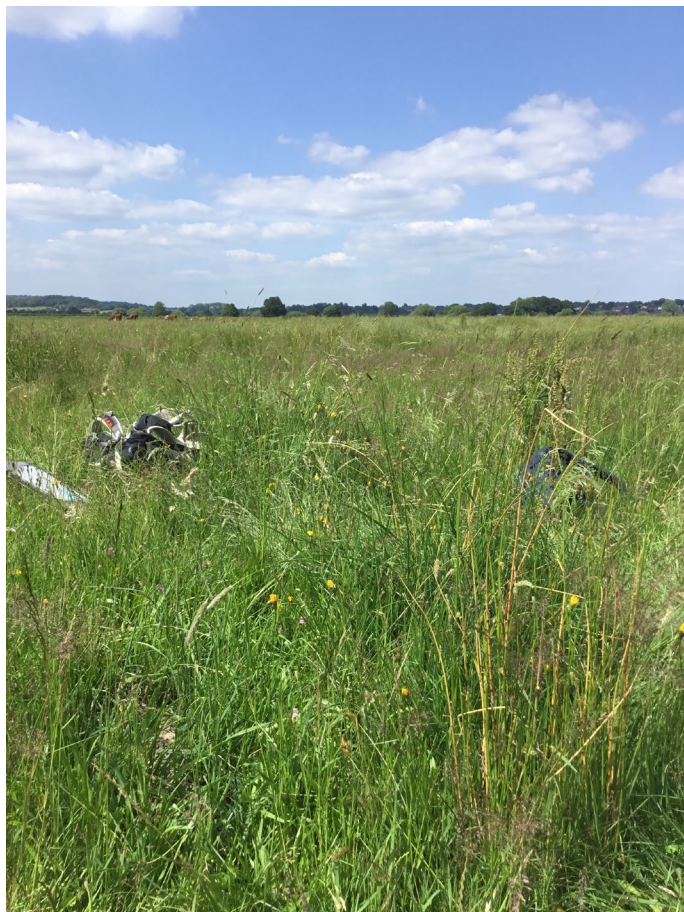
Figure 9.4 - Grassland in Pulborough Brooks SSSI. Photo by Natural England.

This site consists of a series of wet meadows on the floodplain of the River Arun between Pulborough and Greatham. The fields (Figure 9.4) are subject to winter and occasional summer flooding, which supports wintering wildfowl and breeding waders. Historically the site has been managed as flood meadows, which are cattle grazed and cut for hay during the summer. Much of the grassland is semi-improved, with most fields consisting of species-poor rough damp pasture. The majority of the site consists of plants which form a wet grassland community: Yorkshire-fog *Holcus lanatus*, tufted hair-grass *Deschampsia flexuosa*, coarse grassland and Creeping Bent *Agrostis stolonifera* and Marsh Foxtail *Alopecurus geniculatus* wet pasture. The fields support such typical plants as Soft Rush *Juncus effusus*, Hard Rush *Juncus inflexus*, Hairy Sedge *Carex hirta* and Marsh Ragwort *Jacobaea aquatica*.
