Natural England Commissioned Report NECR141

New Forest SSSI Ecohydrological Survey Overview

Annex N: Sway Mire

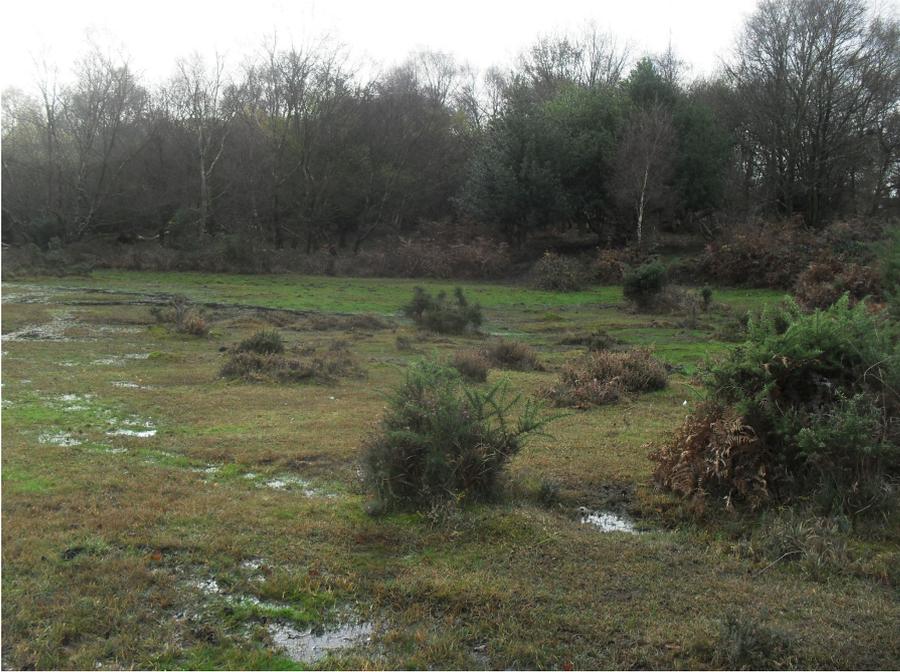
This small site lies within a narrow valley on the edge of a plateau. In the upper part of the valley, a small drain cuts through an area of wet grassland (see Figure 1-2). Further south this drain forms a gully (see Figure 1-3). The point at which the gully forms is likely to be where the substrate underlying the drain changes from the relatively cohesive Headon Formation to the weaker Becton Sand Formation.

Figure 1-2: Wet Grassland Area with Small Drain in the Foreground (NGR 428020, 099301 looking southwards)

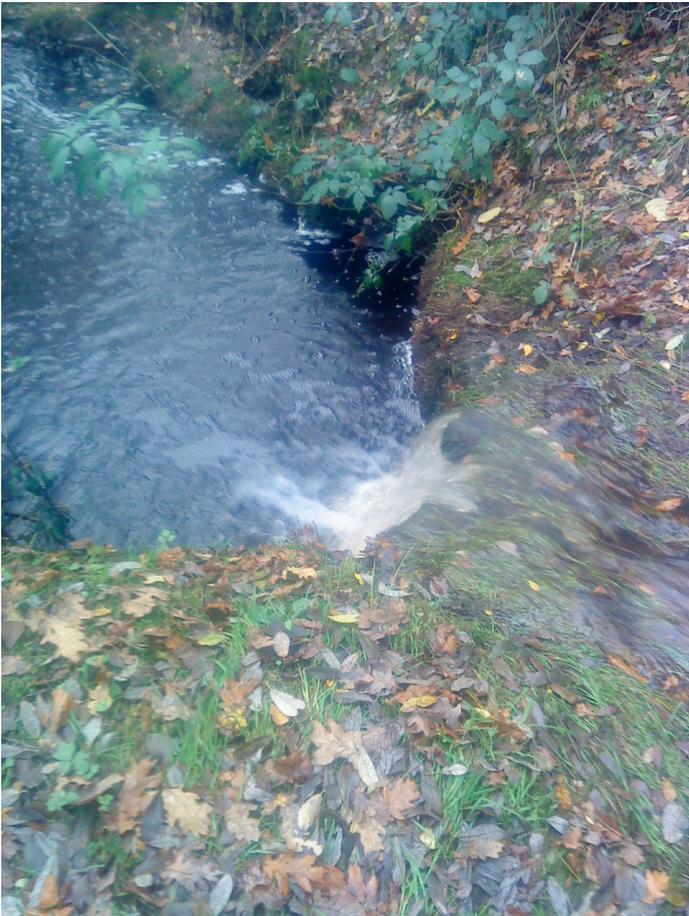
Figure 1-3: Drain at point that it forms a gully (NGR 428018, 099228)

The gulleying only begins where the Headon Formation gives way to the Becton Sands. Further headward erosion of the gulley into the Headon Formation may be limited, as it is likely to be more consolidated and less prone to erosion than the Becton Sands. The rate of headward erosion is unclear so monitoring of the gulley head is recommended before any restoration measures are suggested. At a maximum, restoration would consist of a 4-6 small wooden dams, set within the gulley to limit the erosion.

The site contains flush dominated wetlands with thin peats or peaty soils - groundwater monitoring is unlikely to be appropriate for such a site. A fixed point camera survey of the gulley would help to elucidate the rate of headward erosion at the gulley head.

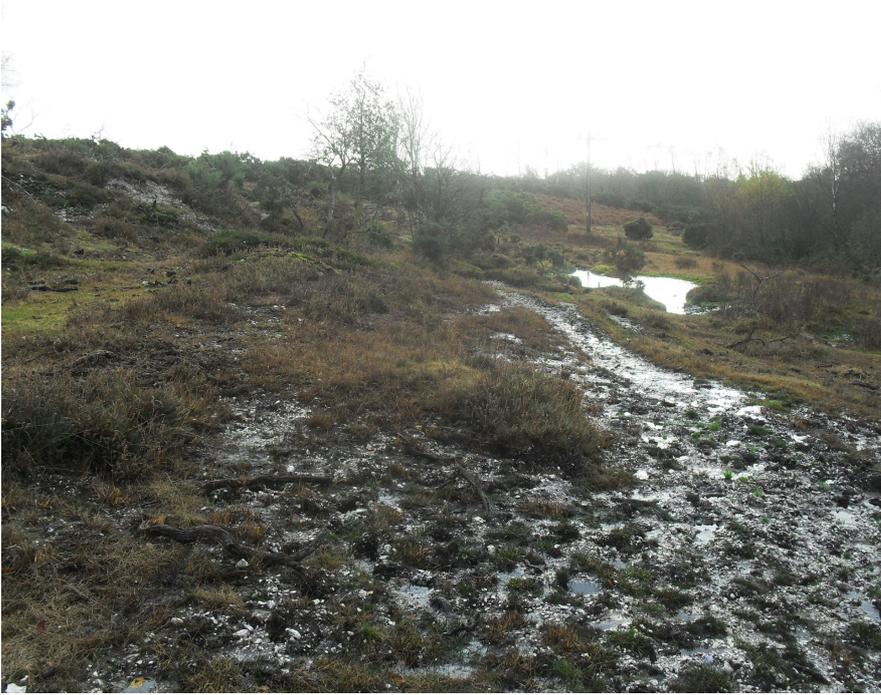
There is one section of valley side mire along a relative steep slope in the south western corner of the site.

Figure 1-4: Valley Side Mire with evidence of animal poaching (NGR 428146, 099077 looking southwards)

Towards the south of the site, the unit becomes much wetter with Deergrass *Trichophorum germanicum*, Purple Moor-grass *Molinia caerulea*, Bog Myrtle *Myrica gale* and *Sphagnum* mosses becoming increasingly dominant. White Beak-sedge *Rhynchospora alba* is also present in this area. A seepage face is present here, and associated mire habitat as well. The mire habitat is not in favourable condition due to the extensive drainage and poaching by animals on site and this is leading to the erosion and loss of the seepage mire and its associated species (Figure 1-4).

- Gulley Head - at the lower end of the valley bottom wetland the gulley is improving drainage. It is unclear whether the gulley is natural or developed from an artificial drain.
- Poached Area - the valley side wetland appears to be subject to significant poaching of the peat soils by animals.

It will be necessary to monitor the poached area and implement a grazing management plan across the site to reduce the pressure upon the more fragile mire habitats.

Poaching across the site can be monitored by taking fixed point camera surveys of specific areas within the site on a bi-annual basis. Quadrats may also be used to monitor vegetation recovery within the managed grazing areas.

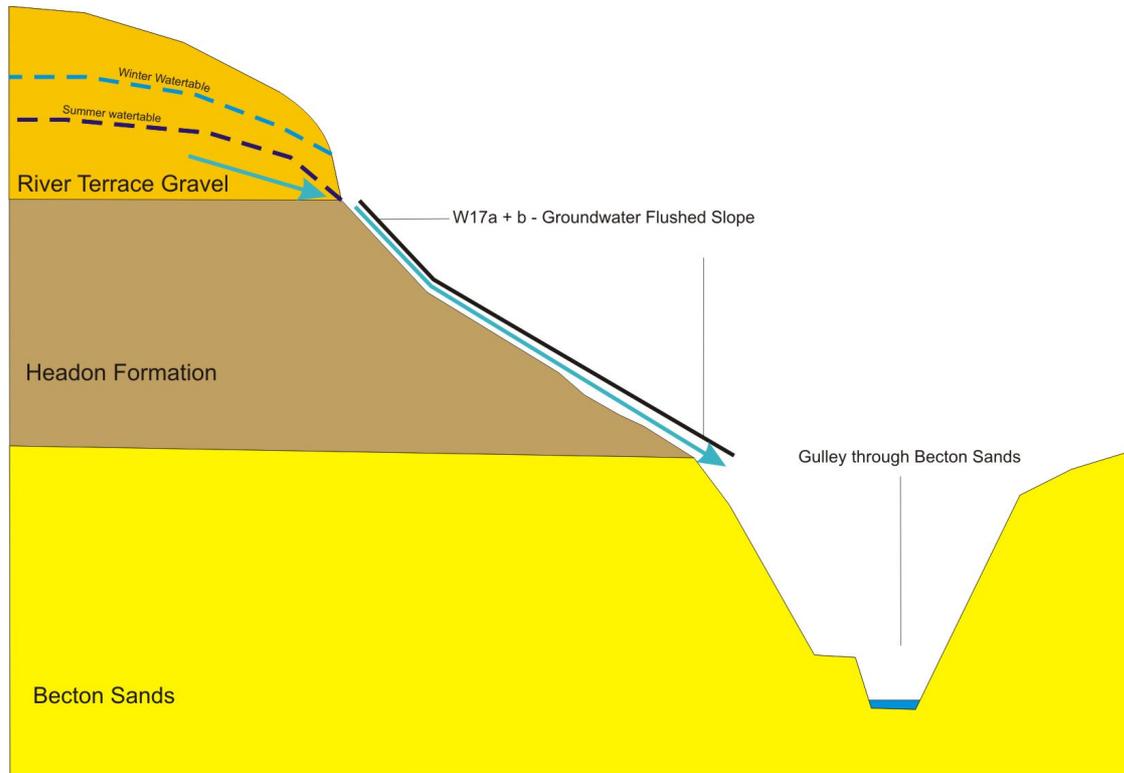
The two wetlands are flush dominated and appear to have very separate mechanisms. The river terrace gravels intersect the side of the valley in only a few very limited places. Where this occurs, a seepage face forms at the junction between the river terrace gravels and the underlying Headon Formation. Water runs over the low permeability Headon Formation, supporting a wetland community.

Figure 1-5: Conceptual Model Diagram of valley side wetland

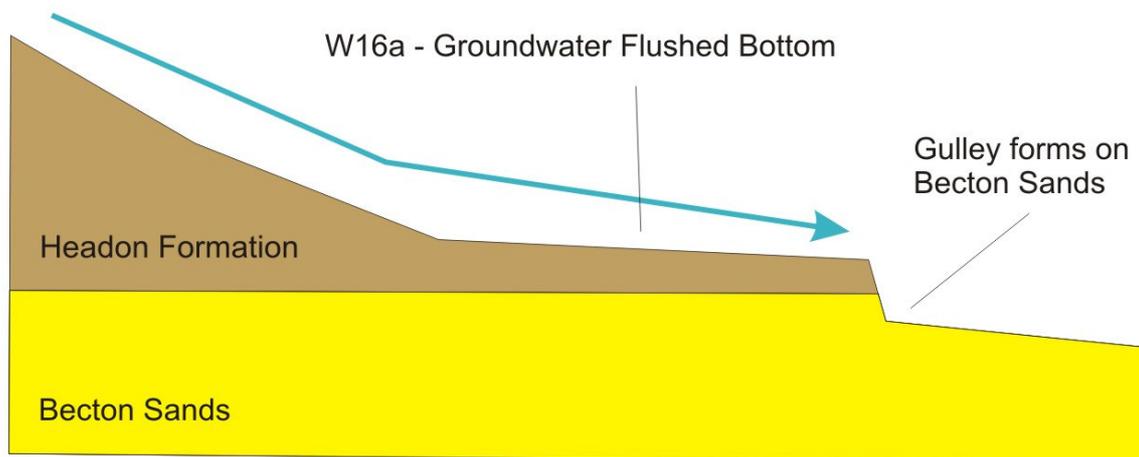
The valley bottom wet grassland area situated at the top of the site is within a depression and is underlain by the low permeability Headon Formation deposits. It is supplied by surface run-off channelled along the valley from the plateau. The area is poorly drained so the surface run-off collects in the area.

Figure 1-6: Conceptual Model Diagram of valley bottom wetland

Surface Water from plateau channelled into valley

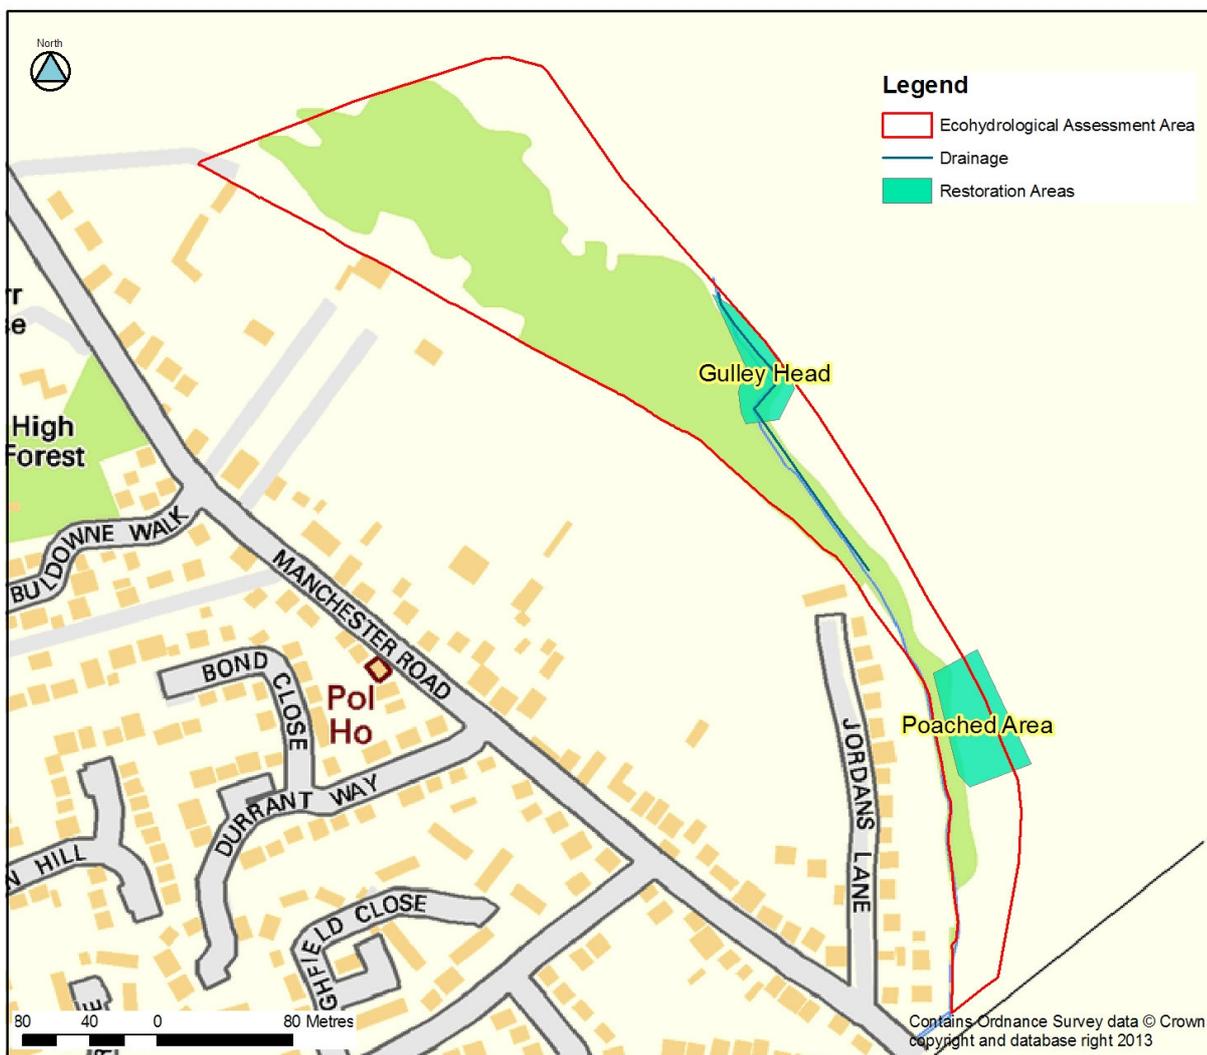
There are two areas of slight damage (see Figure 1-7):

Figure 1-7: Restoration Areas Map

Restoration Area	Damage Type	Restoration Proposals	Improvement	Constraints and Issues
Gulley Head	Drainage	Monitoring	Will ensure the extent of wet grassland remains the same and does not deteriorate further.	None
Poached Area	Poached Ground	Grazing management	Prevents sensitive mire habitat becoming trampled and damaged continuously.	Grazing rights may restrict any limitations on the existing grazing regime

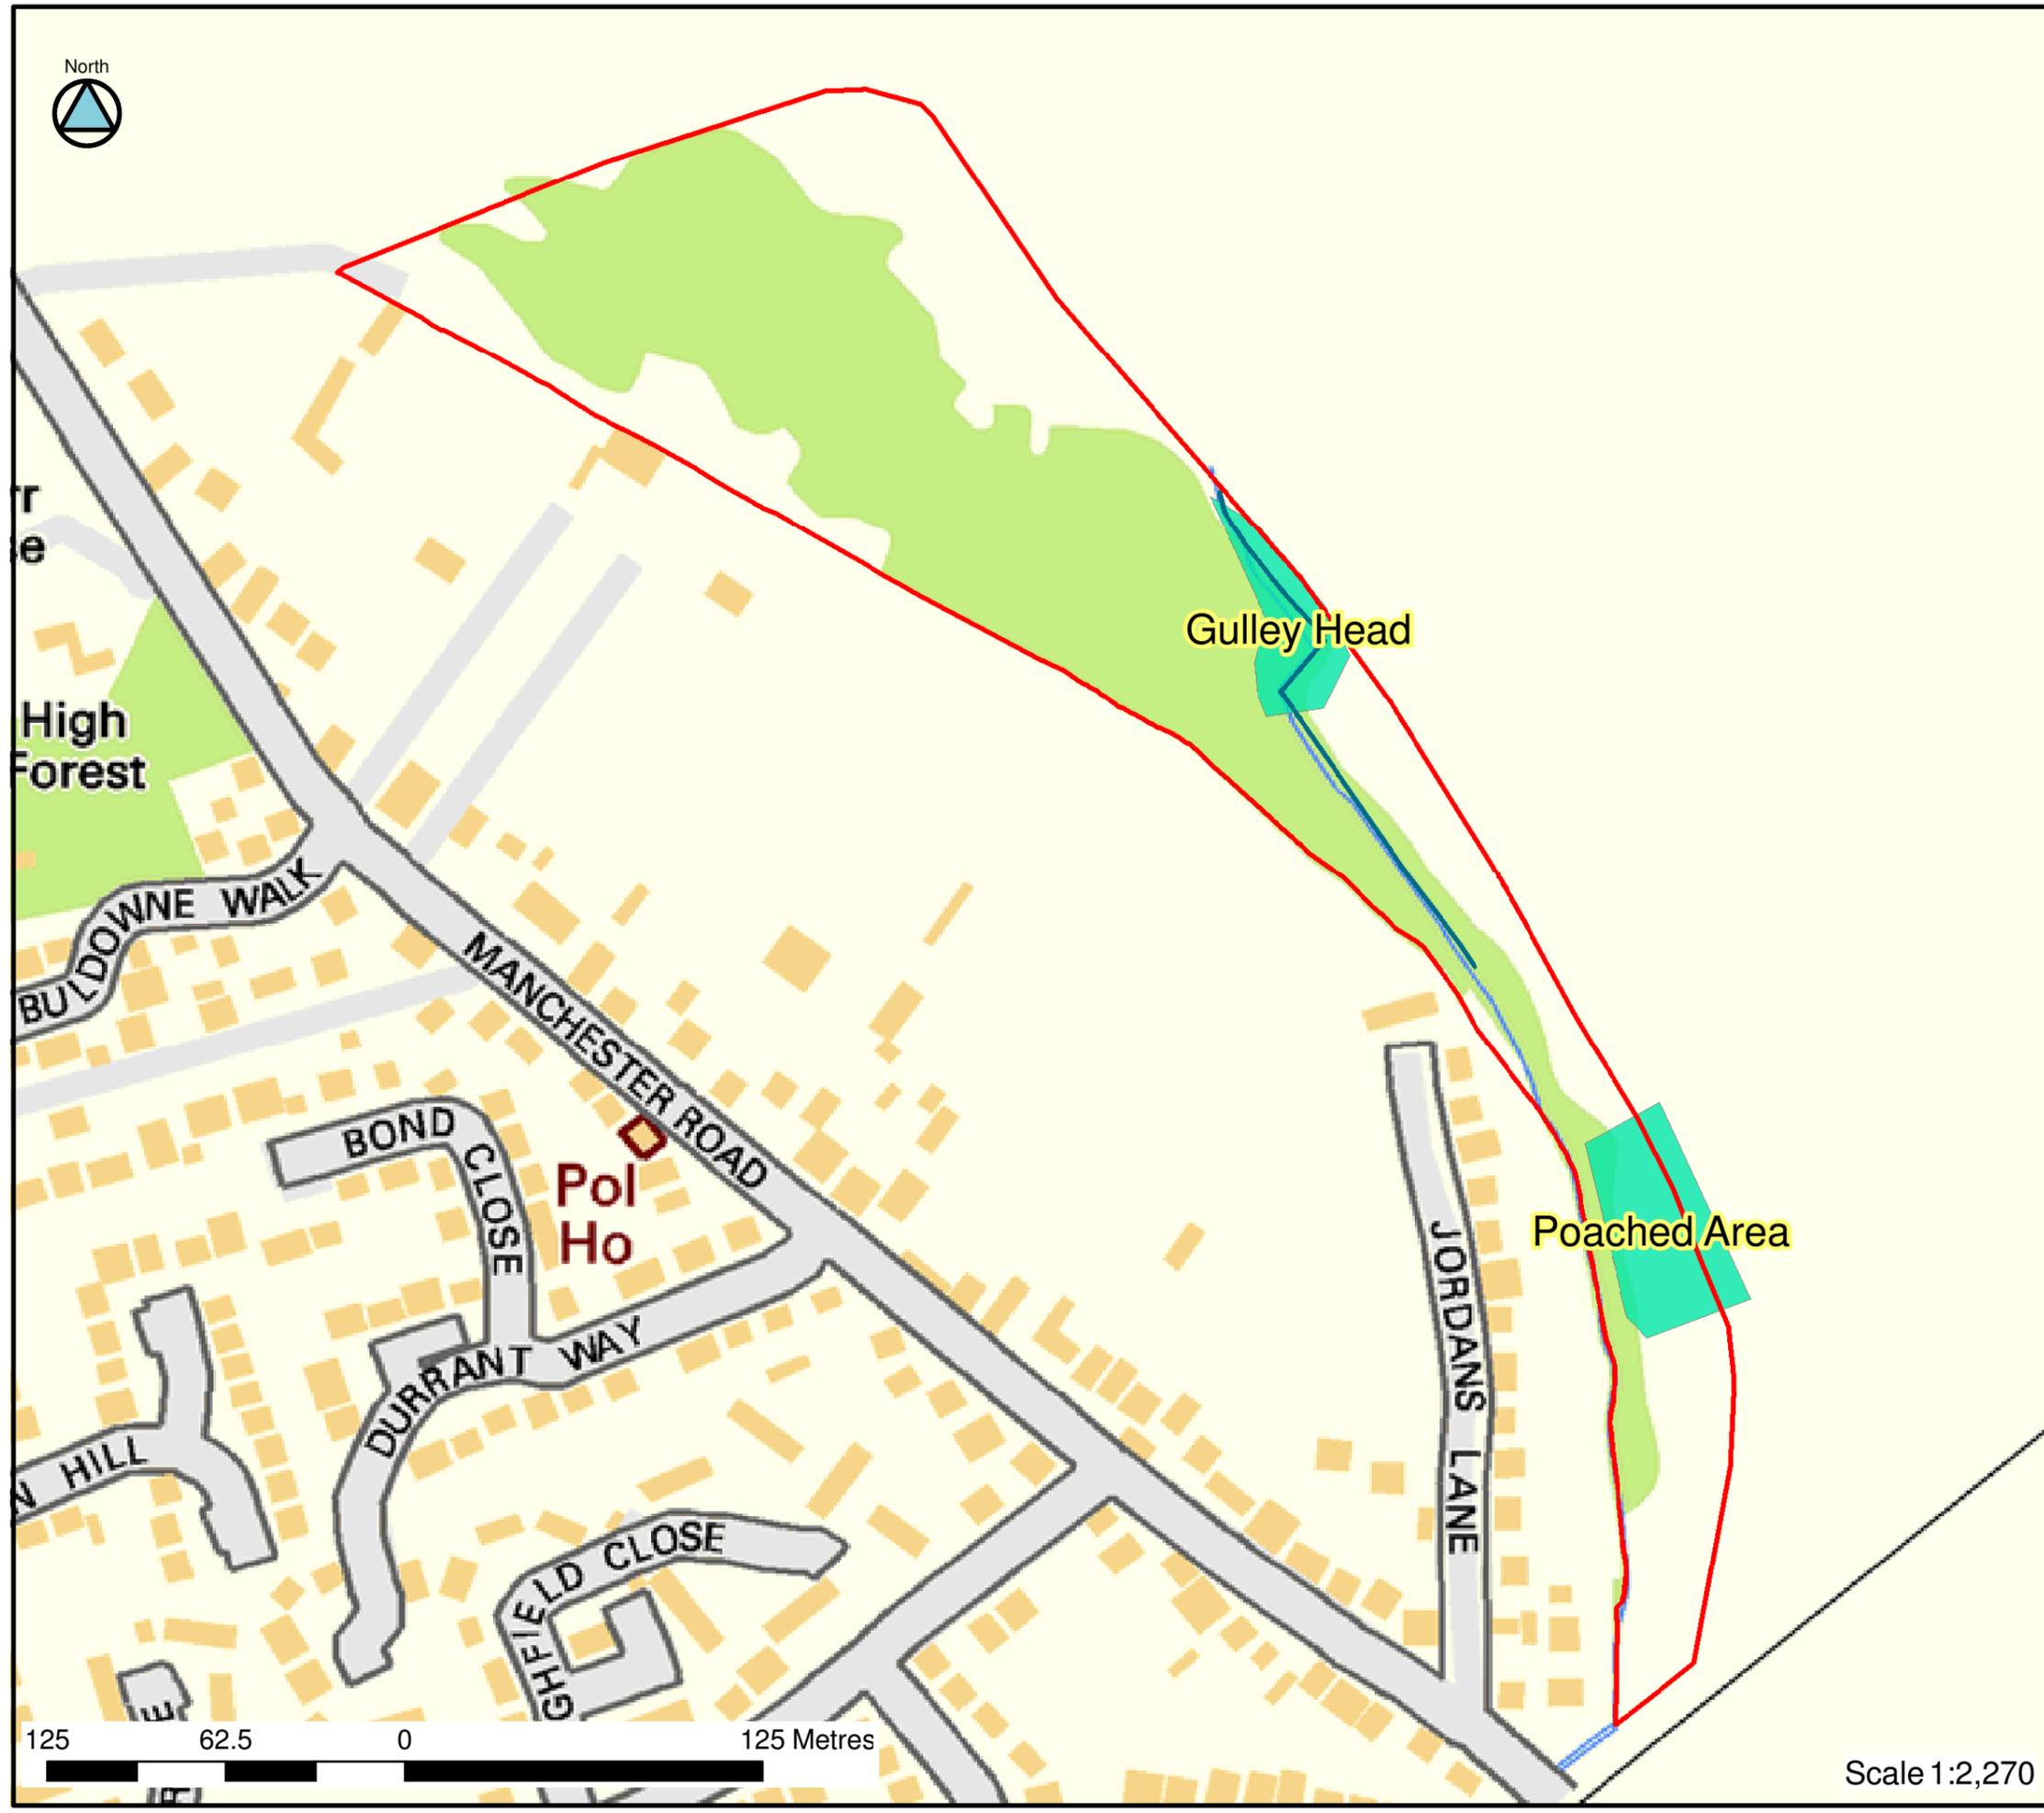
MAP 8

Restoration Plan
