Northey Island managed retreat

Report 4: Overview to February 1994

**Northey Island Managed Retreat
Report 4
Overview to February 1994**

**Institute of Estuarine and Coastal Studies
University of Hull
March 1994**

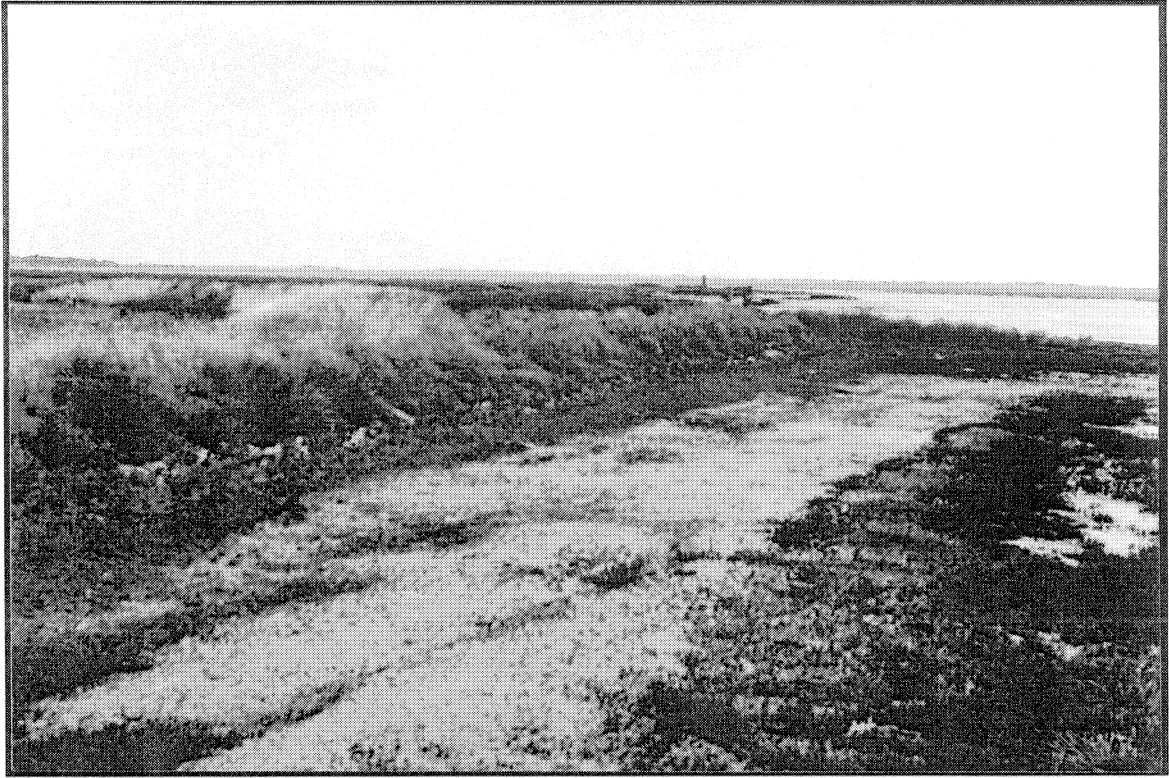
Plate 3: July 1993

The condition of the wall at the eastern end of the site was originally causing significant problems with erosion along much of its length, possibly through the action of internally generated wind waves. This necessitated maintenance work to strengthen the wall with geo-fabric although the continued erosion resulted in the geo-fabric being exposed again as shown in Plate 2. After this time, however, the general increase in vegetation cover over the entire site and the sea walls in the next growing season resulted in the eastern wall becoming much better stabilised as shown in Plates 3 and 4. These plates show that this wall is now well-vegetated in both summer and winter, increasing the overall levels of protection.

Eastern end of the site 2 years after implementation. Note significant increase in vegetation cover on the wall, and consequent reduction in wall erosion problems

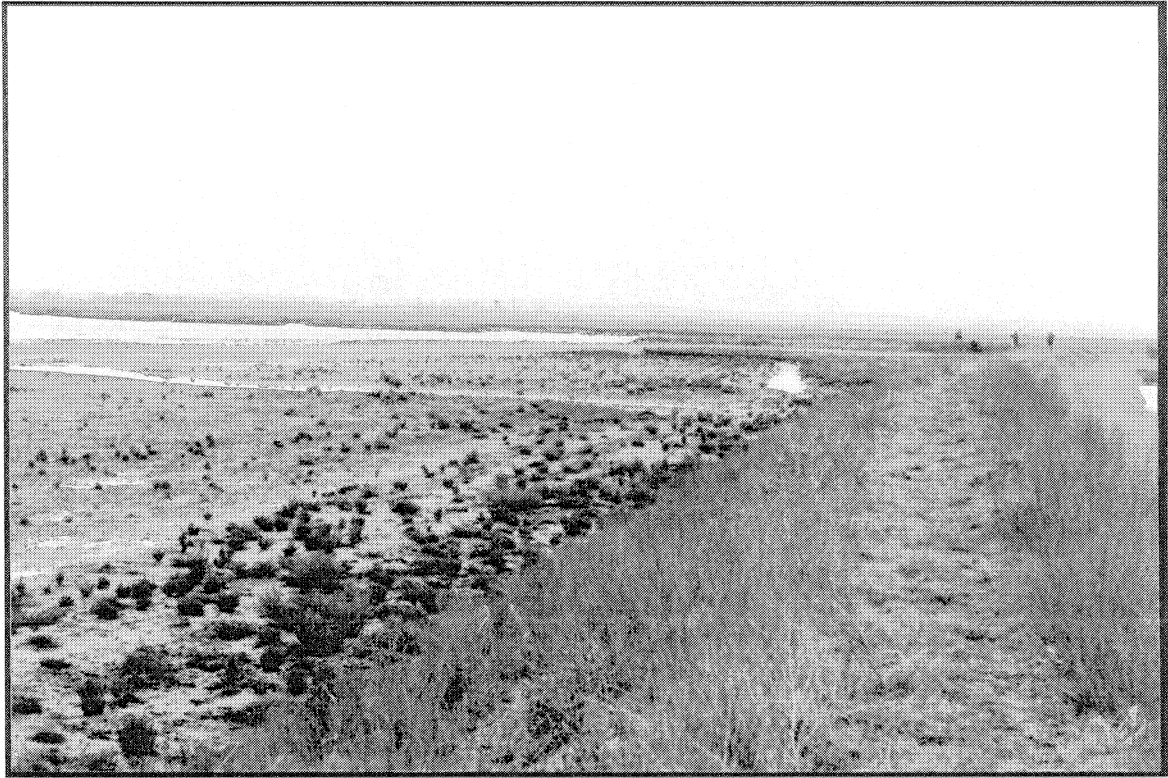
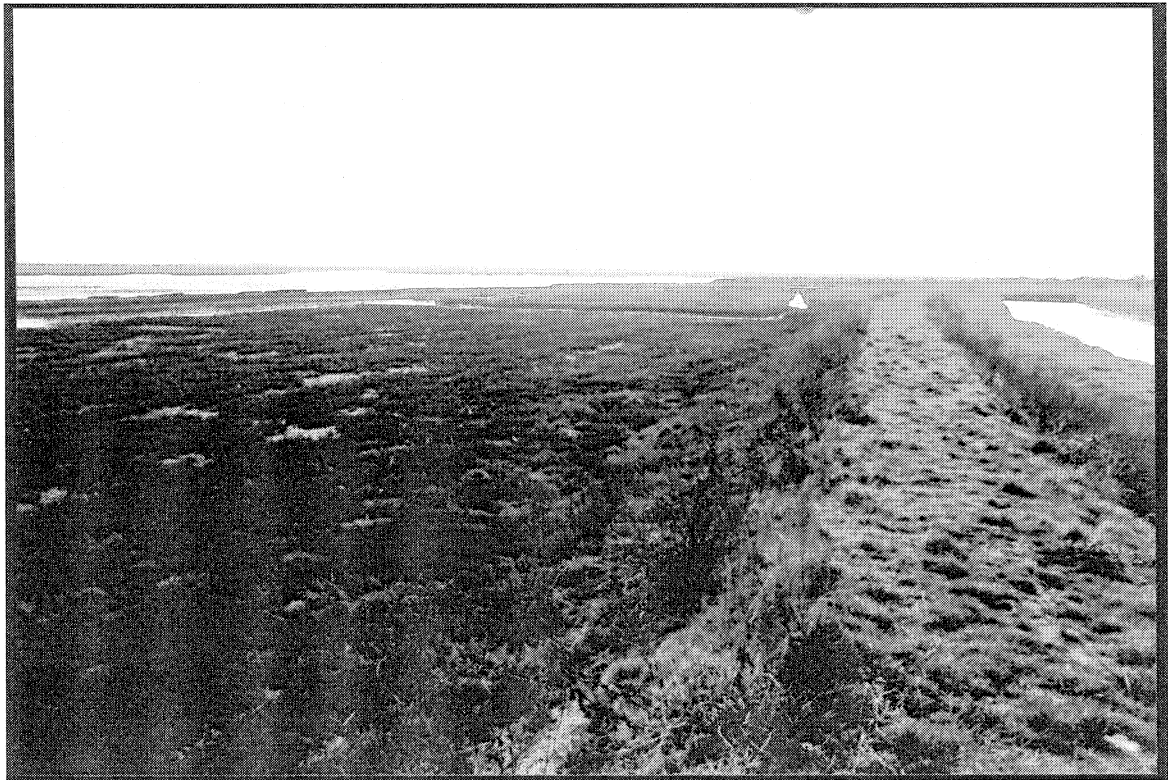
Views looking west across site showing dramatic increase in vegetation cover. Note distinct line of creek running from right to left, and old borrow pit running into distance

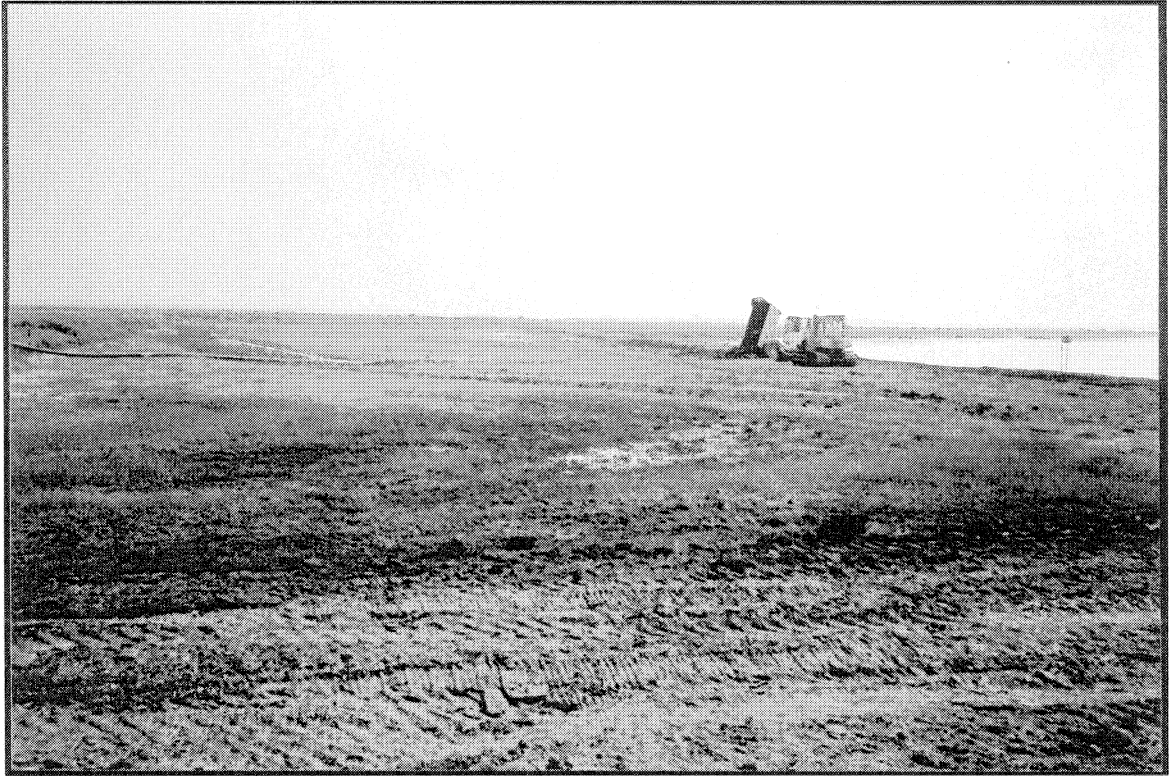
Plates 7 and 8 show the changes which have followed since the maintenance work to infill the borrow pits which took place in June 1992. This work has been successful from the point of view of stabilising the sea walls along the front and the eastern edge of the site, although incomplete in not filling the inner borrow pit. In addition, the tracks of the machinery to the outer wall remain visible 18 months after completion of the work, as shown in Plate 8 to the right of the standing water area.

Plate 7: June 1992
View looking east across site during maintenance work to infill the borrow pits

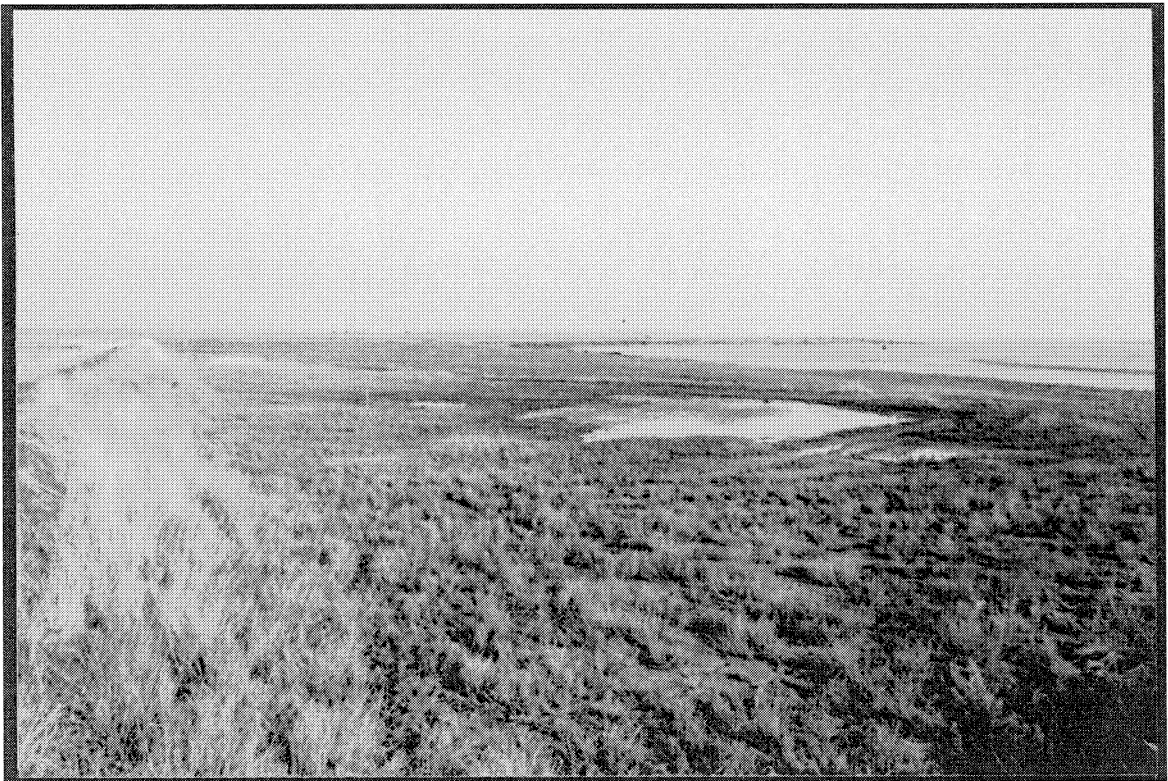
Plate 8: February 1994
View looking east across the site. Note raised vegetated line alongside old borrow pit, and large area of standing water unconnected to drainage network

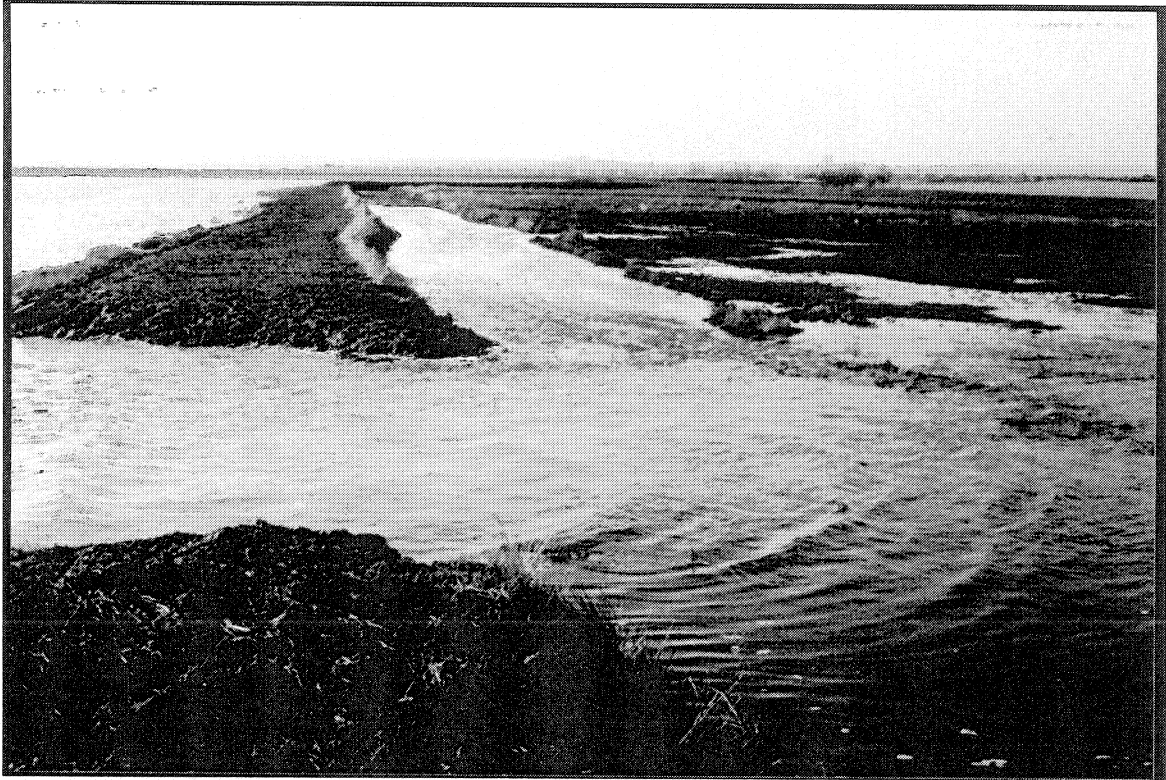
The degree of success achieved through infilling the front borrow pit may be seen in Plates 9 and 10. The first of these shows the rapid flows of water into the borrow pit, with the water reaching the far end of the site before the near end is flooded. After infilling the flow spreads more evenly across the site. The reduction in relative height of the outer wall produces a

Plate 9: January 1992
View across the spillway showing wave diffraction patterns and current flows into the front borrow pit before this was filled

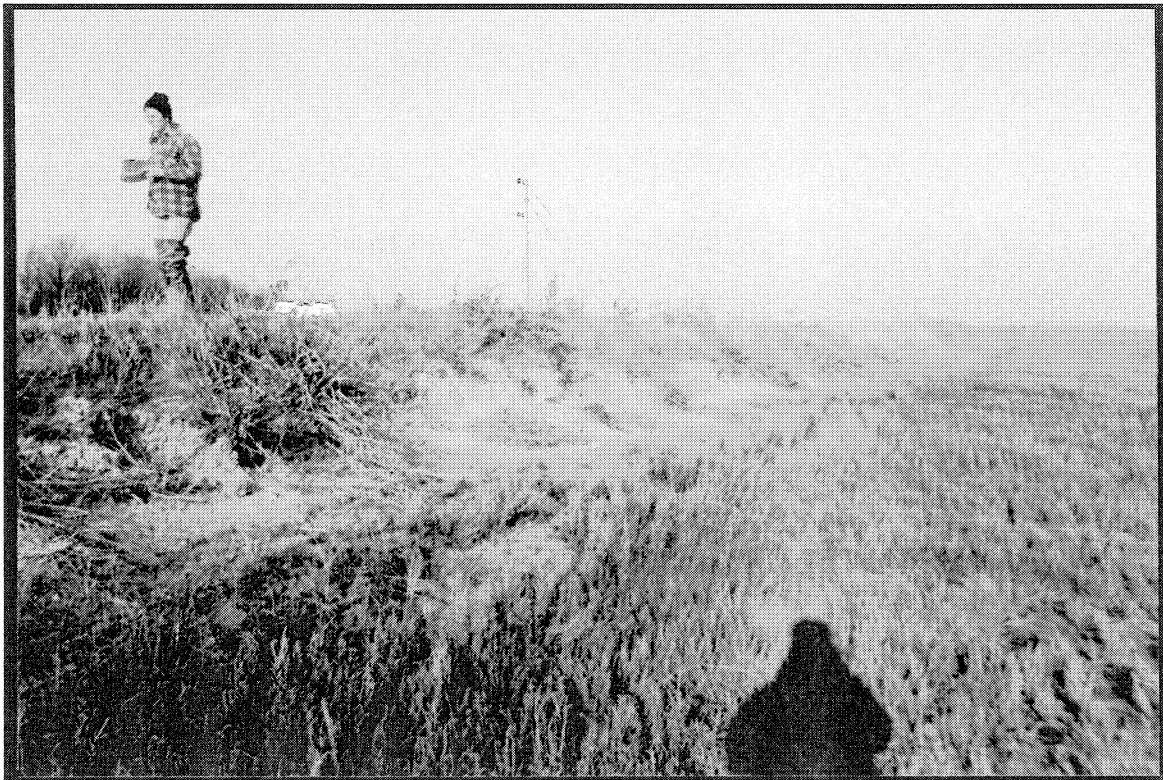
A further area of erosion has also been observed along the inner wall as shown in Plates 11 and 12. The erosion, which is located at the head of the central creek, is still relatively minimal, and is possibly caused by current flows up the creek impacting on the wall. Continued observation of this potential problem is recommended to ensure that the integrity of the wall is not compromised.

Plate 12: February 1994
Closer view of erosion of the inner sea wall

The early problems with erosion of the eastern wall have been alleviated by the development of a good vegetation cover. However, further minor problems are being experienced by the back wall at the head of the relic creek, possibly from rapid current flows along the creek impacting on the wall. It is recommended therefore that observation of this wall is continued.

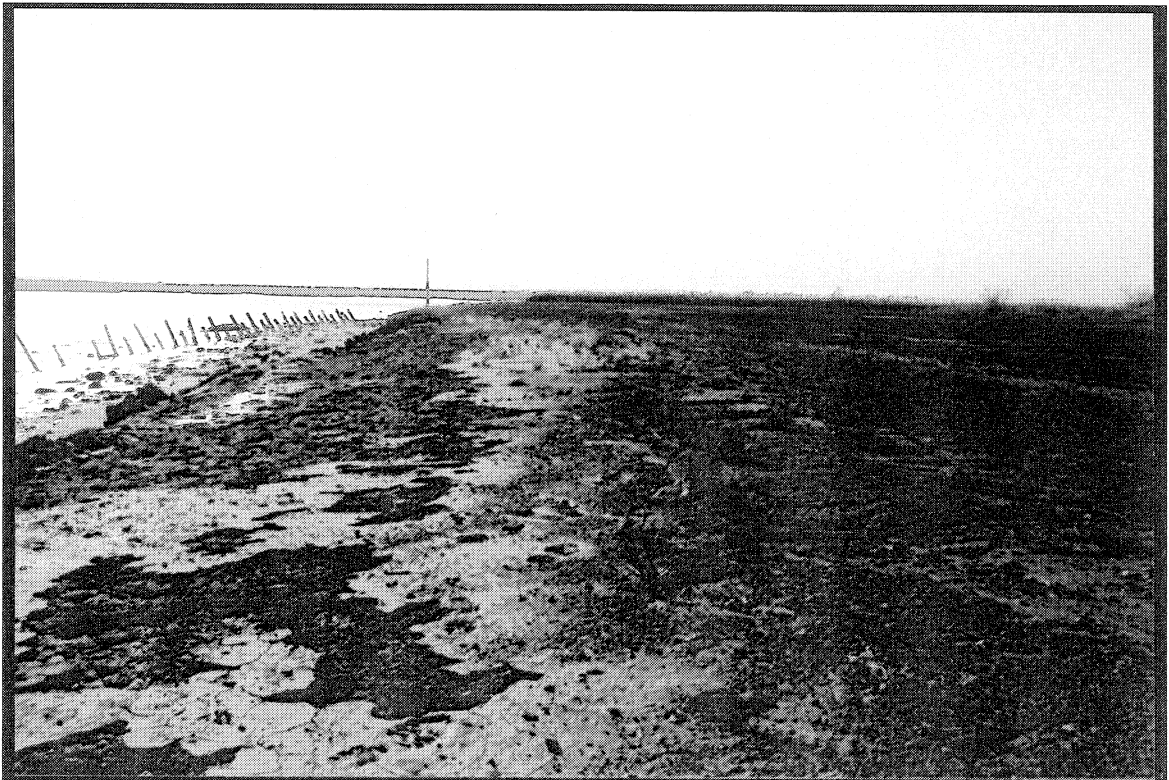
more even grading into both the back marsh and the spillway. This has allowed colonisation by stabilising marsh plant species which helps to reduce the problems of scour from extreme flows down the rear of this wall. However, close observation of this wall has identified that the surface of the front of the wall is being removed in layers, resulting in an overall lowering of the surface elevation, particularly noticeable relative to the remnants of fronting blockwork (Plates 13 and 14).

Plate 14: February 1994
Looking along the front wall from east to west showing flaking of surface sediment layers

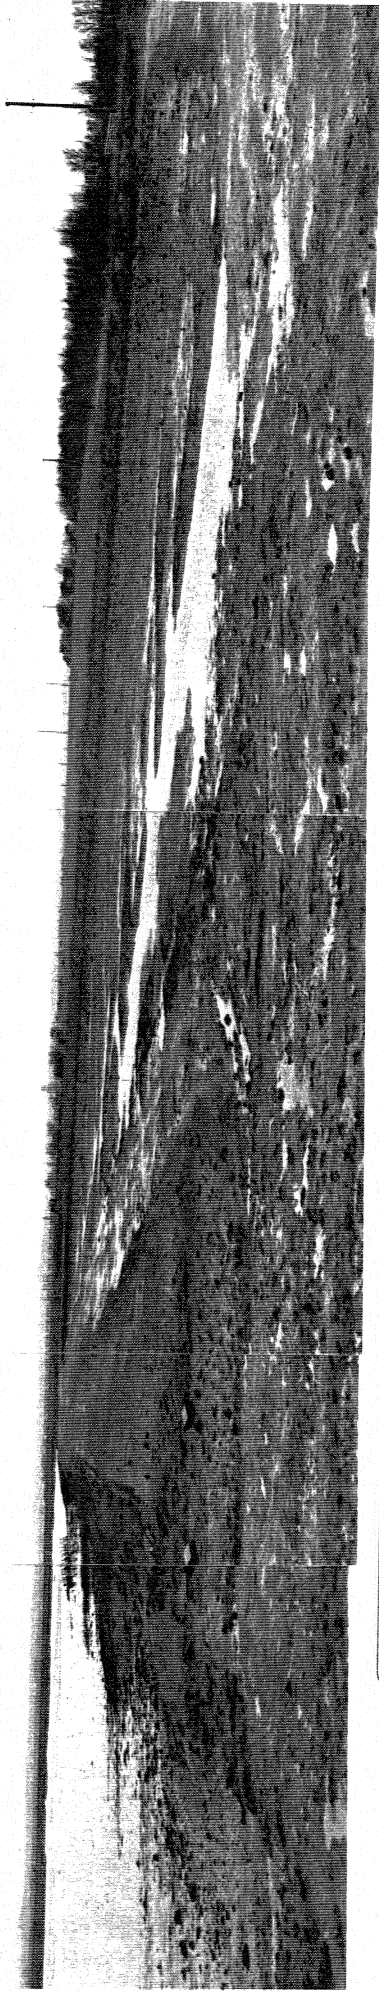
Plate 15: February 1993
General view across the whole site looking west from the spillway corner
