Natural England Commissioned Report NECR141

# New Forest SSSI Ecohydrological Survey Overview

Annex H: Picket and Buckherd Bottom

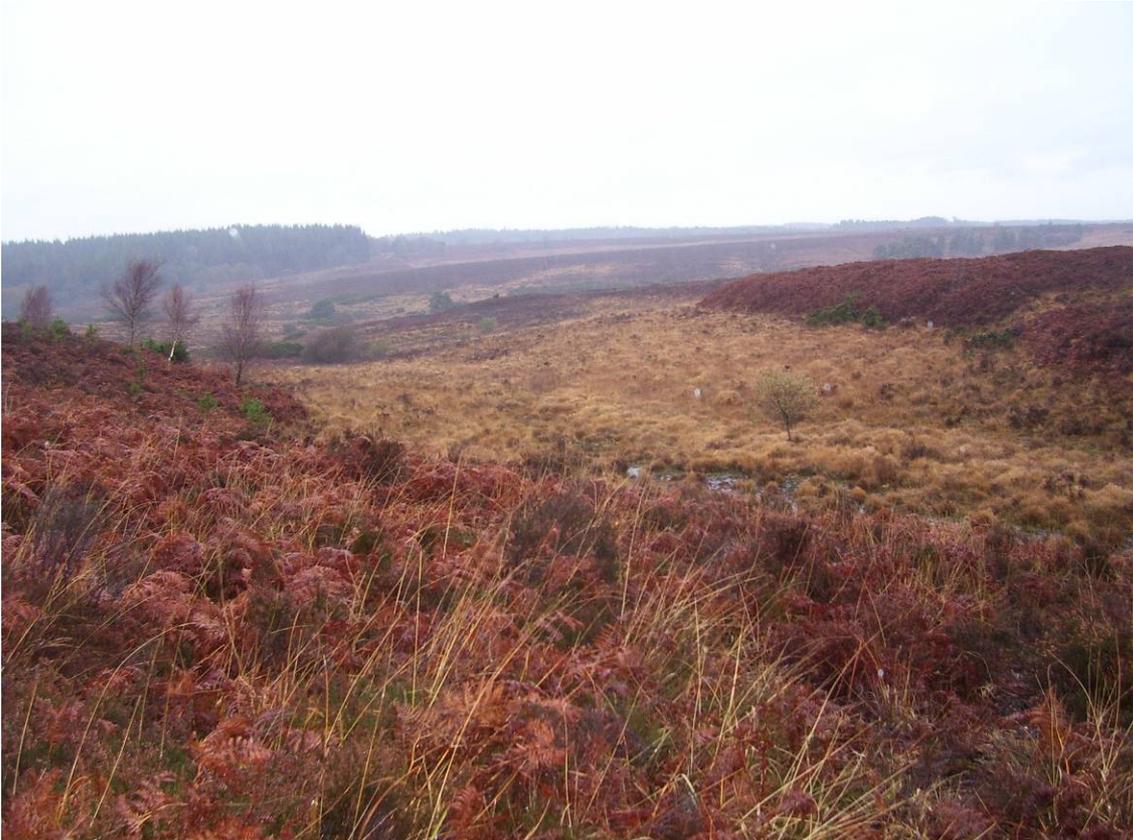
**Figure 1-2: General view looking northwards over Buckherd Bottom from near the A31 (NGR 421211 107859) - the orange/brown bracken-covered areas correspond closely to the river terraces**

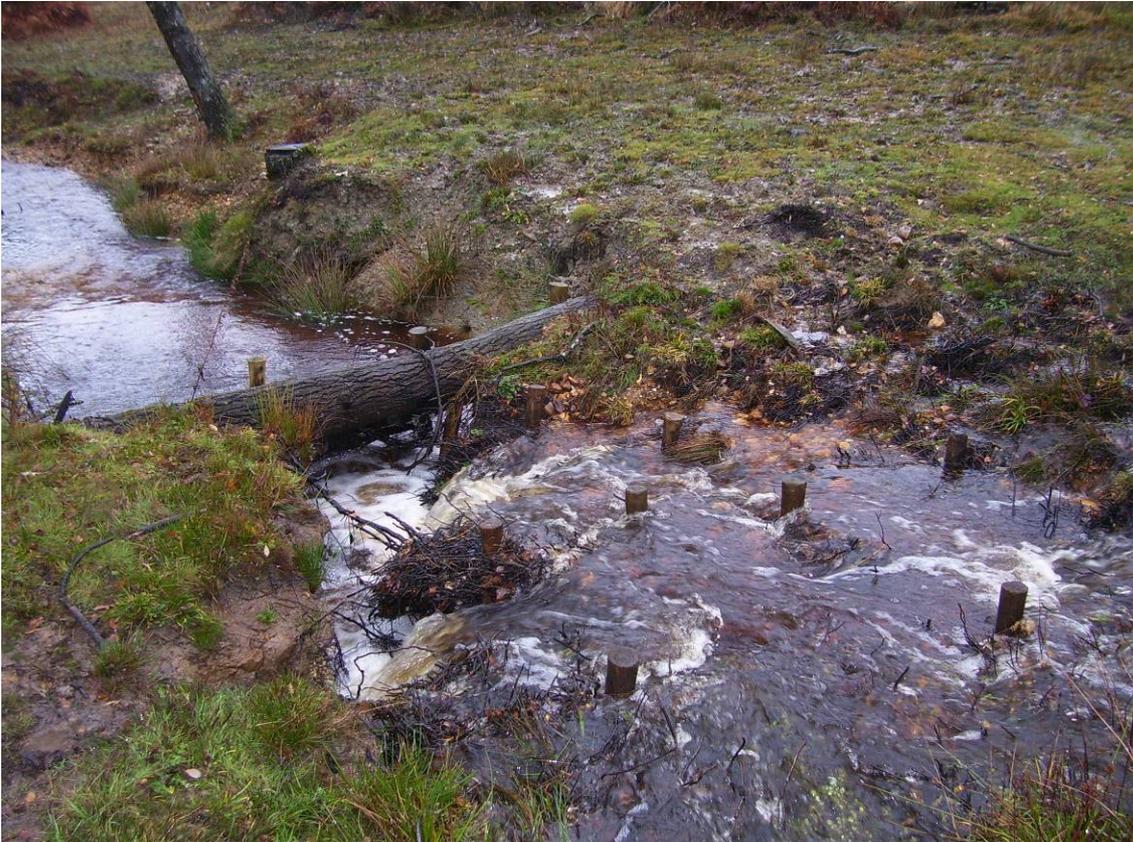
**Figure 1-3: Existing restoration measures to combat erosion: log, posts and heather bales on the outflow channel from Buckherd Bottom (NGR 420763 108453)**

At the outflow from the site the (combined) stream is about 2 m wide and has undergone significant headward erosion. Remediation measures have been put in place in an attempt to prevent the erosion. At one location, logs and heather bales (secured by wooden stakes) have been installed within the channel (Figure 1-3). At another location a short distance downstream, heather bales have been staked in place immediately downstream of a low weir structure (Figure 1-4). These measures have been only partially effective, with heather being washed out by high energy stream flows.

The headward erosion has taken place within the mineral substrate and has not directly affected the peaty soils of the valley mire. However, continued upstream propagation of the erosion would potentially pose a threat to the mire habitats in the future.

No ecohydrological restoration proposals are made for this site, but it is recommended that the outflow channel from Buckherd Bottom be monitored to detect any further significant headward erosion. If a problem is identified then it may be necessary to take further steps to prevent the erosion by modifying, adding to, or replacing, the existing structures. Further slope control measures could potentially include the installation of more weirs with infilling/re-profiling of the channel, forming a stepped morphology. The engineering design of suitable control measures would need to be based on a detailed study beyond the scope of this report.

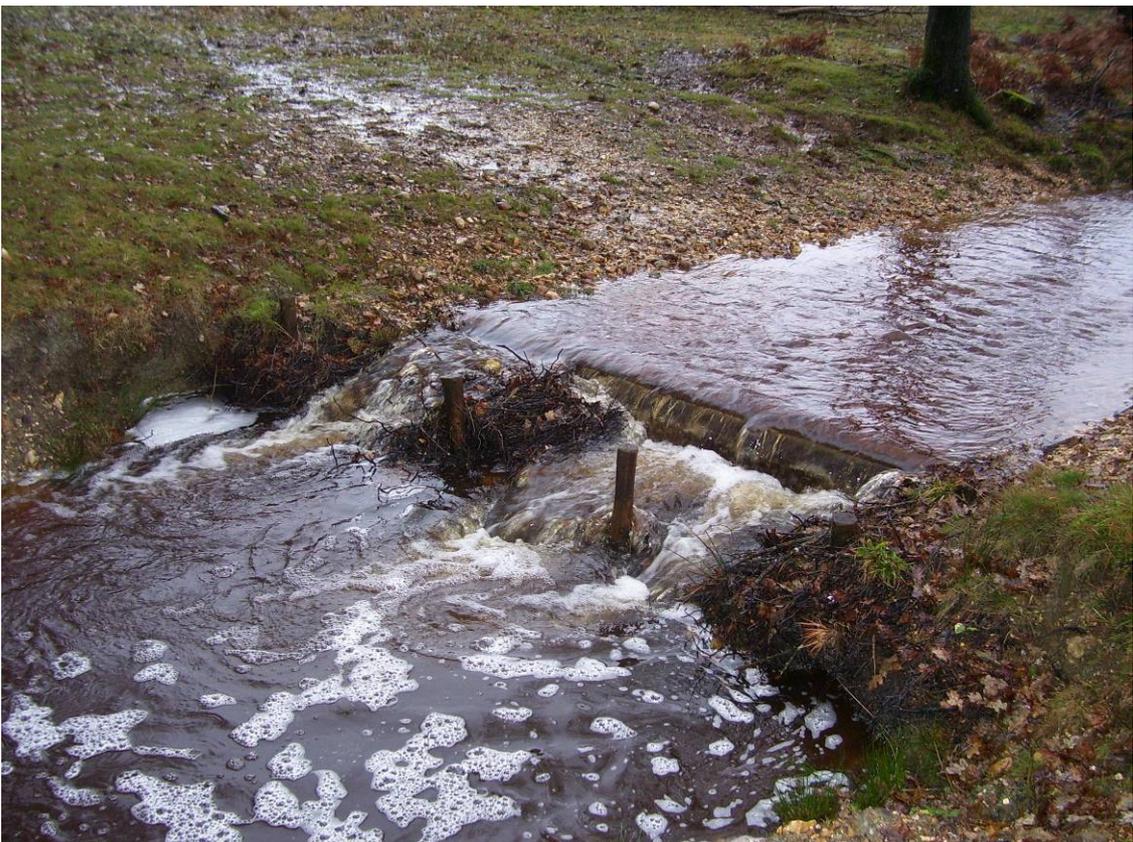
**Figure 1-4: Existing restoration measures to combat erosion: low weir, posts and heather bales on the outflow channel from Buckherd Bottom (NGR 420717 108488)**
