### Chapter 9. Illustrated examples – open coast

The examples in this chapter are adapted from real sections of coast, but intended only to illustrate how new coastal access rights might be implemented in a range of situations. Each example features several of the common coastal scenarios discussed in chapters 7 and 8, to demonstrate how we intend to balance the public and private interests in complex coastal situations.

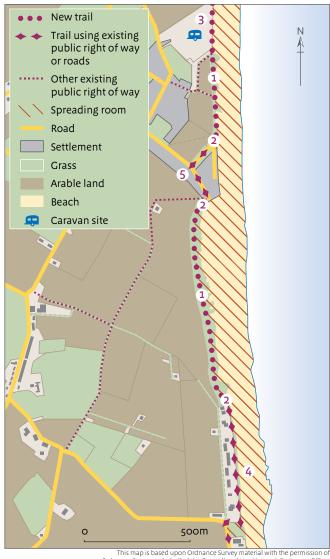
### Figure 22

# Features: unenclosed arable land, cliff erosion, settlements, caravan site.

Figure 22 illustrates the trail passing along the seaward edge of unenclosed arable fields on an eroding cliff. There is spreading room on the cliff and beach below. The trail occupies a grassy margin left by the farmer for operational safety reasons ①. In these sections, the trail will roll back automatically as the cliff erodes, but it will remain a fixed distance measured from the edge of cultivation. The map shows its starting position.

Signs at strategic locations explain to the public how the trail rolls back and give other useful information, such as beach access points 2.

The trail passes along the seaward edge of a caravan site ③ and through two cliff-top settlements. It passes along the seaward edge of one row of houses ④, but cuts inland round others because the gardens extend to the cliff edge ⑤. The trail cannot roll back automatically in these sections; when the present route is no longer viable, we will recommend a new one to the Secretary of State. We will take account in our recommendation of the need for the trail on the affected section to join up with the sections of trail to either side.

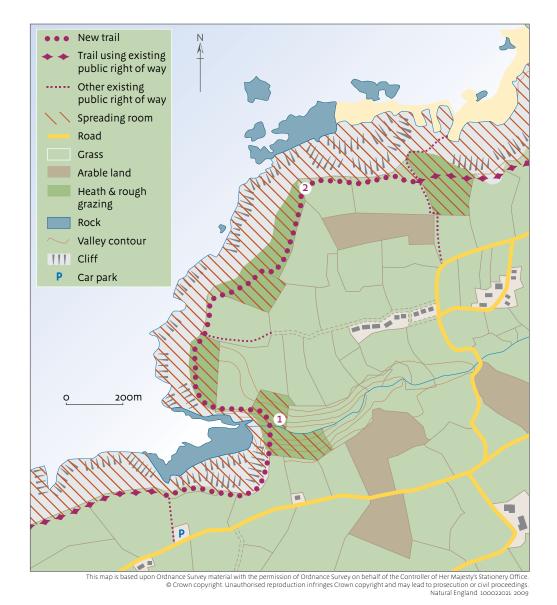
### Figure 23

# Features: enclosed and unenclosed arable land, cliff erosion, ravine.

Figure 23 illustrates an eroding cliff interrupted by a steep ravine. The trail passes around the fenced edge of the ravine because this is the safest and most convenient route.

To the southeast of the ravine the trail follows the edge of an unenclosed arable field, overlooking the cliff ①. Here the trail will roll back automatically as the cliff erodes. The map shows its starting position.

To the northwest of the ravine, the trail is on grassland overlooking the cliff. The map shows its starting position, a fixed distance to the seaward side of a field wall ②. When the cliff erodes significantly, this route will no longer be safe for walking. At that stage the access authority will install signs indicating that the trail has moved to a safe route behind the wall

The ravine, cliff, beach and other areas seaward of the trail will be spreading room.

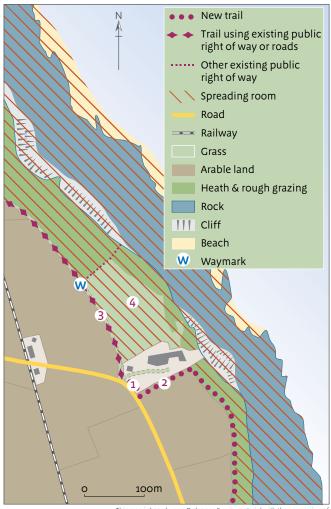
### Features: cliff, enclosed pasture, coastal valley, spreading room.

Figure 24 illustrates cliff top fields interrupted by a coastal valley.

The trail crosses the valley near the sea ①. Although the route is quite steep here, it is preferred to any inland alternative because it is more direct.

The trail broadly follows the cliff edge elsewhere along this section. It stays on the seaward side of field walls wherever a safe and convenient route can be found along the cliff top. Where this is not possible, gates allow people to enter enclosed fields and walk along them on the seaward edge, for example at ②.

A sign at the car park provides advice to walkers on how to behave around any livestock they encounter, in particular how to keep their dogs under effective control.

The areas of rough grazing, cliff, rock and beach seaward of the trail are spreading room, together with rough grazing land landward of the trail up to the first field boundary.

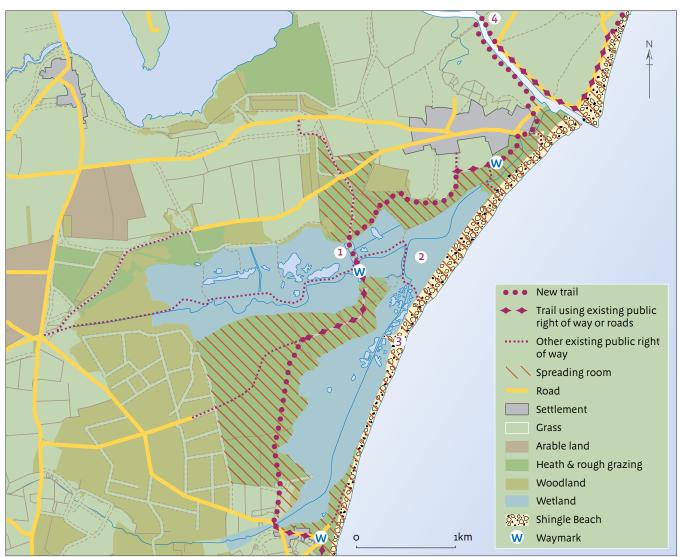
### Features: shingle beach, spreading room, circular walks, sensitive wildlife.

Figure 28 illustrates a shingle beach backed by wetland. The wetland is fringed by gently sloping ground with a mixed cover of heath, rough grass, woodland and enclosed fields.

The shingle is difficult to walk on. It is also prone to flooding during storm conditions and is not actively maintained for flood defence. The route chosen for the trail follows higher, firmer, drier ground, crossing the wetland on an embankment ①. This is a less direct route along the coast than the beach, but it is a more convenient and reliable walking surface for the long-term. It offers fine views of the sea and surrounding wetland landscape and wildlife.

Land seaward of the trail is accessible as spreading room, enabling people to walk along the shingle beach if they wish to. This creates possibilities for circular coastal walks. Way markers at strategic point wo point out the main route and the alternative along the beach.

We have used our discretion to create further spreading room over heath and rough grassland landward of the trail. In these places, the inland boundary of the spreading room coincides with an existing boundary, in this case the boundaries of adjoining woodland and wetland areas.

Access to the wetland seaward of the trail is excluded to prevent disturbance to wetland birds 2, though the public may walk through it along an existing right of way if they wish to. There are small fenced sections on the shingle which are used by nesting birds 3, but these do not prevent the public from walking past. Signs here explain the need for people to prevent their dogs from approaching birds or nests.

In the northeast of the map, the trail follows a river bank inland for a short distance, before crossing it at the first pedestrian bridge 4 and returning to the open coast.
