Natural England Commissioned Report NECR141

New Forest SSSI Ecohydrological Survey Overview

Annex T: Suburbs Wood

First published 06 March 2014

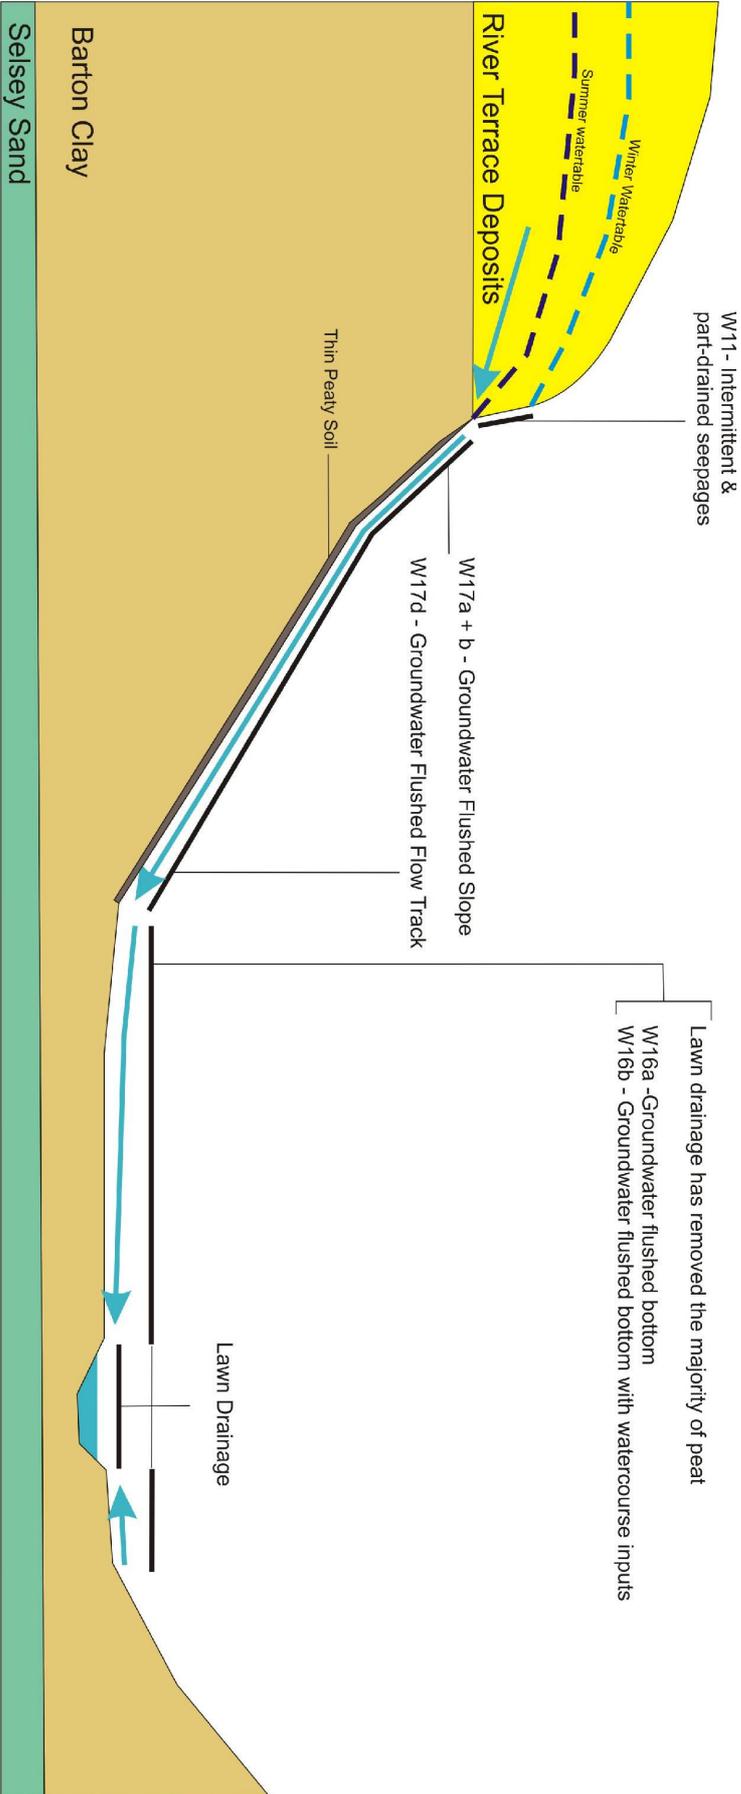
Figure 1-5: Conceptual Model Diagram

The wetlands on site are flush dominated (see Figure 1-5). They receive water from a seepage face at the junction between river terrace deposits (aquifer) and the underlying Barton Clay Formation (aquitard). The water runs over the surface of the low permeability Barton Clay forming narrow flushed slopes in the main valley before reaching the shallow lawn valley bottoms. The lawn drainage has been effective over much of the area and has led to the degradation and removal of any peaty soils or peat that might have previously been present on in these areas.

The river terrace gravels only intersect the valley sides in two locations, one at the top of each of the feeder arms of the unit. In both locations at the heads of the two valleys, a valley side wetland has formed. Their differing lengths are controlled by the local topography.

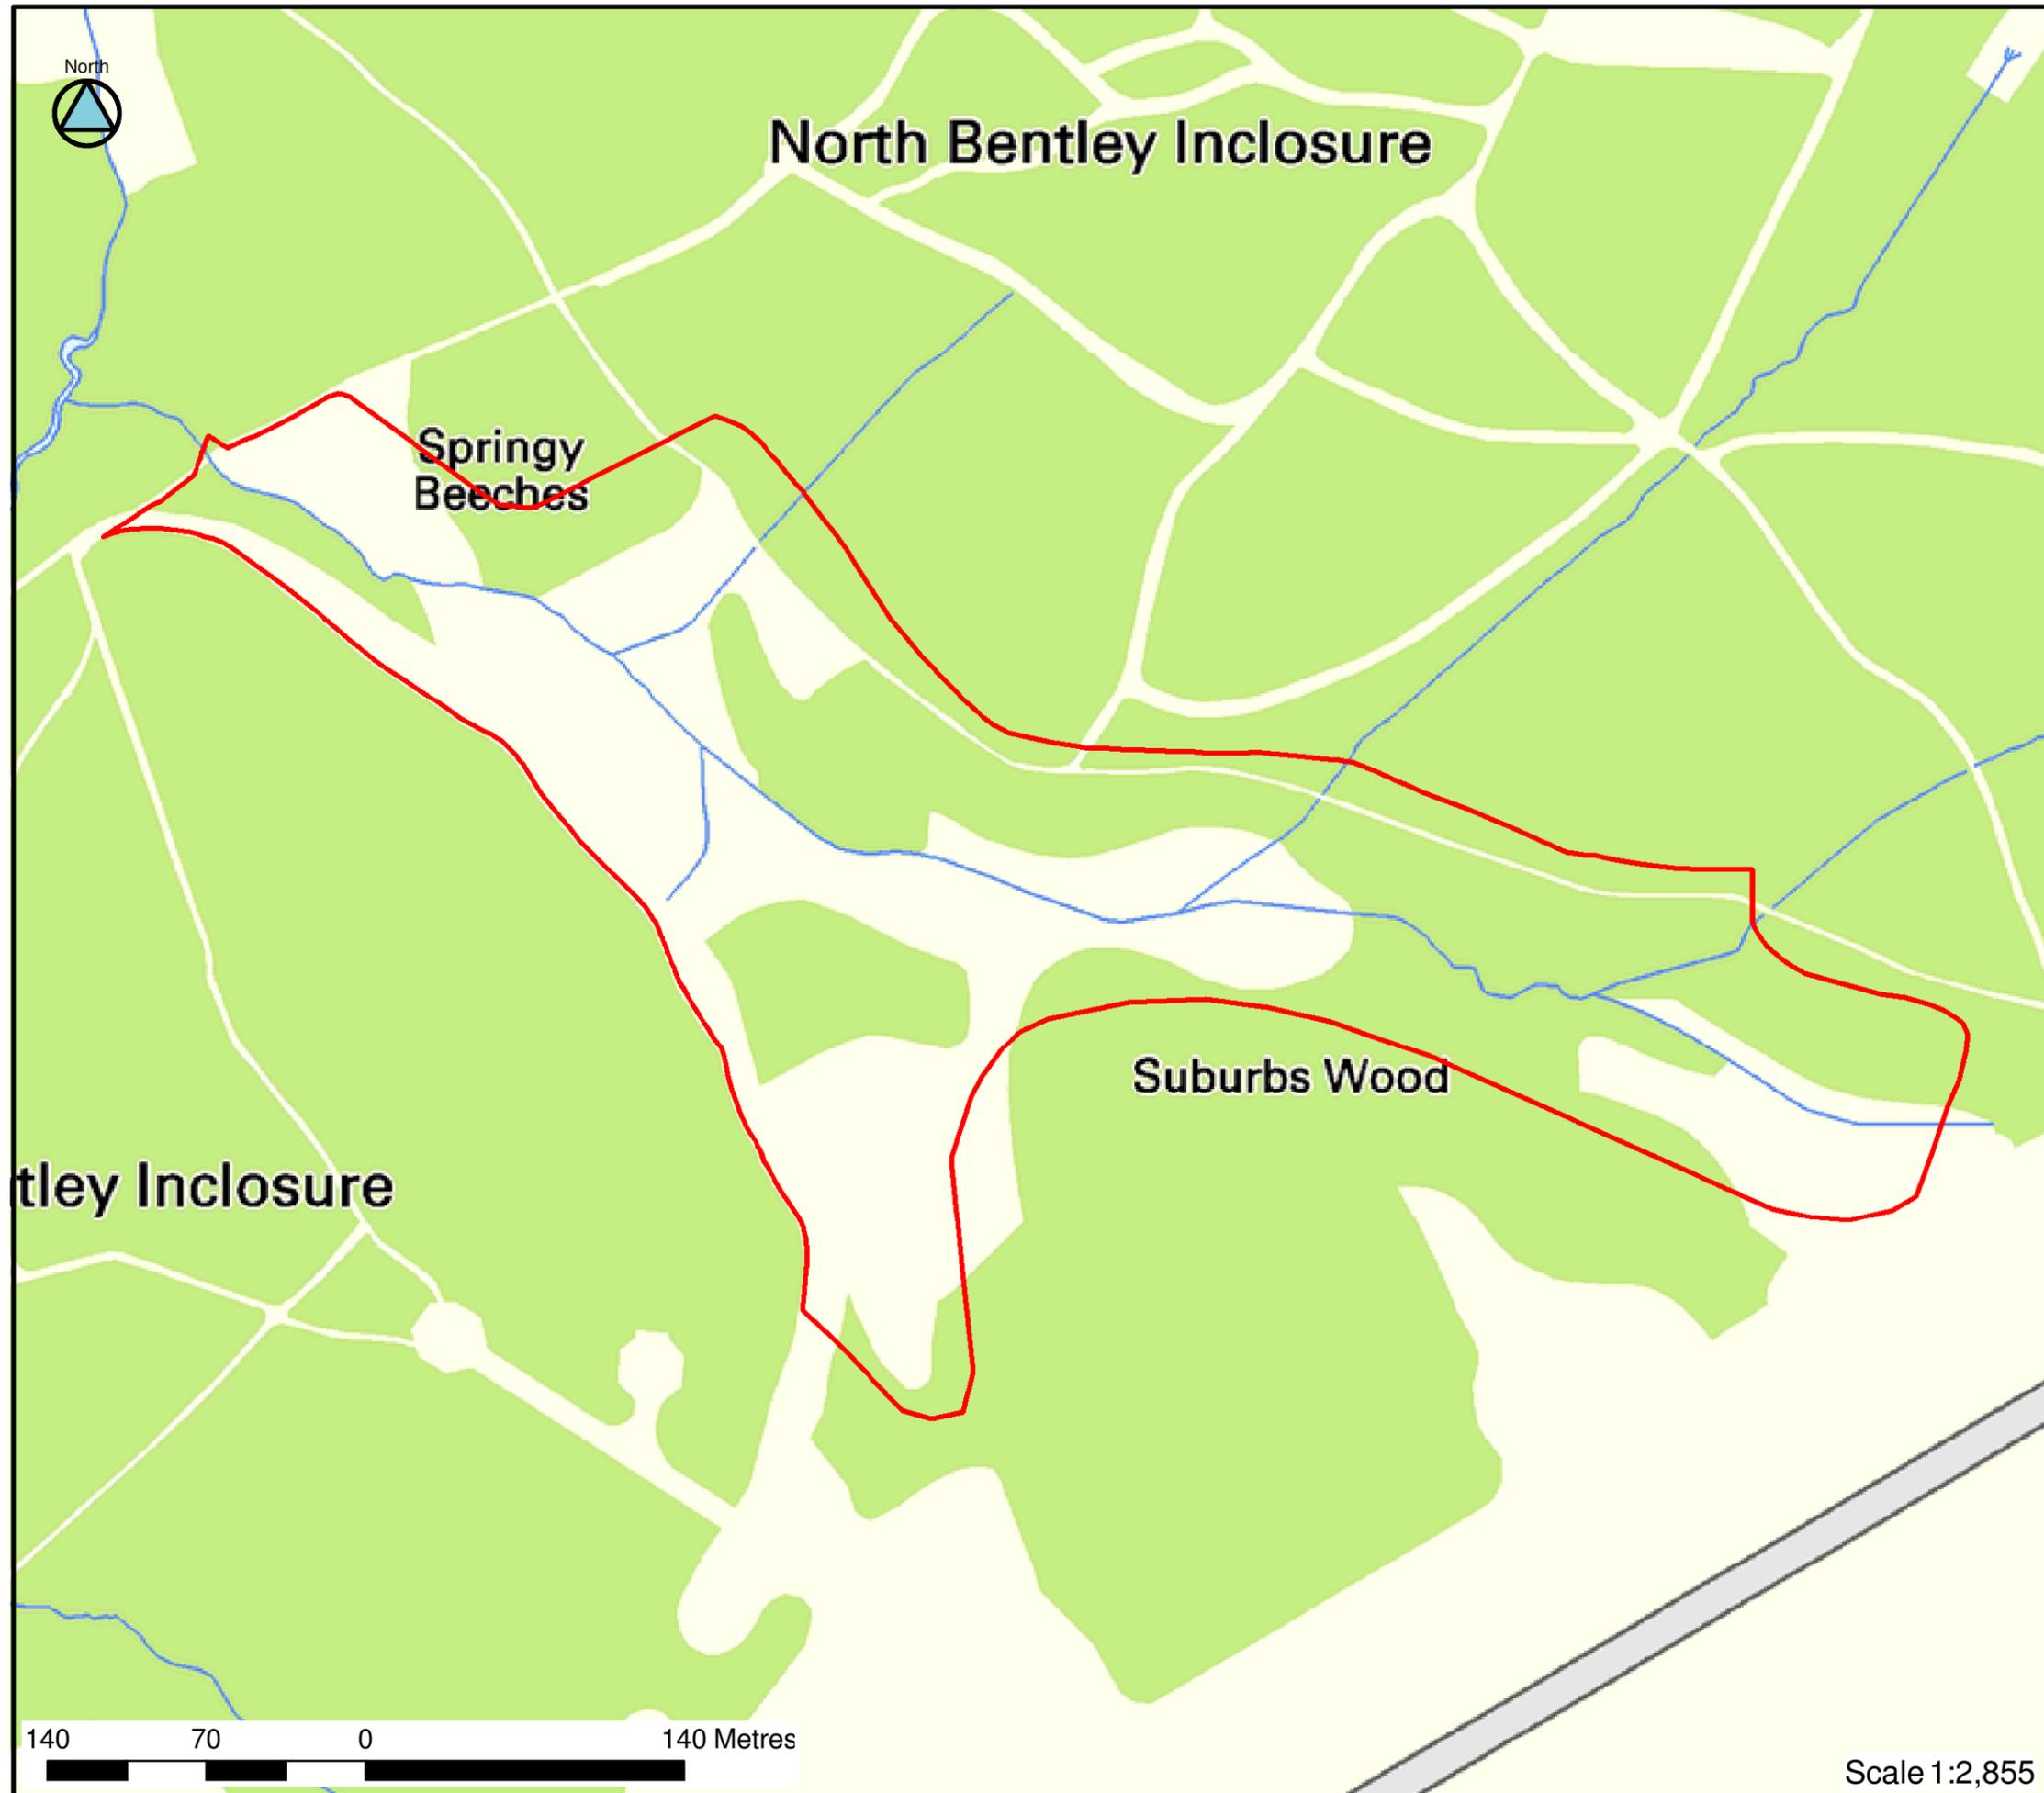
Map 8: Restoration Plan

There is one area of damage (see Figure 1-6). This is at the top of the main valley, where the lawn drainage channel continues into the valley side wetland. The seepage from the river terrace gravels has overwhelmed the drainage and so a transition between a lawn habitat and an intact valley side wetland has formed. The drain in this area could be infilled or blocked with suitable earth or wooden plugs although this is already happening naturally as the drain silts up. All other areas of lawn are dependant on the drainage so no other restoration is recommended.

No restoration of the lawn areas is recommended as they appear to be reliant on the current drainage and no vestige of the original pre-drainage wetland remains.

Restoration Area	Damage Type	Restoration Proposals	Improvement	Constraints and Issues
Upper lawn	Drain	Infilling or plugging of the drain	Limit drainage of valley side wetland and increase mire area	The drainage may allow some lawn habitat in this upper areas
