Natural England Commissioned Report NECR140

New Forest SSSI Geomorphological Survey Overview

Annex O: Ferny Croft South Restoration Plan - SSSI Unit 426

1 Ferny Croft South Restoration Plan - SSSI Unit 426

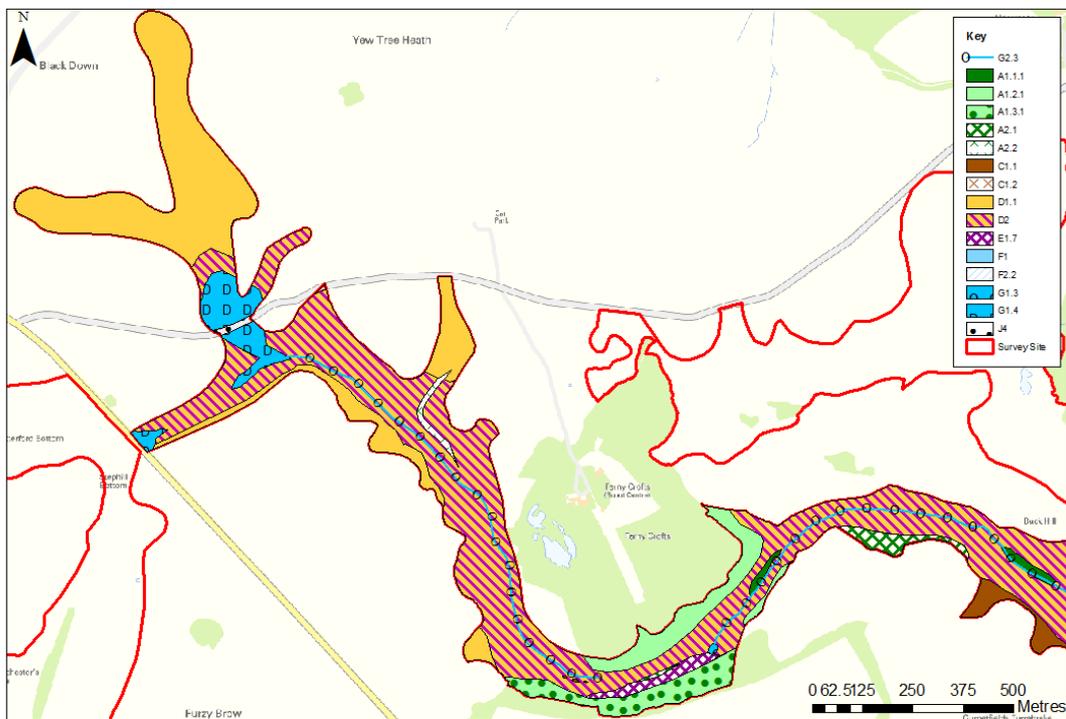
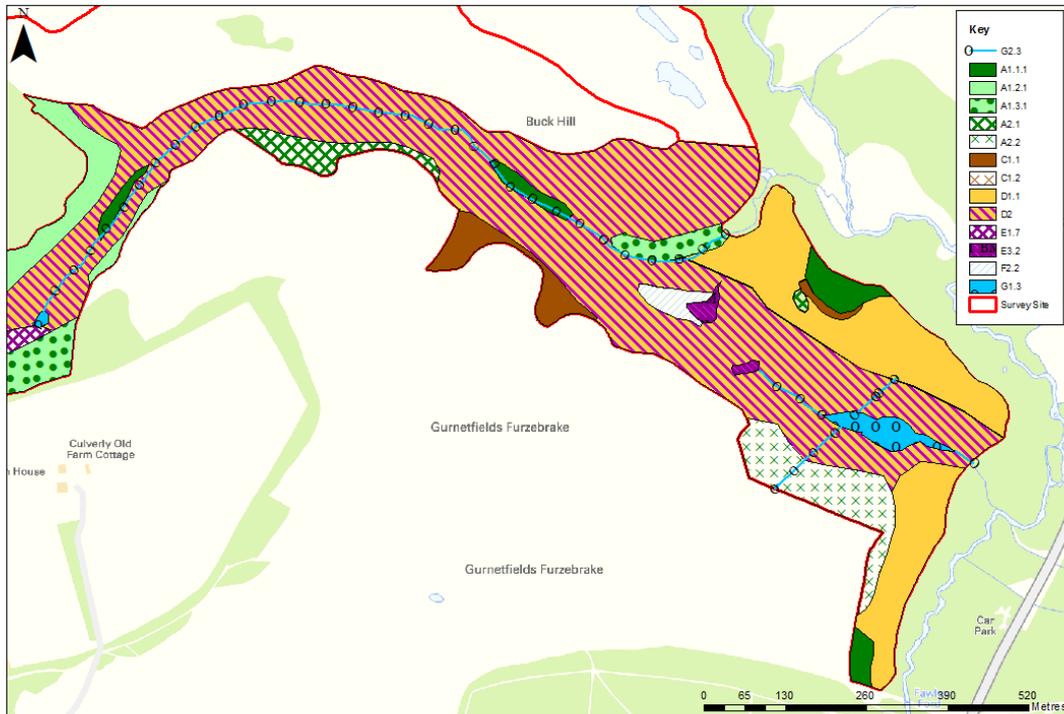
Figure 1-11: Phase 1 Habitat Map

No invasive species were recorded at this unit and the site does not appear to be badly damaged by grazing, even though grazing pressure is evident across the unit. Figure 1-11 shows the Phase 1 Habitat Map for Unit 426.

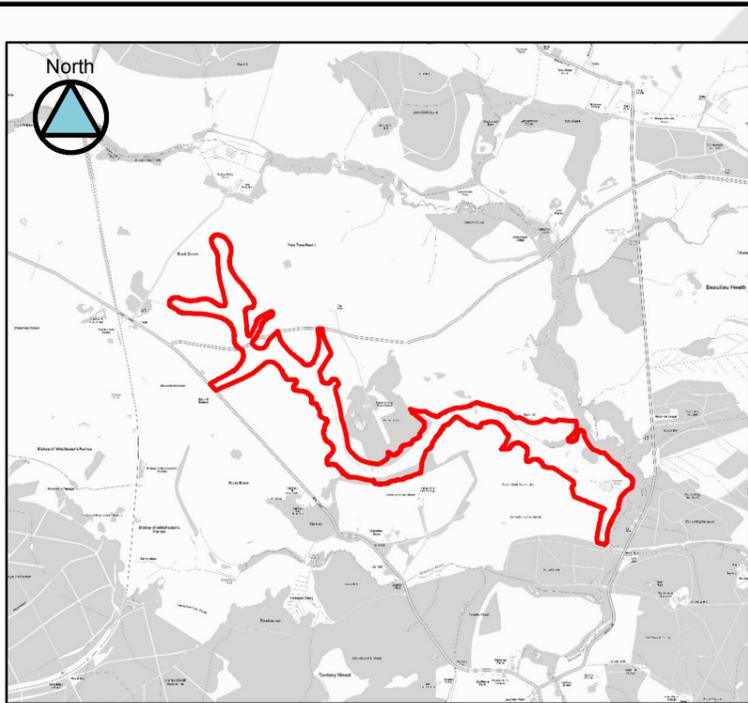
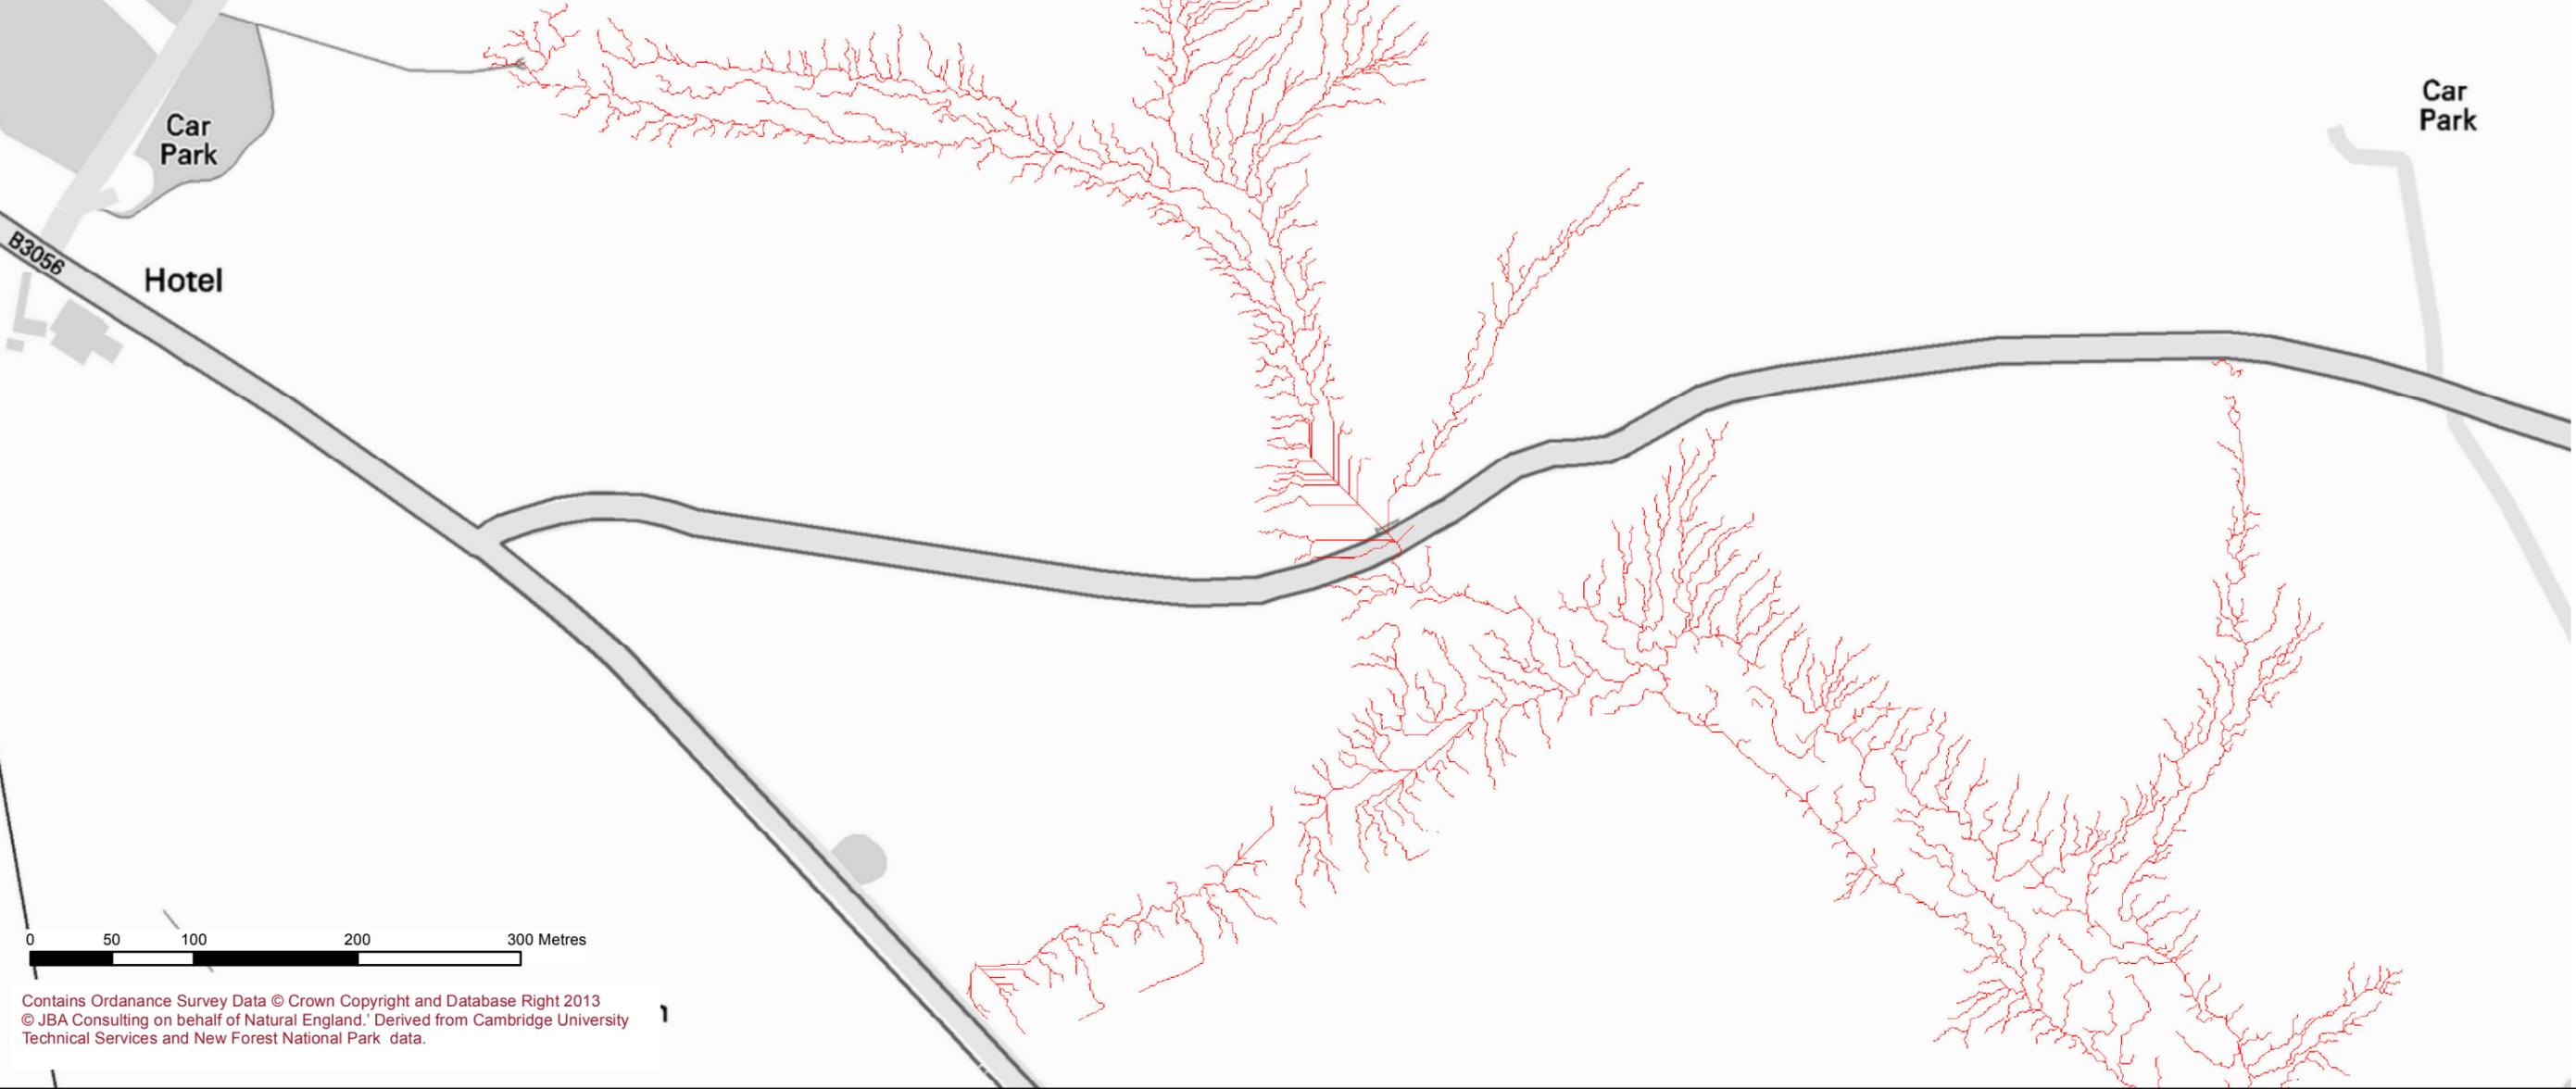
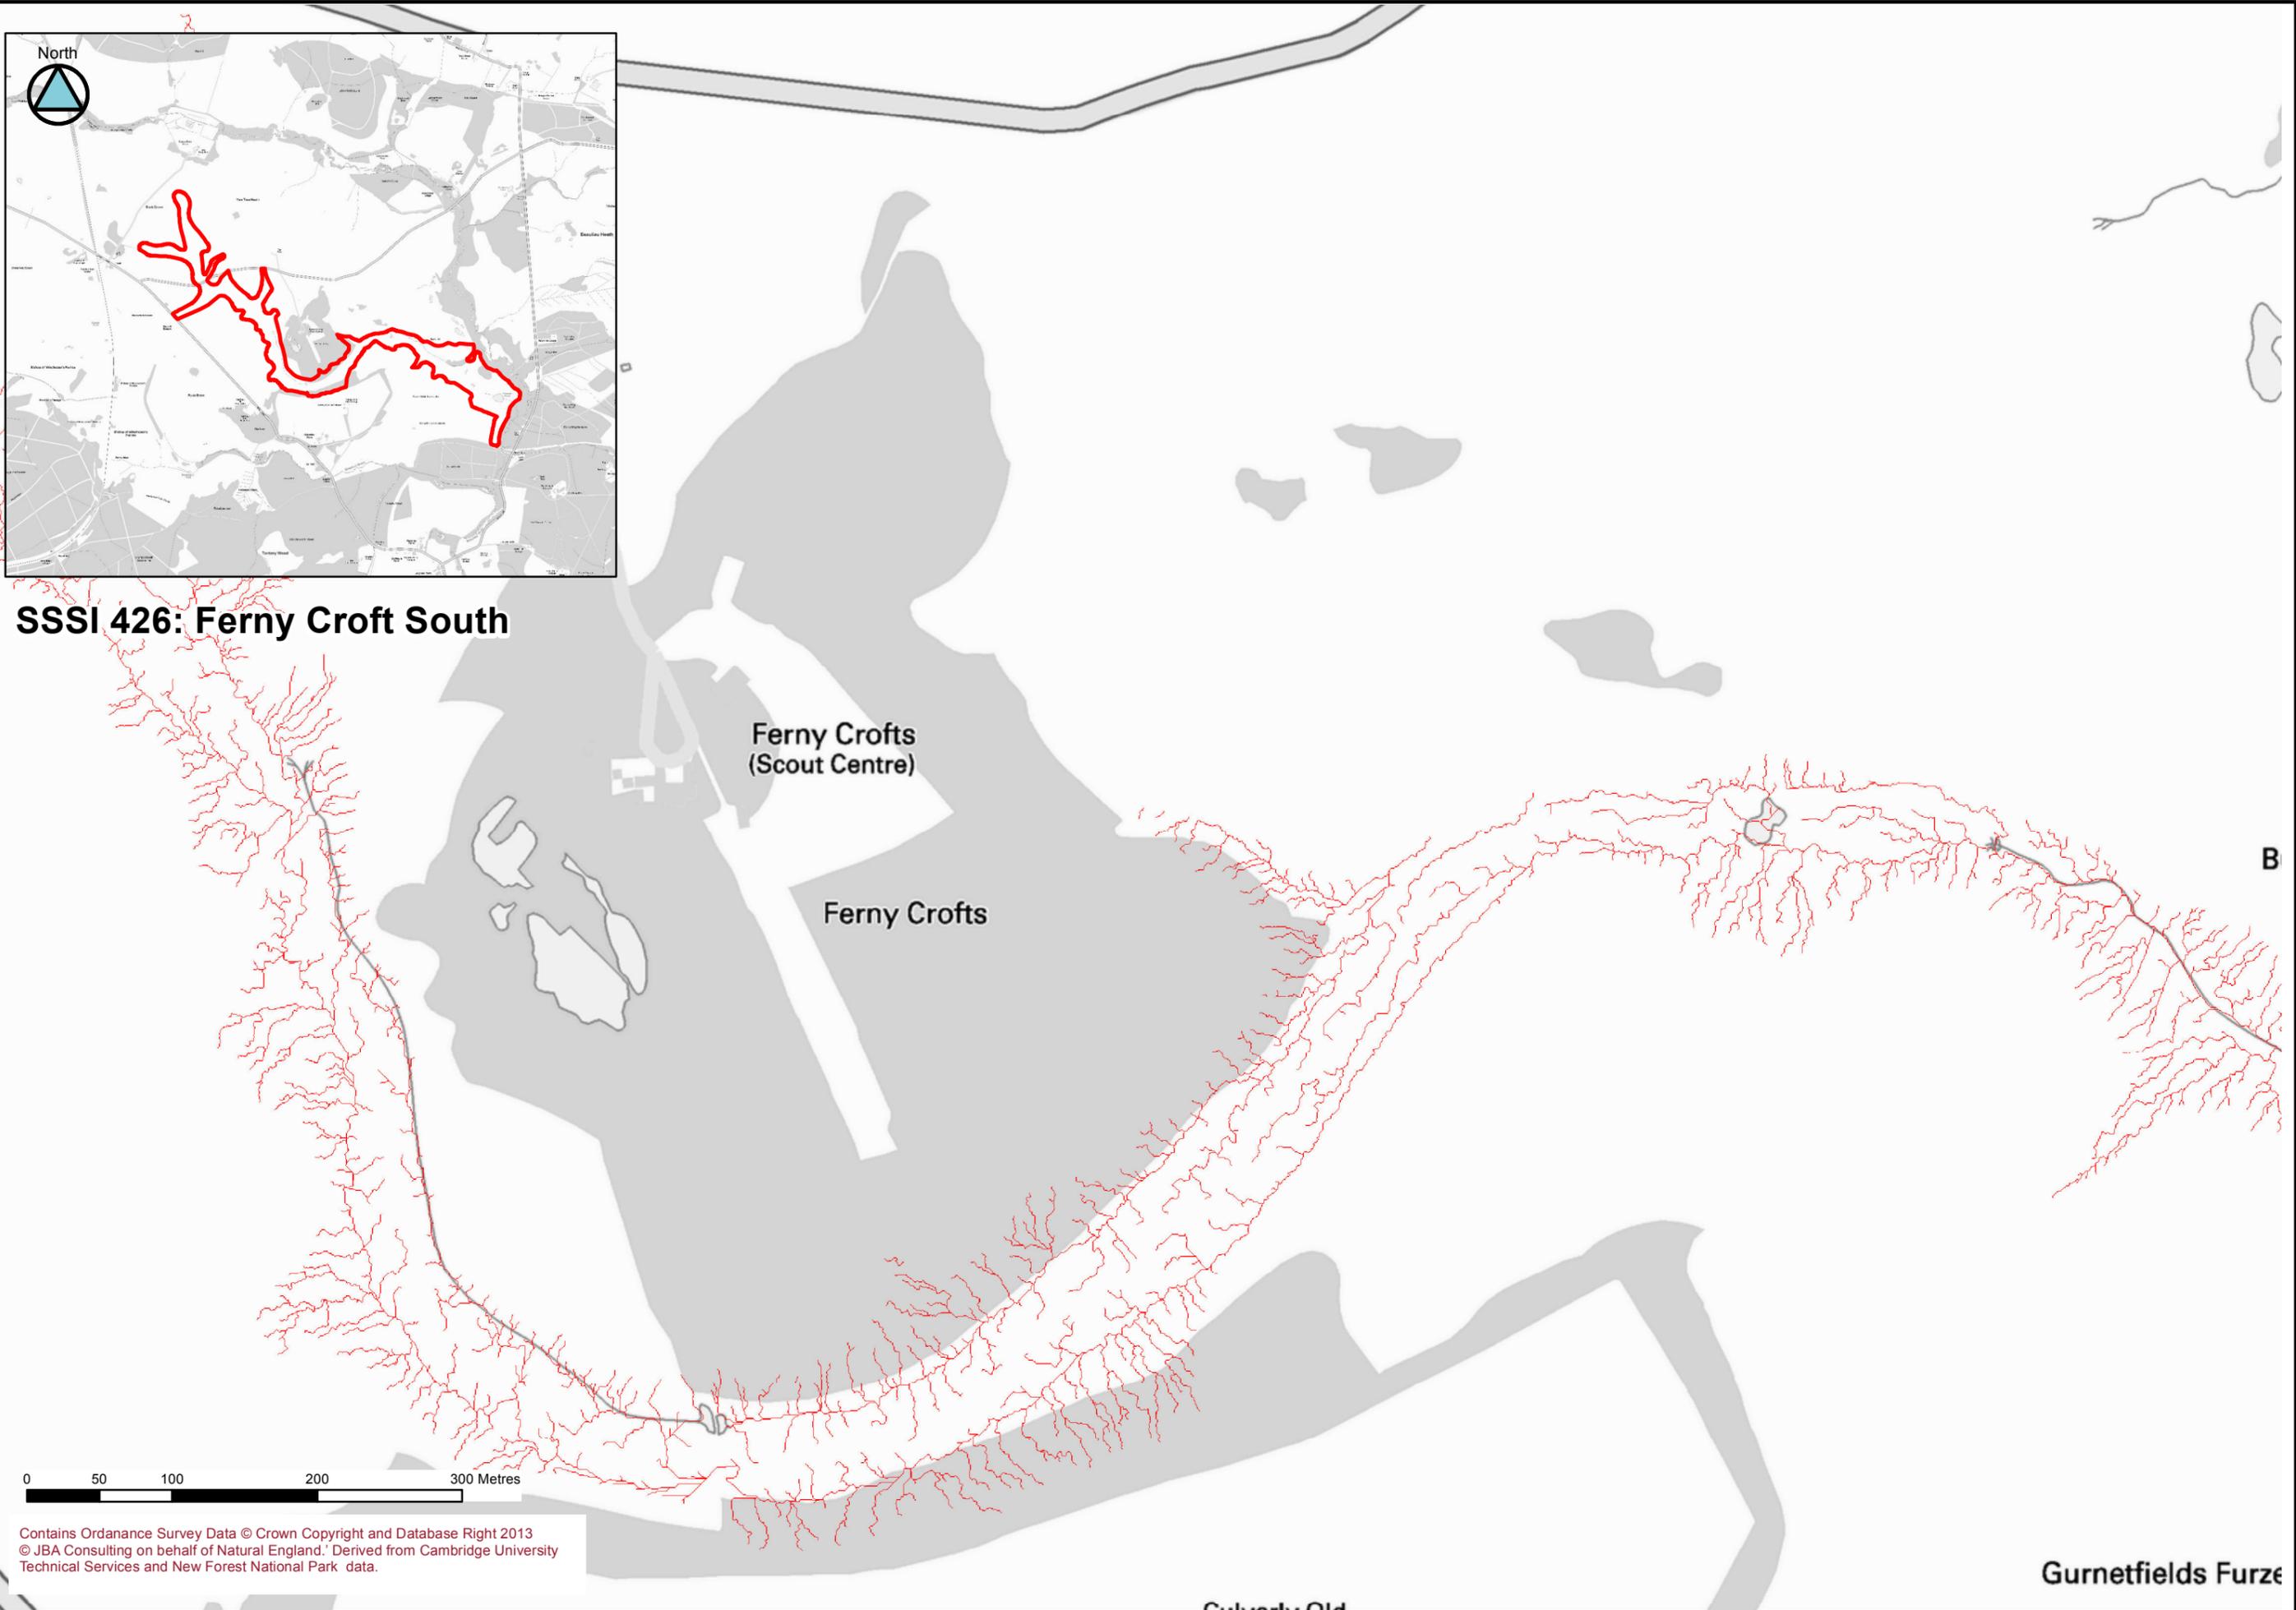
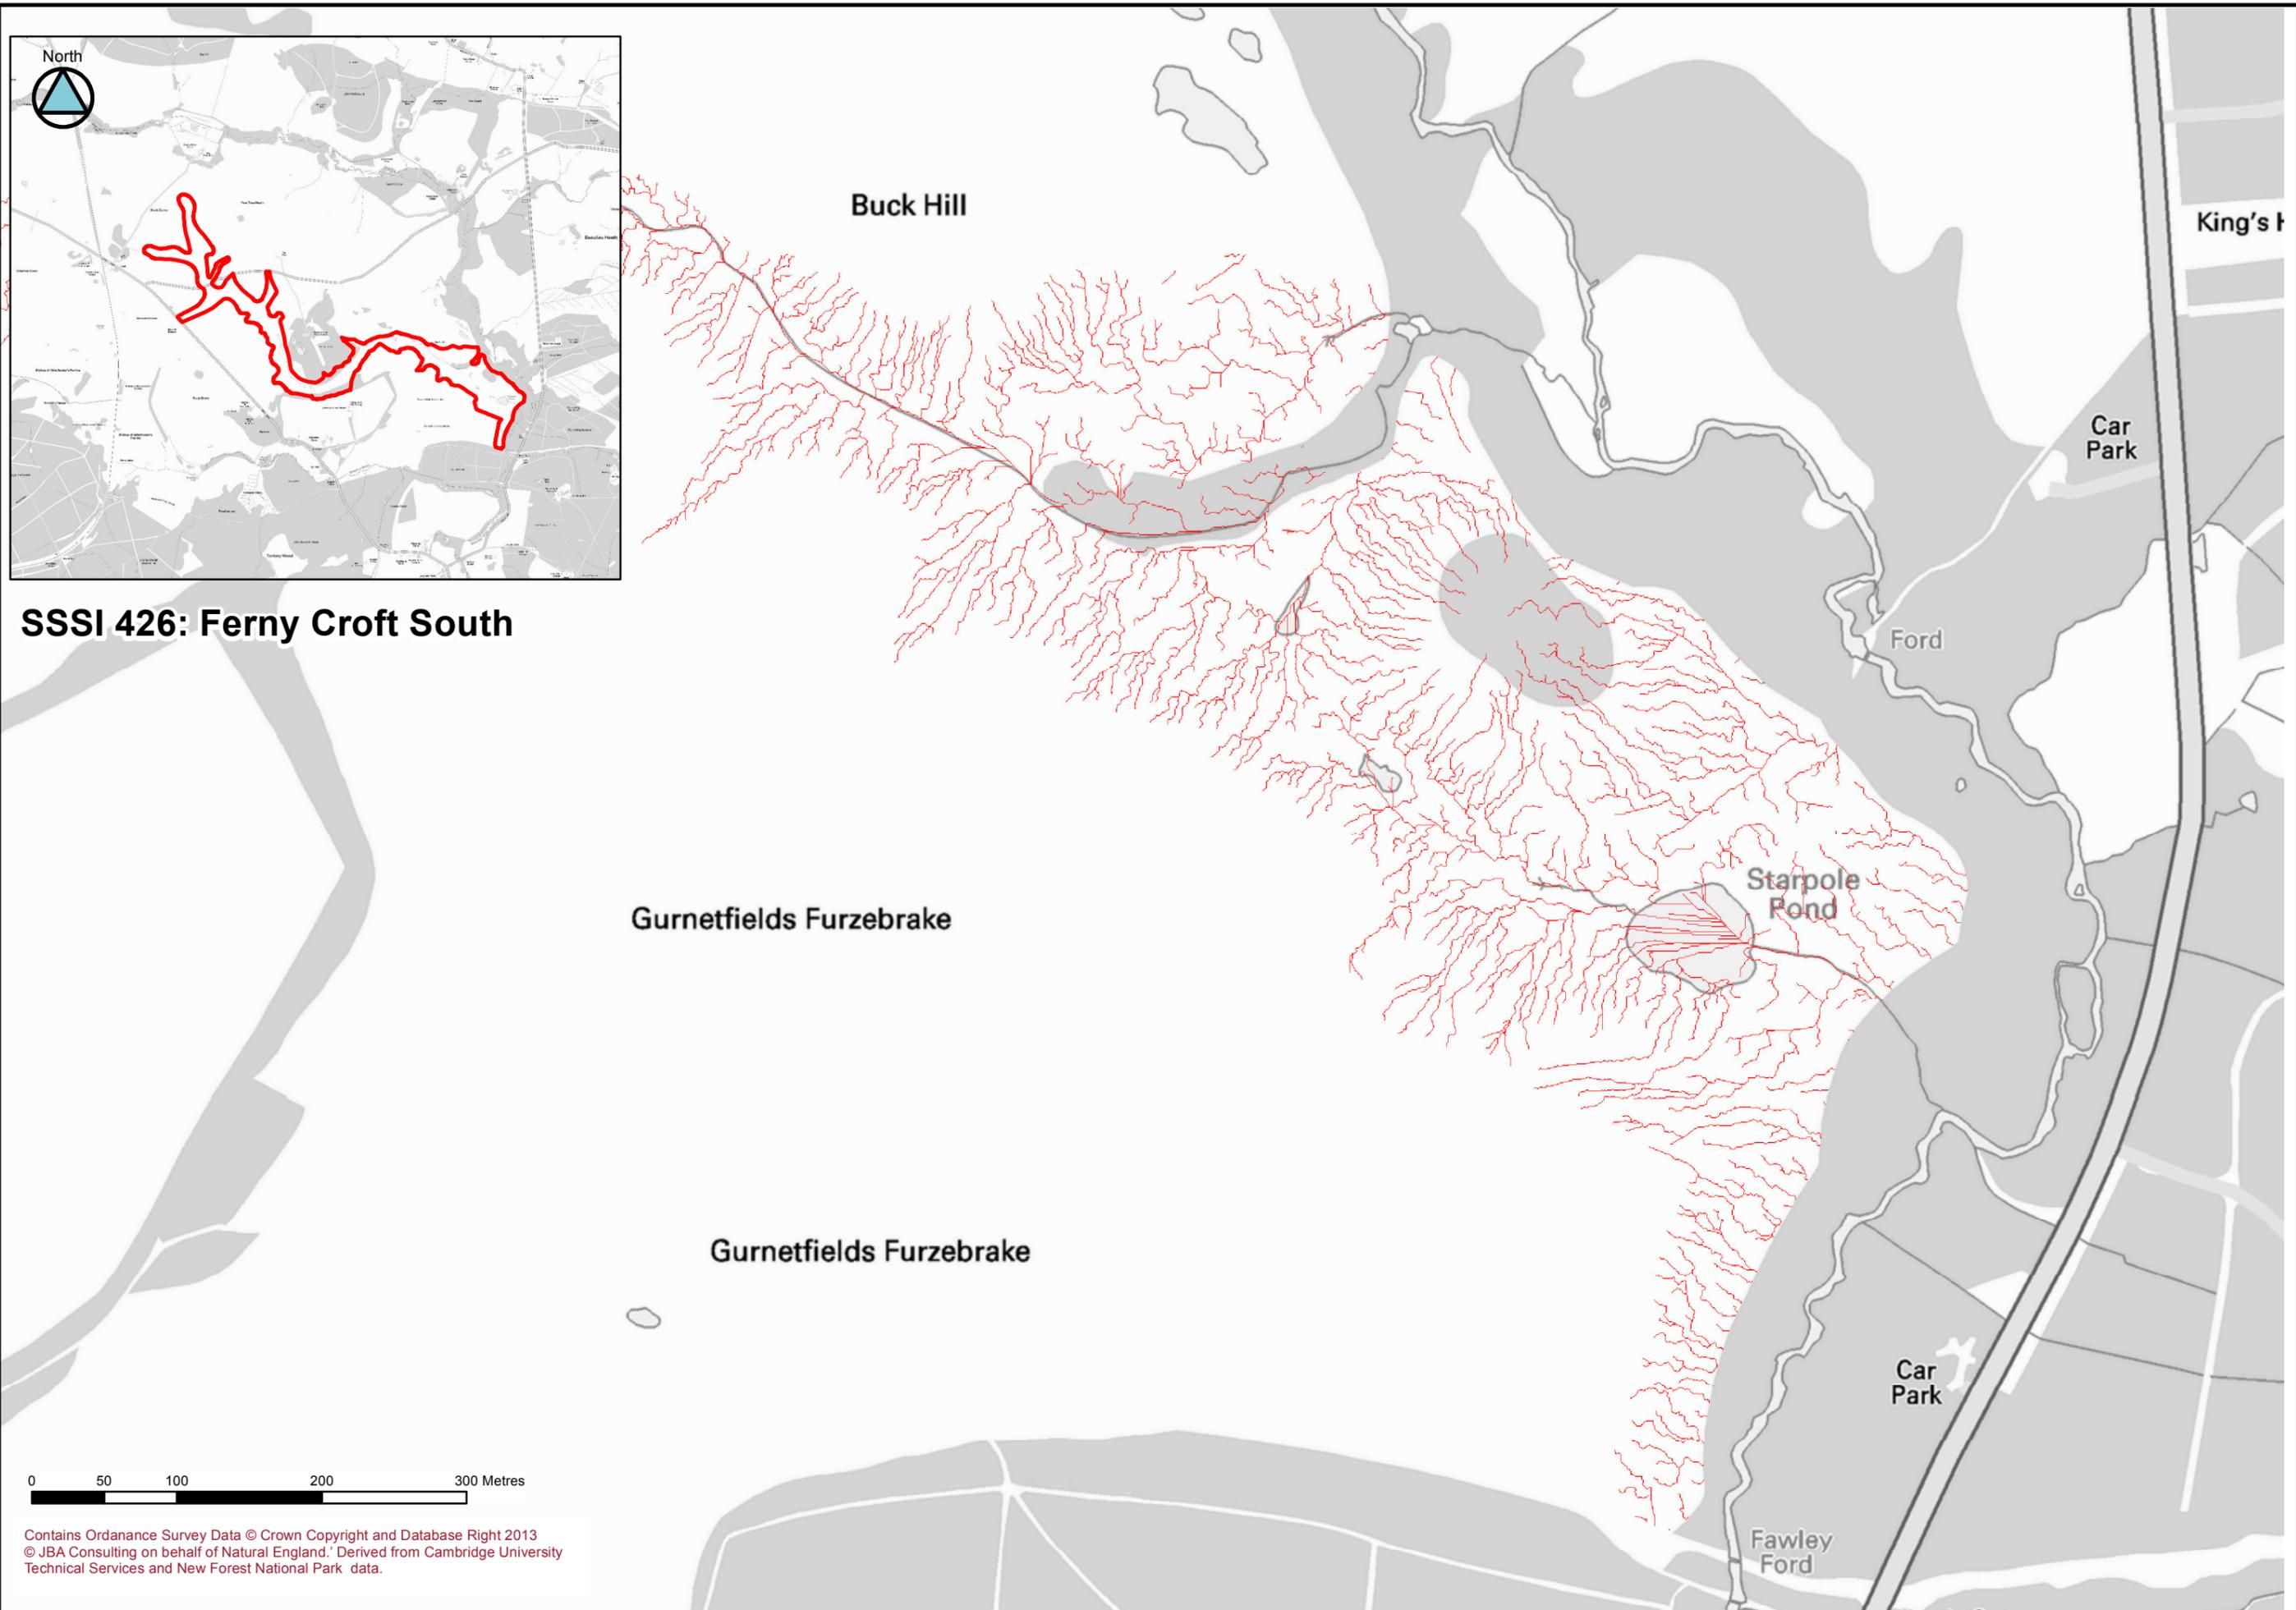
Appendix A - Artificial drains and flow lines - SSSI Unit 426

The LIDAR and drainage lines in Appendix A show that there has been artificial straightening / ditching of flows lines and drains flowing into the main channel (Figure 1-7), these areas are also highlighted in Figure 1-4. This may have been a contributing factor to the formation / maintenance of the single thread sections, where flows are concentrated at one point, creating conditions favouring a dominant channel and giving enough excess energy to maintain a single thread channel rather than promoting siltation, similar to the spreading sections within this unit. This flow concentration has also resulted in drier floodplain sections as this flow would normally be spread over a wider area.
