Coastal Catch-Up: How a soft rock cliff evolves when coastal defences fail

Godwin Battery, Kilnsea

Mark Lee. 2018. *Coastal Catch-Up: How a soft rock cliff evolves when coastal defences fail. Godwin Battery*. Natural England Commissioned Reports, Number 256.

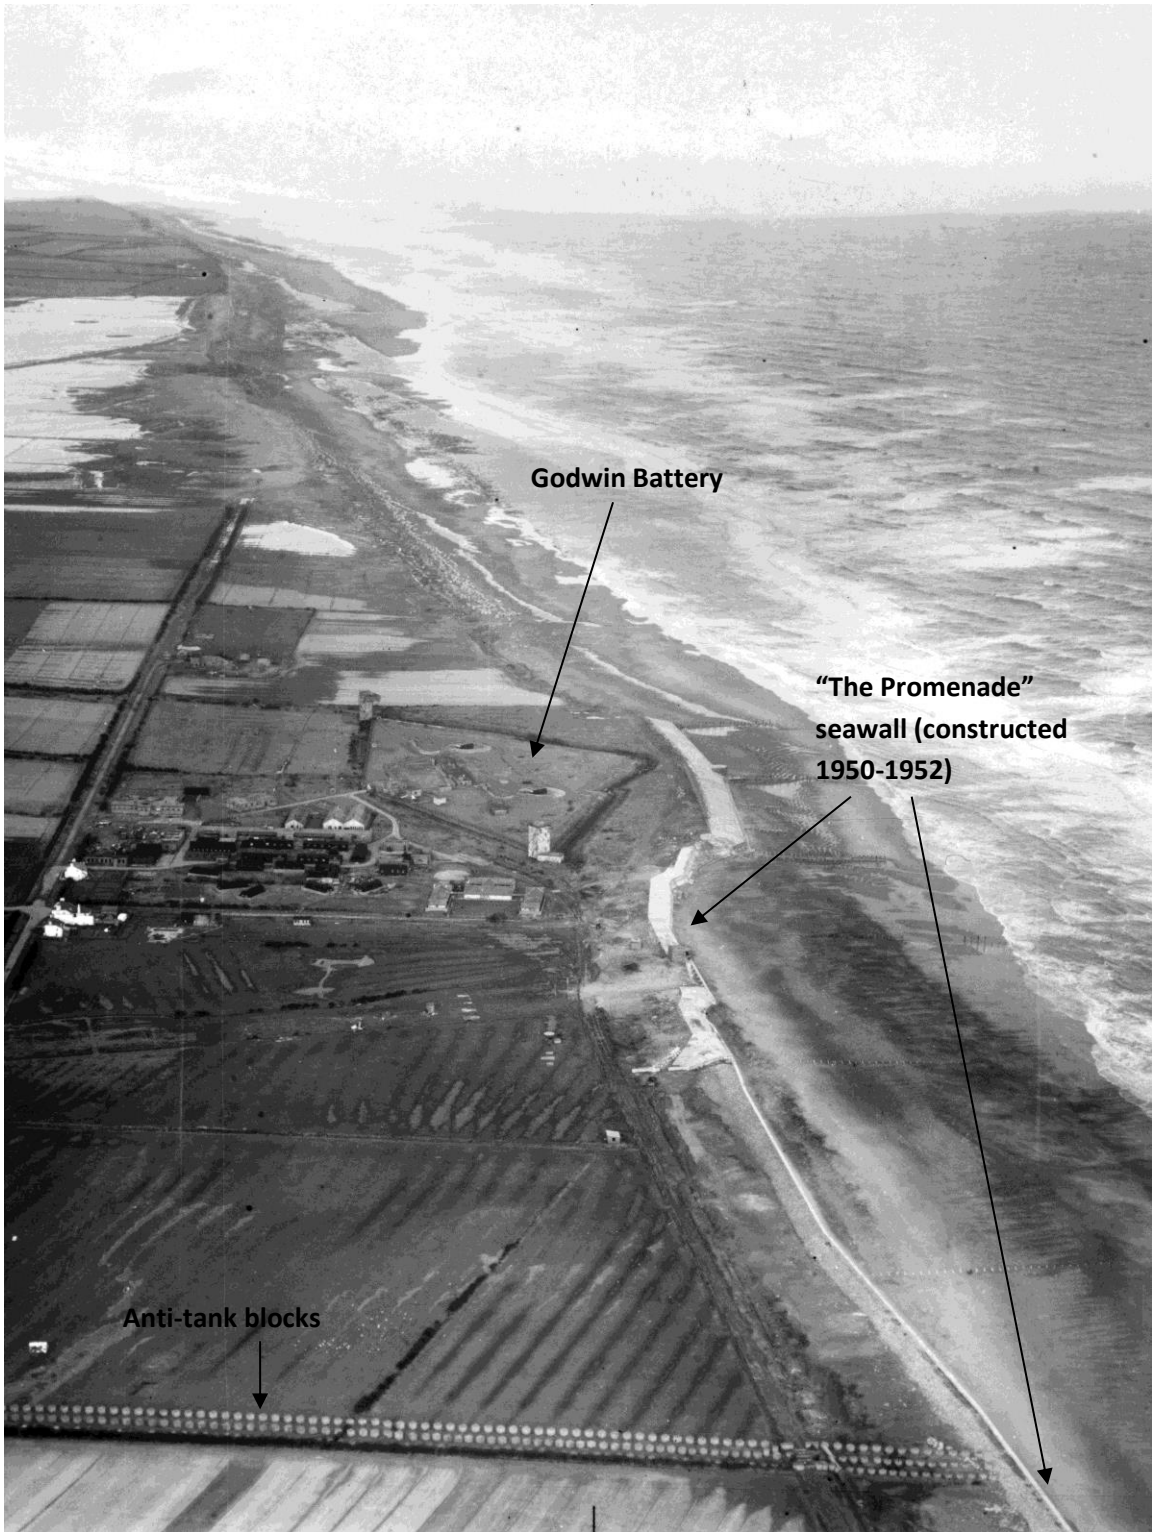
Photo 4 Godwin Battery immediately after the 1953 storm surge (photo date 3.2.1953; source Air Images Ltd.)

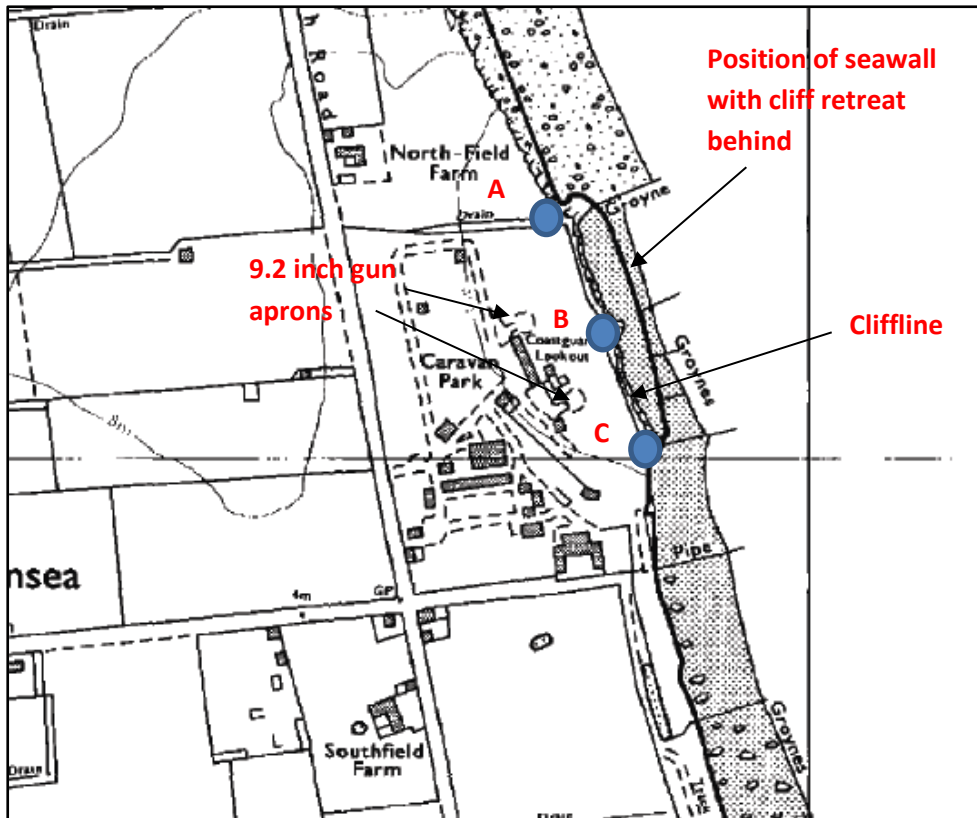
Although many of the monuments were lost between 1993 and 1997 (Anderton, 2000), it is clear that this had been preceded by a period of cliff recession which removed the undeveloped strip of land between gun aprons and the cliffline. Available map evidence indicates that the seawall failed at some point between 1956 and 1972-75, triggering the renewal of cliff recession (Figures 2 and 3). The recession distance between these dates ranges from 2.5m (Point C) to 25m (Point B).

Figure 3 Yorkshire, 1972-75 series (Original scale 1: 10,000). Points A-C are cliff recession measurement point established for this study

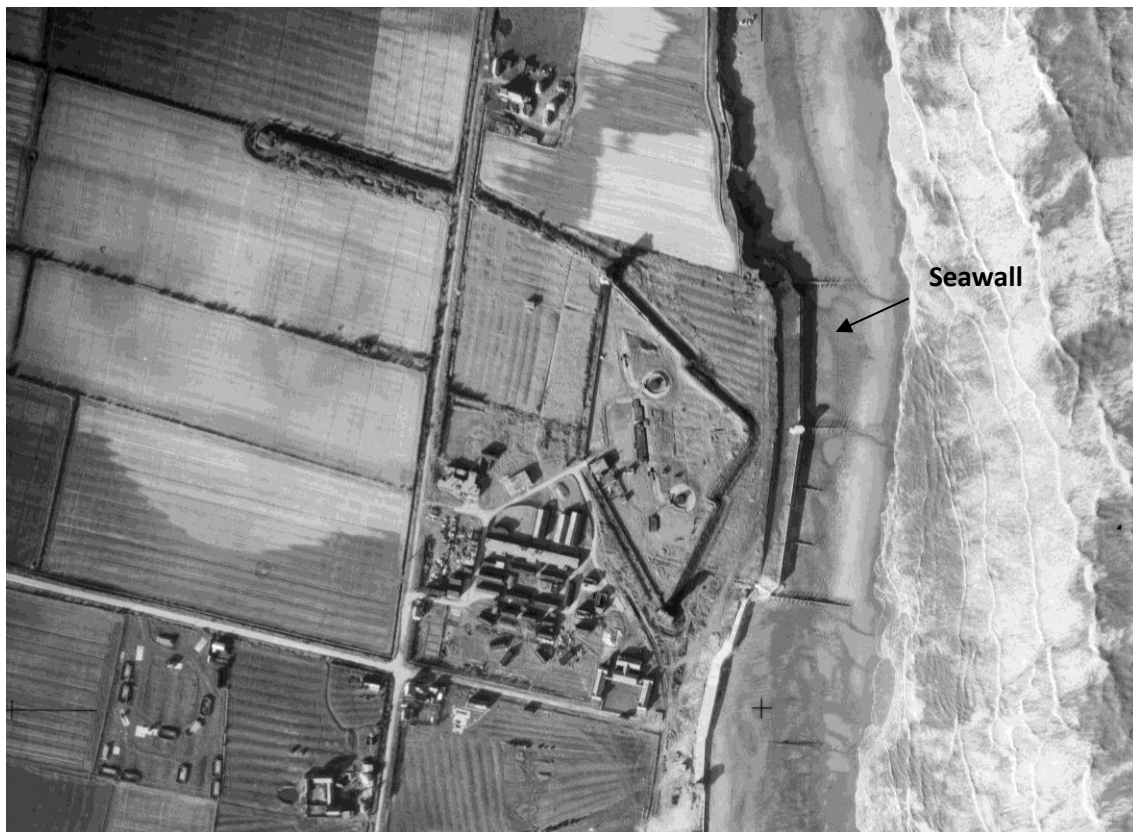
The cliff retreat and loss of the monuments between 1953 and 2008 can be observed on the sequence of vertical aerial photographs presented as Photos 7 to 13. The 1969 photograph clearly shows on-going cliff recession behind the seawall and provides evidence of seawall failure at some time prior to that date.

Photo 7 Aerial photograph (3.2.1953); original scale 1:5,400 (source: Air Images Ltd.)

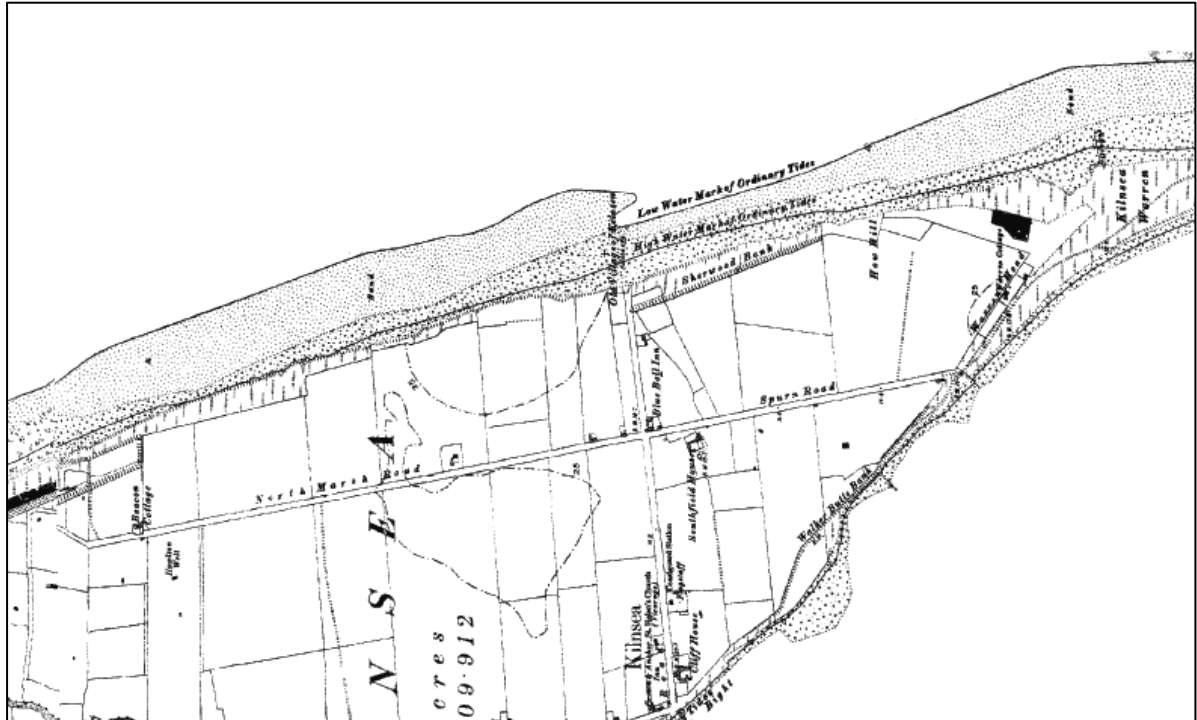
Since 1915, the cliffline in front of the Battery (Point B on Figure 2) has retreated around 110 - 130m. The cliffline would have been expected to have retreated further if the defences had not been constructed, matching the recession of the adjacent unprotected cliffs. The result has been the formation of a small headland. If it is assumed that, if unprotected, the 2km long cliffline between the southern end of the Easington Lagoons to the Warren would have developed as a straight line (as it almost was in 1892; Figure 5), then the Battery headland currently projects in front of this cliffline by

around 60-70m at its maximum point (Photo 21).

Figure 5 County Series map: 1892 (Original scale 1: 10,560). showing the almost straight coastline between the future site of Easington lagoons and the Warren

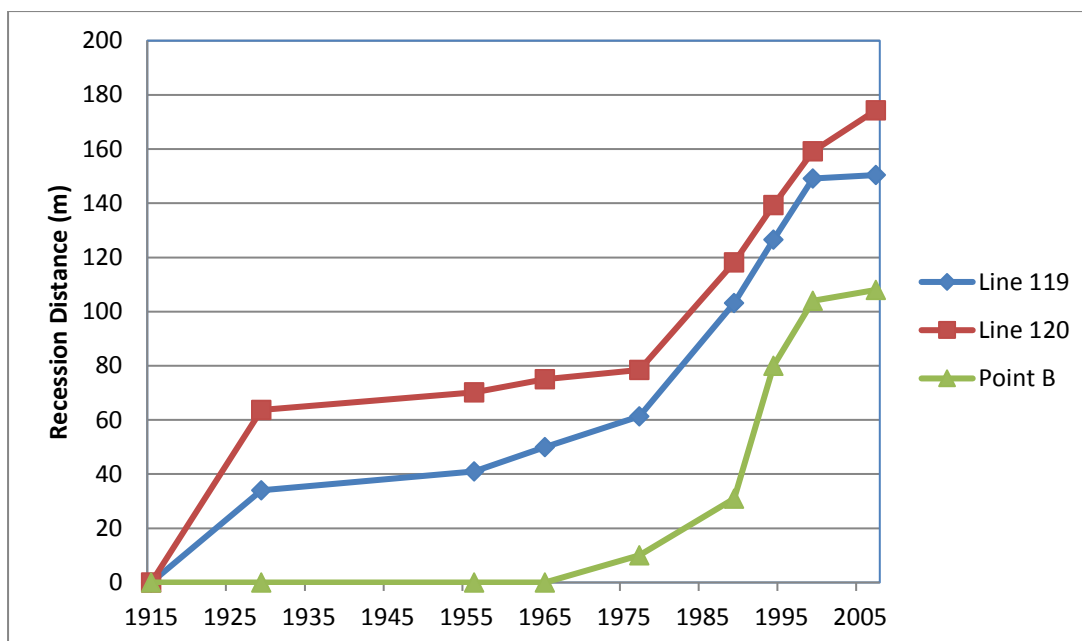
Figure 6 A comparison between the recession distance at Point B (Godwin Battery) and ERYC erosion lines immediately north and south of the Battery site (using the seawall construction date, 1915, as a baseline).

An indication of the recession distance since WWI immediately north and south (Lines 119 and 120, respectively³) of Point B at the Battery (see Figures 1 and 2) is shown in Figure 6. This suggests that prior to seawall failure (around 1965) Point B (on the headland) was around 50m seaward of Line 119 and 75m seaward of Point 120. By around 1994, Point B was 47m seaward of Line 119 and 59m seaward Line 120, indicating that there had been only minor “catch-up” since seawall failure. Since the concrete structures collapsed onto the foreshore in the early-mid 1990s the position of Point B seaward of these 2 profile lines has remained broadly similar (Table 3). This clearly indicates that since seawall failure there have been relatively consistent recession rates along the entire frontage and that the section in front of the Battery has remained as a headland.

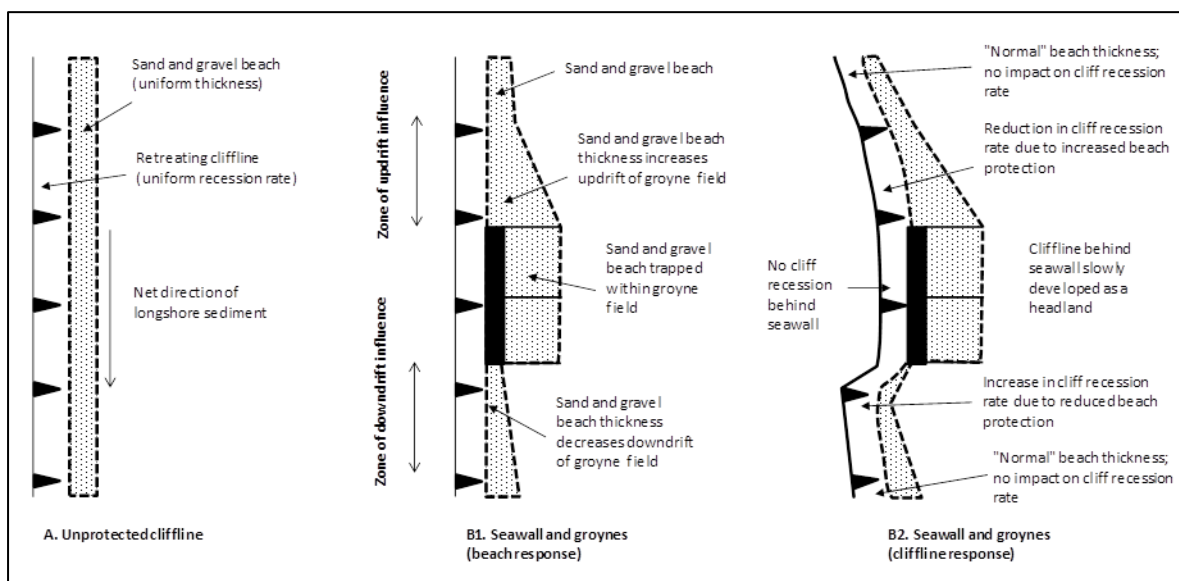
- trapping sediment within and immediately updrift of the groyne field. This results in increased beach volume on the northern side of the works, enhanced “natural” cliff toe protection and reduced cliff recession rates. The reverse occurs on the downdrift side of the works, with the groynes disrupting longshore sediment transport, leading to accelerated cliff recession.

Figure 7 Schematic model highlighting the impact of coast protection works (seawall and groynes) on shoreline development

- modification of local sediment transport rates. The contrast between no cliff recession behind the seawall and continued cliff recession on the adjacent unprotected cliffline eventually results in the emergence of a hard-point (headland). On the updrift side of this hard-point, the shoreline orientation slowly rotates anti-clockwise, resulting in a decrease in longshore sediment transport rate and beach accretion (see Pethick, 1996). On the downdrift side, the shoreline rotates clockwise, sediment transport rates increase and beach volumes decline. The updrift and downdrift shoreline orientation changes lead to a local decreases and increases in cliff recession rate, respectively.

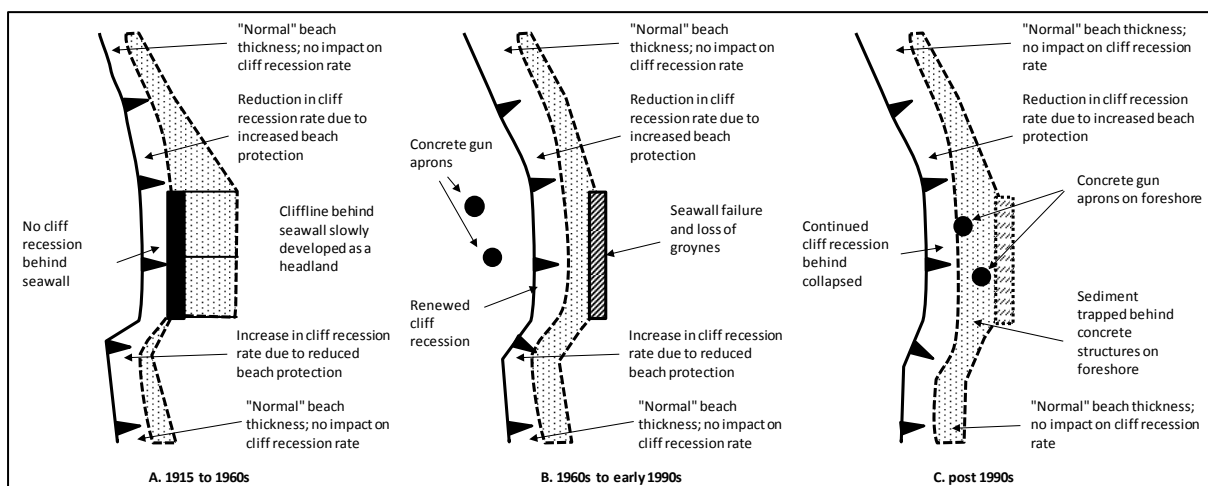
It would be expected that the Battery seawall and groynes (1914/15 to the mid-1960s), and concrete ruins (1993/97 onwards) might have trapped sediment and acted as hard-points, influencing the local shoreline orientation and processes to the north and south (Figure 8). One test of the impact of the Battery would be determine whether there are significant differences in recession rate to the north and south of the frontage. A model of the possible impact is presented in Figure 9, with recession rates shown for hypothetical erosion lines, spaced 1km apart, to the north (N) and south (S) of the battery:

Figure 8 Schematic model highlighting the impact of Godwin Battery on shoreline development

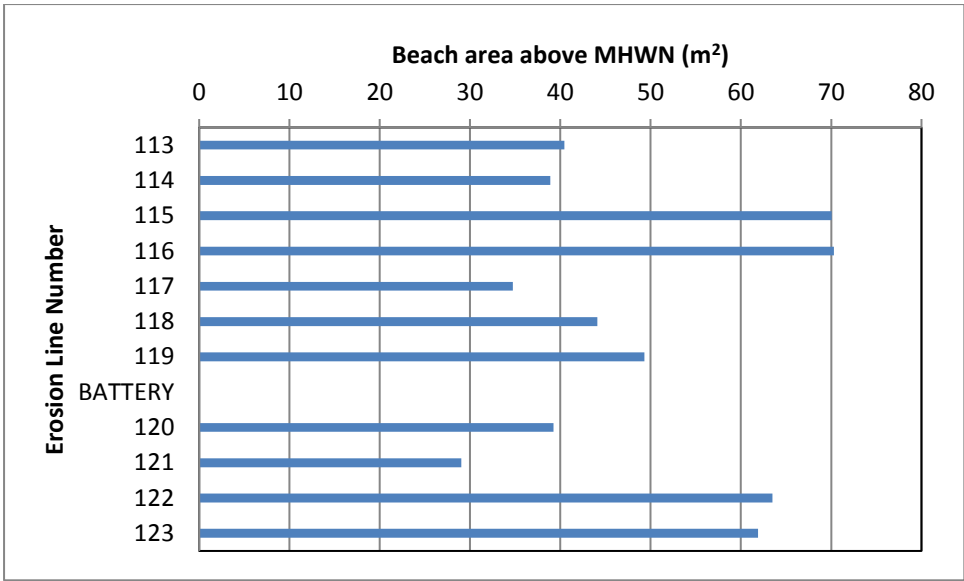
At the Battery, there are no groynes to actively trap sand and shingle along the frontage and any beach growth is dependent on the slow change in shoreline orientation updrift of the ruins. An indication of the beach trends between Easington (line 113) and the Battery ruins (line 119) is presented in Figure 13. This has been derived from ERYC beach monitoring data for a single date, September 2011 (available from: <http://www.eastriding.gov.uk/coastalexplorer/lines.html>). The beach area has been calculated as the cross-sectional line area of beach material above MHW neap tides (+1.55m). The results indicate that the beach cross sectional area (a measure of beach volume for a 1m wide profile) declines from line 119 (north of the Battery ruins) to line 117 (in front of the middle of the Southern Lagoon). This suggests that, in September 2011, the tapering wedge updrift of the concrete ruins only reached the southern end of the lagoons.

Figure 13 Beach area (September 2011) at profiles between Easington and Spurn (data from ERYC)

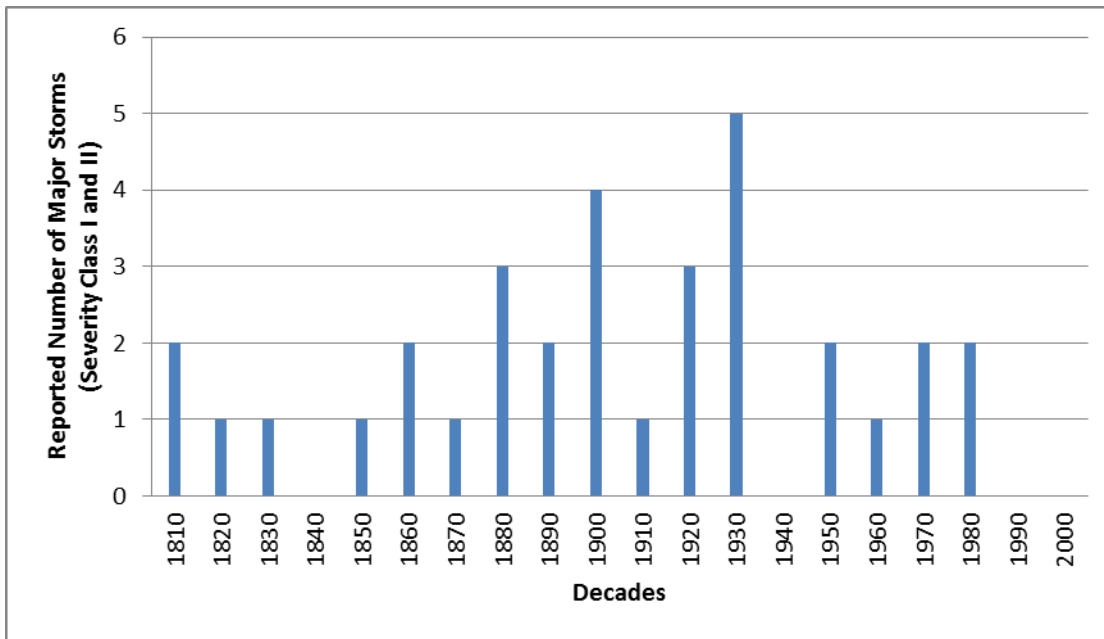
Figure 16 Major North Sea storms (Lamb's Severity Classes I and II) between 1810 and 1990)

Contrary to the de Boer model, Spurn actually appears to have been a very resilient feature over the last Millennium. The barrier breached in 1849 during a Severity Class IV/V storm⁶ (i.e. relatively low severity), having survived many previous major storm events and storm surges⁷ (Figures 16 and 17). The period 1920 to the 1960s appears to have been particularly high frequency of major storms and surges. However, there are no reports of breaches. In contrast, the 1840s appears to have occurred within a “calm” period and yet a relatively minor storm initiated a breach in 1849. It seems likely, therefore, that Spurn is more vulnerable to the prolonged effect of sediment budget deficits (caused by gravel extraction) rather than short-term very high energy wave loadings.

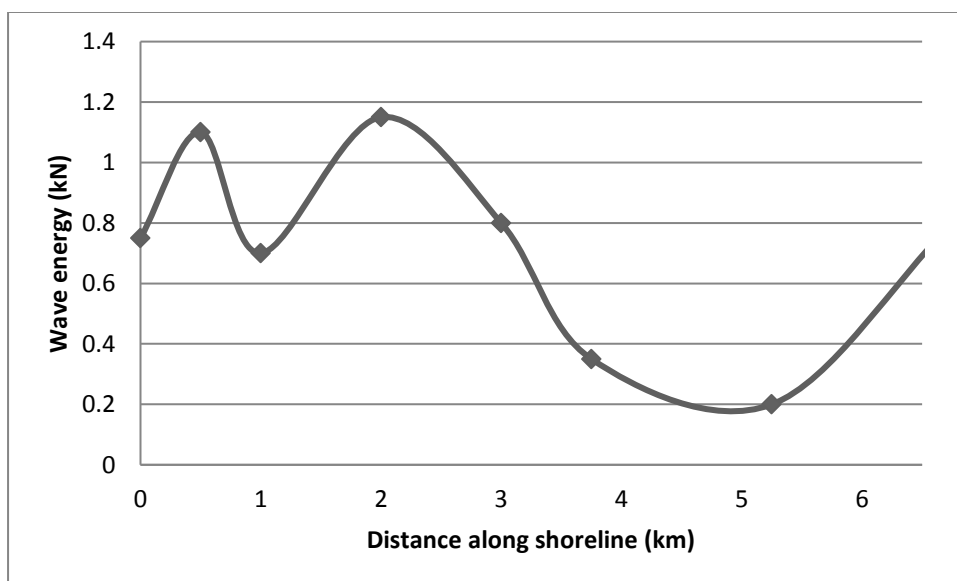
Figure 18 Longshore wave energy gradient along Spurn seaward shoreline (adapted from IECS, 1992)

The longshore wave power gradients generated by NE waves along the seaward shoreline of Spurn are controlled by the shoreline orientation (Figure 18; adapted from IECS 1992). A positive longshore power gradient (i.e. increasing wave energy) indicates shoreline erosion, whereas a negative gradient (i.e. decreasing wave energy) indicates deposition. On Spurn, maximum erosion for the current shoreline orientation coincides with the northern end of the neck (with a second peak at km 2 close to the southern end of the neck). Maximum accretion is predicted to occur in the centre of the neck (km 1) and on the head (km 4, north of the lighthouse). These energy gradients are believed to have strengthened as a result of the orientation change since the early 19th century (IECS 1992).

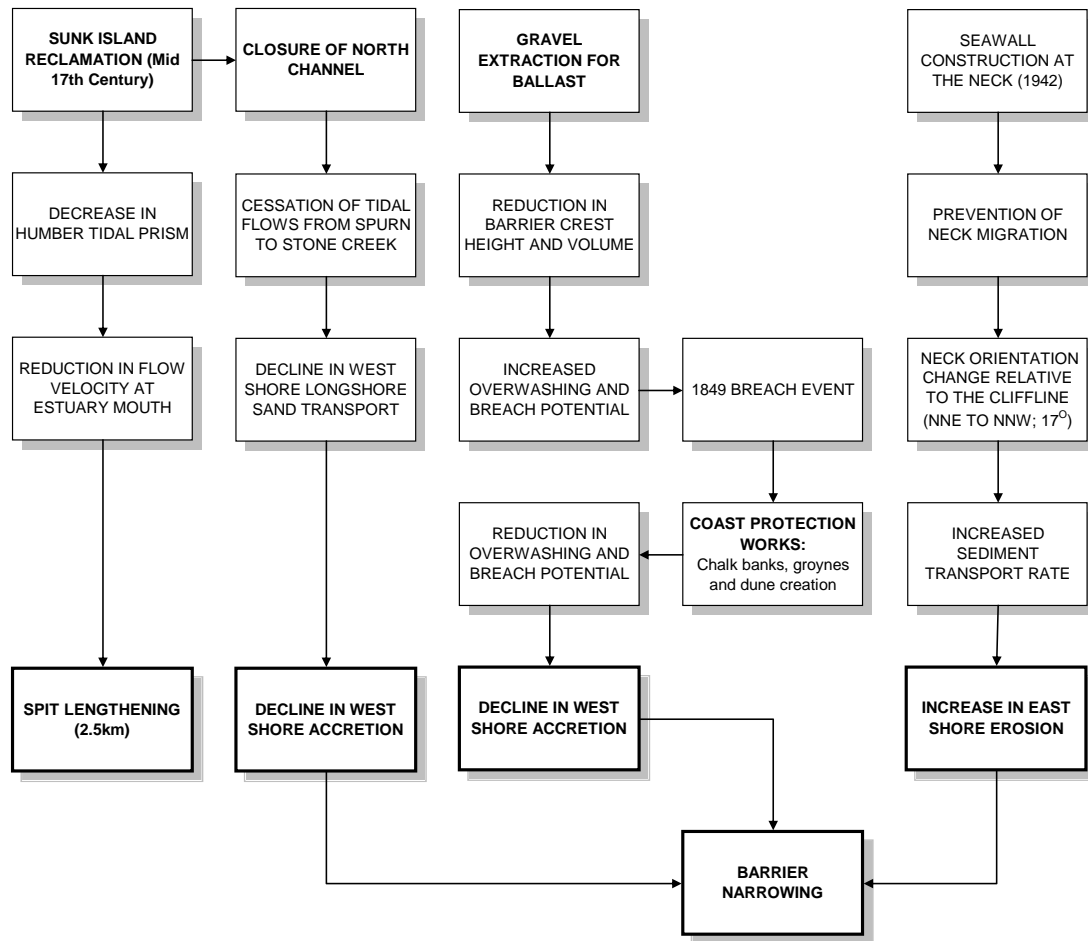
Figure 19 A summary of the man-made causes of contemporary change to Spurn (from Lee, 2009; developed from IECS 1992)

Given the experience elsewhere on the Holderness coast, it might be expected that the Godwin Battery seawall and groynes (1914/15 to the mid-1960s), and concrete ruins (1993/97 onwards) would have trapped sediment and disrupted sediment transport toward Spurn. This may have been the case, but it does not appear to have been as significant as other factors influencing the development of Spurn over this time period. Indeed, the main controls on the development of Spurn over the last few centuries have been (Figure 19):

- the decline in west shore accretion, resulting from reduced overwashing potential caused by dune creation and coastal defence works, and the long-term changes in sediment transport on the west shore associated with 19th century land reclamation in the Humber⁸;
- an increase in the seaward shore erosion that can be linked to the construction of coastal defences and the resulting changing orientation of the neck relative to the cliffline.
