Natural England Commissioned Report NECR140

# New Forest SSSI Geomorphological Survey Overview

Annex Q: Islands Thorns / Amberwood Restoration Plan - SSSI  
Unit 540

# 1 Islands Thorns / Amberwood Restoration Plan - SSSI Unit 540

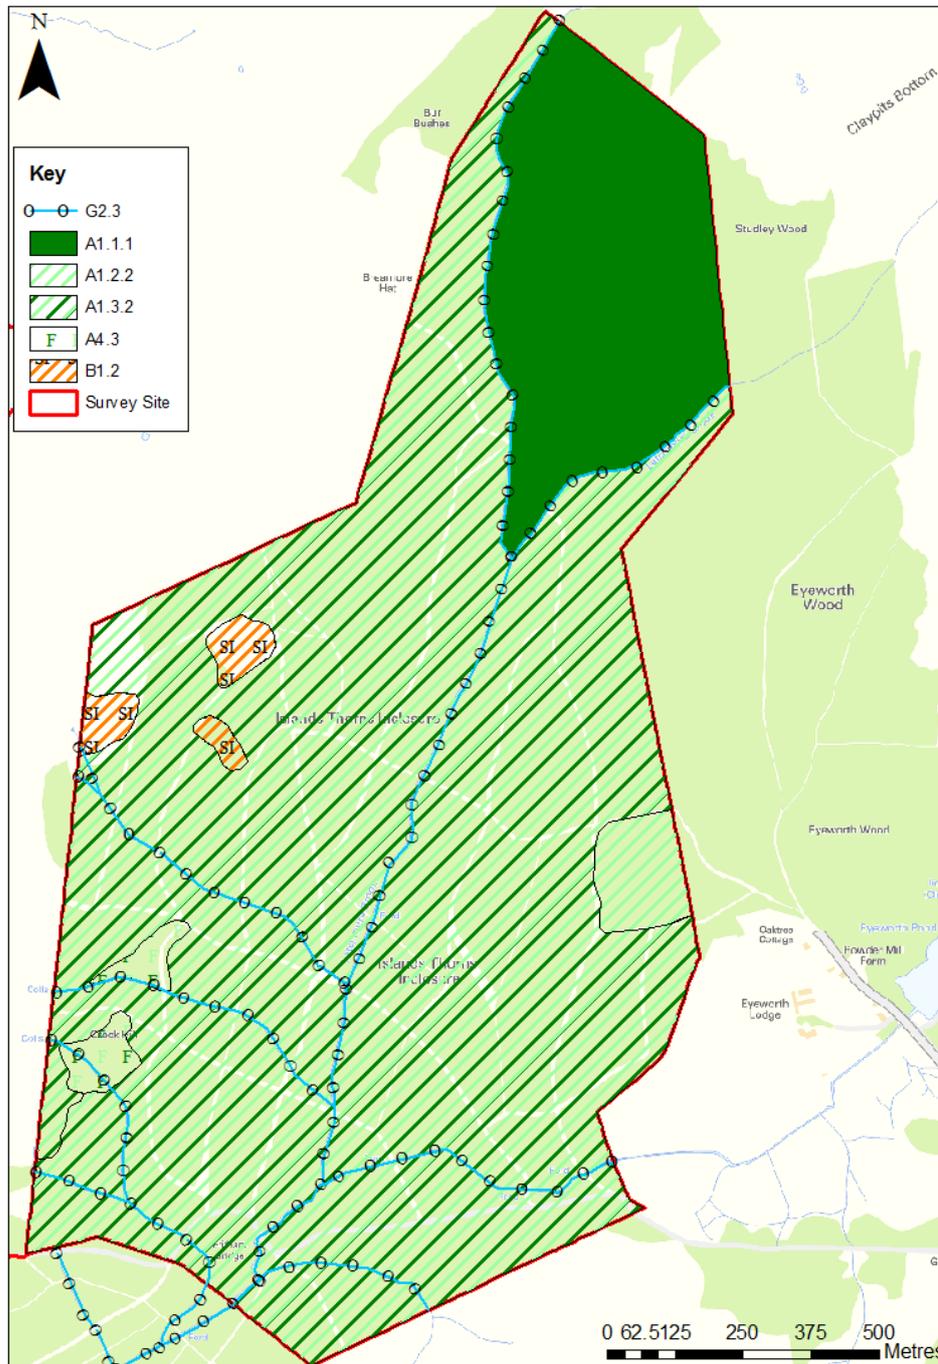
Figure 1-12: Phase 1 Habitat Map

At the time of the site walkover survey there was no aquatic vegetation present within the channel.
