POST WORKS ASSESSMENT OF THE STREAM RESTORATION PROJECT SITES AT UPPER WOODFORD ON THE RIVER AVON

Summary of post works assessment following final site visit
on 9th April 2009

the River Restoration Centre

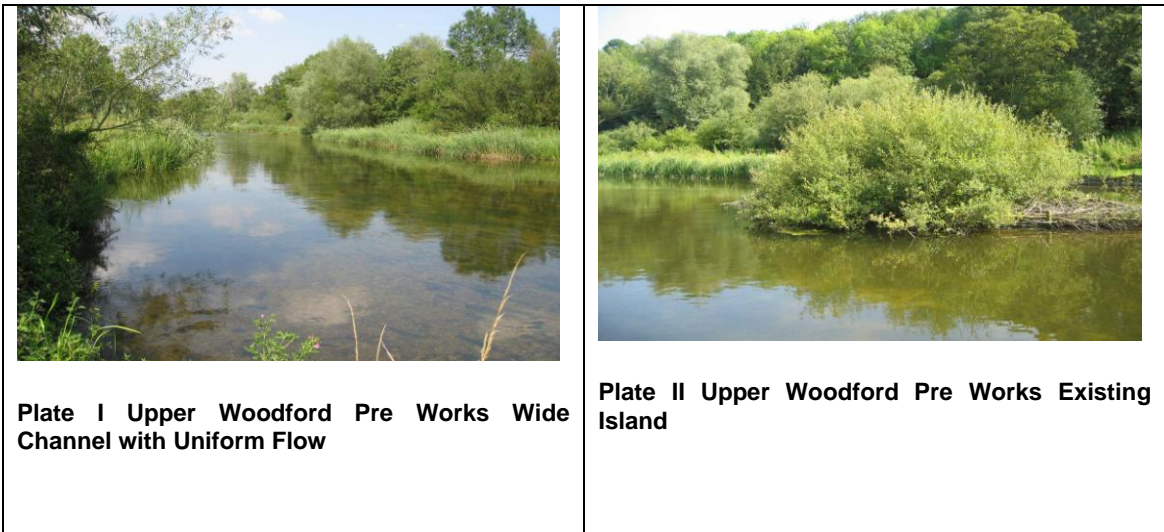
Figure 2.1 Upper Woodford Site

Eight 'D' deflectors were installed in Reach 2 and one in reach 3. None of the deflectors in Reach 2 have been vegetated to any significant degree. They are however, providing areas of refuge for fish fry and there is evidence that silt is being trapped within the brushwood in-fills (see Figure 2.1). The lack of vegetation may be the result of persistent high flows over the winter of 2008/2009. The deflector have created areas of variable flow.

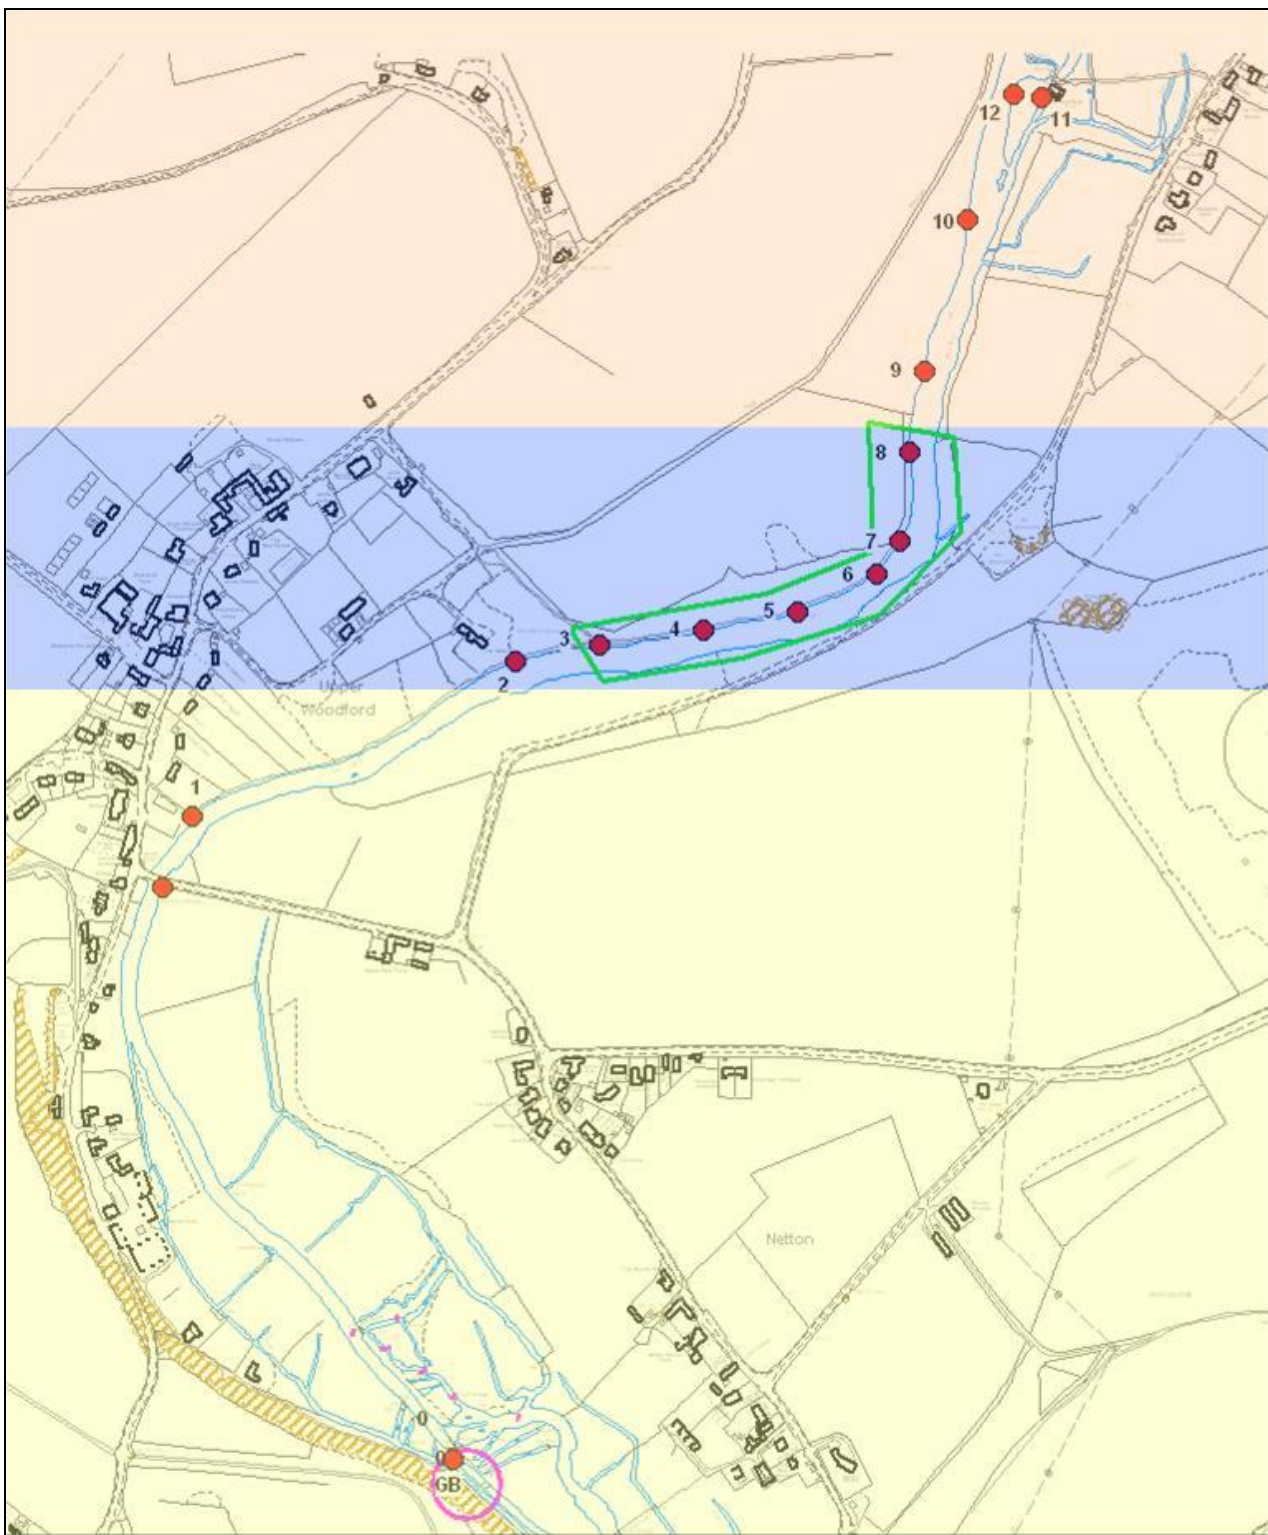
Figure 3.1 Hatch Operation Trial Location of Water Level Recordings

The opening of the hatches can clearly have an influence on water levels upstream. During the construction period in October 2006, when there was very little weed growth in the channel or downstream, the hatches were opened to allow completion of the causeway, and levels were reported to drop over 10 centimetres. However, when there is significant weed growth in the channel (as in 2008) this reduces the influence of the hatches on water level.
