POST WORKS ASSESSMENT OF THE STREAM RESTORATION PROJECT SITES AT FOVANT

(R. NADDER)

Summary of post works assessment following final site visit
on 9th July 2009

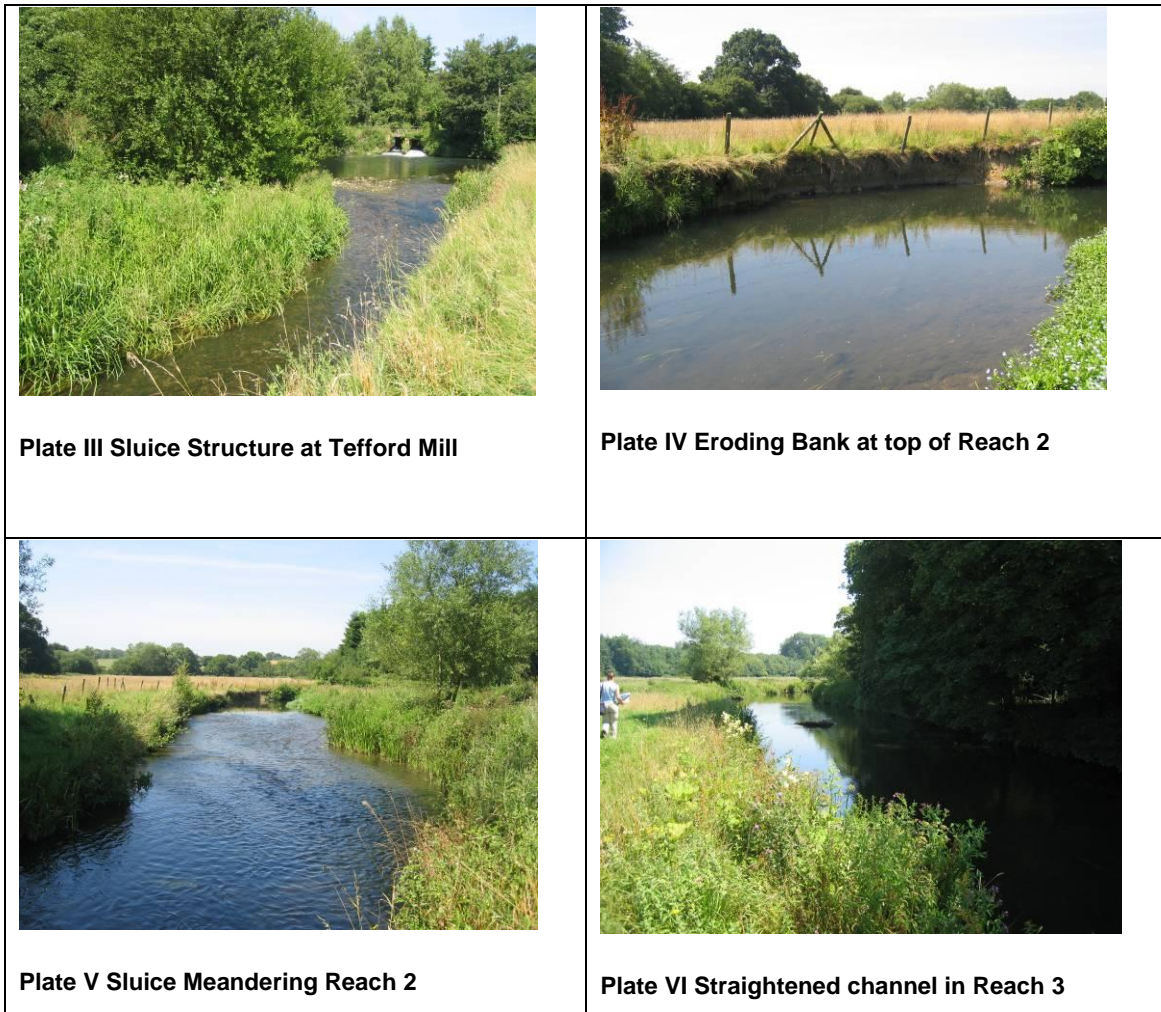
Figure 2.1 Reaches 1 to 3

Over the whole of the upstream section of Reach 3 the right bank (RB) was typically dominated by woodland, causing over-shading in parts, whilst the left bank (LB) was dominated by open grassland. Bank cover was typically high (90-95%), the proportion of marginal vegetation varied widely (5-90%) and the percentage of in-channel cover was typically low (2-5%). A water vole survey had not been carried out on this section of the site but their presence had been recorded further downstream, within the restoration reach. A high number of dragonflies and damselflies were observed on the day of the site visit. The dense woodland, which dominates the RB, should provide good habitat for birds.

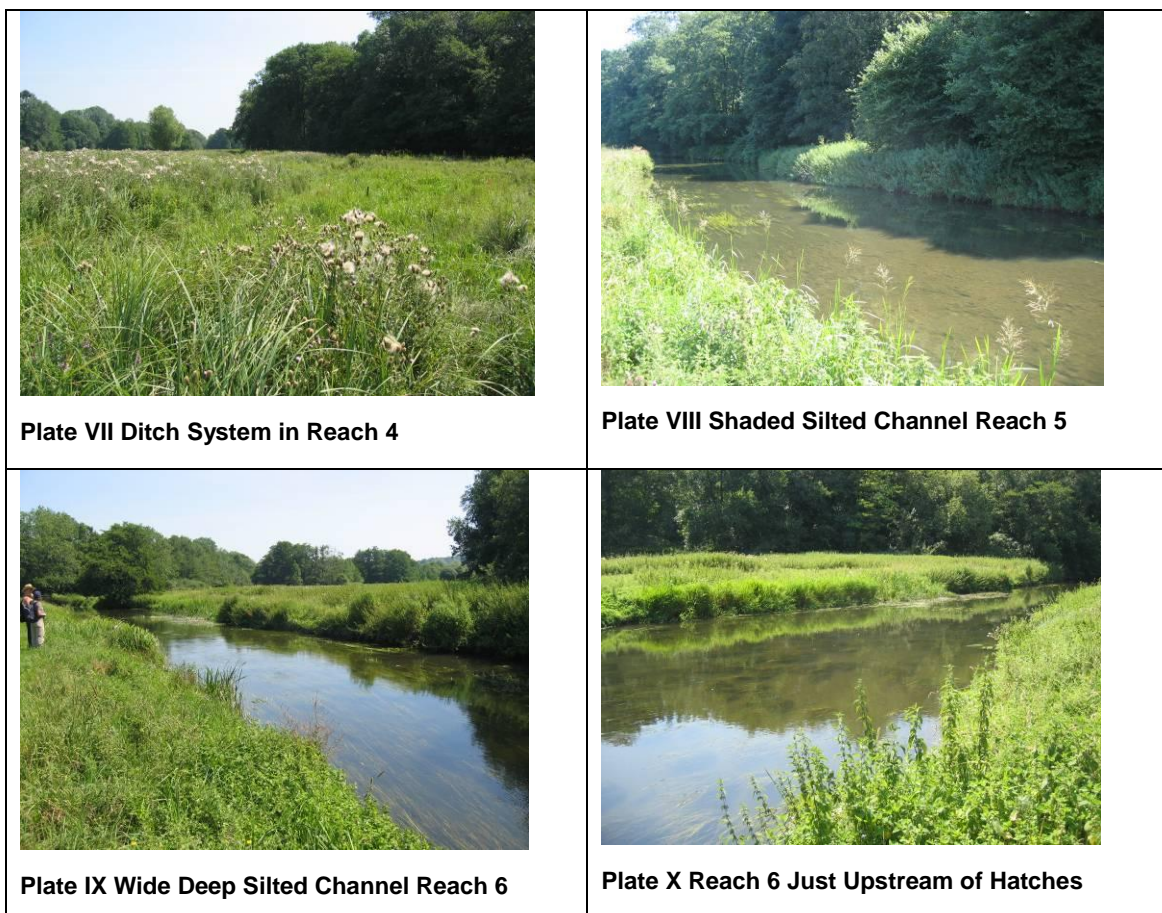
Figure 2.2 Reaches 4, 5 and 6

coarse fish rather than salmonids. The dense shading in Reach 5 and low diversity in flow throughout the reach will have altered the aquatic invertebrate community composition found in this reach in comparison to reaches upstream or downstream.

The network of ditches within the water meadow (Reach 4 see **Plate VII**) was, at the time of the assessment, fairly dry with no flow of water and few aquatic species present. The area had been identified as potential habitat for Desmoulin's whorl snails. Whilst these ditches were not part of the original STREAM bid as the ditches were within the floodplain and not in the river or riparian zone, however it was suggested that they could be a good source of infill material and aquatic emergent vegetation.

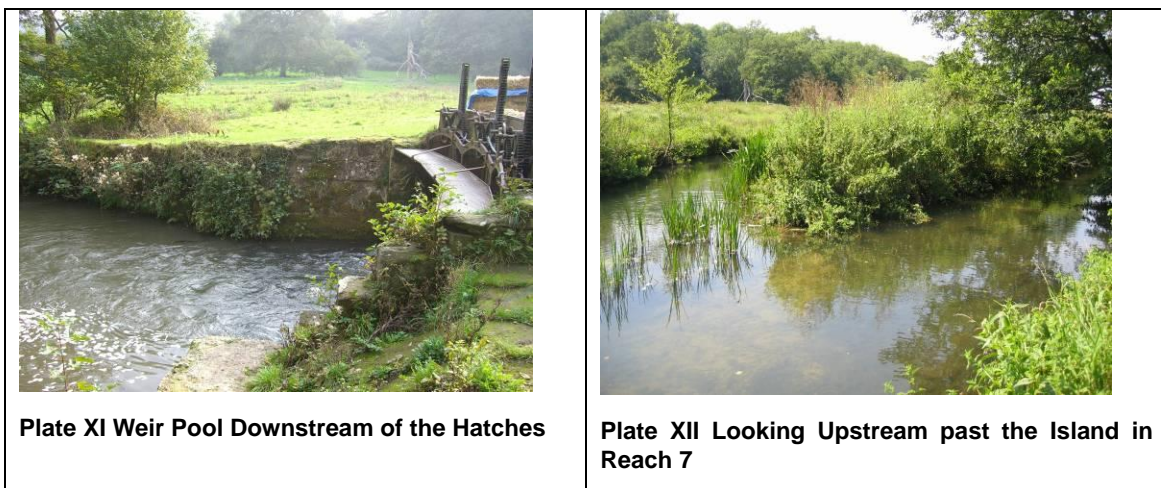
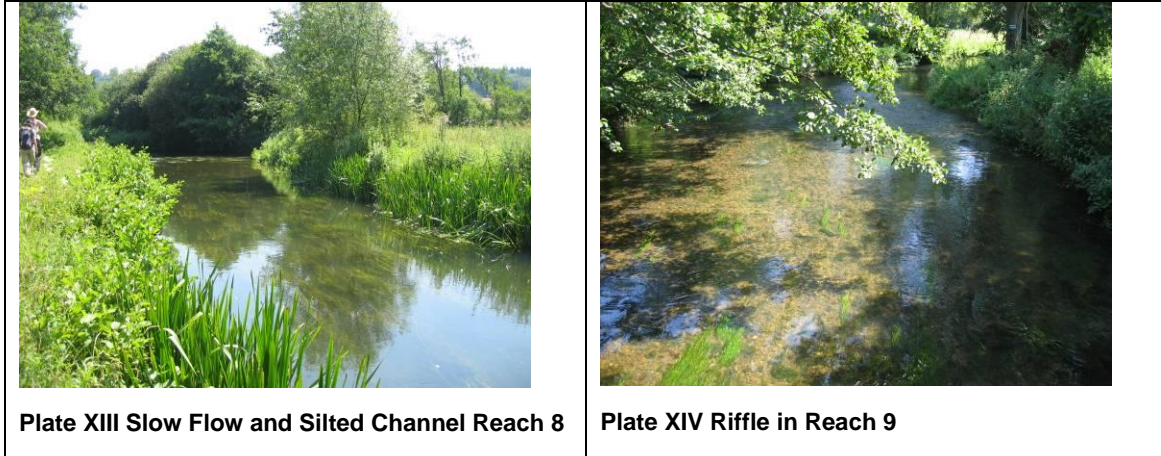
Figure 2.3 Reaches 7, 8 and 9

Over the whole downstream section the geomorphological features of the river varied, from a pool and split channel immediately downstream of the sluice (Reach 7 see **Plate XII**); through a straightened, sluggish reach with few geomorphological features; into a good quality chalk river habitat with *Ranunculus* and spawning gravels. The physical features of the units were reflected in their instream ecological characteristics. The final unit (Reach 9 see **Plate XIV**), which had a diversity of geomorphological features and variation in flow conditions, provides spawning areas for fish and good habitat for aquatic invertebrates; the unit immediately downstream of the sluice (Reach 7) exhibited some of these ecological characteristics but to a lesser extent. The central unit (Reach 8 see **Plate XIII**), which were geomorphologically less diverse than units Reach 7 and Reach 9, appears to have limited suitable habitat for fish and aquatic invertebrates.

The downstream section was characterised by a mixture of tree cover and open space on both the LB and RB, some locations would benefited from an increase in the amount of tree cover. The vegetative bank cover varies from 30-90%, the proportion of marginal vegetation varied from 5-30% and the instream cover varied from 30-60%. This section of the river was observed to support a diversity of wildfowl including mallards, swans and moor hens.
