# New Forest SSSI Geomorphological Survey Overview

Annex K: Spring Wood Riverine Woodland Restoration Plan -  
SSSI Unit 371

# 1 Spring Wood Riverine Woodland Restoration Plan - SSSI Unit 371

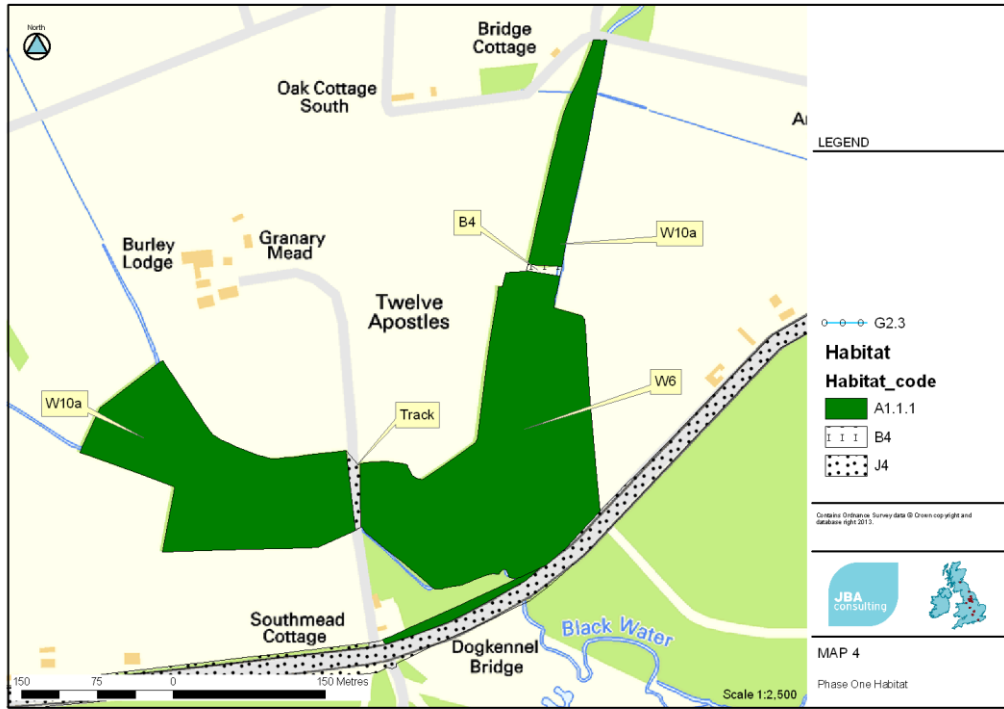
Figure 1-10: Phase 1 Habitat Map of Unit 371 (Spring Wood)

Unit 371 is a varied area of broadleaved woodland, the western arm of which is dominated by a grass and Bracken *Pteridium aquilinum* understorey with Oak *Quercus robur* woodland forming the canopy (Figure 1-10). This woodland is fenced-off and there does not appear to be much grazing taking place at the present time (Figure 1-11). However, the lack of a developed ground flora and the presence of grasses, mainly Tufted Hair-grass *Deschampsia cespitosa* and Rough Meadowgrass *Poa trivialis*, indicate that it is likely this woodland was heavily grazed in the recent past.

To the east of the lane to Burley Lodge, the woodland character is very different (Figure 1-10). Here the woodland floor is criss-crossed with drains which are now incised and flowing freely. The ground flora is more varied and the area is fenced-off from both people and livestock: indeed it is clear that the former are discouraged from entering the wood. The ground is very uneven and this leads to differential levels of waterlogging and all this has led to a greater variety in the ground flora here than upstream. Wood spurge *Euphorbia amygdaloides* is common here, especially near the Lyndhurst Road. Within this compartment the stream from Spring Wood (Black Water) is confined within a large drainage channel and eventually joins the Blackensford Brook channel (which is also straight) after it cuts its way along the designation boundary to its confluence with the Blackensford Brook at Dogkennel Bridge. In this area Alder *Alnus glutinosa* is the dominant woodland tree and there are a few palaeochannels as well as a large lawned area, separating two sections of woodland upstream on the Blackensford Brook.

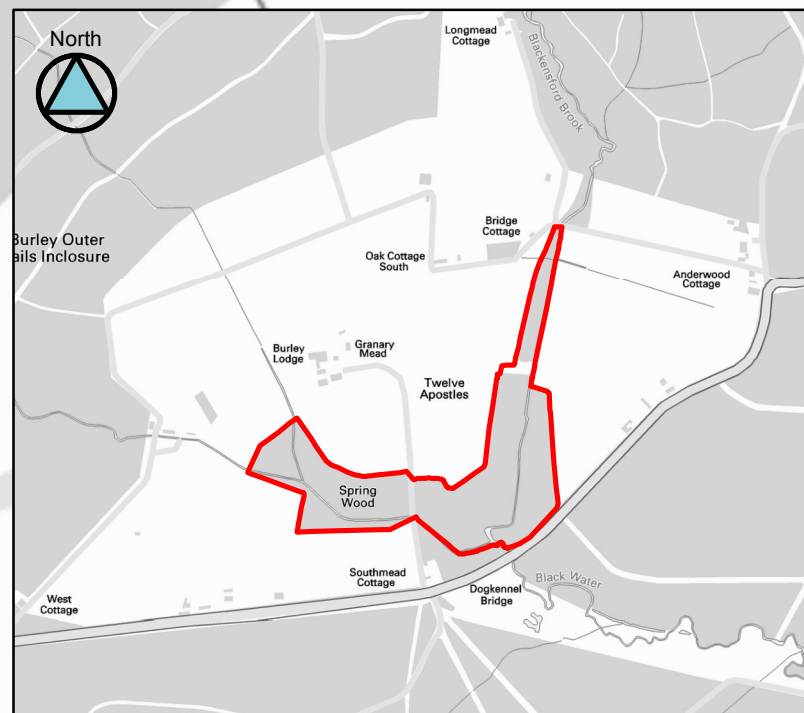
## **Appendix A - Artificial drains and flow lines - SSSI Unit 371**

The gradient of the watercourses through unit 371 is moderate promoting an anastomosed system where engineered channels have not concentrated flows. Many floodplain palaeo channels are present, albeit currently disconnected. It is clear that significant channel straightening has been undertaken (from maps and LIDAR) in the past, particularly along the lower reach (Figure 1-5 - A). Straightening of the watercourse has had a significant effect on the nature and functioning of the river. The length of watercourse will have been shortened leading to a steepening of the system and the associated dredging will have over-deepened the channel. This in combination will have increased flood shear stress levels promoting erosion. The initial impact of straightening would have been incision along significant lengths of the wooded watercourse (Figure 1-6) and localised widening. This incision episode appears to have been mild and no knick points were seen on the tributary / drain systems (Figure 1-7). Ditching along the reach will have impacted slightly on the flood flow regime of the watercourse. Groundwater levels have been altered slightly as a result of post engineering channel incision, but the impact is considered minor. The degree of artificial drain creation is shown in Appendix A.

Drainage into the SSSI is stable and management of the drains themselves will not be required if they are retained. Drainage channel infilling is recommended.
