West Penwith Ecohydrological Investigation and Characterisation – Site Visit Report

Phase 3 2020-21

Natural England Research Report NECR402

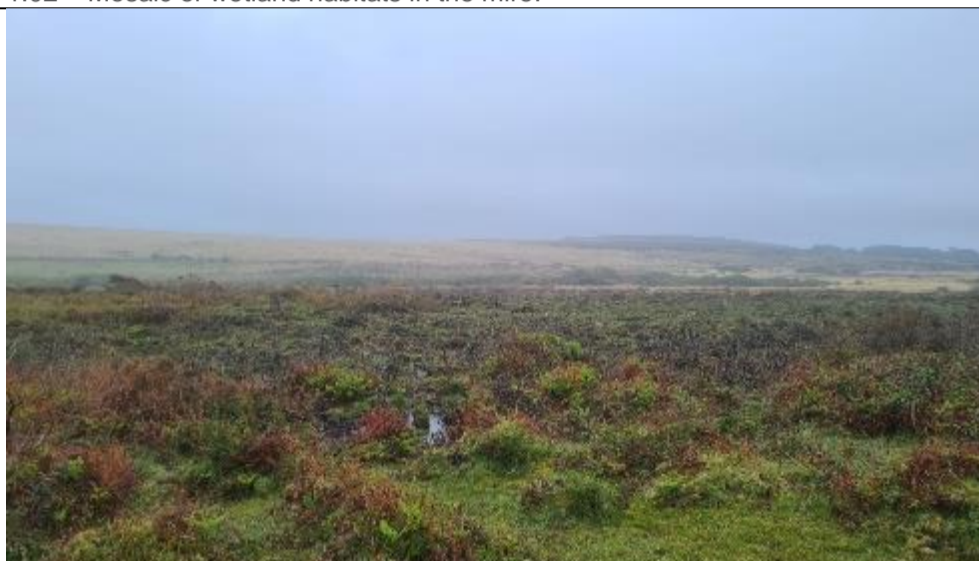
1.04 – Grass, bracken and fern species in the upper areas of the mire.

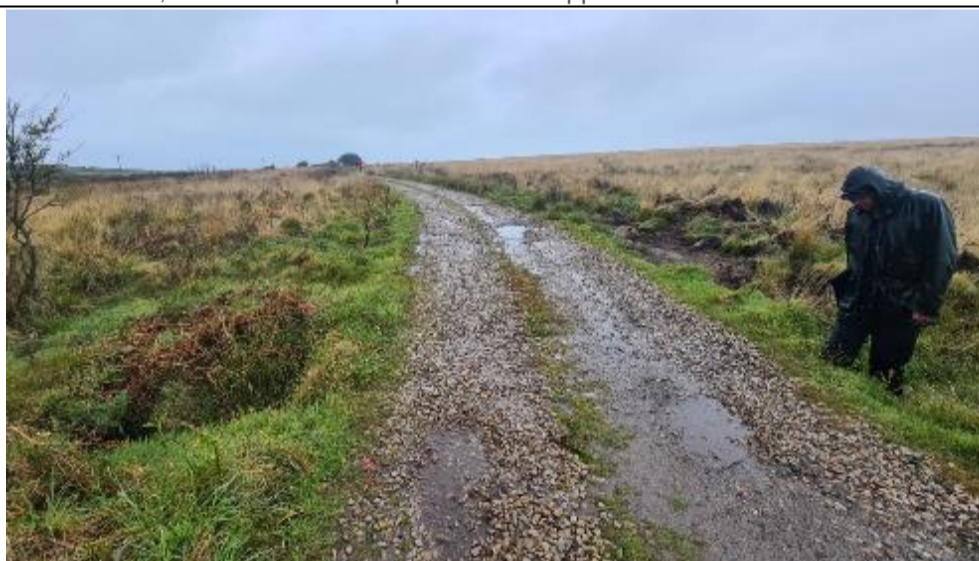
1.05 – Flow pathway leading from semi-natural rough ground on the right of the image, through the culvert under the track, to the mire on the left of the image.

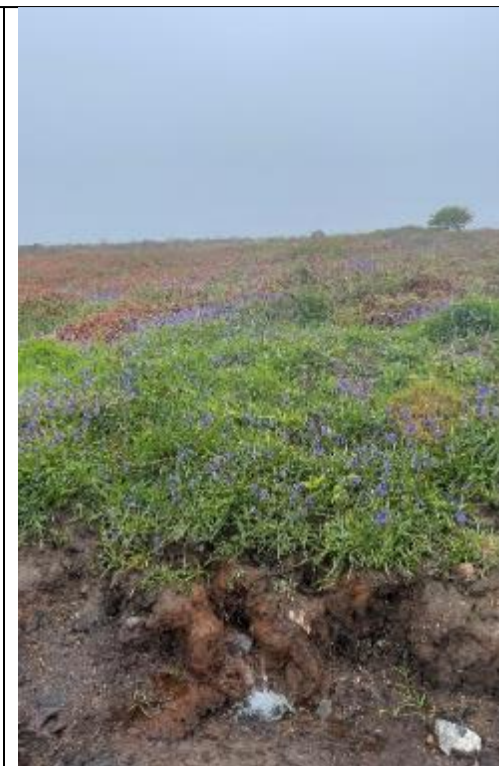
1.09 – Pipe drain flow through peat.

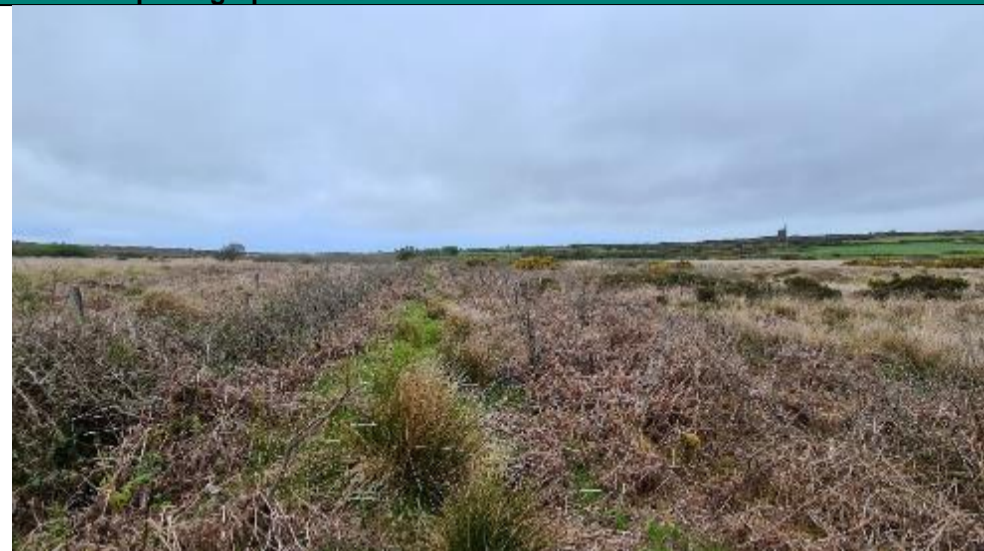
2.01 – Straightened ditch with limited flow (on left of image). Photo taken looking upstream. Habitat directly adjacent to the left bank of the ditch is not classified as mire habitat and is likely drained by the ditch.

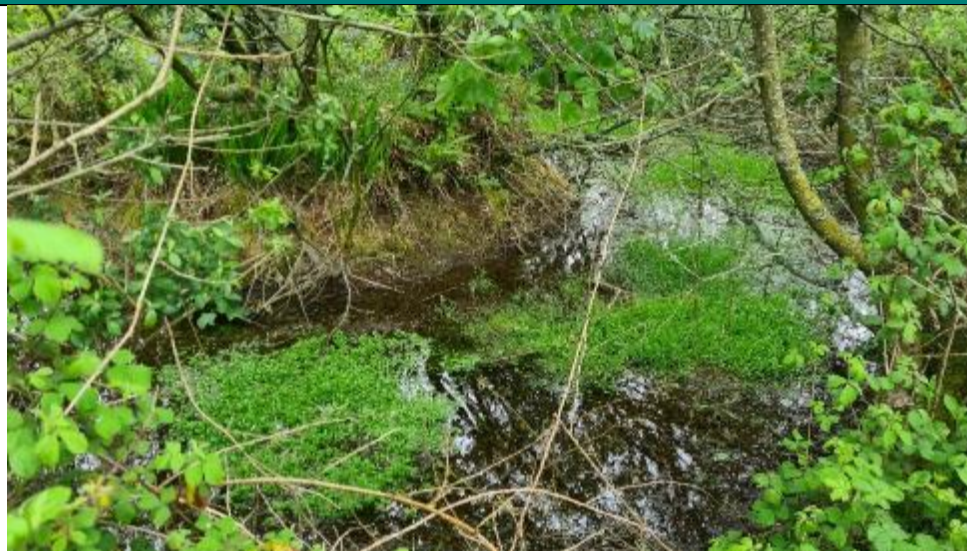
2.02 – Manmade pond at top of watercourse with an inch of water in bottom.

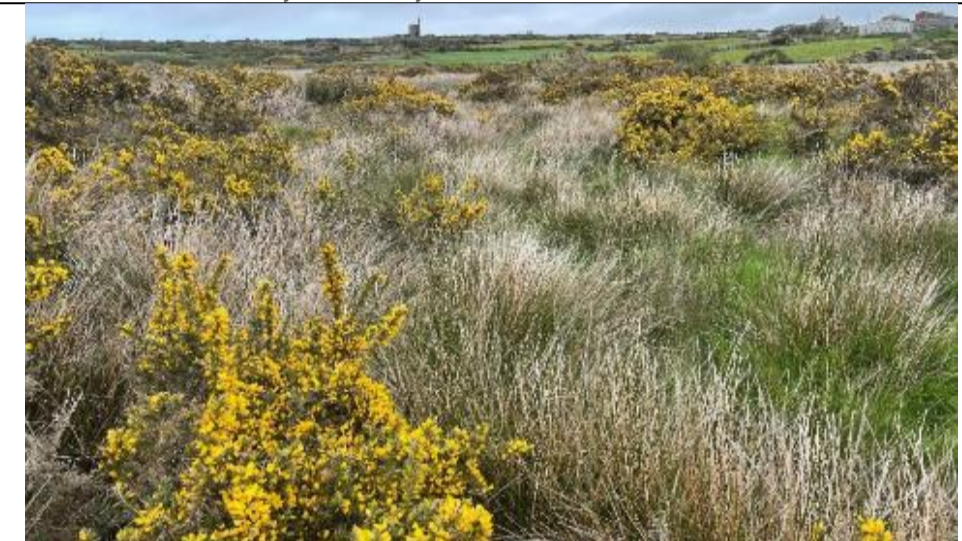
2.03 – Drier habitat near to watercourse dominated by Molinia moor grasses and gorse.

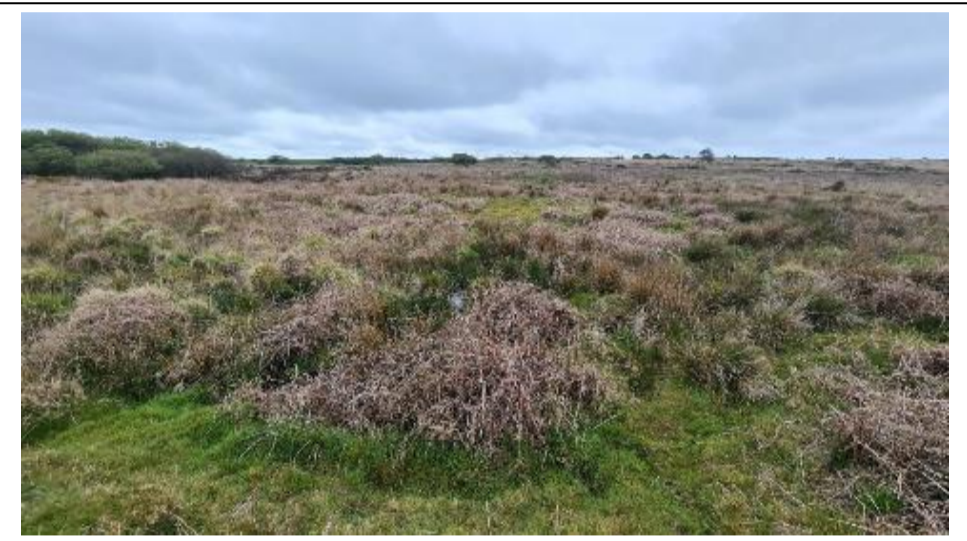
2.04 – Purple moor grass and sedges indicating a wetter mire habitat set back from the watercourse.

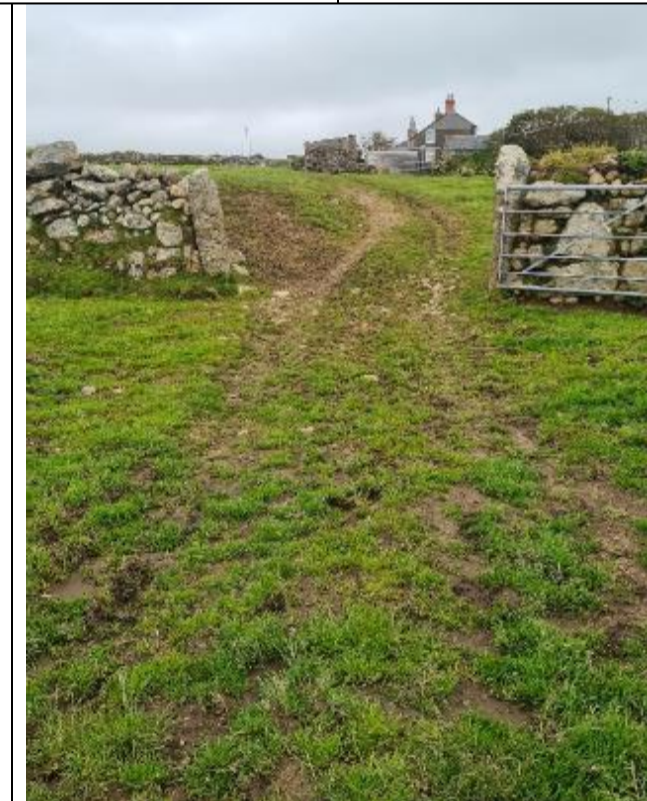
2.06 – Flow pathway flowing through field gate.

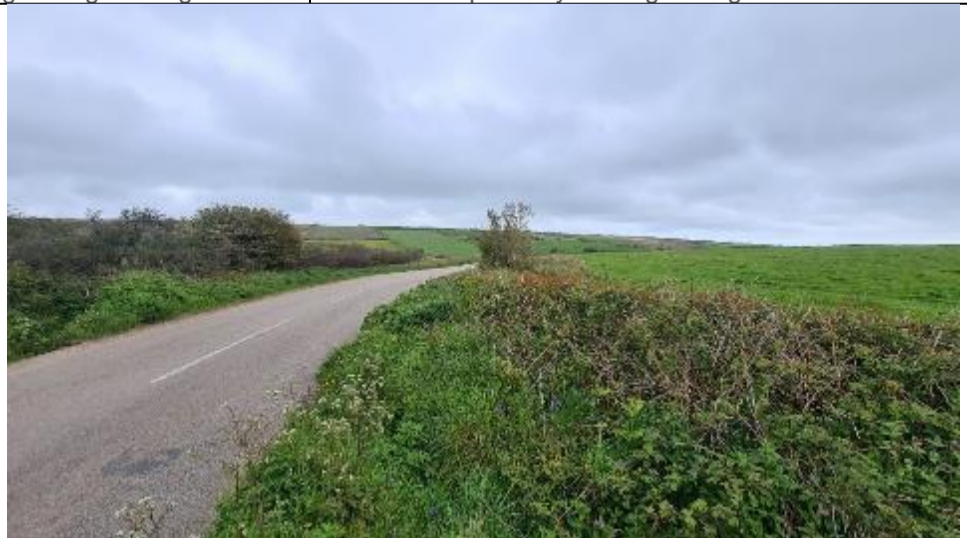
2.09 – Intensively managed grass field mapped within catchment boundary but water from the flow pathway is captured by the road and redirected to the watercourse downstream of the mire.

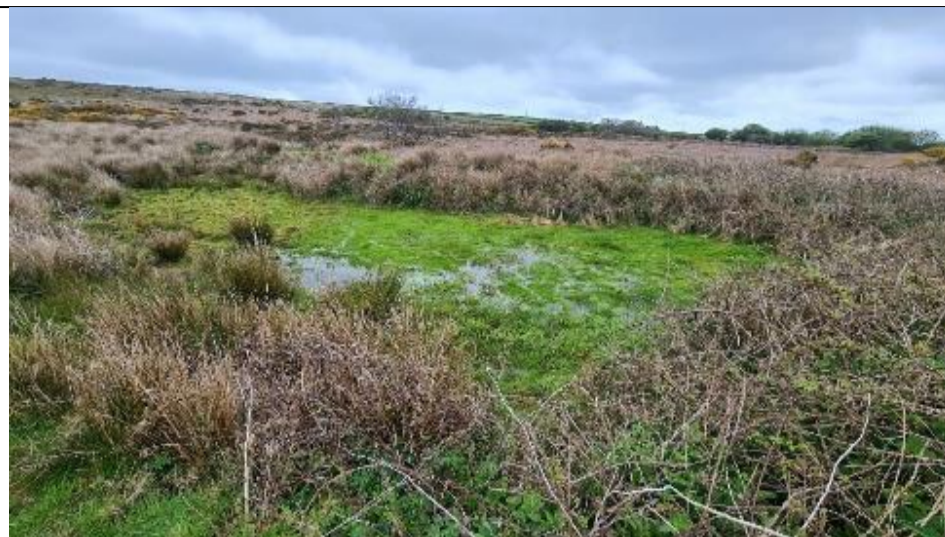
2.11 – Seepage to west of watercourse that dries out in the summer. Bund covered with bracken to capture flow.

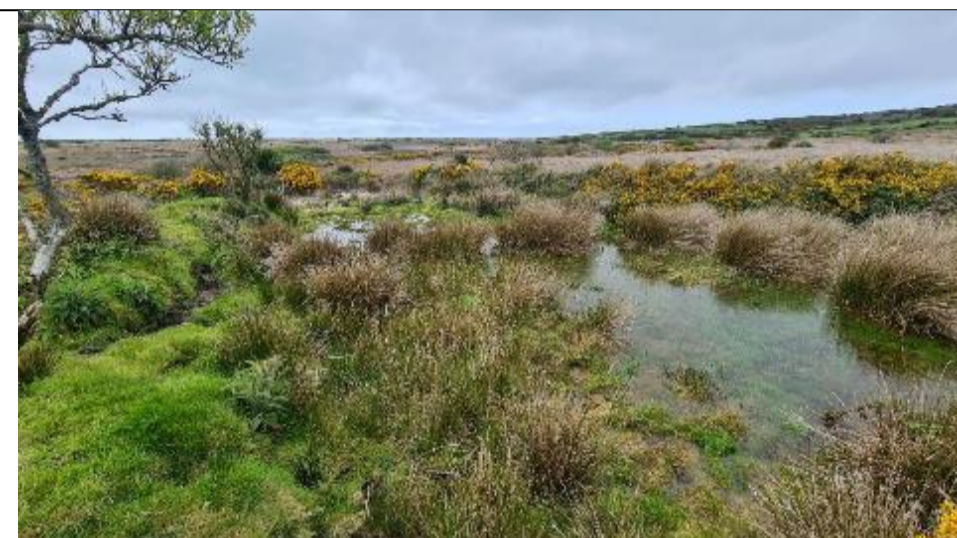
2.12 – Spring leading to watercourse. Watercourse is banded to create a series of cascading pools.

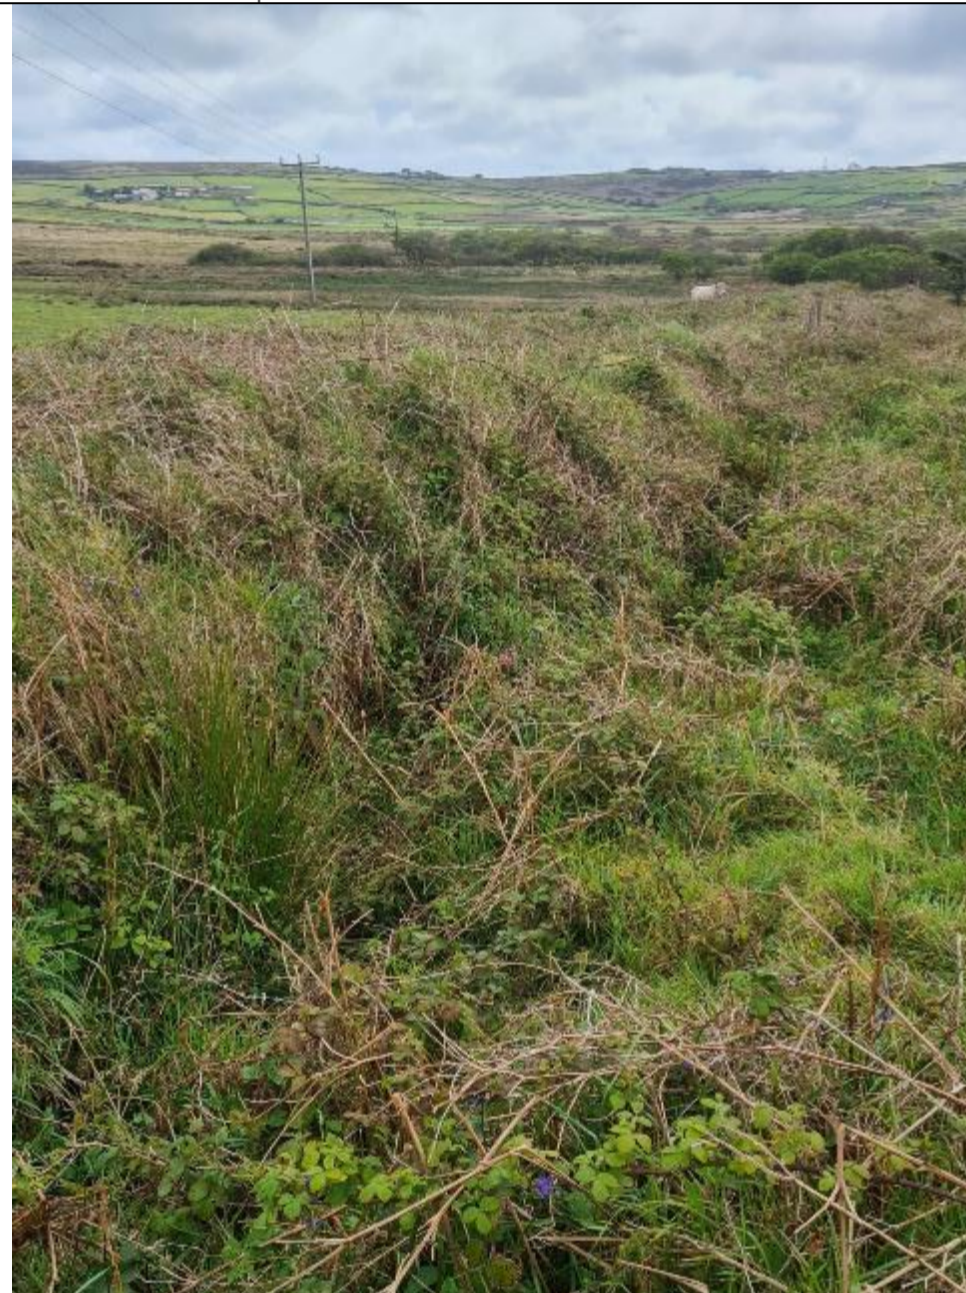
3.03 – Ditch down northern flow pathway.

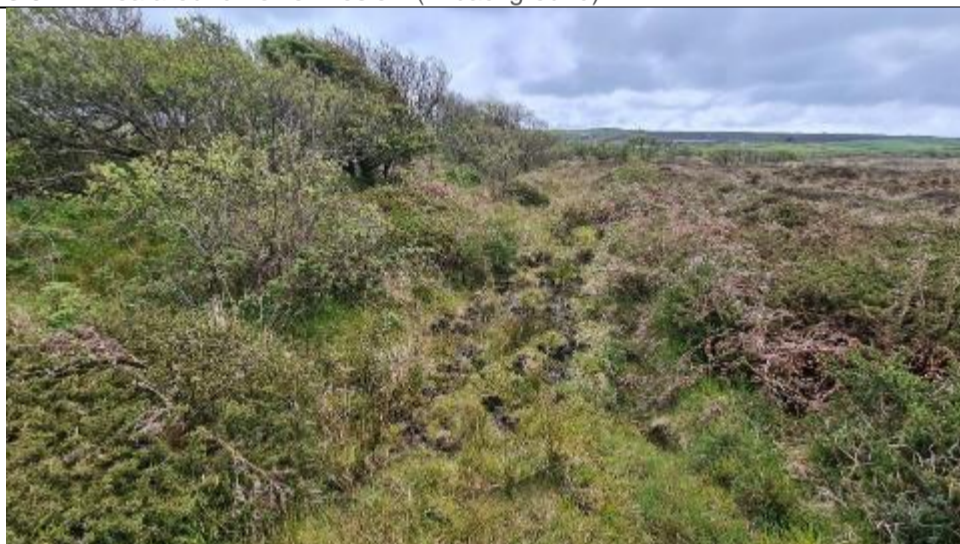
3.05 – Edge of mire habitat showing exfiltration and Cornish hedge.

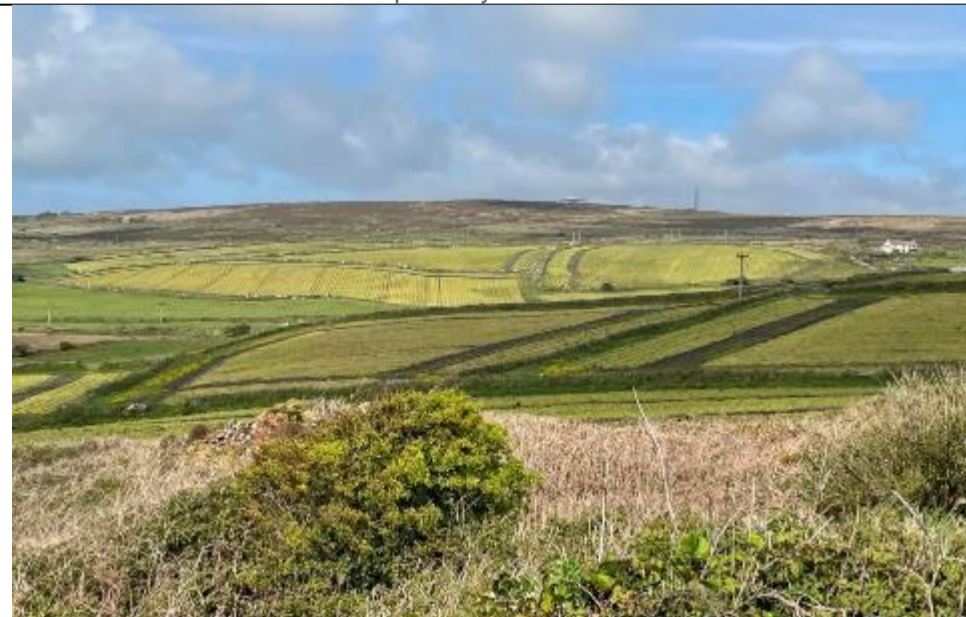
3.06 – View across the south of the Bostraze basin where Daffodils are grown.

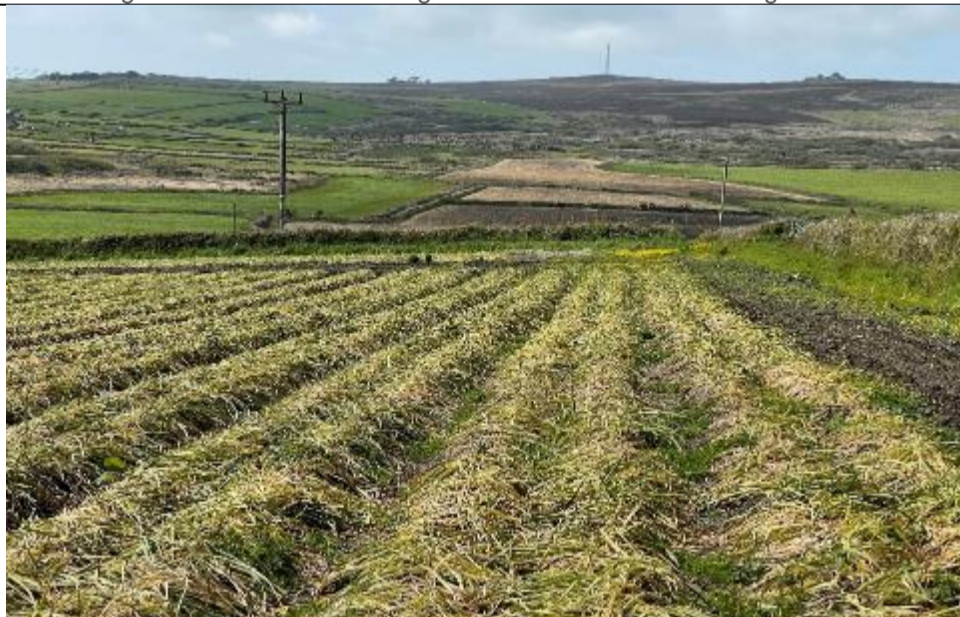
3.07 – View of sloping daffodil fields with mire habitat on opposite side of valley.

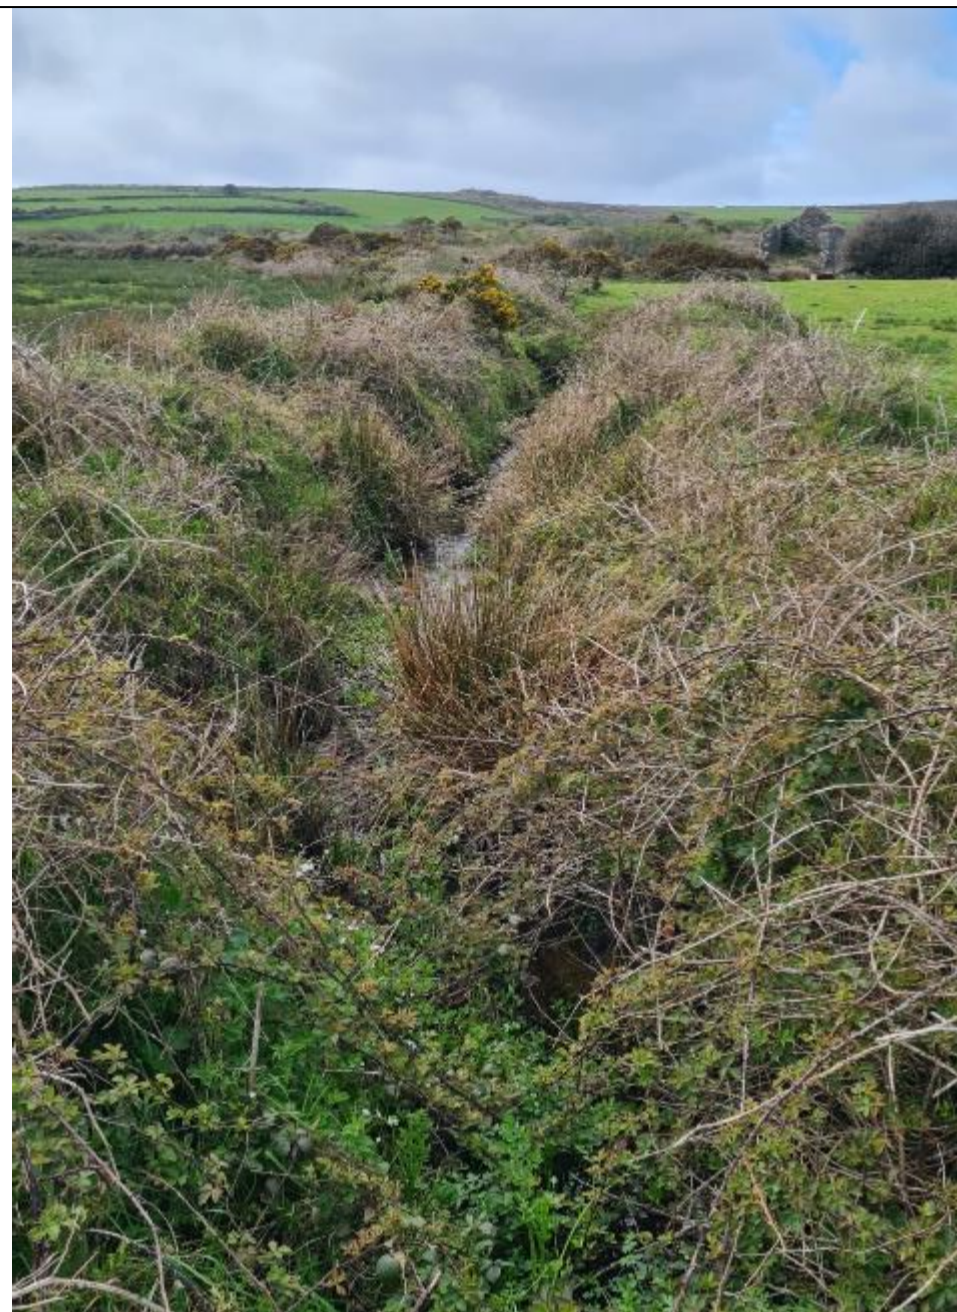
3.08 – View of artificially deepened and straightened watercourse to the south of mire habitat.

<p>Opportunities identified</p>	<p>Although unconfirmed in the field, the desk-study has shown that the site is characterised by a series of watercourses that contribute to drainage of the mire and catchment.</p> <p>As with many of the sites considered as part of the study, blocking of artificial ditches and drains present across the site would serve to restore the natural hydrology of the Bostraze basin.</p> <p>Due regard should be given to potential effects on local landholdings if this is pursued. There is also potential that these types of activities could activate a more frequent influence of other parts of the catchment on mire habitat, although mainly those most downslope that are adjacent to the watercourse.</p>
<p>Other risks</p>	<p>-</p>

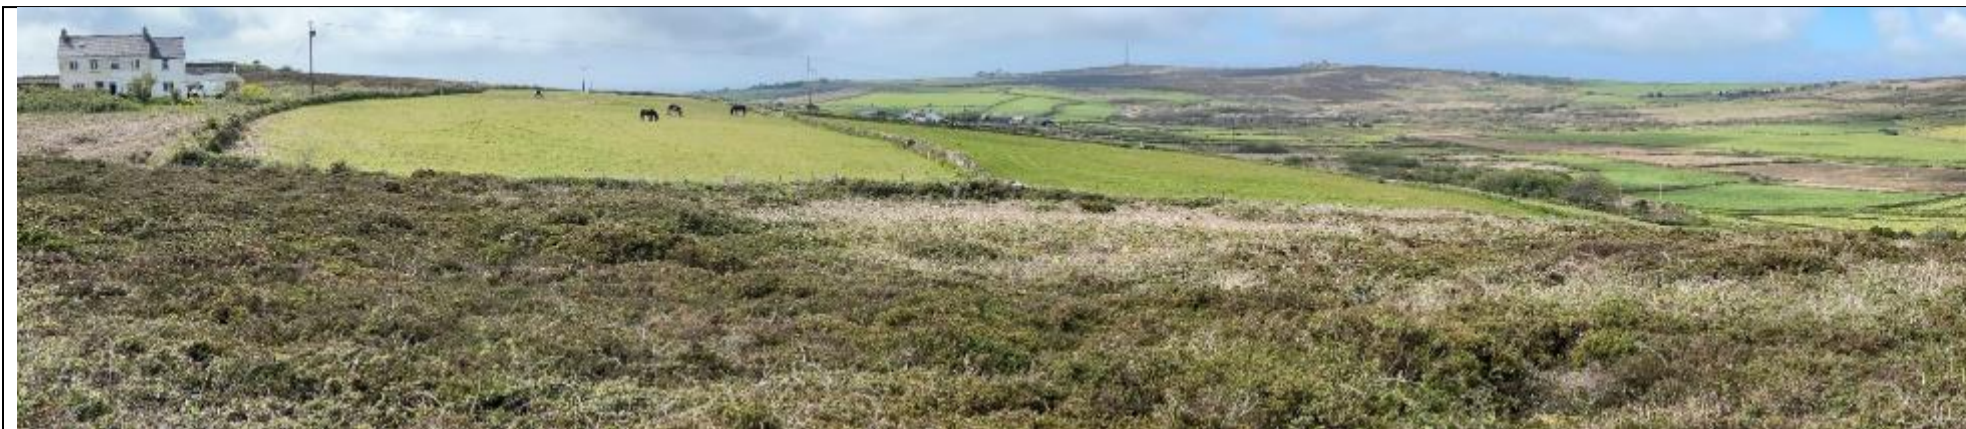
3.15 – Bostraze catchment panoramic photograph taken in the south catchment looking north towards the mire.

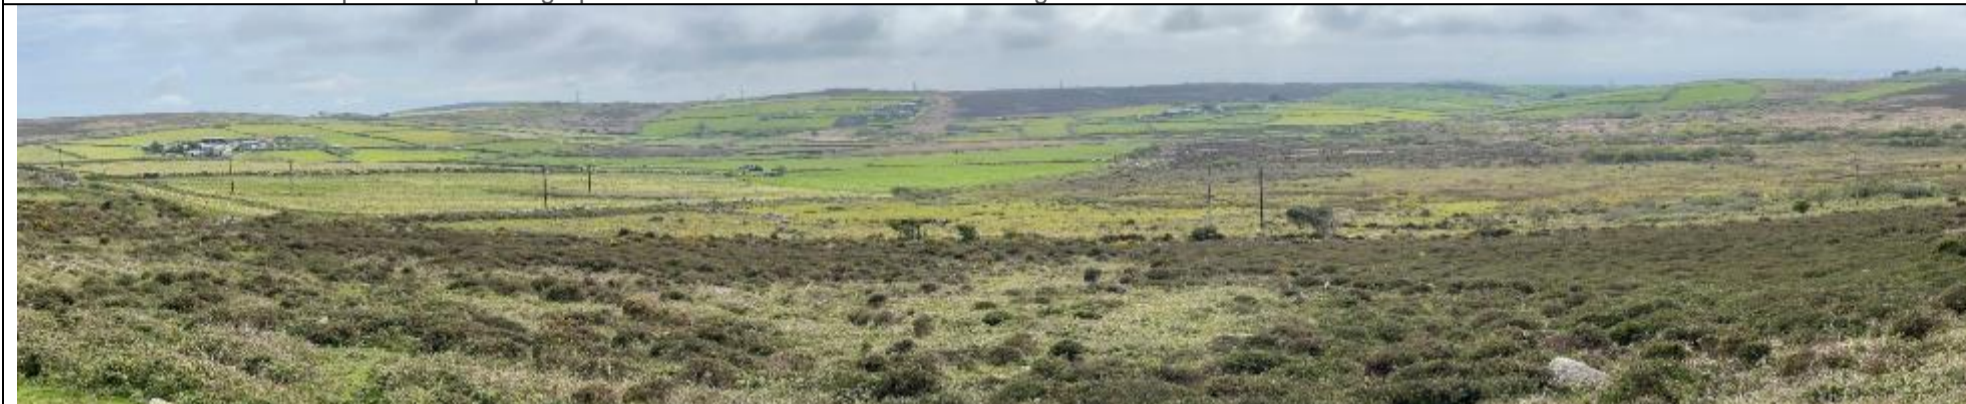
3.16 – Bostraze catchment panoramic photograph taken looking south west on the boundary between catchments (south catchment on the left and north catchment on the right).

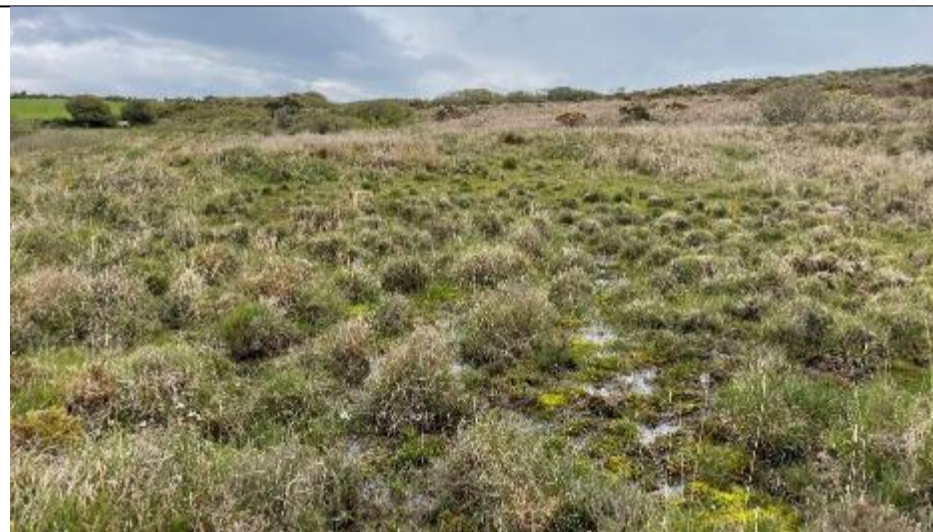
4.03 – Area of groundwater exfiltration.

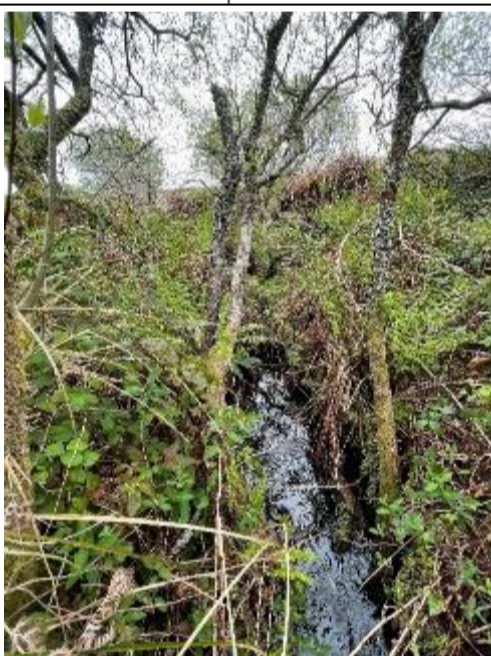
4.04 – Watercourse along flow pathway.

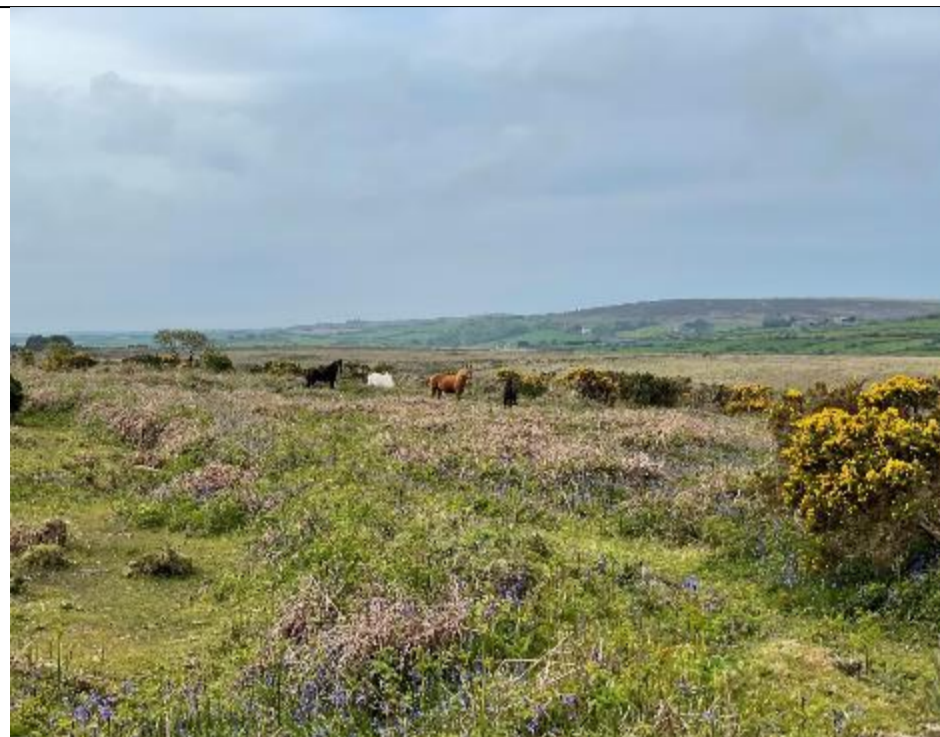
4.08 – Ponies used to graze the mire as part of an HLS agreement.

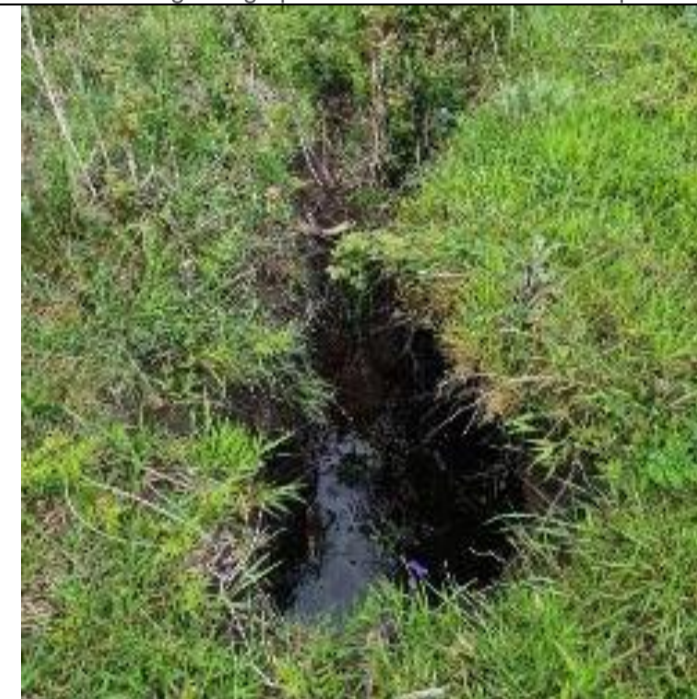
4.11 – Chamber of collapsed large peat pipe carrying water along flow pathway.

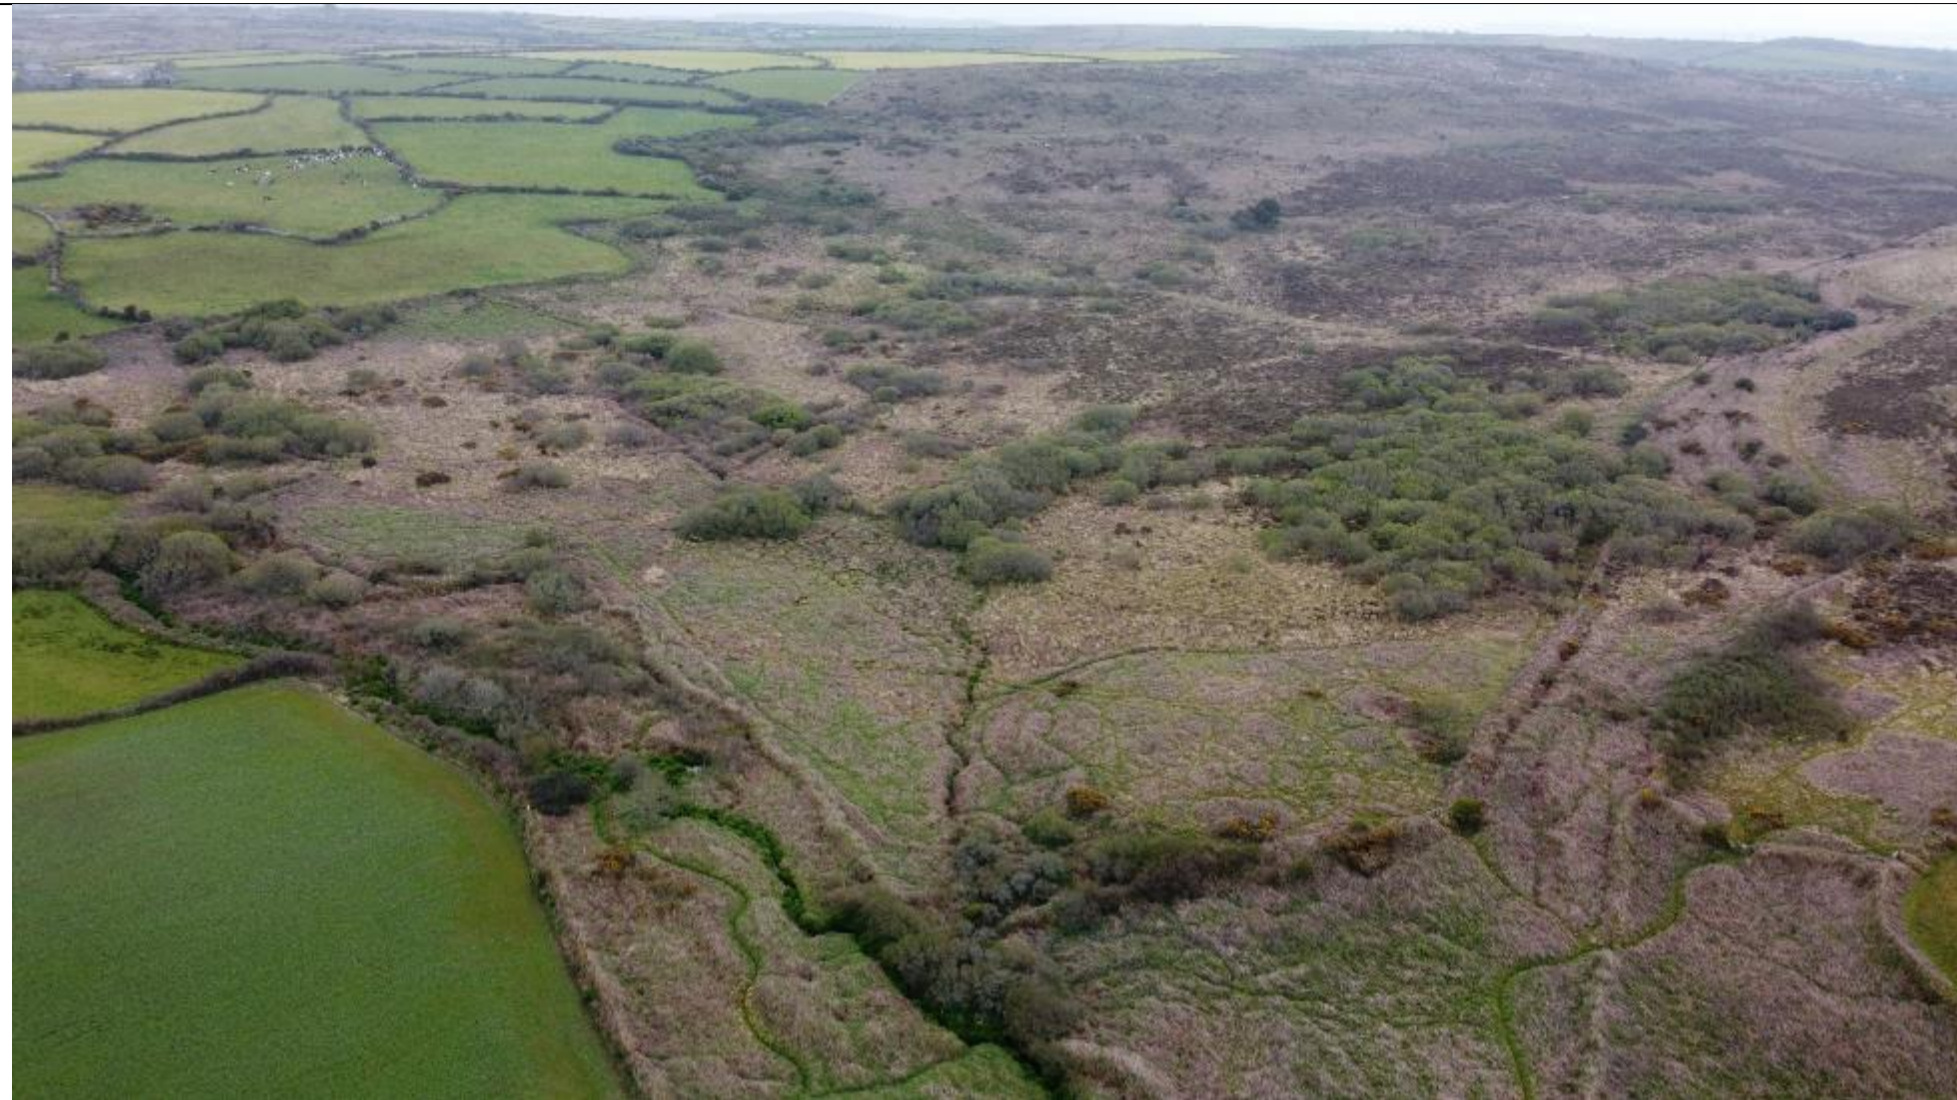
4.14 – UAV photograph of Boswarva catchment flying east from the outlet of the catchment (location of photograph not shown on map).

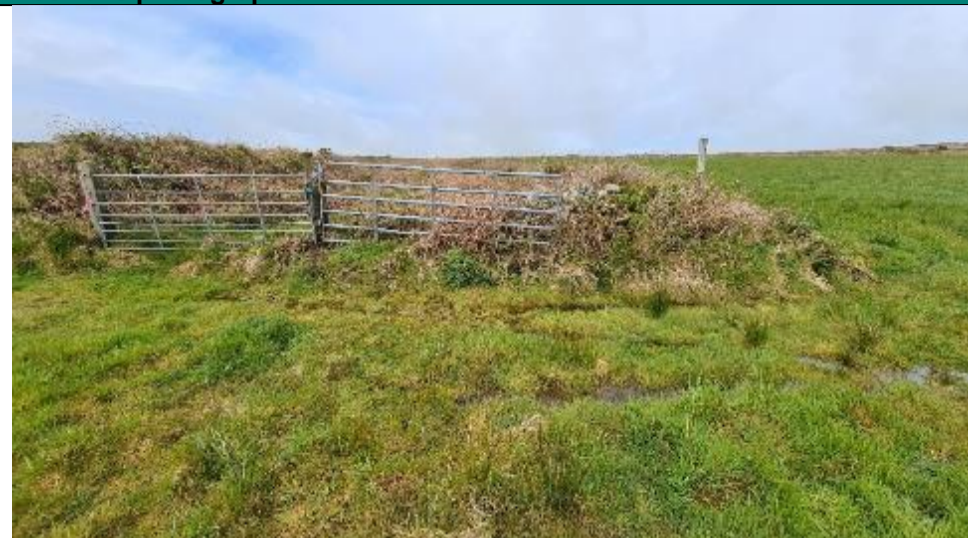
5.01 – Spring feeding watercourse identified further upstream than mapped by the ecohydrology report in 2019 (Pendleton Hydro, 2019). Photograph taken looking upstream, with water flowing from spring downstream.

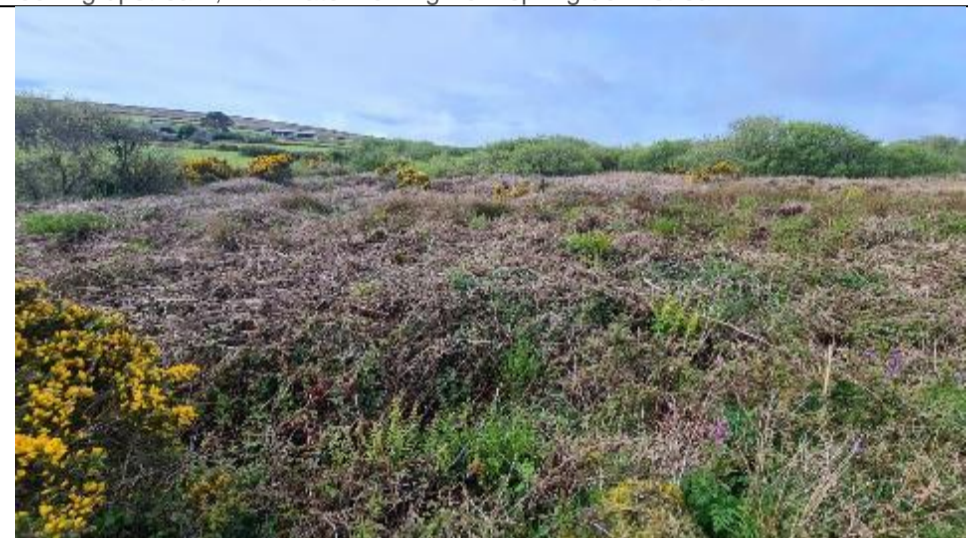
5.03 – Drier mire species such as bracken, gorse and heather at the downstream end of the mire.

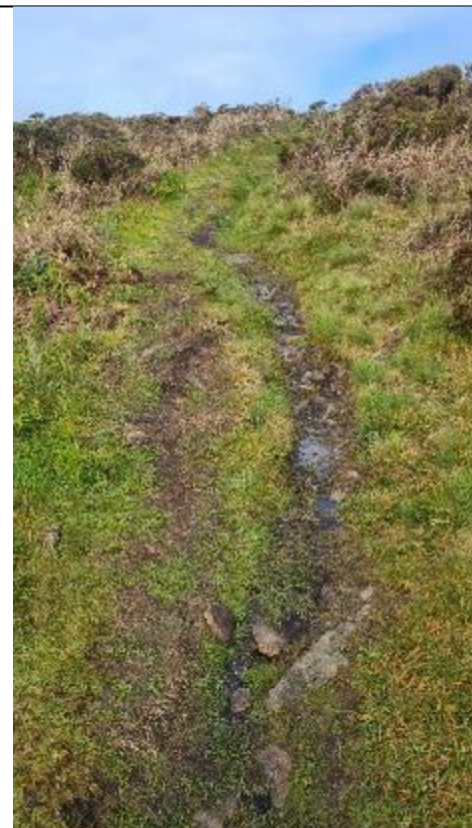
5.06 – Flow seepage on steep footpath.

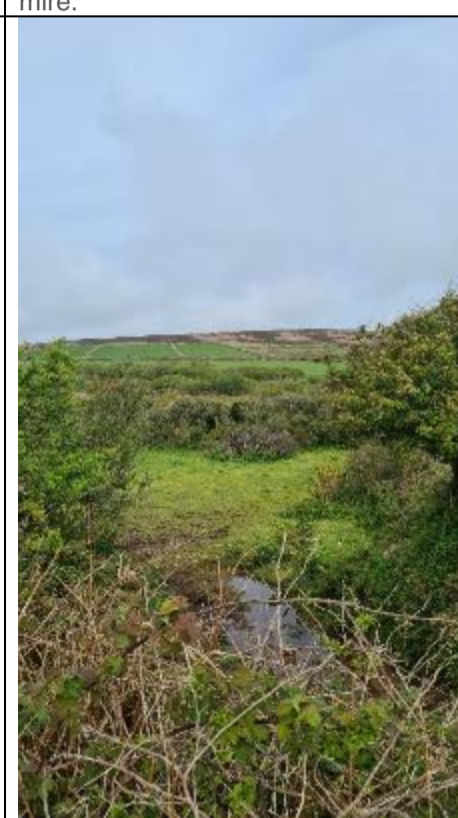
5.10 – Cross-slope drain along field boundary flowing towards watercourse downstream of mire.

Opportunities identified	<p>Opportunity to block the watercourse at the outflow of the mire to increase drainage base by approx. 1.5 m. This would reconnect the mire with the watercourse increasing the wetland species present in the mire.</p> <p>Opportunity to block/fill-in the cross-slope drain to restore surface water runoff into the mire from the southern flow pathways.</p>
Other risks	If increased drainage were implemented within the fields adjacent to the mire downstream it could potentially lower water table within the mire. If the watercourse downstream of the mire was deepened this could also increase the hydraulic gradient from the mire to the watercourse leading to a reduction in mire water levels with an adverse impact upon the mire habitat. Therefore, whilst not part of the hydrological catchment, these fields may still be considered to influence the functioning of the mire.

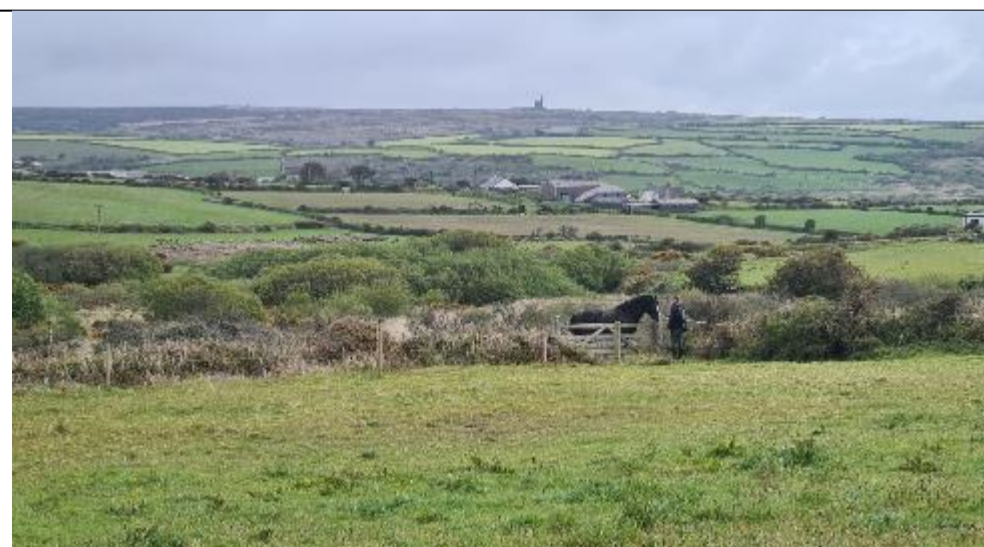
5.11 – Shire horse grazing in the long field adjacent to the mire, downstream of the cross-slope drain.

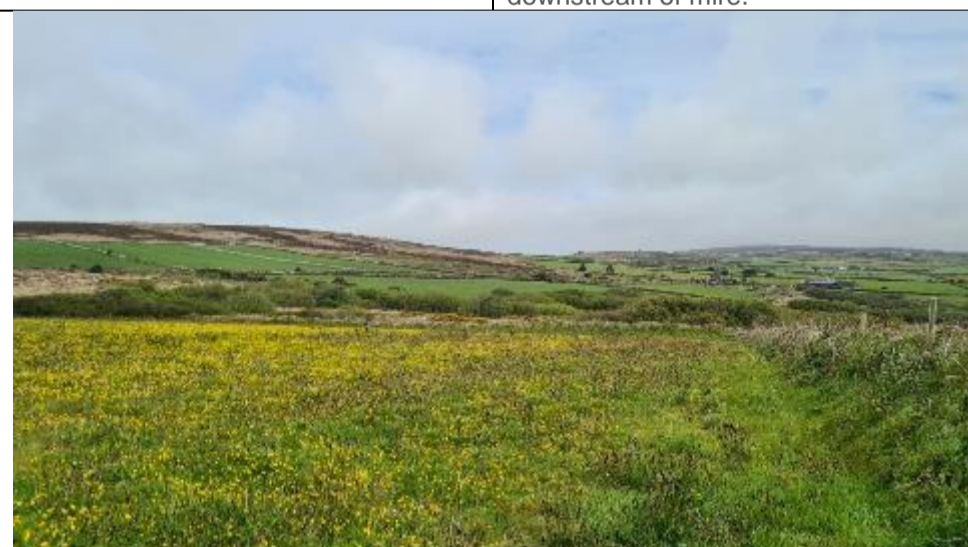
5.12 – Flow pathway leading directly to mire (pale vegetation at bottom of slope).

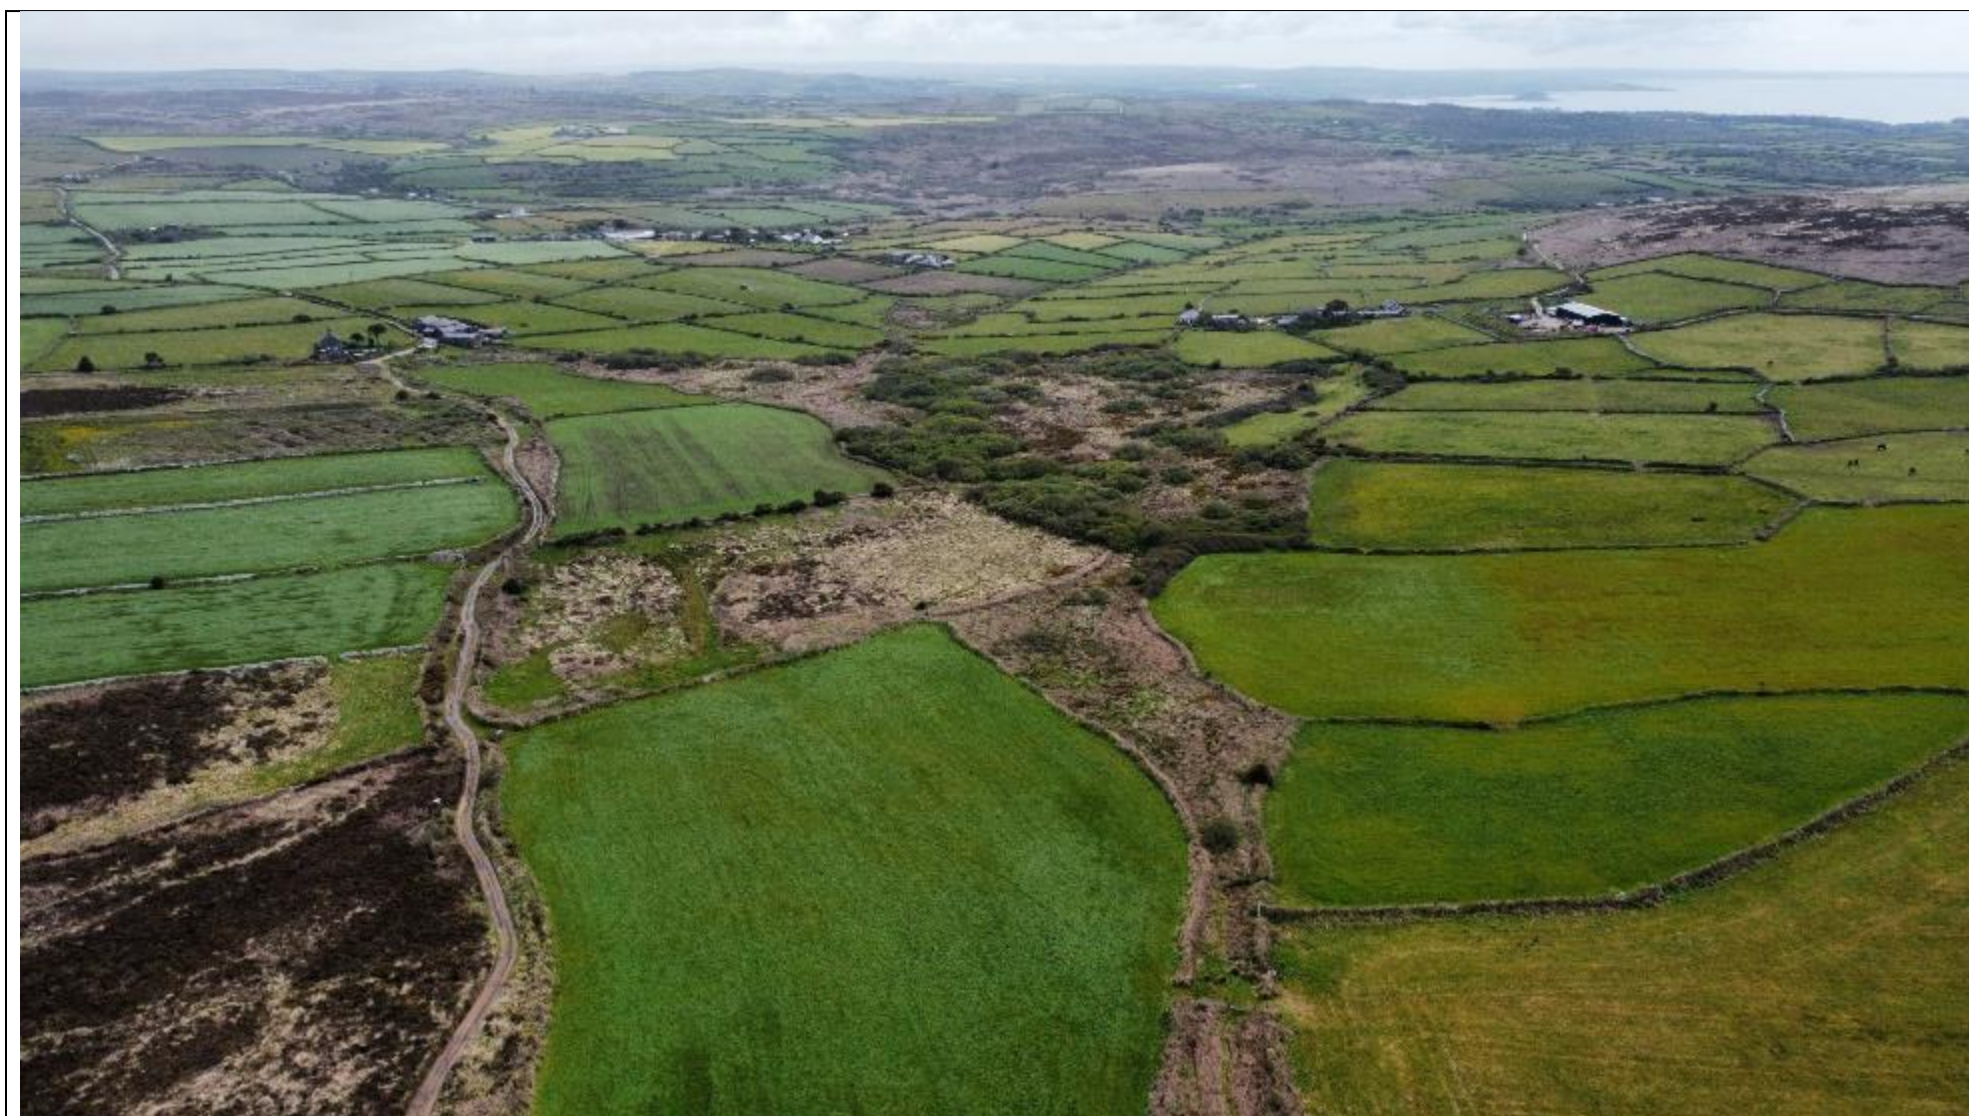
5.13 – UAV image looking up the Boswens Bog catchment in a north westerly direction from the catchment outlet. Location of photograph not shown on map

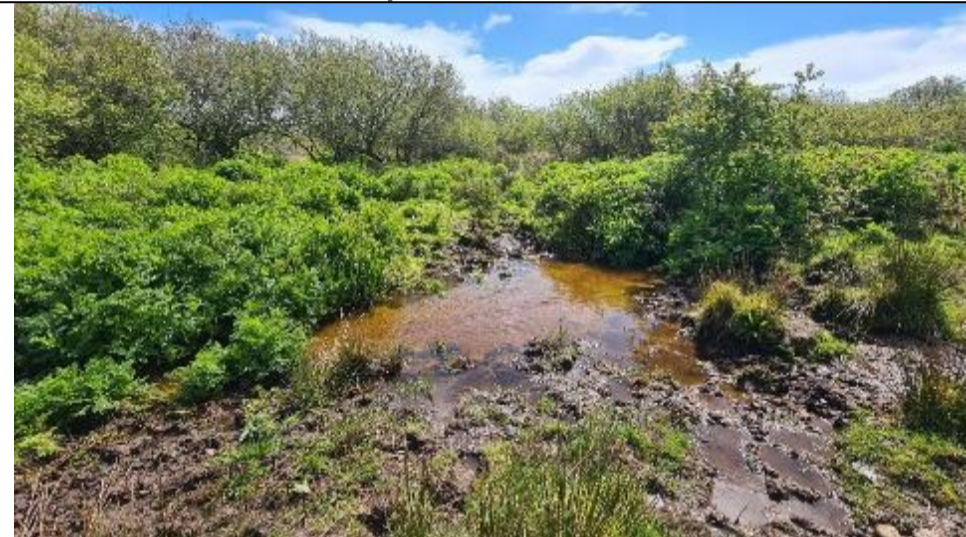
6.03 – Poaching of watercourse banks in mire habitat by livestock. Note the brown colour of the water indicating peat upstream.

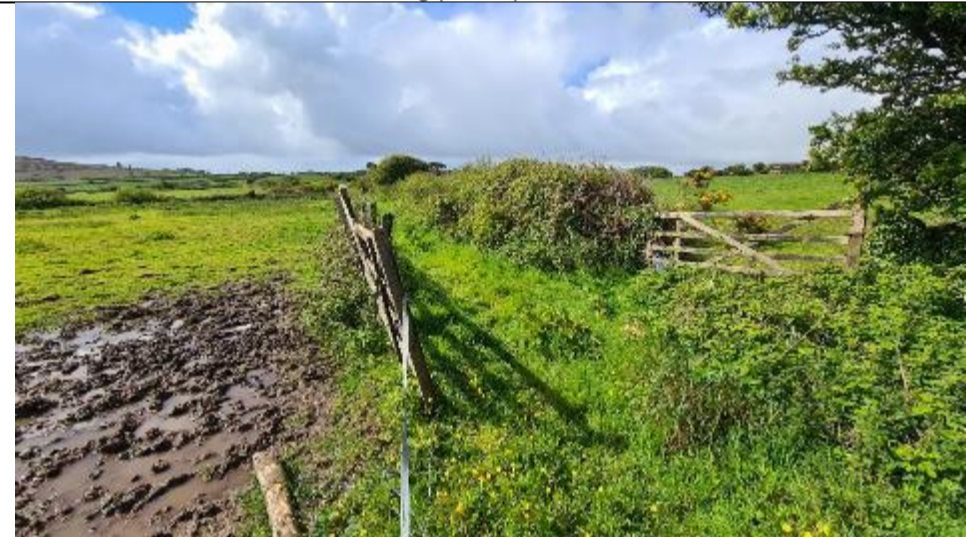
6.05 – Area of seepage as the flow pathway gradient becomes less steep. Seepage area is a field frequented by cattle.
