West Penwith Ecohydrological Investigation and Characterisation – Site Visit Report

Phase 3 2020-21

Natural England Research Report NECR402

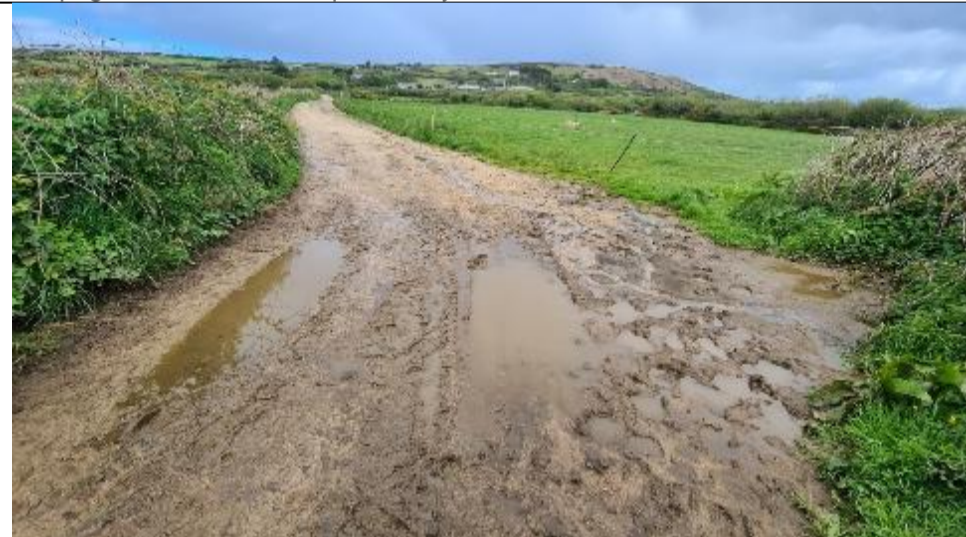
6.07 – Flow pathway along track entering watercourse and creating an accumulation of fine material to the right of the photo.

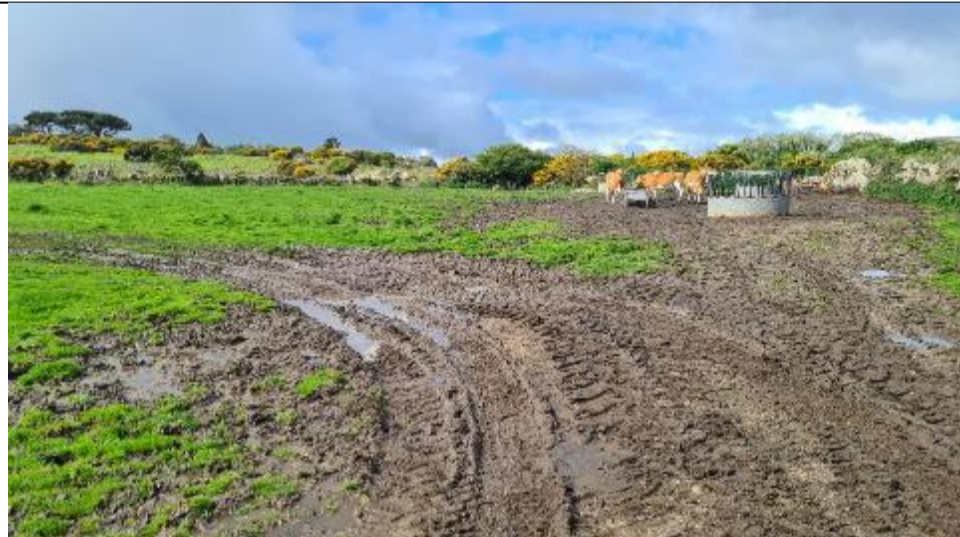
6.08 – Evidence of poached ground as a result of managing the land for cattle including heavy machinery tracks and ring feeders creating a concentration of cattle.

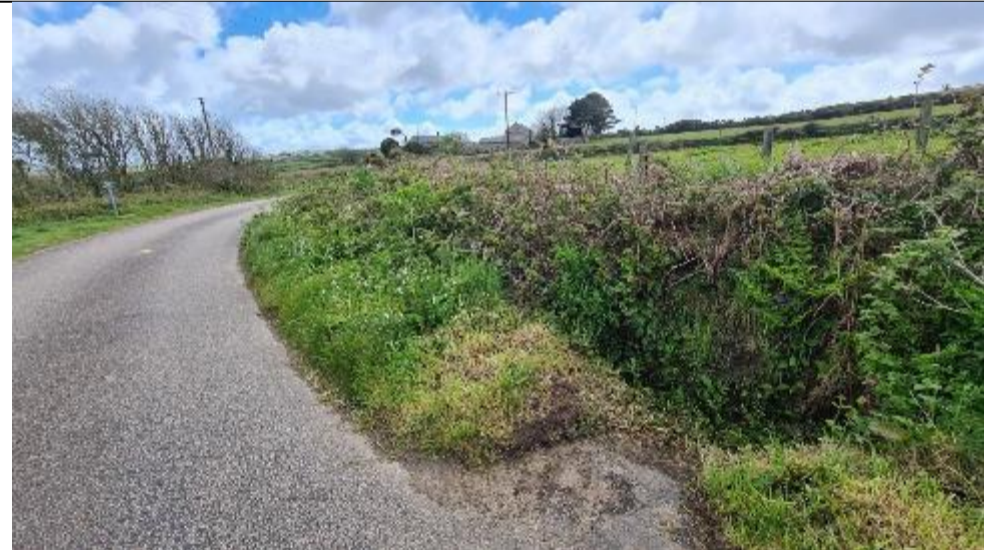
7.08 – Road verges cut to provide road drainage.

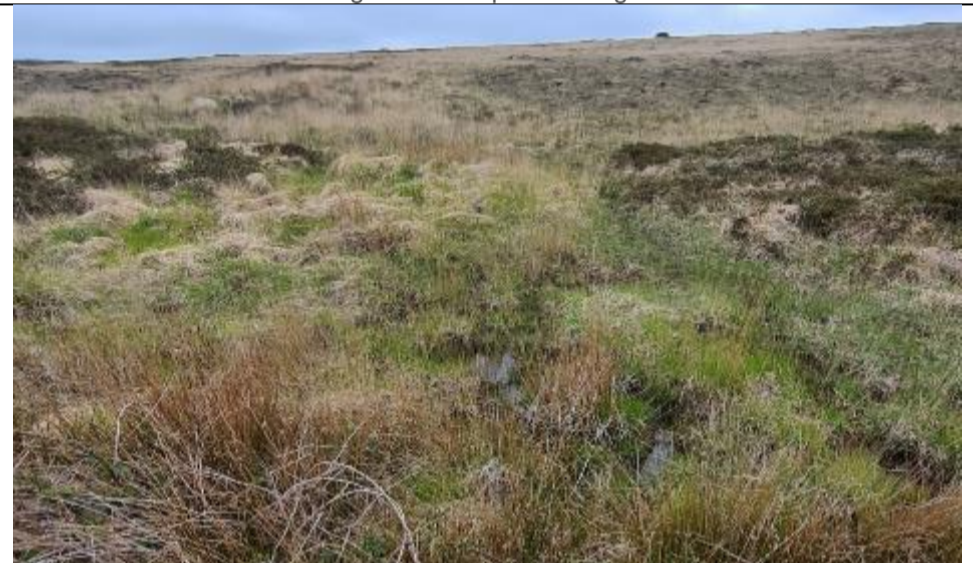
8.07 – Wet habitat upslope of road suggesting that road ditch may be blocked.

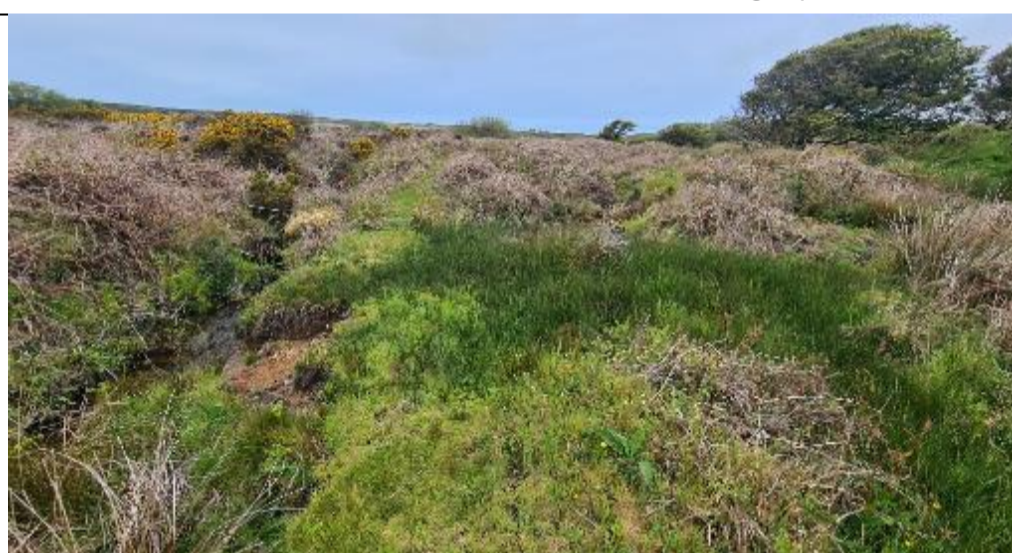
9.06 – Southern mire looking upstream with the watercourse that is artificially incised on the left. Zone of seepage leading to watercourse on left bank of river (right of photo) whereas right bank is steeper with drier mire vegetation at a higher elevation.

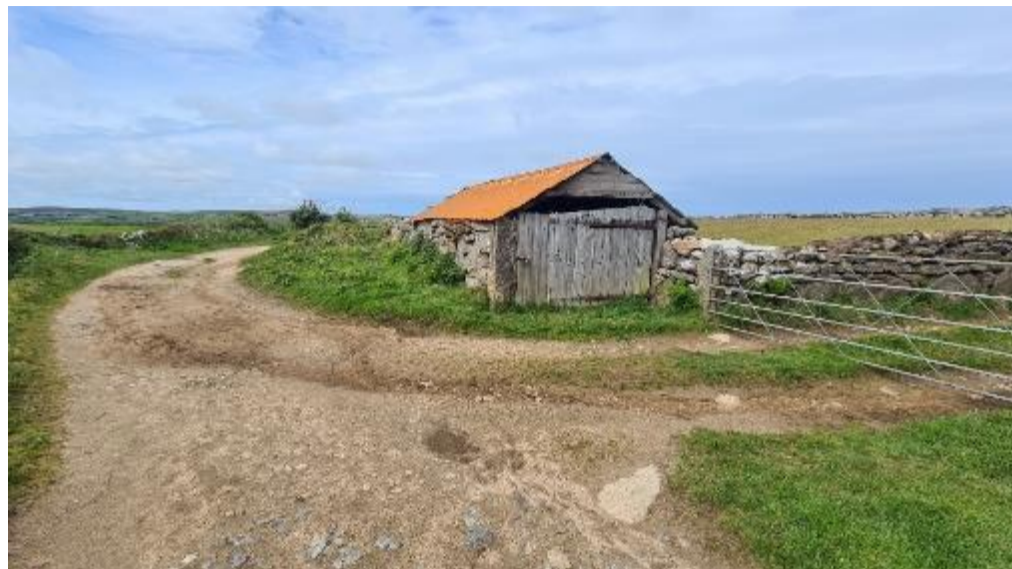
9.08 – Runoff from fields near abandoned farm buildings running down track to track-side ditch on left of photograph. Photo taken looking south west towards the catchment boundary.

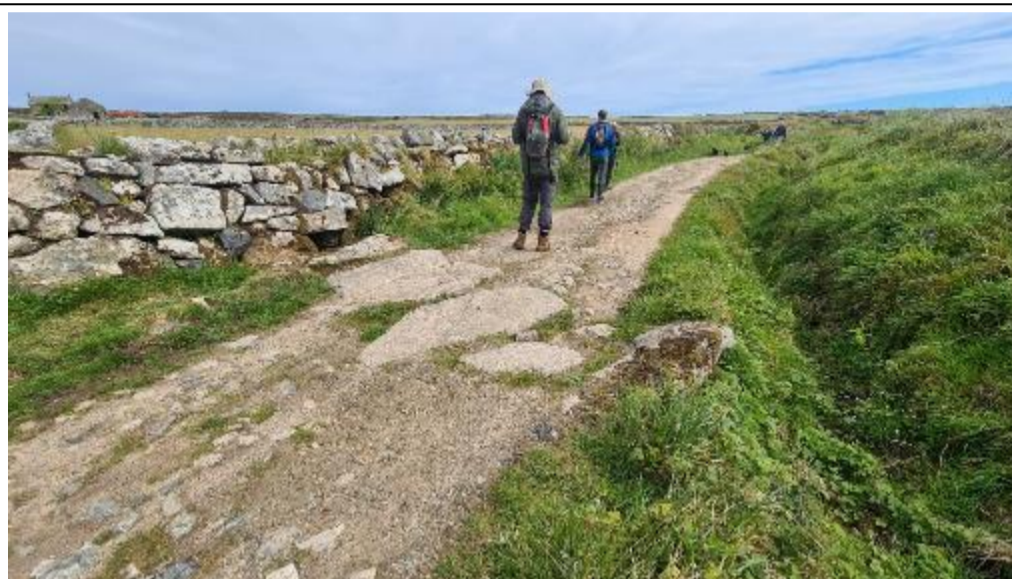
9.09 – Flow from large flow pathways channelled into field drain which passes under track into drain flowing towards mire.

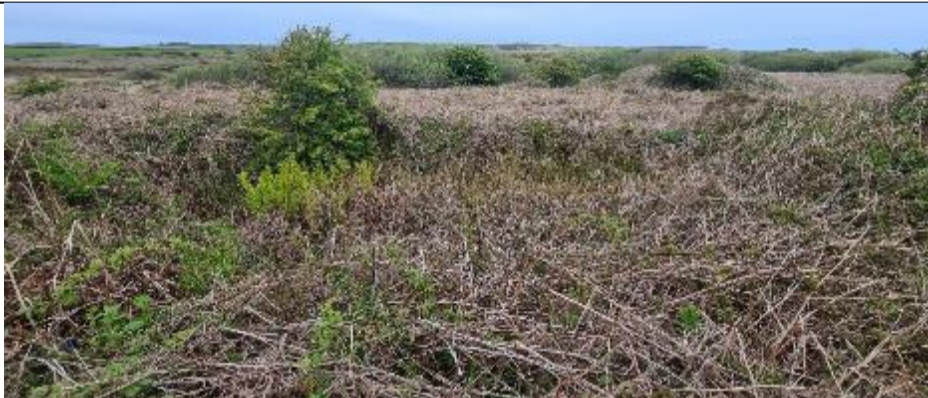
9.12 – Mine shaft topped with bracken with wetland species such as Juncus and ferns growing in the water captured by the shaft.

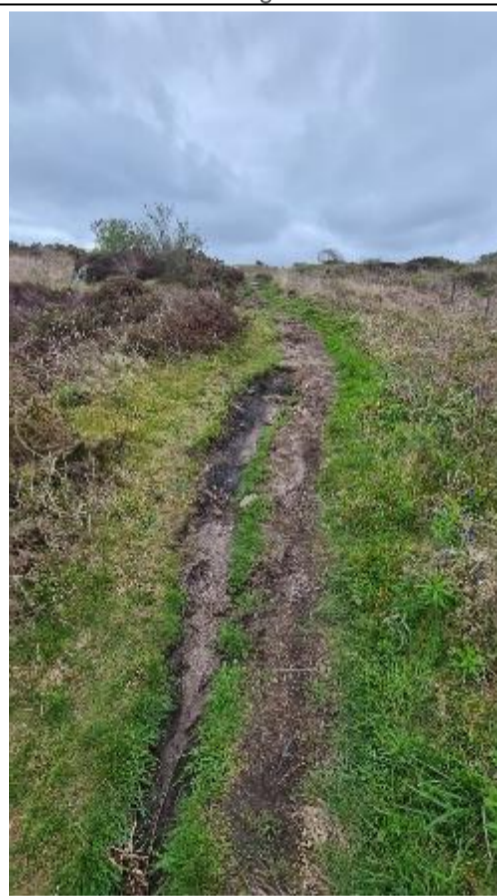
9.11 – Footpath on flow pathway showing evidence of erosion.

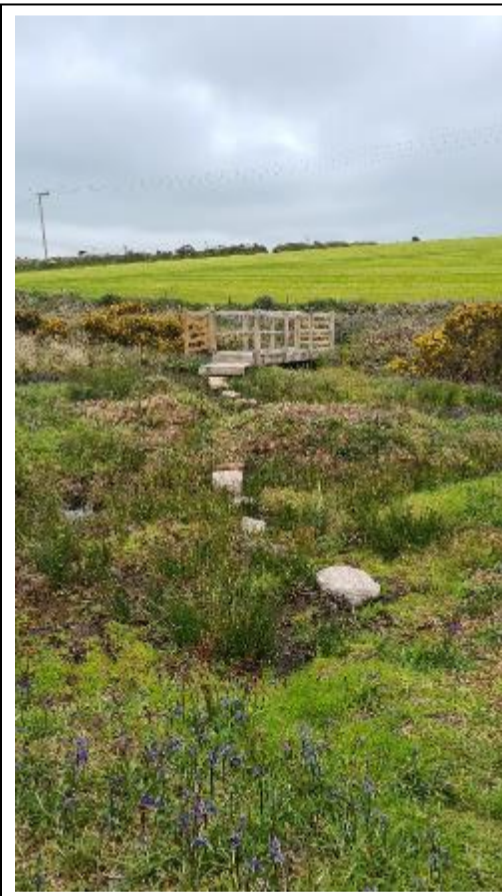
9.13 – Silage field in background of photograph. Drainage from these fields bypasses the mire habitats.

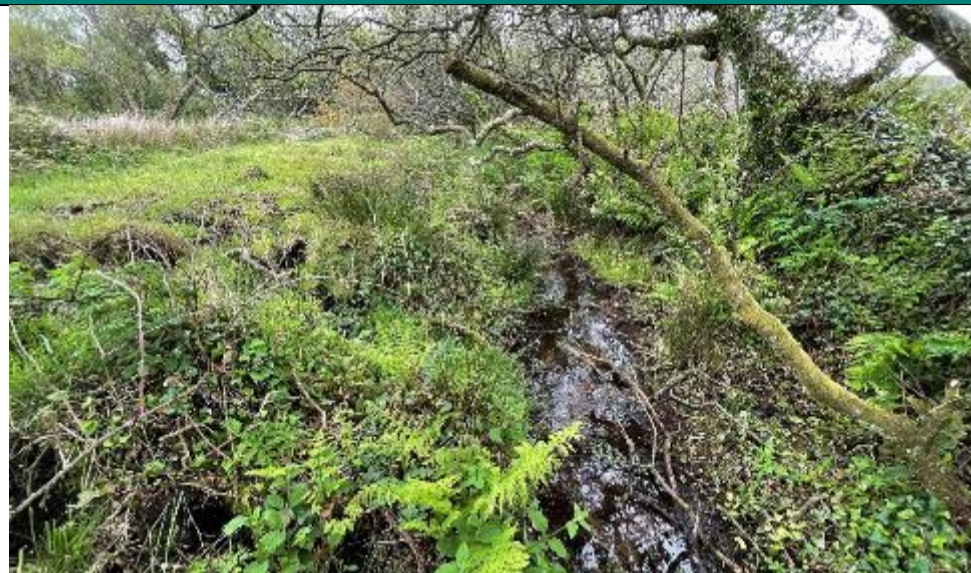
11.02 – Woodland cover along ditch running alongside western section of mire. Photo taken looking downstream with mire to the left.

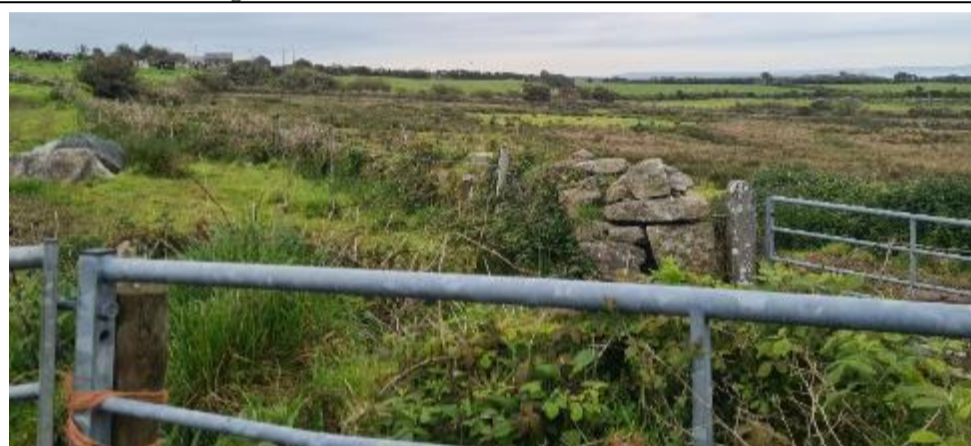
11.04 – Northern flow paths over pasture to the left of the wall feeding mire to right of the wall. Cattle were observed in these fields during survey.

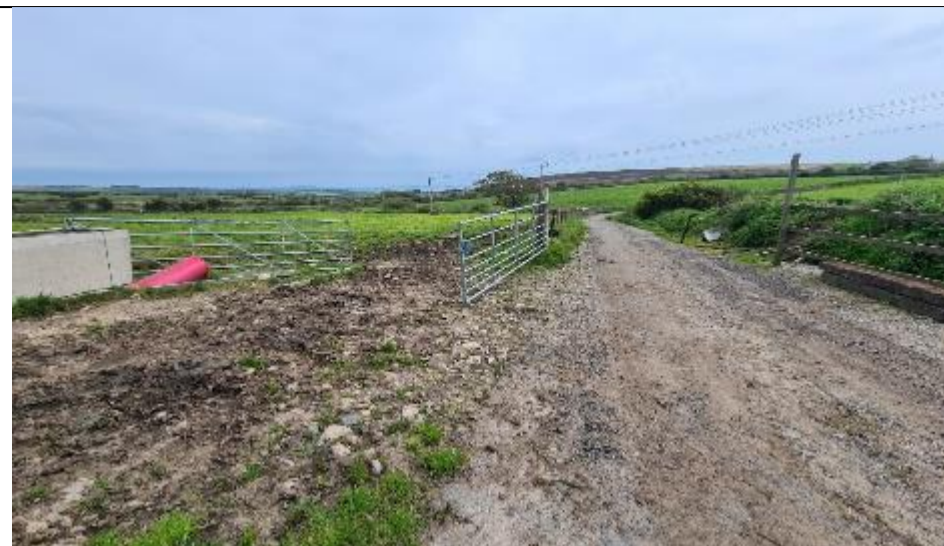
11.09 – Run-off along track leading from Middle Tregerest Farm.

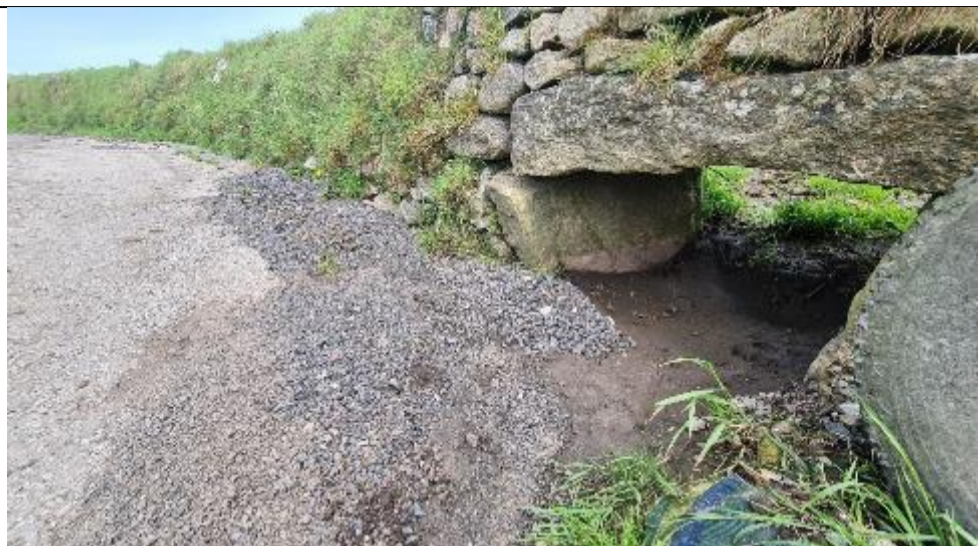
11.10 – Sediment deposited on path during rainfall events. Hole in field wall (filled with fine sediment) and sandbag in foreground used to direct water into field.

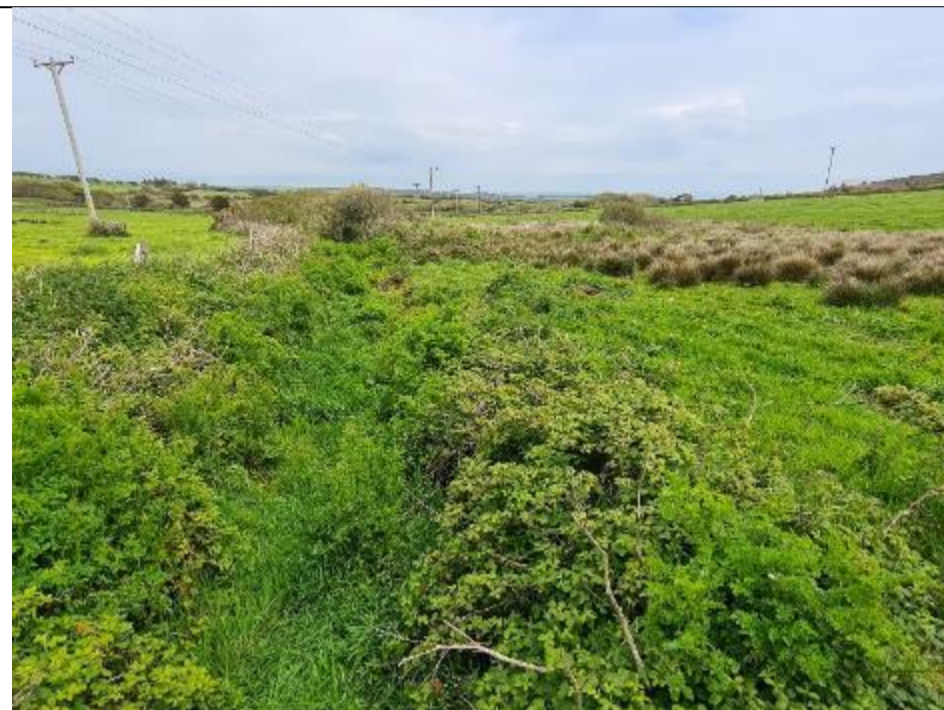
11.11 – Depression on edge of superficial geology. Wetland vegetation is present.
