# New Forest SSSI Ecohydrological Survey Overview

## Annex I: Soldier's Bog

First published 06 March 2014

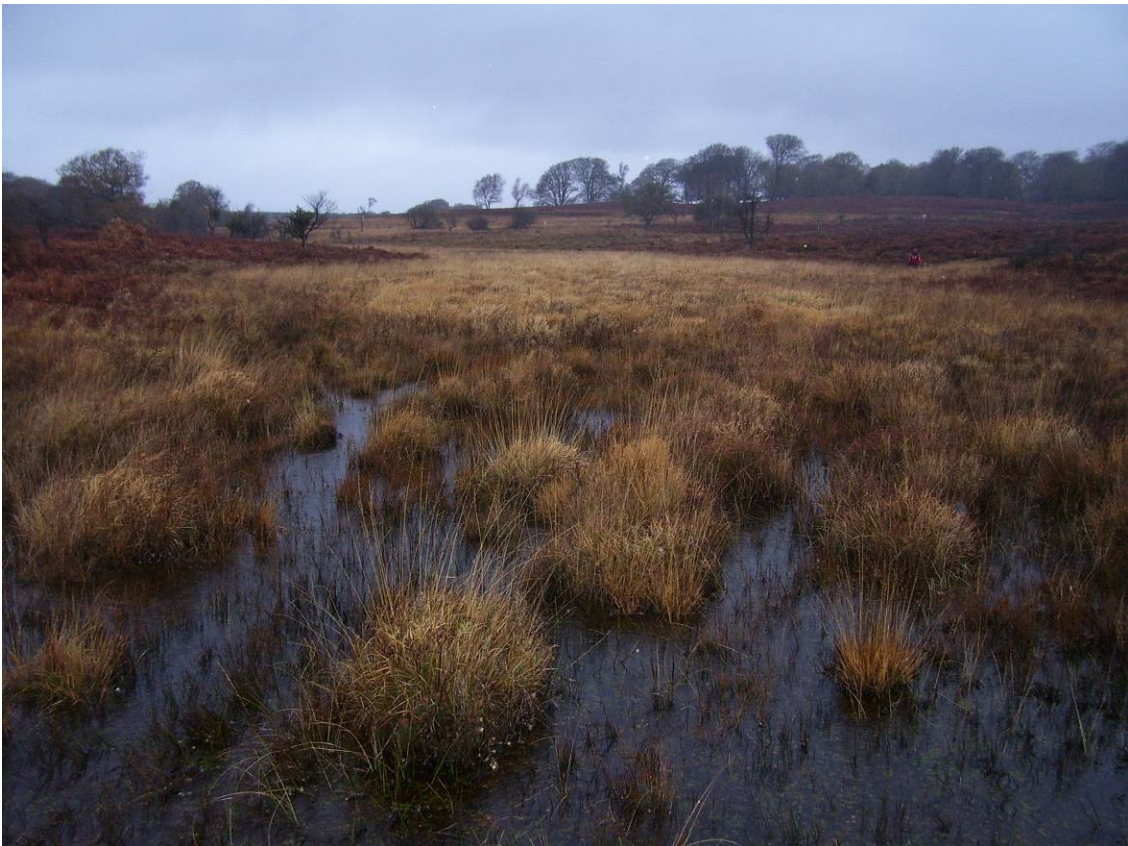
**Figure 1-2: General view of Soldier's Bog, looking north-westwards from the footpath crossing the centre of the site (NGR 422768 107765)**

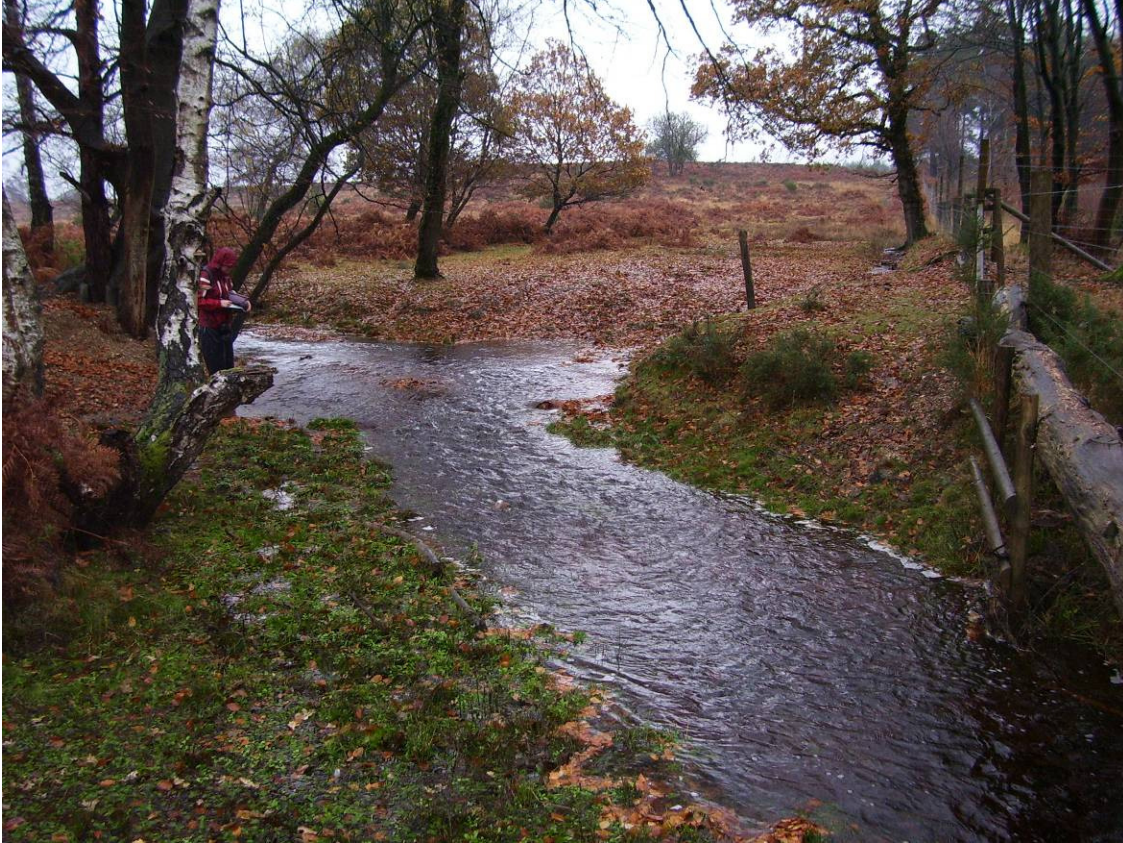
Figure 1-5: View of the main watercourse where it leaves the southern boundary of the site (looking upstream - NGR 423076 107041)

The southernmost stream segment has been straightened where it leaves the southern boundary of the site. Where the stream is crossed by a footbridge there is a small weir. The stream is fairly incised close to the southern boundary of the site and there is evidence of localised bank failure (Figure 1-4). It is understood that gravel has been artificially emplaced within the channel as part of restoration works, as discussed above.

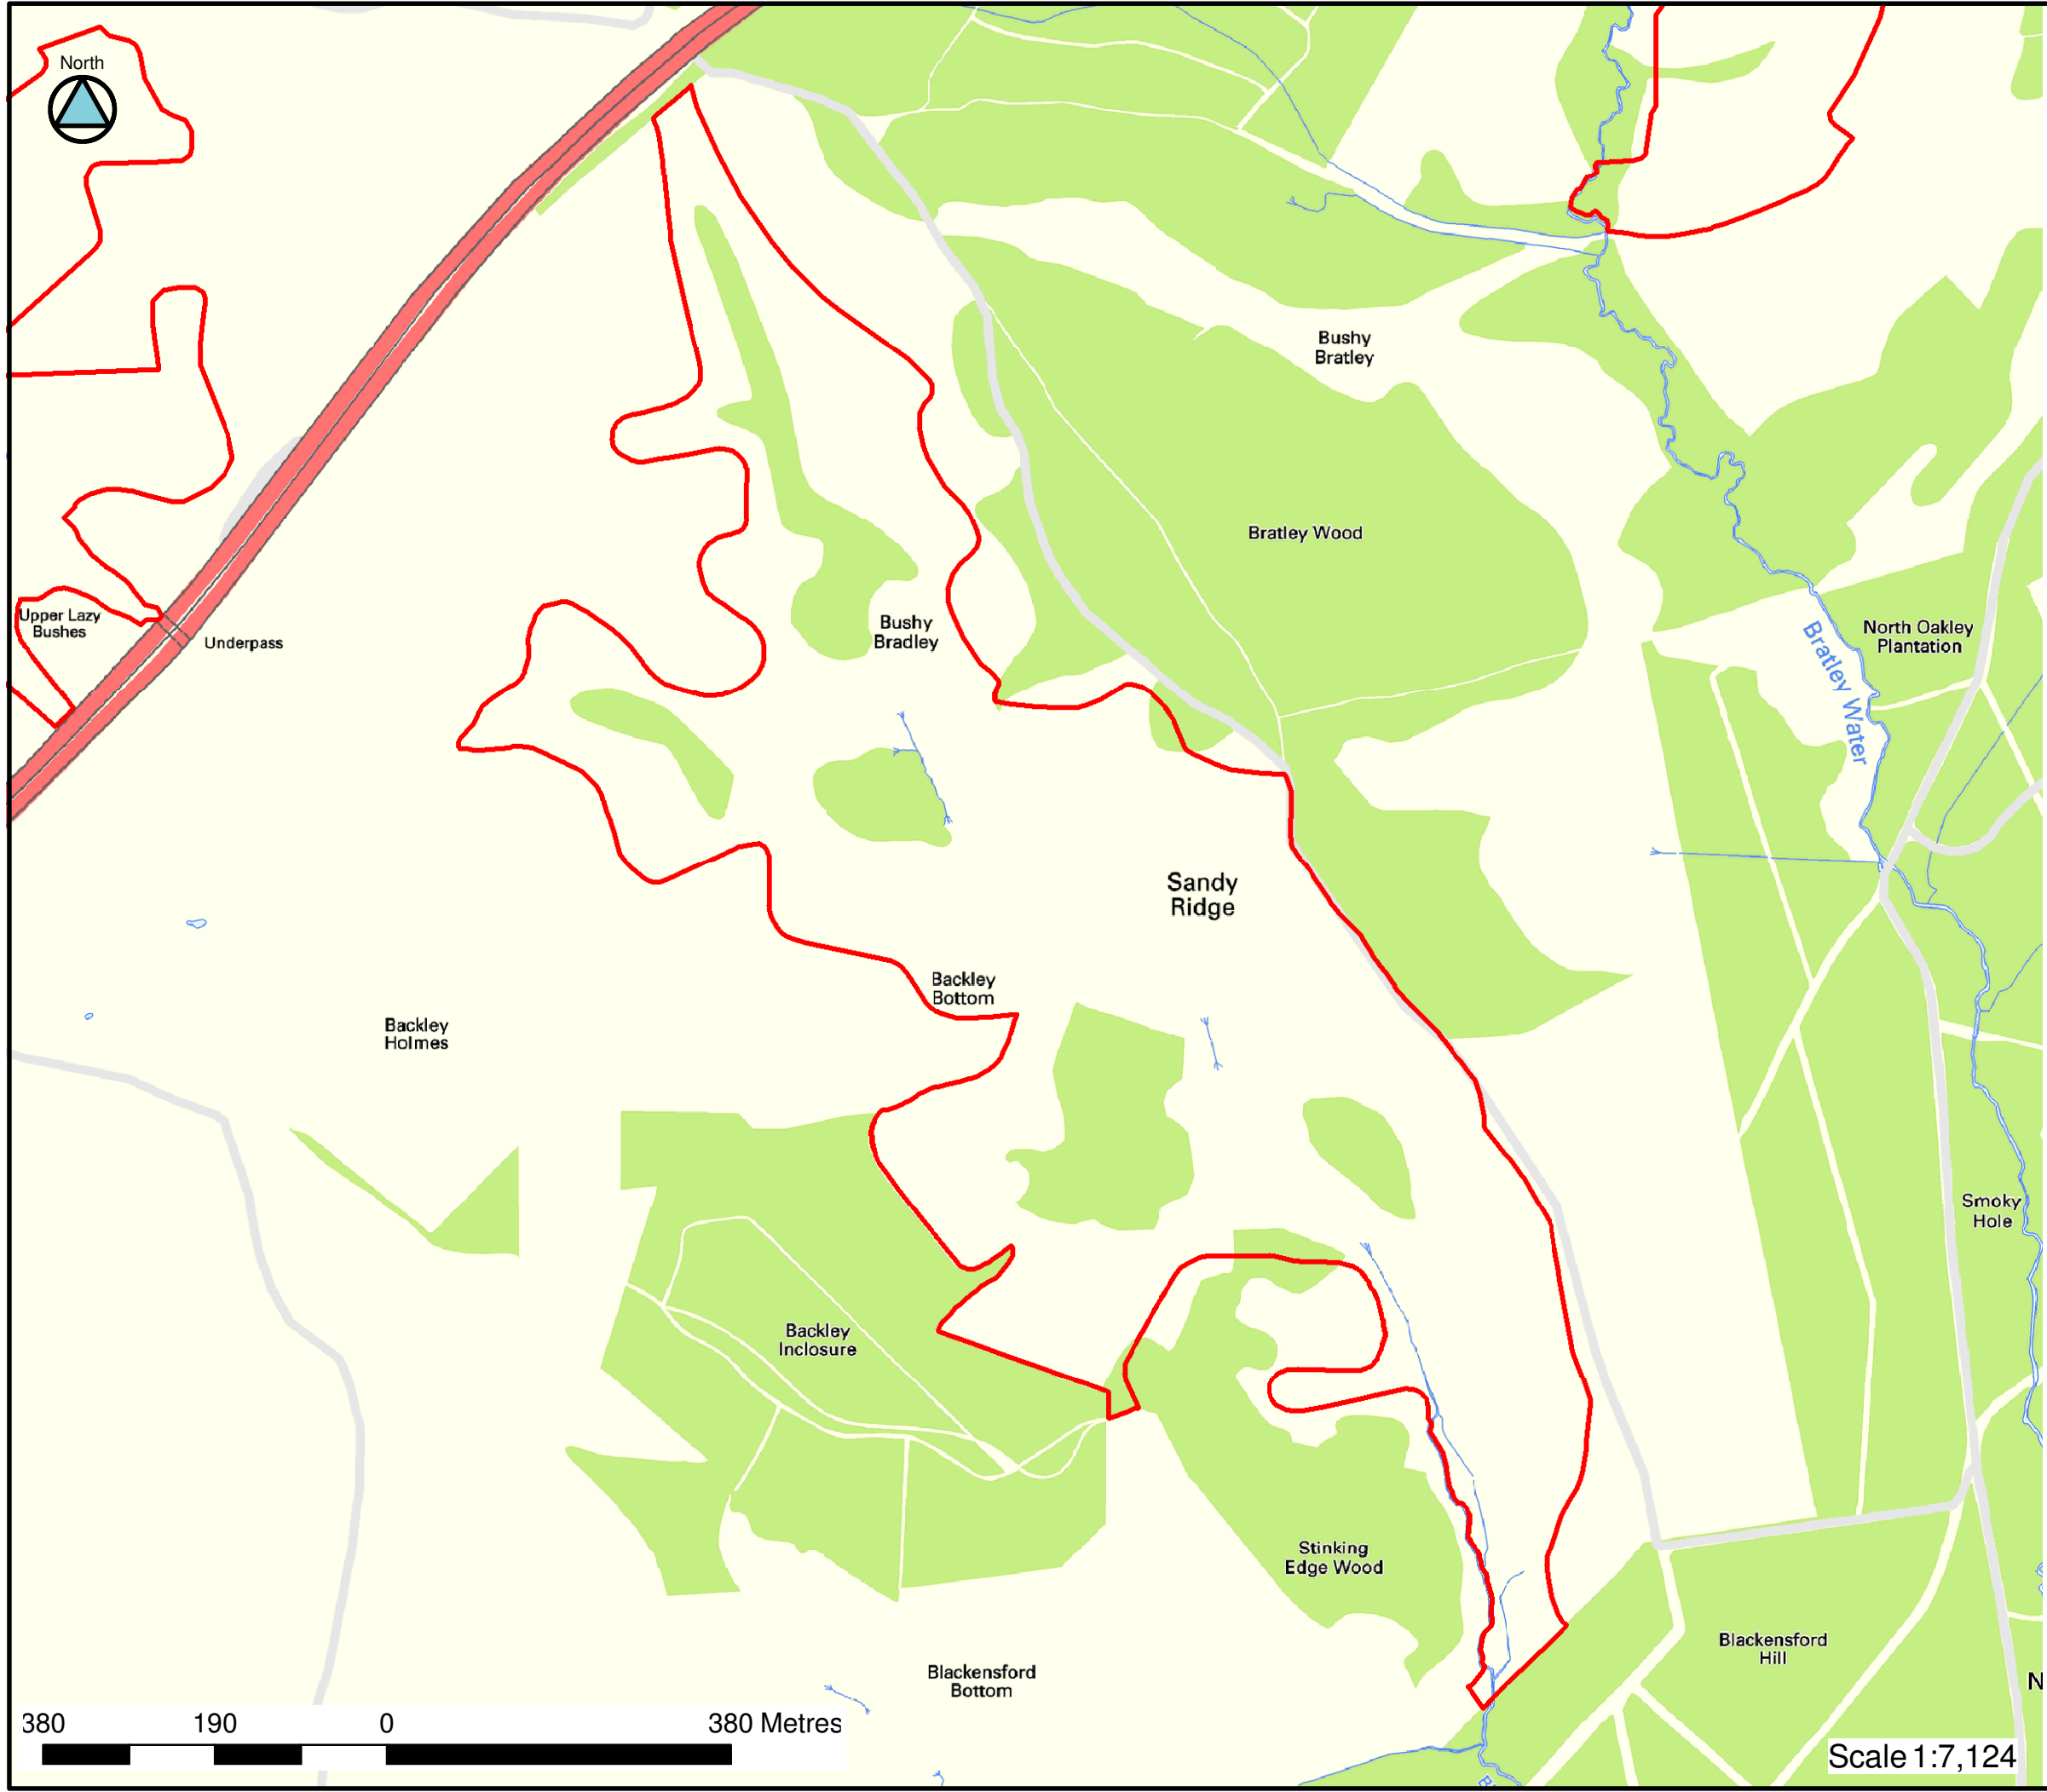
**Map 8: Restoration Plan**

There is one area in the southern part of the site in which straight drainage channels have been cut, probably to improve the land between the drains and the main watercourse for grazing (see Figure 1-9). Here valley mire is replaced by wet dwarf shrub heath and marsh/marshy grassland. The area is still wet (i.e. the drains are not very effective), and represents only a small proportion of the total area of the site. However, blocking or infilling of the drainage ditches could be considered as a means of restoring wet heath or valley mire in this location, through increasing ground water levels locally.

The small knick point described in Section 1.4 cuts into an area of swamp (with fringing mire) in the southern part of the site (see Figure 1-9 for location). It is a small feature and has thus far done little damage. However, it would be prudent to take measures to prevent it from growing in size and extending upstream. Such measures could take the form of staked heather bales within the channel and/or channel infilling/re-grading.

Restoration Area	Damage Type	Restoration Proposals	Improvement	Constraints and Issues
Drained Area	Drainage	Blocking or infilling of drainage ditches	Encourage the re-establishment of a valley mire community.	Only a small portion of the site, so not a large gain. The area is marshy, but not a valley mire.
Knick point in central watercourse	Erosion	Staking of heather bales within the channel and/or use of channel infilling/re-grading.	Protection of the mire from headward erosion and upstream migration of the knick point.	The erosion protection measures would be small in scale and relatively inexpensive. However, they would need to be monitored to ensure that they weren't being compromised over time (e.g. through the washing away of heather bales).
Spoil bank along main watercourse	Artificial modification of bank morphology	Remove bank	More natural hydrological function.	
Two most northern footpaths	Ponding of water from inappropriate footpath and crossing points	Modification of footpaths (e.g. boardwalks) and/or culverts (e.g. upsizing) to remove impediment to flow	Localised restoration of valley mire and wet heath habitats	Footpaths are an important amenity resource which could suffer from short-term disruption
