Natural England Commissioned Report NECR140

# New Forest SSSI Geomorphological Survey Overview

**Annex P: Wootton Riverine Woodland - SSSI Unit 539**

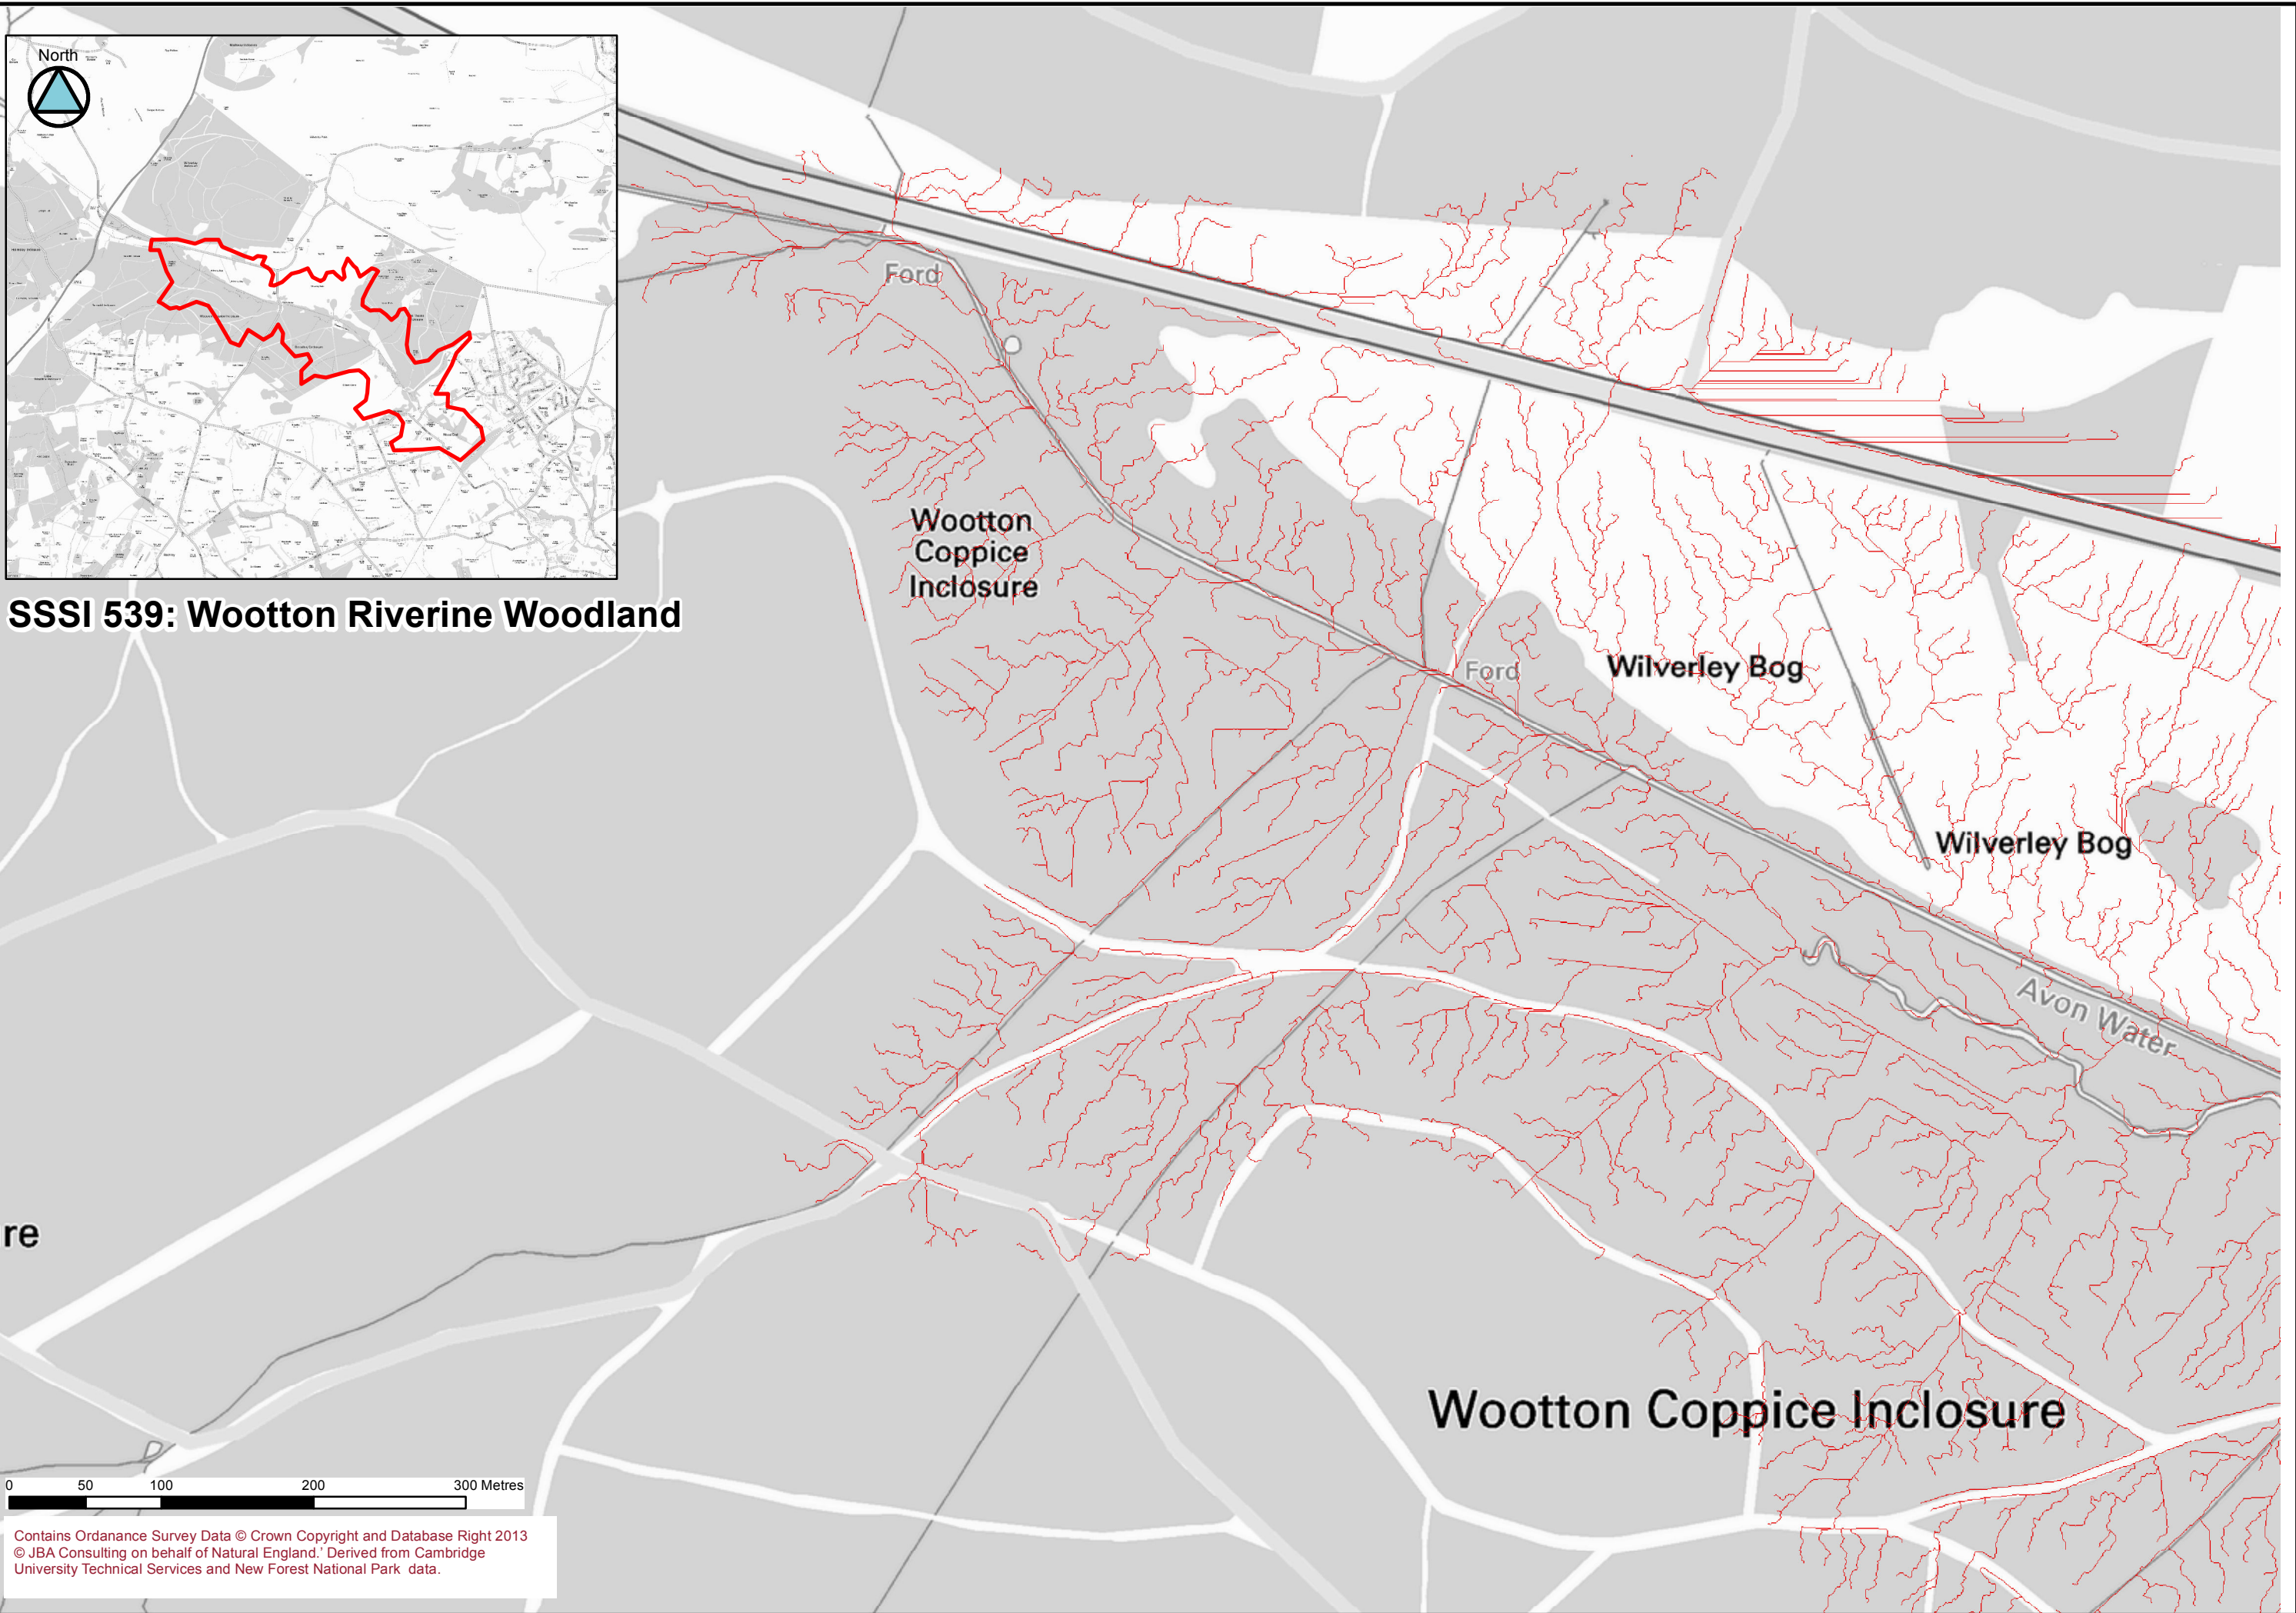
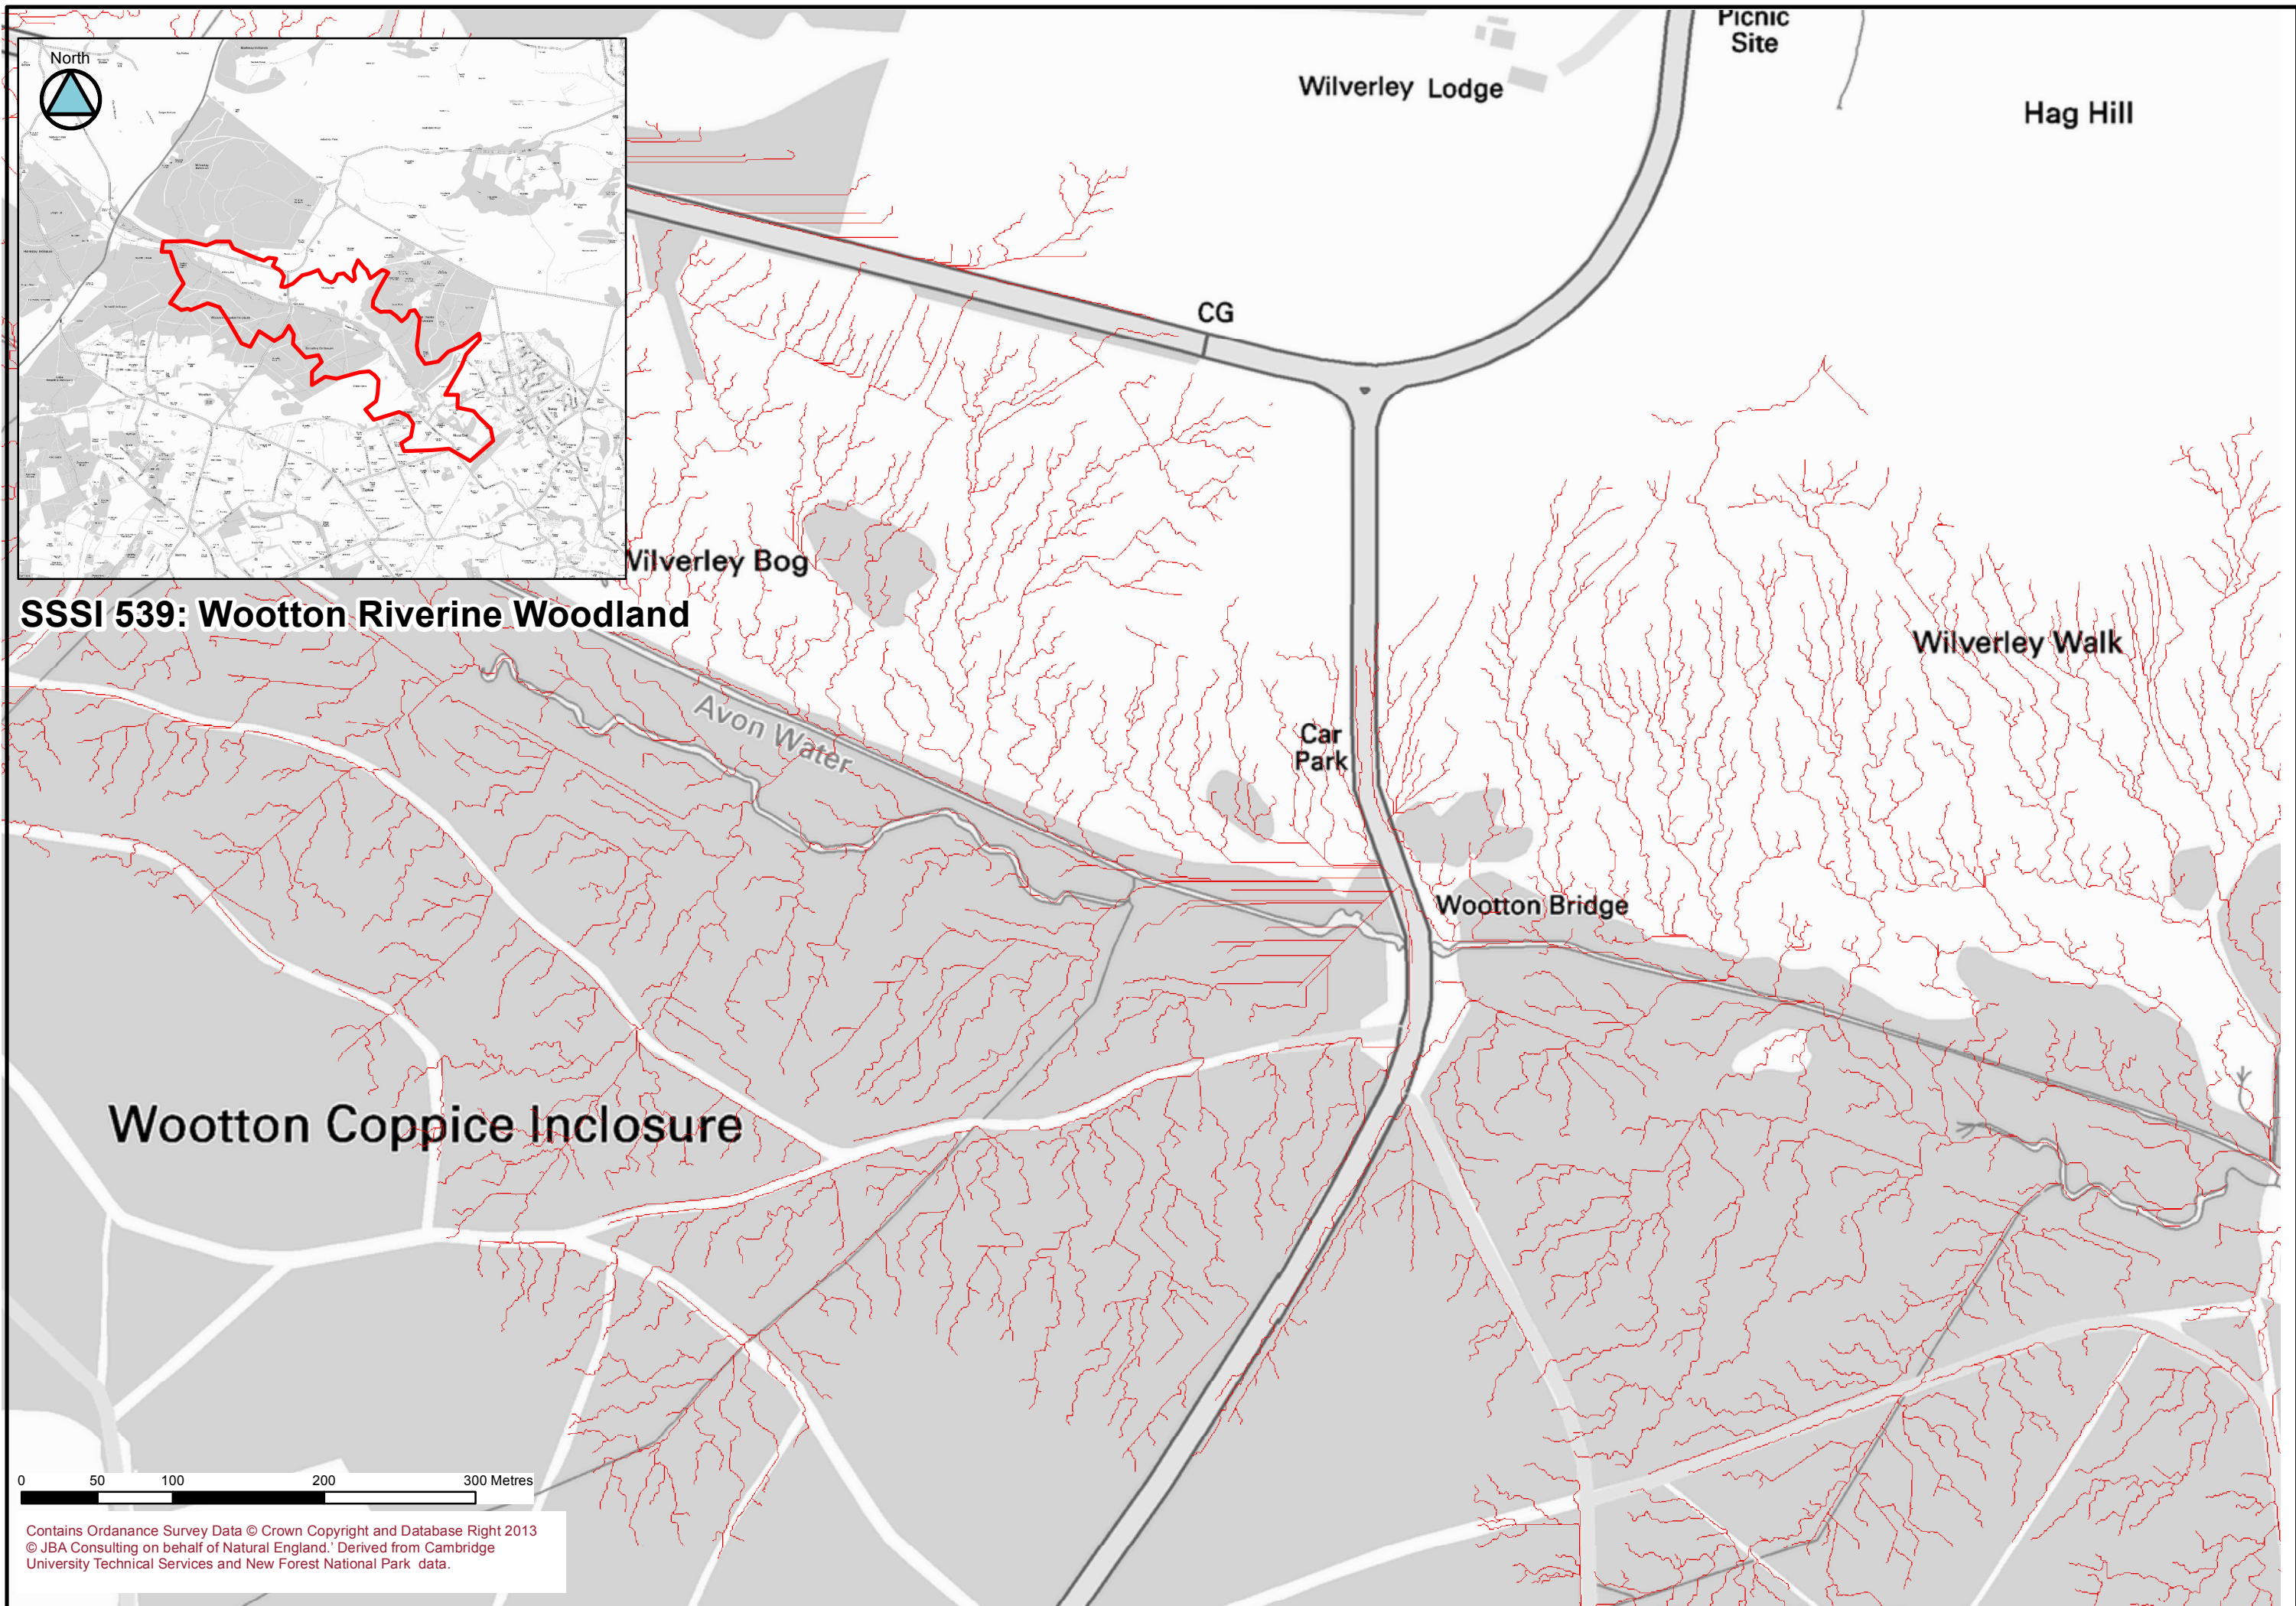
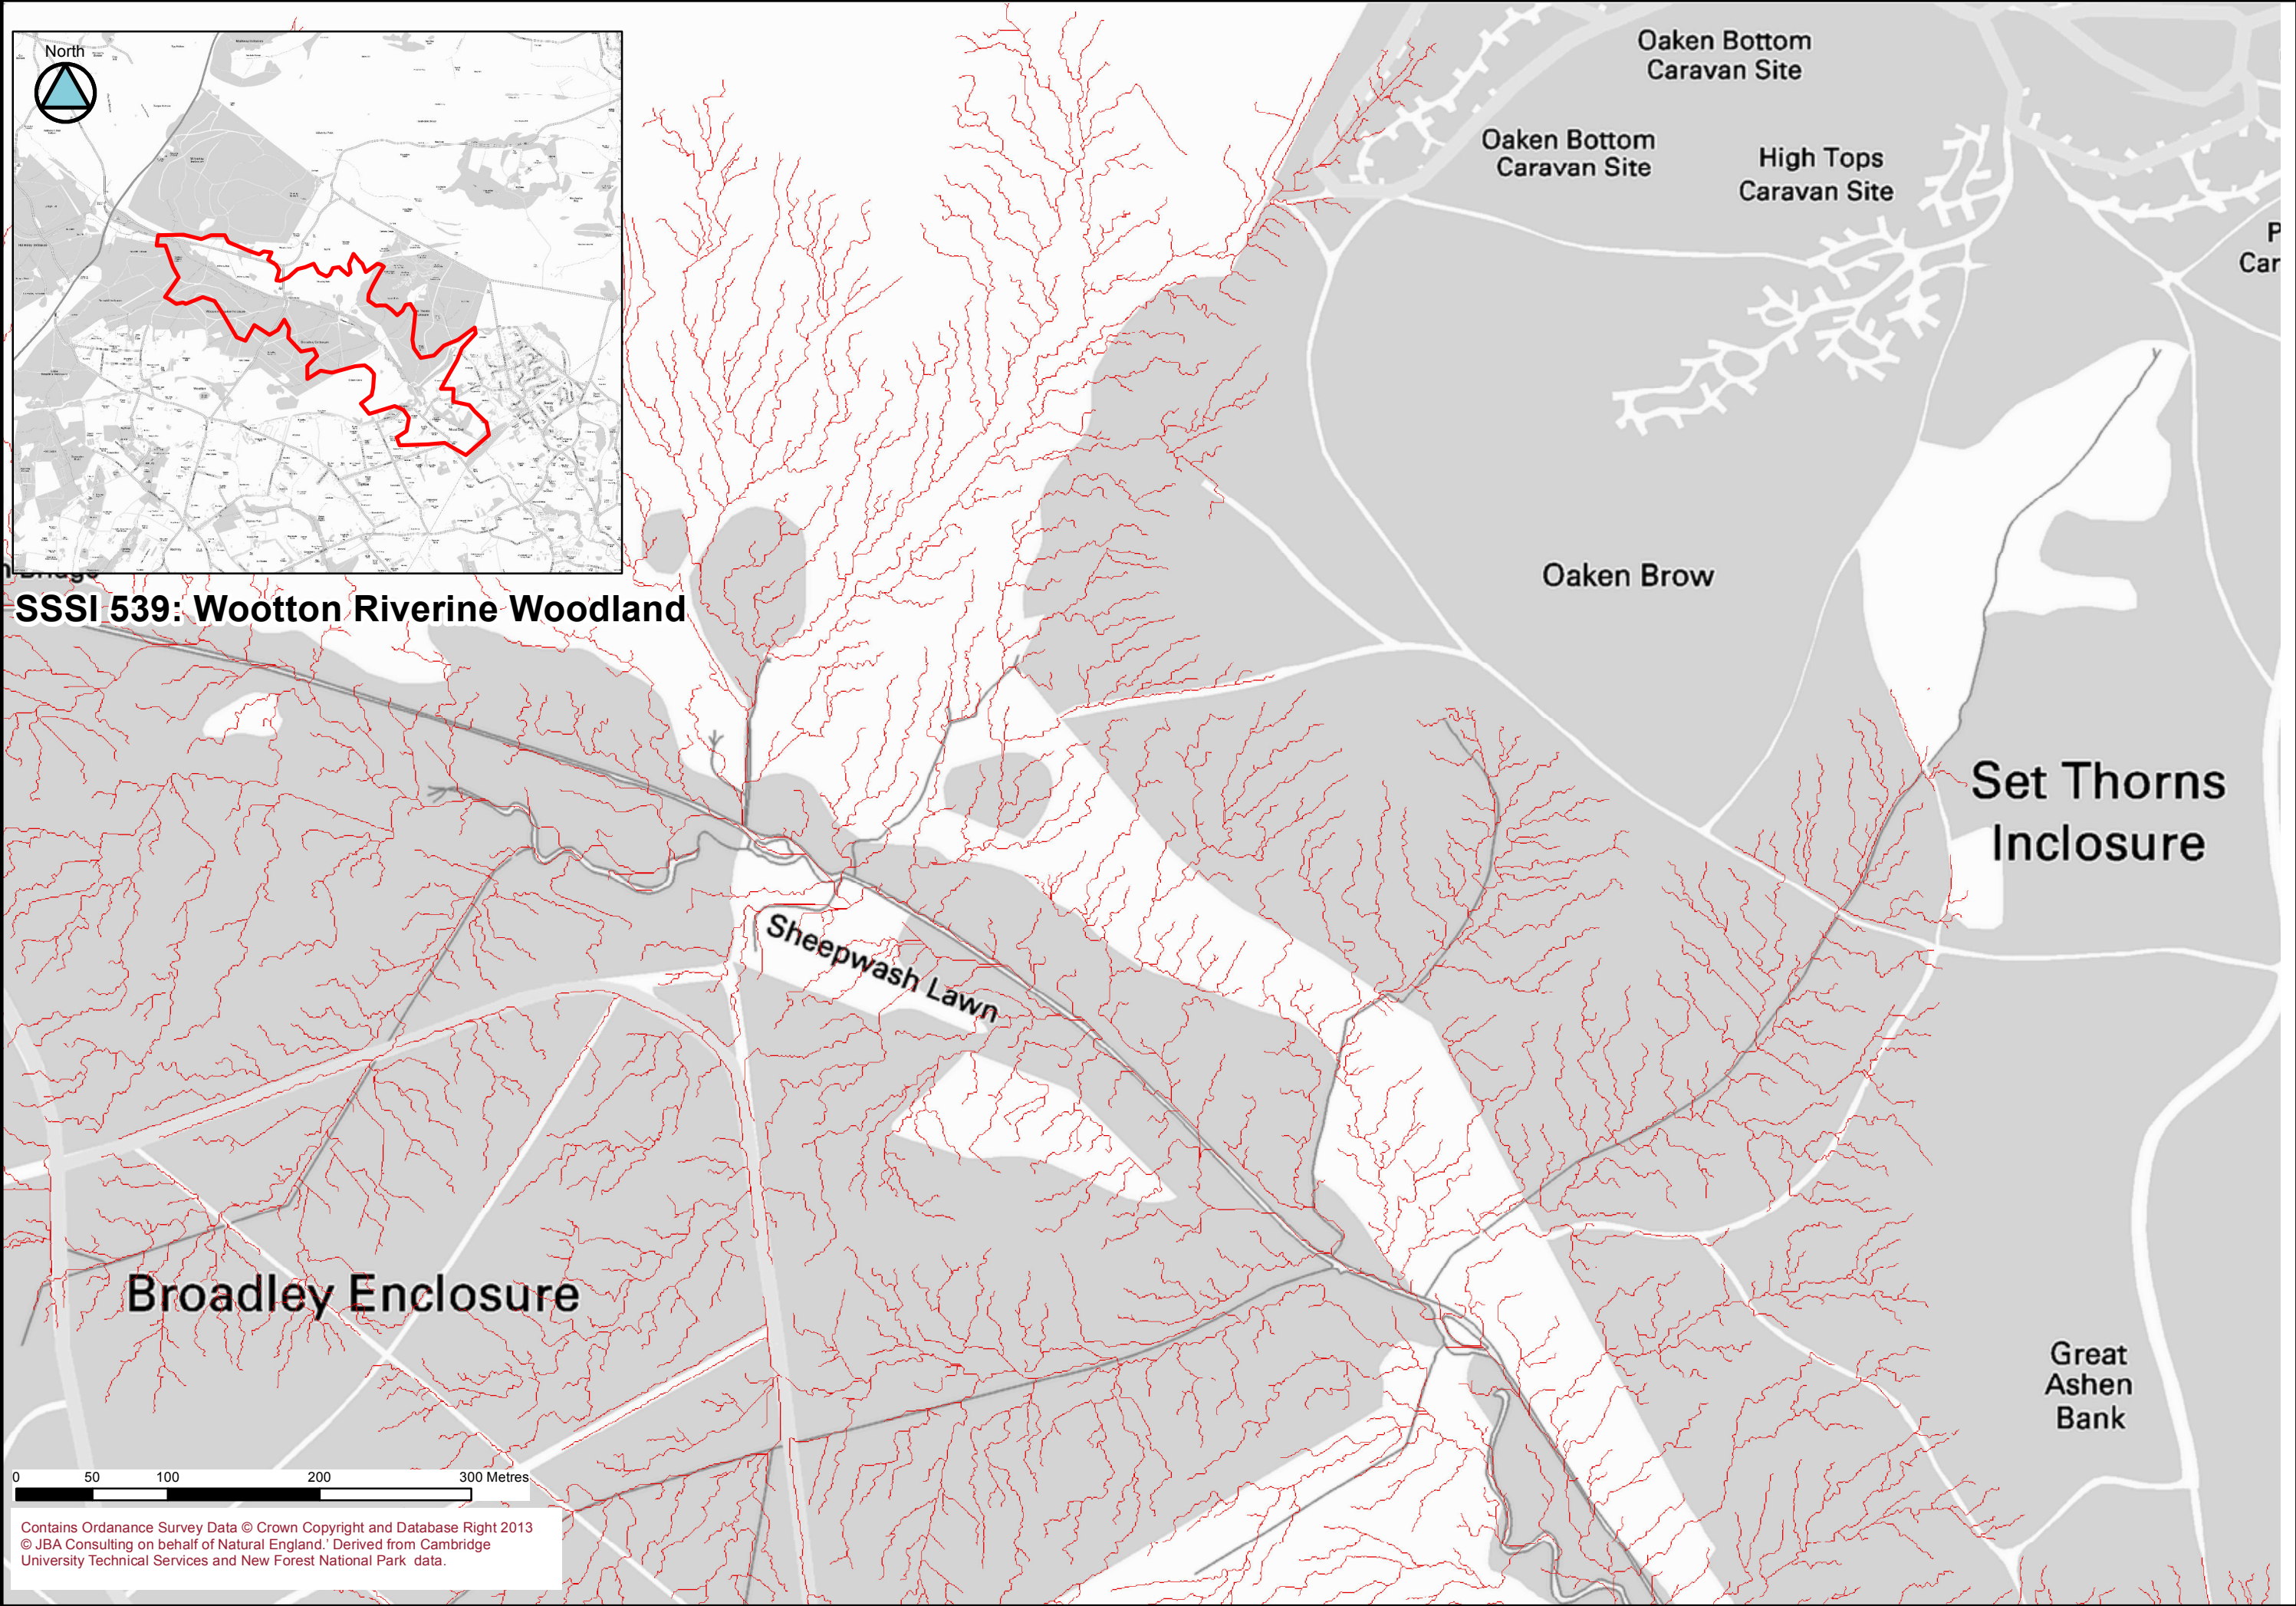
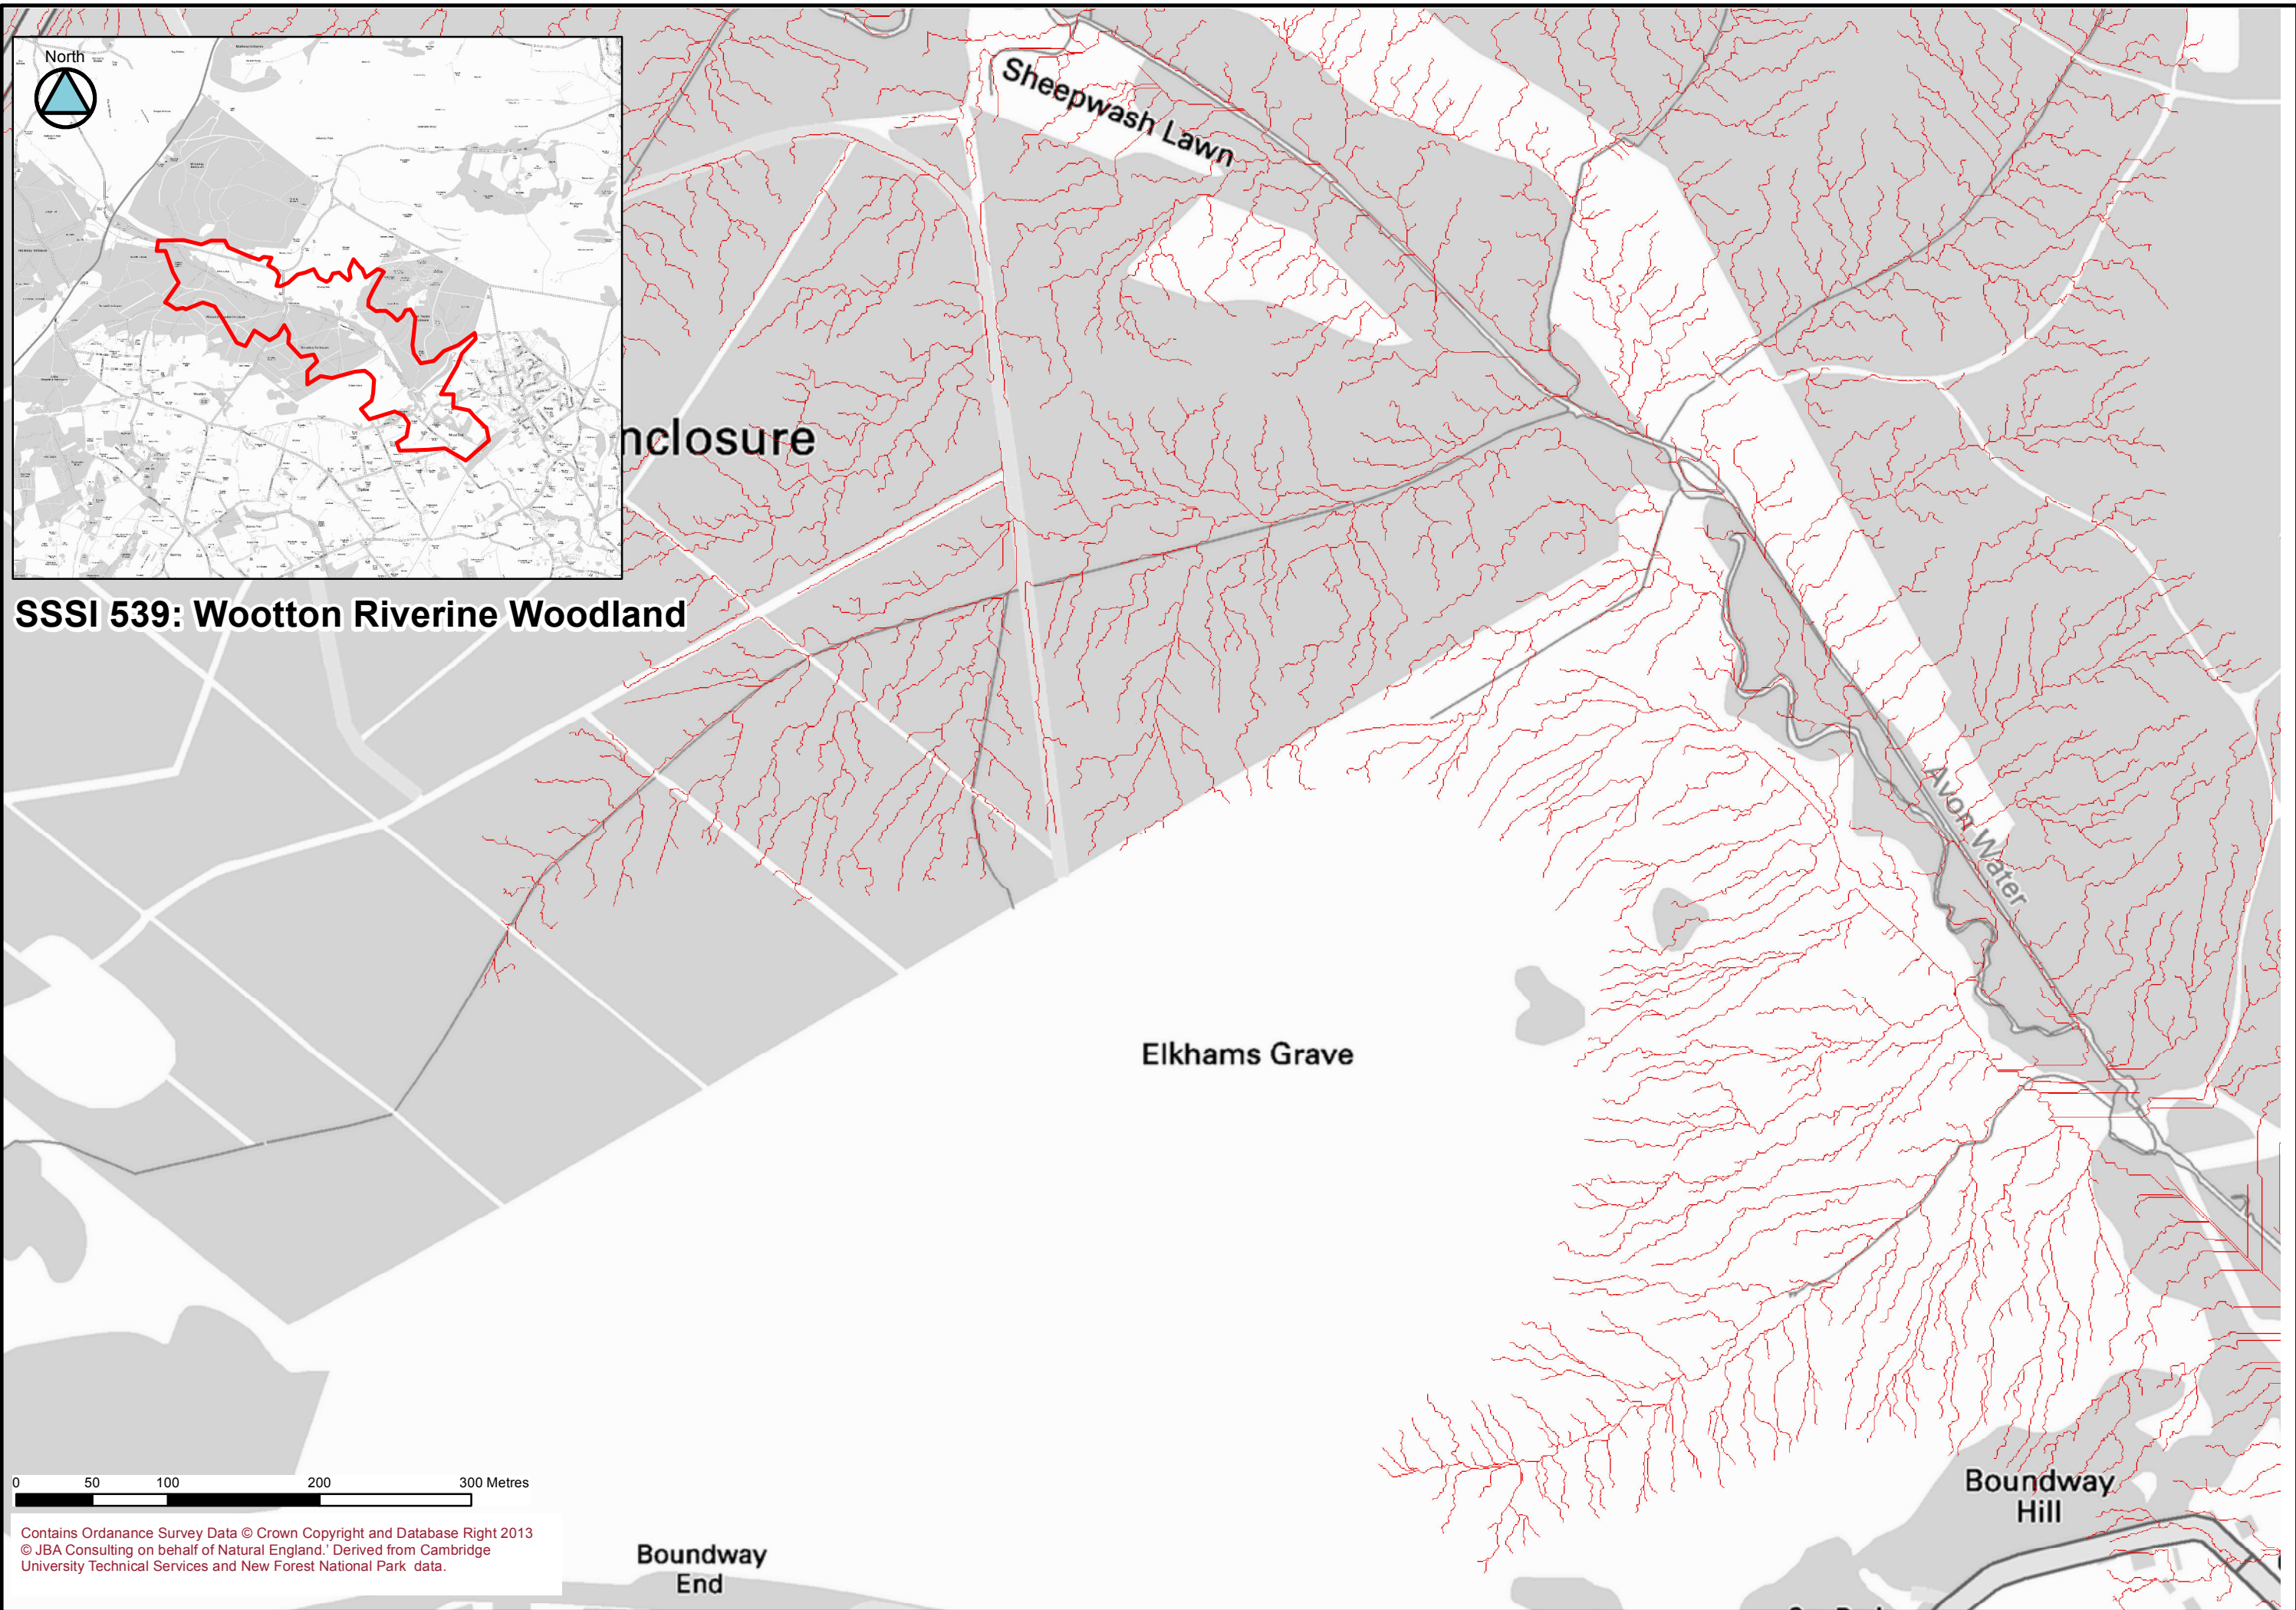
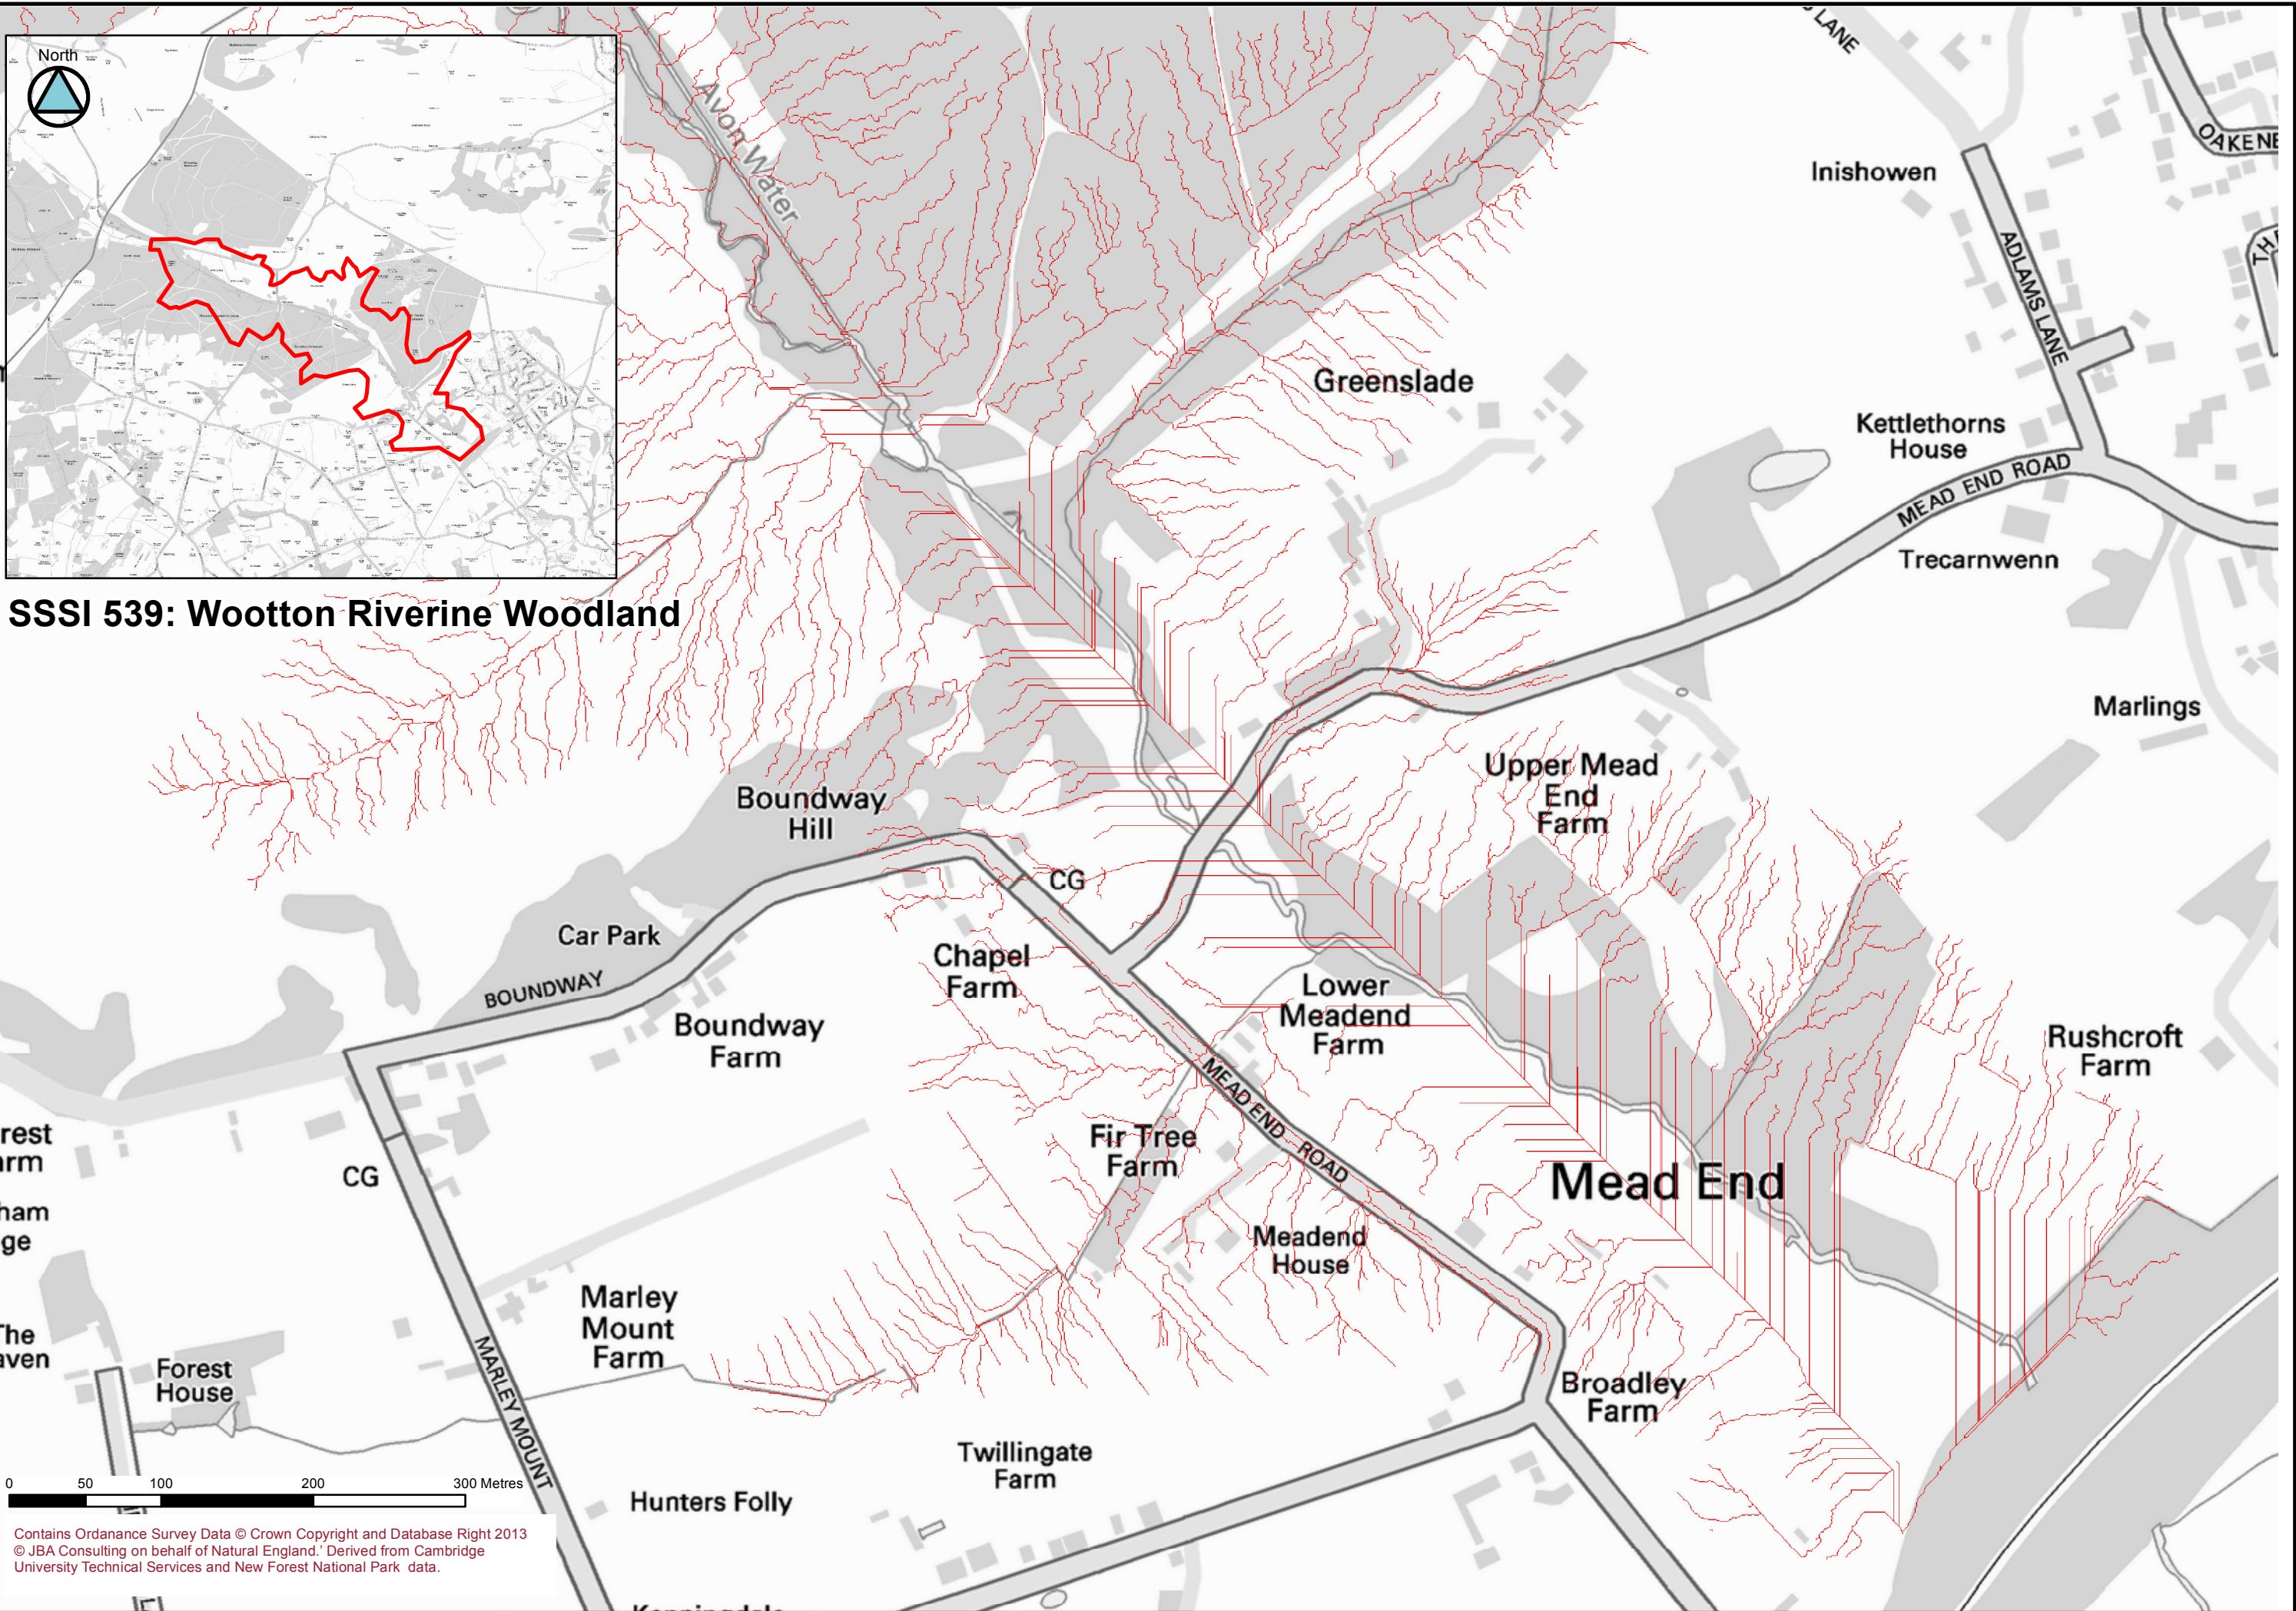
## **Appendix A - Artificial drainage and flow lines - SSSI Unit 539**

The major straightened / modified drainage channels are identified in Figure 1-12. Other minor modifications could be considered for infilling and Appendix A should be used for reference.
