New Forest SSSI Geomorphological Survey Overview

Annex B: Latchmore Shade Restoration Plan - SSSI Unit 48

1 Latchmore Shade Restoration Plan - SSSI Unit 48

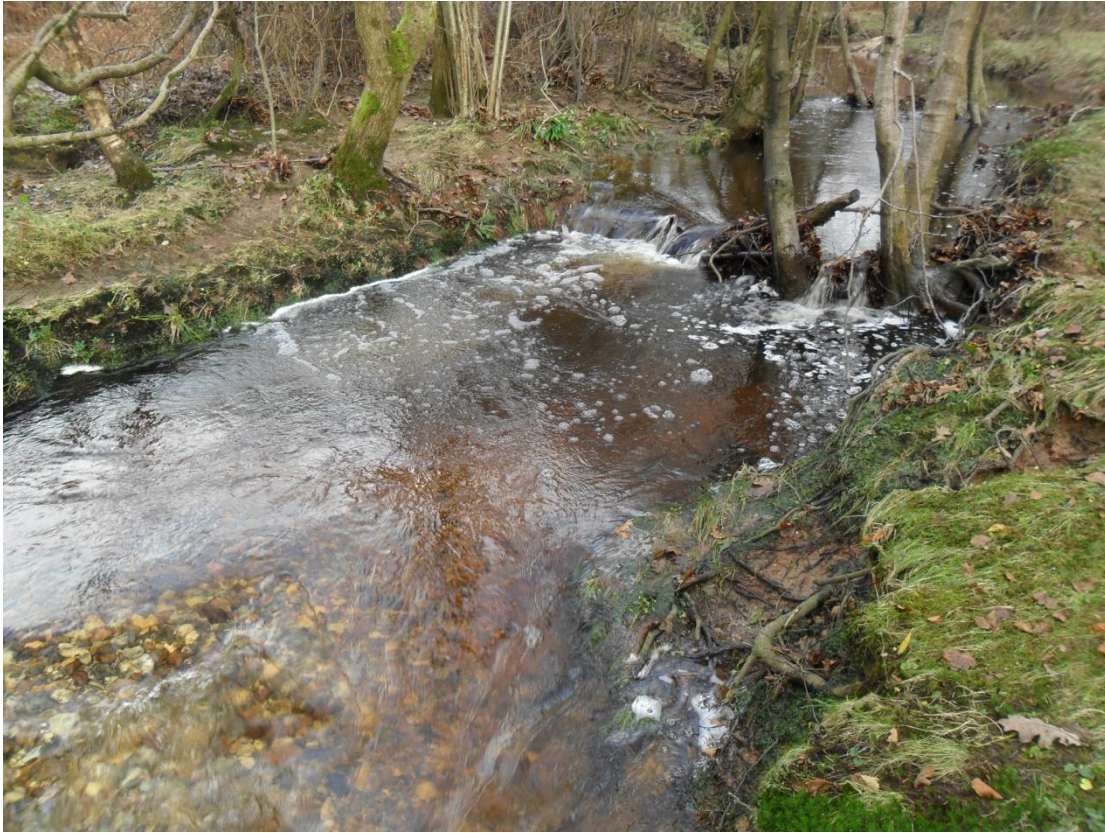
- A weakly anastomosing lower course characterised by a wooded local floodplain and multi-channel flow network (Figure 1-2).
- A single thread, mildly incised channel running through floodplain woodland with disconnected palaeo-channel features including a well defined sinuous single thread channel on the left bank (Figure 1-3).

Figure 1-2: Weakly anastomosed lower course of Latchmore Brook SSSI Unit 48.

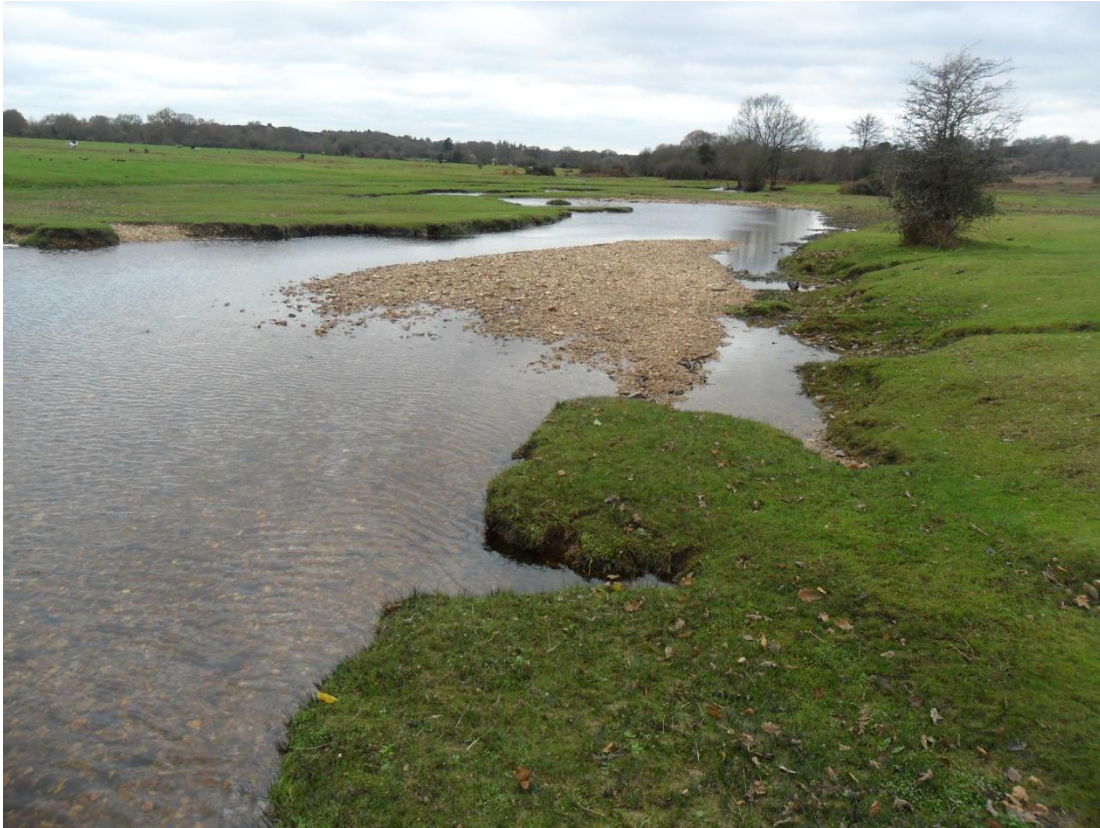
- A stabilised wandering reach characterised by an inset floodplain and numerous vegetated gravel bars, dissected by a shallow dominant channel and several sub-channels all with abundant mobile gravels accumulating as shoals and more permanent riffle zones (Figure 1-4).

Figure 1-4: Stabilised wandering reach of Latchmore Brook SSSI Unit 48.

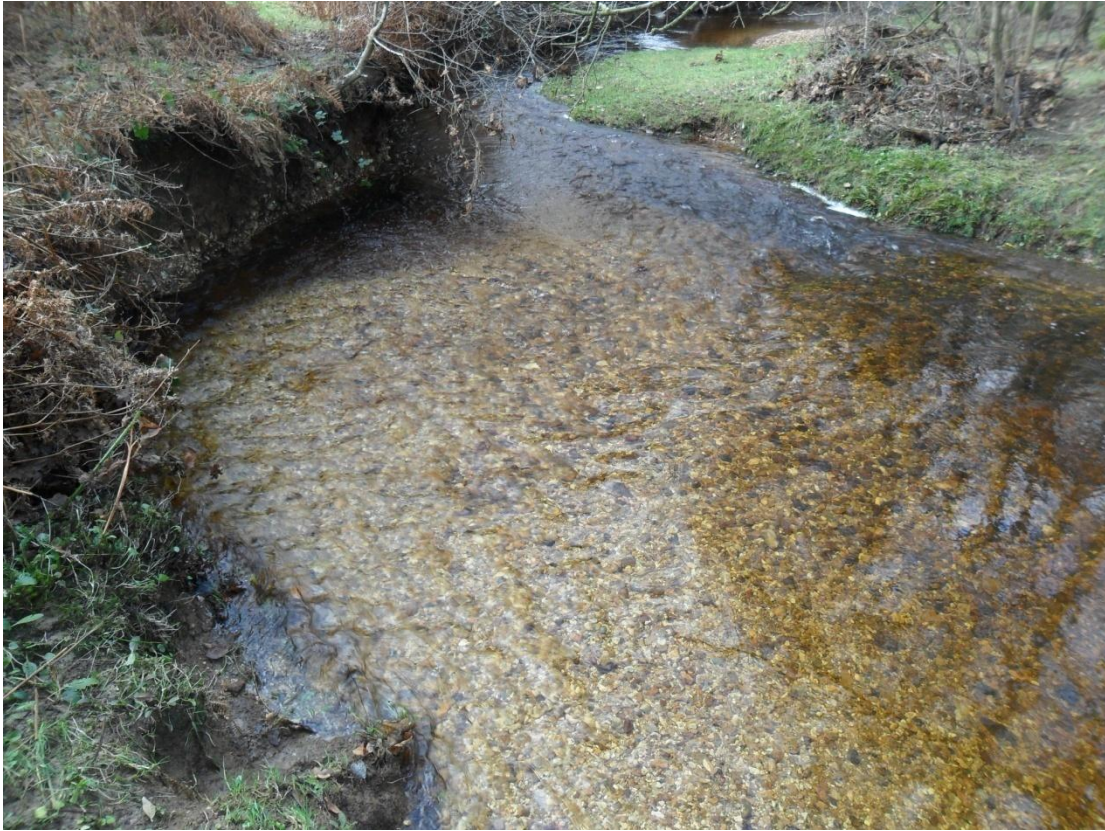
- A short 'infilled' plane bed single thread reach characterised by a generally shallow uniform depth with mobile gravels and strong floodplain connectivity (Figure 1-6).

Figure 1-6: Plane bed single thread reach of Latchmore Brook SSSI Unit 48.

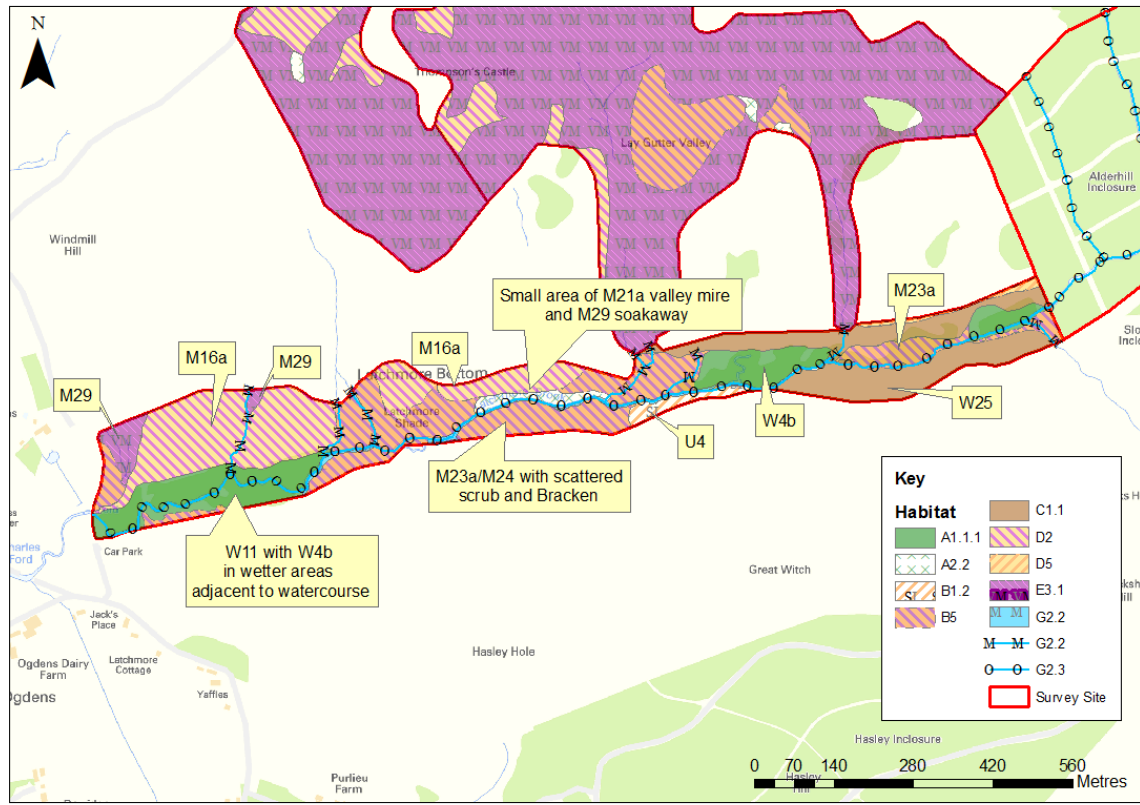
Figure 1-12: Phase 1 Habitat Map

The historical modifications to Latchmore Brook and associated drainage impacts have resulted in damage to adjacent habitats. In particular, the mire and wet heath habitats, found mostly to the north of the watercourse, within the western end of the unit, are degraded with a lack of *Sphagnum* species, and it is likely that these habitats were once more extensive.

Two small patches of Rhododendron *Rhododendron ponticum* were recorded within the eastern end of the unit.
