POST WORKS ASSESSMENT OF THE STREAM RESTORATION PROJECT SITES AT SEVEN HATCHES

(R. WYLYE)

Summary of post works assessment following final site visit
on 30th April 2009

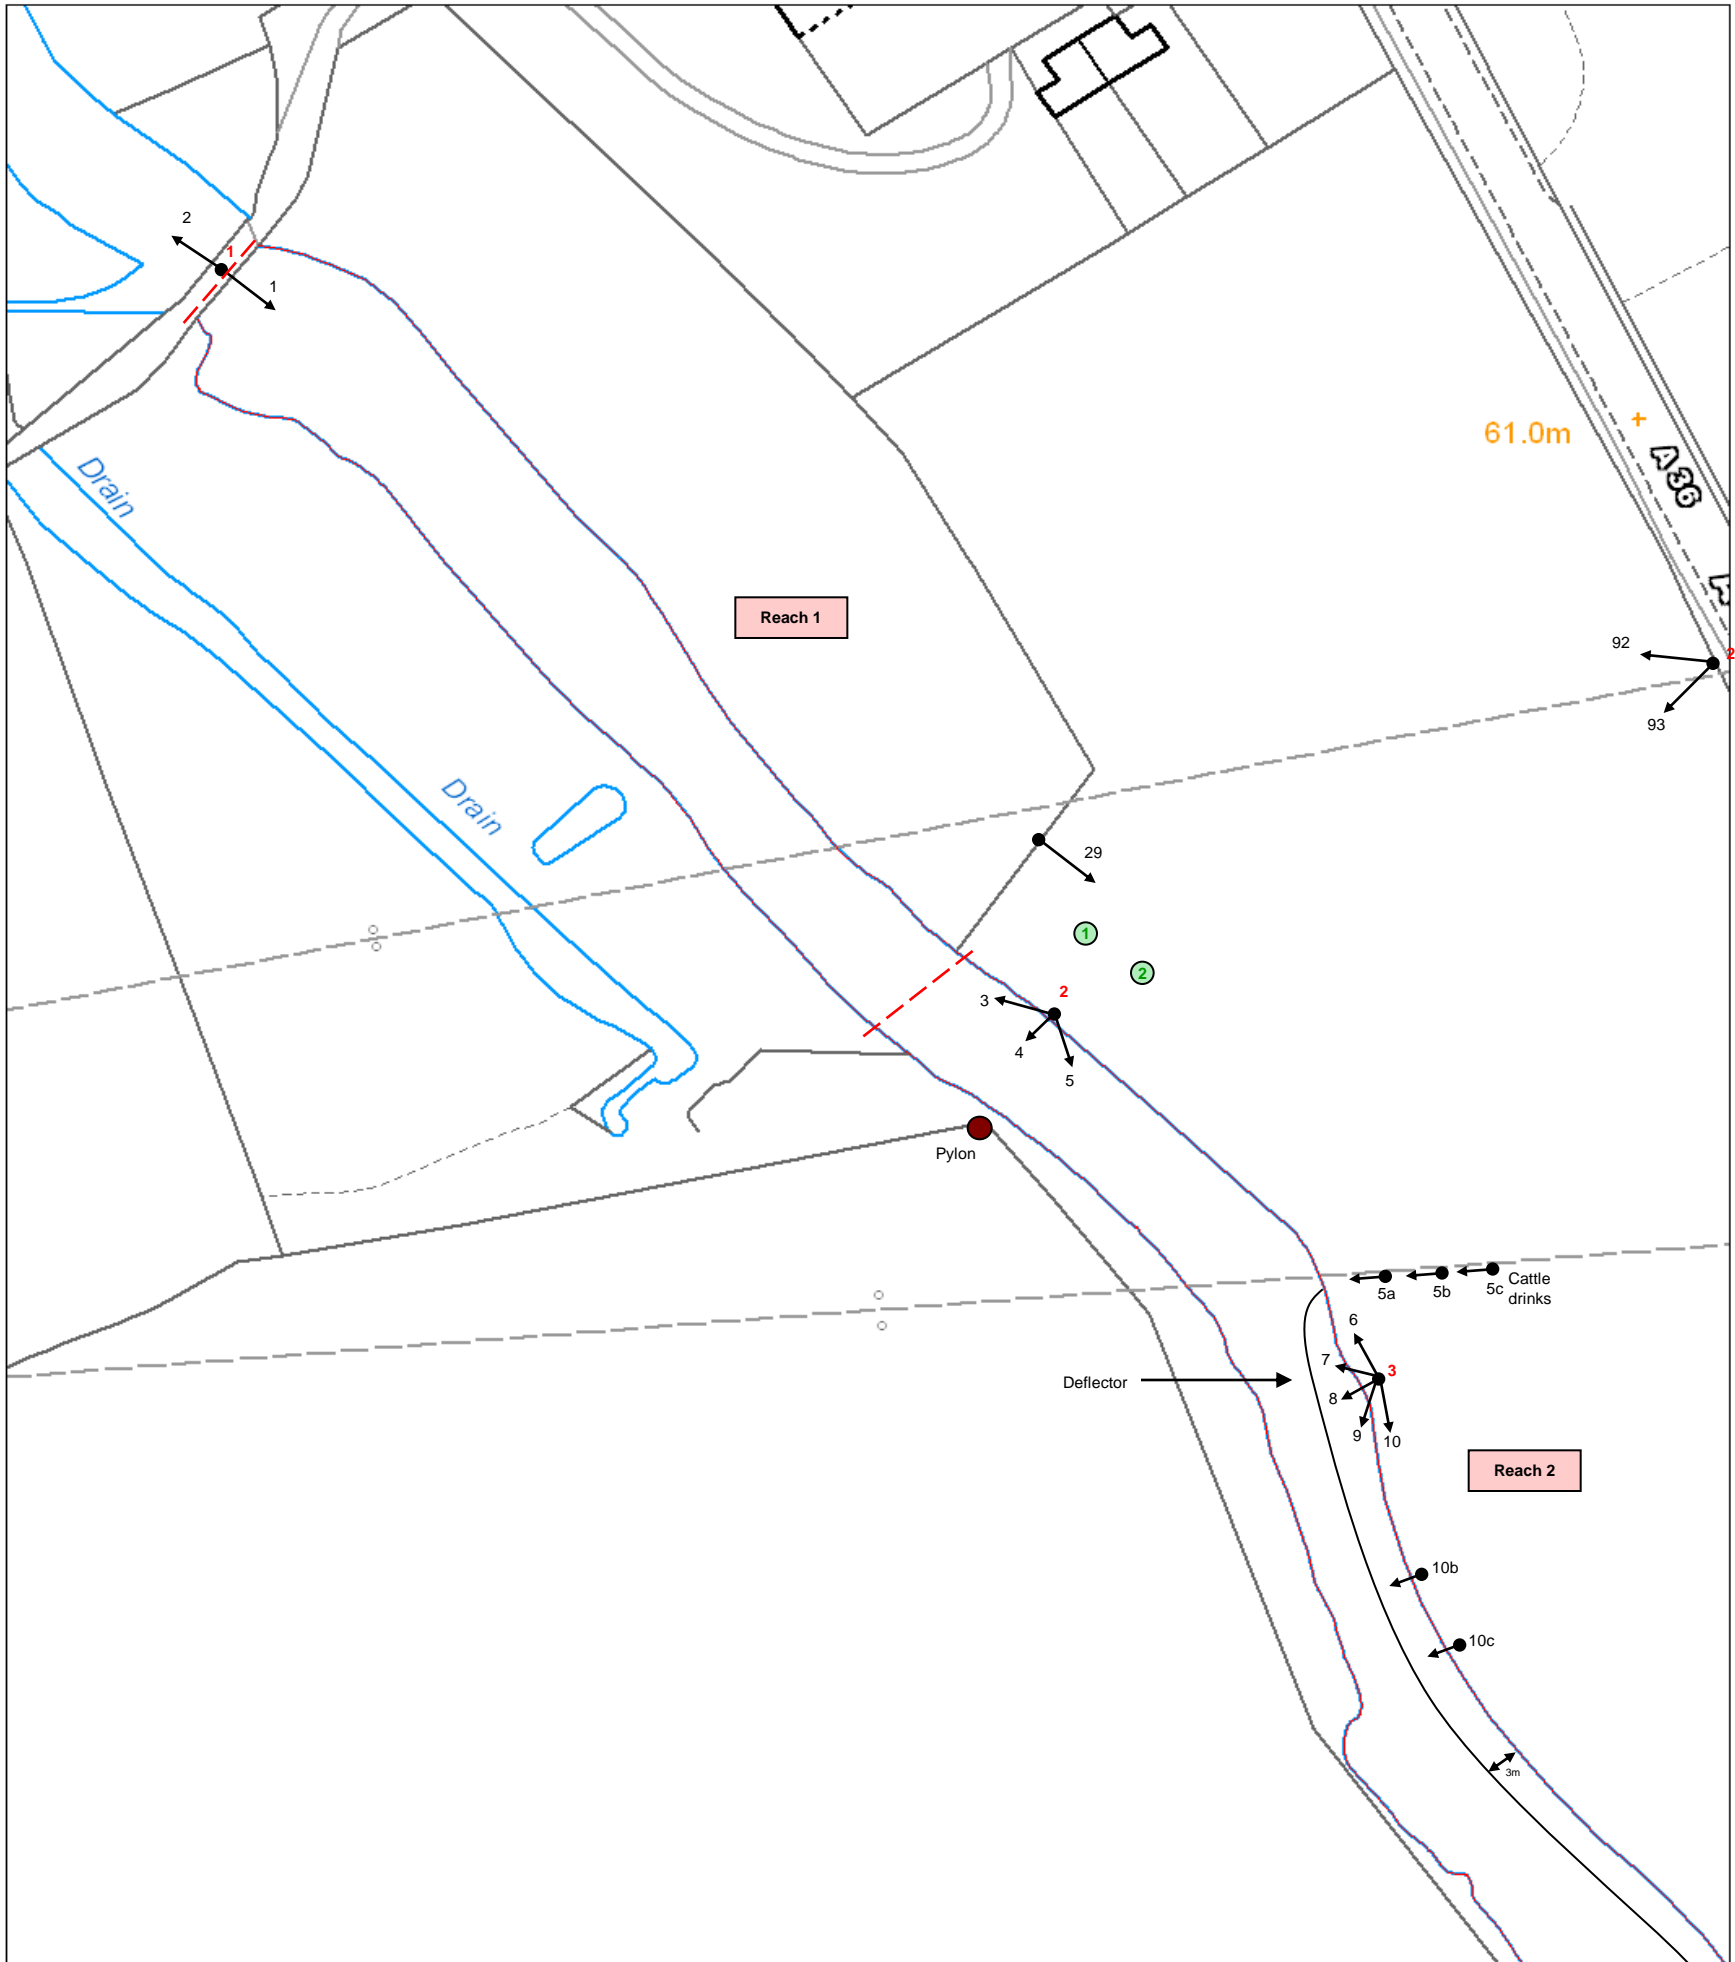
Figure 2.1 River Wylfe at Seven Hatches Reaches 1 and 2

Reach 1: On the pre works site visit Reach 1 was identified as having a straight uniform channel, with trees on both banks, marginal vegetation and no in channel vegetation. The only potential adverse effect of the proposed restoration scheme was the possibility of increased siltation should the channel narrowing cause a backing up of water. No positive impacts were envisaged.

Reach 1: During the construction phase no noticeable short term effects were observed.

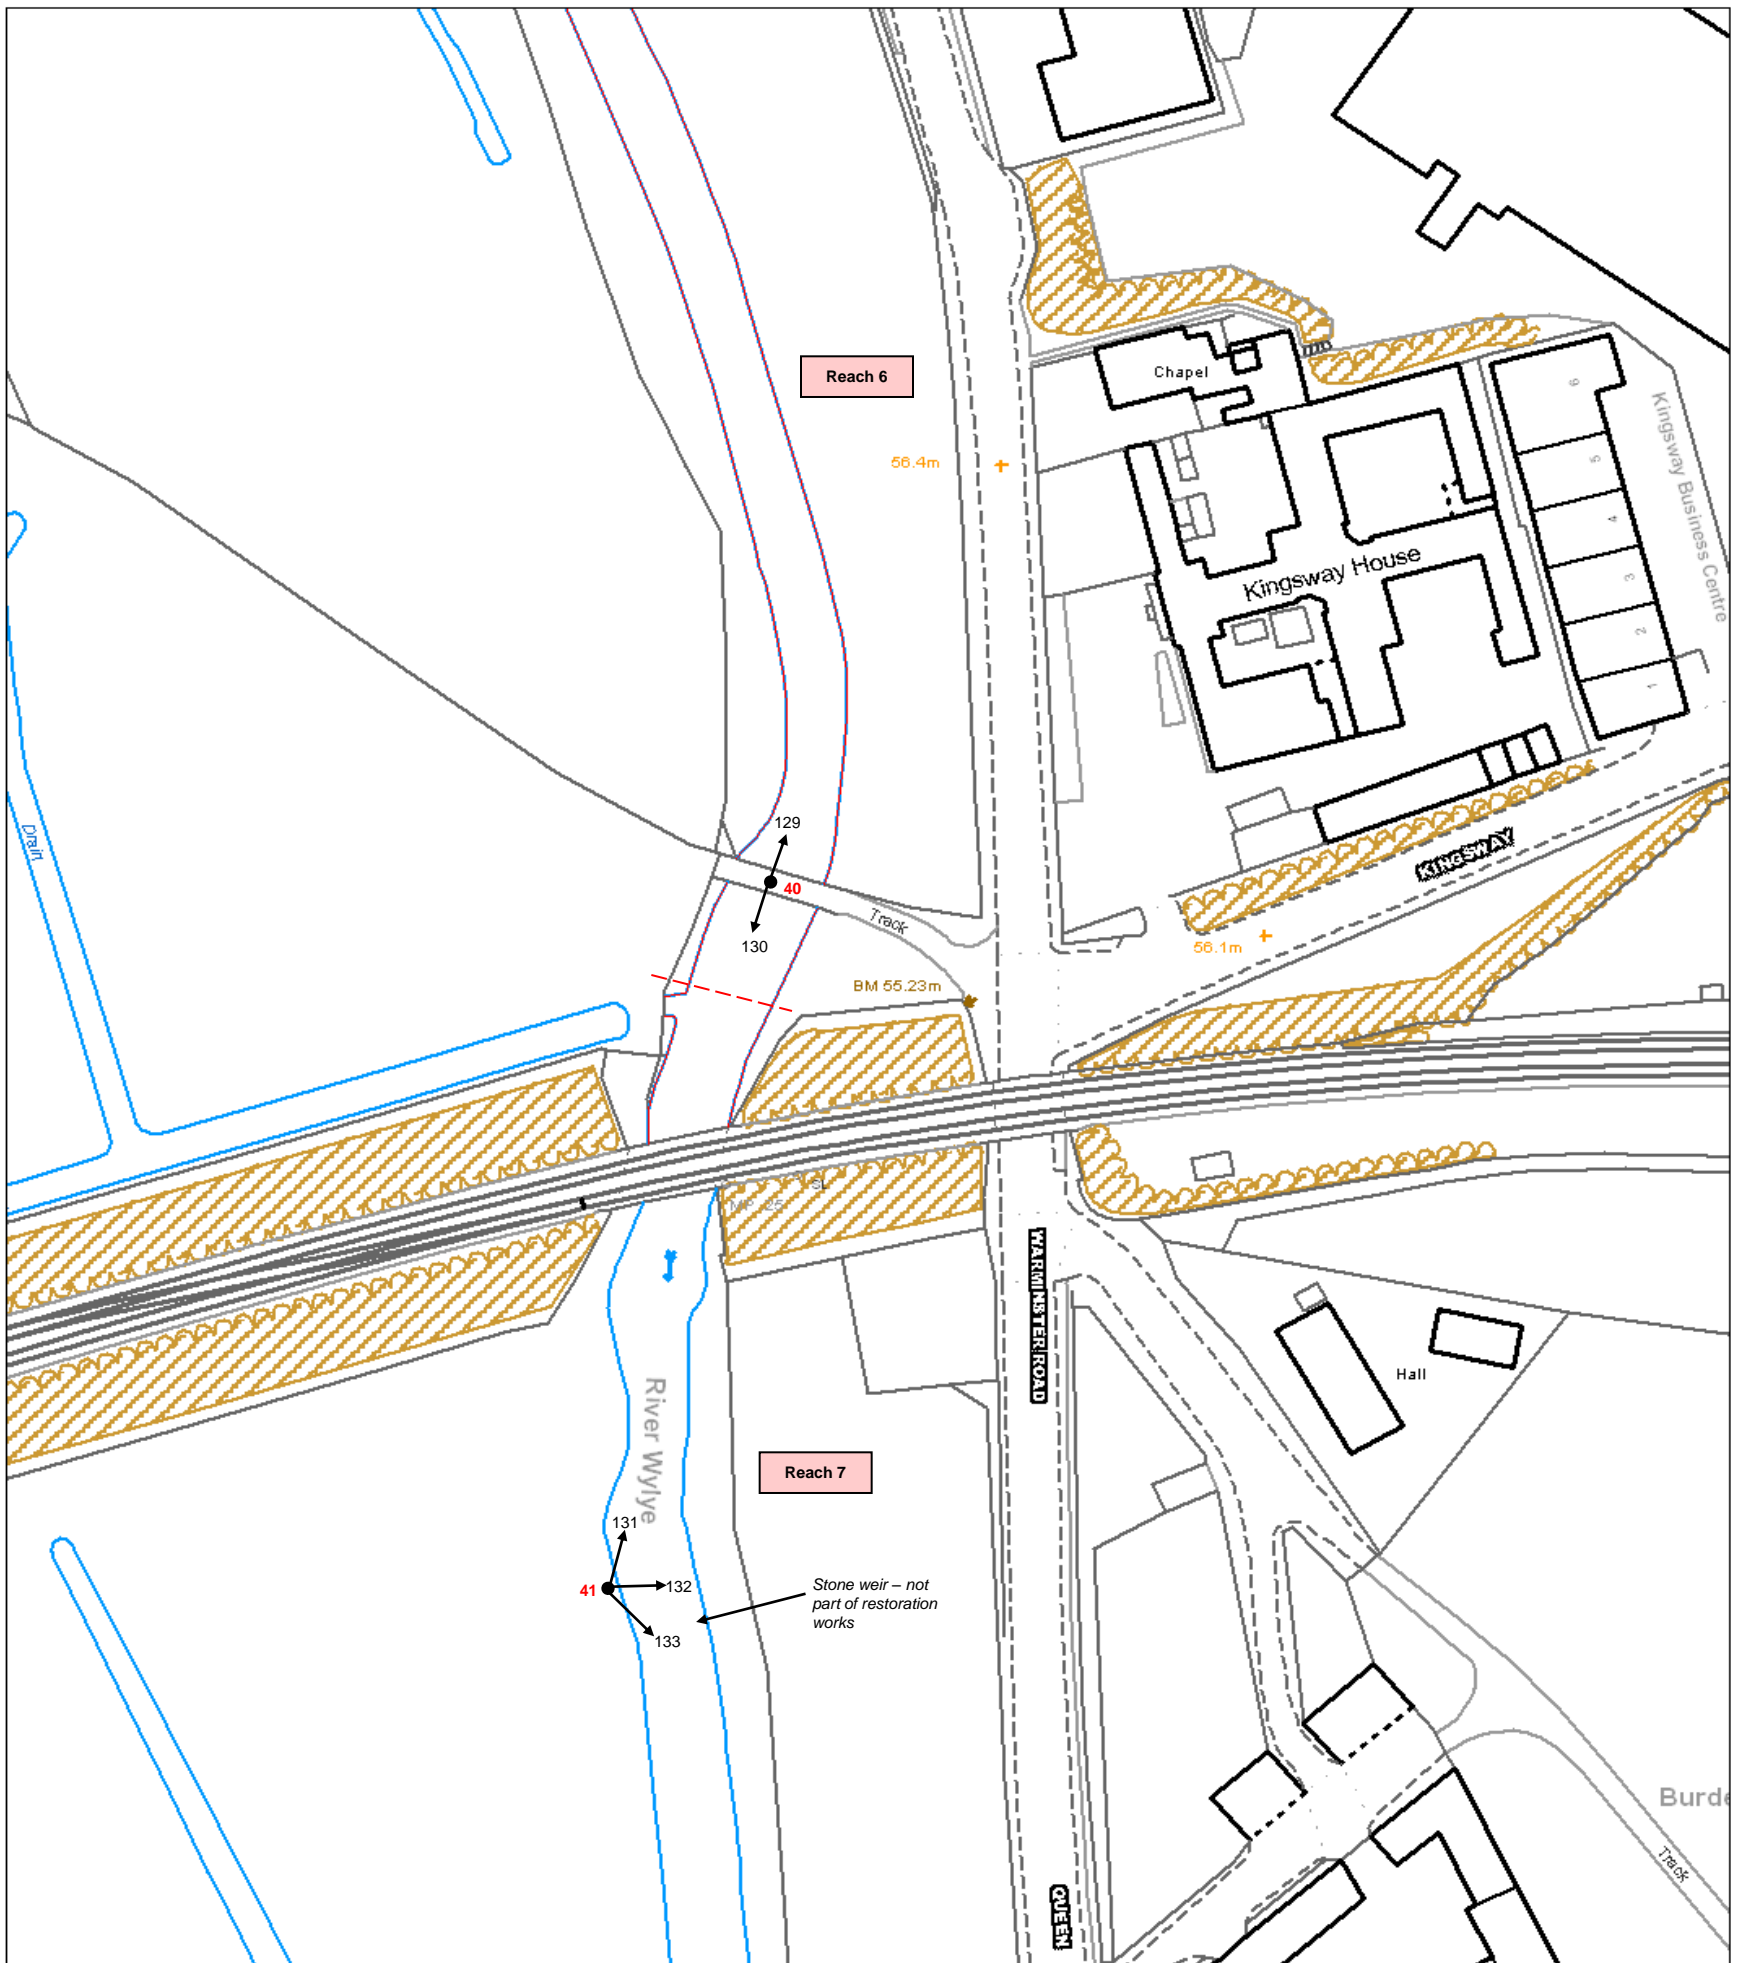
Figure 2.6 River Wylve at Seven Hatches Reach 6 (lower) and 7

Reach 6: This reach lay between the two railway bridges. Both banks, which were steep, were covered in dense stands of nettles. The channel had a gravel substrate but was silted in places. There was some in channel vegetation in evidence and the presence of woody debris was creating flow variability. Numerous holes were observed in the left bank which may well have been made by water voles. The expected negative impacts were disruption to vegetation in the short term only. Long term benefits were expected to be increased vegetation and habitat for fish and invertebrates and localised movement of bed material and the formation of riffles and areas of deposition.

Reach 6: No changes were observed in this reach.

Reach 7	No positive impacts were envisaged for this section.	Potentially this reach could be impacted by deposition of sediment as a result of the upstream restoration works, however it was already of poor quality in terms of habitat and geomorphological features	No obvious deposition of silt had occurred (as had been suggested as a possible negative impact).	No noticeable changes were observed	No obvious deposition of silt had occurred (as had been suggested as a possible negative impact).	No noticeable changes were observed	No obvious deposition of silt had occurred (as had been suggested as a possible negative impact).	No noticeable changes were observed
	Upstream of restoration reaches							
	Restoration reaches							
	Downstream of restoration reaches
