Physical and biological monitoring of STREAM restoration projects

Year Three Report

Natural England

April 2009

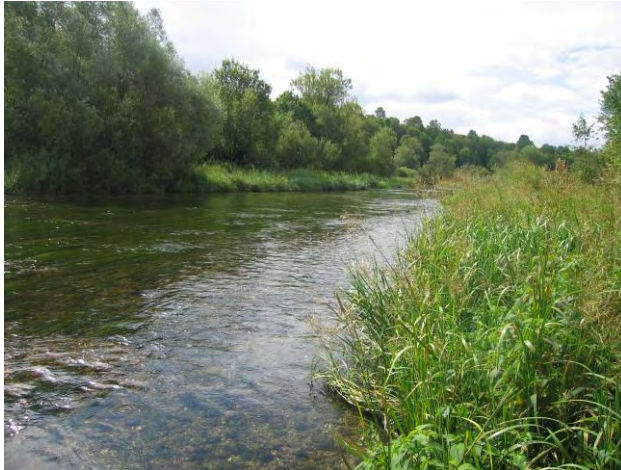
Photo 3.1.2 - UWC MS03: Glide biotope towards middle of site UWR, looking upstream.

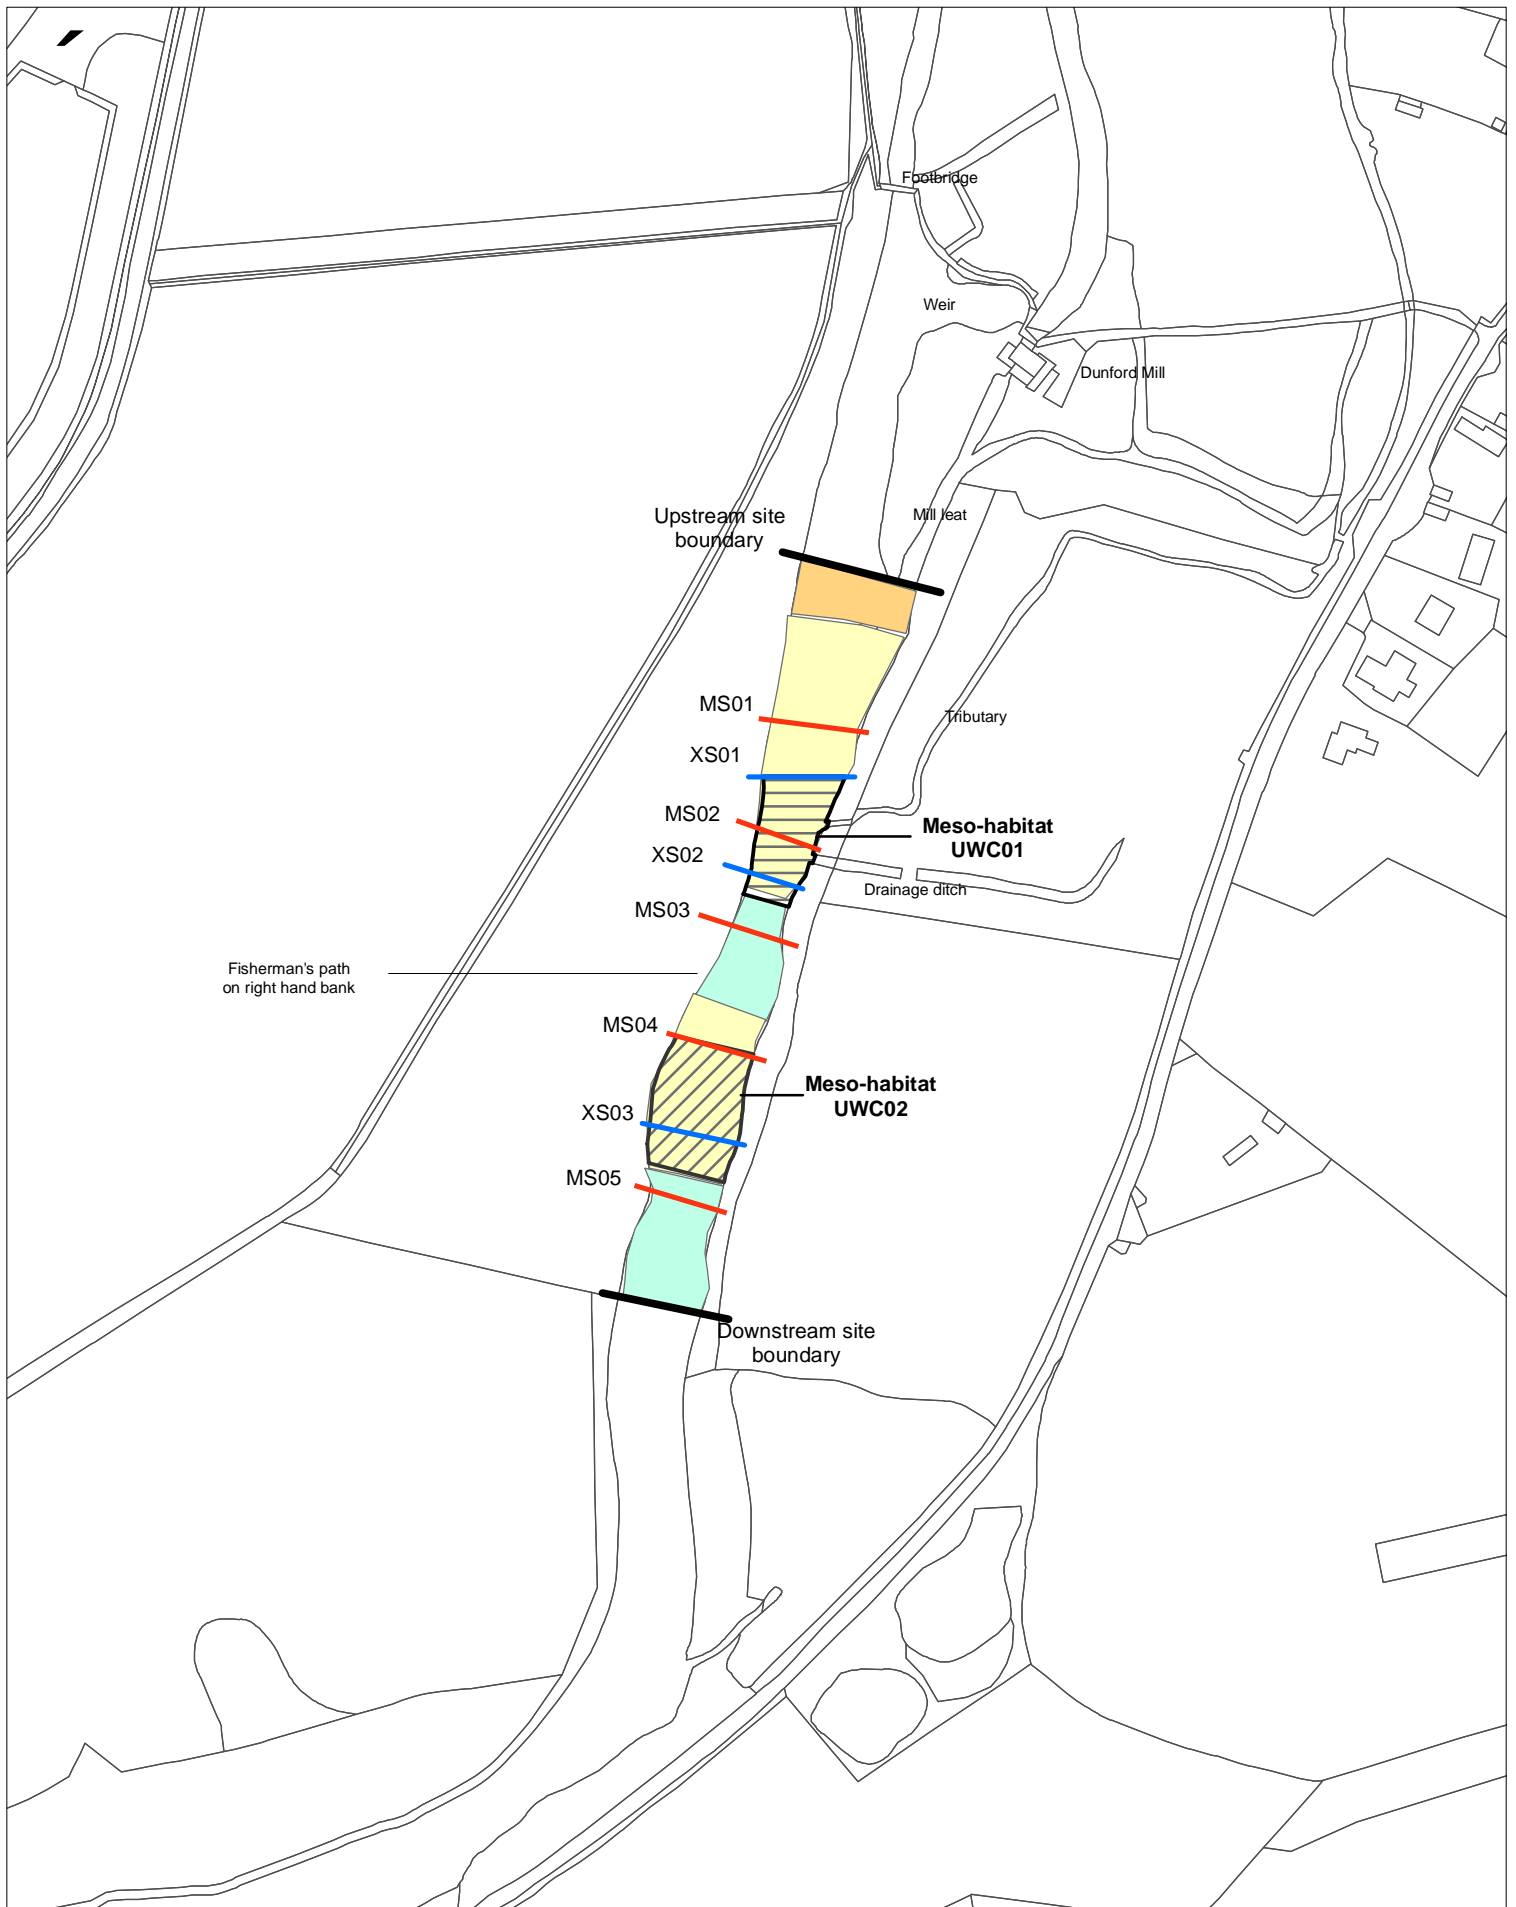
One run and four glides were recorded within the site during the Physical Biotype Mapping survey as illustrated in **Map 3.1**. The run is a short section just downstream of the upstream site boundary and is characterised by shallow, fast flowing water. The remainder of the reach was observed as a glide, split into two slow and fast sections. These biotopes occur alternately as illustrated in **Map 3.1**. The fast flowing sections are shallower with rippled flow while the slower sections are deeper with smooth flow.

In 2006, a number of runs were observed within reach UWC with rippled flow and a visible gravel bed (**Photos 3.1.1a and 3.1.3a**). In 2008, at the same locations, glides were observed with rapid but smooth flow (**Photos 3.1.1b and 3.1.3b**). This difference in physical biotope is related to the increased depth of water, acting to “drown out” the run features. A similar difference was evident in runs throughout the reach.

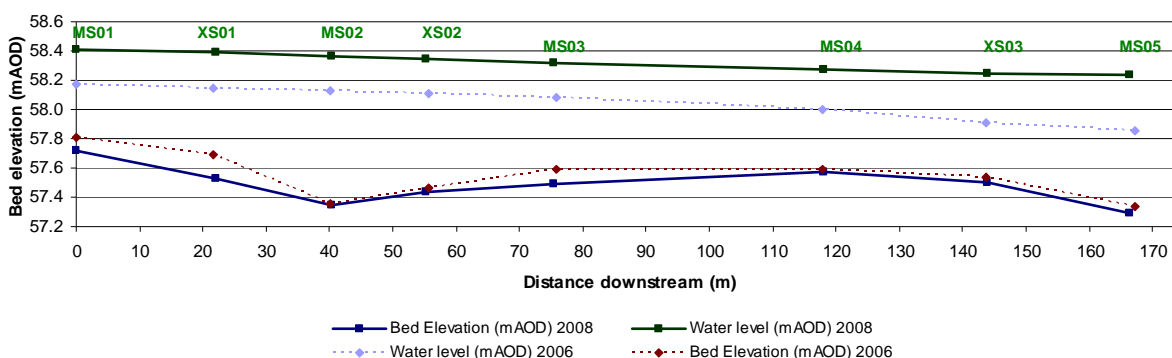
Figure 3.1 Long profiles derived from cross-sectional data from MS01 to MS05 in 2006 and 2008

Over a distance of 171m (between cross-section MS01 and MS05), there is a fall in bed elevation of 0.43m, corresponding to a gradient of 0.003 (**Figure 3.2**). The long profile illustrates that the channel is deepest at cross sections MS02 and MS05 which are located in the slow glide biotope sections.

There has been a decrease in bankfull width at the majority of cross-sections. This is related to increased growth and encroachment along the channel banks of marginal vegetation, as a result of wetter marginal conditions and limited access. Cross-sectional profiles have also changed in response to the undermining of previous channel narrowing measures at some locations (e.g. cross-sections XS03 and MS03) (**Appendix D**). Localised scour is evident at the base of the channel banks where higher velocities and water levels have led to flow behind the willow spiling.

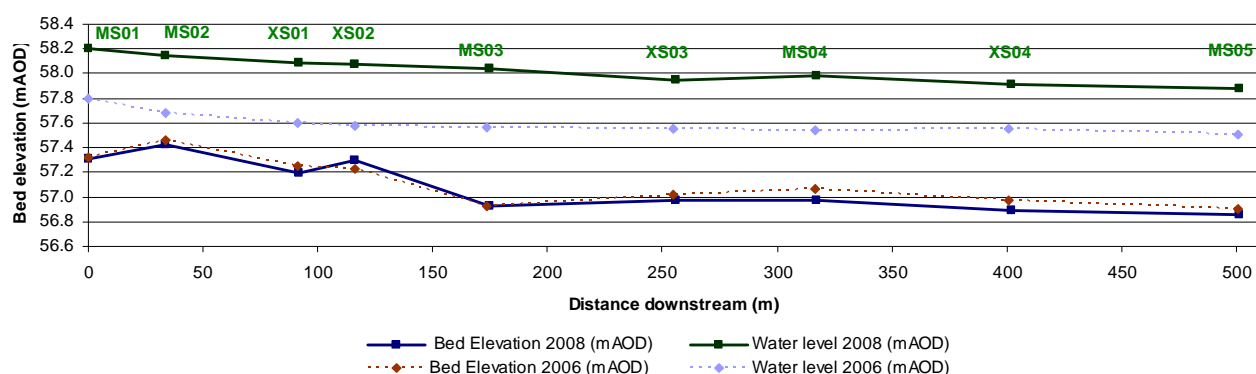
Figure 3.4 Long profiles derived from cross-sectional data from MS01 to MS05 in 2006 and 2008

Over a distance of 506m (between cross-section MS01 and MS05), there is a fall in bed elevation of 0.46m (a gradient of 0.001). The long profile illustrates that the channel is generally deeper towards the downstream end of the reach downstream of MS03.

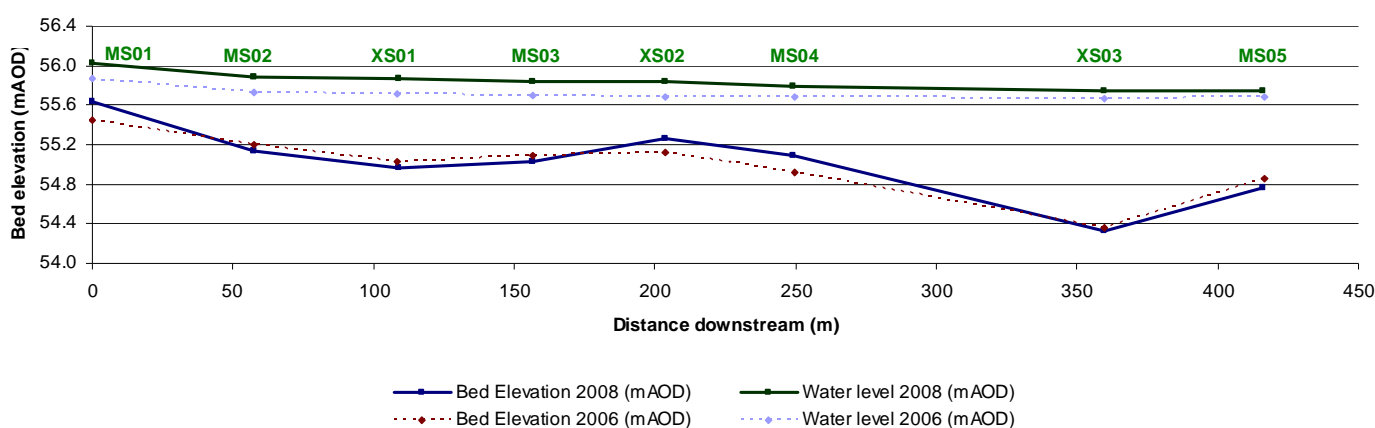
Figure 3.7 Long profiles derived from cross-sectional data from MS01 to MS05 in 2006 and 2008

Over a distance of 416m (between cross-section MS01 and MS05), there is a fall in bed elevation of 0.86m (a gradient of 0.002). The long profile illustrates the relative uniformity of bed elevation and water depth upstream of cross-section MS04 and how the channel deepens downstream as it flows around the meander bend. The cross-sectional profile of the channel downstream of MS04 is overdeep in comparison with the channel upstream.

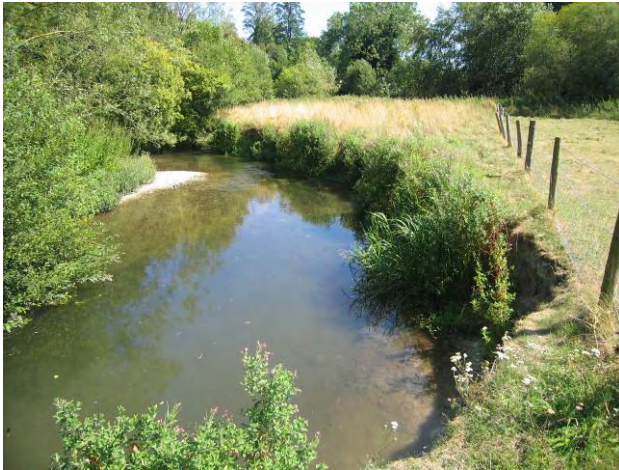
Photo 3.4.2 - SHR02 MS03a: Looking upstream at new riffle

The reintroduction of excavated gravel and stone bed material and the introduction of large woody debris have increased variable bed morphology as illustrated in **Photo 3.4.2a and 3.4.2b**.

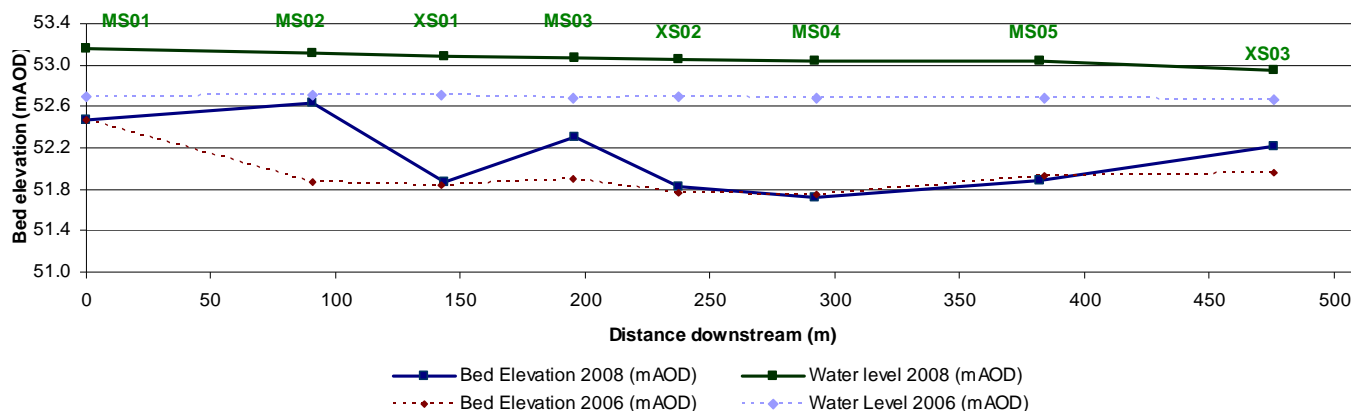
Figure 3.10 Long profiles derived from cross-sectional data from MS01 to MS05 in 2006 and 2008

Over a distance of 476m (between cross-section MS01 and XS03), there is a fall in bed elevation of 0.26m (a gradient of 0.001). The long profile also illustrates that the shallowest sections occur at the riffles (MS02, MS03 and XS03).
