Natural England Commissioned Report NECR141

New Forest SSSI Ecohydrological Survey Overview

Annex O: Norley Mire

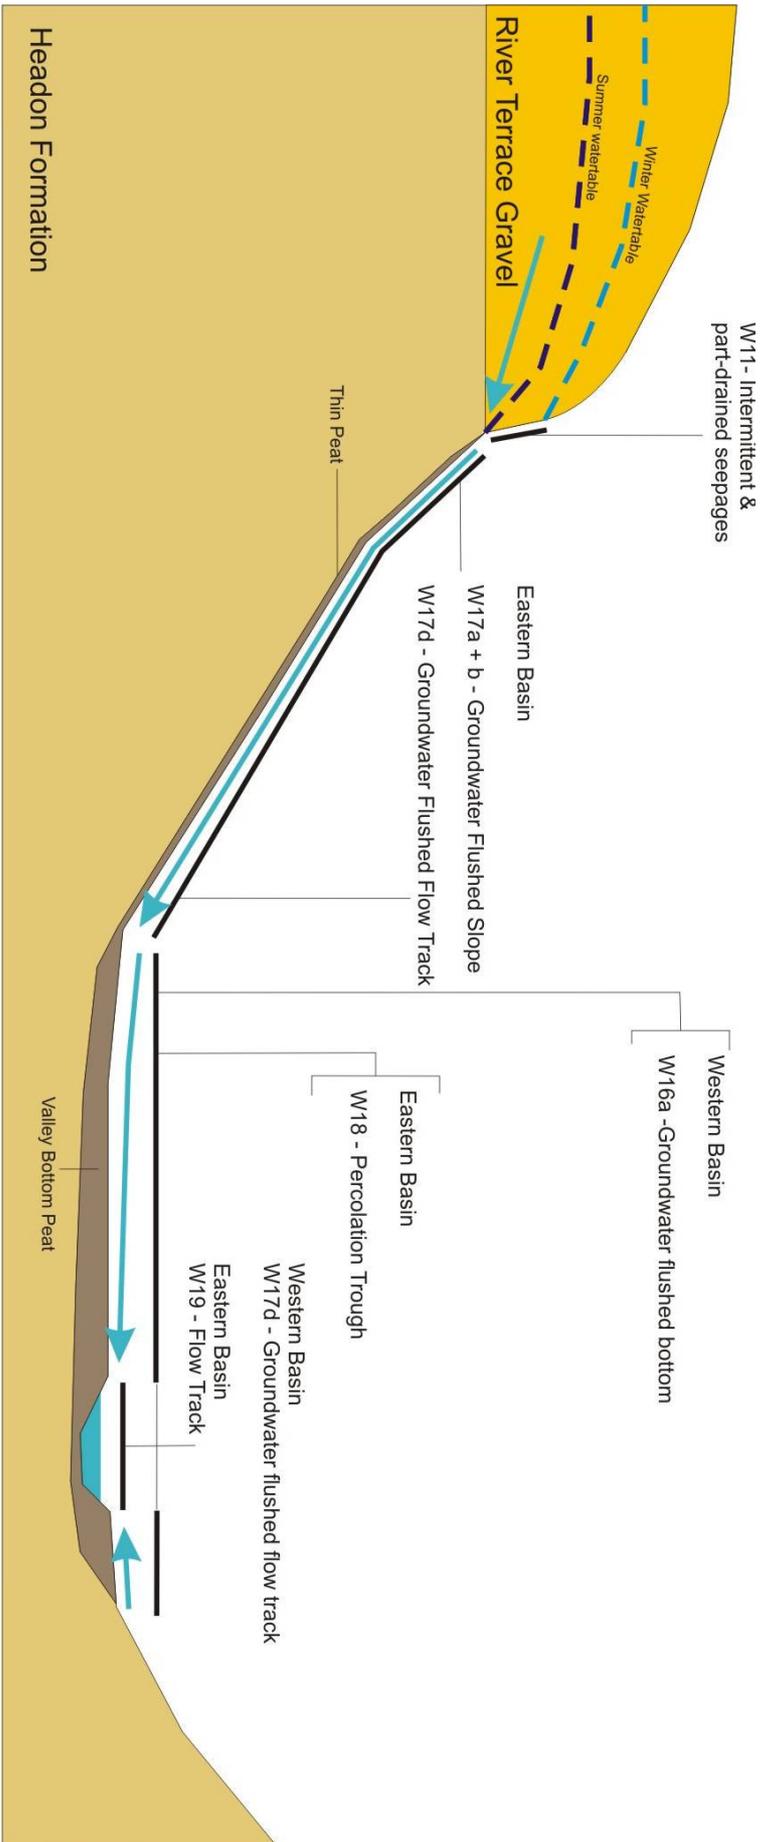
Figure 1-5: Conceptual Model Diagram

The wetlands in the unit are flush dominated (see Figure 1-5). They receive water from a seepage face at the junction between river terrace deposits (aquifer) and the underlying

Headon Formation (aquitarde). The major seepage faces at this junction have been mapped by the survey. The seepage supporting the eastern wetland appears stronger than that supporting the western wetland, this might be due to variations in the River Terrace Gravels and how the valleys intersect them.

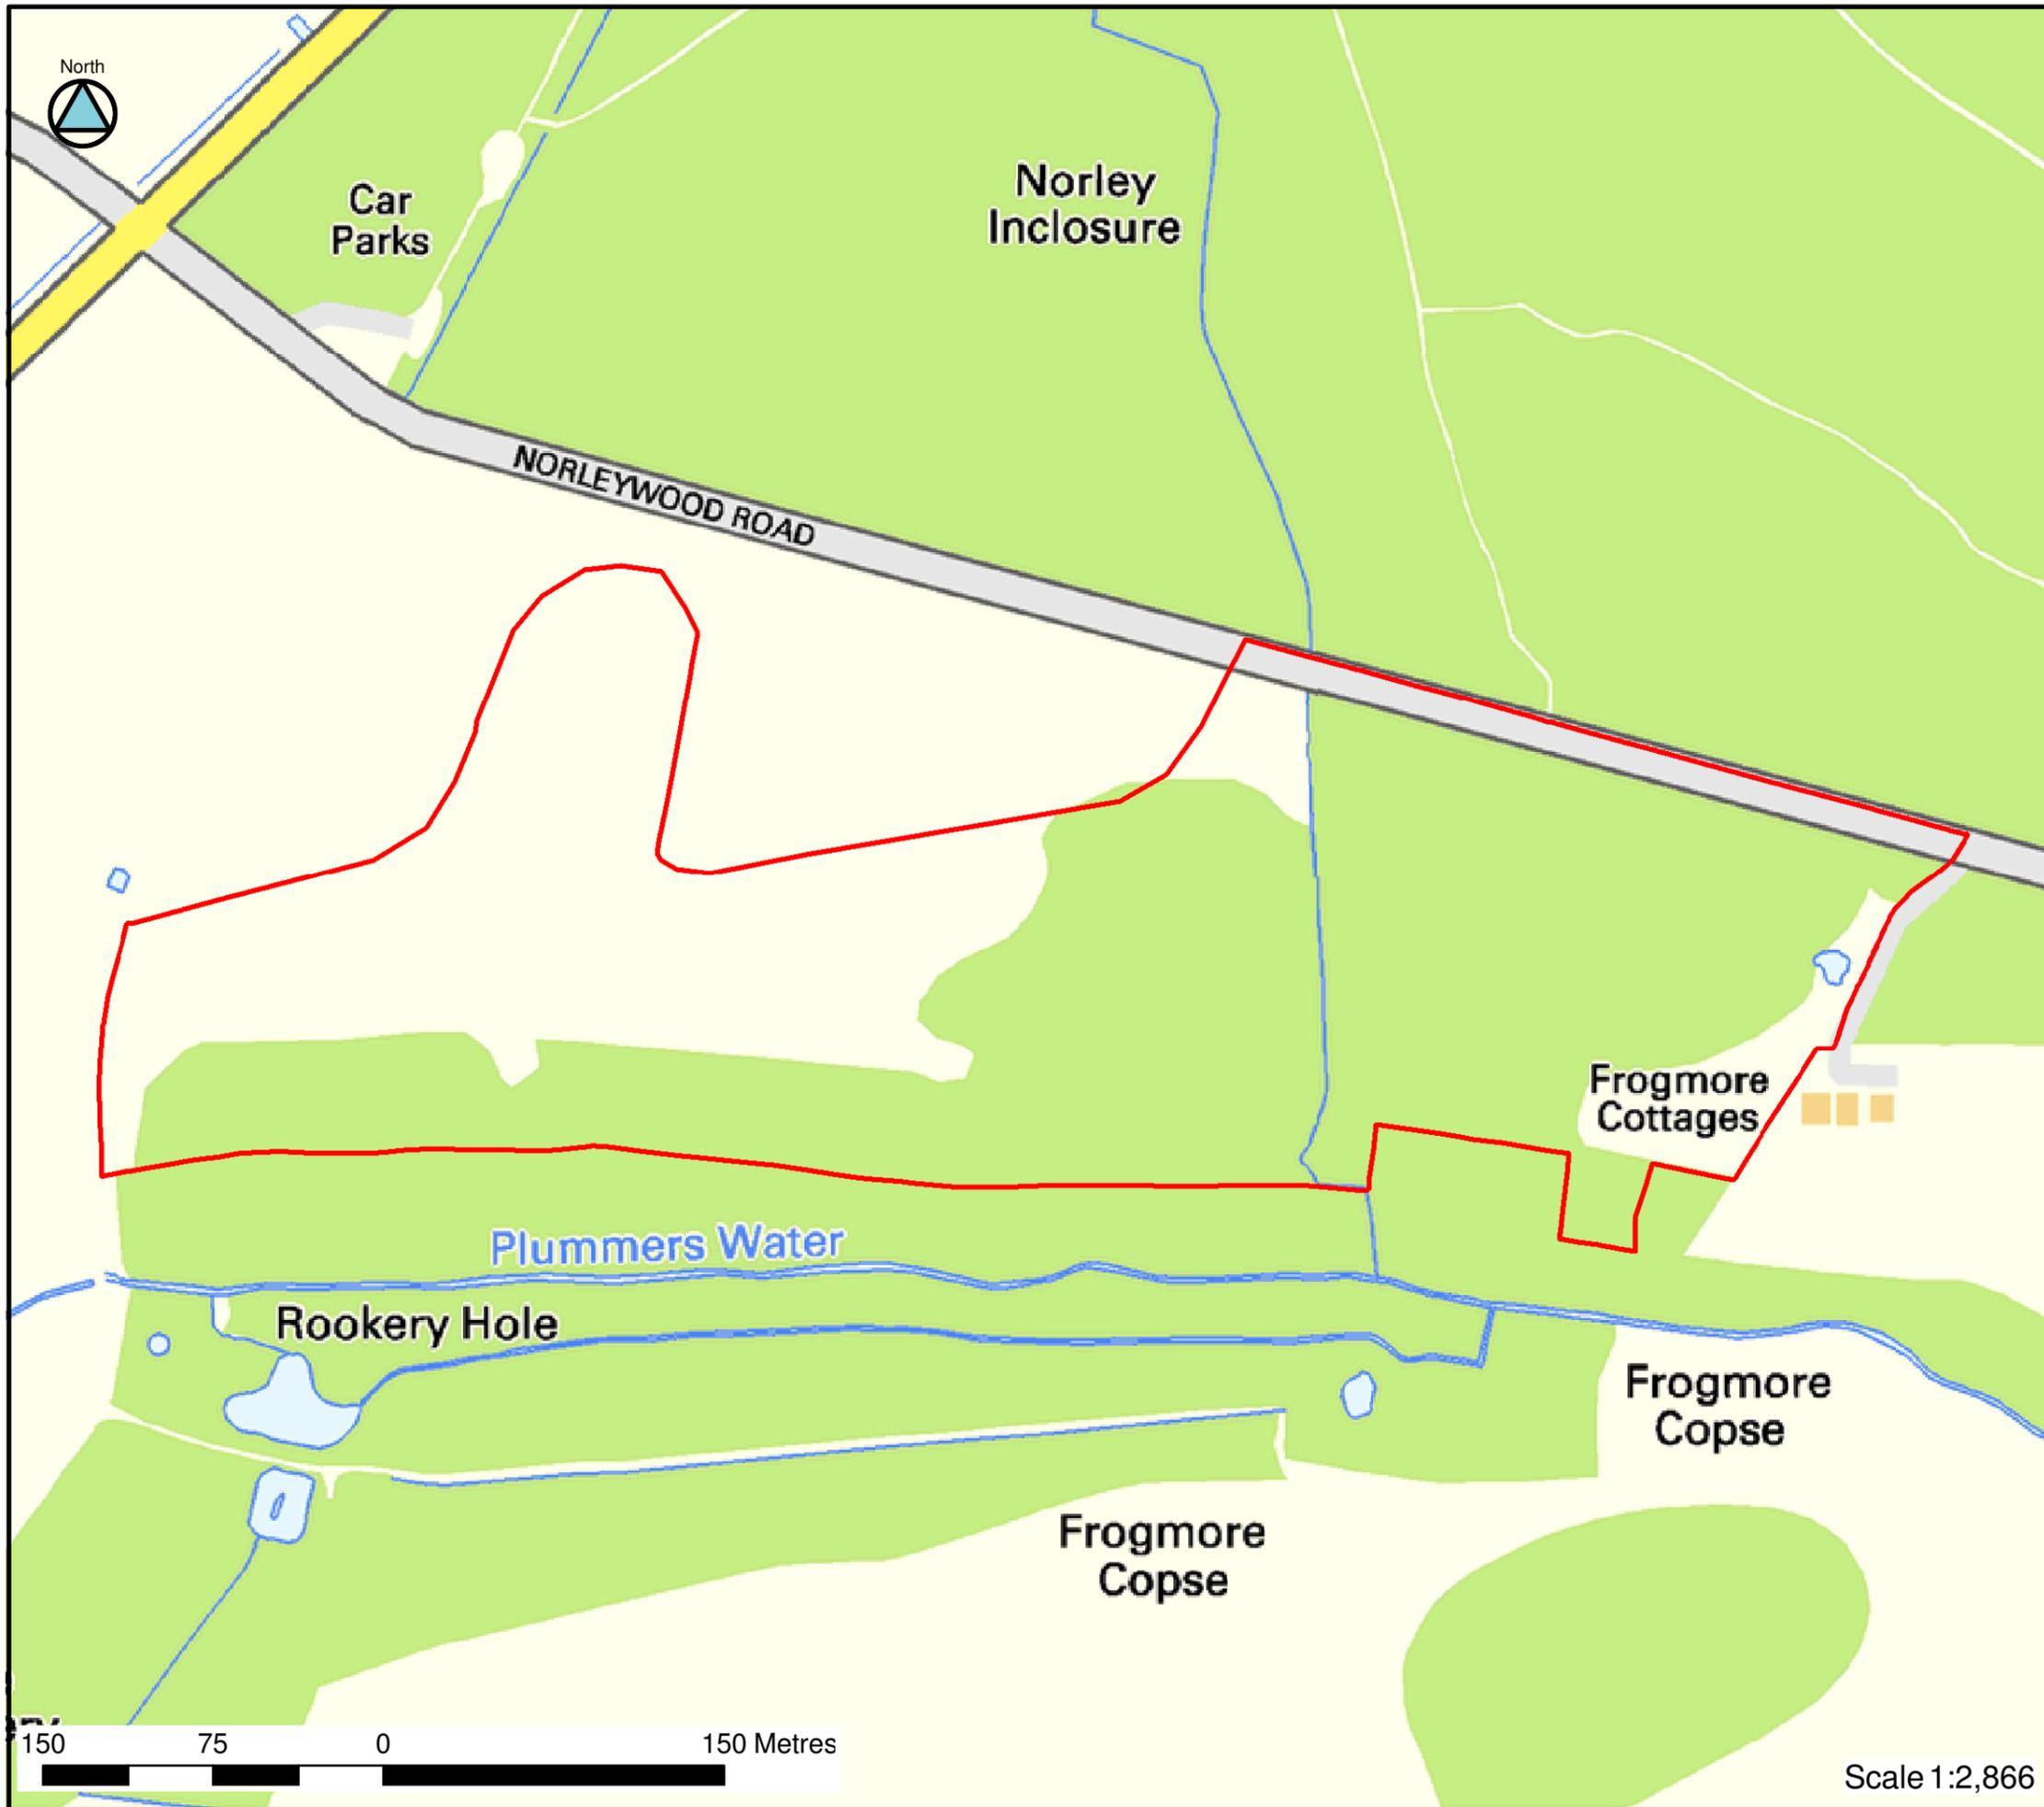
Map 8: Restoration Plan

There is one area of significant damage (see Figure 1-6). The valley bottom wetland in the eastern valley has a small drain cut through the middle. This drain should be infilled, possibly with heather bales, with wooden dam supports built into the infilling and the water diverted across the mire surface to restore the quality and extent of the mire habitats. As the valley enters the area of forestry, the drainage has been more effective and the mire completely removed. There are possibilities for wetland creation in this area too (through removal of forestry, earth bunds and infilling the drains).

Area		Proposals		
Centre Drain	Small centre drain through mire	Infilling drain with heather bales	Stop drainage and degradation of mire habitat. Increase in quality and extent of adjacent mire and wet heath habitats	Drain is an outfall of the road drainage system
Centre Drain in East of Unit	Poached Ground	Grazing management	Prevents sensitive mire habitat becoming trampled and damaged continuously	May be constrained by current grazing rights
