Natural England Commissioned Report NECR141

# New Forest SSSI Ecohydrological Survey Overview

Annex W: Denny Bog and Penny Moor

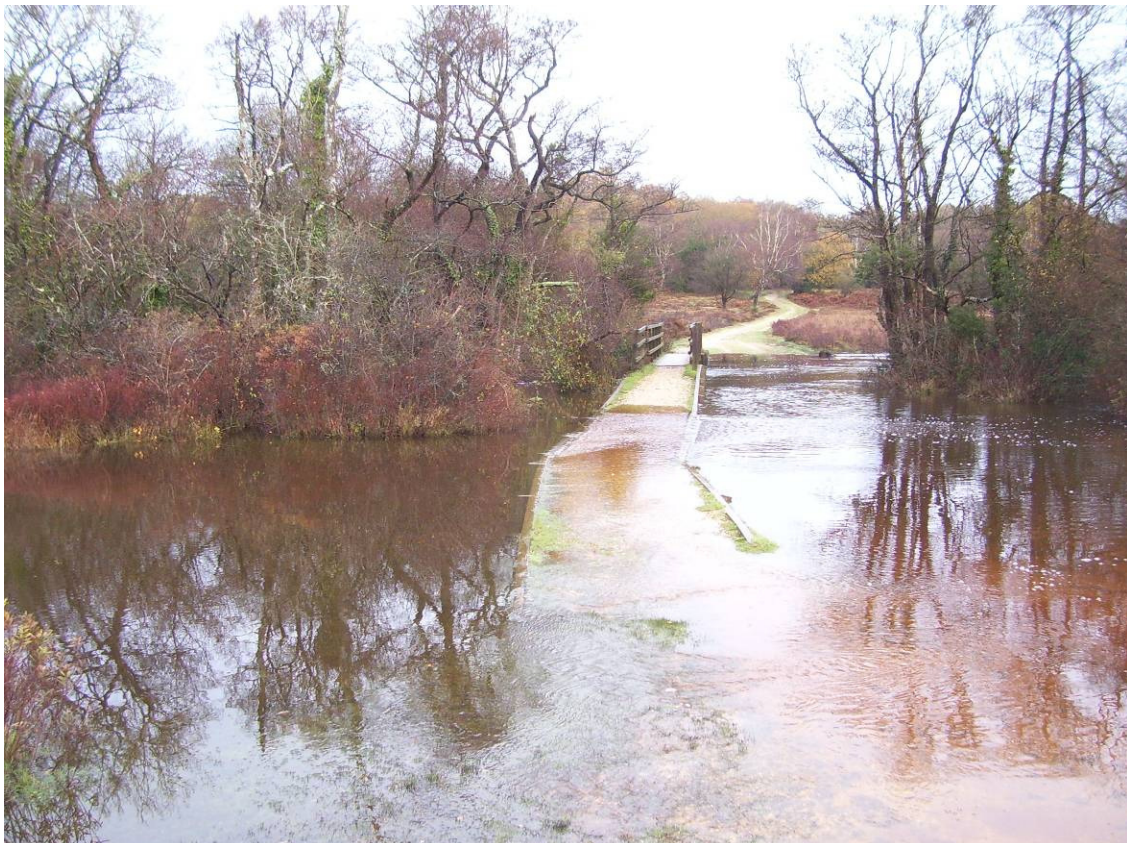
**Figure 1-2: View of Shepton Water at Pigbush Passage (Ford), the point of outflow from Denny Bog East (NGR 436239 104570, view looking north-eastwards; flow from left to right)**

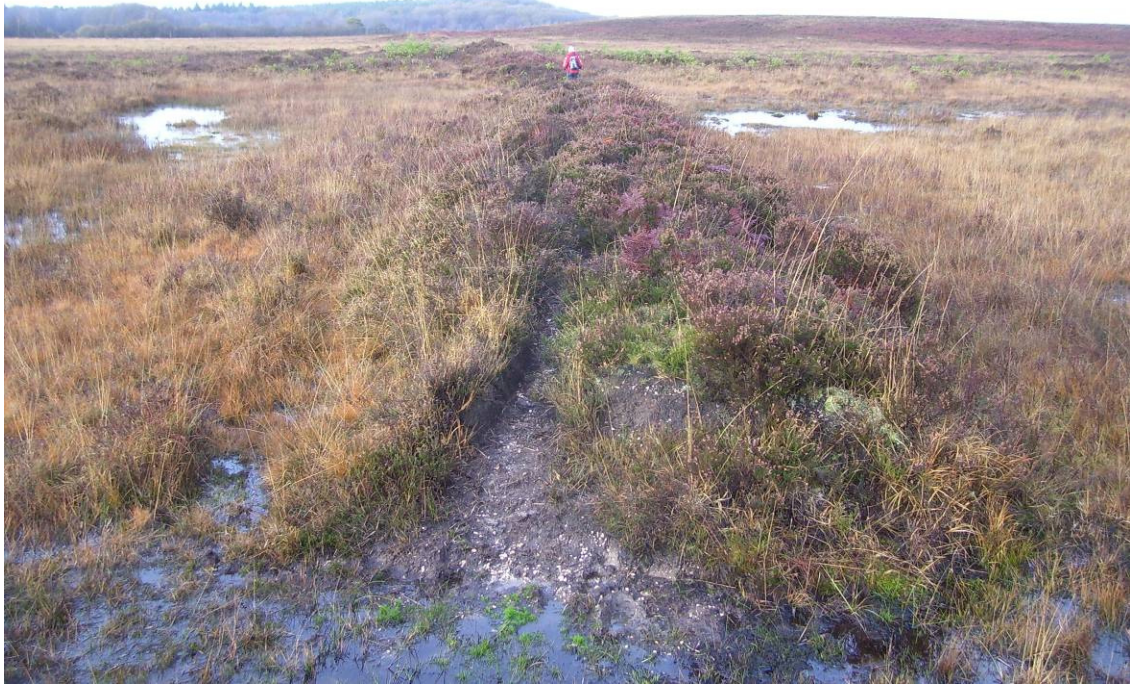
Denny Bog and Penny Moor are surrounded by a historical earthwork/embankment known as Bishop's Dyke. It is generally about 1.5 m high, with a small ditch on either side. Where the material making up the embankment is exposed it is seen to consist of brown soil (locally peaty) and orange/brown fine sand, both containing scattered flint gravel. There are gaps in the embankment that allow surface runoff through into the bog, although water does pond up-slope of the embankment in places. In general, the embankment is not likely to represent much of a barrier to water movement, partly because of the gaps and partly because of the relatively permeable nature of the embankment material.

**Figure 1-3: Bishop's Dyke, a historical embankment surrounding Denny Bog and Penny Moor - view from near the eastern end of the site, looking westwards (NGR 436036 104725)**

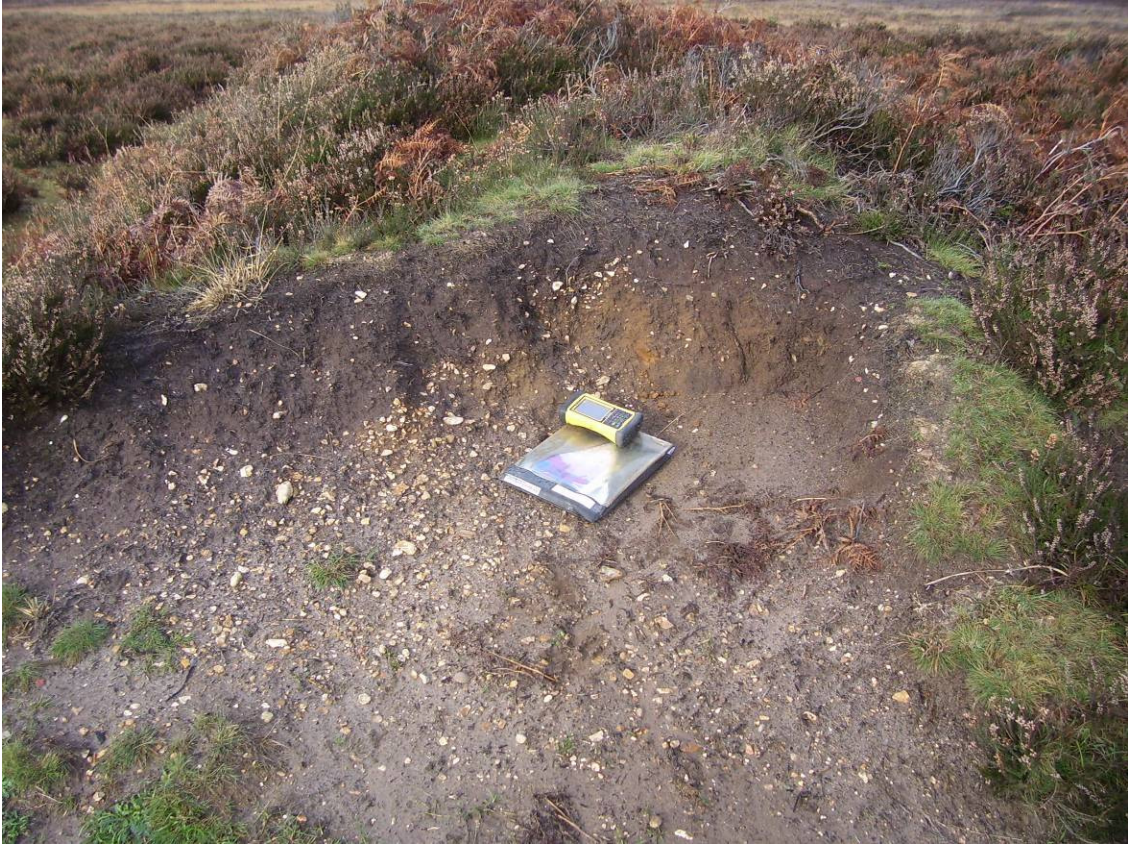
**Figure 1-4: Cross-section through Bishop's Dyke embankment (NGR 434857 105322)**

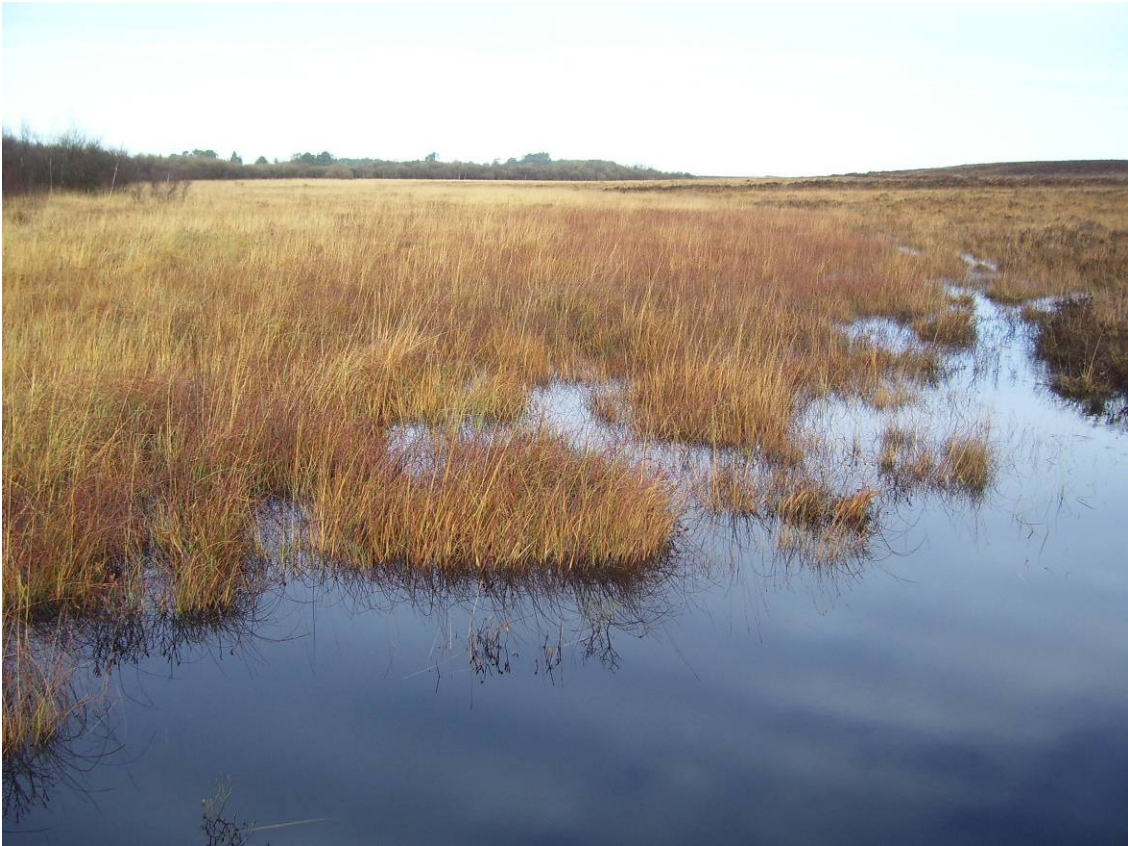
It is understood that headward erosion has taken place in the watercourses draining Denny Bog East<sup>1</sup>. The affected area is located some 500 m east of the railway line, close to the point where the footpath shown in Figure 1-5 crosses the bog (435488 104758)<sup>1</sup>. High water levels meant that the erosion could not be observed at the time of the site visit. However, it is understood that some restoration work has previously been undertaken here using heather bales<sup>1</sup>.

**Figure 1-6: General view of the valley mire in Denny Bog East (NGR 435515 104773, looking northwest)**

It is understood that some restoration work has already been undertaken on Denny Bog, with heather bales being used to combat headward erosion in the eastern part of the bog<sup>2</sup>. It is recommended that the situation be monitored to determine the success of the restoration. If erosion continues then further preventative measures will be required. These could include the use of staked heather bales (where flows are not too energetic), the installation of wooden weirs and/or the infilling or re-profiling of the channel. The engineering design of suitable measures would need to be based on a detailed study beyond the scope of this report.

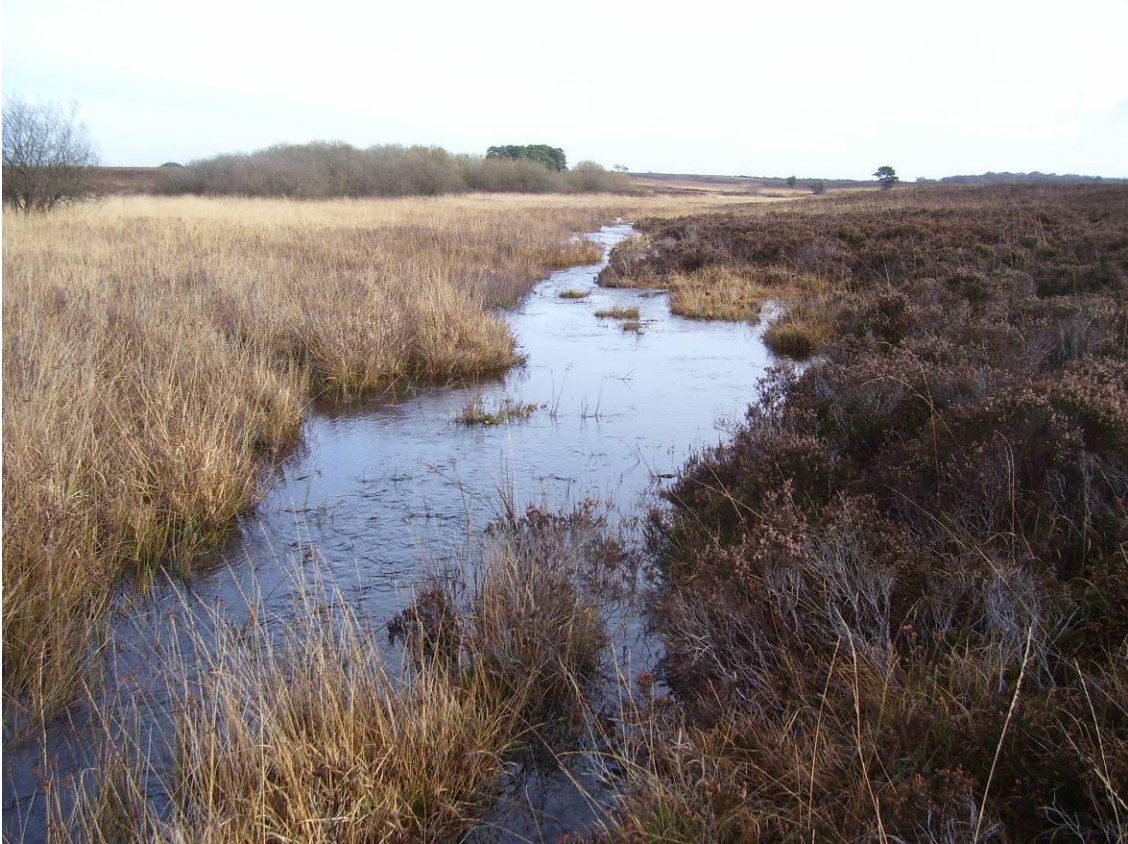
Figure 1-8: Valley mire in Stephill Bottom (NGR 435138 105681, looking east-northeast)

At Stephill Bottom, valley mire habitat, in good condition, is present in the valley bottom, with significant thickets of Grey Willow dominated scrub, and some stands of Bog Myrtle. Very wet Deergrass and White Beak-sedge dominated mire (M21a) is also present in significant patches along with an area of dystrophic standing water, which had ponded adjacent to the road.
