River Mease SSSI/SAC Restoration Plan

Technical Report

March 2012

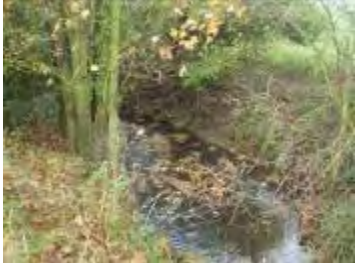
Unit	Reach	Length (m)	Riparian zone character	Surrounding land use	Photograph
4	GIL001	1348	Single continuous line of trees/shrubs along both banks.	Grazed pasture / arable fields

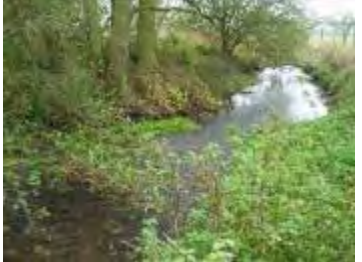
GIL002	662	Single semi-continuous line of trees /shrubs along both banks. Where gaps in trees are present, the land is grazed up to the bank top.	Grazed pasture

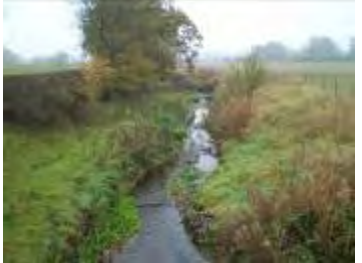
GIL003	457	Occasional isolated (scattered) trees along both banks. Where gaps in tree cover are present there is strip of scrub between 1 and 3 m in width.	Grazed pasture / arable fields

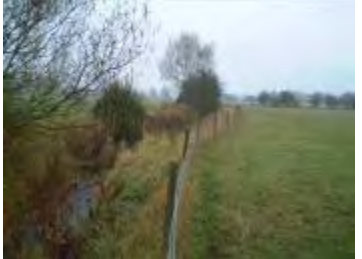
GIL004	282	Single semi-continuous single line of trees /shrubs along both banks.	Grazed pasture / arable fields

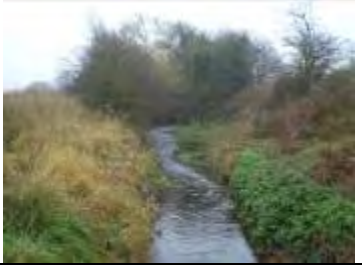
Unit	Reach	Length (m)	Riparian zone character	Surrounding land use	Photograph
	GIL005	1633	Single generally continuous line of trees /shrubs with some wider areas of woodland along both banks.	Grazed pasture / arable fields Area of woodland along left bank

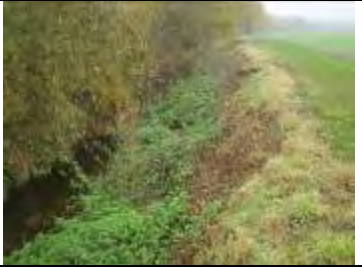
GIL006	1175	Narrow uncultivated margin along left bank generally devoid of trees. Single continuous line of trees /shrubs along right bank.	Grazed pasture / arable fields

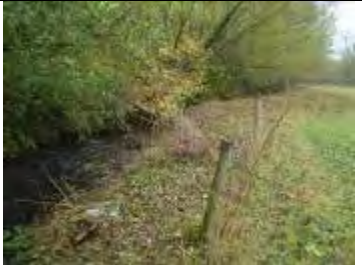
GIL007	756	Single continuous line of trees /shrubs with some wider areas of woodland along the left banks. Some gaps present.	Grazed pasture

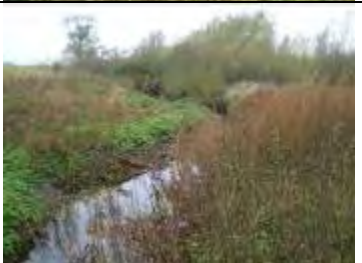
3	MEA001	1254	Single semi-continuous line of trees /shrubs along left bank. Woodland along right bank.	Arable fields along left bank, woodland to right

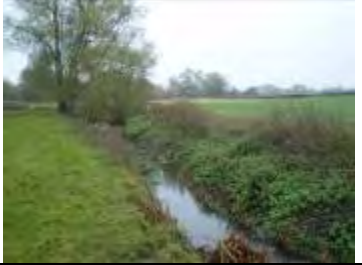
Unit	Reach	Length (m)	Riparian zone character	Surrounding land use	Photograph
	MEA002	1281	Occasional isolated (scattered) trees along right banks. Uncultivated margin of scrub along left bank of variable thickness	Arable fields along left bank Graze pasture along left

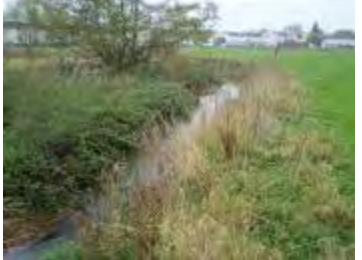
MEA003	230	Occasional single lines of trees along both banks. Significant gaps present.	Arable fields and grazed pasture along left bank and recreation land or urban along right bank

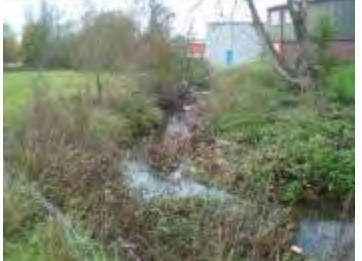
MEA004	752	Occasional clumps of trees along both banks. Numerous gaps. Narrow (1-3 m) strip of scrub where trees absent.	Grazed pasture along left bank. Industrial estate along right bank.

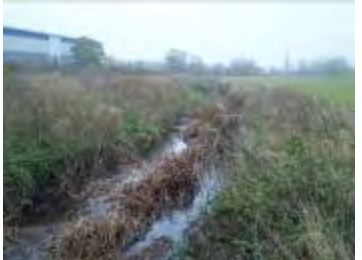
MEA005	520	Occasional clumps of trees however, tree lining is generally absent. Narrow (1-3 m) strip of scrub along both banks.	Grazed pasture along both banks.

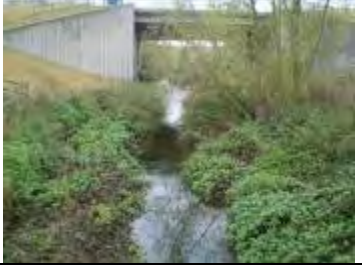
Unit	Reach	Length (m)	Riparian zone character	Surrounding land use	Photograph
	MEA006	115	Occasional trees along both banks. Strip of scrub 1-2 m wide along both banks.	Access tracks and dual carriageway.

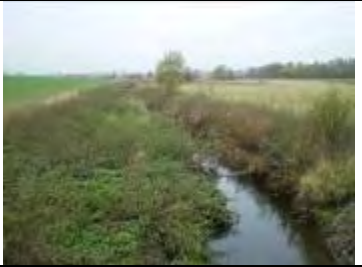
MEA007	2114	Occasional trees along both banks. Strip of scrub 1-3 m wide along both banks. One isolated clump of woodland on left bank.	Grazed pasture or arable fields along both banks.

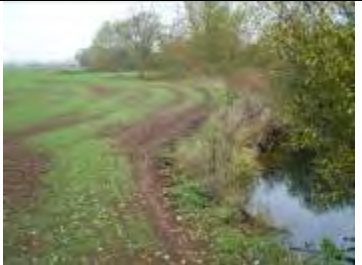
2	MEA008	2340	Isolated sections of tree lining, primarily along the right bank. Numerous sections devoid of trees with narrow undisturbed strip 0.5-2 m in width along both banks.	Arable fields and occasional grazed pasture along left bank. Grazed pasture along right bank.

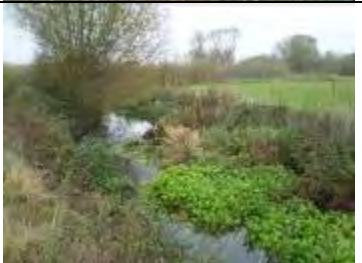
MEA009	2200	Isolated sections of tree lining along both banks. Gaps present but scrub present along both banks.	Woodland along right bank with some arable fields to right at lower end of reach. Grazed pasture along left.

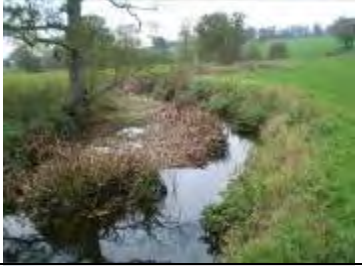
Unit	Reach	Length (m)	Riparian zone character	Surrounding land use	Photograph
	MEA010	1766	Occasional trees along both banks. Strip of scrub 1-3 m wide along both banks. Narrow uncultivated margin where gaps in tree lining present. Gaps in tree lining are extensive.	Arable fields to right and occasional and arable fields grazed pasture along left bank. Grazed pasture along right bank.

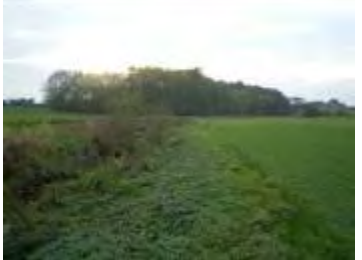
MEA011	504	Occasional small isolated trees along right but trees generally absent Strip of scrub 1-3 m wide along left bank. Narrow uncultivated margins (1-2 m wide) along right bank.	Arable fields along both banks. Area of wet grass land to left of river at downstream end of reach.

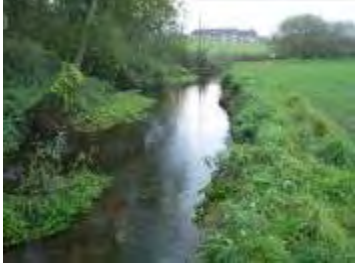
MEA012	1191	Occasional tree lining along left bank. Occasional isolated trees along right bank. Strip of scrub 1-3 m wide along both banks. Narrow uncultivated margin where gaps in tree lining present. Gaps in tree lining are extensive along the right bank.	Arable fields along both banks.

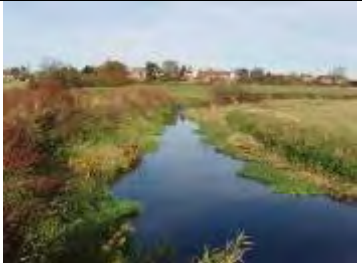
MEA013	1550	Occasional isolated trees along both banks. Strip of scrub 1-3 m wide along both banks. Narrow uncultivated margin where gaps in tree lining present.	Arable fields and grazed pasture along either side of channel.

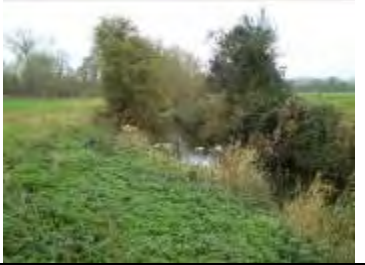
Unit	Reach	Length (m)	Riparian zone character	Surrounding land use	Photograph
	MEA014	2200	Occasional tree lining along both banks. Strip of scrub along both banks where trees are absent. The width of this strip varies.	Arable fields and grazed pasture along either side of channel. Area of wet grassland in one location along left bank.

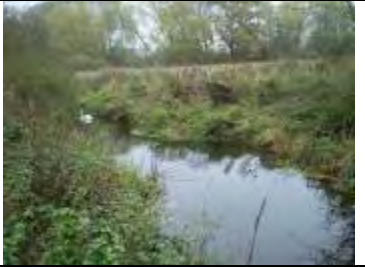
MEA015	587	Semi-continues tree lining along both banks. Where trees are absent there is a wide margin of scrub.	Arable fields to right and grazed pasture along left side of channel.

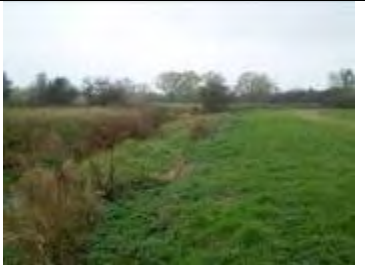
MEA016	1024	Occasional tree lining along both banks. Strip of scrub along both banks where trees are absent. The width of this strip varies. Gaps in tree lining are more extensive than the tree lined sections.	Grazed pasture along left bank. Arable fields and woodland plantation along right bank.

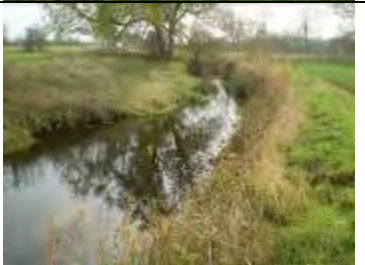
MEA017	1614	Occasional trees along the left bank. Strip of scrub along both banks where trees are absent. The width of this strip varies considerably from up to 6 m along the left bank to 1 m along the right bank.	Grazed pasture along left bank. Arable fields and some grazed pasture along right bank.

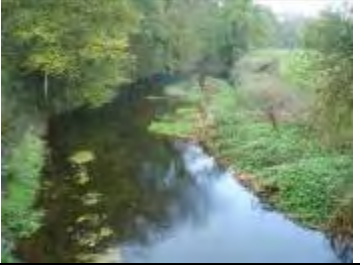
Unit	Reach	Length (m)	Riparian zone character	Surrounding land use	Photograph
1	MEA018	374	Continuous tree lining along left bank. Occasional clumps of trees along right bank. Where trees are absent along the right bank there is a strip of scrub 1-3 m in width along the right bank.	Sports field to right of river.

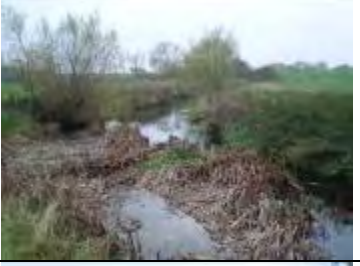
MEA019	607	Occasional scattered trees along both banks. Strip of scrub along both banks where trees are absent. The width of this strip varies. Some sections of the right bank are grazed to the top of the bank. Gaps in tree cover are more extensive than the tree lined sections.	Arable land to left. Grazed pasture to right.

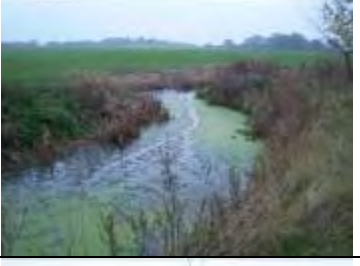
MEA020	690	Trees are absent along the left bank. There is a narrow uncultivated margin (1-2 m wide). The right bank is wooded.	Arable land to left. Woodland to right.

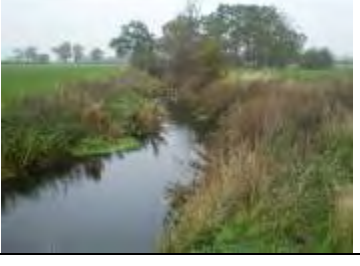
MEA021	1834	Occasional scattered trees along both banks. Strip of scrub along both banks where trees are absent. The width of this strip varies. Some sections of the left bank are grazed to the top of the bank. Gaps in tree cover are more extensive than the tree lined sections.	Arable to right of river and grazed pasture to left,

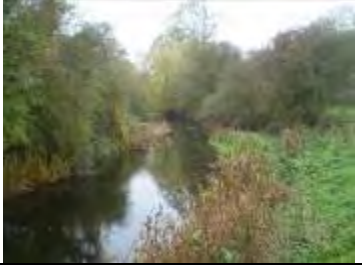
Unit	Reach	Length (m)	Riparian zone character	Surrounding land use	Photograph
	MEA022	926	Semi-continuous lining of trees scrub and shrubs along both banks.	Grazed pasture

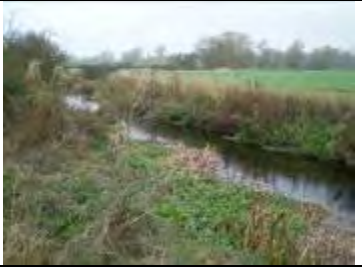
MEA023	621	Occasional scattered trees along both banks. Strip of scrub along both banks where trees are absent. The width of this strip varies (1 – 3 m). Gaps in tree cover are more extensive than the tree lined sections.	Grazed pasture and arable fields to left arable fields to right.

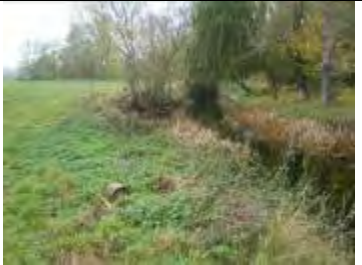
MEA024	1126	Occasional scattered trees along left banks. Uncultivated margin along top of left bank varies from 1 m to 3 m in width. Gardens/Parkland of Croxall Hall along right bank. Isolated trees along the left bank.	Arable fields to left of river. Garden/Parkland and mown grass land to the right of the river.

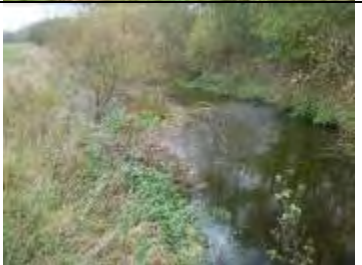
MEA025	928	Scattered trees along the left bank. Where gaps between trees are present there is a strip of scrub which is generally around 4 m wide. Continuous tree lining associated with woodland along the right bank.	Grazed pasture along left bank. Woodland along right bank.

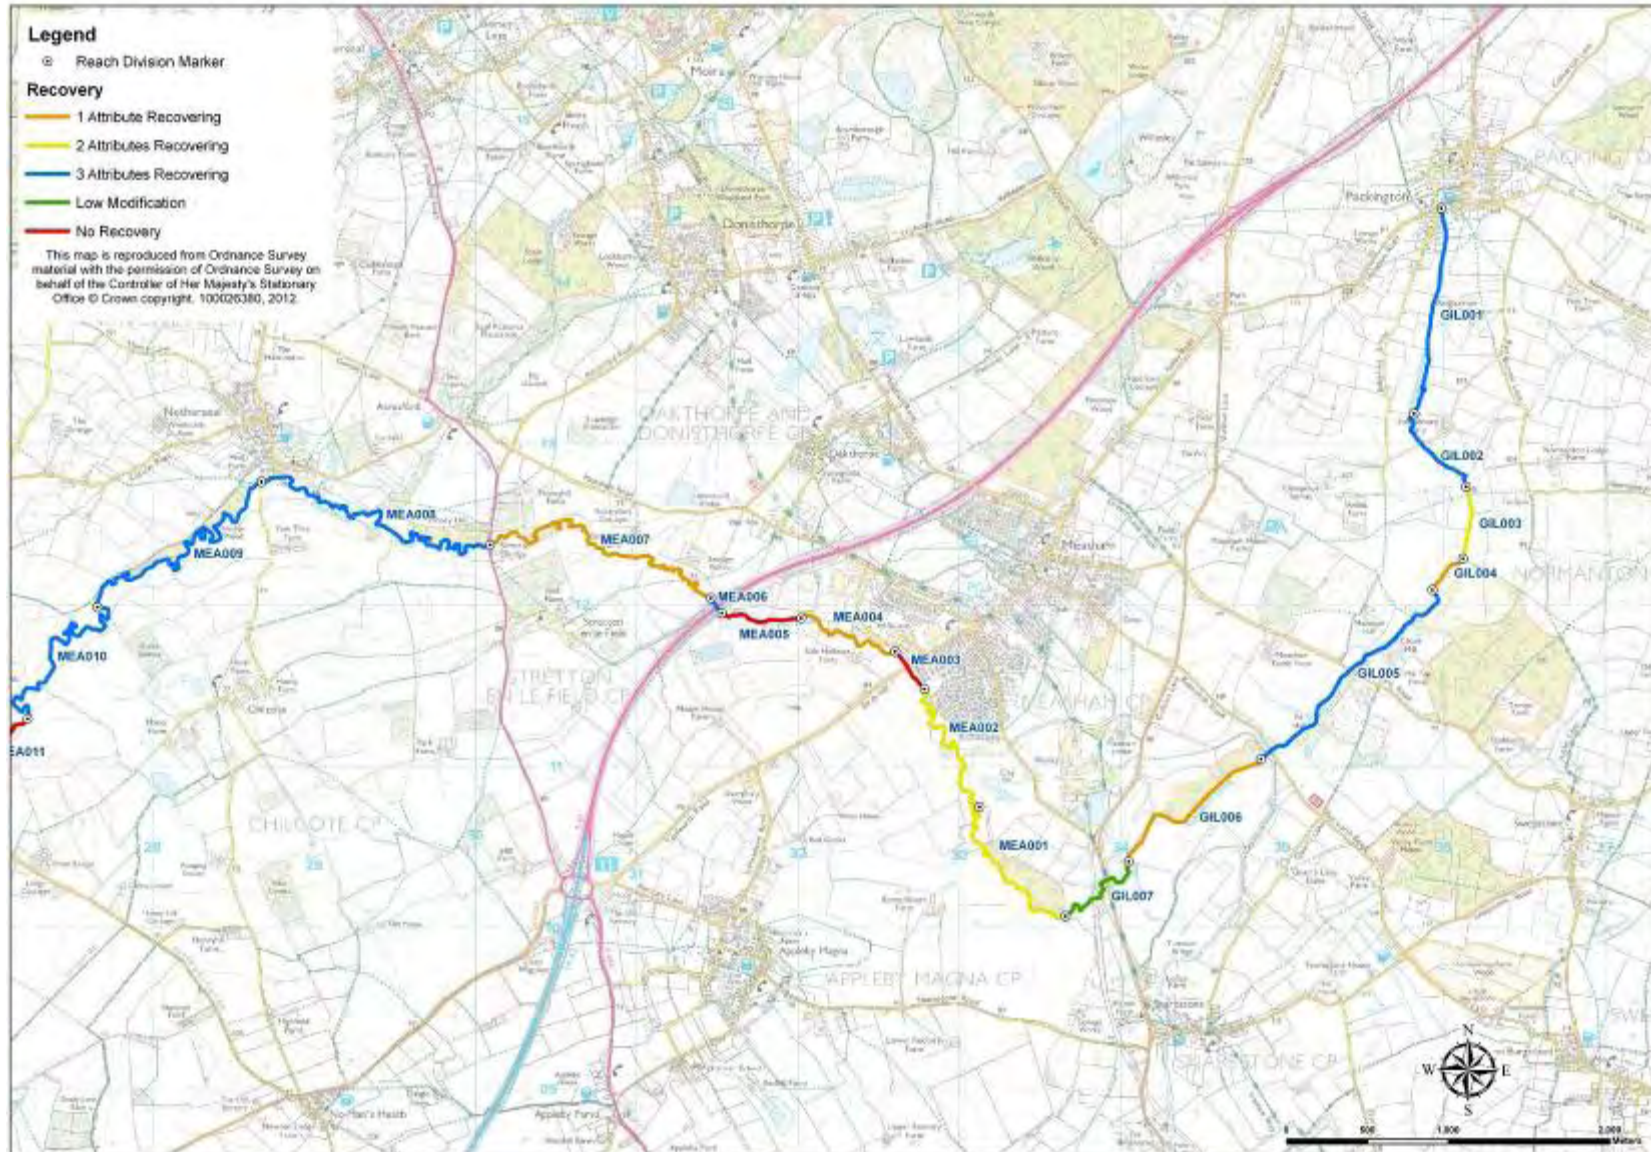
Observations made during the field survey revealed that many of the reaches showed some degree of readjustment of the channel or riparian zone following modification, which is leading to ongoing natural recovery (although this is not complete recovery). Evidence of adjustment to pressures on each attribute, in each reach, is indicated in Table 5.12. The degree of channel adjustment, and therefore ongoing recovery, along the SSSI/SAC is variable. Some reaches only show recovery of a single attribute, while others show recovery to a number of different attributes. The different degree of channel recovery, according to the number of attributes which are adjusting, is summarised in Figure 5.10. This allows a spatial distribution of on-going recovery to be appreciated.

Figure: 5.10: (a) Map showing the number of different attributes that are recovering within each reach in the upper half of the SSSI/SAC; the more attributes showing recover the greater the overall degree of recovery.

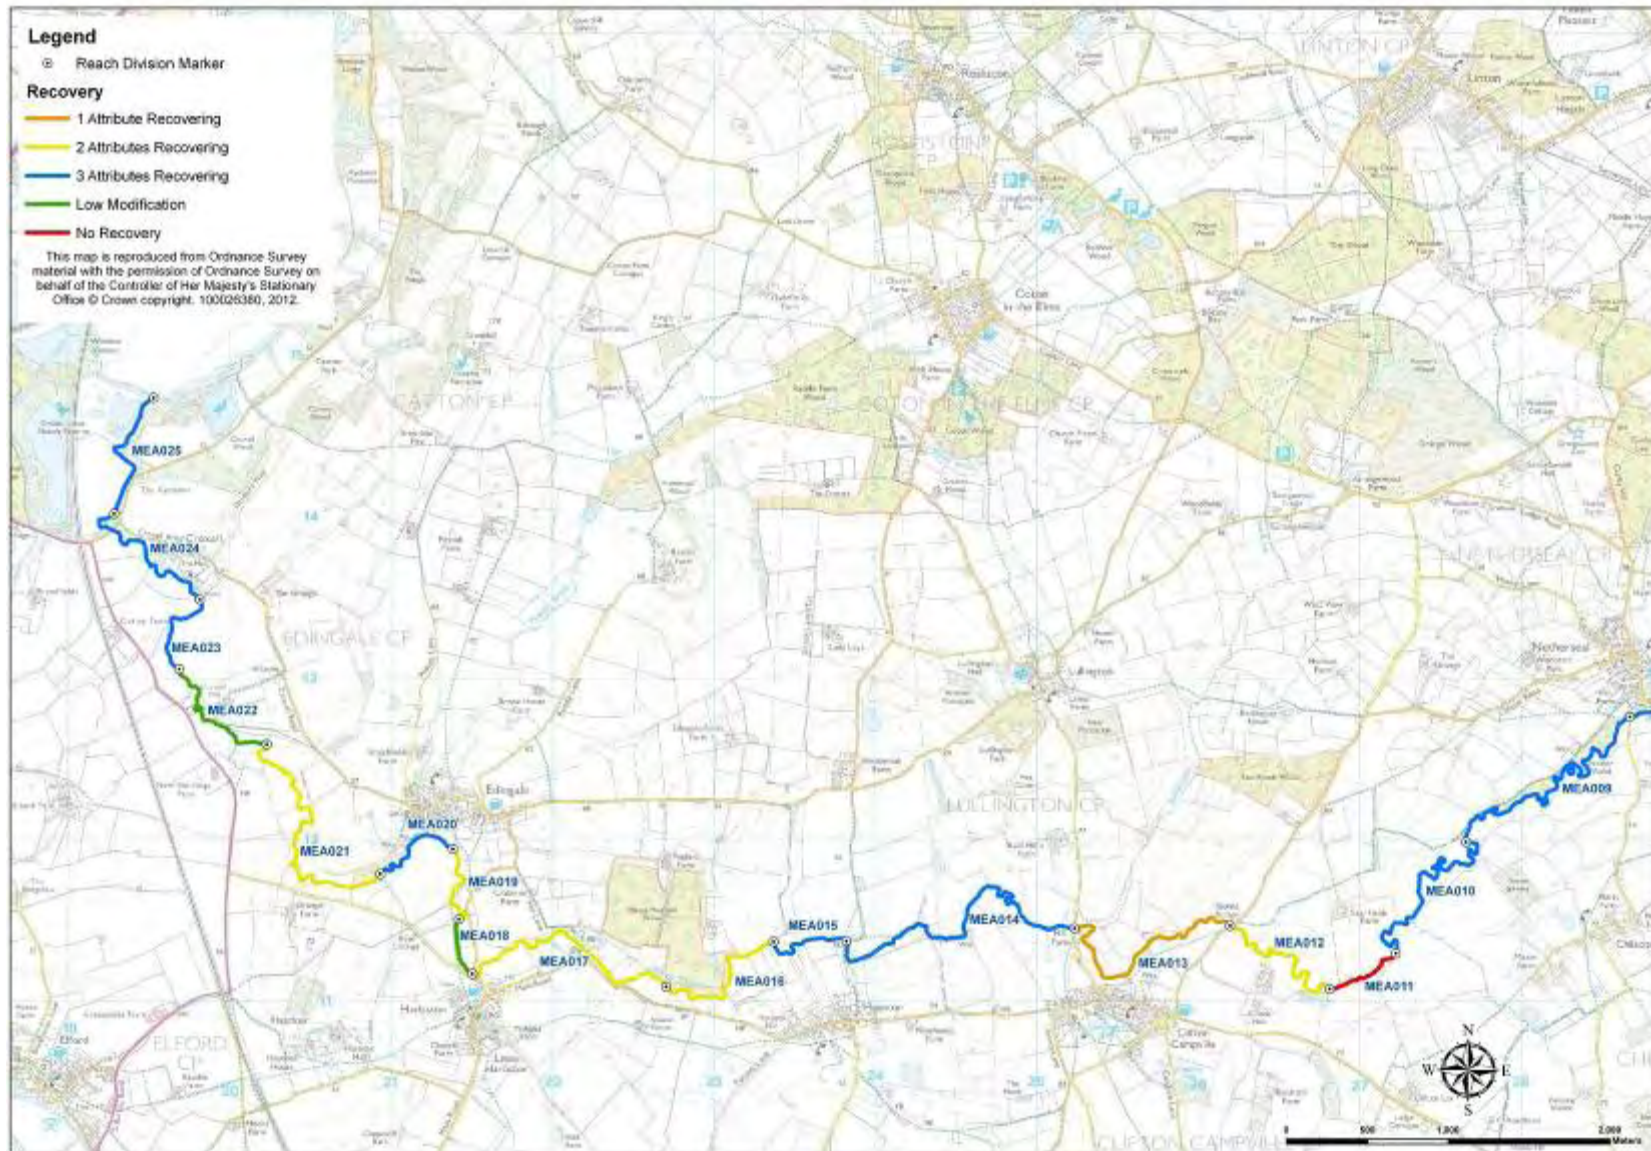
Figure: 5.10: (b) Map showing the number of different attributes that are recovering within each reach in the lower half of the SSSI/SAC; the more attributes showing recover the greater the overall degree of recovery.
