Natural England Commissioned Report NECR141

New Forest SSSI Ecohydrological Survey Overview

Annex K: Ma 5 Wet 5 Part 2

First published 06 March 2014

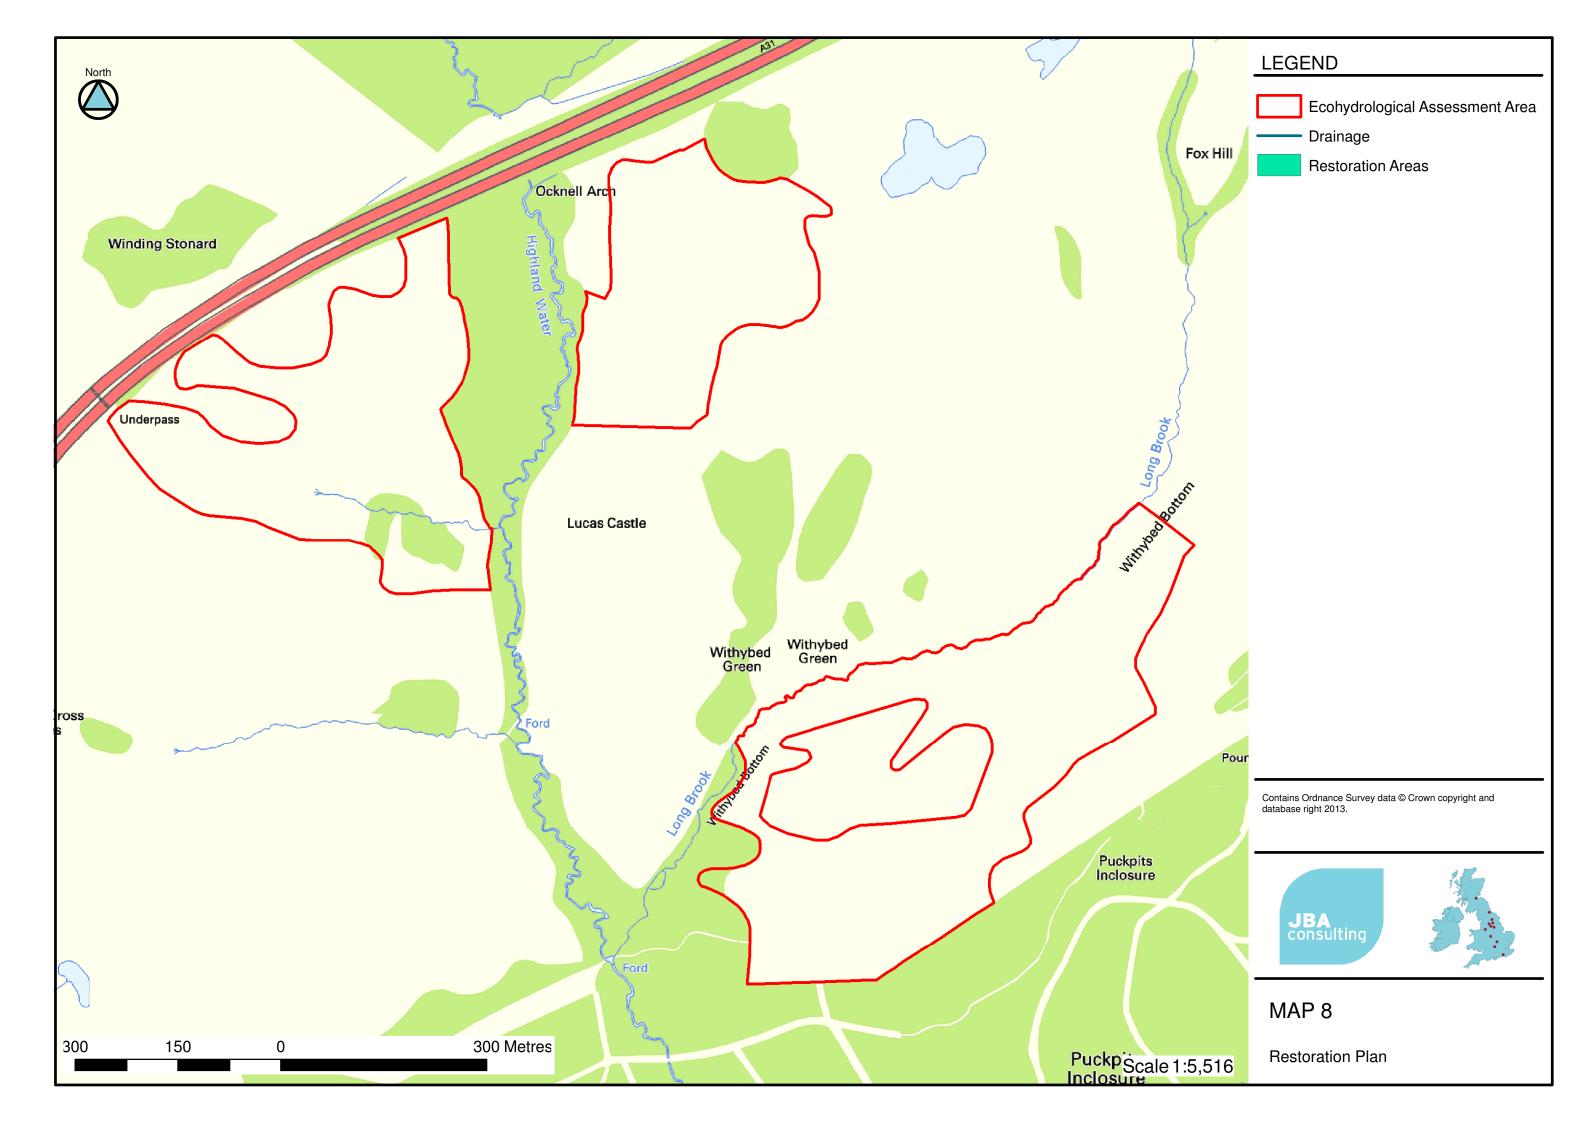
Map 8: Restoration Plan

Within Withybed Bottom, particularly in the south-western portion, Scot's Pine seedlings are beginning to encroach into wet heath areas; control of this should be undertaken to prevent further encroachment and degradation of habitats.

Restoration Area	Damage Type	Restoration Proposals	Improvement	Constraints and Issues
Withybed Bottom	Scot's Pine encroachment	Scrub clearance	Removal of Scot's Pine which could result in localised drying of wet heath and mire habitats impact on communities present	None identified
