# New Forest SSSI Geomorphological Survey Overview

Annex C: Amberwood / Alderhill Restoration Plan - SSSI Unit  
66

# 1 Amberwood / Alderhill Restoration Plan - SSSI Unit 66

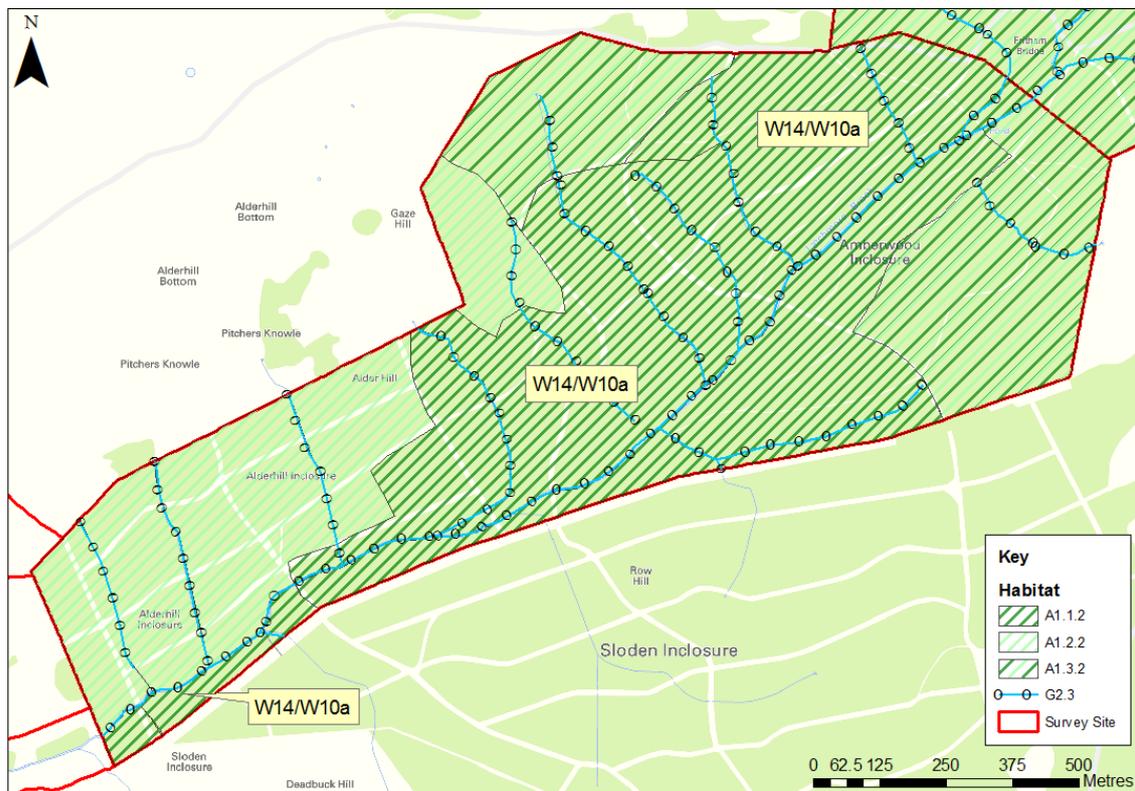
Figure 1-10: Phase 1 Habitat Map

At the time of the site walkover survey there was no aquatic vegetation present within the channel of Latchmore Brook. *Rhododendron pomticum* was present along the banks of the watercourse.

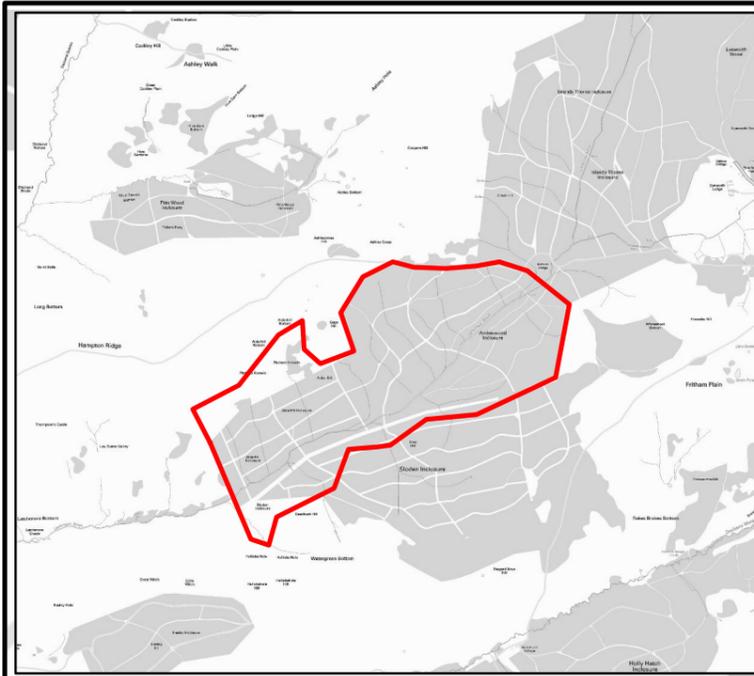
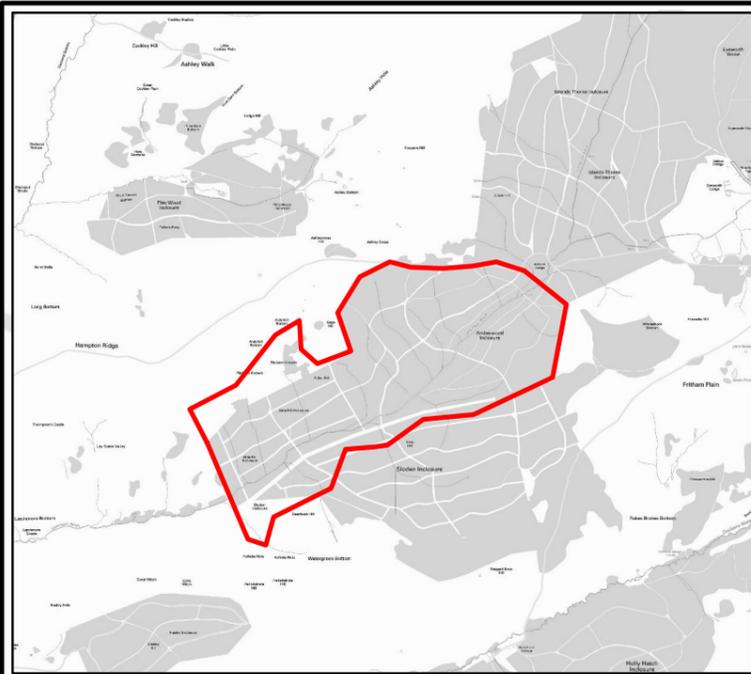
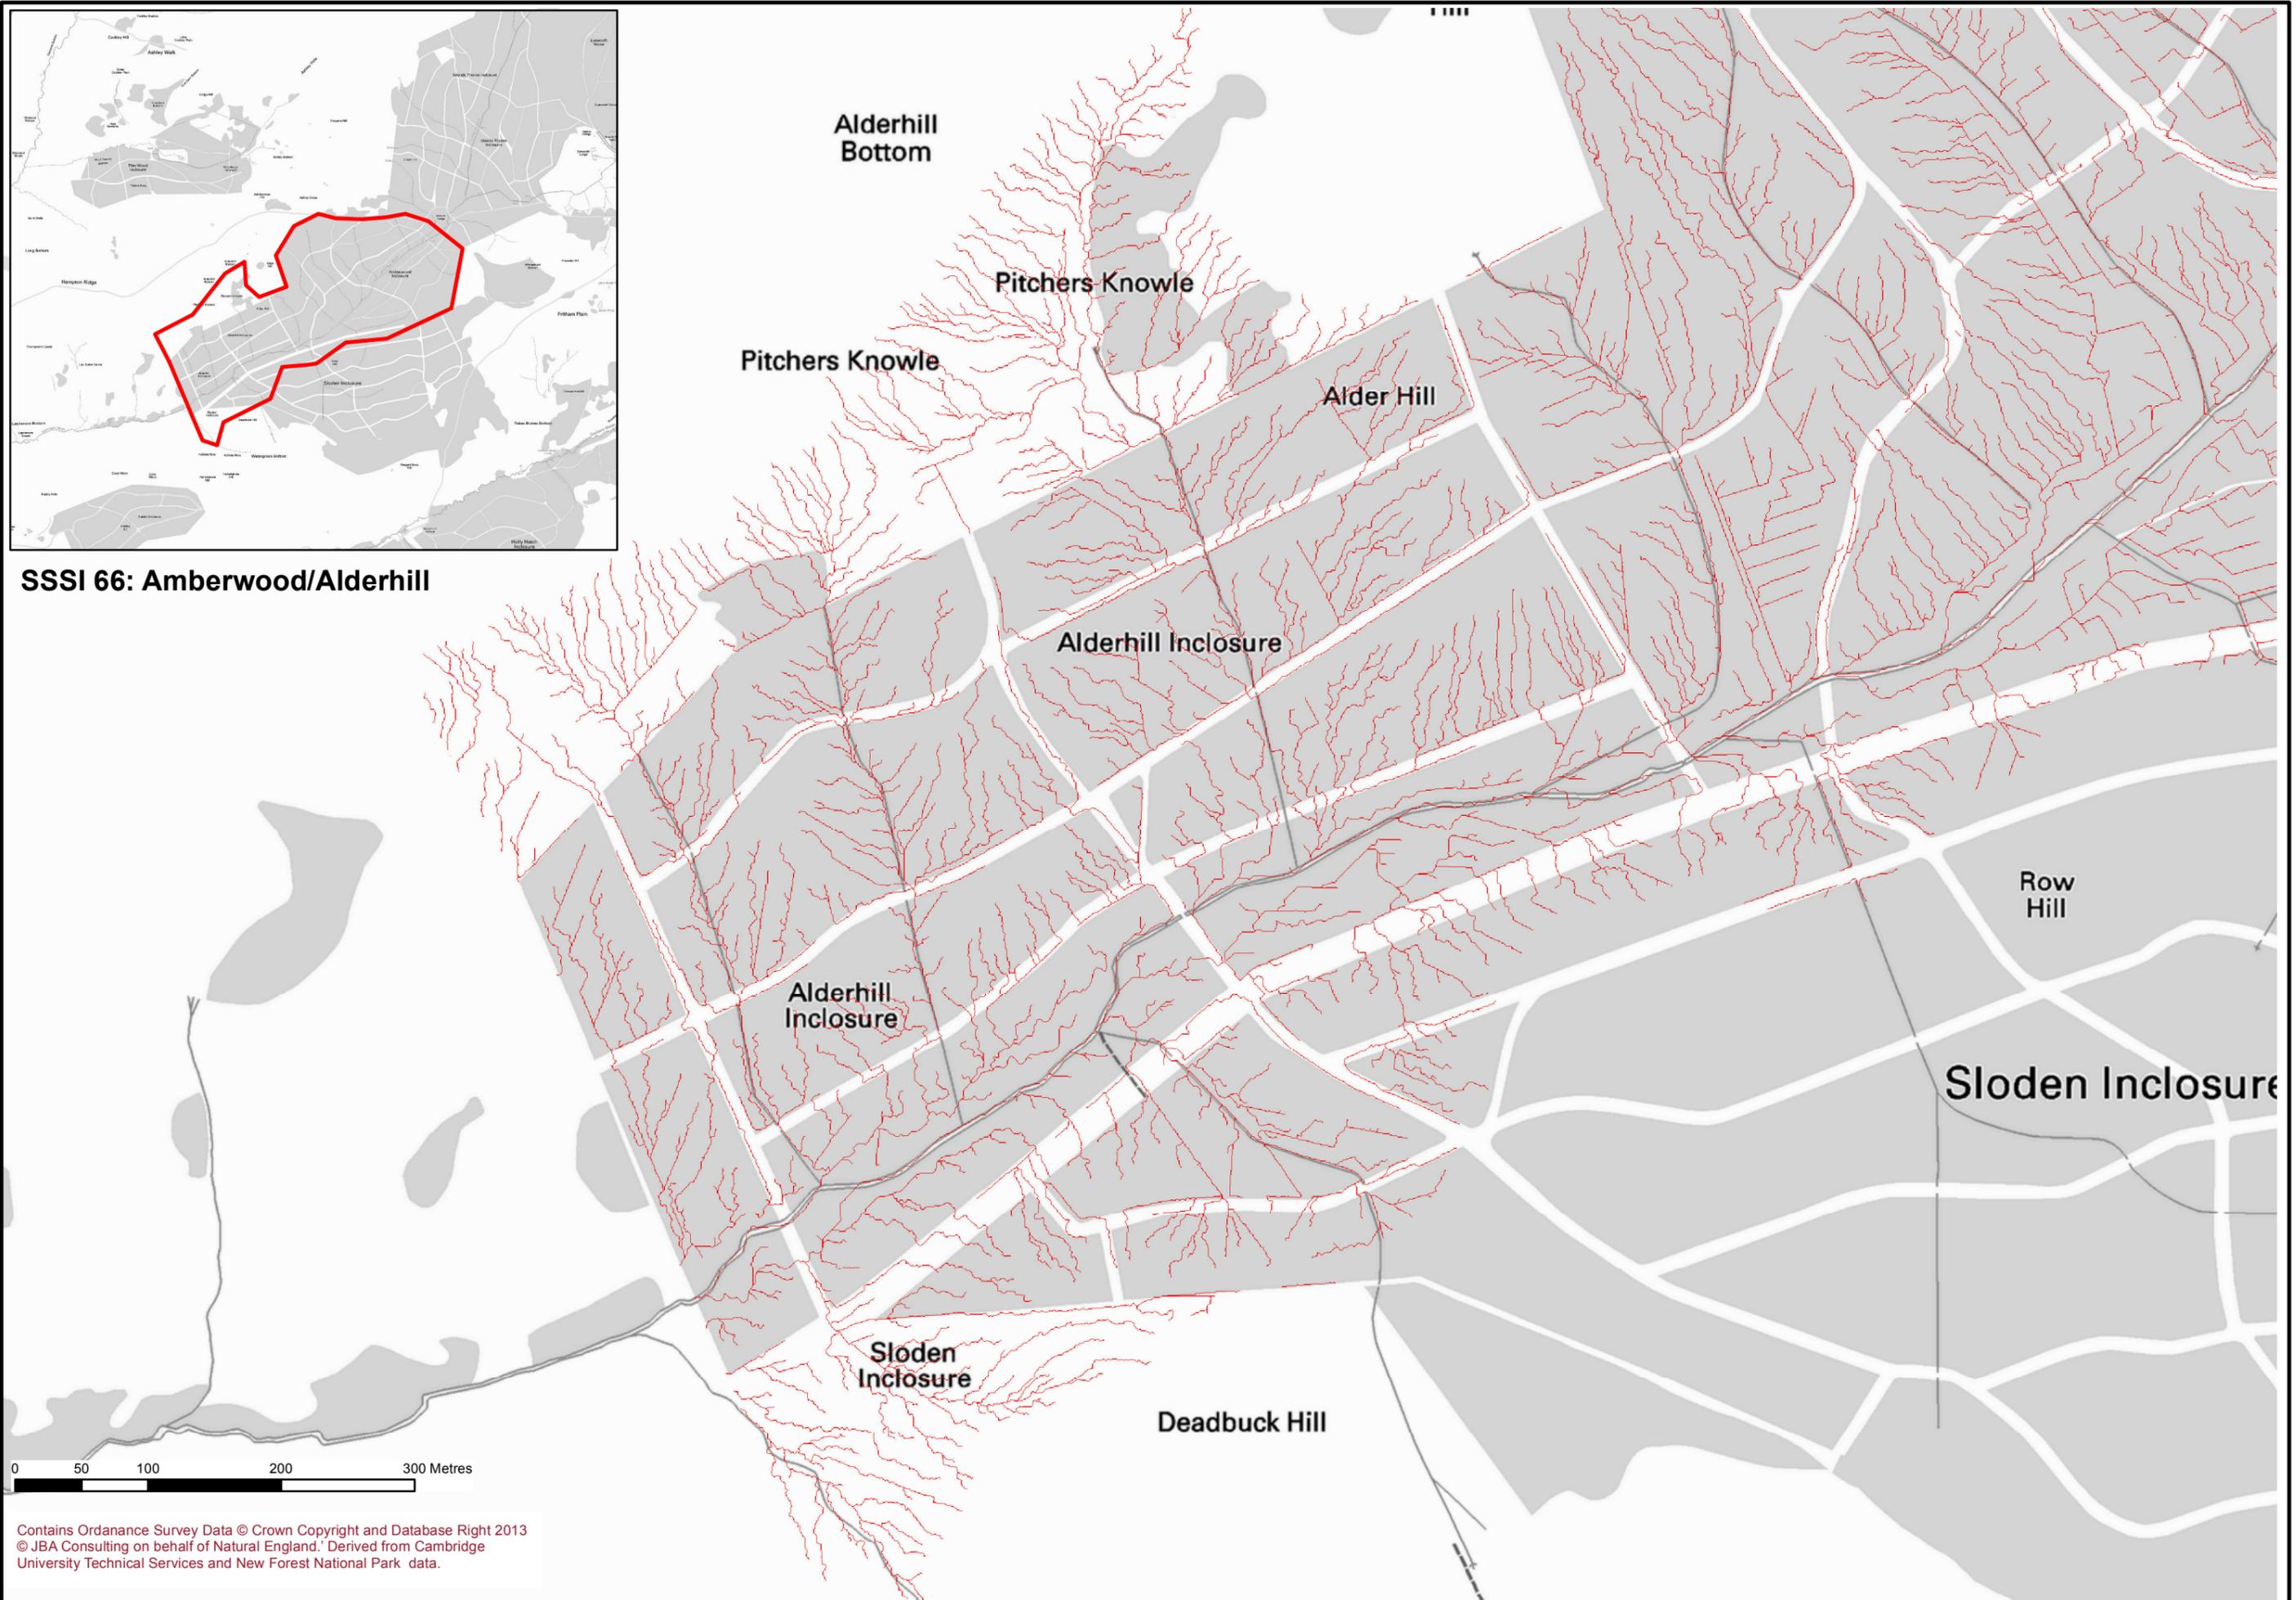
## **Appendix A - Artificial drains and flow lines - SSSI Unit 66**

The major straightened / modified drainage channels are identified in Figure 1-11. Other minor modifications could be considered for infilling and Appendix A should be used for reference.
